## **AIRCRAFT ACCIDENT REPORT**

**WHEELS-UP LANDING  
CONTINENTAL AIRLINES FLIGHT 1943  
DOUGLAS DC-9 N10556  
HOUSTON, TEXAS  
FEBRUARY 19, 1996**

**Adopted: February 11, 1997  
Notation 6804**

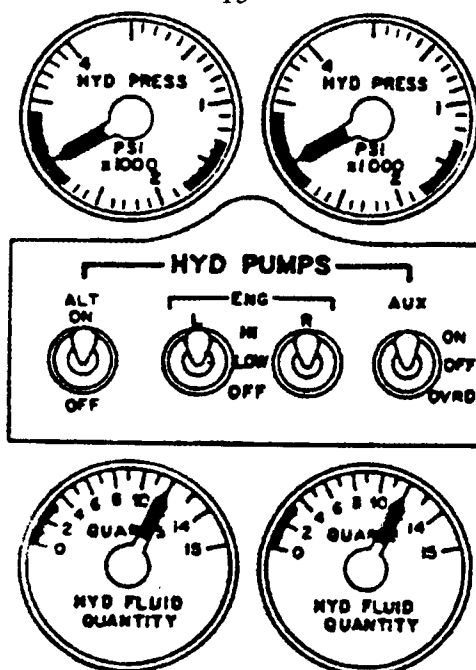
**Upper Illustration - Hydraulic switch panel in high pressure configuration.**

**Bottom Photo - Photo of accident airplane's hydraulic switch panel in low pressure configuration (see section 1.12).**
