Research
Paper
FPL-RP-570

Field Performance of Timber Bridges

16. North Siwell Road Stress-Laminated Bridge

James A. Kainz

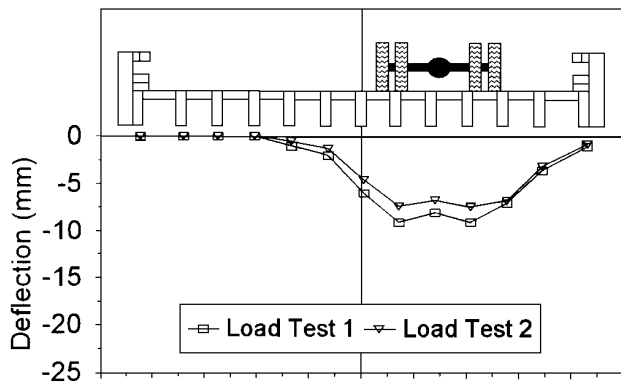
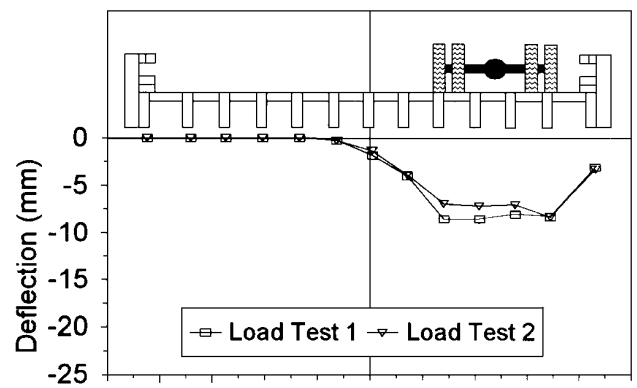
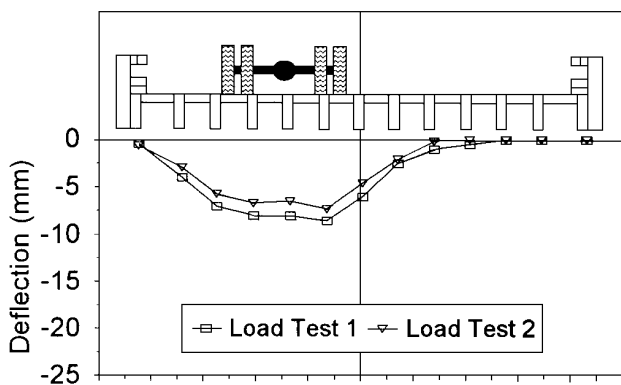
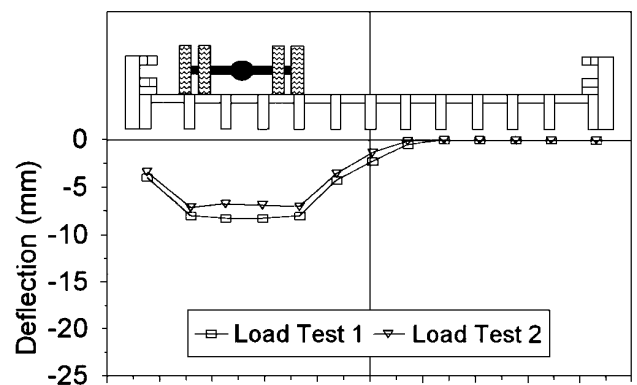
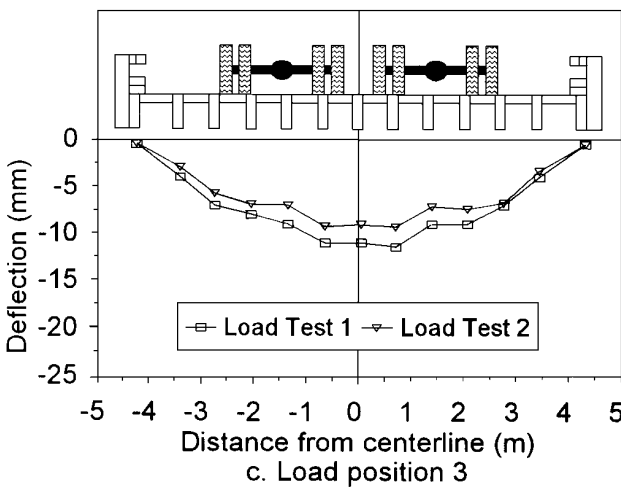
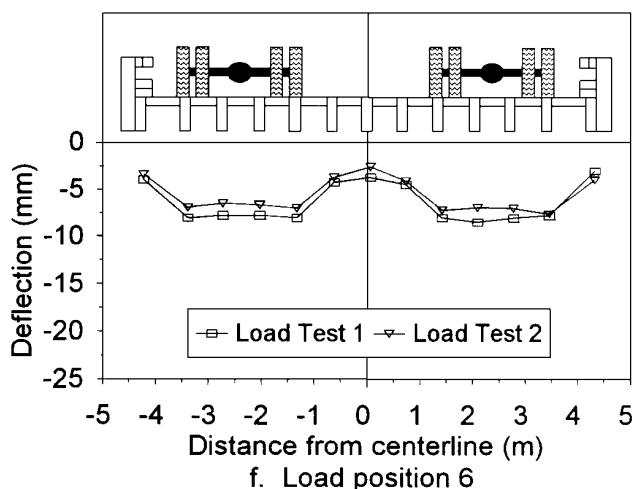
Figure 21—Comparison of load tests 1 and 2 at all load positions.

An examination of the results from load tests 1 and 2 revealed similar maximum deflection locations for each load position (Fig. 21). As shown, the second load test exhibited smaller deflections than the first load test. The decreased deflections were due to 15% lighter loading on the second load test. If the deflections for load test 2 were factored to account for the 15% load reduction, they would appear very similar to the deflections for load test 1.
