**ADIEM II END TERMINAL FOR
CONCRETE BARRIER**

Final Report

**Experimental Features
Project #96-01**

Oregon Department of Transportation

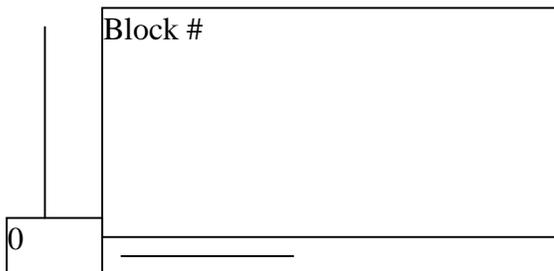
Block #	Side	Horz meters	Vert meters	Dia mm.	Shape
1	East	0.66	0.30	25.4	cir
1	West	0.12	0.12	38.1	cir
1	West	0.18	0.14	38.1	cir
2	West	0.21	0.18	38.1	cir
2	west	0.73	0.27	38.1	cir
2	west	0.73	0.46	38.1	cir
3	East	0.27	0.20	50.8	cir
3	East	0.44	0.17	38.1	cir
3	East	0.53	0.30	63.5	cir
3	west	0.11	0.30	50.8	cir
4	east	0.23	0.15	101.6	cir
4	east	0.40	0.20	50.8	cir
7	east	0.69	0.32	19.05	cir
7	West	0.12	0.12	1.5x.61	rec
7	west	0.46	0.18	2.1x1.5	rec
8	East	0.61	0.30	25.4	cir
8	West	0.79	0.26	50.8	cir
9	east	0.50	0.26	1.8x.61	rec
10	East	0.12	0.18	76.2	cir
10	East	0.40	0.23	101.6	cir
10	east	0.56	0.17	50.8	cir
10	West	0.38	0.23	50.8	cir
10	west	0.53	0.17	50.8	Cir

The origin was taken as the south edge and base of the block
