# SEISMIC PROTECTION DEVICES STUDY – MARQUAM BRIDGE

## SEISMIC PROTECTION DEVICES STUDY FOR THE W. MARQUAM INTERCHANGE – MARQUAM BRIDGE SECTION

**Experimental Features Project 93-03**

April 2000

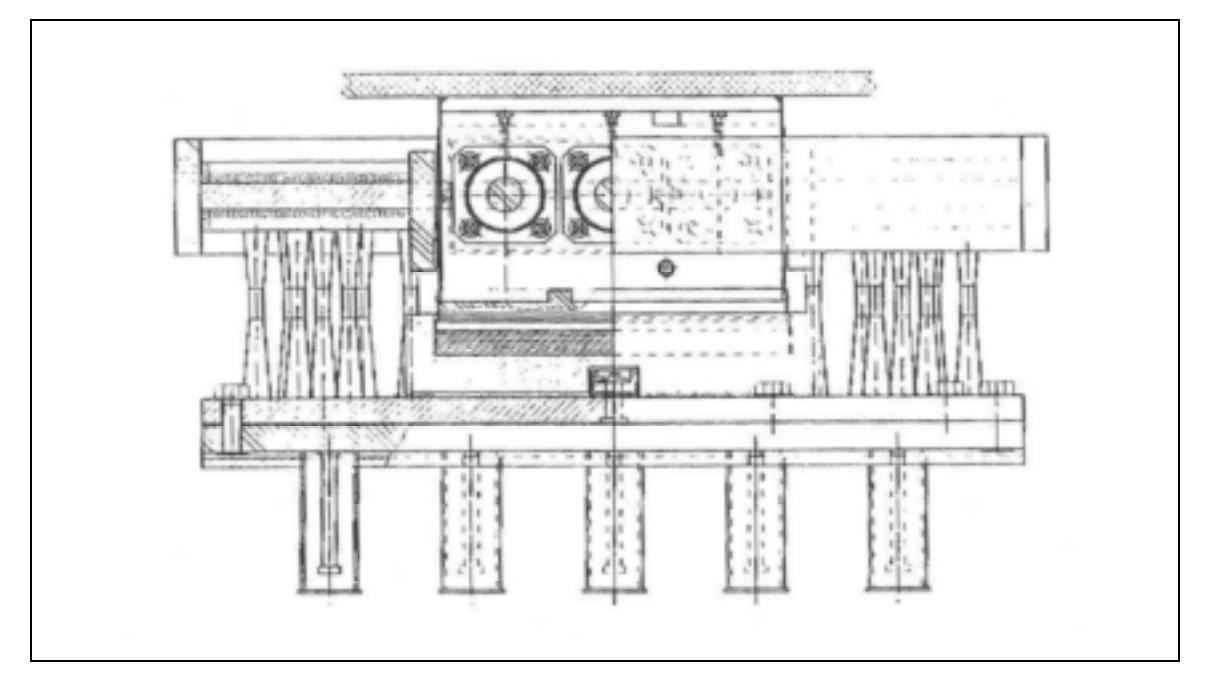
Figure 2.1: Bearing Restraint Devices; Piers #2 and #5 (FIP Device Number: VEP 1400/280-ST)

Shortly after the installation of the 1400/280-ST devices at Piers #2 and #5, Teflon shavings were found in the guide bar area in each of the bearings. On October 18, 1995, Dr. Rene Medeot of FIP Industries, Inc. met with ODOT representatives to jointly inspect the bearings and review the problem. Dr. Medeot attributed the shavings to Teflon sliding element extrusions into the guide bar region (*Starkey 1997*).

Dr. Medeot theorized that the Teflon was able to extrude because the rivets holding the brass restraining bars had broken. This was caused by the plastic flow of Teflon under the brass retaining strips, which produced unanticipated tension on the rivets. According to Dr. Medeot, the driving force for this action was the sustained dead loading on the bearing. He believed the rivets failed because the restrainer bars were designed for a sustained dead load of 4,005 kN (900 kips) which was about 20% less than the apparent dead load present (4,893 kN (1,100 kips)). The higher load produced Teflon plastic flow between the restrainer bar and its attachment, which in turn caused the rivet tensile force and the rivet shear force from containment.

Recently, on January 31 2000, ODOT's contract inspector and Region 1 bridge inspector visually inspected the bearings on Pier #2. They found some Teflon shavings around each of the bearings, but it appears that the Teflon extrusion process has subsided. The amount of Teflon found indicates the problem has diminished considerably and no further action is required at this time. However, further monitoring is necessary to ensure there are no long-term affects.

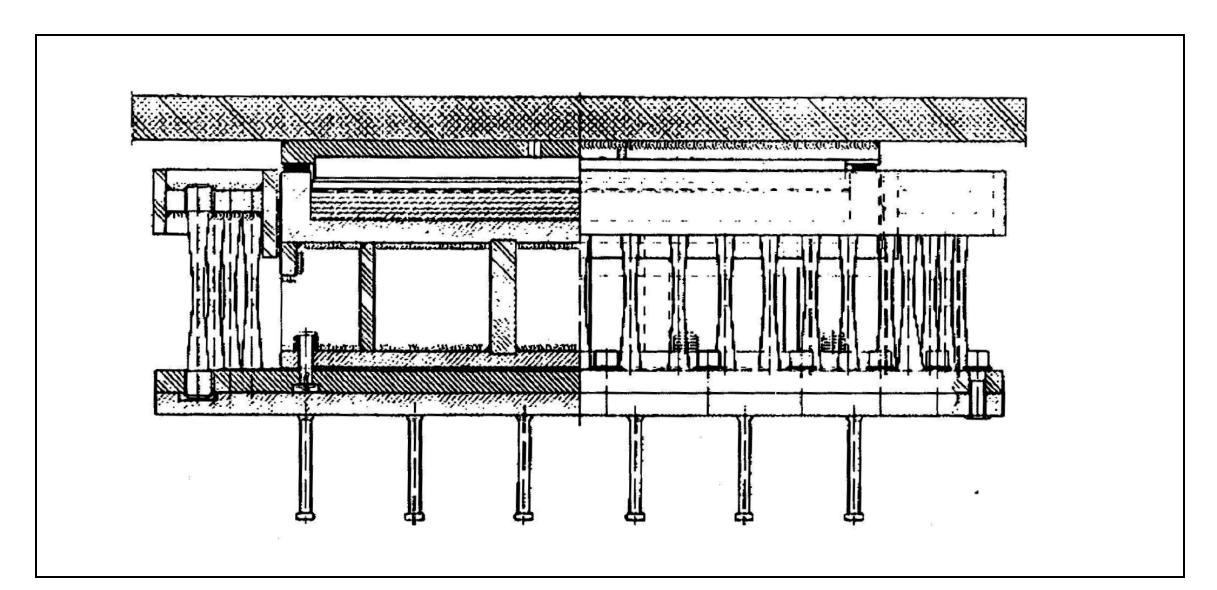
Figure 2.2: Bearing Restraint Devices; Piers #3 and #4 (FIP Device Number: VEP 5200)

There have been no problems reported with any of the bearing/restraint devices on Piers # 3 and #4. Additionally, in the most recent bridge inspection performed by ODOT's Region 1 bridge inspector in July 1998, no problems were noted associated with any of the seismic protection devices.
