COST-EFFECTIVENESS OF GEOTEXTILES

Review of Performance in Alaskan Roads

Final Report

**September 1989
Revised February 1991**

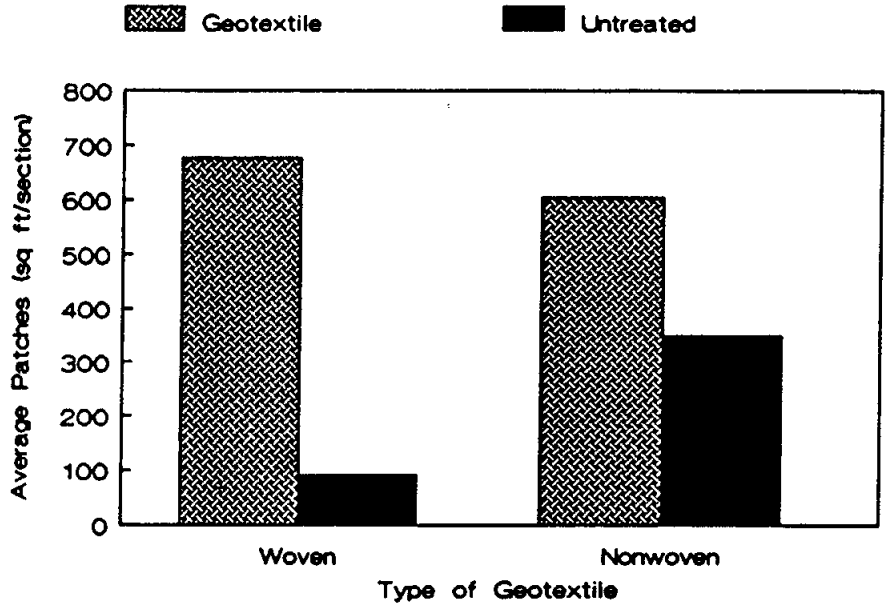
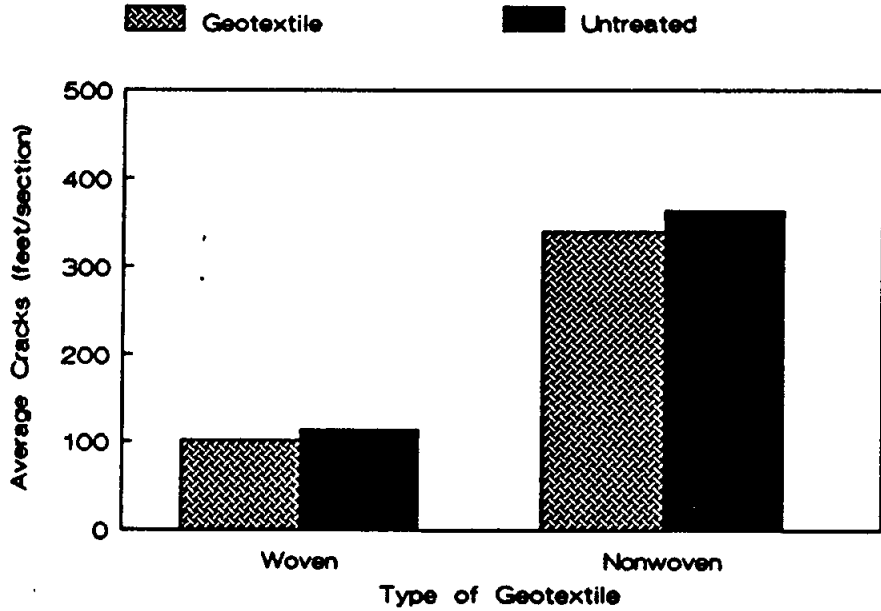
Figure 2. Crack and Patch Mapping Results Sorted by Geotextile Type

The type of fabric used had no discernible effect on cracking; in both cases the treated sections had slightly less cracking than adjacent untreated areas. Nonwoven sections were patched 73% more than their adjacent untreated areas, while this difference was more than 700% in the sections with woven geotextiles (see Figure 2). This seems to indicate better performance by the nonwoven materials, although it is not clear why this would be so. The data are perhaps an illustration of the inadequacy of the untreated areas as controls for comparative purposes. Alternatively, it may reflect the specification of woven fabrics for areas having a history of more severe settlement.

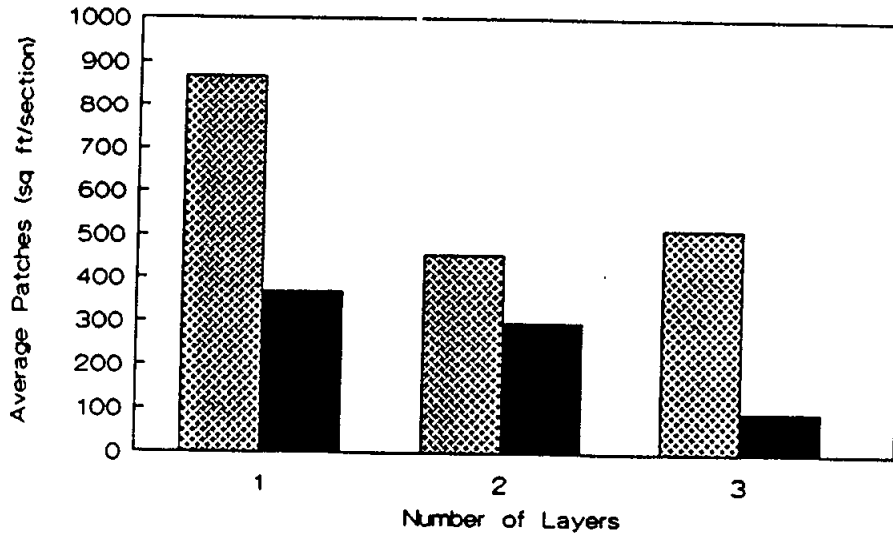
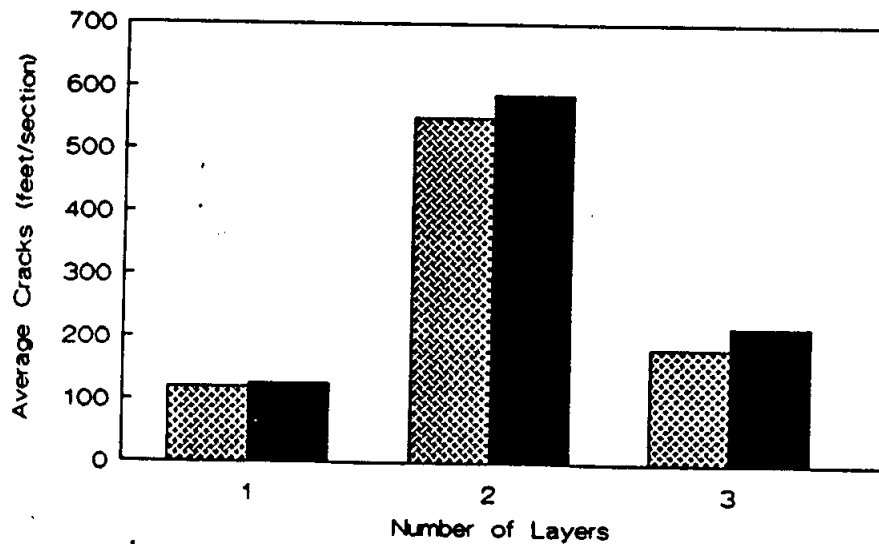
Figure 3. Crack and Patch Mapping Results Sorted by Number of Layers

The average amount of cracking in two layer sections is about four times as great as in one layer sections, but the same is true of the untreated areas adjacent to the sections (see Figure 3). In both cases, cracking is slightly less inside sections than in adjacent untreated areas. This is largely due to the greater patching in the treated areas, which covered up some of the cracks.

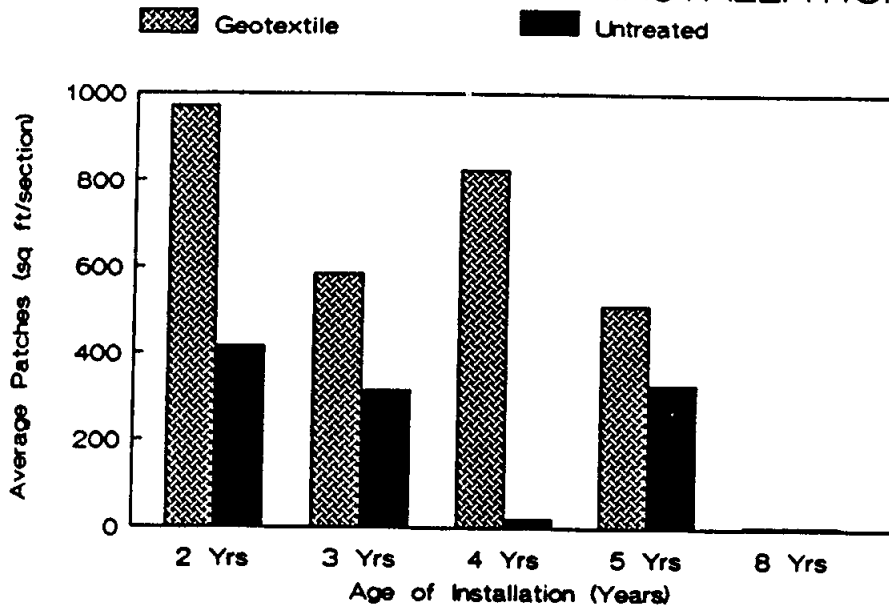
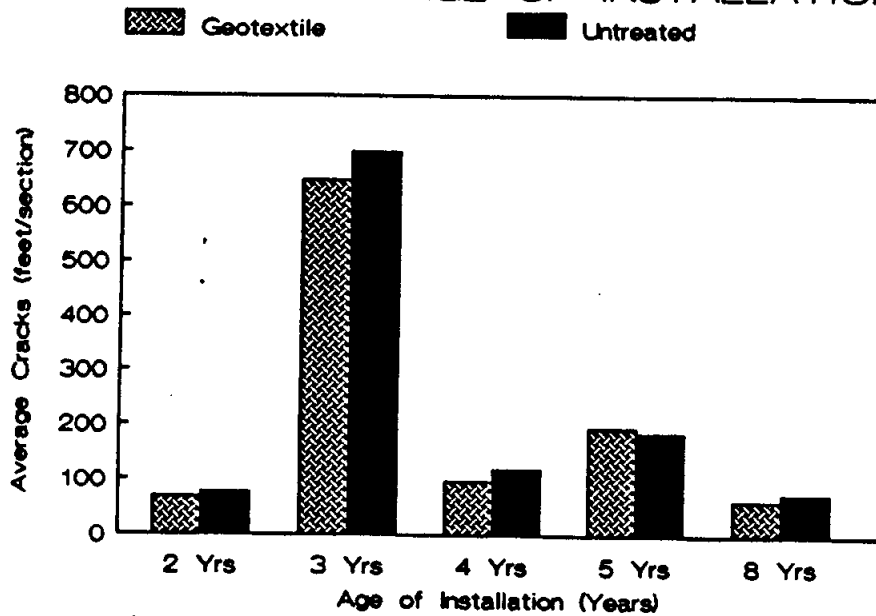
Figure 4. Crack and Patch Mapping Results Sorted by Age of Installation

The age of the geotextile sections has no major discernible effect on the cracking and patching amounts (see Figure 4). The amount of cracks inside and outside of the sections was found to be roughly the same whatever their age. The amount of patching inside the sections seems to decrease, if anything, with age. This could indicate that as geotextiles were used more often in the Northern Region they also were used less effectively (i.e. installations with higher present value were constructed first). This, however, may also be merely coincidence.

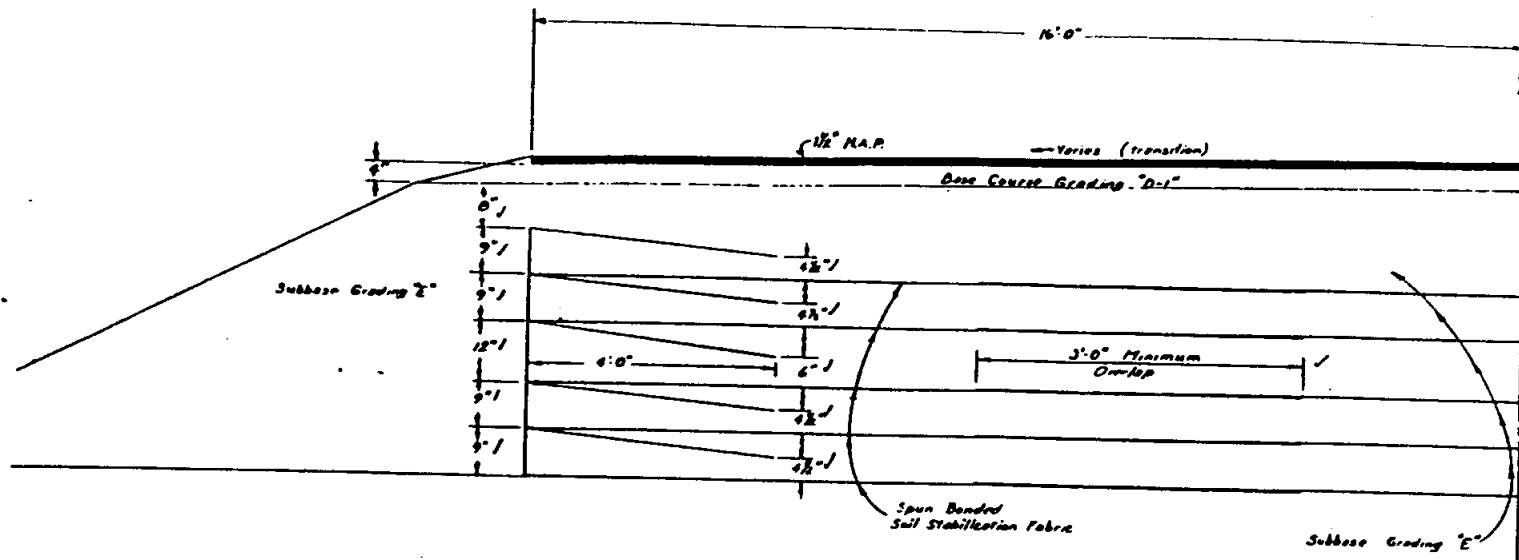
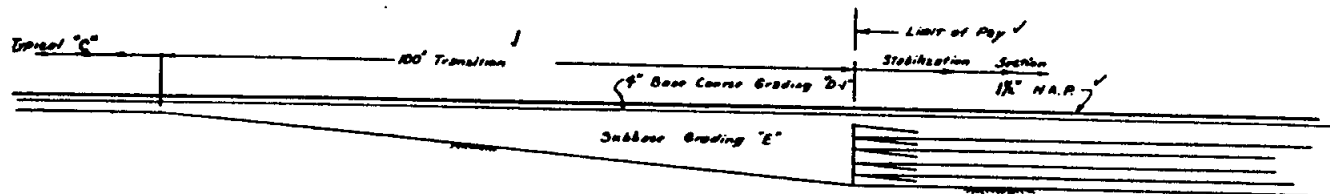
SPECIAL SOIL STABILIZATION SECTION

In June 1987, an excavation was made with a small backhoe in the center of the road to expose this end of the geotextile installation (see Photos 8 and 9). Although the as-built plans indicate a vertical geotextile wall at the end of the section (which would have required temporary form work to build), what was found was a stepped or terraced configuration of layers. The planned wrapping or folding over of the ends of the geotextile was missing on two of the layers. The thicknesses of the gravel between geotextile layers also did not conform to the as-built plans, although this may be a result of construction difficulties at the ends. Farther into the section the layers may be spaced as indicated in the plans.

The exposed geotextile was in good condition. It was not torn or noticeably deformed. The geotextile was punctured in some places by stones in the fill, however. The fill material was clean, rounded alluvial sand and gravel, with few or no sharp edges or fractured faces. There were no visible cracks in the fill. The geotextile, then, did not appear to be "bridging" over voids in the fill.

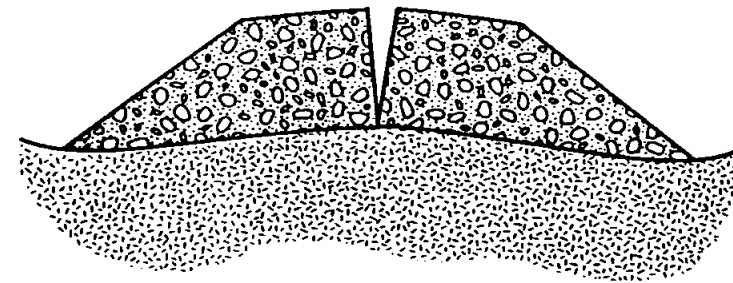
Figure 6b: Unreinforced embankment after thaw settlement

Although the installation seems successful, the reason for this success is not clear. Longitudinal cracks of the sort seen at this site occur when settlement of subgrades is greater in the road shoulder areas than beneath the road centerline. This is typical of permafrost thaw settlement. An idealized view of this situation is shown in Figure 6b.

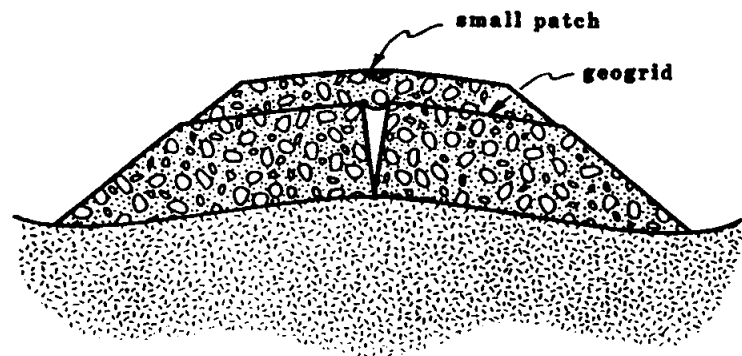
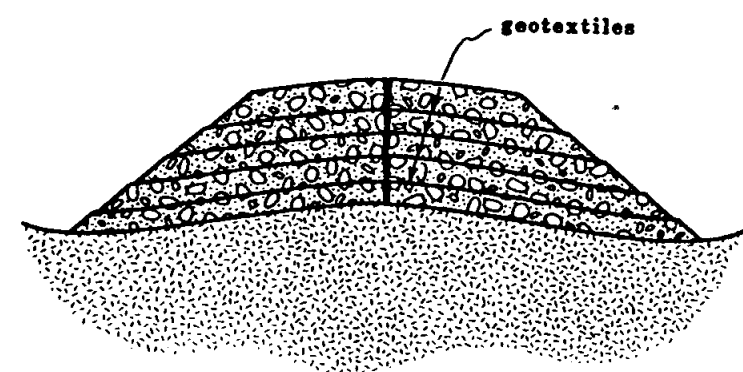
It is not realistic to expect geotextiles to prevent a road from settling along with the subgrade in such a situation. To do so would require cantilevering the sides of the embankment out over the settled shoulder areas. Geotextiles, however, may be used to modify the effects of such settlement on the road surface.

Figure 6c: Geogrid bridging longitudinal crack

Figure 6d: Geotextile-induced shear failures minimizing crack width
