**A FIELD STUDY OF PCC
JOINT MISALIGNMENT
NEAR FERGUS FALLS, MINNESOTA**

Final Report

Thomas R. Burnham, P.E.

May 1999

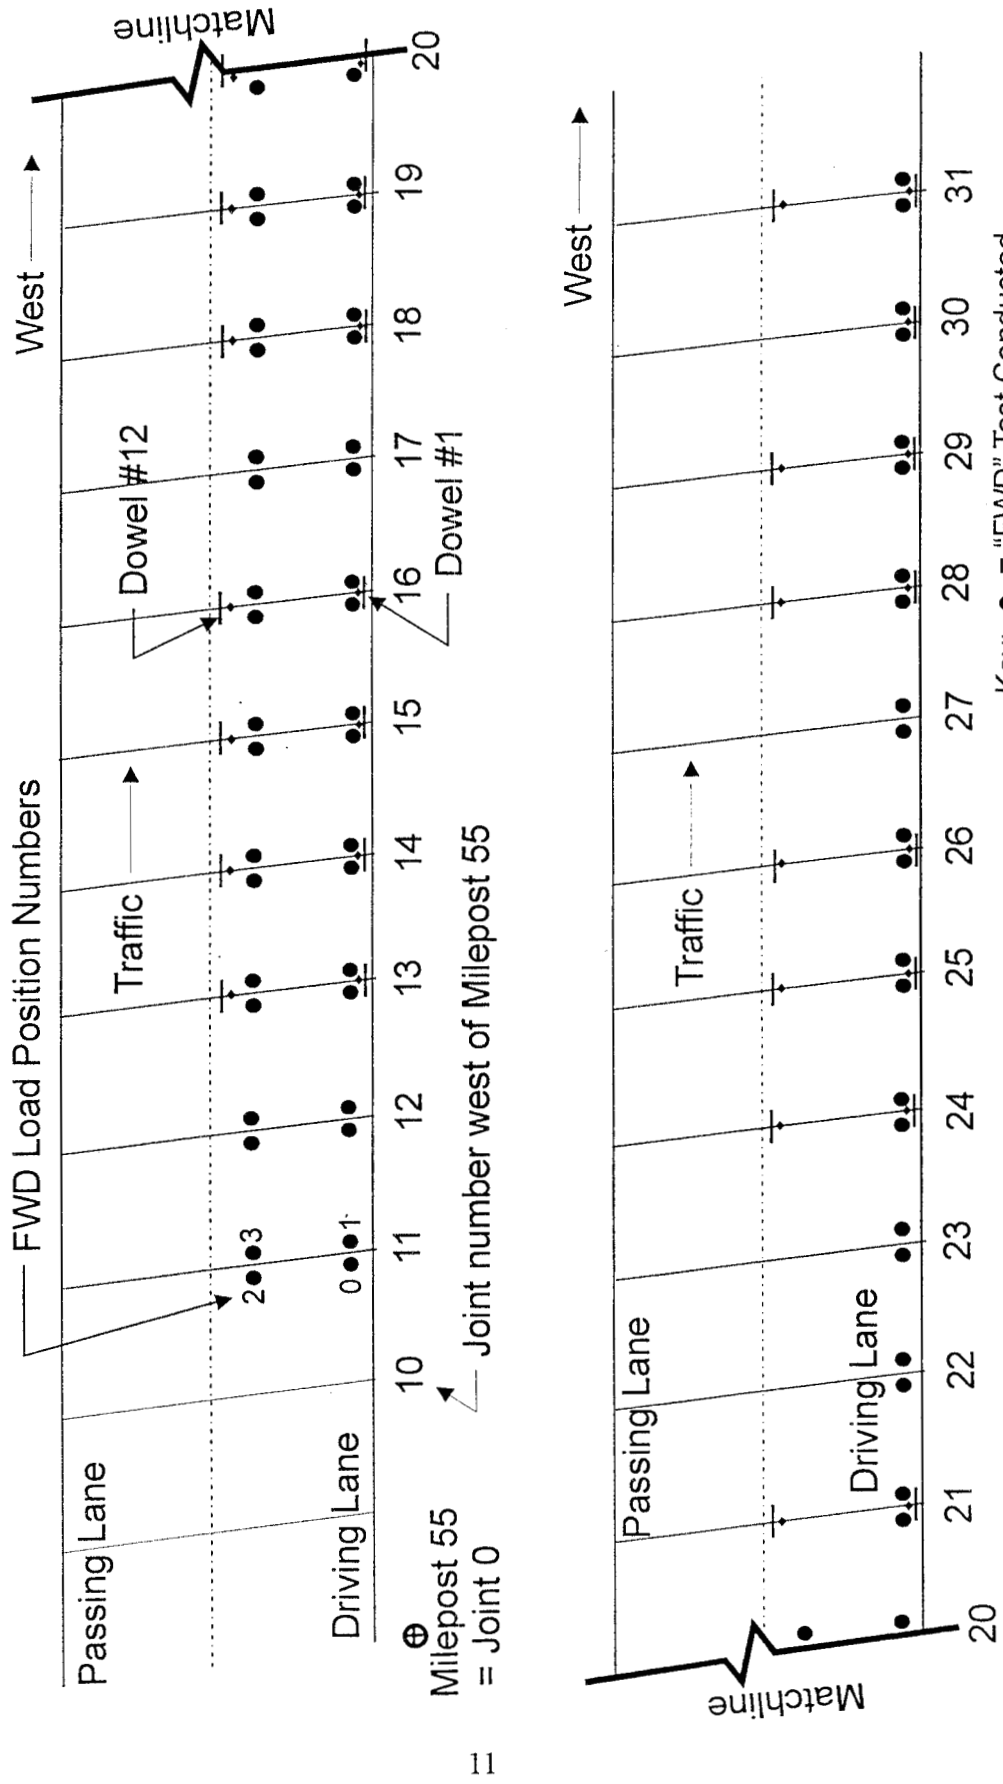
Figure 1. Test Site

Dowel bar alignment measurements were taken along fifteen selected driving lane transverse joints in the area under investigation. See Figure 1. A Proceq PROFOMETER 3 Rebar Locator was used to determine the lateral and longitudinal location of four to five of the twelve dowel bars in each joint. Dowel bars 1,2,10,11, and 12 were located; where dowel number 1 designates the dowel bar closest to the driving lane shoulder. The measurements are believed to be within ± 13 mm (± 0.5 in) of the actual location.

Faulting (vertical stepping) measurements were taken at two locations along each selected joint. See Figure 1 for locations. A Georgia type faultmeter was used to obtain the measurements. See Table 2 for results. Several of the joints have faulting in excess of 6 mm (0.25 in), with the highest reading measured at 12.8 mm (0.50 in).

Load transfer efficiency (LTE) results from each of the load positions (see Figure 1) is presented in Table 3. LTE values were calculated using the method outlined in section 3.5.4 of the *AASHTO Guide for Design of Pavement Structures (1993)*[1].

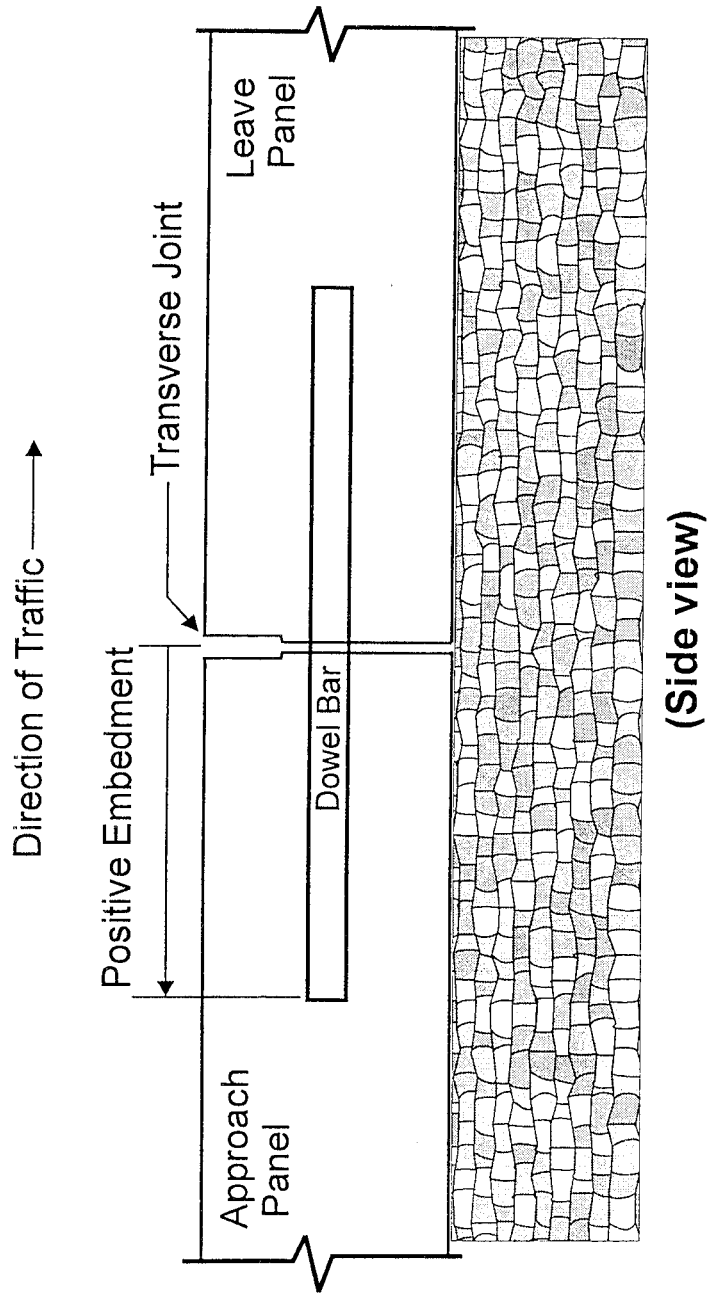
Figure 2. Embedment length notation

Based on the longitudinal measurements, dowel bar embedment lengths were determined. Table 1 clearly shows the large variation in embedment lengths found. Positive embedment values correlate to lengths on the approach panel side (see Figure 2). Figure 3 shows embedment lengths graphically. Note that embedment lengths greater than 356 mm (14 in) or less than zero are shown as zero on this graph.

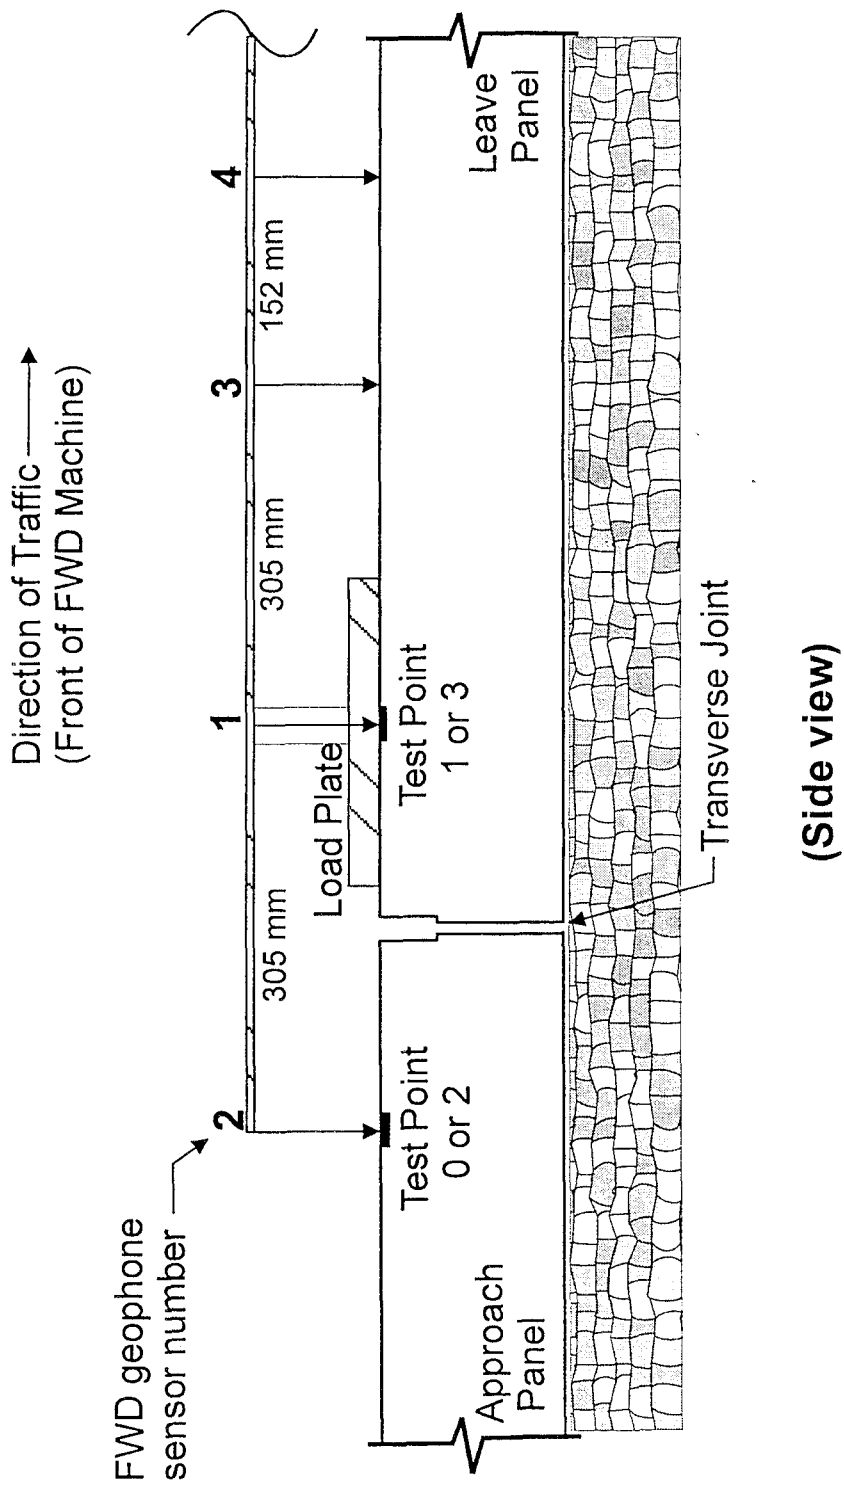
Figure 4. FWD Geophone Arrangement Scheme

The current load transfer efficiency of both the selected joints and several other joints nearby the area of study, was determined. A Dynatest Model 8000 Falling Weight Deflectometer (FWD) was used with the geophone sensors arranged as shown in Figure 4. Loading consisted of 3 drops at each load level of 26.7 kN, 40 kN, and 66.7 kN (6000, 9000, and 15000 lbs). Testing occurred from 11 AM to 2 PM, with pavement surface temperatures ranging from 2.8 to 10 °C (37 to 50 °F).
