RAILROAD ACCIDENT REPORT

COLLISION OF AMTRAK TRAIN 304-26
WITH A HIGHWAY VEHICLE AT A
HIGHWAY-RAIL GRADE CROSSING
MCLEAN, ILLINOIS
SEPTEMBER 26, 1999

**NTSB/RAR-01/03
PB2001-916303
Notation 7385
Adopted September 18, 2001**

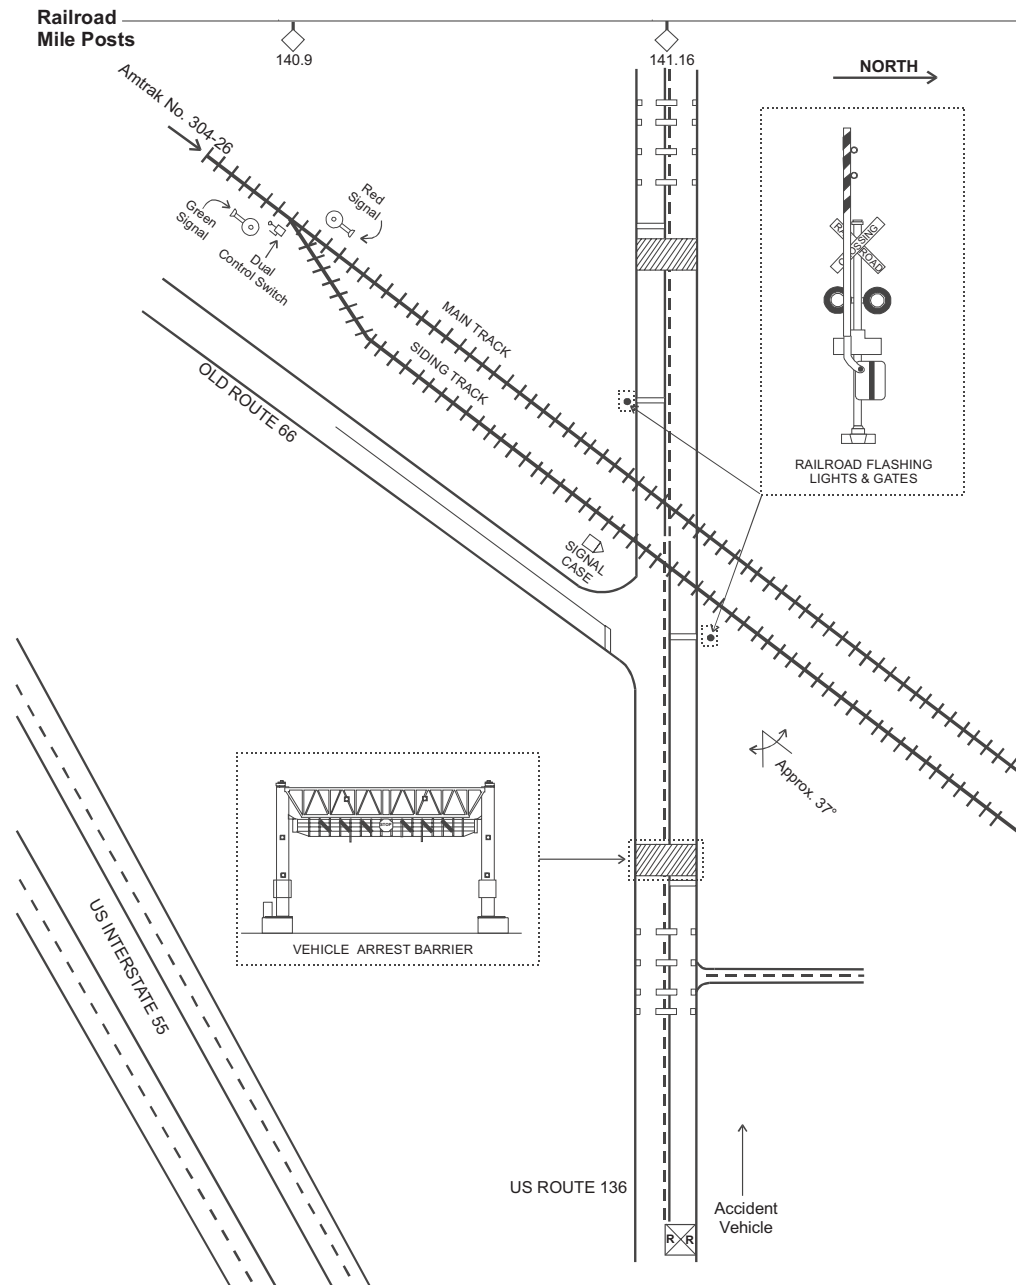
Figure 3. Layout of the accident area.

See figure 3 for a diagram representing the accident location.

The automobile separated into two parts as a result of the impact. The front portion of the automobile became lodged on the front of the locomotive, while the rear portion came to rest about 203 feet north of the crossing and 7 feet east of the railroad tracks. Both automobile occupants were ejected from the vehicle. According to State police reports, windshield obstructions and radio volume settings could not be determined due to the induced damages to the automobile. No brake light lamp filaments from the automobile were available for testing due to collision damage.

U.S. Route 136 Grade Crossing Signage. Nearest the crossing, a stop line extending across the approach lane is about 36 feet from the nearest rail. Near the vehicle arresting barrier apparatus, a 20-foot zone of diagonal stripes, beginning at about 171 feet from the nearest rail, indicates an area in which vehicles should not stop. Immediately to the east of the striped zone is a second stop line extending across the approach lane. About 225 feet to the east of the nearest rail is a set of three short lateral stripes, one across the center line and one at each road edge. This three-stripe set is repeated at 275, 325, and 375 feet from the nearest rail. The grade crossing pavement marking, consisting of a large “X” and the letters “RR,” extends from about 512.6 to 564.6 feet east of the nearest rail. The solid yellow stripe demarking a no-passing zone extends from the crossing itself out to a point about 543.6 feet east of the crossing. (Refer to figure 3 for layout of crossing.)
