Whitetopping Construction And Early Performance In Illinois

**CONSTRUCTION REPORT
PHYSICAL RESEARCH REPORT NO. 144
JUNE 2002**

Illinois Department of Transportation

11. Contract or Grant No. IHR – R07	
12. Sponsoring Agency Name and Address Illinois Department of Transportation Bureau of Materials and Physical Research 126 East Ash Street Springfield, Illinois 62704-4766		13. Type of Report and Period Covered Construction Report January 1998 – December 2001

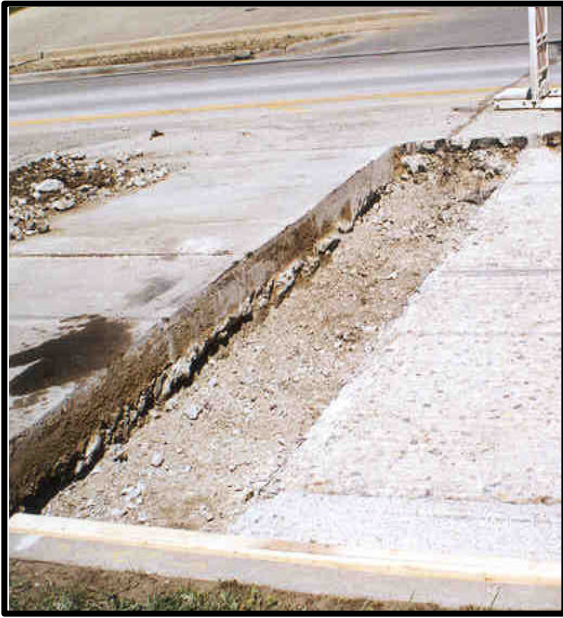
Figure 3. Full-Depth Patch

Pavement preparation began by milling 3.5 inches of the existing bituminous surface. This was followed by brooming and high pressure water cleaning of the milled surface. One full-depth and one partial-depth patch were also placed in the existing pavement before the inlay. The full-depth patch (Figure 3) was located at the west end, while the partial-depth patch (Figure 4) was located near the east end of the project.

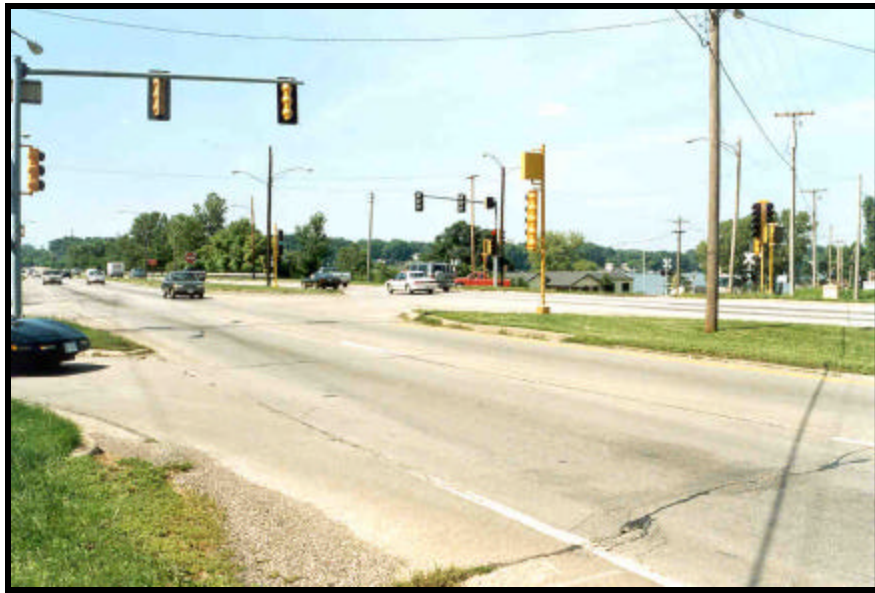
Figure 7. U.S. Highway 36 And Country Club Road (Looking West)

The existing bituminous pavement was severely rutted in both directions, with the most severe rutting in the westbound direction. The existing overlay also displayed a frequent amount of reflective transverse cracking from the underlying concrete pavement. In addition, there was a small amount of longitudinal cracking and block cracking noted. Figures 7 and 8 are photographs of the typical distresses noted before rehabilitation of the intersection. The existing surface was constructed in 1988, and consisted of a 1.25-inch bituminous concrete resurfacing of a previous bituminous concrete surface.

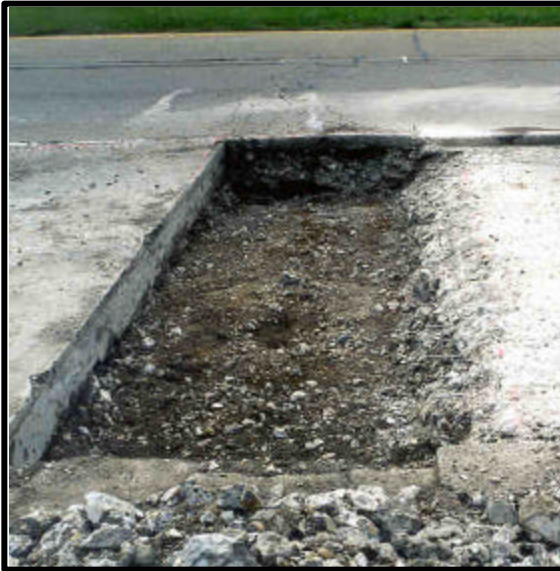
Figure 9. Full-Depth Patch

The eastbound and westbound driving lanes were milled down to bare concrete at the start of stage 1. The depth of milling was 3.5 inches in the eastbound direction, and 2.5 inches in the westbound direction due to a different bituminous concrete overlay thickness. The milling was followed by brooming and high pressure water cleaning of the milled surface. Four full-depth and three partial-depth patches were placed in the eastbound driving lane. Three full-depth and seven partial-depth patches were placed in the westbound driving lane. These patches were placed at areas of severe transverse cracking and durability cracking of the underlying concrete pavement. The boundaries for these patches were determined by visual identification of the distressed area. Material was removed for partial-depth patches with the milling head, while the full-depth patches were jackhammered. Figures 9 and 10 are typical examples of a full-depth and partial-depth patch.

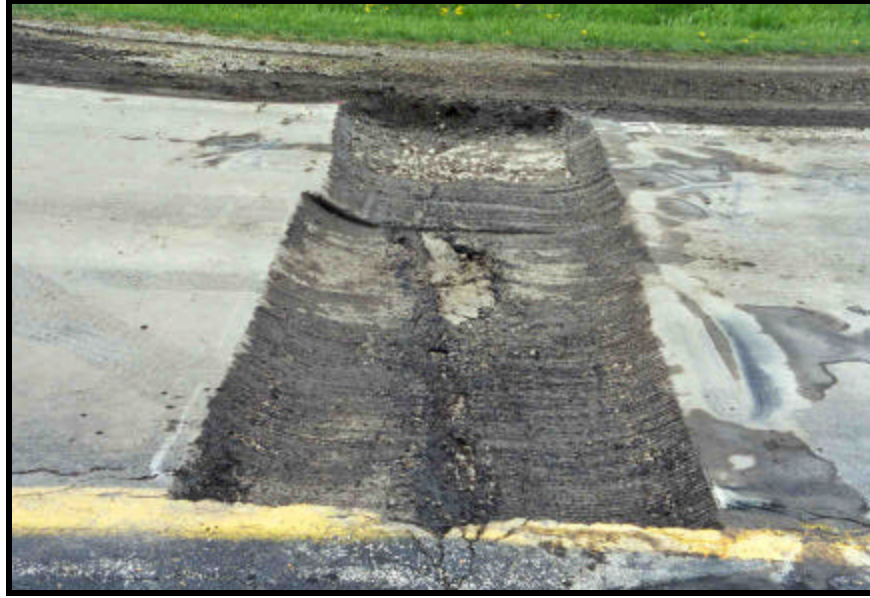
Figure 19. Milled Out Area For Bituminous Patch

Prior to the overlay placement, 18 partial-depth patches were placed to repair these high severity cracks. The area surrounding the crack was milled out, as shown in Figure 19, and a bituminous patch was placed. Areas of the existing bituminous overlay were also milled out at each end of the project in order to create a butt joint with the existing pavement. The entire length of the project was not milled. The concrete overlay was placed directly on the existing bituminous overlay with no added surface texture given to the bituminous overlay. However, the existing pavement was broomed and cleaned with high-pressure water before the overlay was placed.
