## EVALUATING LOAD TRANSFER RESTORATION

**DISTRICT 1**  
Mendocino County  
Route 101 – North Bound

**DISTRICT 3**  
Placer County  
Route 80 – West Bound

July 2002

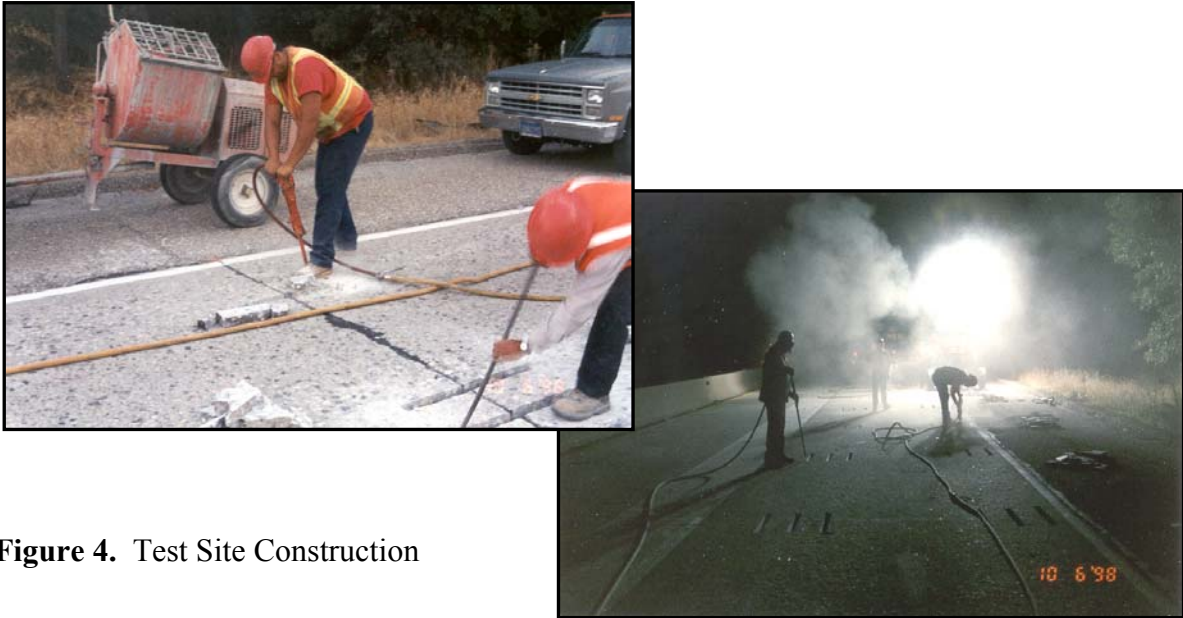
**Figure 4.** Test Site Construction

Construction of the test site took place on October 6, 1998. The Penhall Company performed the DBR (Figure 4). A total of six dowel bars were placed at each retrofitted joint, three each in the inner and outer wheel paths.

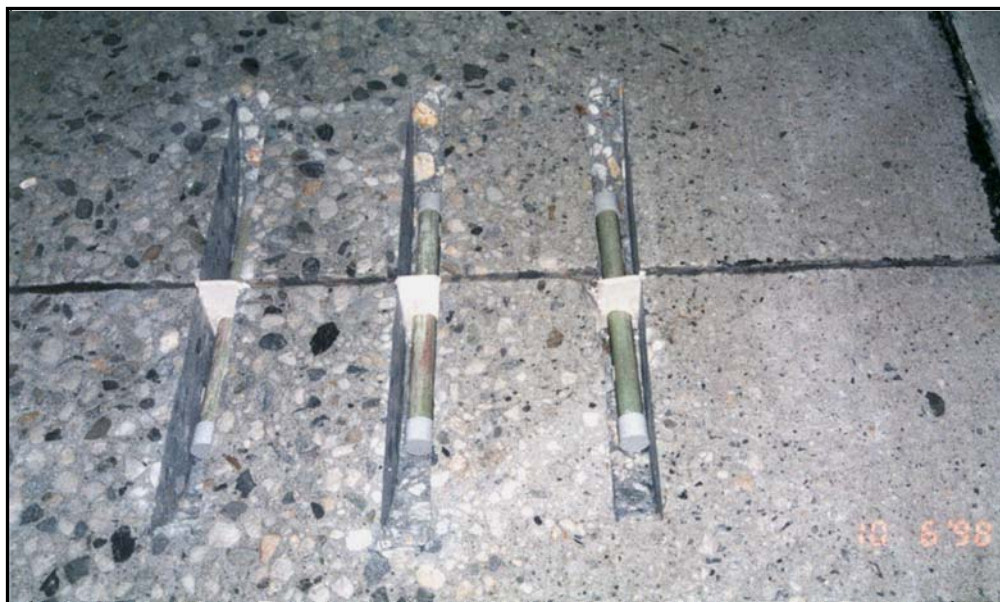
**Figure 5.** Dowel Bar Installation

Dowel bars were installed by saw-cutting slots parallel to the direction of traffic in the existing pavement (Figure 5). A dowel bar with chair supports, expansion caps, and a foam board insert and was placed in each slot. The slots were then backfilled with Fosroc/Patchroc 10-60 (now known as Thoroc 10-60), a fast setting grout.

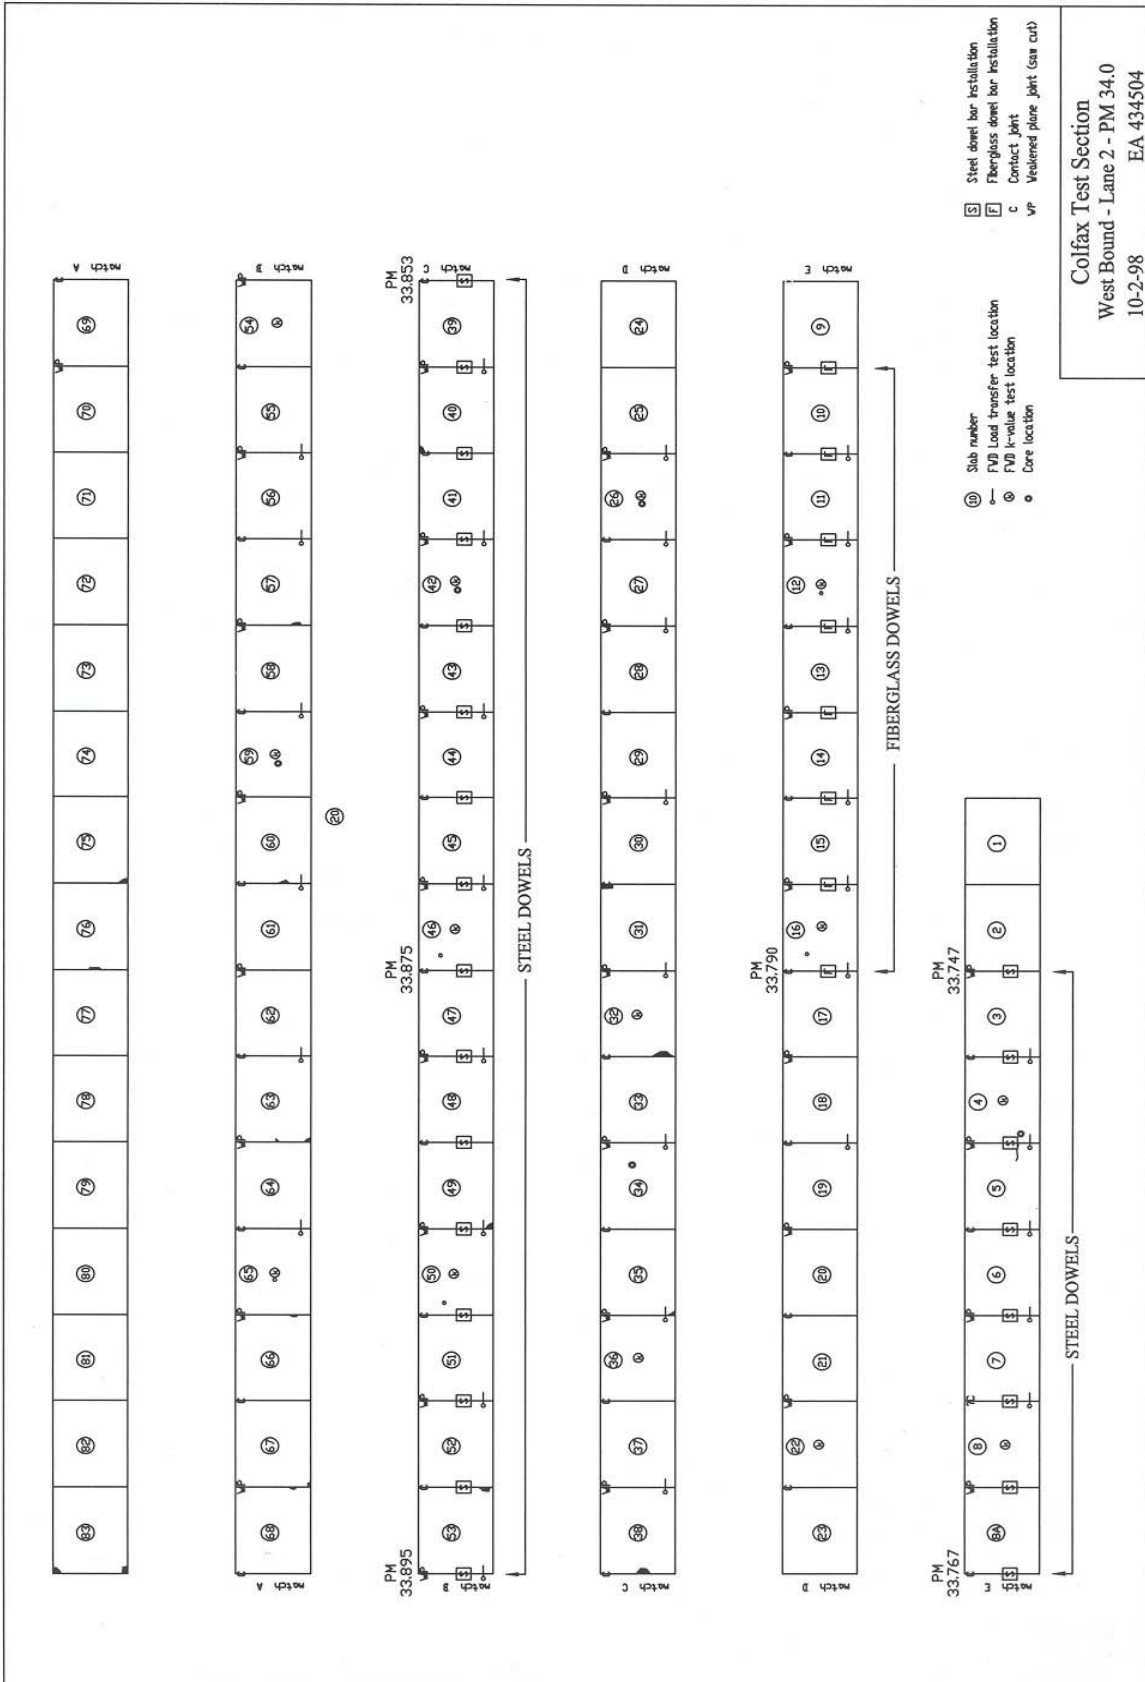
Figure 6. Colfax Test Site - Plan Layout

Figure 6 is a plan layout of the test site showing test sections and numbered panels. Two types of dowel bars were installed in the designated sections of the test site. Epoxy-coated steel dowel bars were placed in panels 3 through 8A (8 joints total), and also panels 39 through 53 (22 joints total). Fiberglass dowel bars were placed in panels 9 through 16 (8 joints total).

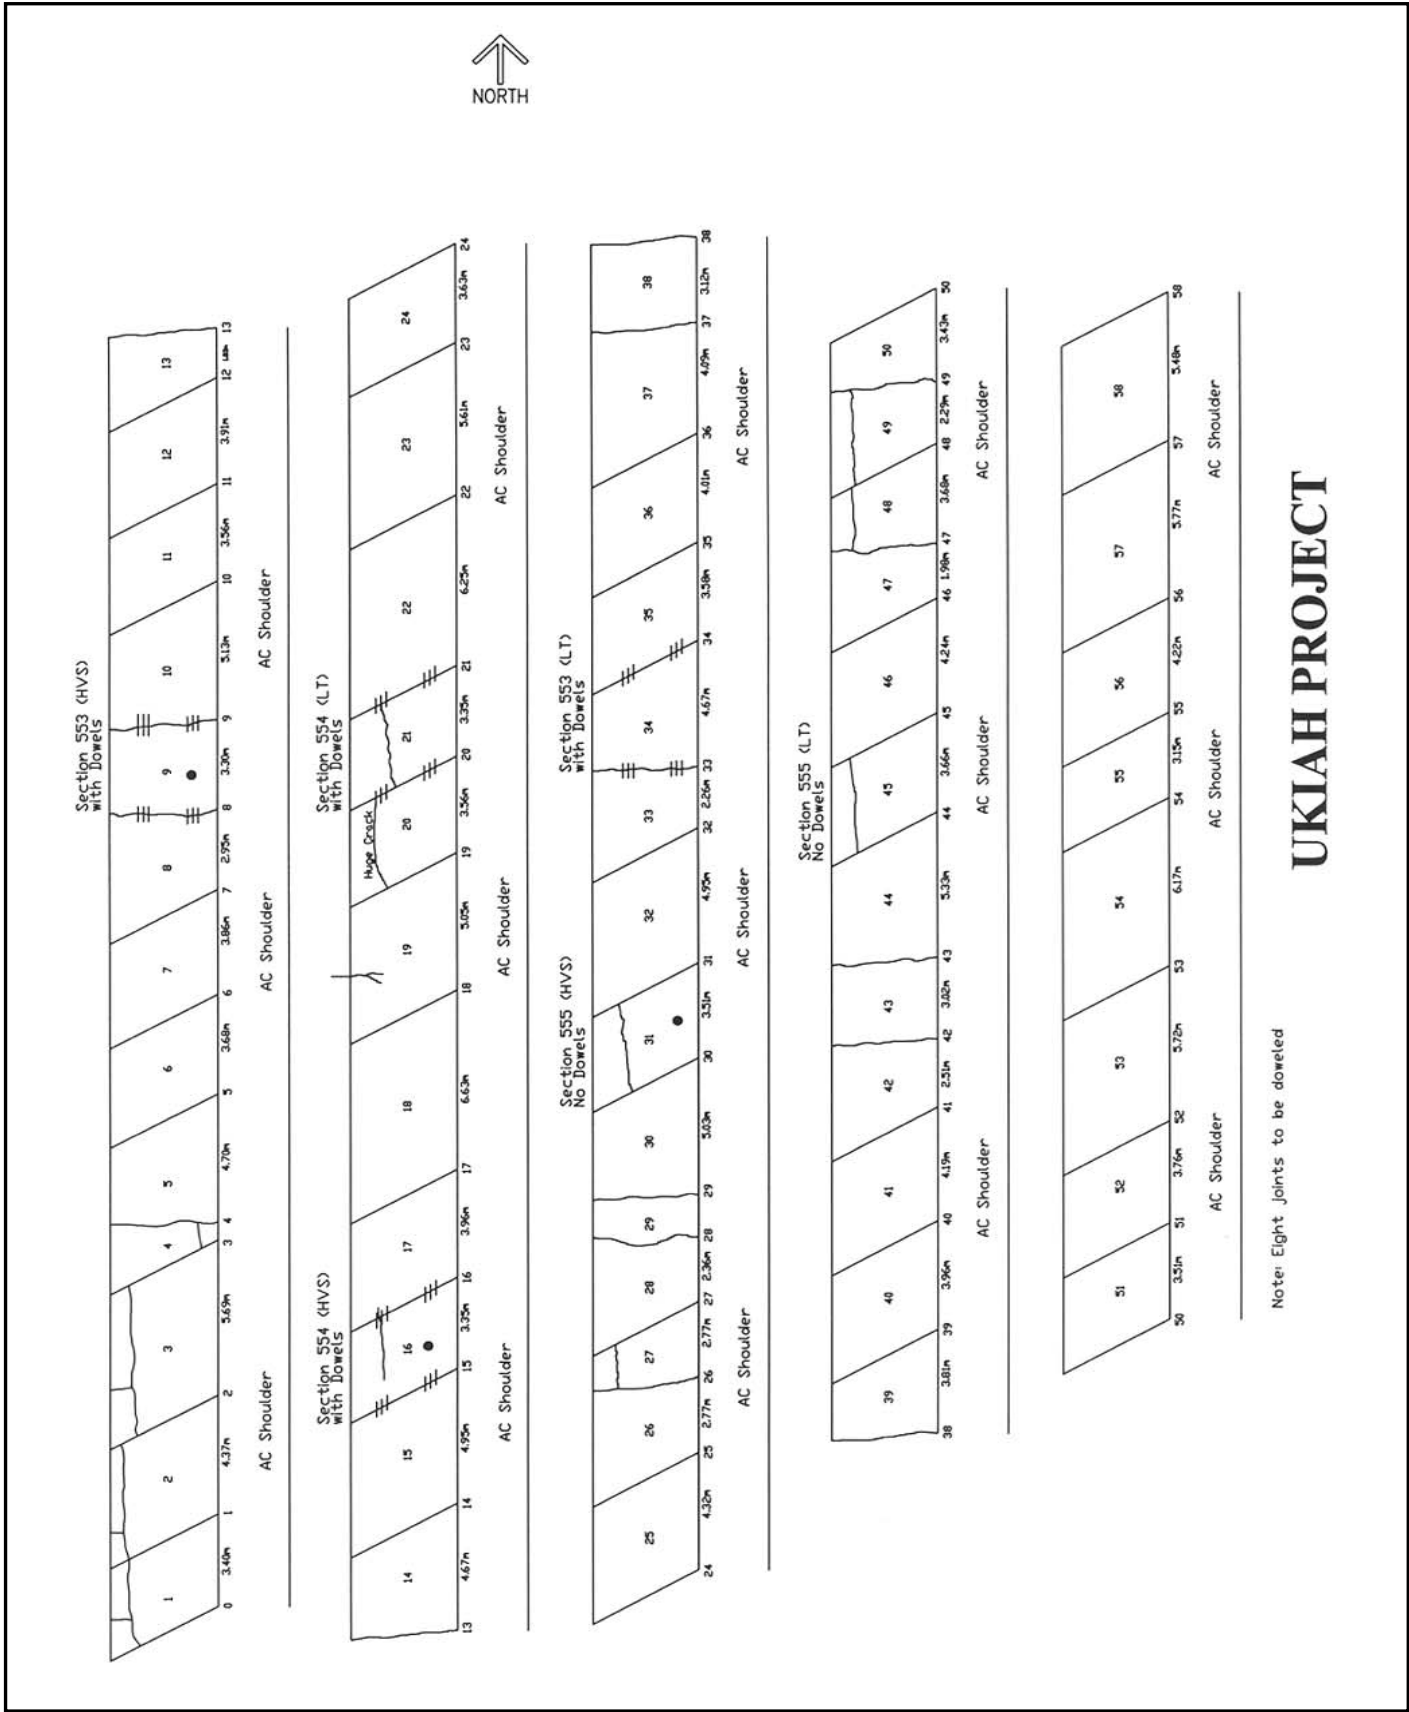
**Figure 13.** Ukiah Test Site - Plan Layout

Figure 13 is a plan layout of the site showing the test sections, retrofitted panels, and the numbering sequence of the joints/cracks and panels.
