Interstate 15 – South Bound
PM 55.7 to PM 53.5

POST CONSTRUCTION REVIEW

DISTRICT 8
San Bernardino County
Interstate 15 – South Bound

CONTRACT NUMBER: 08-4277U4

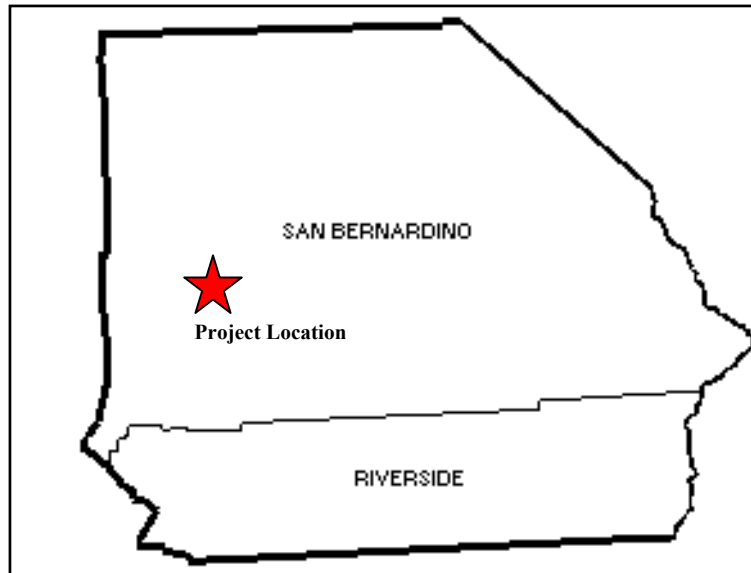
Figure 1. Project Location

A recent concrete pavement project, completed in May 2000 on Interstate 15 (I-15) near Barstow in San Bernardino County, began to exhibit signs of premature deterioration. The project widened a segment of I-15 between Powerline Road and WildWash Road in the southbound direction. Recent counts show that this segment is subjected to an Annual Average Daily Traffic (AADT) of 41,000 vehicles.

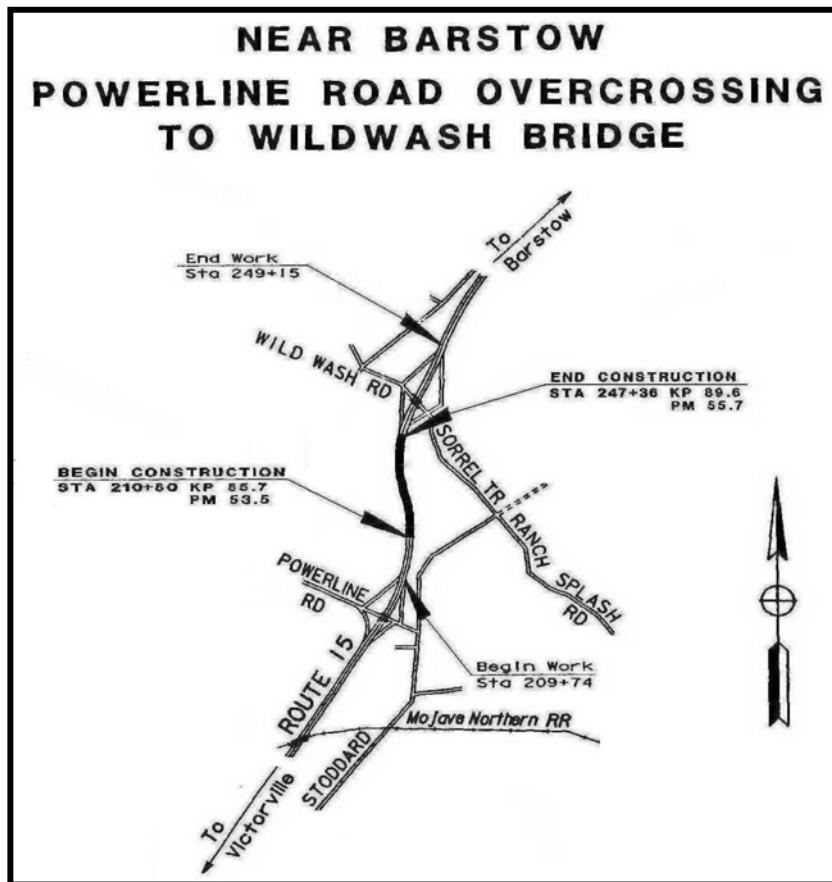
Figure 2. Project Limits

This project widened a 3.66-km long segment of I-15 by adding two lanes of Portland Cement Concrete Pavement (PCCP) to the existing asphalt concrete lanes in the southbound direction. The project limits extended from 2.4-km north of Powerline Road (Sta. 210+80) to Wildwash Road (Sta. 247+36). The new lanes currently serve as a truck climbing lane and a shoulder (to be opened as a traffic lane in the future).

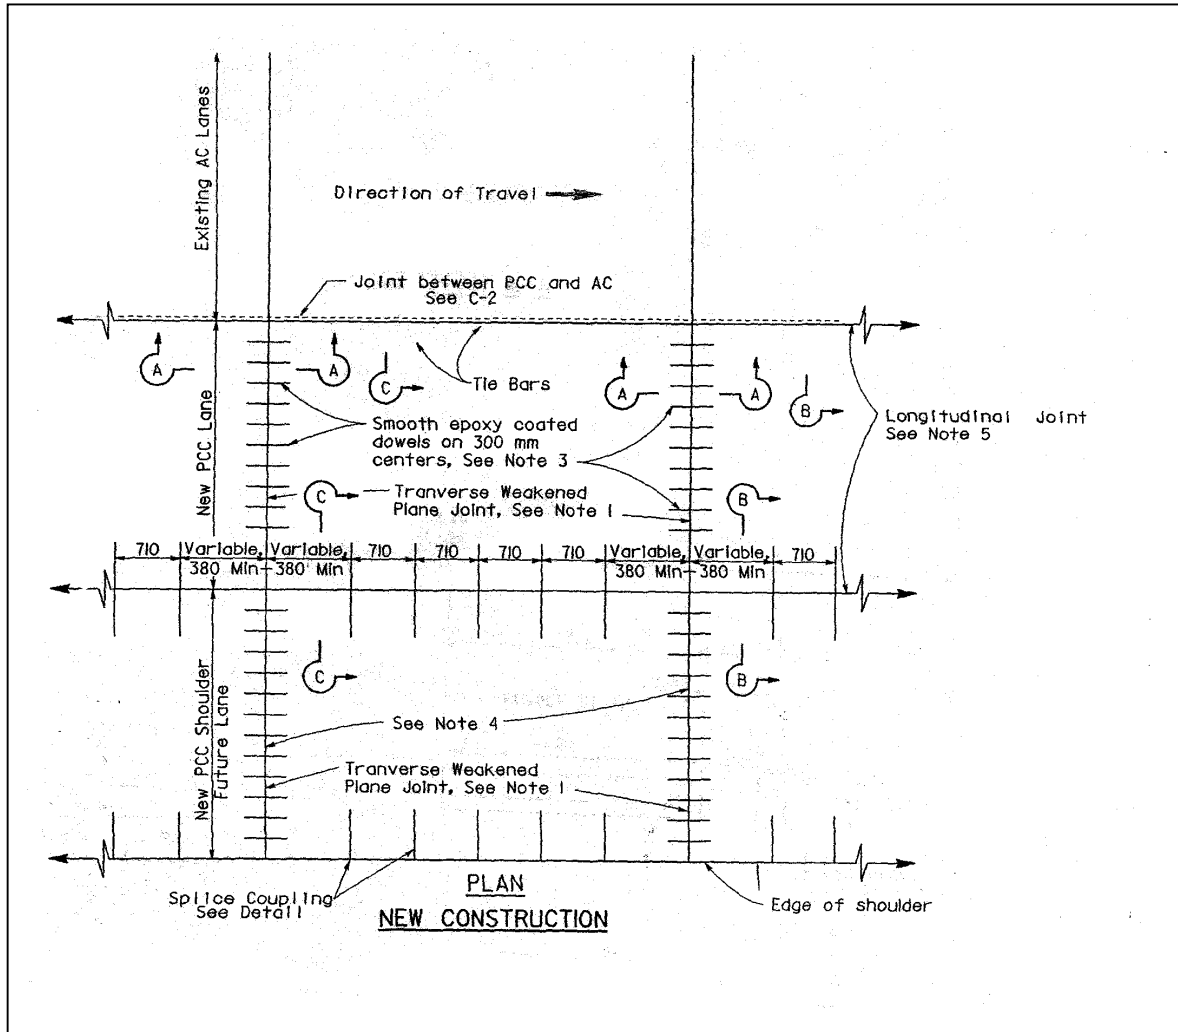
Figure 3. Pavement Construction Plan

The longitudinal joint between PCCP lanes was constructed by the sawing method. It required tie bars. The tie bars specified were epoxy-coated #19 deformed bars, 750 mm long. Tie bars were evenly spaced at 710-mm intervals, on center, and at least 380-mm from transverse joints (Figure 3).

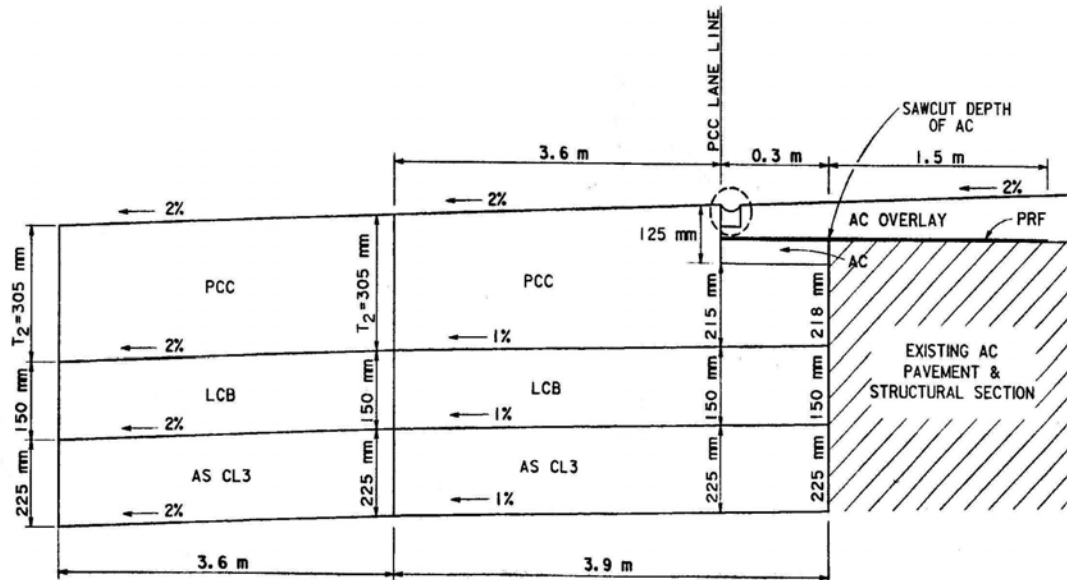
Figure 5. Pavement and Structural Section

The structural section is portland cement concrete (PCC) on a lean concrete base (LCB) and an aggregate subbase (AS CL3). The PCC varies in thickness from 340 to 305 mm. The underlying LCB is 150-mm thick and the AS CL3 is 225-mm thick (Figure 5).
