ARIZONA DEPARTMENT OF TRANSPORTATION

HILFIKER REINFORCED SOIL EMBANKMENT WITH FULL-HEIGHT, CAST-IN-PLACE CONCRETE PANELS

Final Report

May 1992

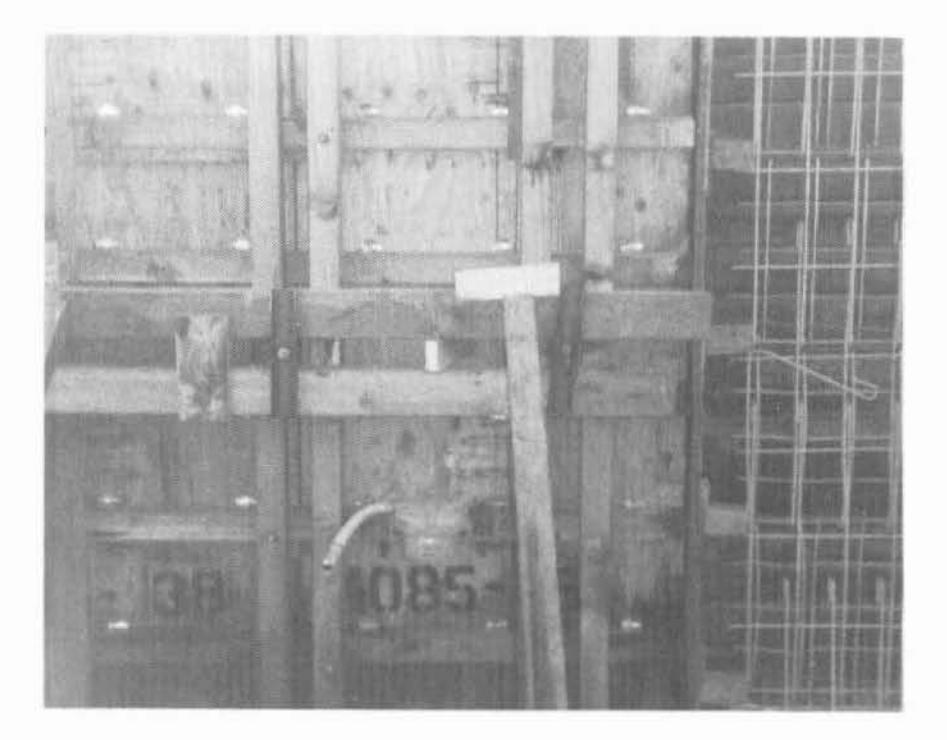
The concrete was mixed at a batch plant and delivered to the site in transit mixers. The concrete was poured down the full face of the embankment, at times over 20'. Upon pouring, the concrete was vibrated with long internal vibrators as shown in Figure 16. After removing the forms, the concrete showed extensive honeycombing and air voids. Therefore, external vibrators were used in addition to the long internal vibrators. However, because the vibrations of the external vibrators did not transfer well through the rubber and wood forms, honeycombing and air voids were still visible. Use of external vibrators is shown in Figure 17. Figure 18 shows an example of the honeycombing and air pockets in the concrete panels.

Figure 17 Additional External Vibrators Later Added to the Lower Sections of the Wall.

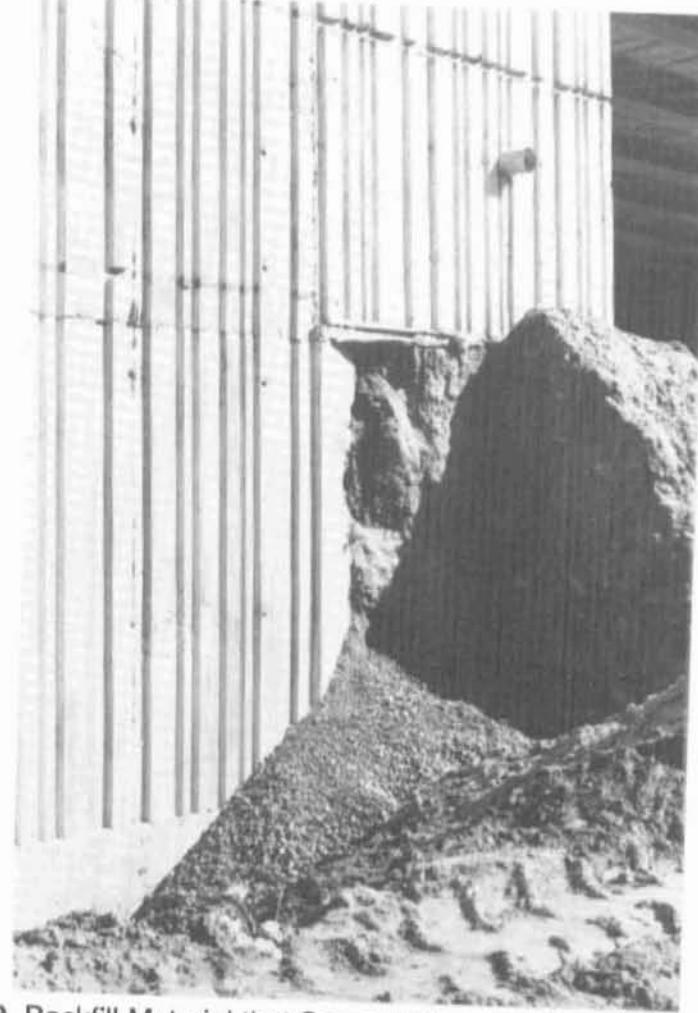
A problem developed at the interface of the bridge abutment wingwall and the Hilfiker concrete panels. Prior to the completion of the last panel of the wingwall, a significant amount of the backfill washed out due to heavy rainfall. Figure 29 shows the backfill material that had been lost through the abutment. Figure 30 is the crevice formed by the seepage. Figure 31 is the void created at the top of the embankment, noticeable because the PCCP had not yet been placed.

Figure 29 Backfill Material that Seeped Through Abutment Wingwall.

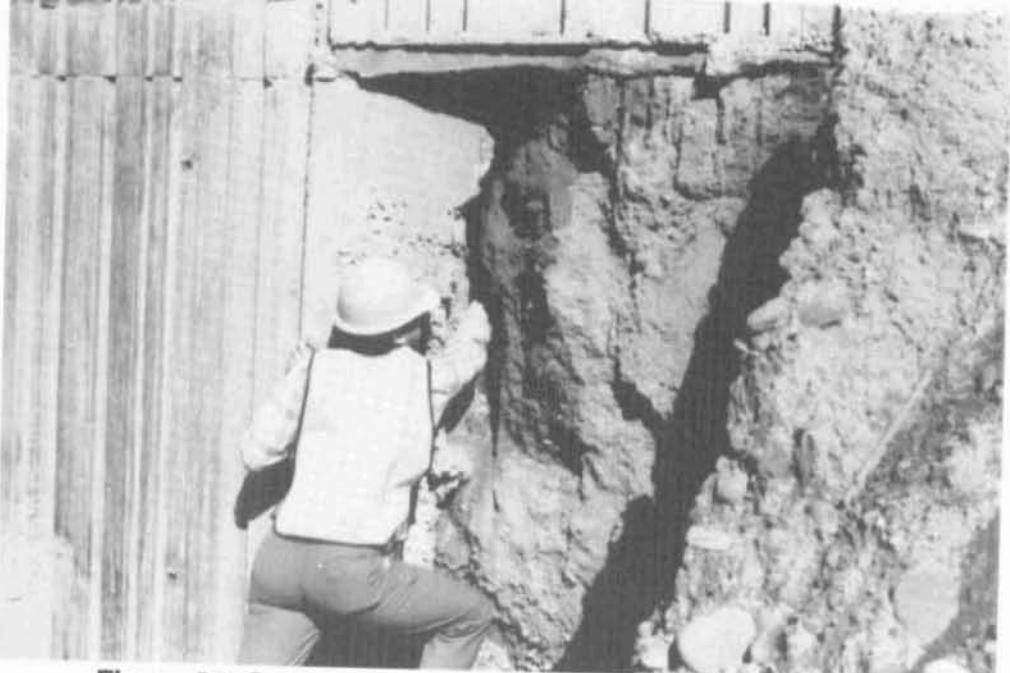
Figure 30 Crevice Formed by Washout of Backfill Material.

A probable cause of the observed deflection of anchor slab is the formation of a void in the embankment. The void could be caused by the washing out of embankment material through the large vertical crack at the wall - abutment interface. This would be consistent with the washout problems encountered with the southwest Hilfiker wall during construction as seen in Figures 30, 31, and 32.

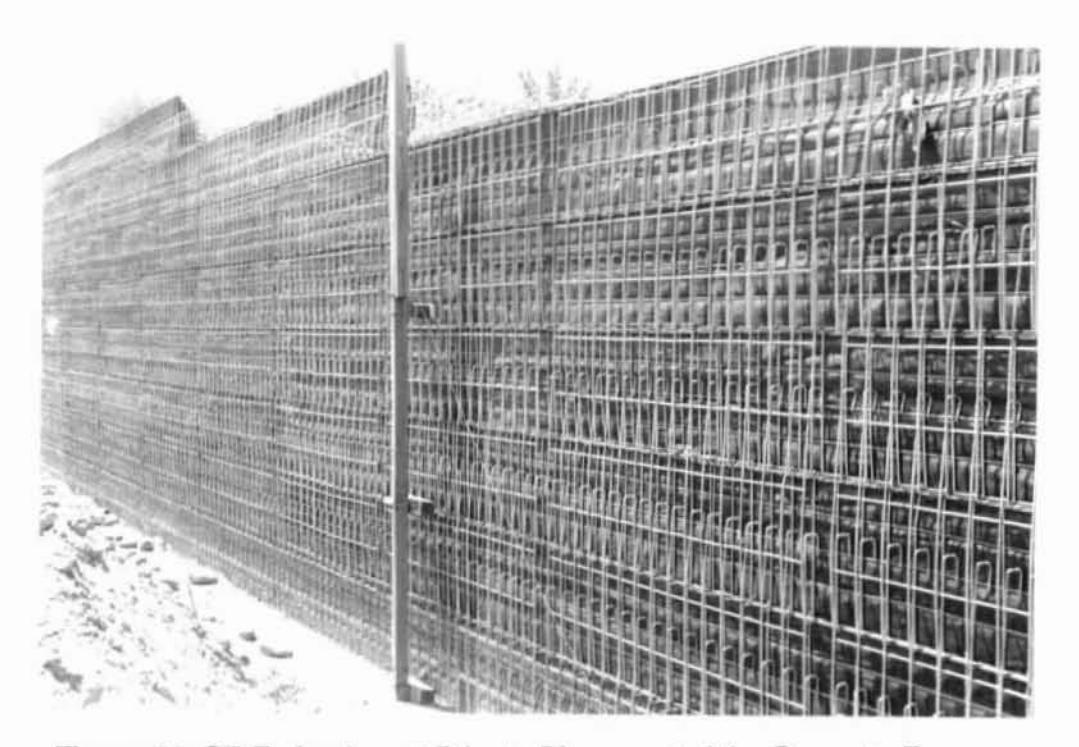
Towards the end of the embankment construction, it became evident that the contractor did not have enough reinforcing mats to raise the embankment to plan elevation. Upon approval from the Hilfiker company, the contractor increased the space between mats to 3' rather than 2.5' as required by the plans. Figure 38 shows the completed embankment prior to placing the concrete forms.

Figure 38 SE Embankment Prior to Placement of the Concrete Forms.

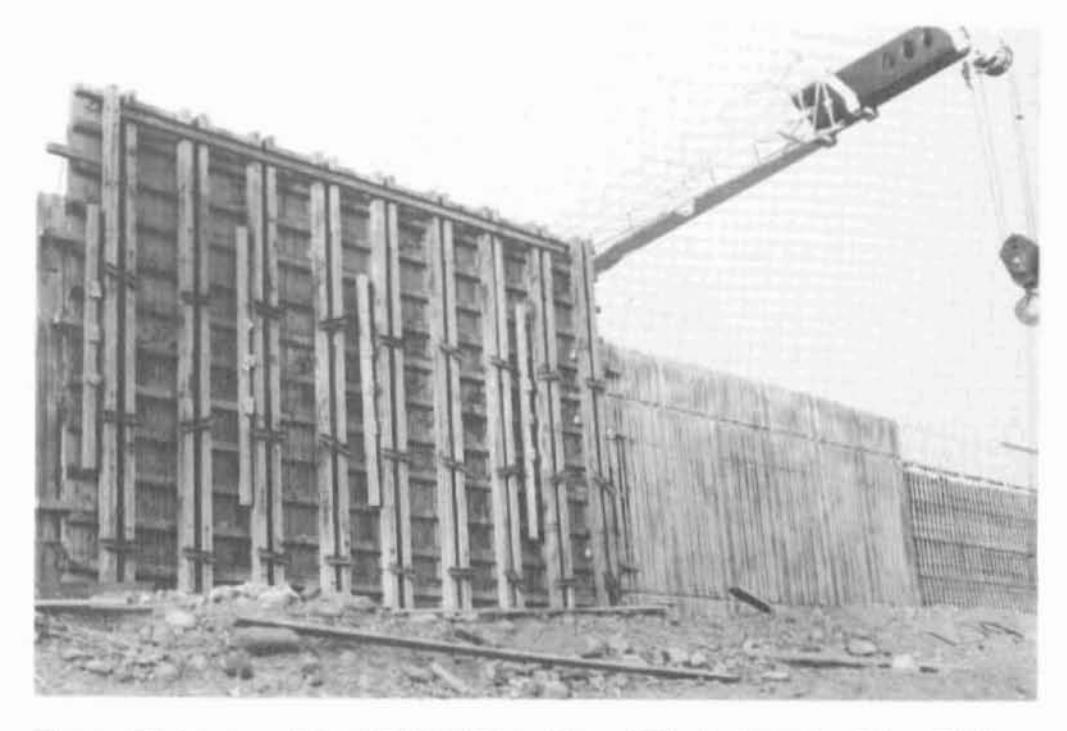
The concrete for the panels of the face of the wall was poured in similar fashion to the other walls. Figure 39 shows the forms in place. The southeast wall panels, like the others, had no drainage outlets specified in the plans. However, this concrete wall had noticeably fewer shrinkage cracks, and a better quality finish than the other walls. This was probably due to the relative height and length of this wall.

Figure 39 Forms of the SE Wall Were Placed Similarly to the Other Walls.

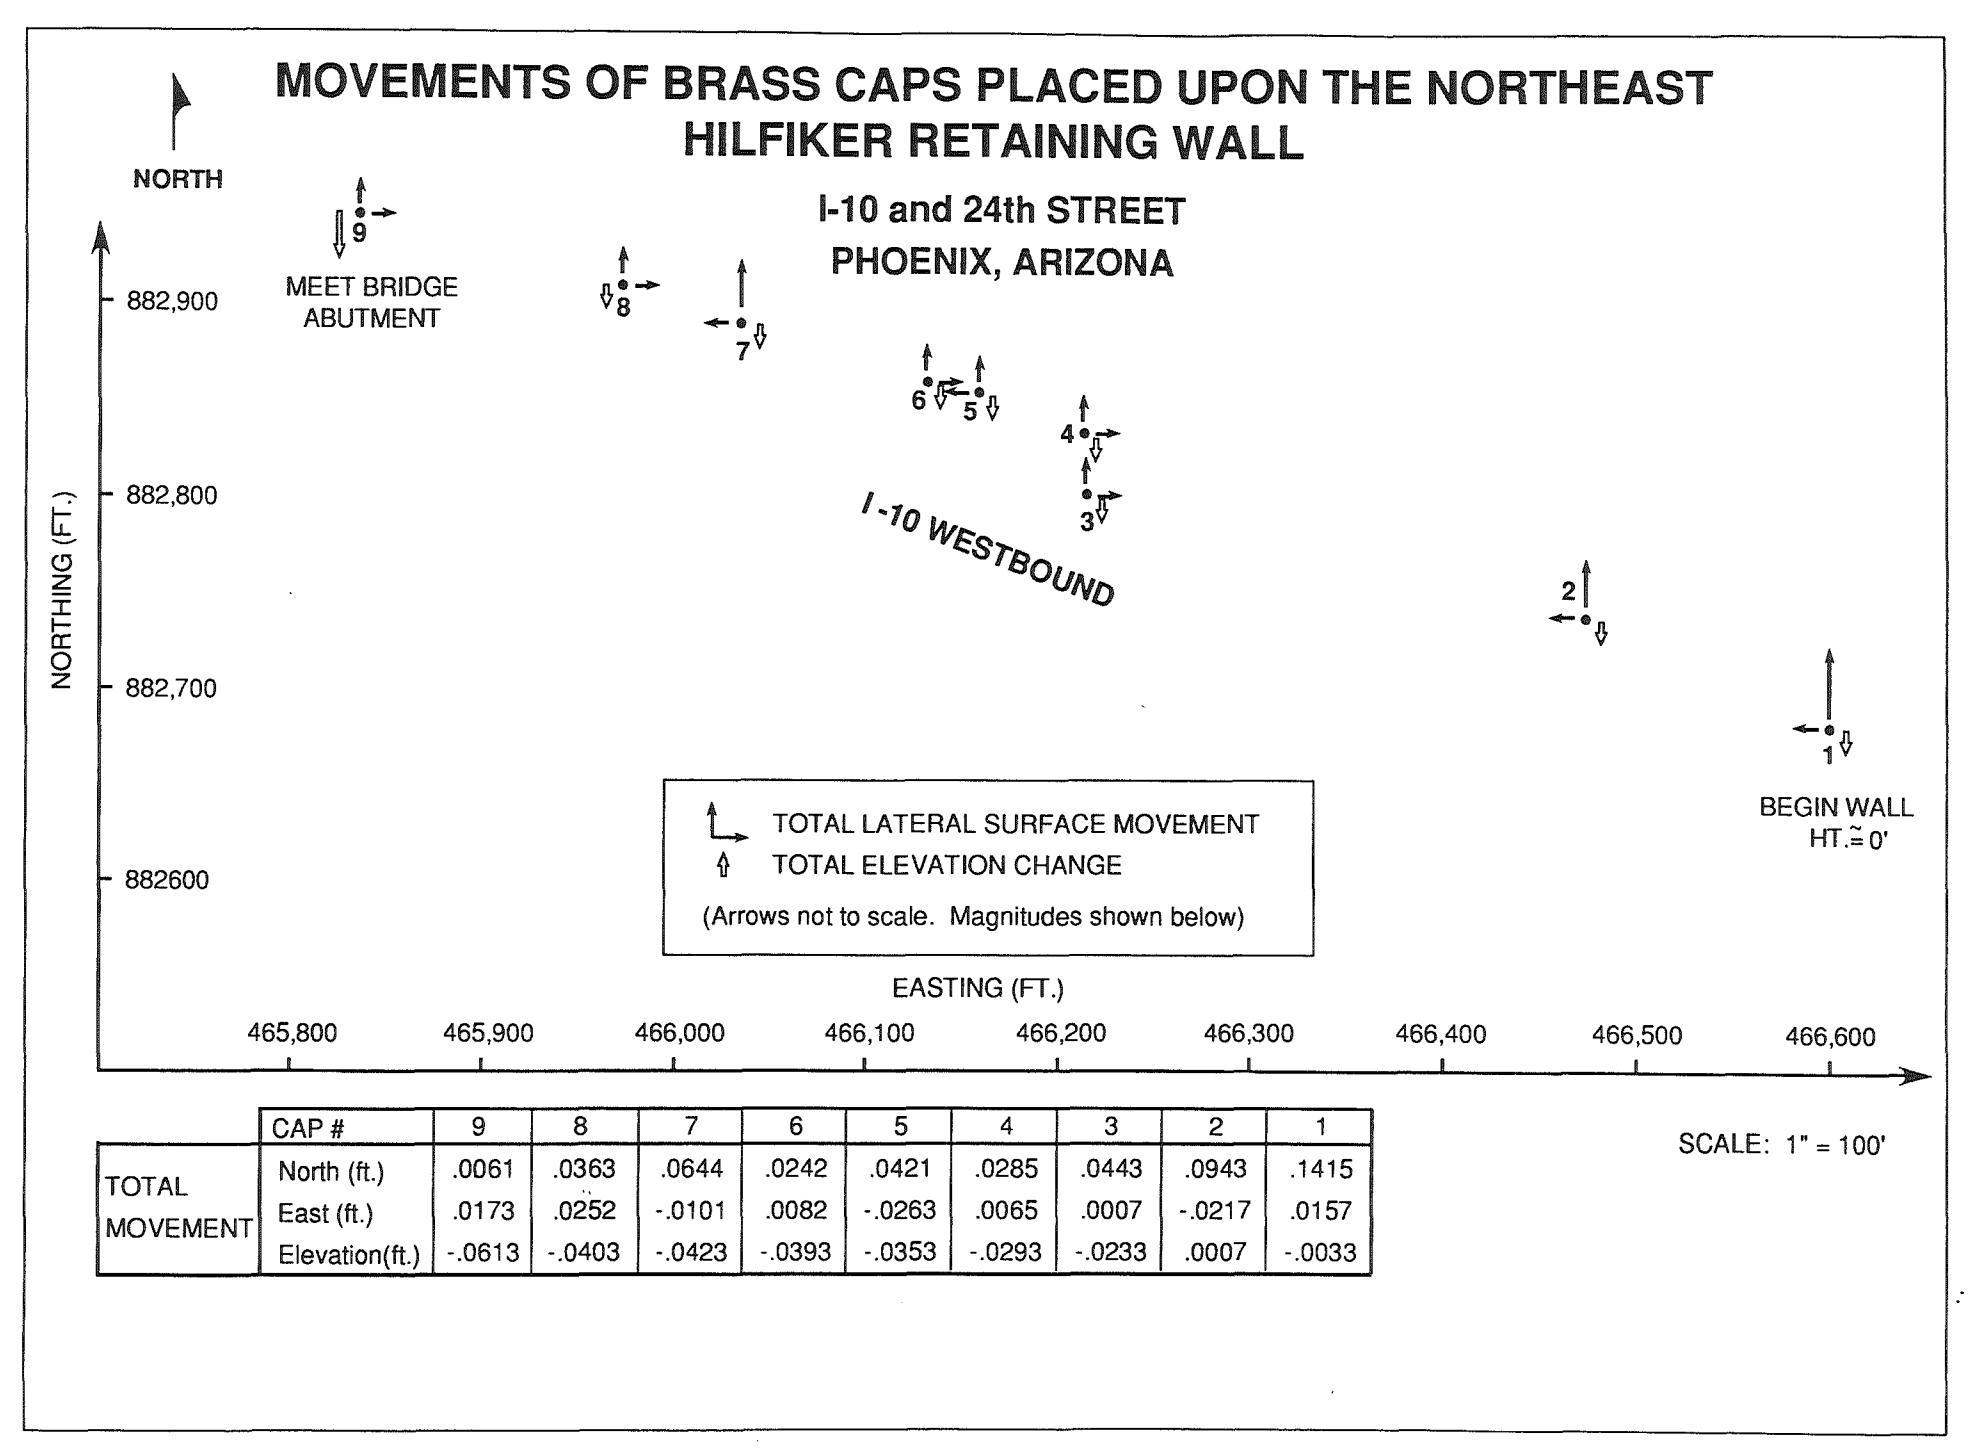
Figure 41 Movements of the Caps Placed on the Northeast Wall.

There is reason to doubt the reliability of the results of the surveys. Notice, for example, the northeast wall. Table 1 indicates that the aluminum cap with the greatest lateral movement, and a significant change in elevation is Cap 1. Figure 41 shows that Cap 1 is at the low end of the wall, and it would be expected that this cap would be the least susceptible to movement.

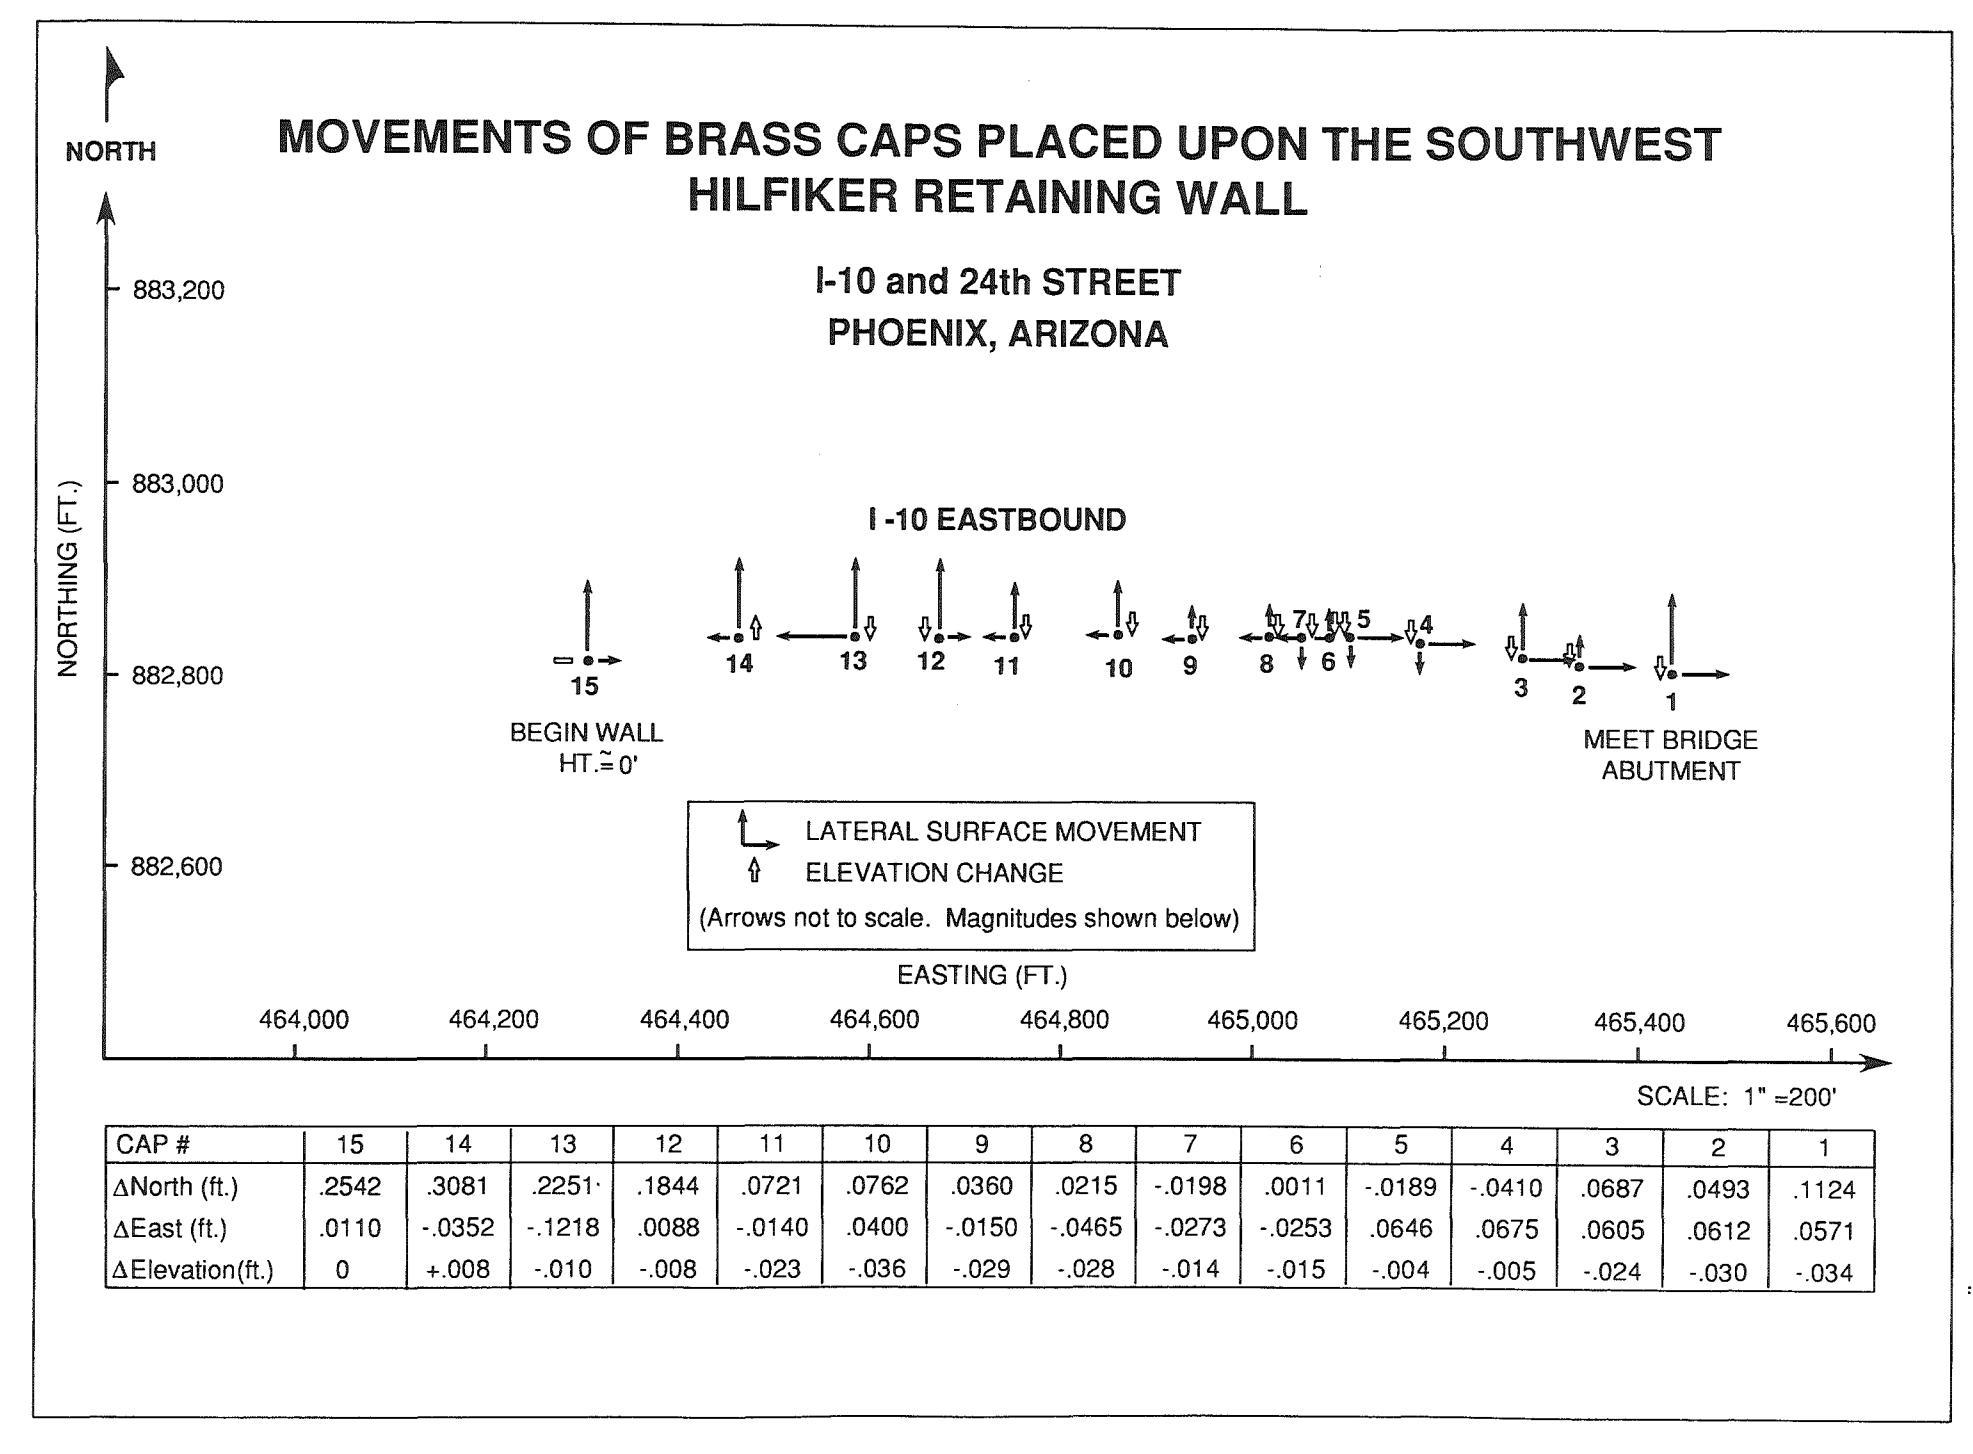
Figure 42 Movements of the Caps Placed on the Southwest Wall.

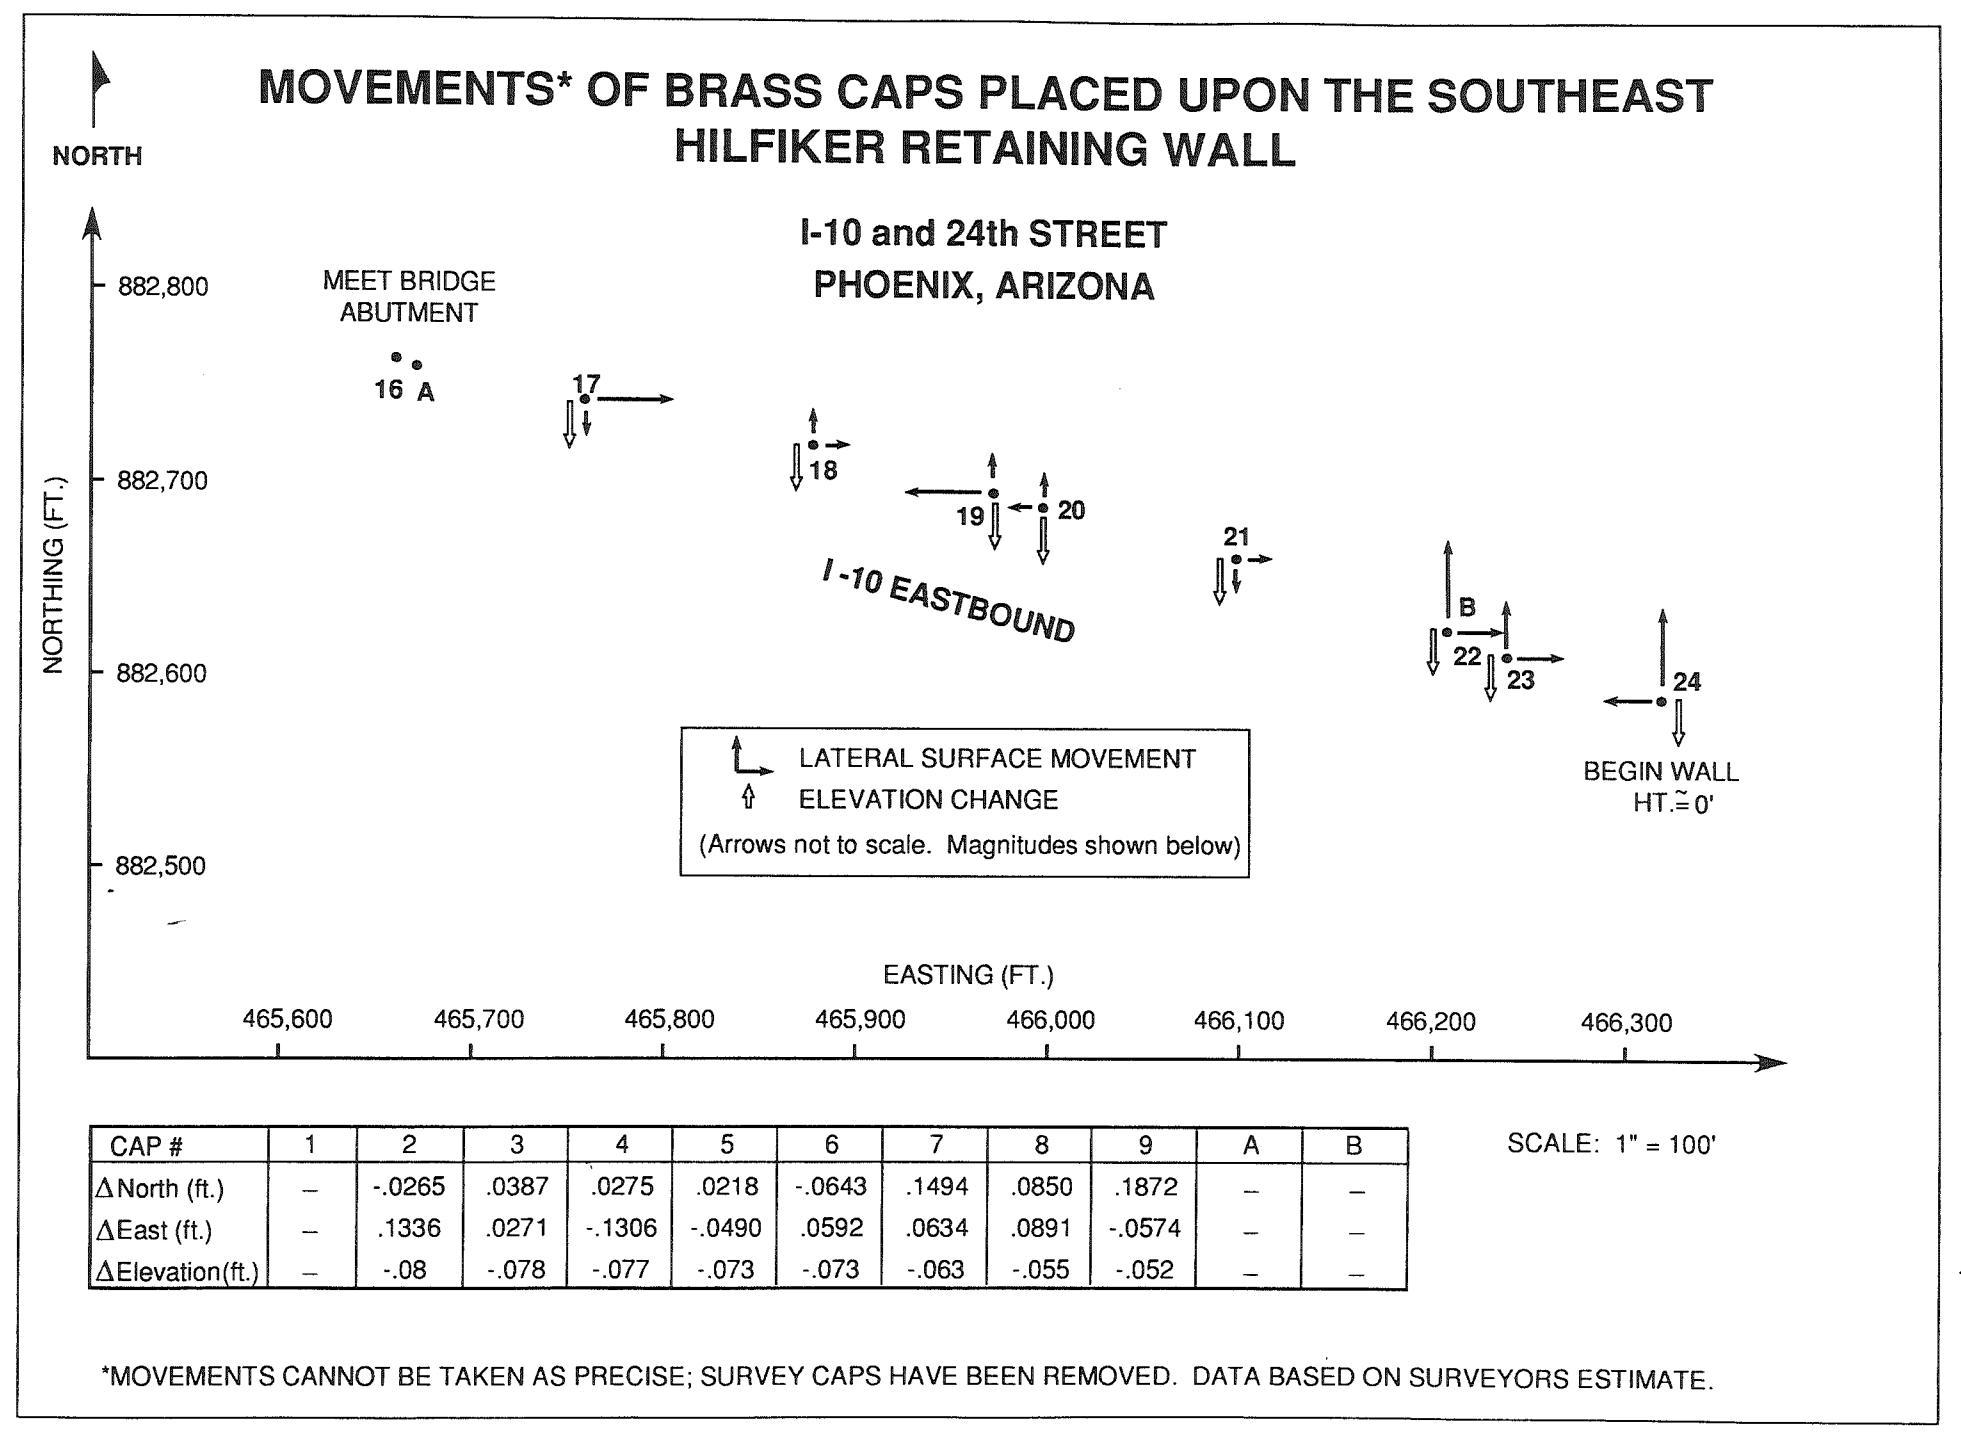
Movements Between Surveys 1/13/88 and 8/3/91. All aluminum caps have been removed. Movements are based on surveyor's estimate of position of caps for 8/3/91 survey.

Figure 43 Movements of the Caps Placed on the Southeast Wall.
