Report No. K-TRAN: KU-06-7 FINAL REPORT

STREAM INSTABILITY COUNTERMEASURES APPLIED AT KANSAS DEPARTMENT OF TRANSPORTATION HIGHWAY STRUCTURES

November 2008

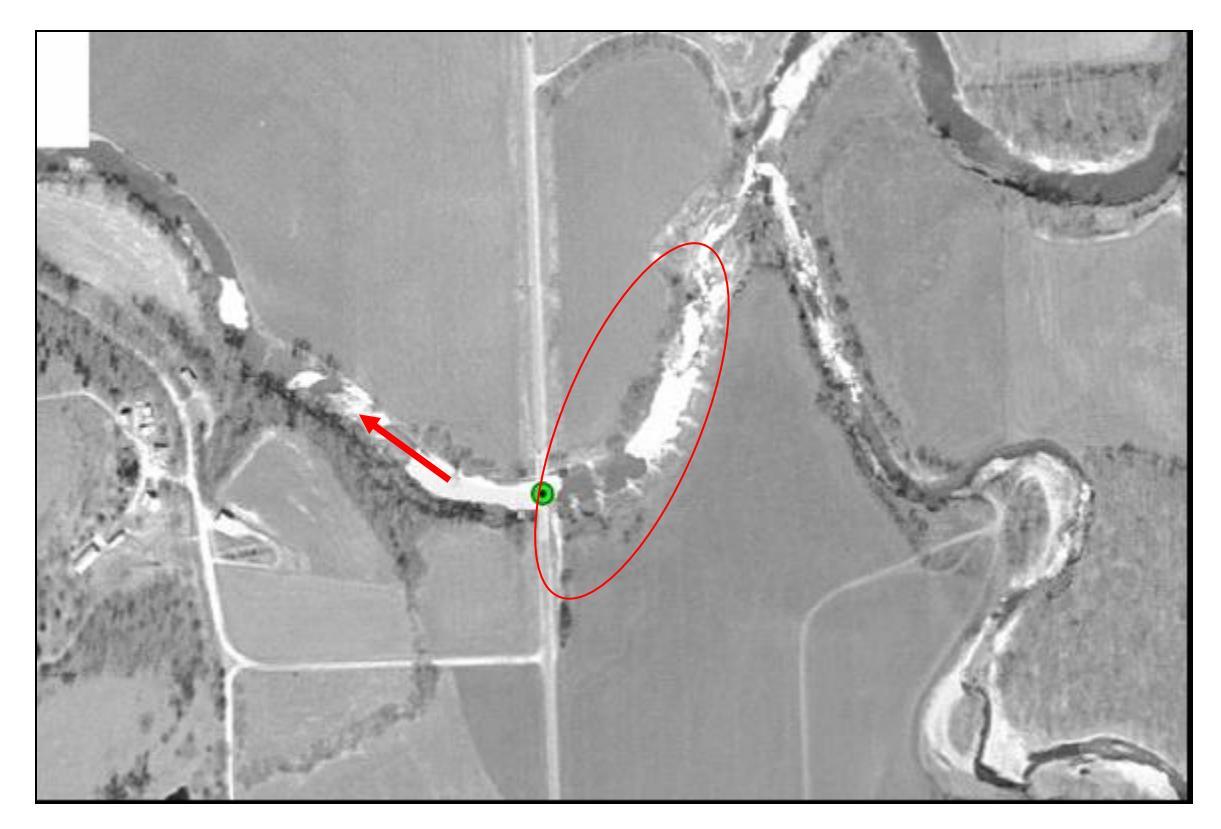
Figure 2.8: Site 16, Aerial, Alma, KS, Wabaunsee County

Lateral channel migration on the left side of the main channel posed a potential problem to the roadway and bridge for Site 16. Figures 2.9-11 show the benway weirs from different locations. Overall, the condition of weirs was excellent and the migration of the main channel appeared to have been arrested.

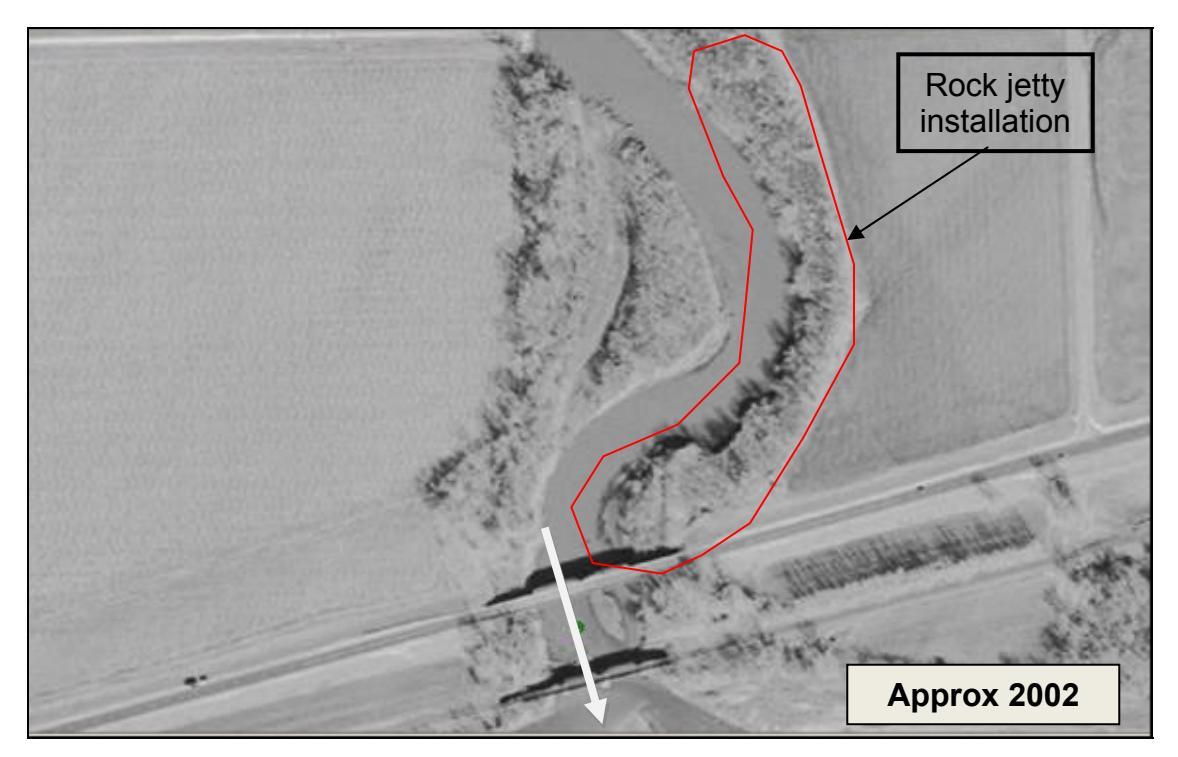
Figure 3.9: Site 3, Aerial, Wamego, KS, Pottawatomie County

Figure 3.8 indicates the rock jetty installation. The left bank of the channel was threatening the roadway and the bridge. These jetties were massive. The degree to which the region between the jetties had filled in and revegetated was impressive. Figures 3.9 and 3.10 are photographs of the jetties.

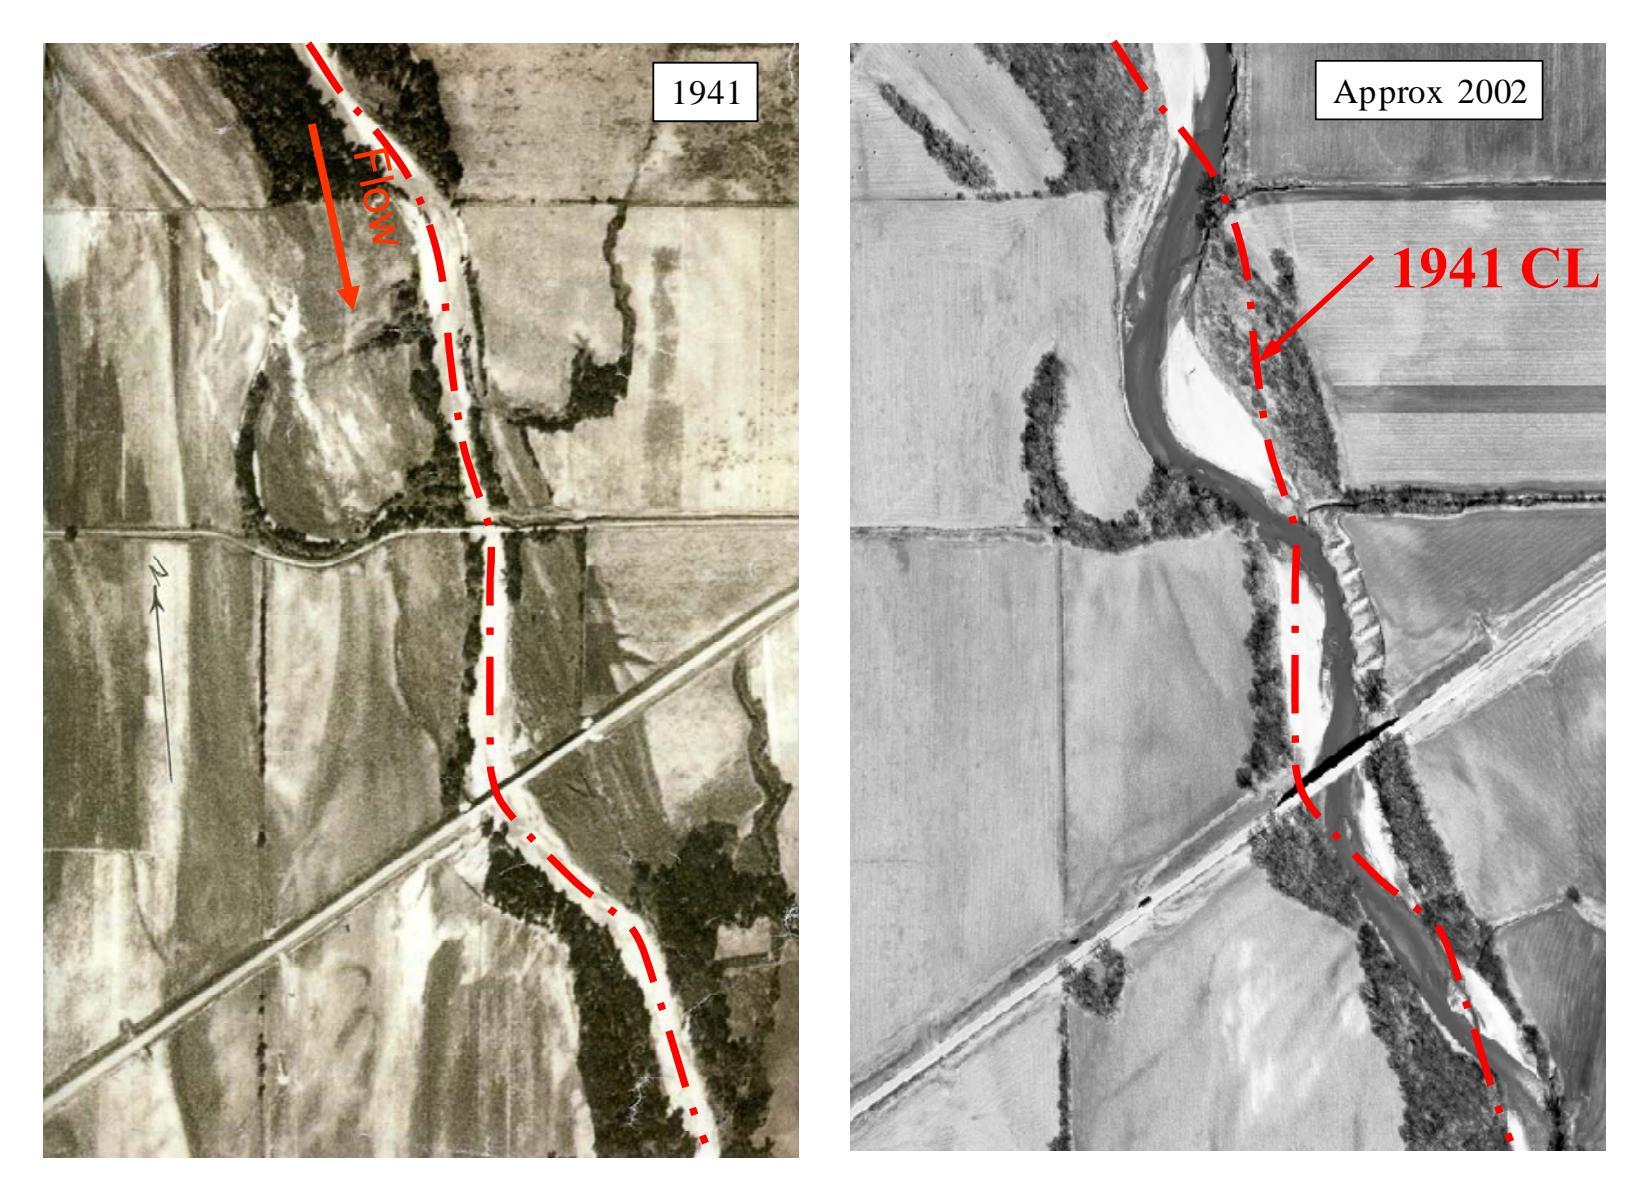
Figure 3.12: Site 4, Rock Jetties, Hanover, KS, Washington County1941 and recent Aerial Photos (Scale is not exactly the same)

Figure 3.11 shows aerial photos from 1941 and from approximately 2002. These pictures dramatically show the significant changes that can occur to a stream over several decades. The 1941 stream centerline is shown on the 2002 aerial for comparison. The 2002 picture clearly shows the jetties. Figure 3.12 is a portion of the plans for the 5 jetties. Figures 3.13 and 3.14 show the jetties in 2001 and 2006, respectively. The area between the jetties had filled in and vegetation was evident throughout the jetty series.

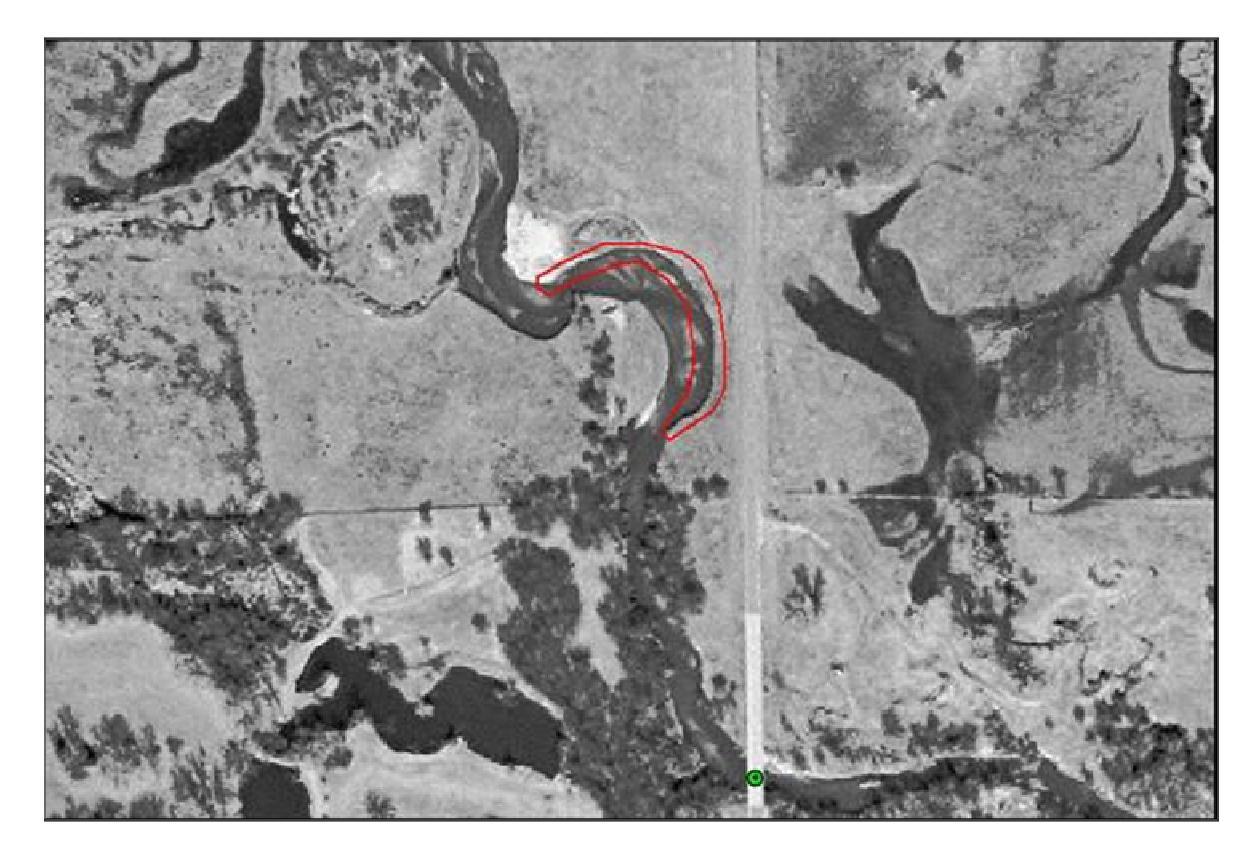
Figure 3.16: Site 1, Aerial, Arlington, KS, Reno County

Figure 2.15 is an aerial view that shows where a series of steel sheet pile jetties were installed. Note in Figure 3.16 that the channel bend made a dramatic migration

between 1986 and 1998 and came very close to the highway. Apparently this was due in large part to a major storm that occurred in 1995. The construction layout of the levees is shown in Figure 3.17. Note that all but the most upstream jetty, No. 9, are oriented upstream with the angle of orientation greater than 90 degrees. Figures 3.18 to 3.22 are pictures of the jetty system in July 2006. This site is characterized by a flat floodplain left overbank.

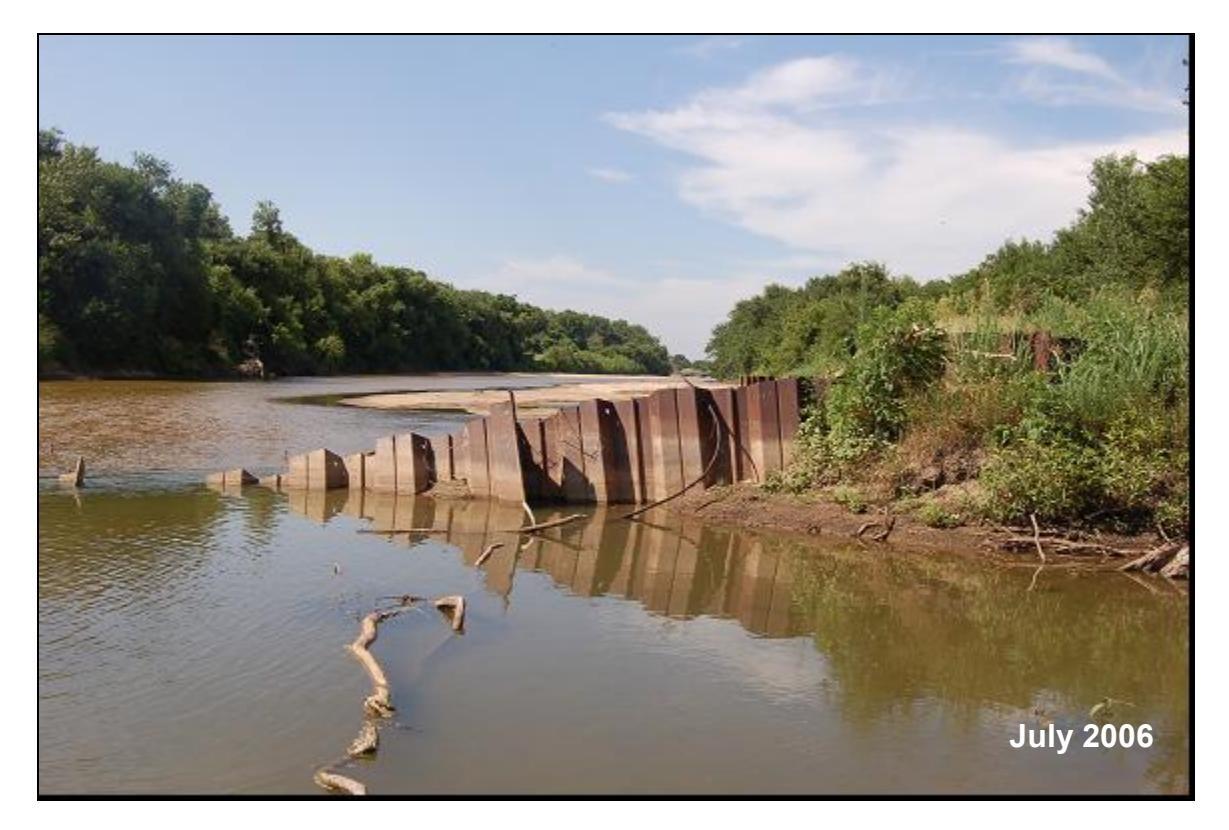
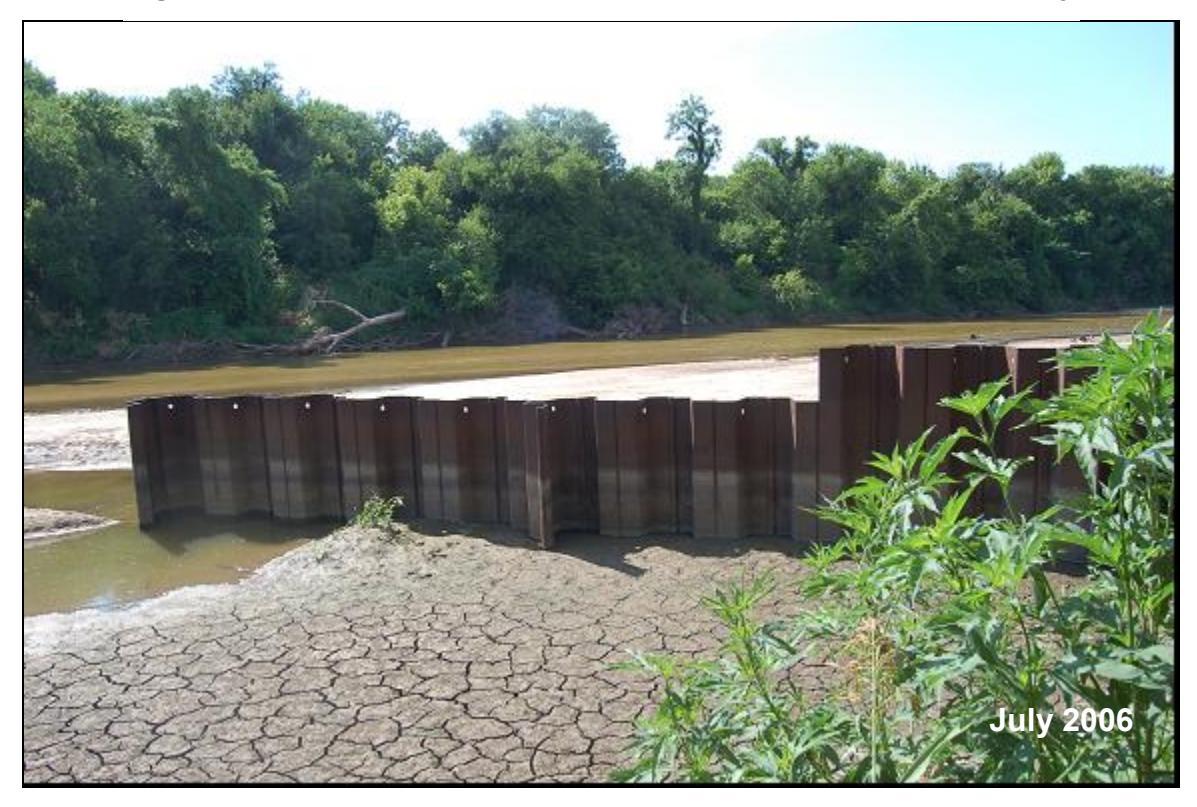
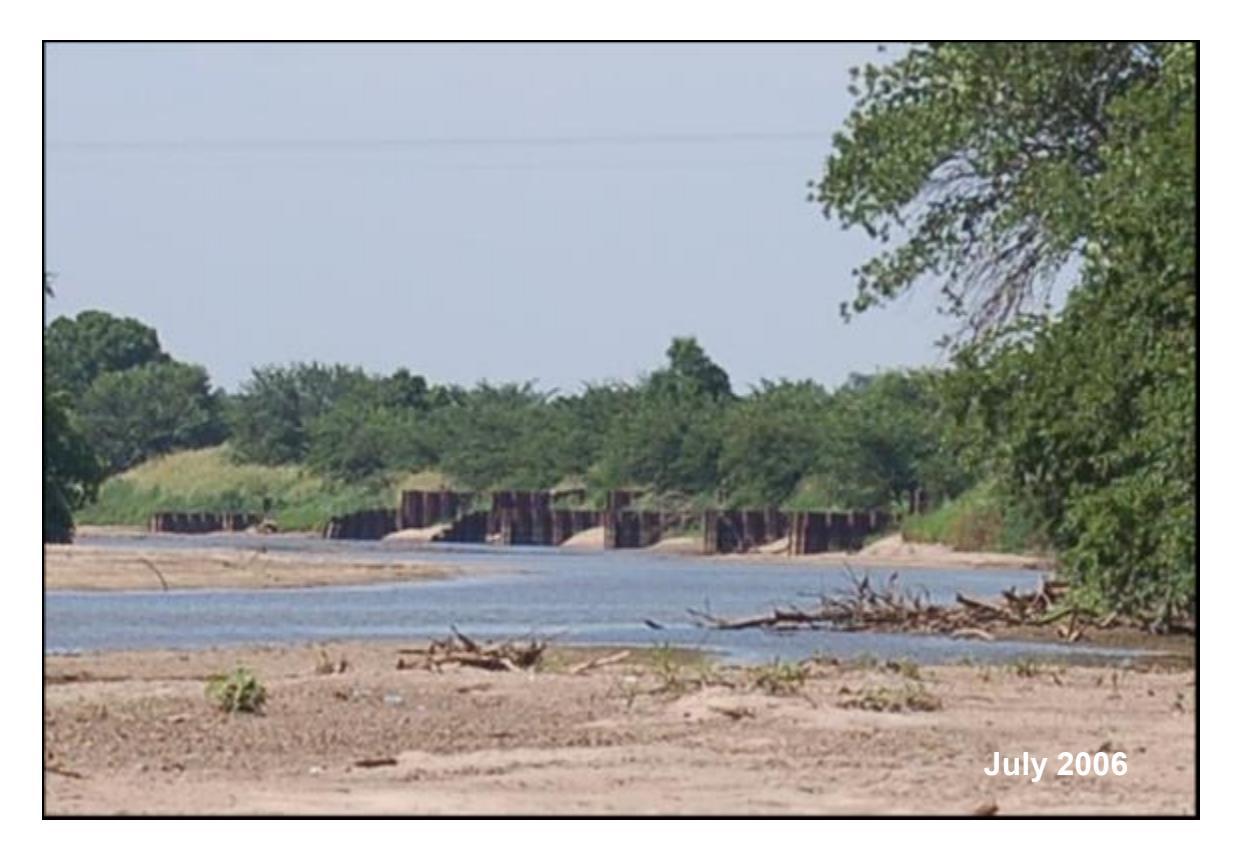
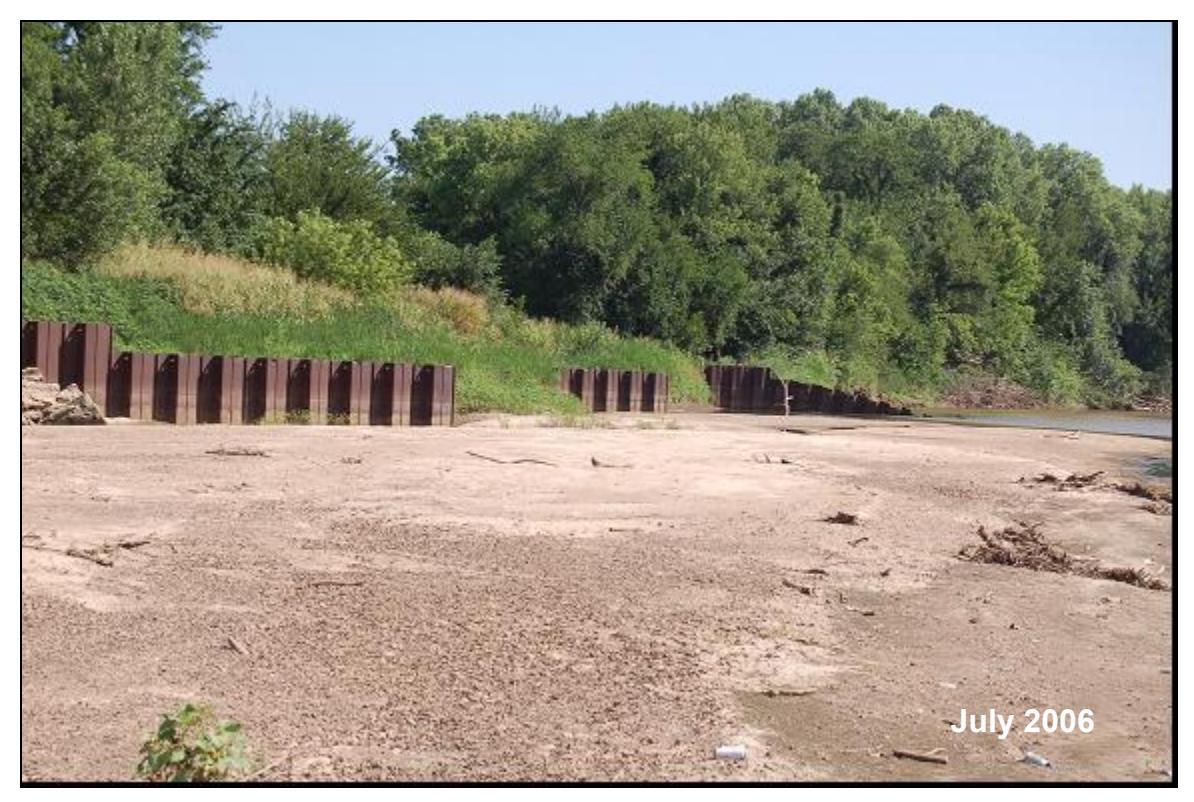
Aerial photos of the site are shown in Figures 3.23-25. The left bank of the river is extremely close to US-81 in the area encircled in Figure 3.23. Figure 3.26 shows the layout for the final 12 jetty configuration adopted. The details of selected jetties are shown in Figure 3.27. The left bank of the river was steep in the region of the 90-degree jetties. The vegetation was well established and significant deposition had occurred between the jetties. Figures 3.28-31 show pictures of the jetties taken July 2006.

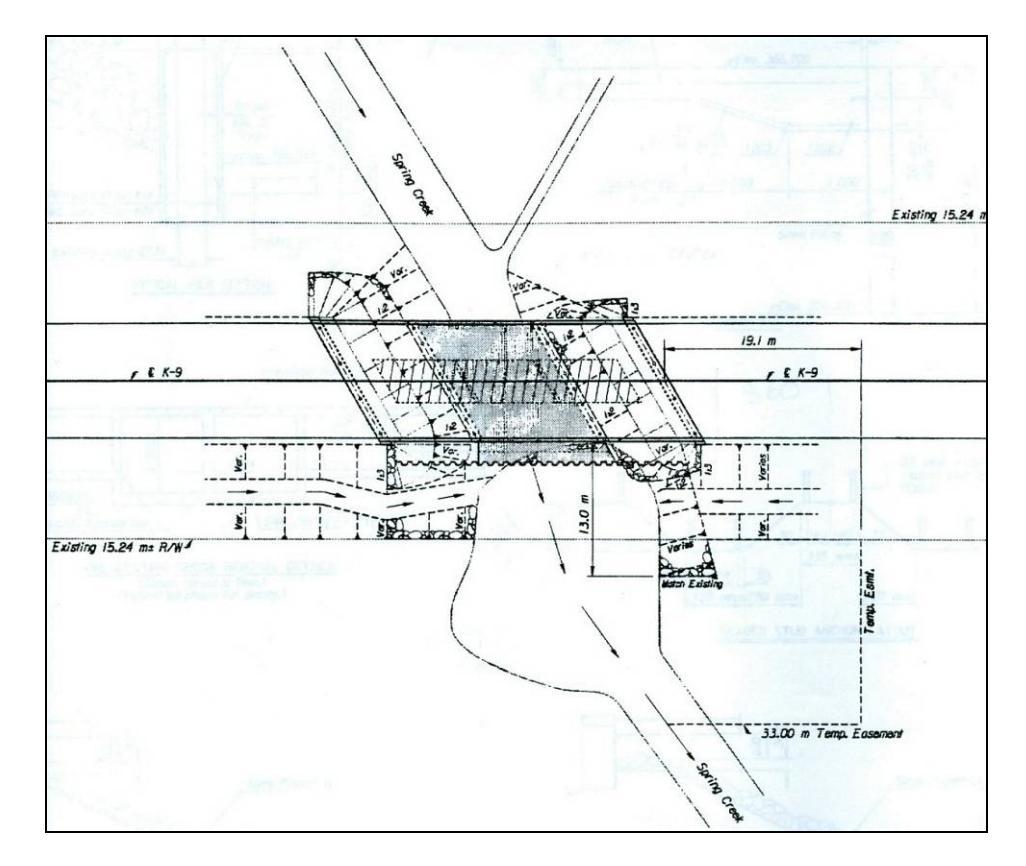
Figure 4.4: Site 14, Sheet Pile Sill, Goff, KS, Nemaha County

so the extent of the scour hole was limited. Figure 4.4 shows the sketch of the scour hole prior to installation of the drop structure. It is apparent that the scour hole was a serious threat to the bridge prior to the installation of the drop structure. Figures 4.5-7 are photographs of the sheet pile drop structure, the post-installation scour hole and the downstream channel.

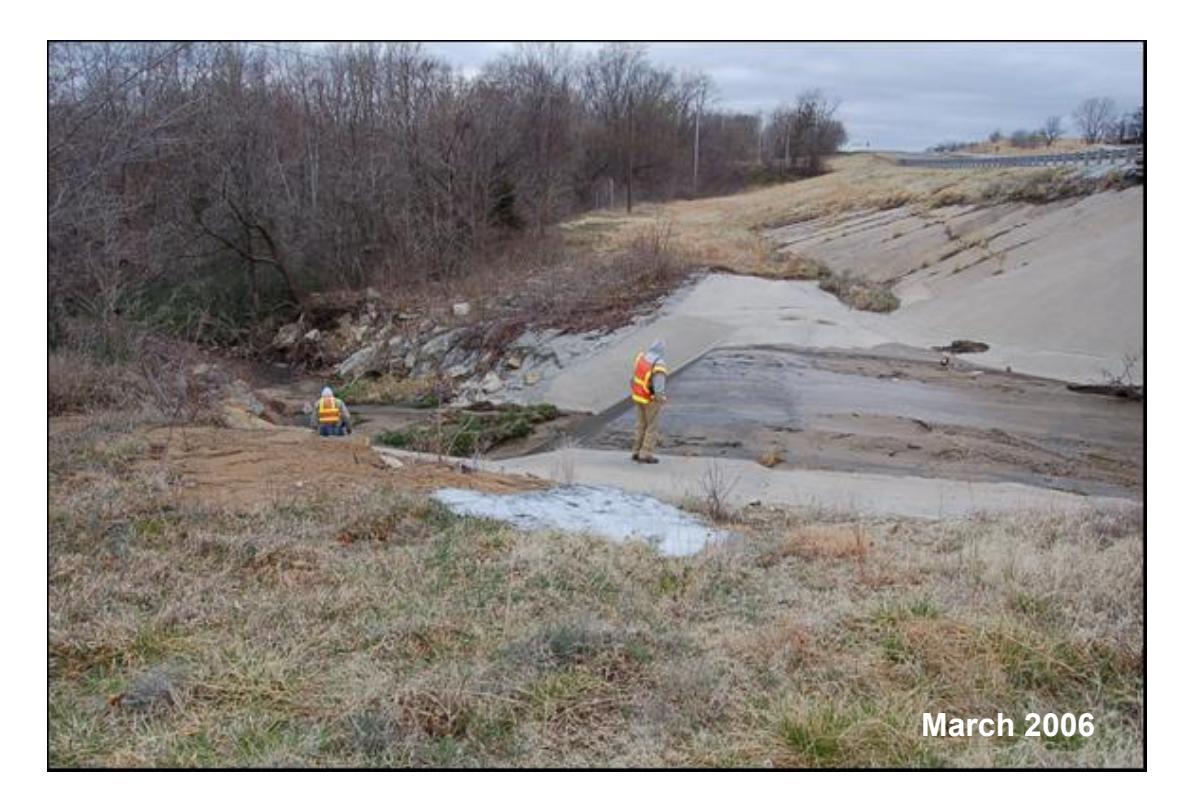
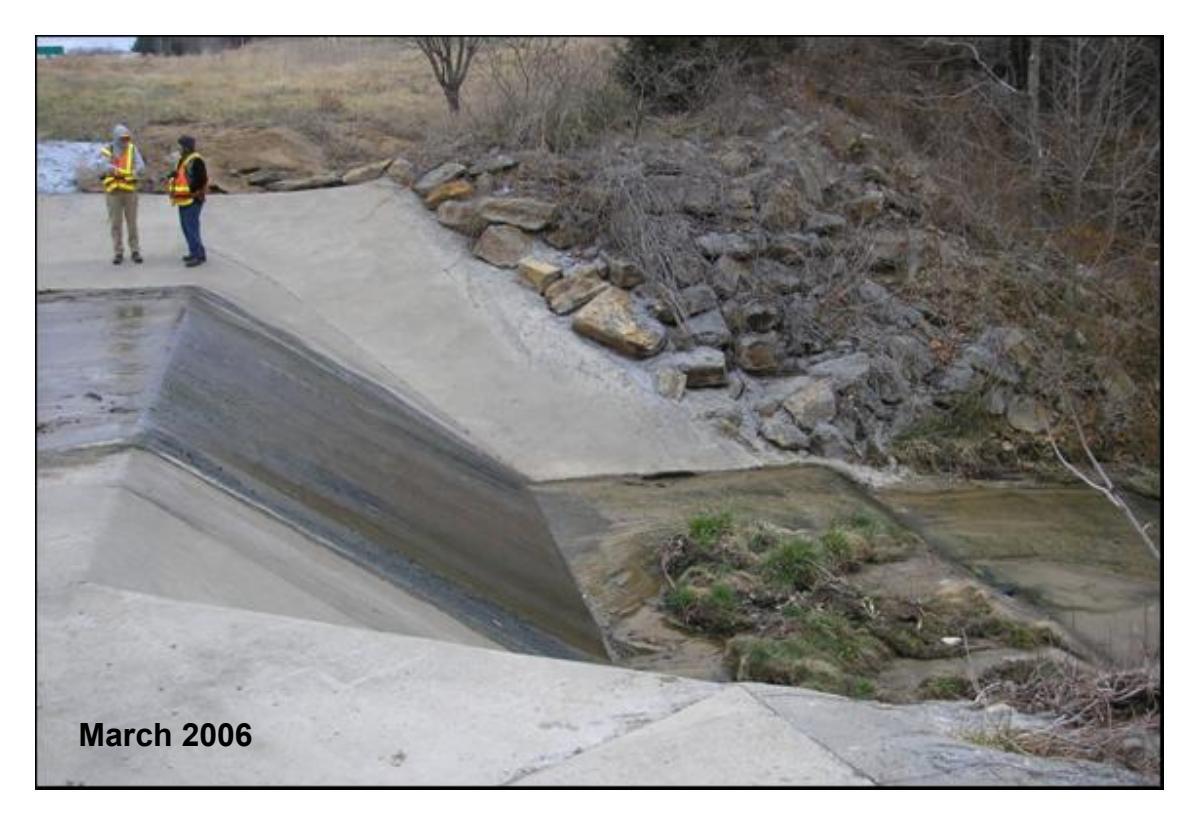
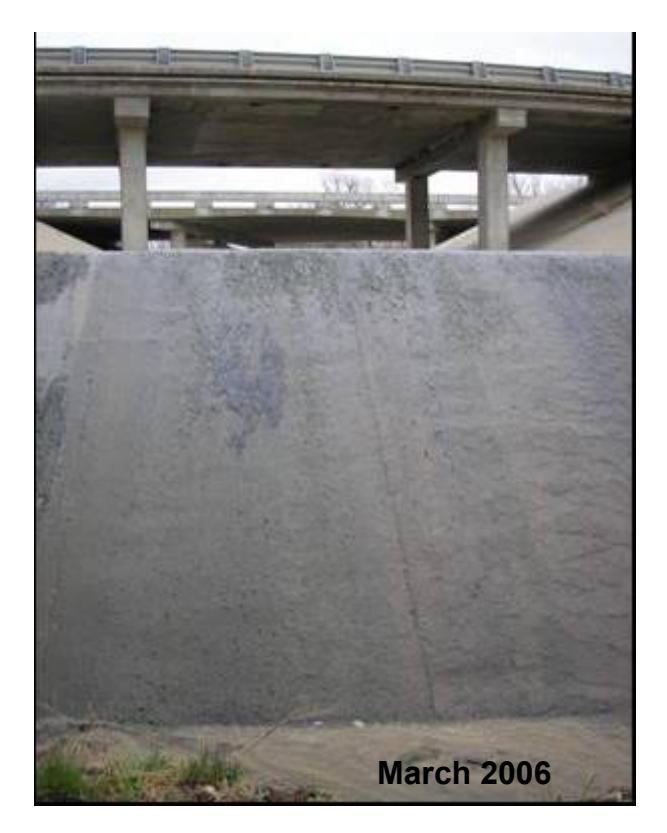
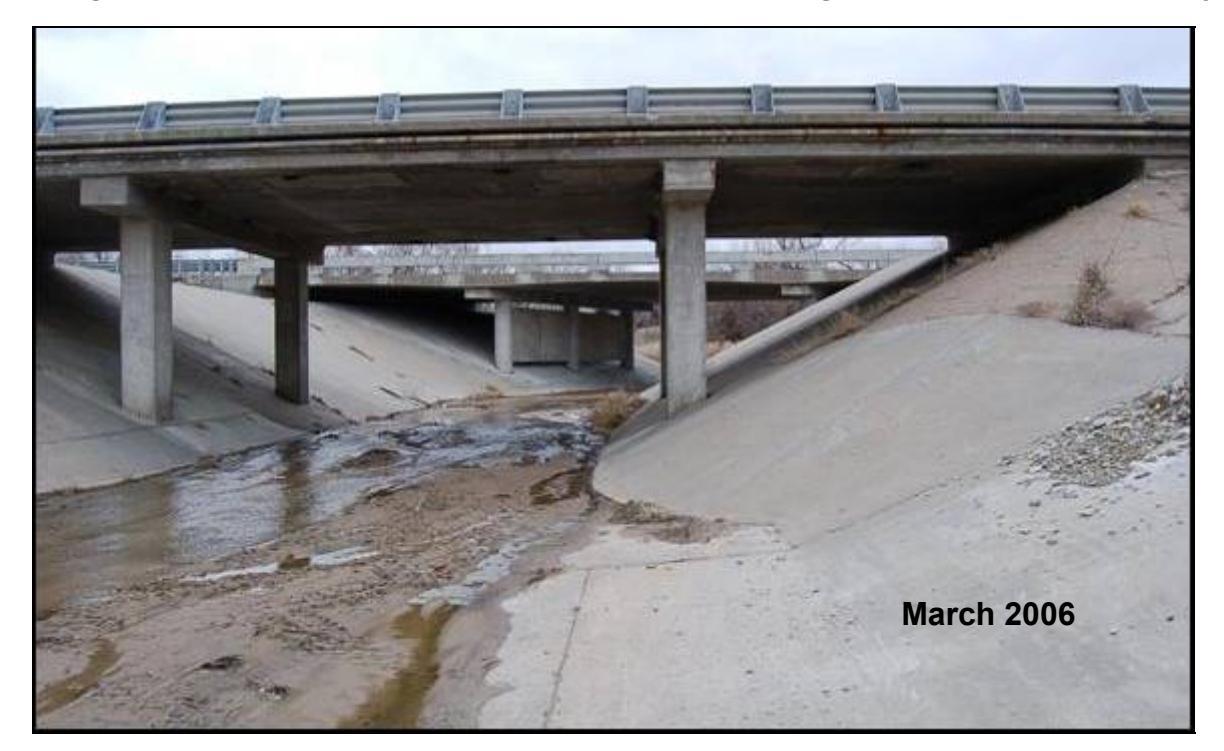
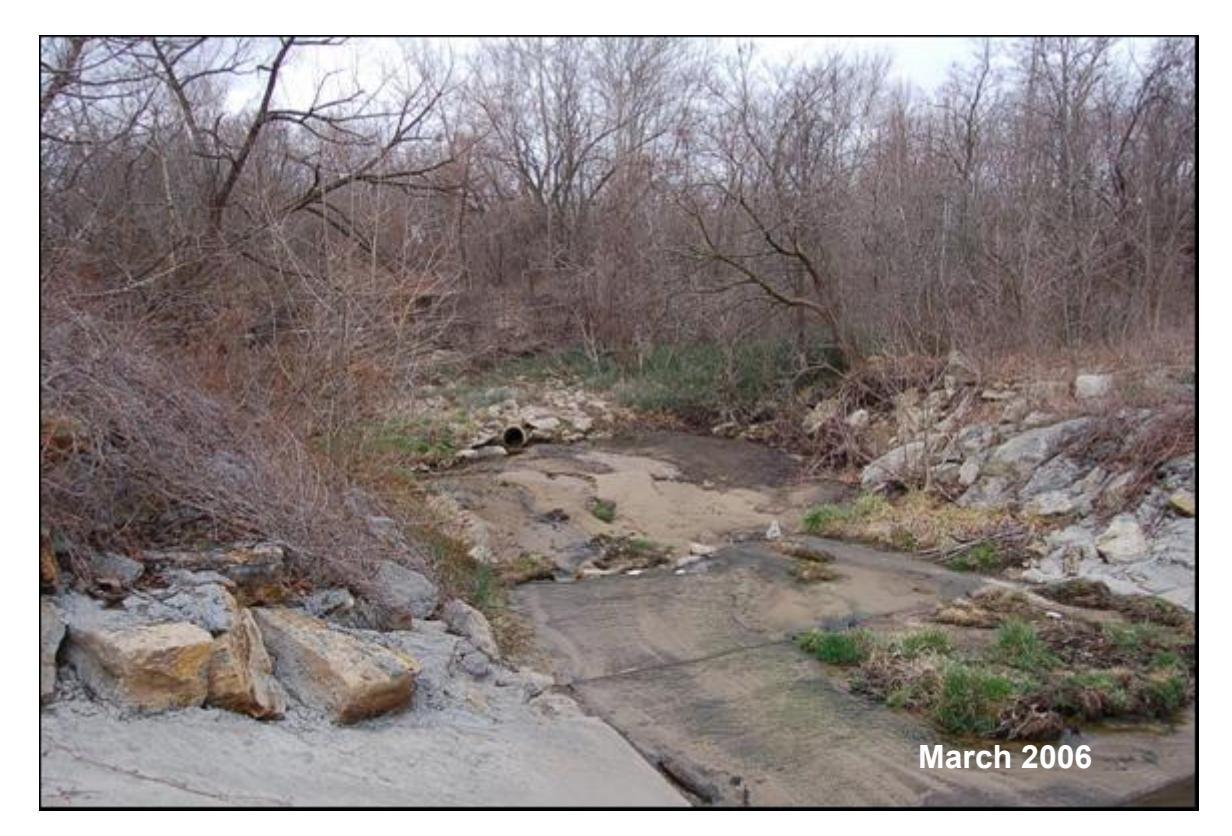
Figure 4.8 shows the location of Site 15. A large head cut was located downstream from the bridge on HW US-24. Figure 4.9 shows the location of the sheetpile wall. Figures 4.10-13 are photographs of the drop structure and upstream and downstream channels.

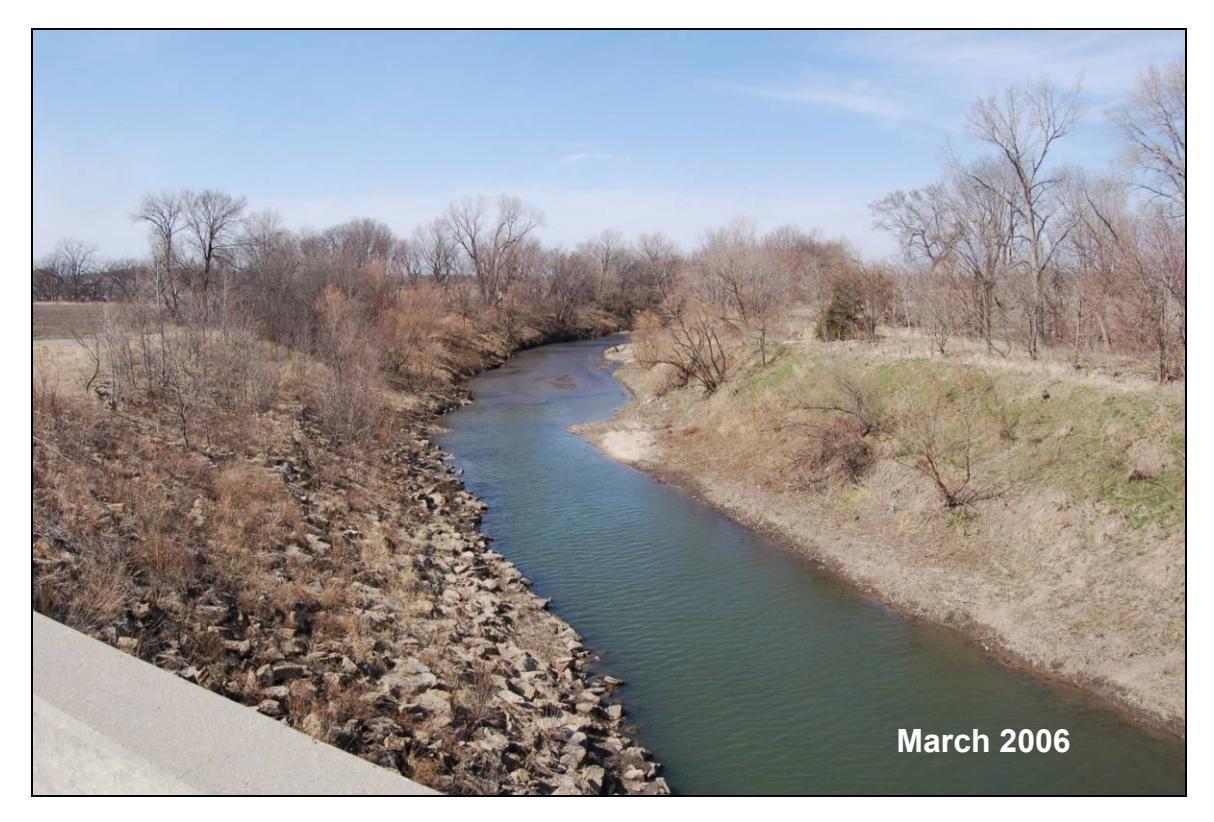
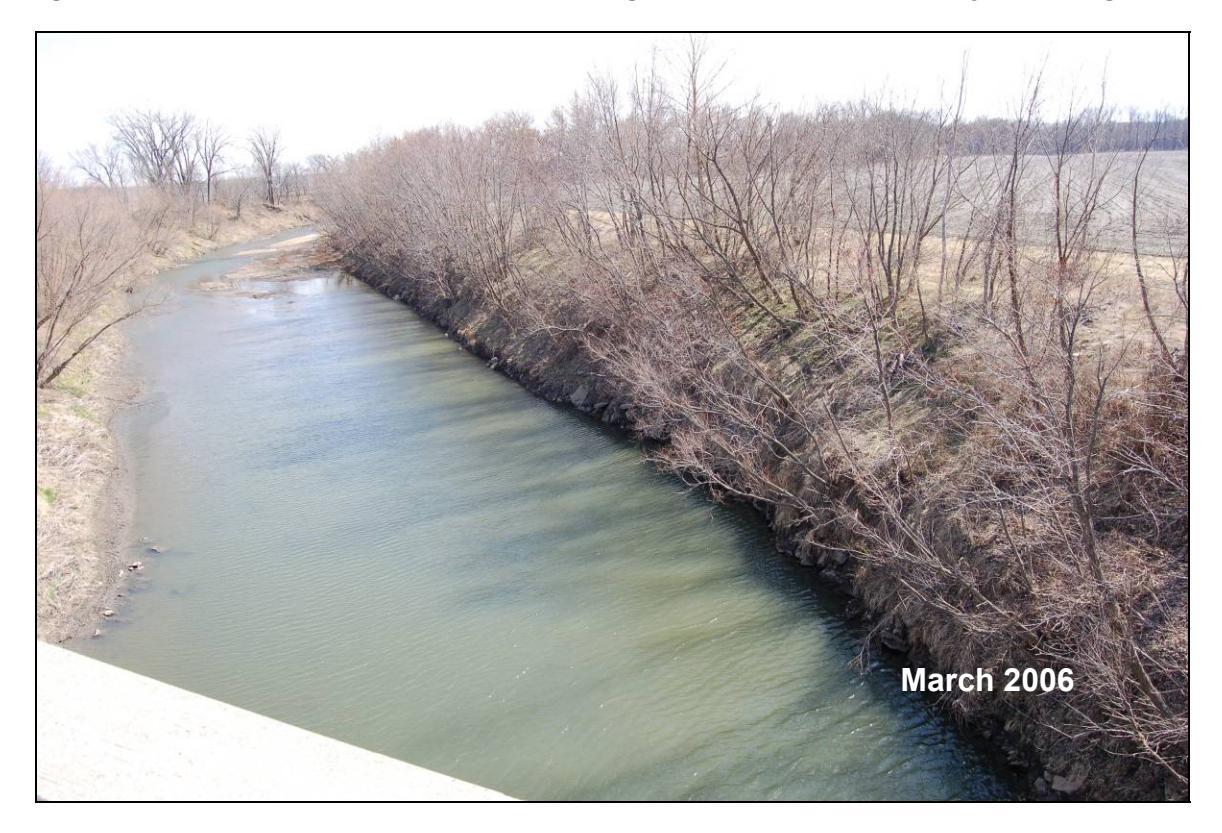
Site 6 is a location where the channel banks were eroding in a relatively straight reach of the Deleware River upstream and downstream from Bridge 3(046) on Highway K-116. Figure 5.2 shows an aerial photo of the site. Figure 5.3 and 5.4 show the location of hard points downstream from the bridge. Note in Figure 5.3 the location of the old channel bed to the east of the current channel. Six hard points are located on the left bank at and downstream from the point where the new and old channels meet. The photos of Figures 5.5 and 5.6 are taken looking upstream and downstream from the bridge as

supported by Figure 5.5. The channel appeared to be in good shape relative to bank erosion. Consequently, the hard points appeared to be working as intended. This side included additional bank protection measures upstream from the bridge.

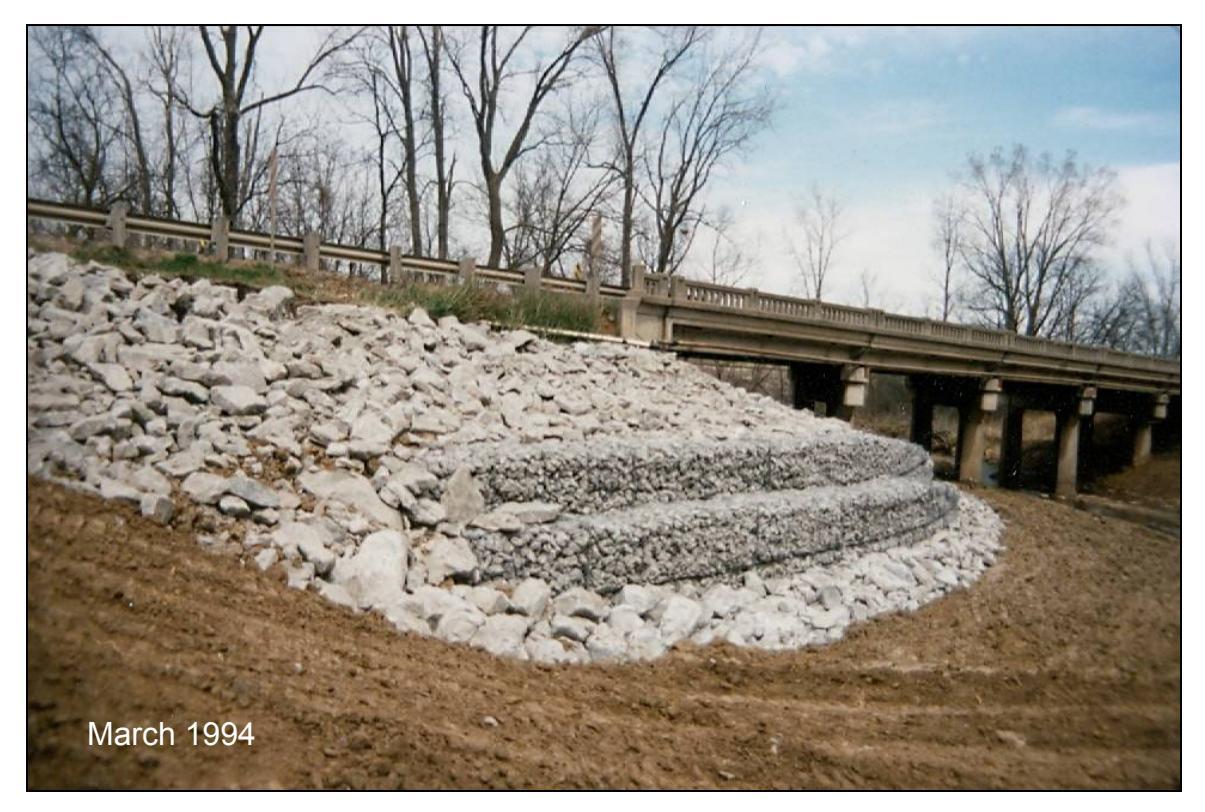
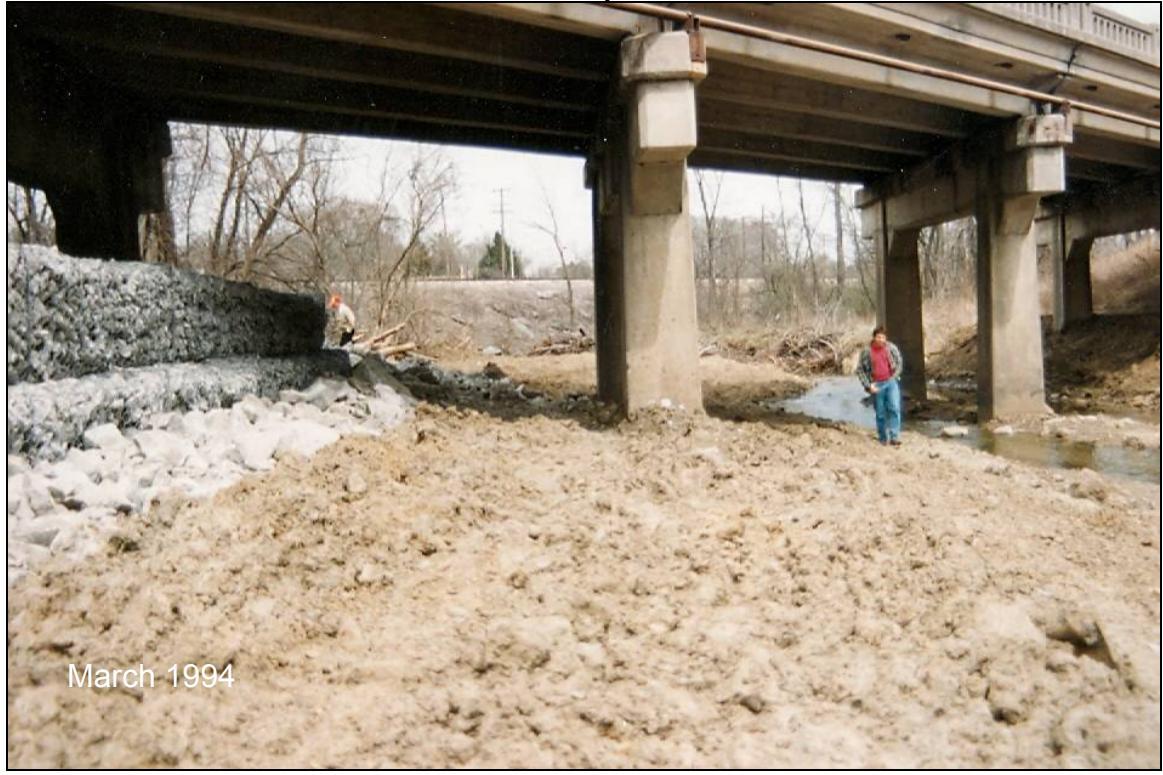
Figure 6.2 shows Site 11 where gabion baskets and bank protection were used to protect a bridge abutment. The damaged left abutment is shown in Figure 6.3. Figures 6.4 and 6.5 show the left abutment in March 1994 right after construction was completed. Figure 6.6 shows the right abutment in 1994. It was also repaired using gabion baskets and riprap bank protection. Figures 6.7-9 show the site in March 2006.

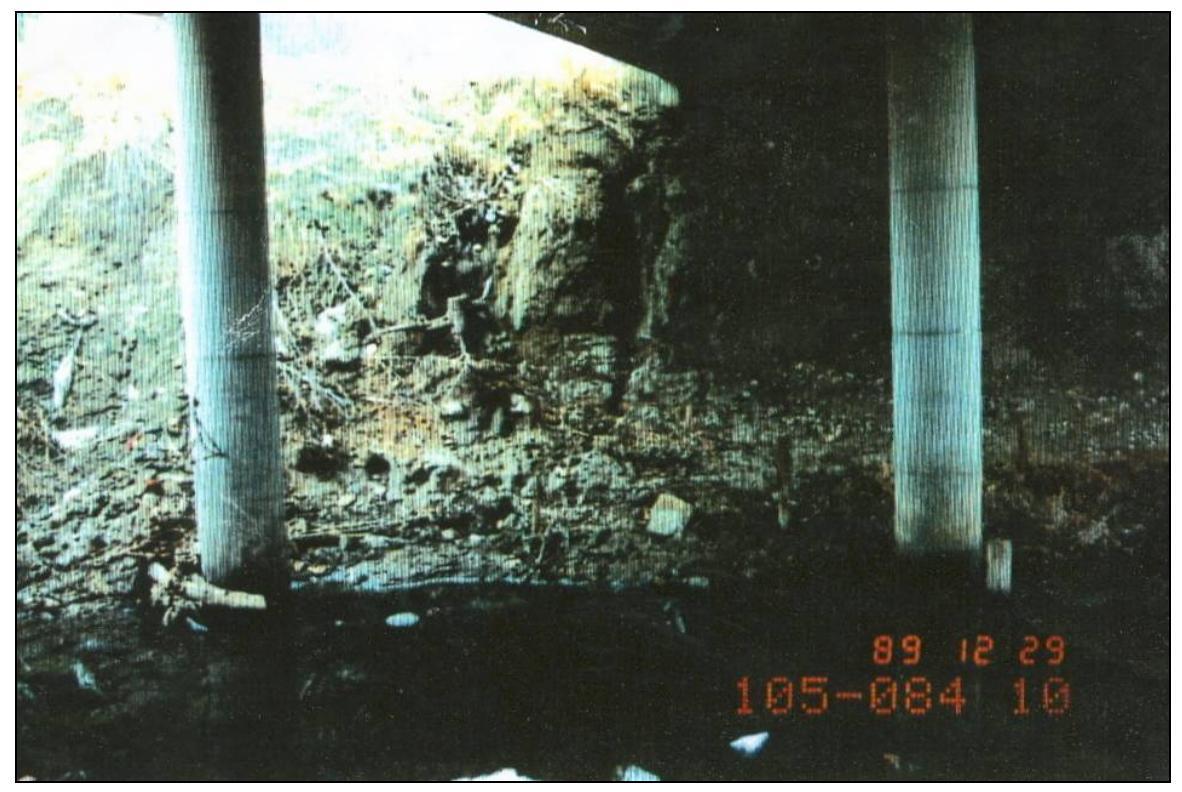
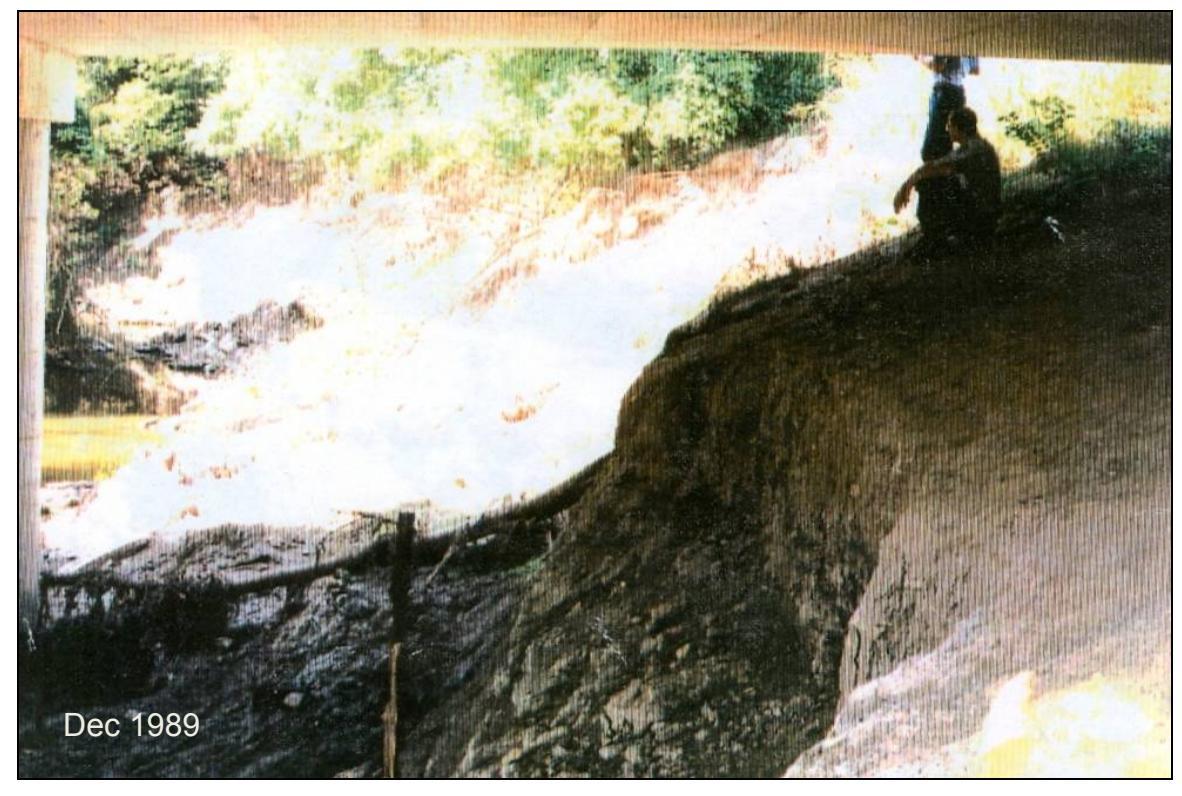
Figure 6.10 is an aerial view of Site 12 in Bonner Springs KS. Note that the channel makes a very sharp bend just upstream from the bridge. Also, the ditch on the upstream east side of the bridge carries flow into the channel directly upstream from the bridge. These flow characteristics may have caused the extensive should shown at the left bridge abutment in Figures 6.11-12. The scour hole allowed a significant portion of the flow to pass through the bridge on the outside of the bridge piers shown in Figure 6.12. Figures 6.13 and 6.14 are sketches from the construction plans showing the backfill and the placement of gabion baskets. Figures 6.14-18 are photographs of the repaired site.
