Report No. K-TRAN: KU-06-7 FINAL REPORT

STREAM INSTABILITY COUNTERMEASURES APPLIED AT KANSAS DEPARTMENT OF TRANSPORTATION HIGHWAY STRUCTURES

November 2008

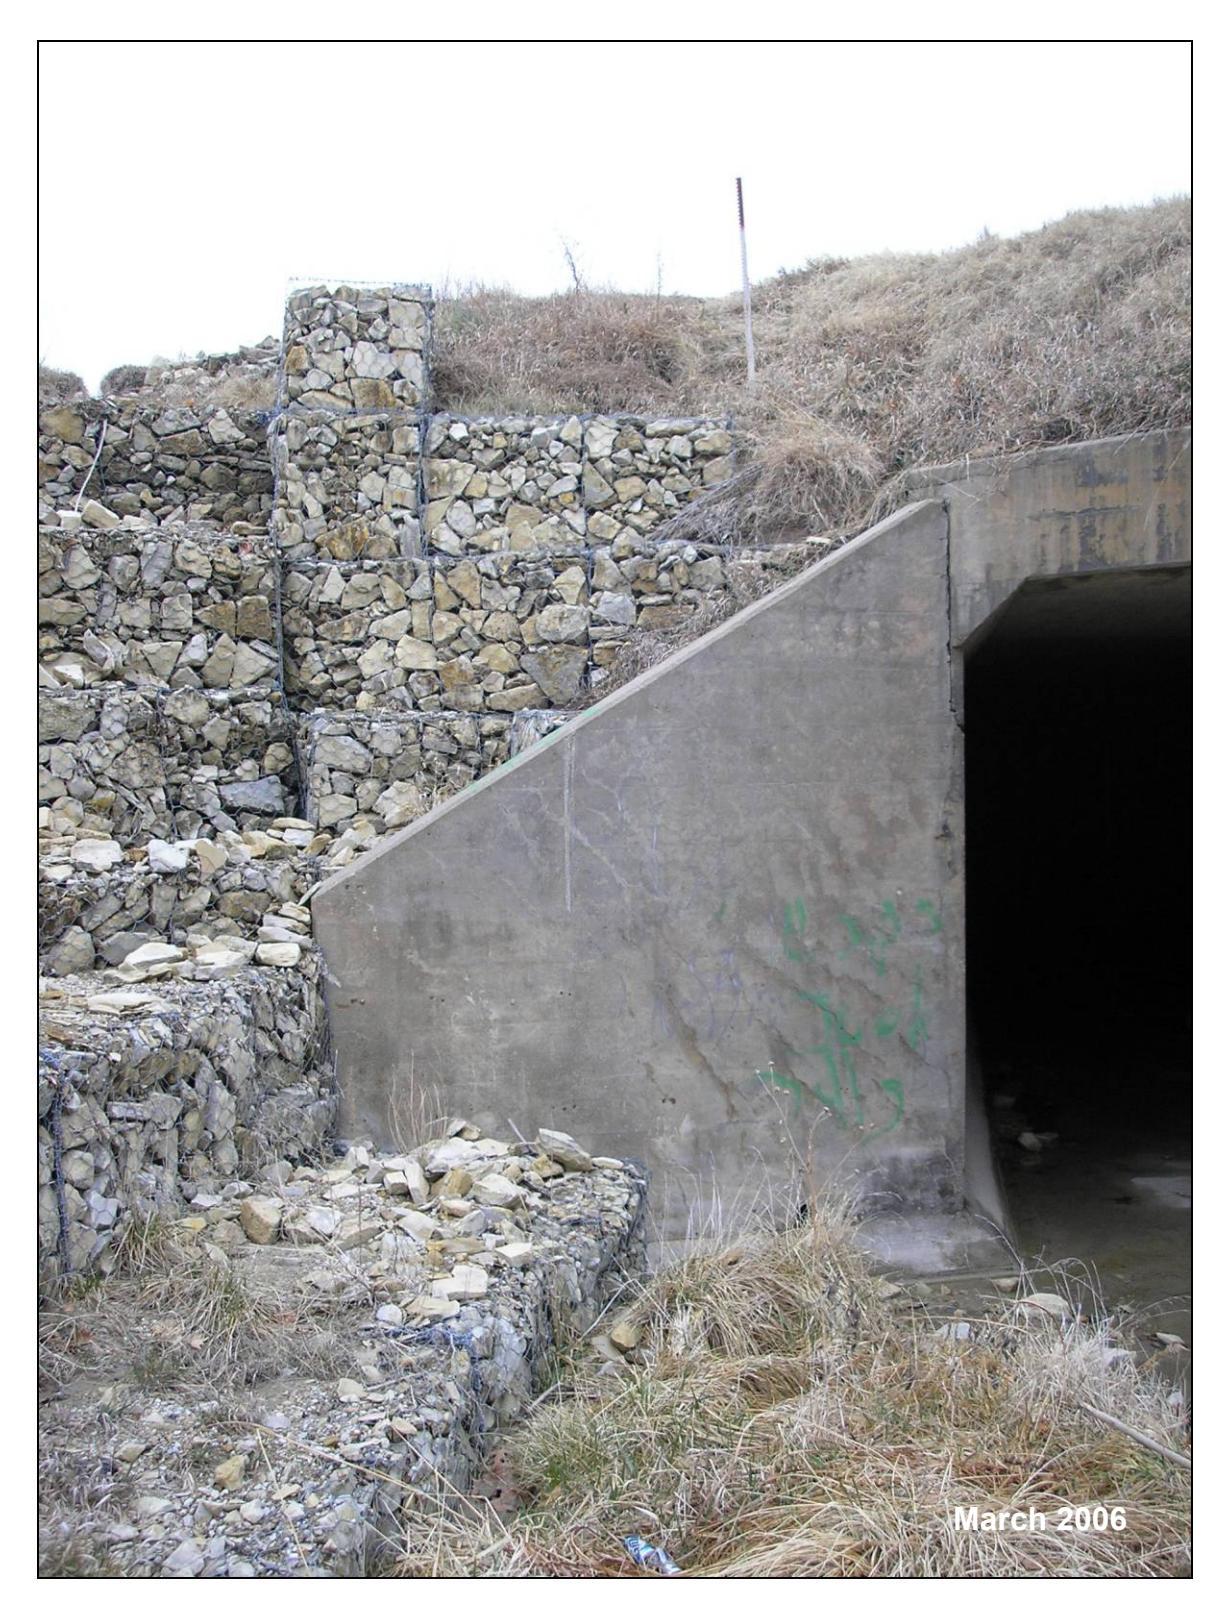
Site 13 addressed scour at the left wingwall of an RCB. Flow entered the channel just upstream from the culvert entrance at a very steep grade. Figures 6.19-21 show the gabion basket arrangement used to control the scour. The steepness of the "ditch" flow is evident from Figure 6.20.

Figure 6.19: Site 13, Manhattan KS, Riley County Gabion Baskets RCB Wingwall Protection

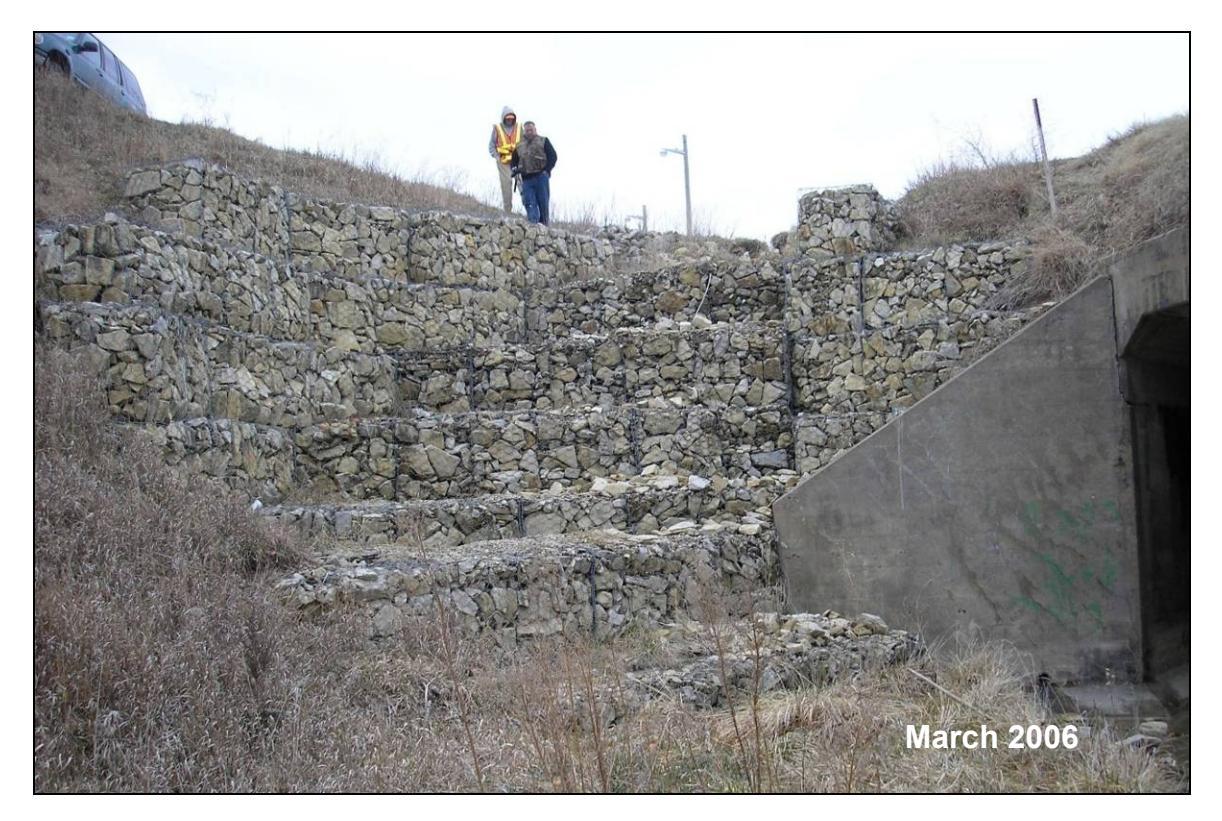
Figure 6.20: Site 13, Manhattan KS, Riley County Gabion Baskets RCB Wingwall Protection

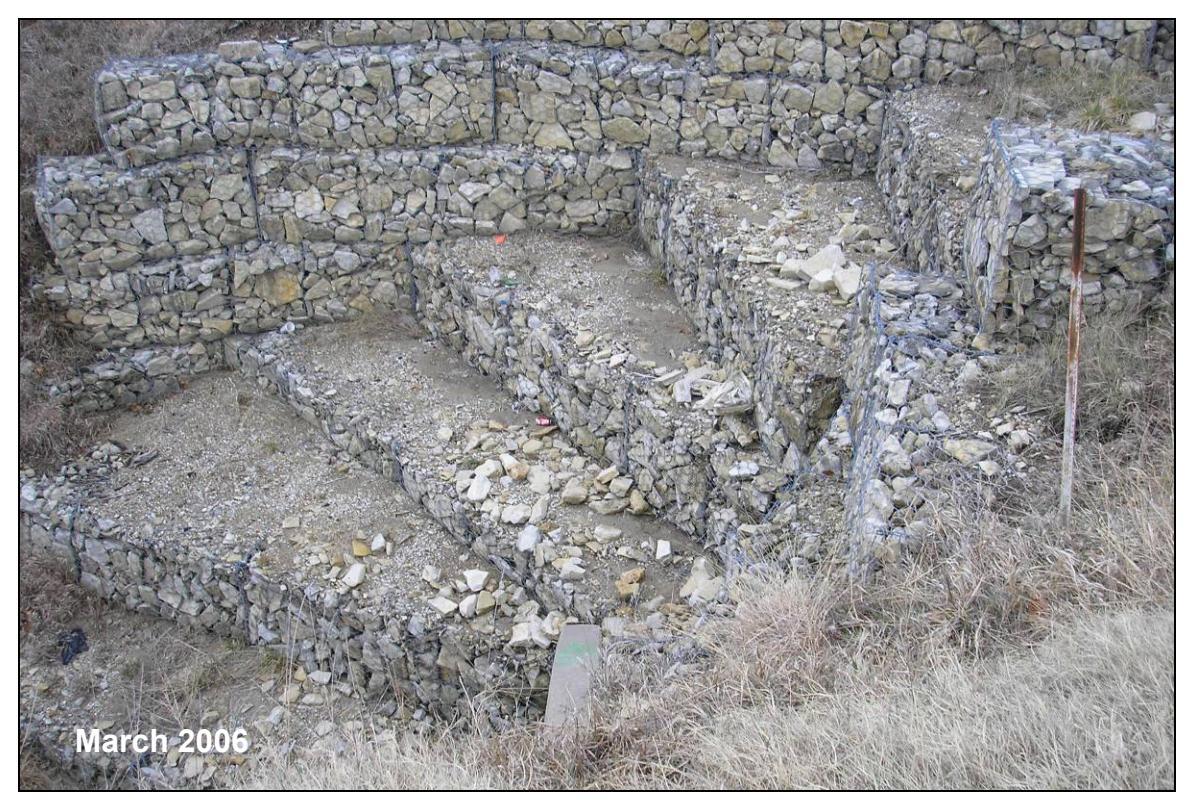
Figure 6.21: Site 13, Manhattan KS, Riley County Gabion Baskets RCB Wingwall Protection
