1. Report No. FHWA/TX-08/0-5210-5		2. Government Accession No.		3. Recipient's Catalog No.	
4. Title and Subtitle CRASH TESTING AND EVALUATION OF TXDOT BURN BAN SIGNS				5. Report Date December 2008 Published: August 2009

**CRASH TESTING AND EVALUATION OF
TXDOT BURN BAN SIGNS**

Report 0-5210-5
Project 0-5210
Project Title: Roadside Crash Testing Program
for Design Guidance and Standard Detail Development

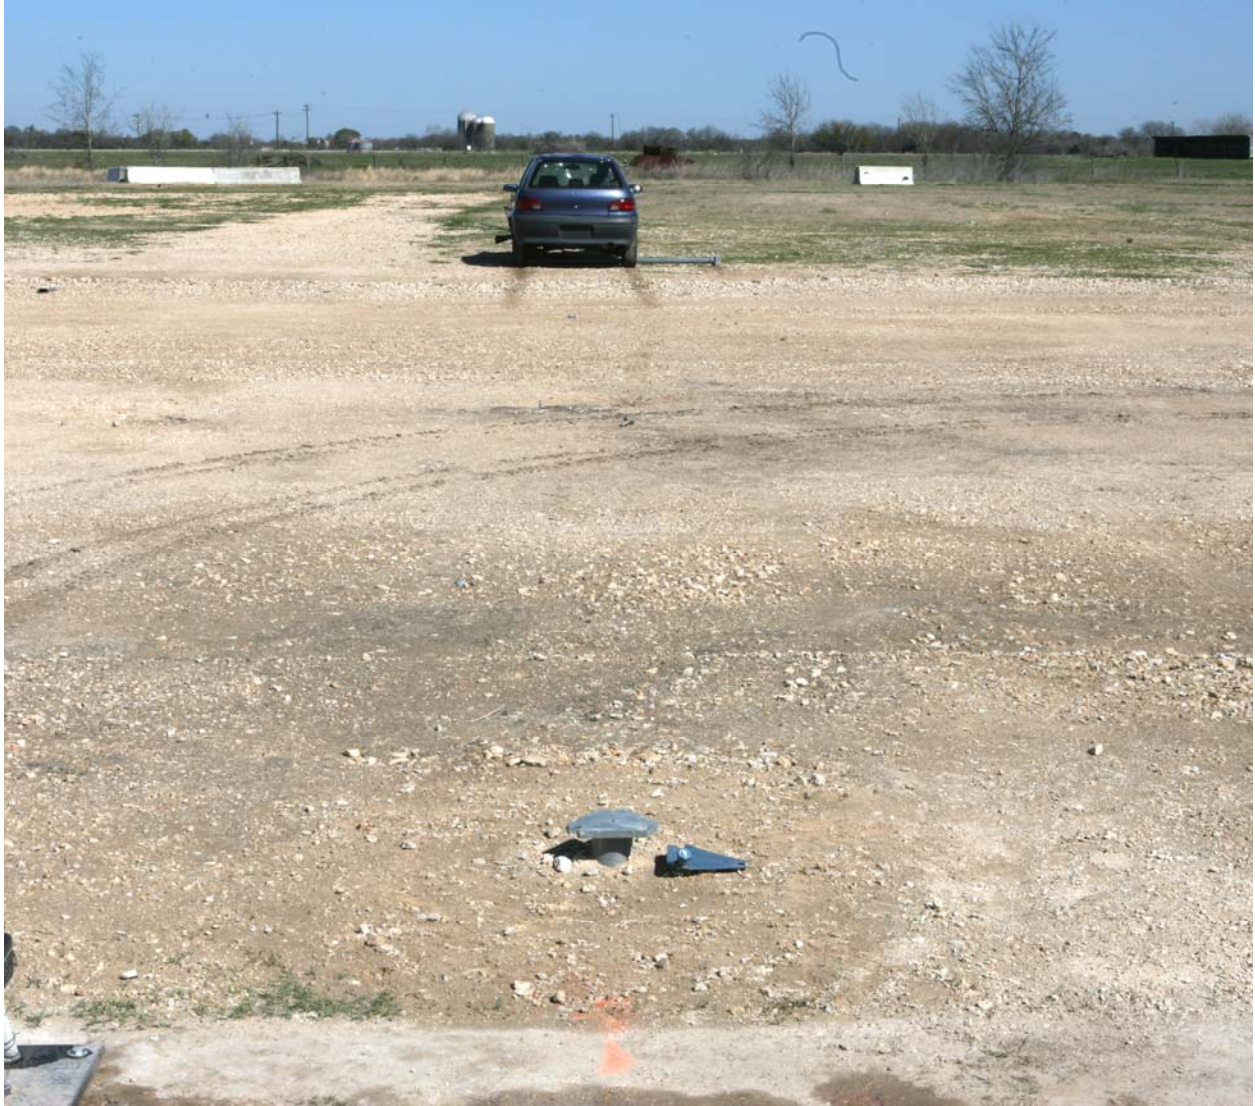
Figure 3.6. After Impact Trajectory Path for Test 452108-1.

Damage to the sign support installation is shown in Figures 3.6 and 3.7. The base showed no movement in the ground. The keeper plate and one bolt remained at the base, one bolt came to rest 12.5 ft downstream of impact, and the third was resting 57.5 ft downstream of impact. The sign panels and support came to rest under the vehicle, which came to rest 92.5 ft downstream from the point of impact.

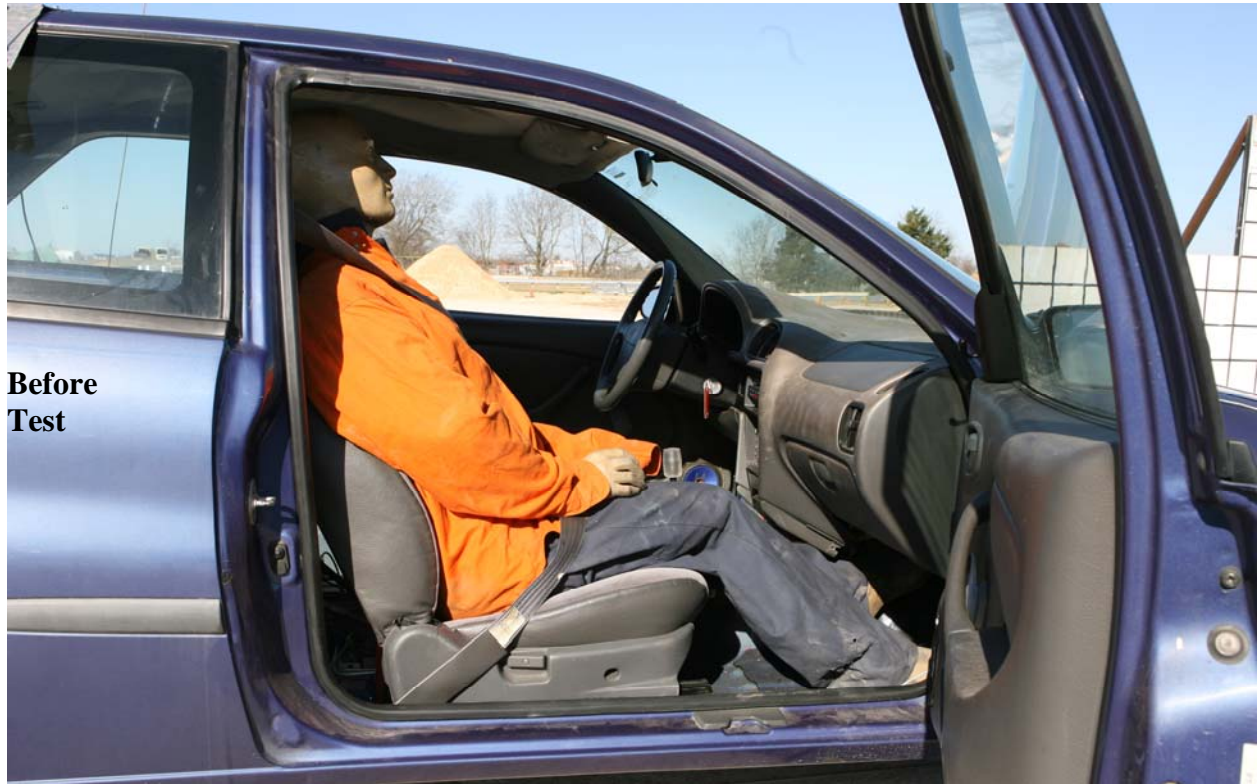
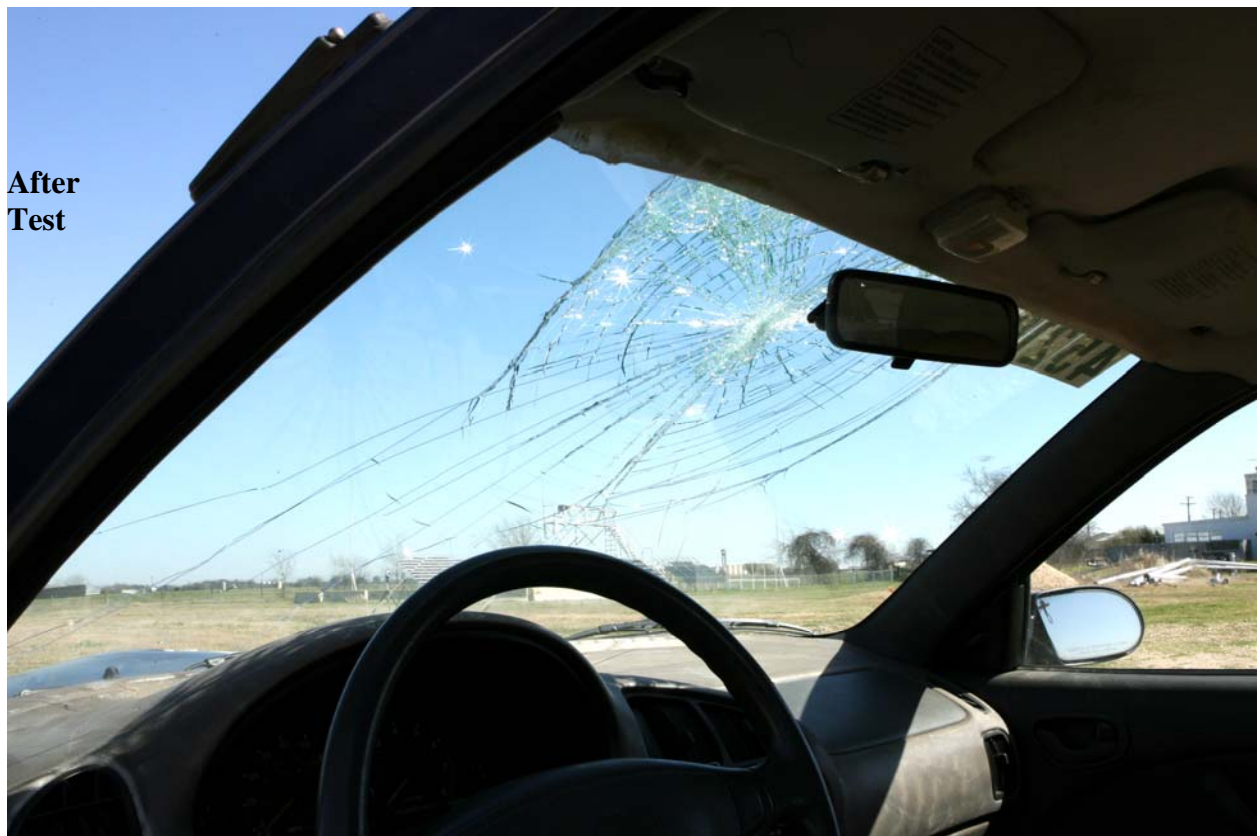
Figure 3.9. Interior of Vehicle for Test 452108-1.

Figures 3.8 and 3.9 show the damage to the exterior and interior of the vehicle, respectively. The front bumper, hood, radiator, and radiator support were deformed. The windshield was cracked near the roof line, but there was no hole. Maximum exterior crush to the vehicle was 6.3 inches on the front of the vehicle at a point 6 inches left (toward the driver side) of centerline. No occupant compartment deformation occurred. Exterior crush and occupant compartment measurements are shown in Appendix B, Tables B1 and B2, respectively.

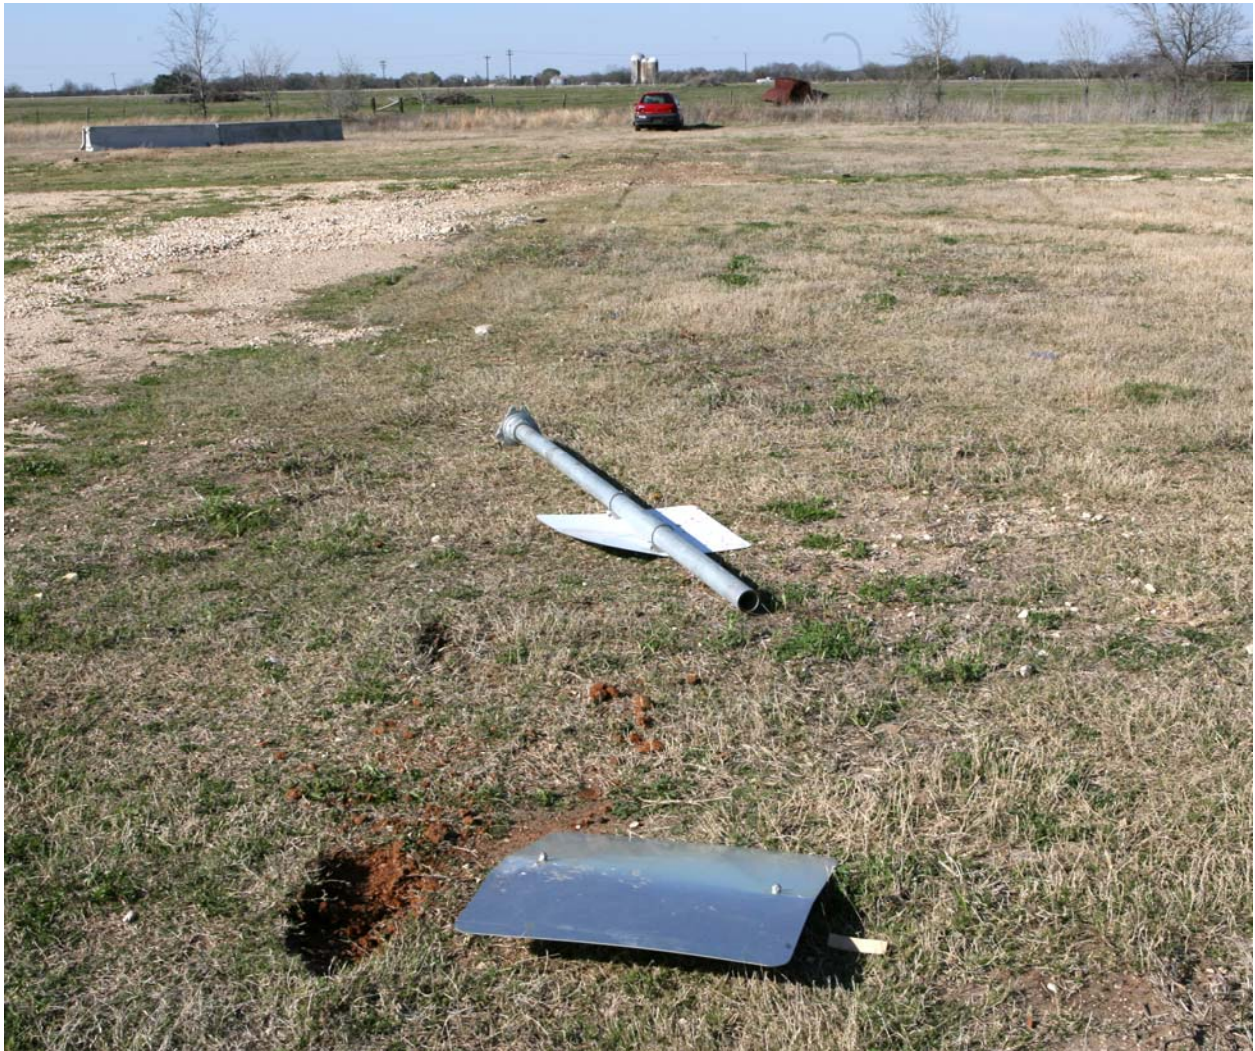
Figure 3.13. After Impact Trajectory Path for Test 452108-2.

Damage to the installation is shown in Figures 3.13 and 3.14. The base showed no movement in the ground. The keeper plate came to rest 28.5 ft downstream from impact and 30 inches to the right of centerline. One bolt remained at the base, one bolt came to rest 12.5 ft downstream of impact, and the third was resting 51 ft downstream of impact. The confirmation sign panel separated from the support came to rest near the support and confirmation sign panel, which came to rest 150 ft downstream from impact.

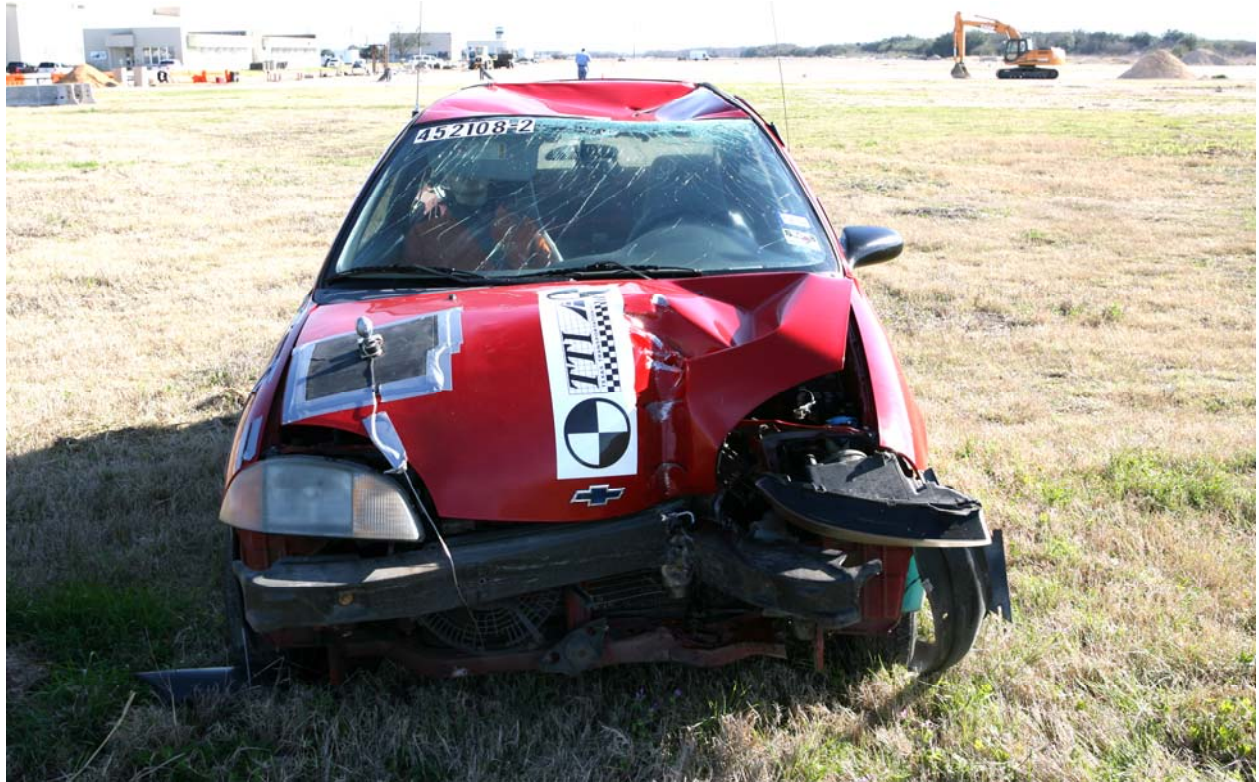
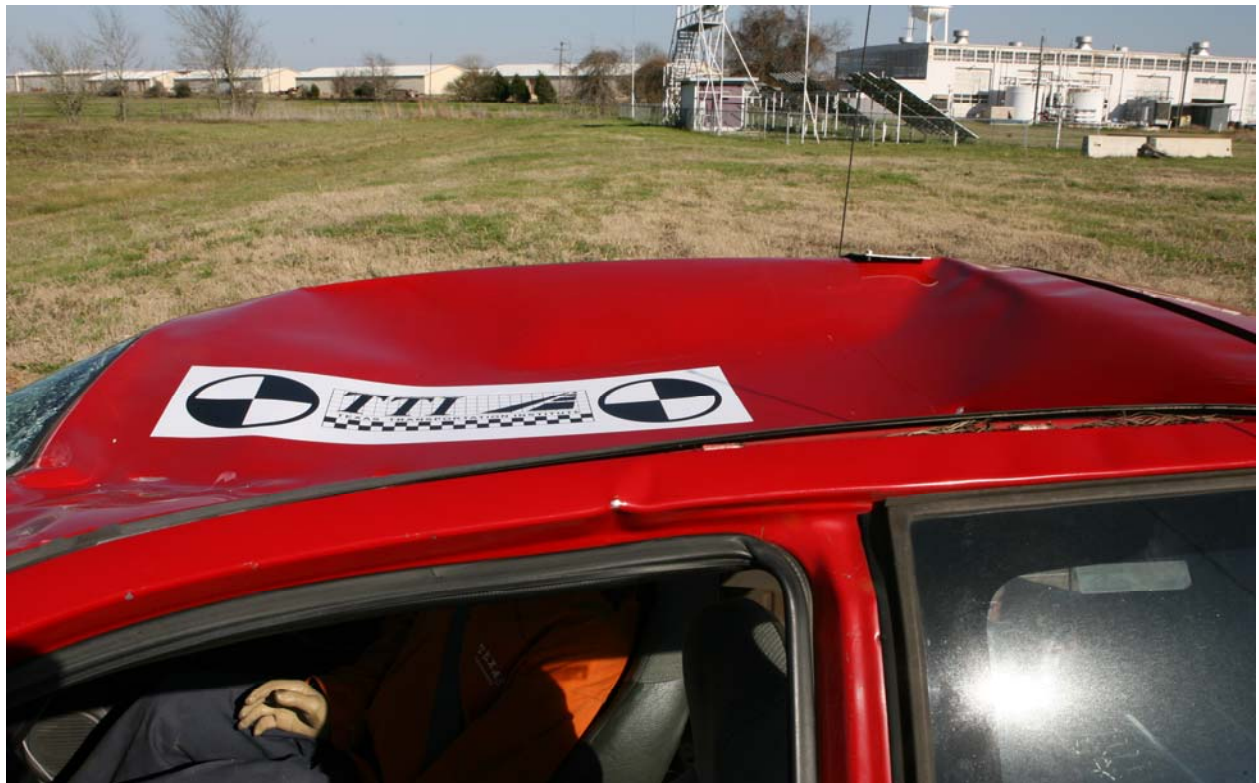
Figure 3.15. Vehicle after Test 452108-2.

Damage to the vehicle is shown in Figure 3.15. The front bumper, grill, hood, radiator, and radiator support were deformed. Maximum exterior crush in the frontal plane at the front bumper was 9.8 inches. The windshield was shattered downward from the roofline, but there was no loss of visibility. Two small cuts were noted in the roof, the largest measuring 0.6 × 1.6 inches. The roof was deformed downward a maximum of 5.1 inches on the exterior of the vehicle and deformed into the occupant compartment 5.0 inches. Photographs of the interior of the vehicle are shown in Figure 3.16. Exterior crush and occupant compartment measurements are shown in Appendix B, Tables B3 and B4, respectively.

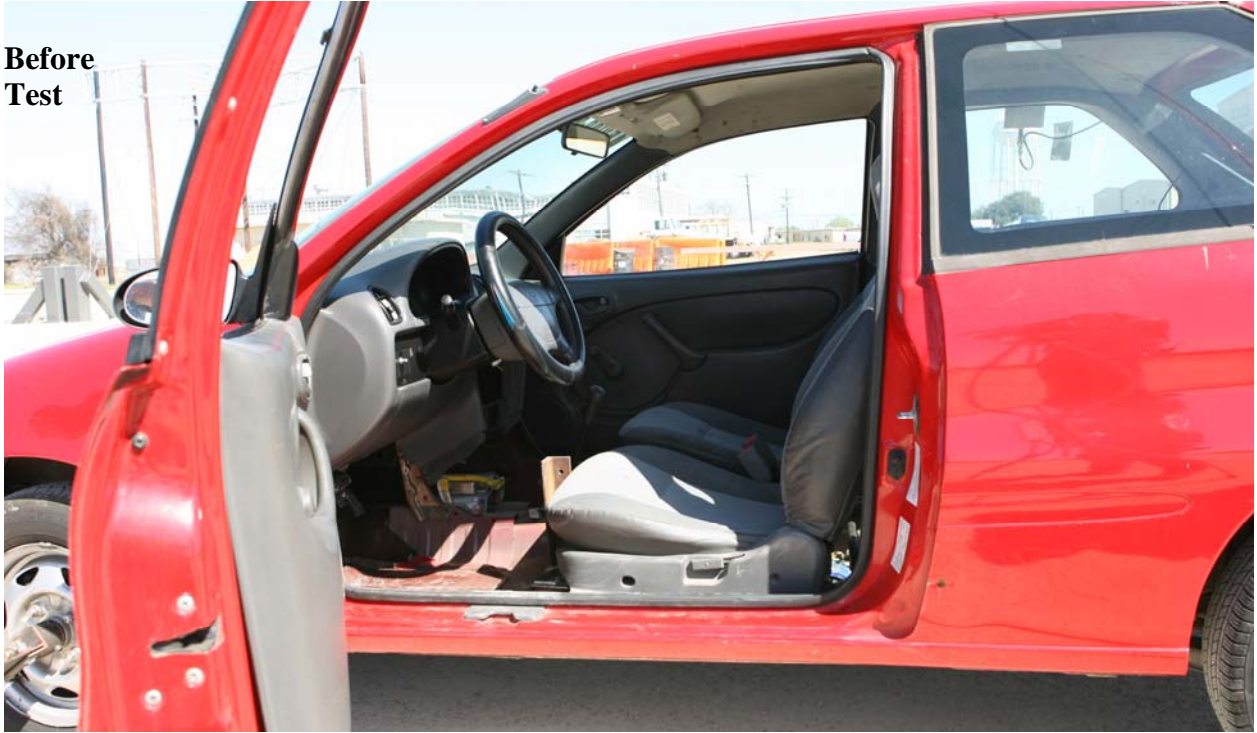
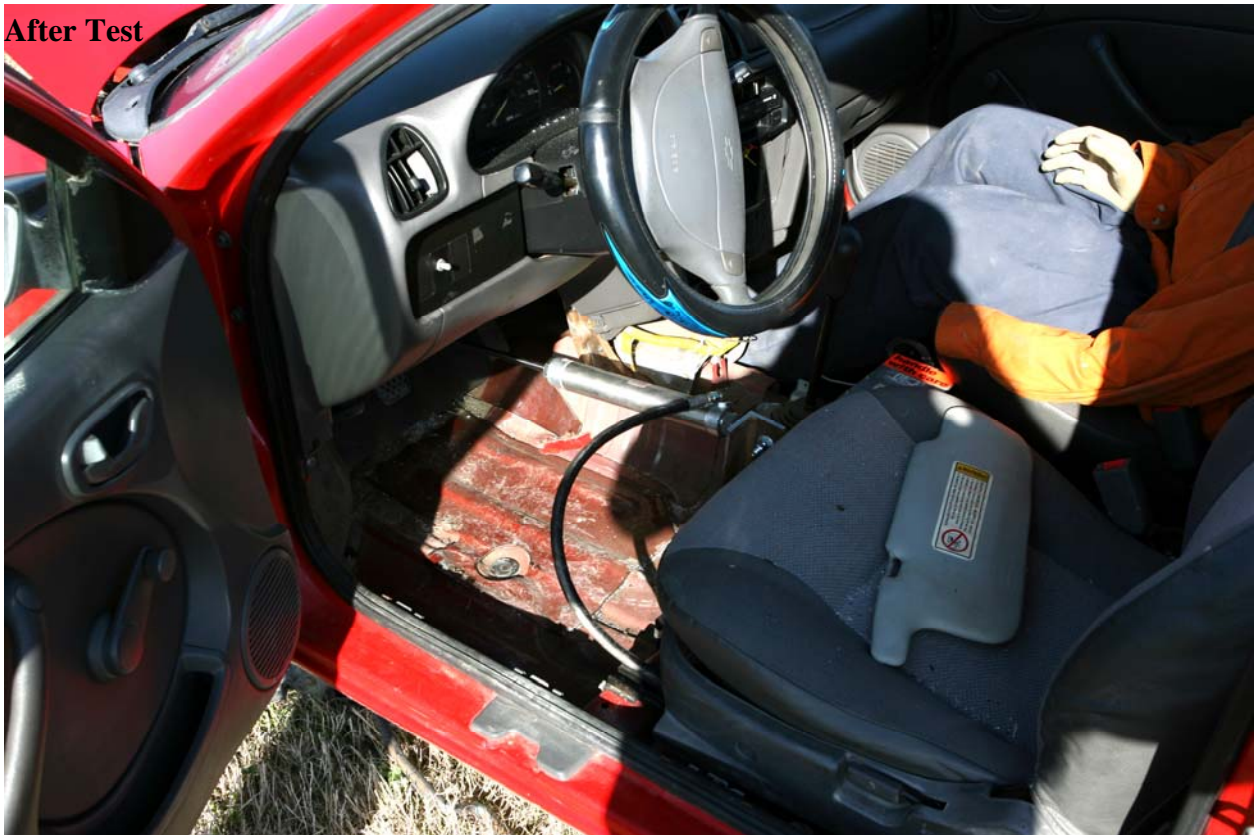
Figure 3.16. Interior of Vehicle for Test 452108-2.

Result: The detached sign support traveled with the vehicle and came to rest along the path of the vehicle. The support did not penetrate nor show potential for penetrating the vehicle, or to present undue hazard to others in the area. Maximum occupant compartment deformation was 5.0 inches in the roof area. (PASS)

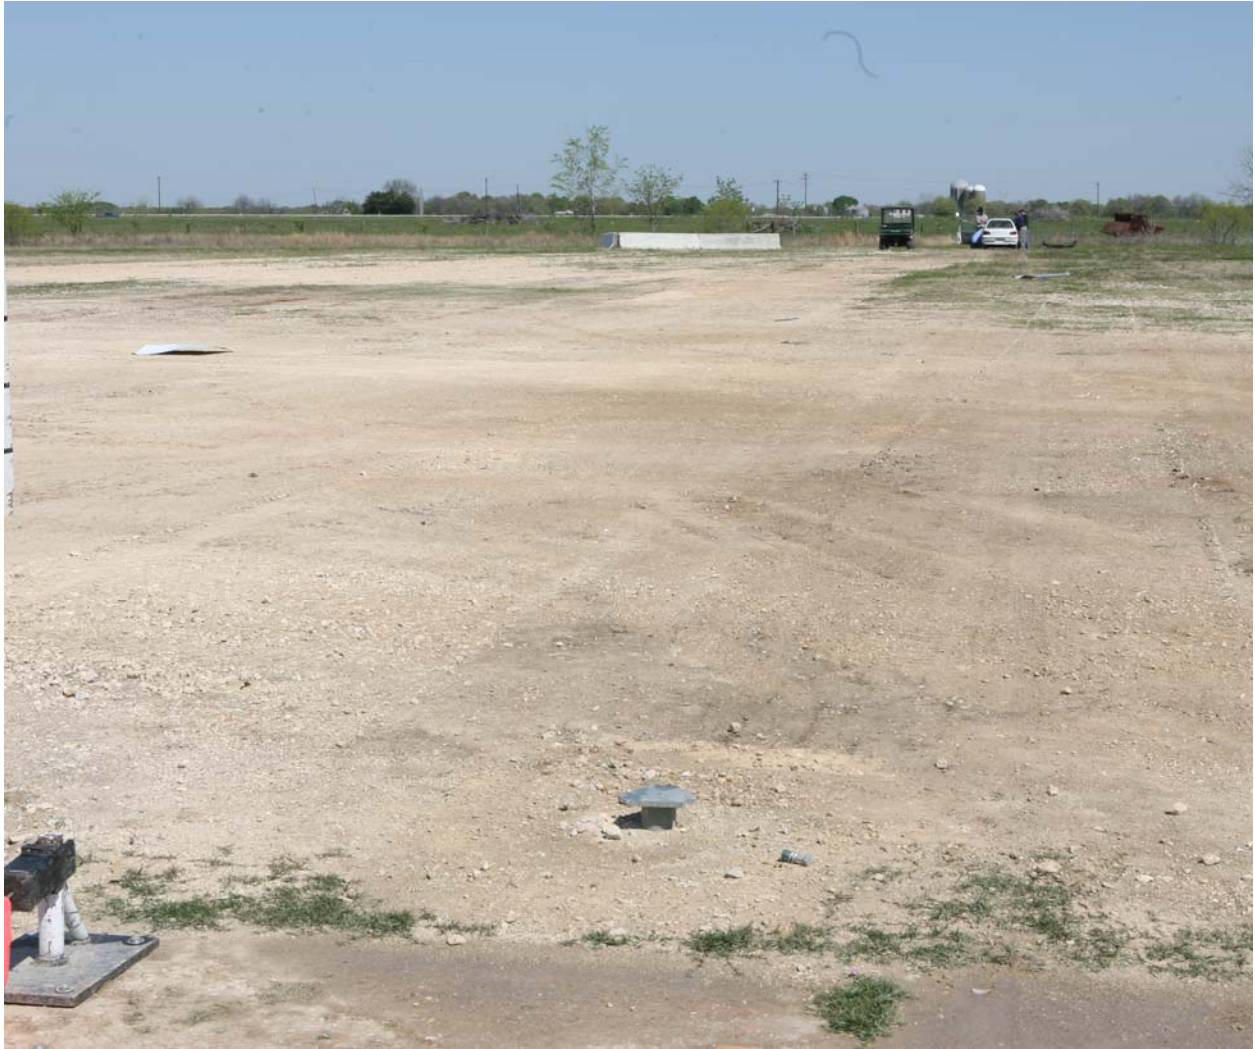
Figure 4.6. After Impact Trajectory Path for Test 452108-3.

Damage to the installation is shown in Figures 4.6 and 4.7. The base showed no movement in the ground. The keeper plate and bolts came to rest near the base. The 30 inch × 36 inch burn ban sign panel separated from the support and came to rest 58 ft downstream of impact and 28 ft to the left of centerline. The 24 inch × 24 inch confirmation sign panel and support came to rest 149 ft downstream of and directly in line with the point of impact. The brakes on the vehicle were applied 160 ft behind the test installation, and the vehicle subsequently came to rest 322 ft downstream from impact.

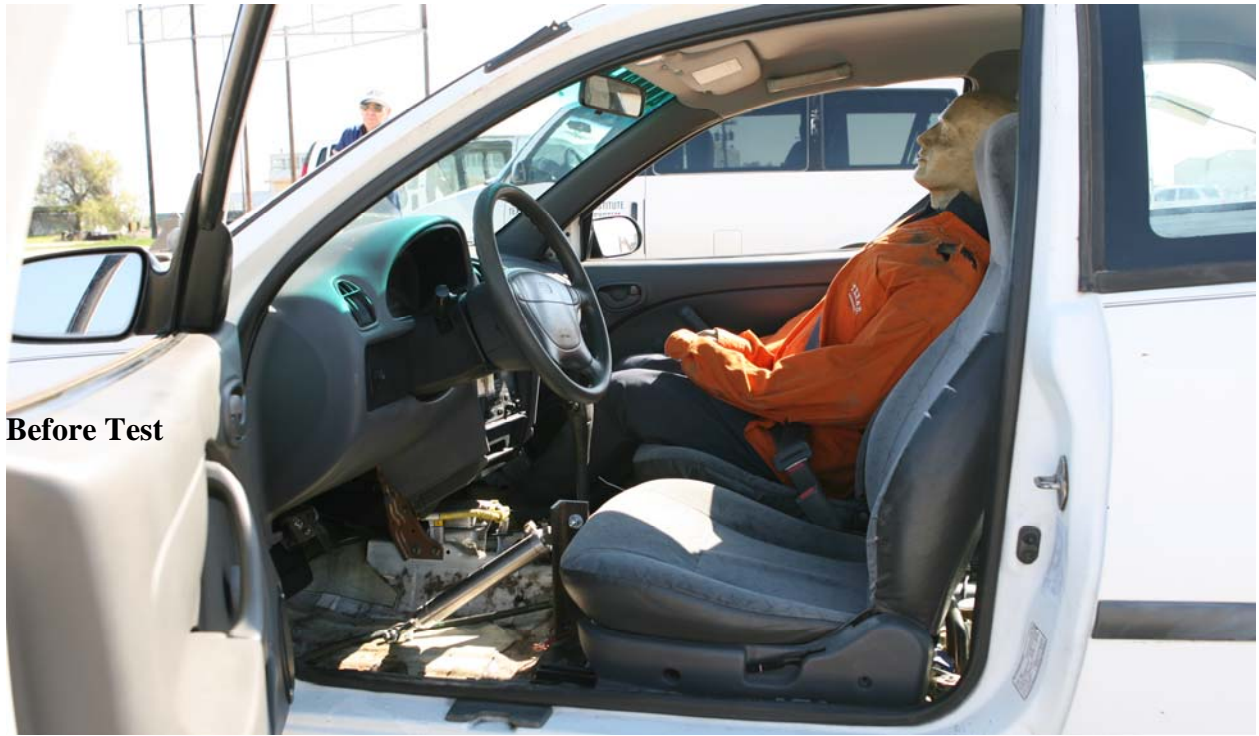
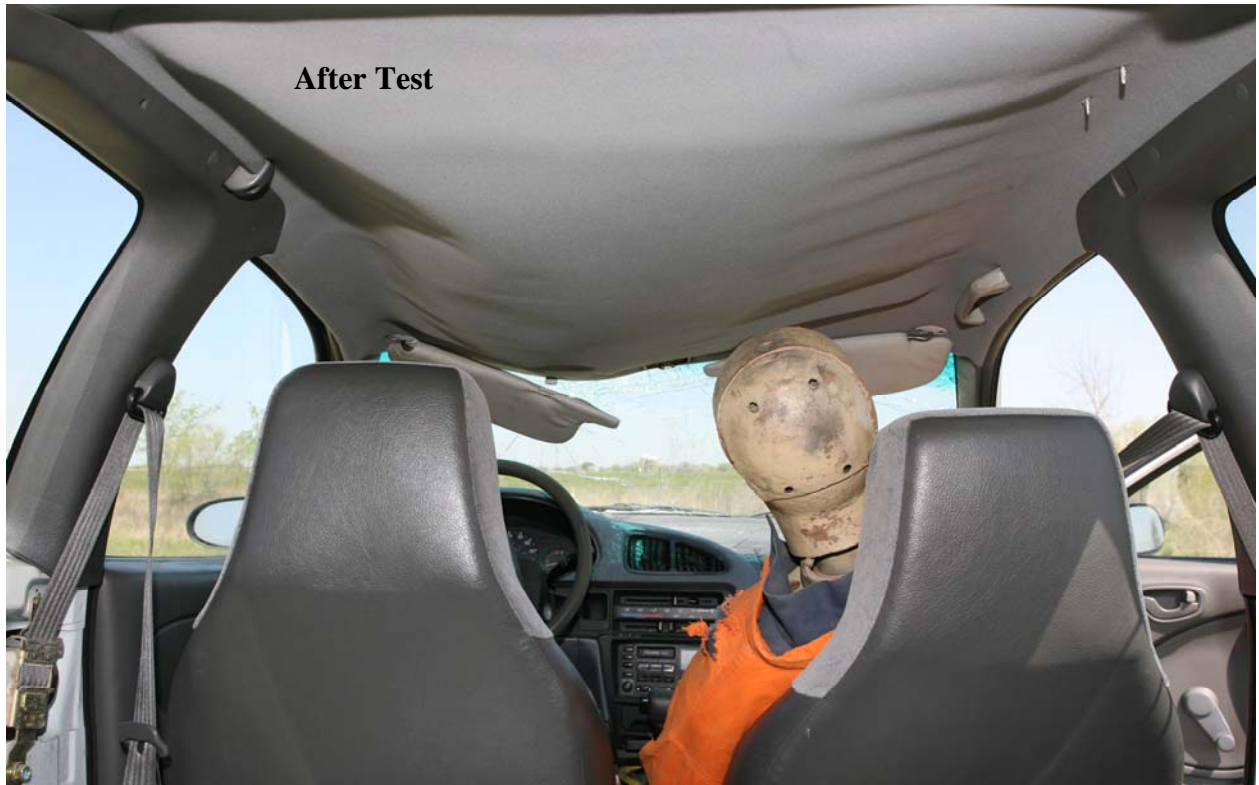
Figure 4.9. Interior of Vehicle for Test 452108-3.

Figures 4.8 and 4.9 show the damage to the exterior and interior of the vehicle, respectively. The front bumper, hood, radiator, and radiator support were deformed. The windshield was cracked near the roof line, but there was no hole. Maximum exterior crush in the frontal plane at the front bumper was 6.0 inches at a point, 6 inches to the left (toward the driver's side) of centerline. Maximum occupant compartment deformation was 5.6 inches in the roof area. Exterior crush and occupant compartment measurements are shown in Appendix B, Tables B5 and B6, respectively.

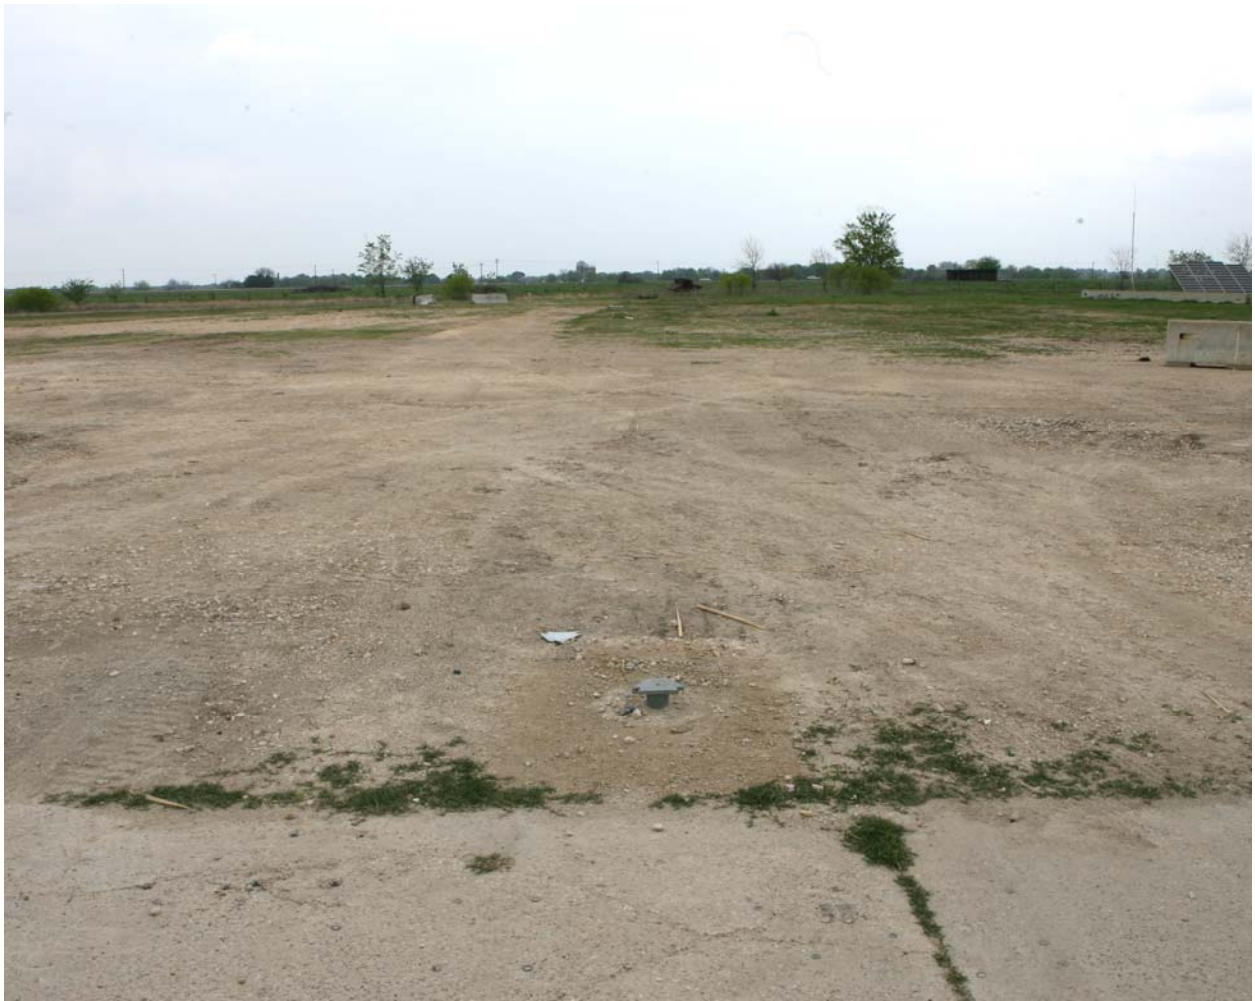
Figure 4.13. After Impact Trajectory Path for Test 452108-4.

Damage to the installation is shown in Figures 4.13 and 4.14. The base showed no movement in the ground. The keeper plate and bolts came to rest near the base. The 30 inch × 36 inch burn ban sign panel separated from the support and came to rest 71 ft downstream of impact and 9 ft to the left. The 24 inch × 24 inch confirmation sign panel and support came to rest 213 ft downstream of impact and 4 ft to the left of centerline. The vehicle came to rest 466 ft downstream and 37 ft to the left of the point of impact.

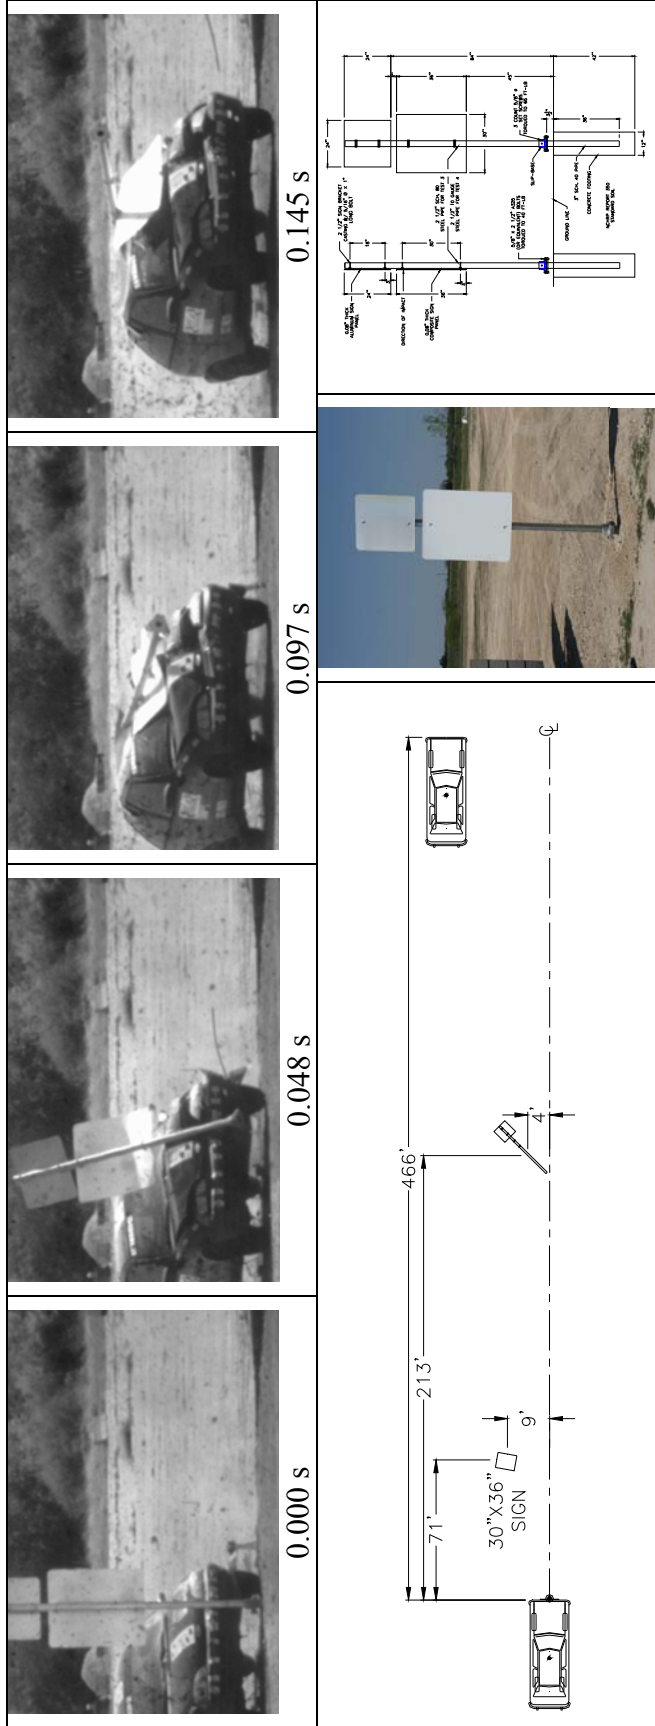
Figure 4.17. Summary of Results for NCHRP Report 350 Test 3-61 on the 10 Gauge Steel Pipe Support with 30 inch x 36 inch Burn Ban Sign.

General Information	Texas Transportation Institute	Impact Conditions	Speed (mi/h) 62.1	Test Article Debris Scatter (ft)	Laterally Left 9.0
Test Agency	452108-4	Angle (deg)	0	Laterally Right	0
Test No.	2008-03-24	Exit Conditions	Speed (mi/h) 61.9	Vehicle Damage	
Date		Angle (deg)	0	Exterior	
Test Article	Sign Support	Occupant Risk Values		VDS	12FL4
Type	TXDOT Slip Base with Burn Ban Sign	Impact Velocity (ft/s)		CDC	12FLEN3
Name	7 ft to bottom of top sign	Longitudinal	3.3	Max. Exterior	
Installation Height (ft)	2-7/8-inch O.D., 10 BWG tube support	Lateral	0.0	Vehicle Crush (inches)	5.9
Material or Key Elements	with slip base, one 24x24 inch sign panel, and one 30x36 inch sign panel	THIV (km/h)	3.9	Interior	
	Standard Soil, Dry	Ridedown Accelerations (g)		OCDI	FL0200000
Soil Type and Condition		Longitudinal	-0.2	Max. Occupant Compartment	
Test Vehicle		Lateral	0.3	Deformation (inches)	4.8
Designation	820C	PHD (g)	0.3	Post-Impact Behavior

Model	1998 Geo Metro	ASI	0.13	(during 1.0 sec after impact)	
Mass (lb)		Max. 0.050-s Average (g)		Max. Yaw Angle (deg)	3
Curb	1772	Longitudinal	-1.5	Max. Pitch Angle (deg)	2
Test Inertial	1812	Lateral	-0.4	Max. Roll Angle (deg)	2
Dummy	170	Vertical	-0.7		
Gross Static	1989

Result: The detached sign support traveled with the vehicle and came to rest along the vehicle path. The support did not penetrate nor show potential for penetrating the vehicle, or to present undue hazard to others in the area. The sign panel and support deformed the roof 4.8 inches into the occupant compartment. (PASS)
