# Evaluation of Rumble Stripes on Low-Volume Rural Roads in Iowa—Phase I

**Final Report  
July 2009**

**Sponsored by**  
the Iowa Highway Research Board  
(IHRB Project TR-577), the Iowa Department  
of Transportation (InTrans Project 07-304),  
the Federal Highway Administration, and  
the Midwest Transportation Consortium

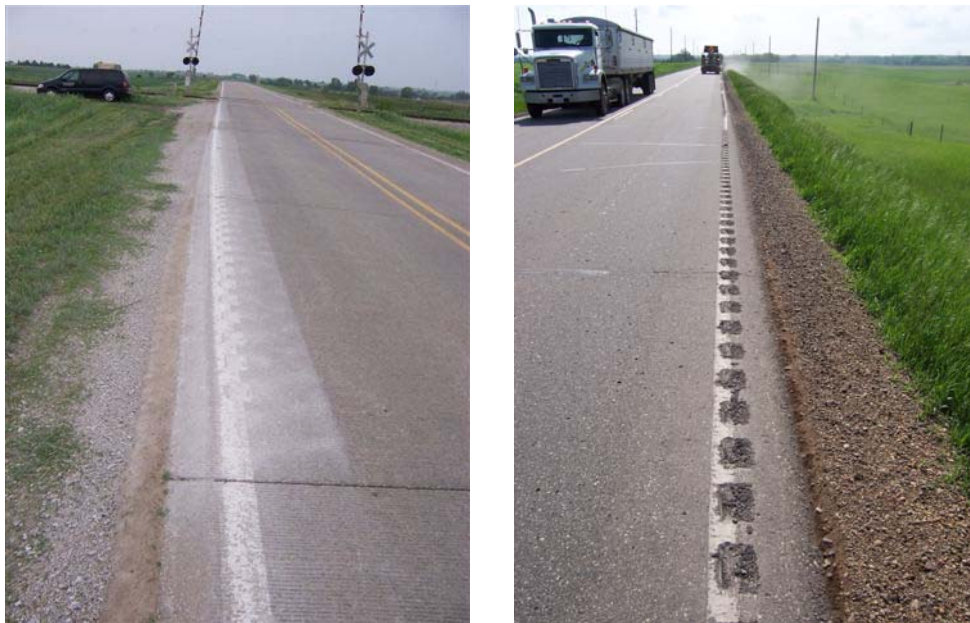
**Figure 3-9. Examples of milling work**

Work was suspended in early June to allow the contractor time to work on modifications to another piece of equipment that could complete the work that had been omitted on the inside of curves due to operational problems that will be described in the next section. The equipment shown in Figure 3-8 was adapted to allow milling along the low side of horizontal curves and to be performed more adequately, although the milling depth was still minimal and the alignment was less than ideal.

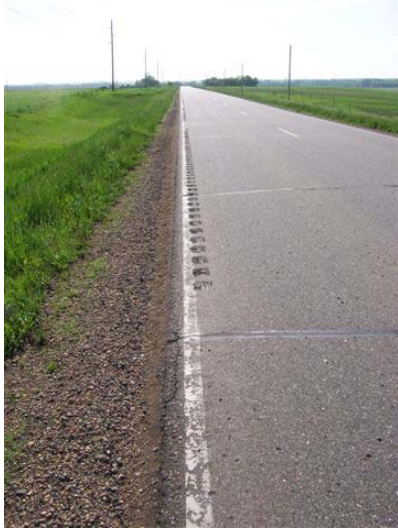
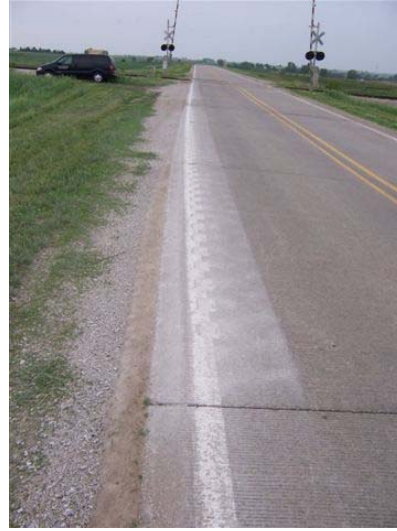
**Figure 3-10. Milling in Sioux and Dallas Counties**

Installation work was quite satisfactory in the tangent sections of roadway, but problems with machine stability were encountered when milling was attempted along the low side of super-elevated horizontal curves due to the high center of gravity of the milling machine. Milling machine instability, less than desirable milling depth, and difficulty in maintaining a satisfactory alignment through curves required omitting these sections until a modified machine was developed later in the season. In addition, it was necessary to add an air compressor to the process to remove millings from the pavement edge prior to application of pavement markings. Figure 3-10 shows sections on County Roads B-30 and P-53 after rumble stripes were cut into the pavement surface. Figure 3-11 shows the machine tipping.

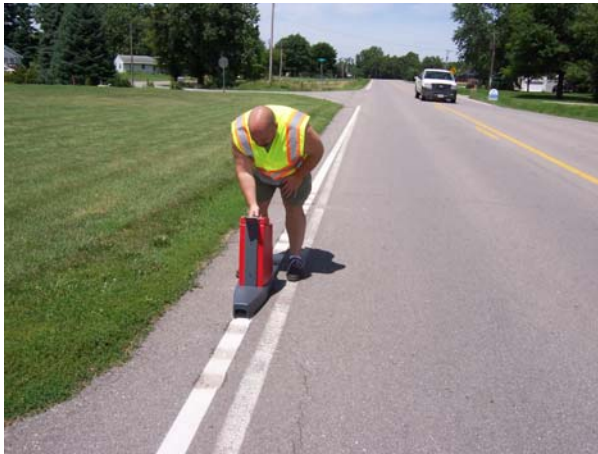
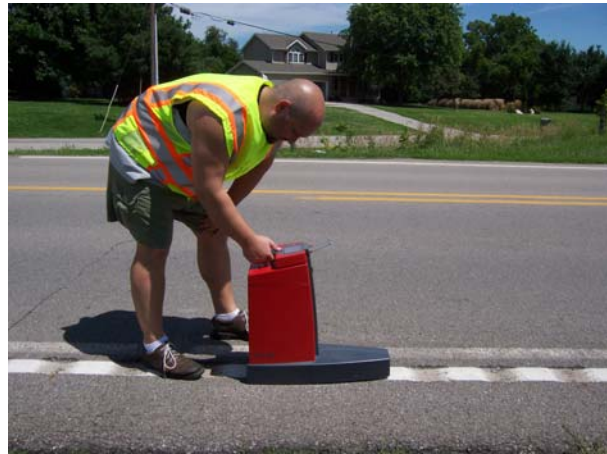
**Figure 5-1. Retroreflectivity data being taken**

Retroreflectometer readings were taken at two positions within each test section. Readings were taken directly over the rumble stripes at approximately 500- to 1,000-foot intervals at locations where the rumble stripes were actually present (within the grooved portion). Four readings were taken in each location and then averaged. When the rumble stripes were installed, an extra 500 feet of edge line was painted beyond the rumble strip so data could be compared for sections without rumble strips. However, some of these areas were repainted by the counties during the period, and while the county repainted areas outside the rumble stripes, they did not repaint the rumble stripes themselves. As a result, those sections could no longer be used as controls. Therefore, data were collected intermittently on the solid painted areas between rumble stripes to further define the comparison. This was used as a control section. Initial data were collected mainly within those 500-foot sections but was expanded (and later eliminated) at each project for subsequent collections. This is shown in Figure 5-1.

(a) Fall readings

(b) More readings in spring after winter snowplow work

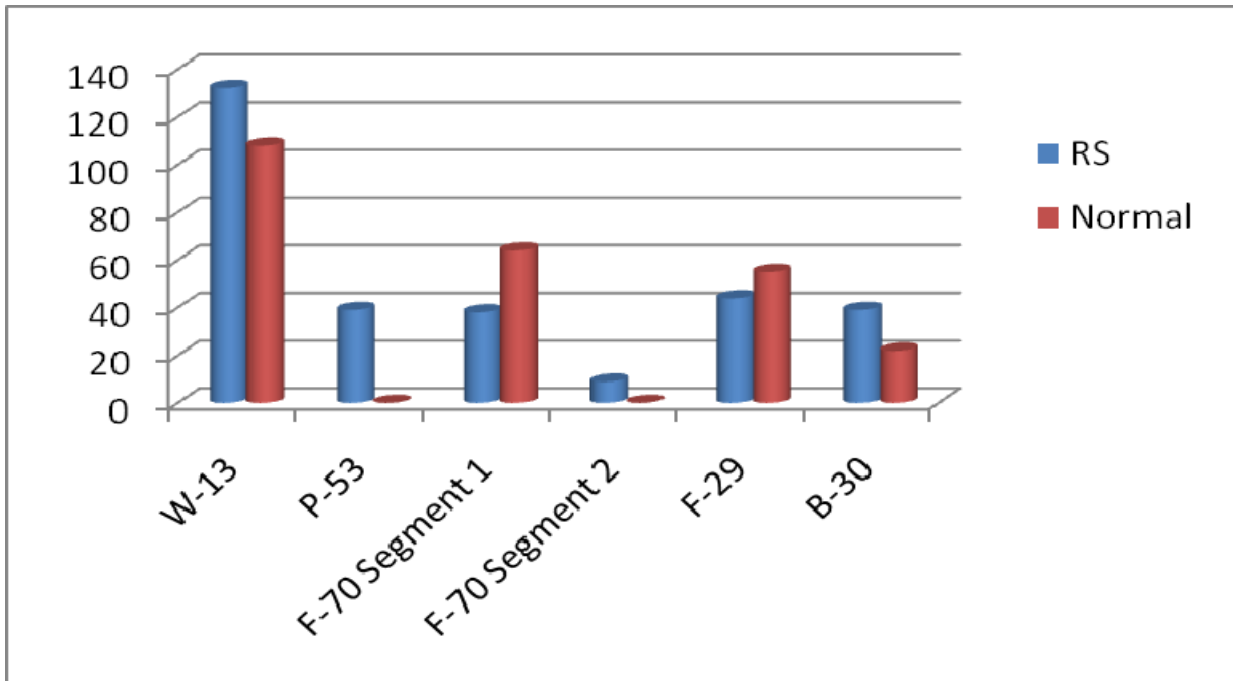
Figure 5-5. Change in average readings from summer to fall

Two readings for each location (within a rumble stripe versus along a “normal” section) were compared for each time period (summer 2008, fall 2008, and spring 2009). Since readings were not taken at exactly the same location each time data were collected, values were averaged and a t-test was used to compare whether readings from one time period were different and statistically significant from a subsequent time period. Results are provided in Table 5-1. The change in average readings from summer to fall is also provided in Figure 5-5, and the change in average readings from summer to spring is shown in Figure 5-6.

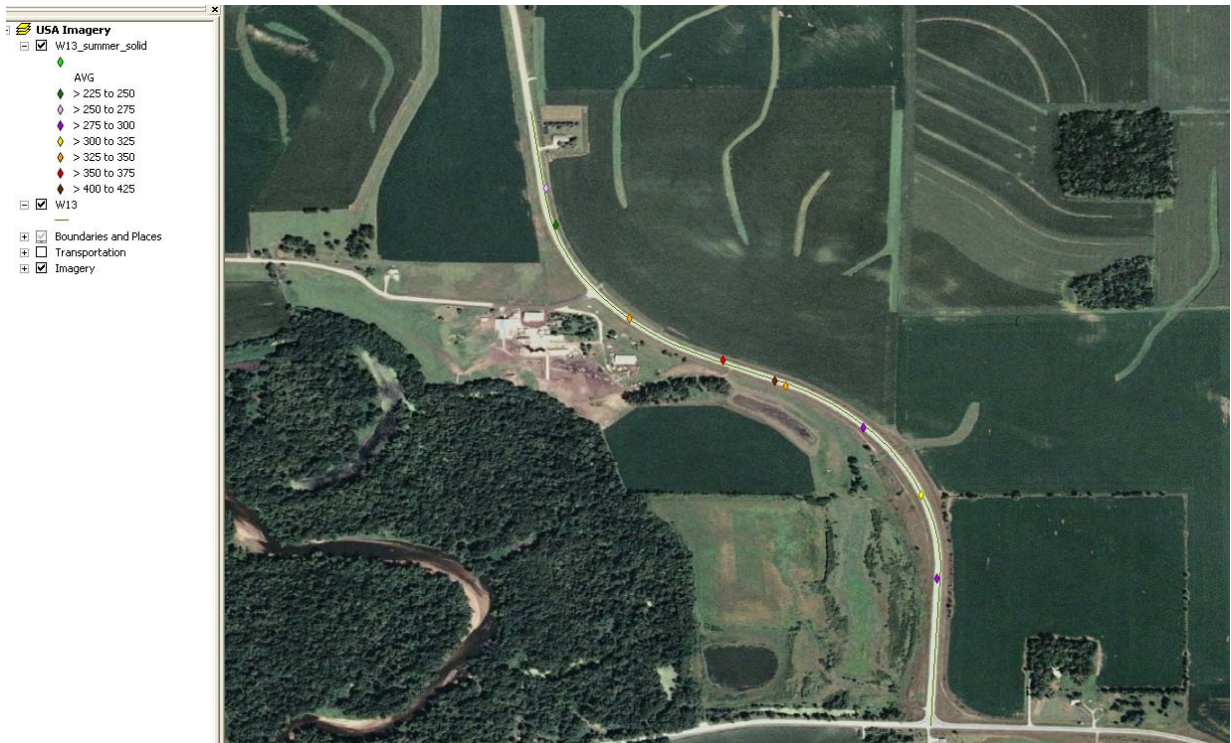
**Figure 5-7. Summer readings for control for test section W-13**

Charts were also made that show individual readings at each site. Figures 5-7 to 5-9 show readings for the control “flat” areas on test section W-13 for summer 2008, fall 2008, and spring 2009, respectively. Figures 5-10 to 5-12 show readings for rumble stripe areas on test section W-13 for summer 2008, fall 2008, and spring 2009, respectively.
