**Final Technical Report**  
TNW 2008-10  
TransNow Budget No. 61-4026 and 61-5916  
De-Bonding Cracking

**De-Bonding of Hot Mix Asphalt Pavements in Washington State:  
An Initial Investigation**

Stephen T. Muench  
Assistant Professor  
University of Washington

November 2008

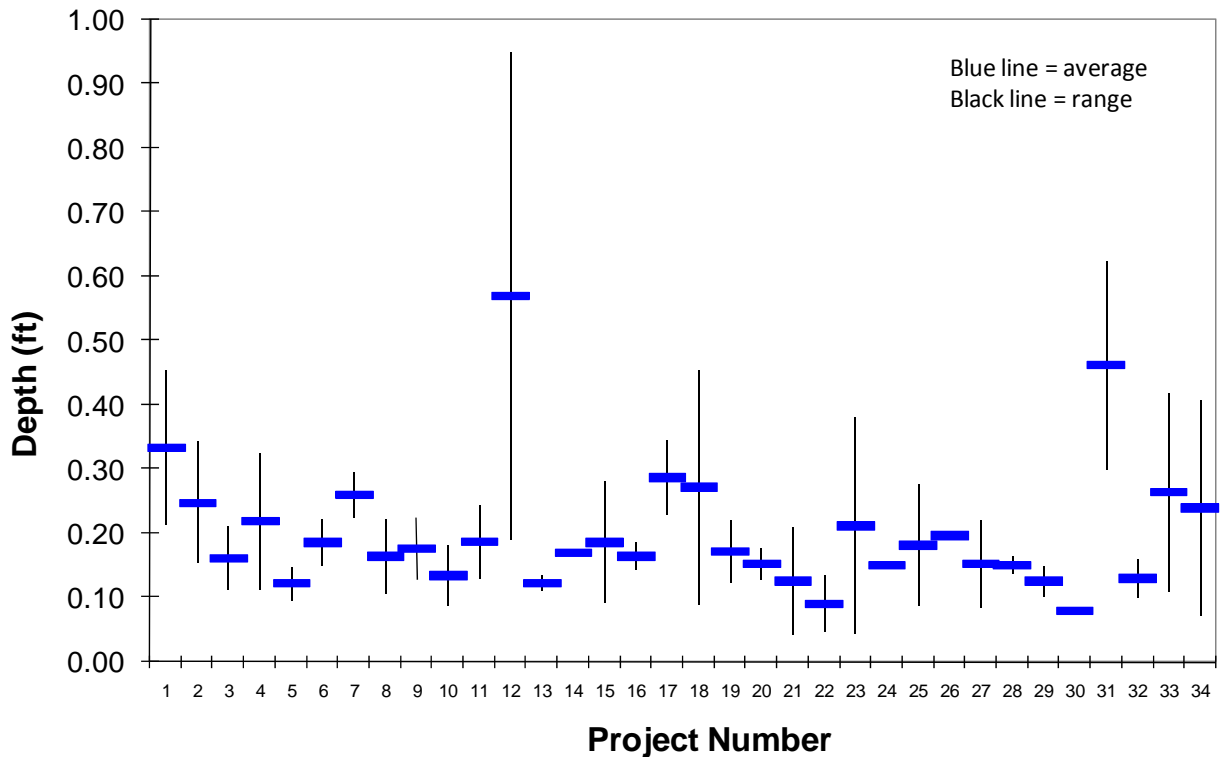
Typical WSDOT overlay thickness is 0.15 ft, which corresponds closely with the average depth to the first de-bonding in those cores with observed de-bonding (Figure 3).

**FIGURE 3: Recorded depth to first de-bonding for all de-bonded projects with recorded de-bonding depths. Note that some projects had a wide range of de-bonded depths (e.g., project 12).**

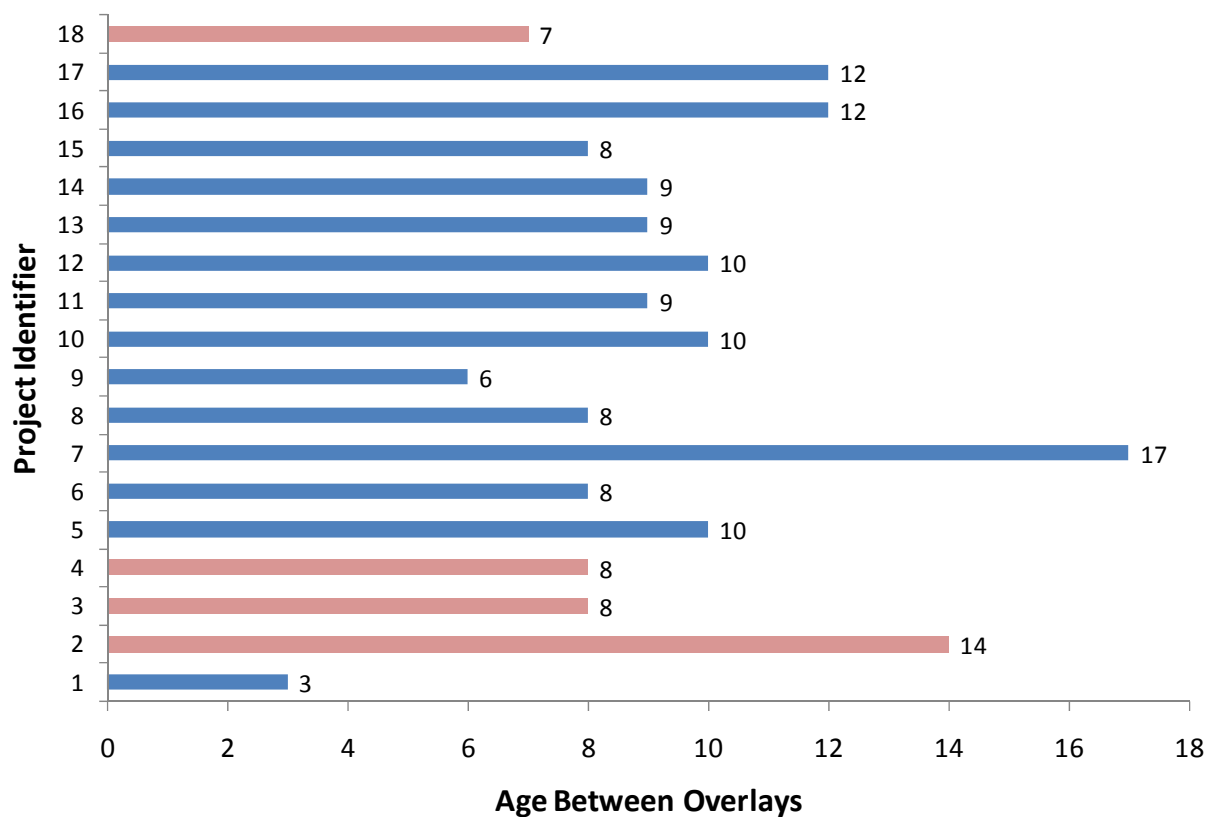
**FIGURE 4: Age between the overlay that was de-bonded and the subsequent overlay in preparation for which the coring was done. This gives an idea of how long the de-bonded surface lasted. Red (light) shaded bars represent projects that were not yet overlaid as of 2006.**

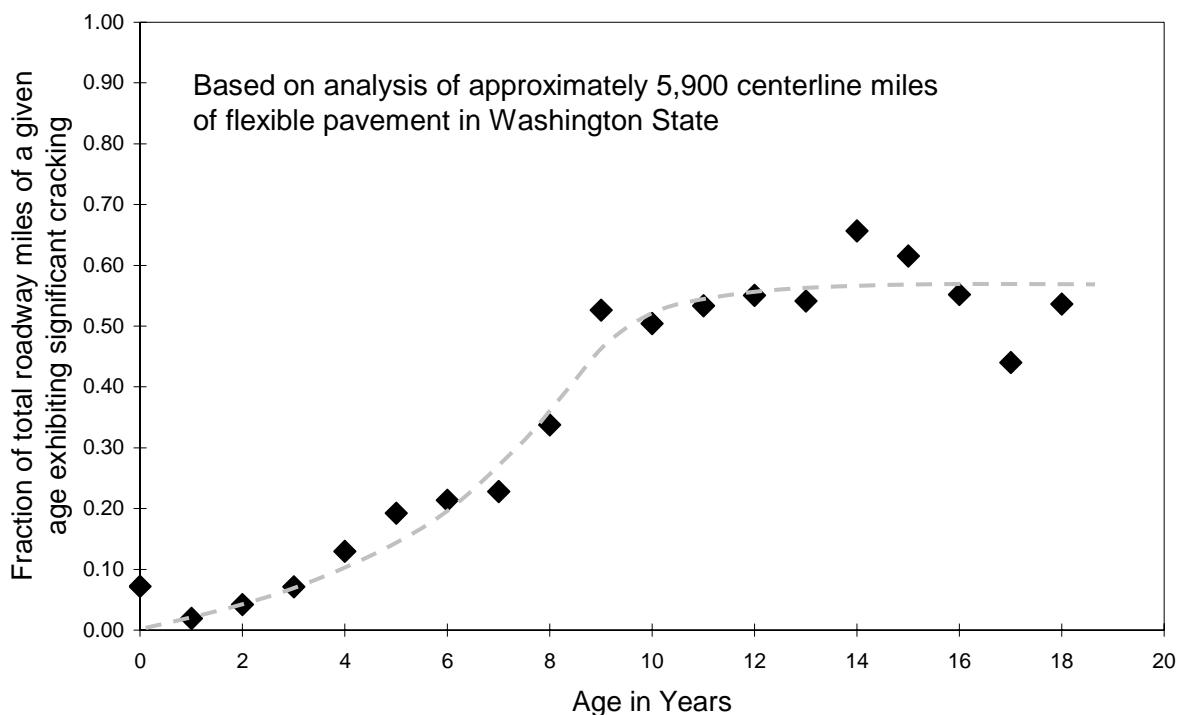
**FIGURE 7: Initiation of Cracking in WSDOT Flexible Pavements (Muench, et al., 2004).** “Significant cracking” is defined as cracking in at least 0.5% of the total roadway surface.

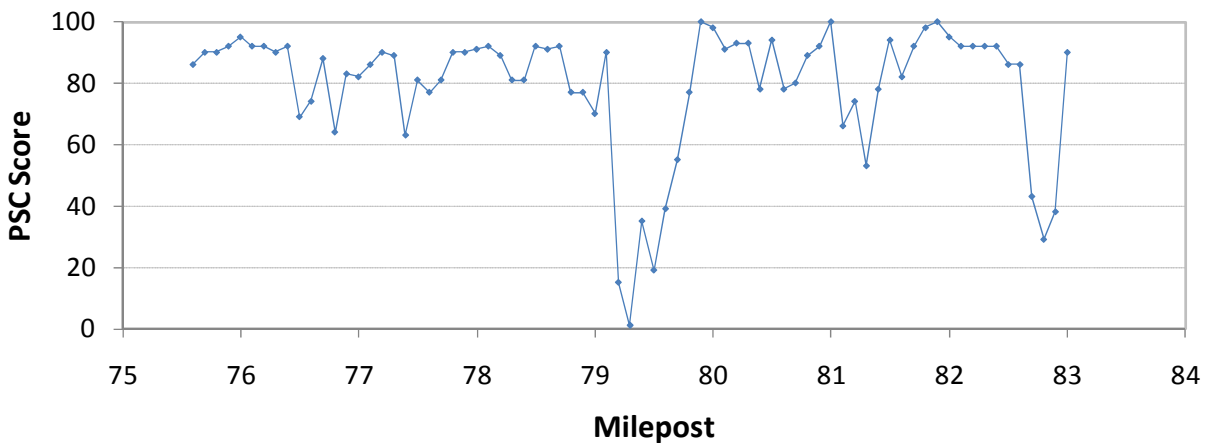
- Even jobs that show significant cracking still have PSC scores that are generally above 80, which is still quite good. This probably means that cracking has started earlier than average but is not yet advanced enough to severely affect PSC scores. It should be noted that PSC scores are not linearly related to the amount of cracking. As cracking increases beyond about 1-5%, PSC scores are designed to drop dramatically (Kay et al., 1993).
- Jobs that score below a PSC of 90 generally do so because isolated sections score significantly lower than the average. Project 5841 is typical of this (Figure 8).

**FIGURE 8: Project 5841, SR 27 MP 75.66 to 83.10 (paved in 2000 – 6 years old) showing PSC vs. milepost.**  
Each data point represents the PSC score for one survey unit.

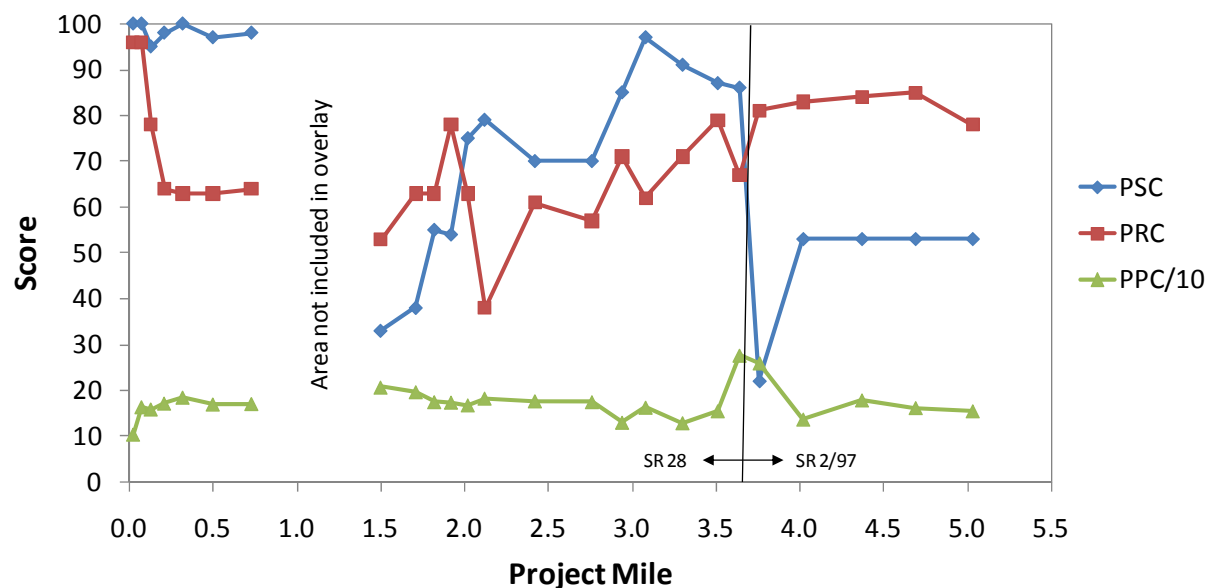
Figure 11 shows the 2006 (most current year available) condition of this project in terms of pavement structural condition (PSC), pavement rutting condition (PRC) and pavement profile condition (PPC) from the Washington State Pavement Management System (WSPMS). Of note, a score of 50 or less is the trigger for rehabilitation and scores are projected out into the future. Therefore, scores shown from 2006 data are likely higher than the actual scores in 2008 when the rehabilitation was done. Explanations of these condition calculations are contained in Kay et al. (1993). Figure 11 shows that the existing pavement is exhibiting generally low scores for rutting and structural condition (cracking). Although it is not reflected in WSPMS, the SR 28 section also shows significant flushing/bleeding (Figure 10).

**FIGURE 11: SR 28 and SR 2/97 pavement condition by project mile.**  
Note the transition from SR 28 to SR 2/97 at 3.64 miles.

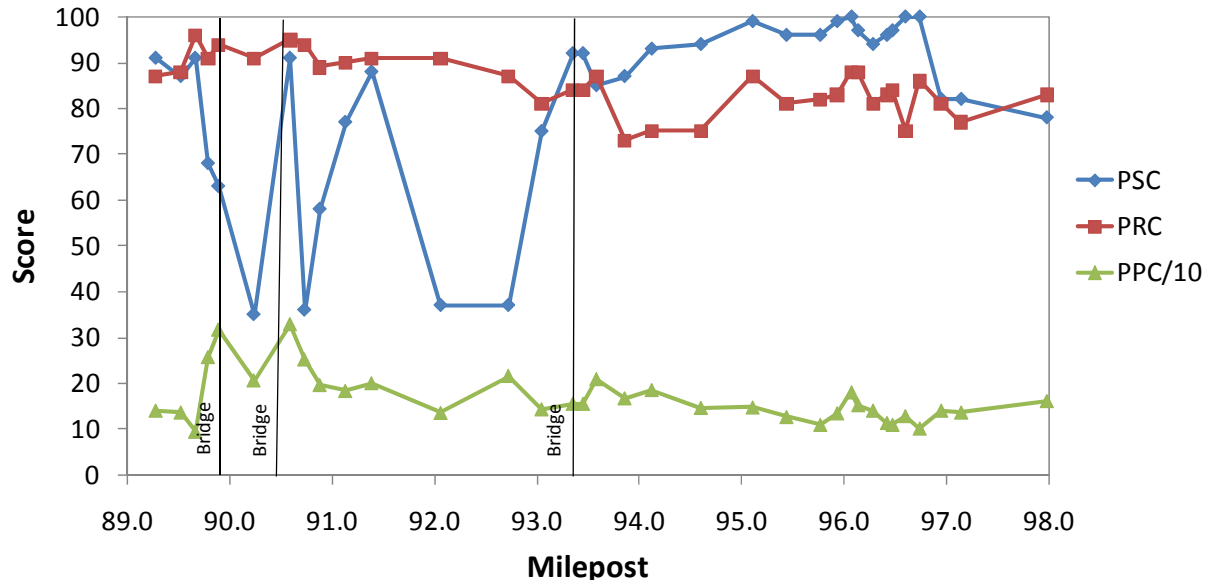
Figure 23 shows the 2006 (most current year available) condition of this project in terms of pavement structural condition (PSC), pavement rutting condition (PRC) and pavement profile condition (PPC) from the Washington State Pavement Management System (WSPMS). Figure 23 shows that the existing pavement is exhibiting generally low scores for structural condition (cracking).

**FIGURE 23: SR 2 pavement condition by milepost. Note the three bridge locations.**

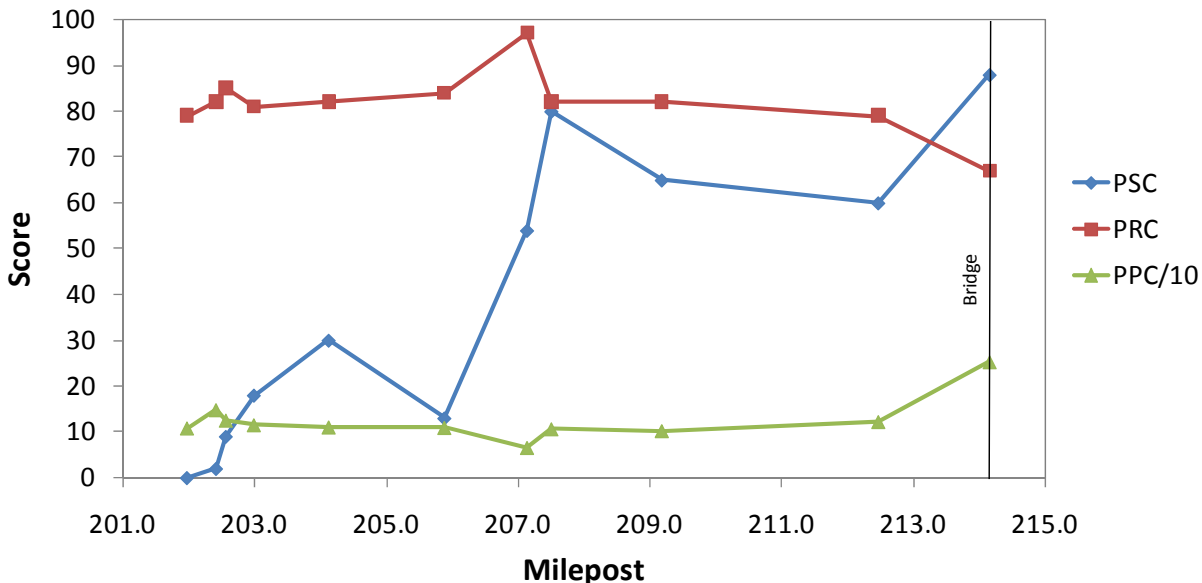
Figure 32 shows the 2006 (most current year available) condition of this project in terms of pavement structural condition (PSC), pavement rutting condition (PRC) and pavement profile condition (PPC) from the Washington State Pavement Management System (WSPMS). Figure

32 shows that the existing pavement is exhibiting generally low scores for structural condition (cracking).

FIGURE 32: SR 97A pavement condition by milepost. Note the location of the bridge.
