**September 2006**  
OR07.002

# **Investigation of Cause of Cracked Stringer on the Blanchette Bridge**

Prepared by Missouri  
Transportation Institute and  
Missouri Department  
of Transportation

RI05-036

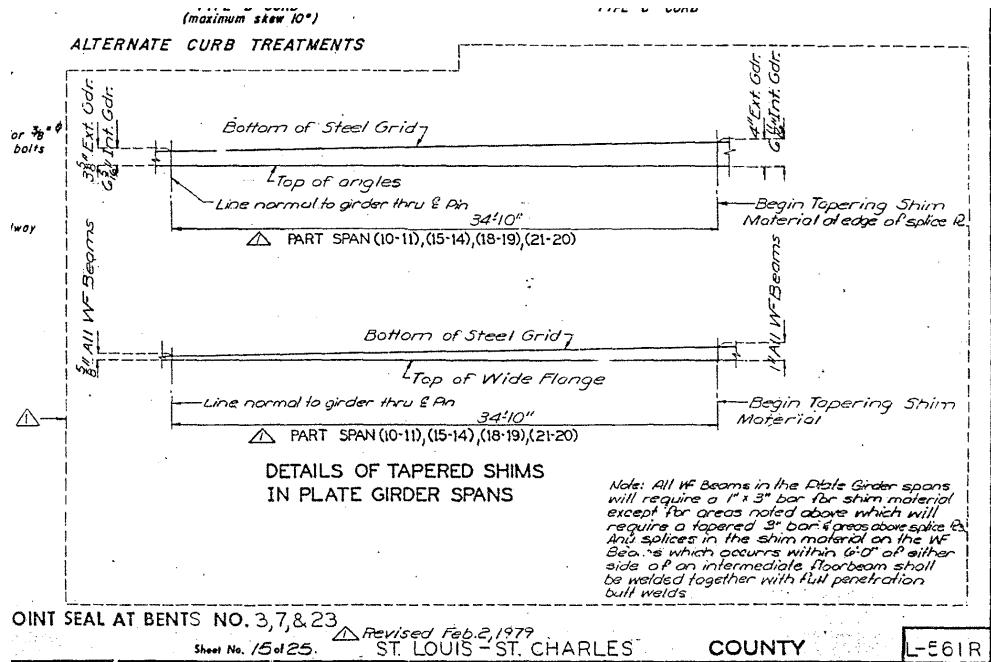
Figure 2-5. Details of tapered shims in plate girder spans.  
(Missouri State Highway Department 1978)

Several aspects of the redecking project are notable in relation to the later stringer cracking. The first is the note on sheet 15 of the redecking plans, added as part of the plan change. This note can be seen in Figure 2-5 and states the following:

All WF Beams in the Plate Girder spans will require a 1"x3" bar for shim material except for areas noted above which will require a tapered 3" bar and areas above splice plates. Any splices in the shim material on the WF Beams which occurs within 6'-0" of an intermediate floorbeam shall be welded together with full penetration butt welds.

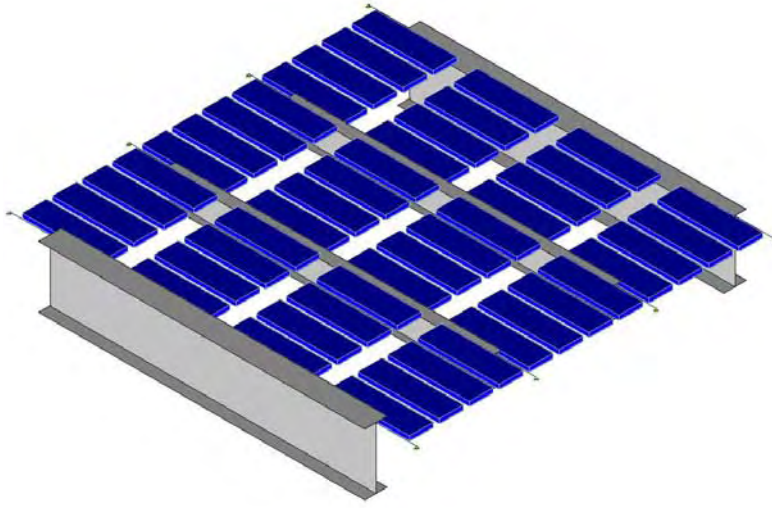
Figure 5-1. RISA model of section of bridge deck.

A RISA 3-D model was developed to study the resulting load distribution. Transversely, the model considered half the width of the bridge and excluded the exterior stringer. In the longitudinal direction, the model considered only the section of the bridge from floorbeam to floorbeam. The model and deflected shape are shown below in Figure 5-1 and Figure 5-2, respectively.

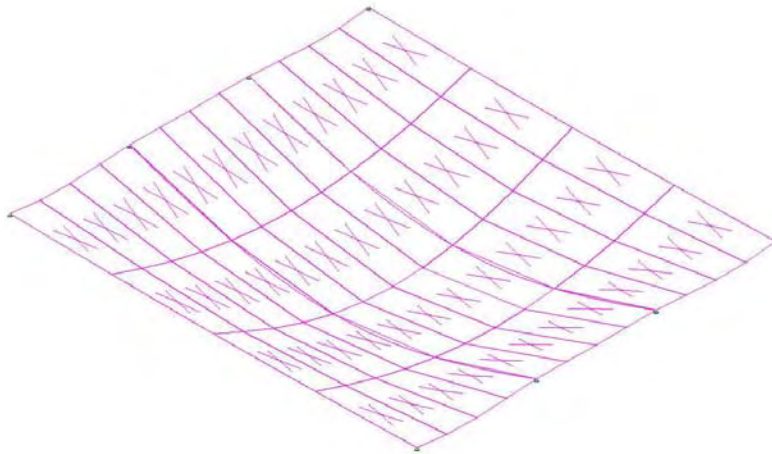
Figure 5-2. Deflected shape of model under uniform load.

Results of the deck-stringer interaction model show that the distribution of dead load to stringers at the midspan (between floorbeams) can be significantly different than the assumptions of the tributary area approach. Approximate calculations showed the stringers with grid deck carrying about 25 percent of the load calculated by the tributary area method.

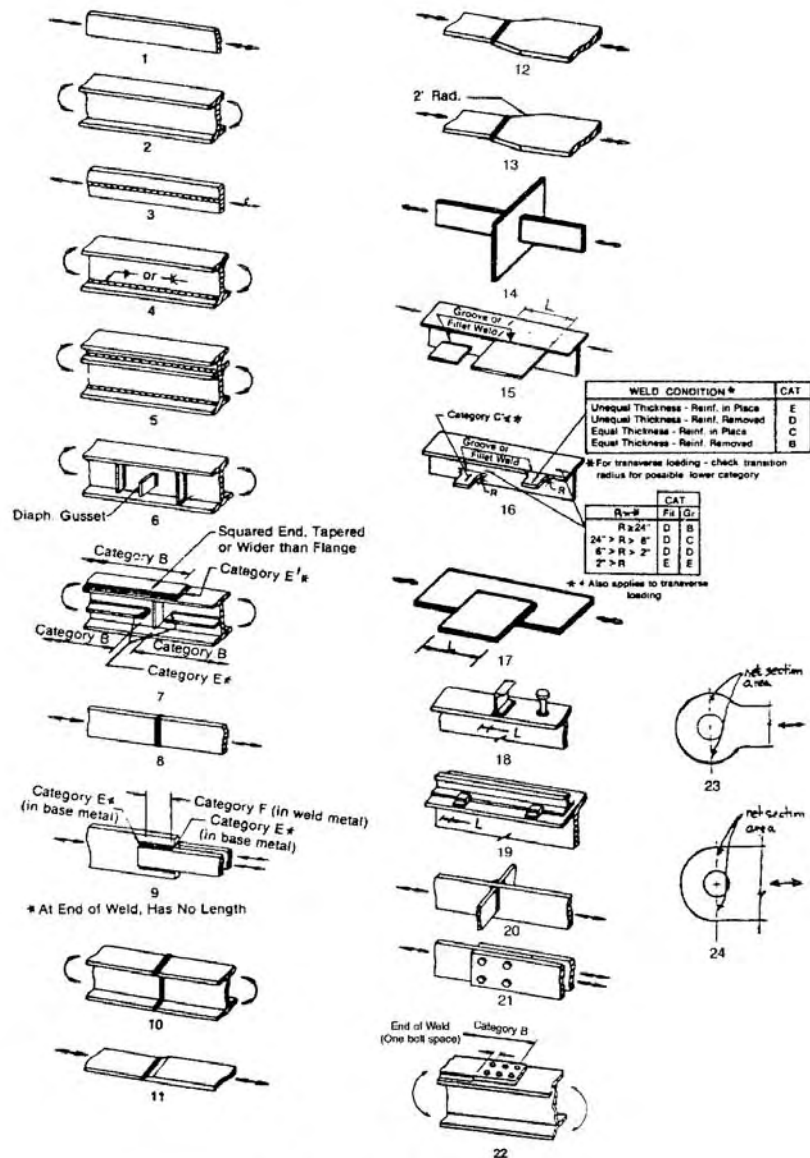
Figure 5-3. Examples of fatigue categories for various details; Blanchette detail is most similar to Category E in Example 7. (AASHTO 2002)

The base metal at the shim butt joint was considered to fall into Category E for the initial analysis, since it involves the termination of a welded cover plate. The detail as a whole, including the weld metal, is actually significantly worse than a Category E. This factor will be discussed more fully later in this report.

The limiting stress range given in this procedure (corresponding to a infinite life at a constant stress range amplitude) is 1.6 ksi for a Category E detail.

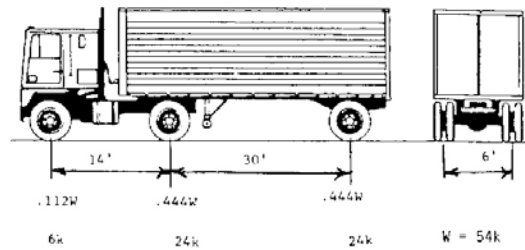
Figure 5-4. Fatigue truck.  
(Moses et al. 1987)

Using the live load results from the RISA run, the calculated load range for the fatigue track passage is  $25.6 + 87.2 = 112.8$  ft-kip per lane. An impact value of 10 percent is recommended for typical cases. The calculated distribution factor is 0.42 lanes per girder, which results in a calculated load range (live load plus impact) per stringer of 52.1 ft-kip. This load range then results in a stress range of 4.9 ksi at the butt joint detail.

The portion of the stress range producing tension in the top flange of the stringer is 1.1 ksi. The calculated dead load stress in the top flange is 2.3 ksi of compression (using the tributary area calculation). According to the recommended procedure, no further analysis should be needed, since the calculated compression is more than two times the calculated tension portion of the stress range.

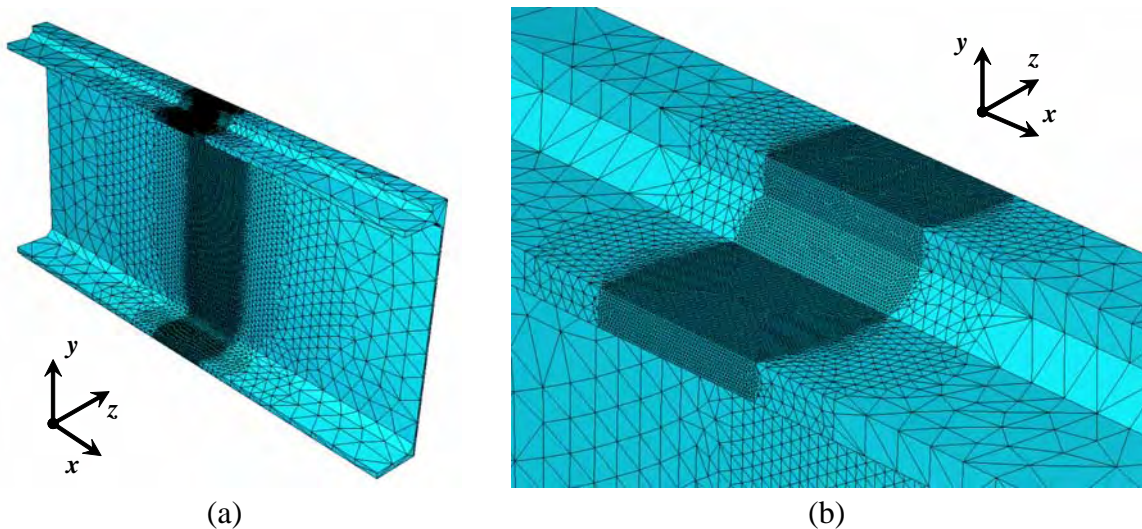
Figure 6-2. (a) FE model for stress concentration characterization: discretization; (b) close-up view of refined mesh at stress singularity zone.

Three-dimensional solid elements (4-node linear tetrahedron C3D4) were used, with a discretization that was progressively refined in the vicinity of the shim plate butt joint section, as illustrated in Figure 6-2. To accurately characterize the stress concentration, the mesh implemented was selected upon verification of standard cases of discontinuous three-dimensional geometry with known stress concentration factors. A typical ASTM A36 stress-strain response was used as input in the model. Yield strength  $F_y = 36 \text{ ksi}$ , elastic modulus  $E = 28.5 \text{ msi}$ , and Poisson's ratio  $\nu = 0.3$  were assumed for both the

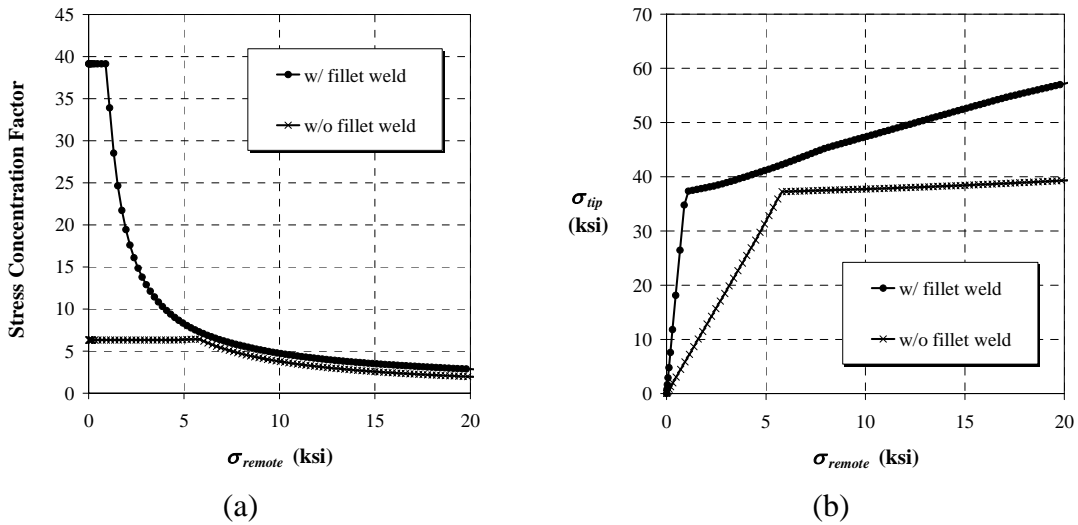
Figure 6-3. (a) Stress concentration factor in fillet weld at butt joint notch section versus remote stress; (b) combined Von Mises stress at notch tip versus remote stress.

The stress concentration factors from both the FE analyses, defined as  $\sigma_{tip} / \sigma_{remote}$ , where  $\sigma$  denotes the combined Von Mises stress (versus the nominal stress in the outer face of the shim plate, away from the notch area, are shown in Figure 6-3(a). The  $\sigma_{tip}$  levels with respect to the associated  $\sigma_{remote}$  are provided in Figure 6-3(b).

The theoretical stress concentration factor in the elastic range,  $K_t = \sigma_{tip} / \sigma_{remote}$  ( $\sigma_{tip}$  and  $\sigma_{remote} \leq F_y$ ), which depends on the geometry and mode of loading only, reaches the extremely high value of 39.1 in the actual detail where the crack occurred. This value is explained by using an uncommon configuration for the shim plate butt joint, which produces a rather severe three-dimensional geometric discontinuity evidently prone to crack initiation, as graphically illustrated by the stress contours in Figure 6-4.

Figure 6-3(b) shows that even under such a relatively ideal condition, remote stresses in the range 0.5–1 ksi (strain ~18–35  $\mu\epsilon$ ), fairly commonly encountered in similar bridge members under service loads, may result in tip stresses approaching or exceeding the yield strength. The yield strength typically lies slightly above the endurance limit approximated as  $0.5F_u$ , where  $F_u$  = ultimate strength (Bannantine et al. 1990). Hence, the fatigue life of the detail inevitably falls far below all of the seven primary  $S-N$  fatigue curves (Cat. A through E') from the AASHTO, AREMA, AWS, and AISC specifications (see Figure 6-5), which are based on the lower bounds of full-scale fatigue test data with a 97.5 percent survival limit.

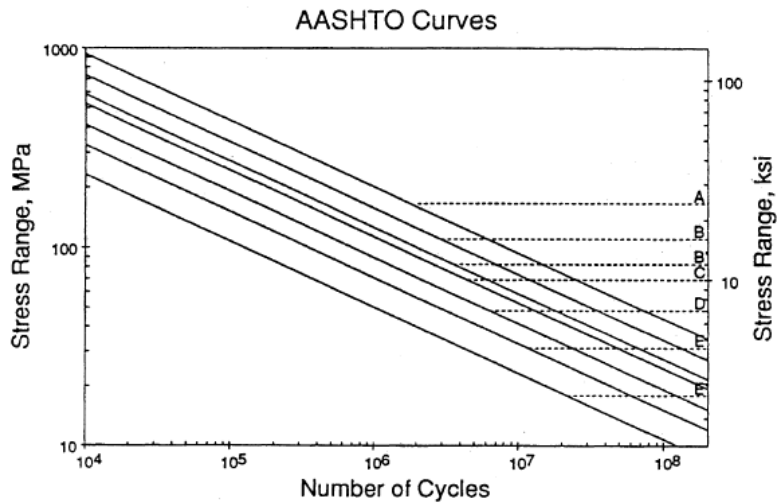
Figure 6-5. Fatigue life ( $S-N$ ) curves from the AASHTO (2004) design specifications.

\*Horizontal lines represent constant amplitude limits that indicate the detail category  
 In reality, when using either a stress-life (*e.g.*, Juvinall approach) or a strain-life (*e.g.*,

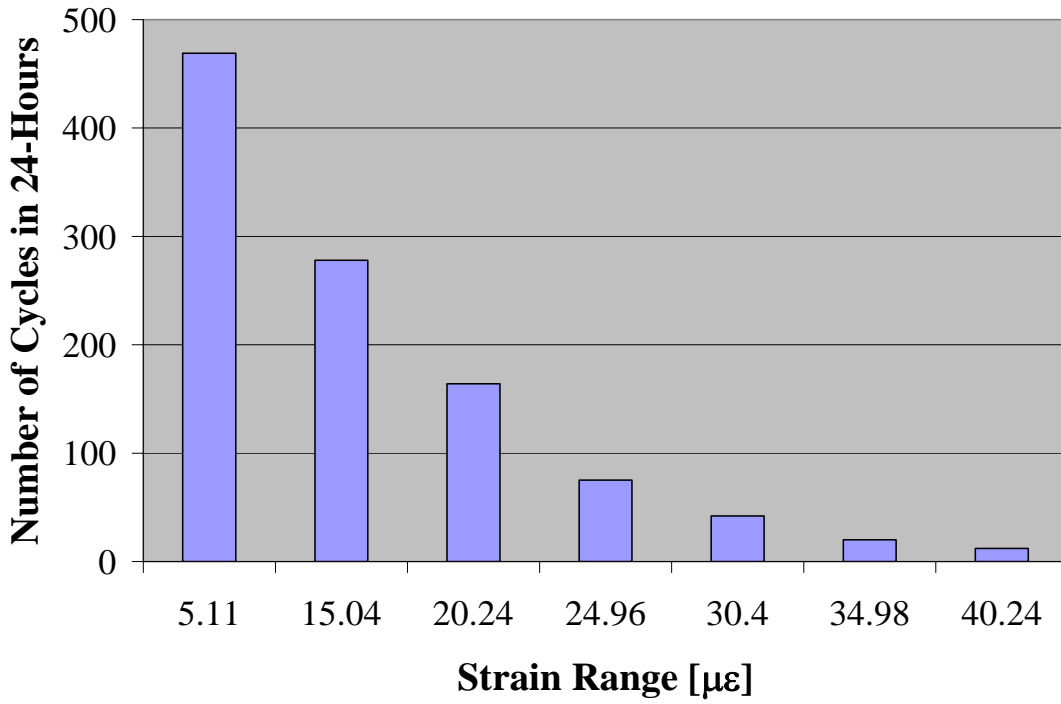
Figure 7-12. Strain range stringer 2 section 2.

Additionally, the maximum variation of the average strain recorded between day and night was of  $16 \mu\epsilon$  (about 0.46 ksi) due to temperature variations in the deck. The variations in temperature cause the deck to move, displacing the stringer and inducing stress in it. This maximum was recorded for stringers 2 and 3 at section 2, and it results in a tensile stress at the top of the shim plates.
