CORROSION OF STEEL IN LOCALLY DEFICIENT CONCRETE Contract No. BD544-31 Final Report to Florida Department of Transportation

A. A. Sagüés Principal Investigator Department of Civil and Environmental Engineering

> UNIVERSITY OF SOUTH FLORIDA Tampa, FL 33620 February 28, 2009

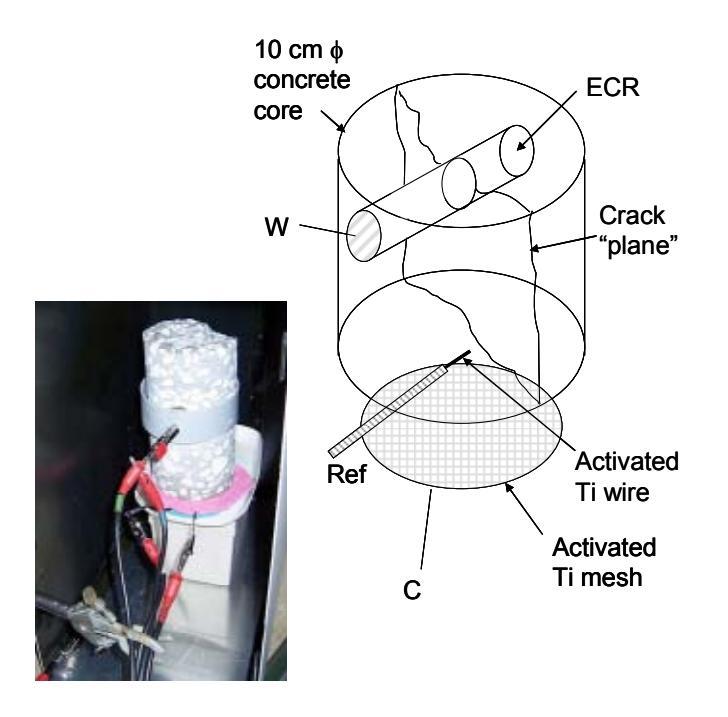
For the Group 3 Bridges carbonation tests were conducted routinely with findings for the sea splash zone similar to those noted for Group 2. However, in a core sample extracted 65 cm AHT from ITB for which bulk penetration was negligible, the on-crack carbonation depth was significant, extending beyond reinforcement depth. In the high elevation SSK cores, there was evidence of deep on-crack carbonation up to reinforcement depth (Figure 5) reflecting dryer conditions. Carbonation in those cores was usually minor through bulk concrete (~1-2 mm), although in one instance it reached ~5 mm.

Figure 5. On crack carbonation testing: SSK high elevation trestle cap concrete core. A. On site crack location (SSK140E1). B. Transverse cross section from crack surface (SSK33W1). C. On crack surface (SSK33W1).

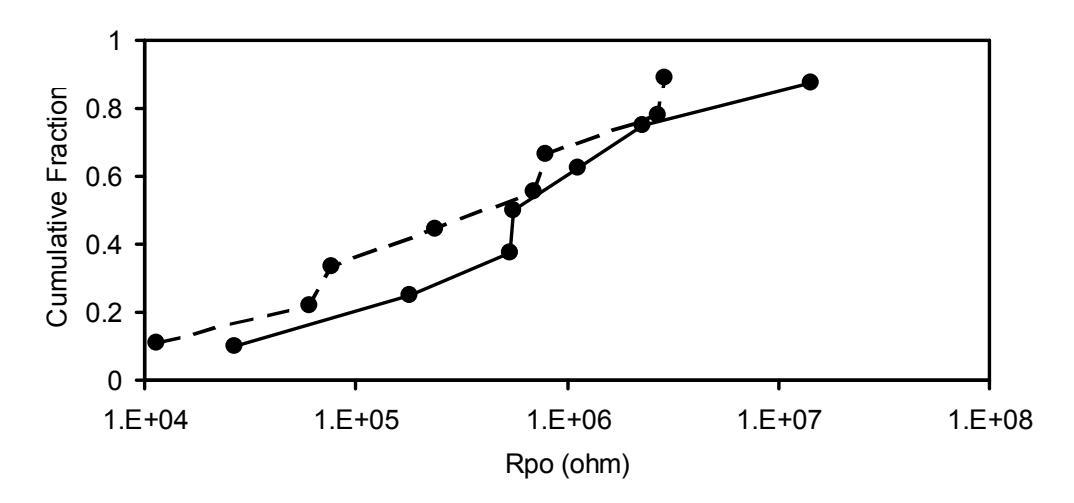
Impedance curves generally showed high frequency (hf) loops with diameters that varied by orders of magnitude in side by side comparisons of EIS responses of epoxy coated rebar from cracked and non-cracked concrete from low elevations. As seen in Figure 10, the ECR from cracked locations generally had smaller hf loops than the ECR from the sound concrete. The hf loop diameter corresponds to the combined coating pore resistance, R_{po}. Cumulative

fraction curves of the pore resistance for all ECR measured with EIS (cracked/non-cracked concrete) are shown in Figure 11. Smaller R_{po} values generally observed at cracked concrete locations likely indicative of larger electrolyte conductance to the steel at crack locations.

Figure 10. ECR Impedance manifestation of presence of a crack in the core (low elevation SSK samples). A,B,C Sound concrete core; A', B', C' Companion on-crack core; crack widths were 0.13, 0.25 and 0.23 mm respectively. (A, A':118W4,118W3. B, B': 118W2, 118W1. C,C': 117E3, 117E1).

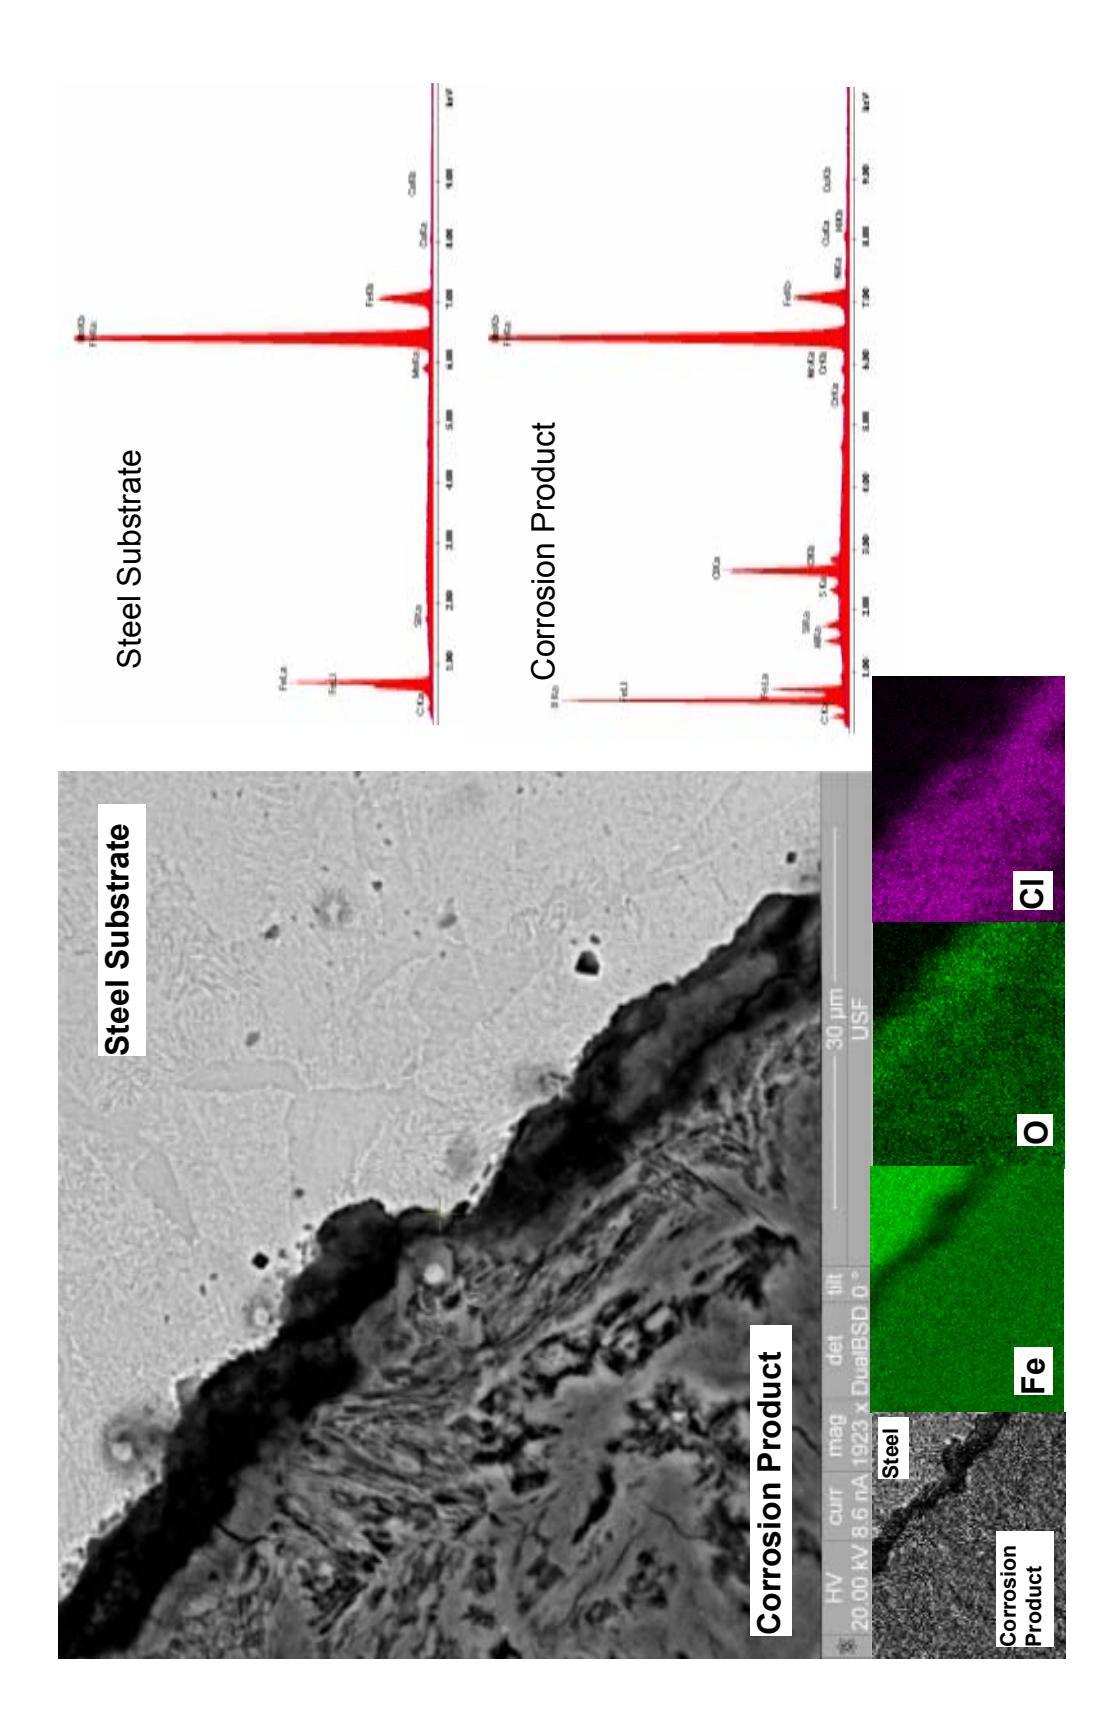
SEM micrographs (Figures 15 and 16) of the corrosion region showed a porous structure. Consistent with optical observations, the pearlitic grain

Figure 15. SEM Image of corrosion product (HFB59E1).

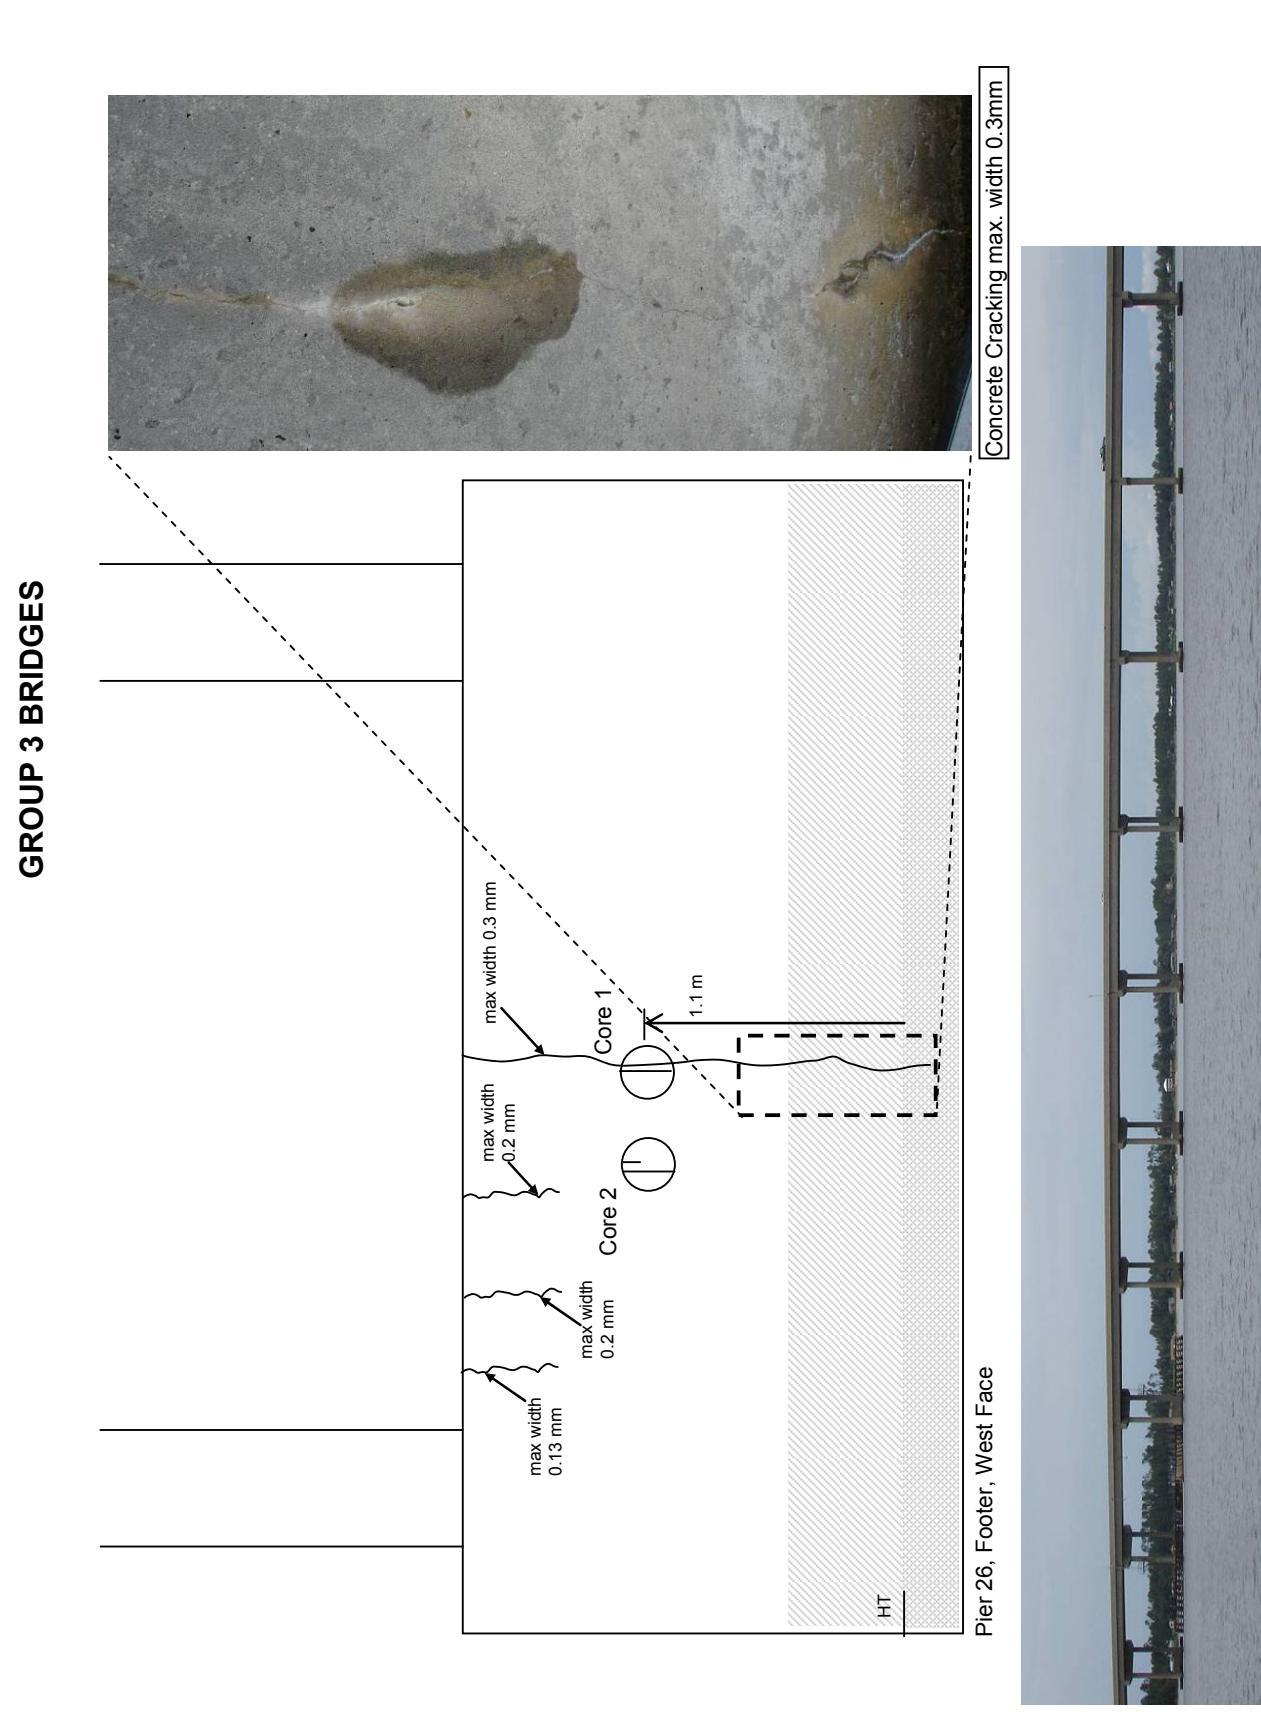
<u>Lillian (PER).</u> Very little concrete deterioration was observed. Thin hairline cracks were observed occasionally. The main span footer had larger cracks (~0.3 mm) with indication of efflorescence, some of which had been repaired earlier on by epoxy-injection. Concrete cores were extracted sampling on and off a crack location at 1.1 m AHT. Also cores were extracted from a column with no concrete deterioration at 0.9 and 1.2 m AHT. Concrete cover ranged from 10.4 to 13 cm. Half-cell potentials ranged from -183 to -656 mV CSE at tidal to 1.5 m AHT. Concrete resistivity of the footer and column ranged from 113 to 275 k Ω -cm at 0.3-2 m AHT (Figure 2b). The large aggregate consisted of granite. The volumetric porosity of the concrete was ~14%. No corrosion or only vestigial signs of surface corrosion discoloration were observed on extracted epoxy coated reinforcement.

Figure A13. Lillian Bridge (PER). Main Span Footer.

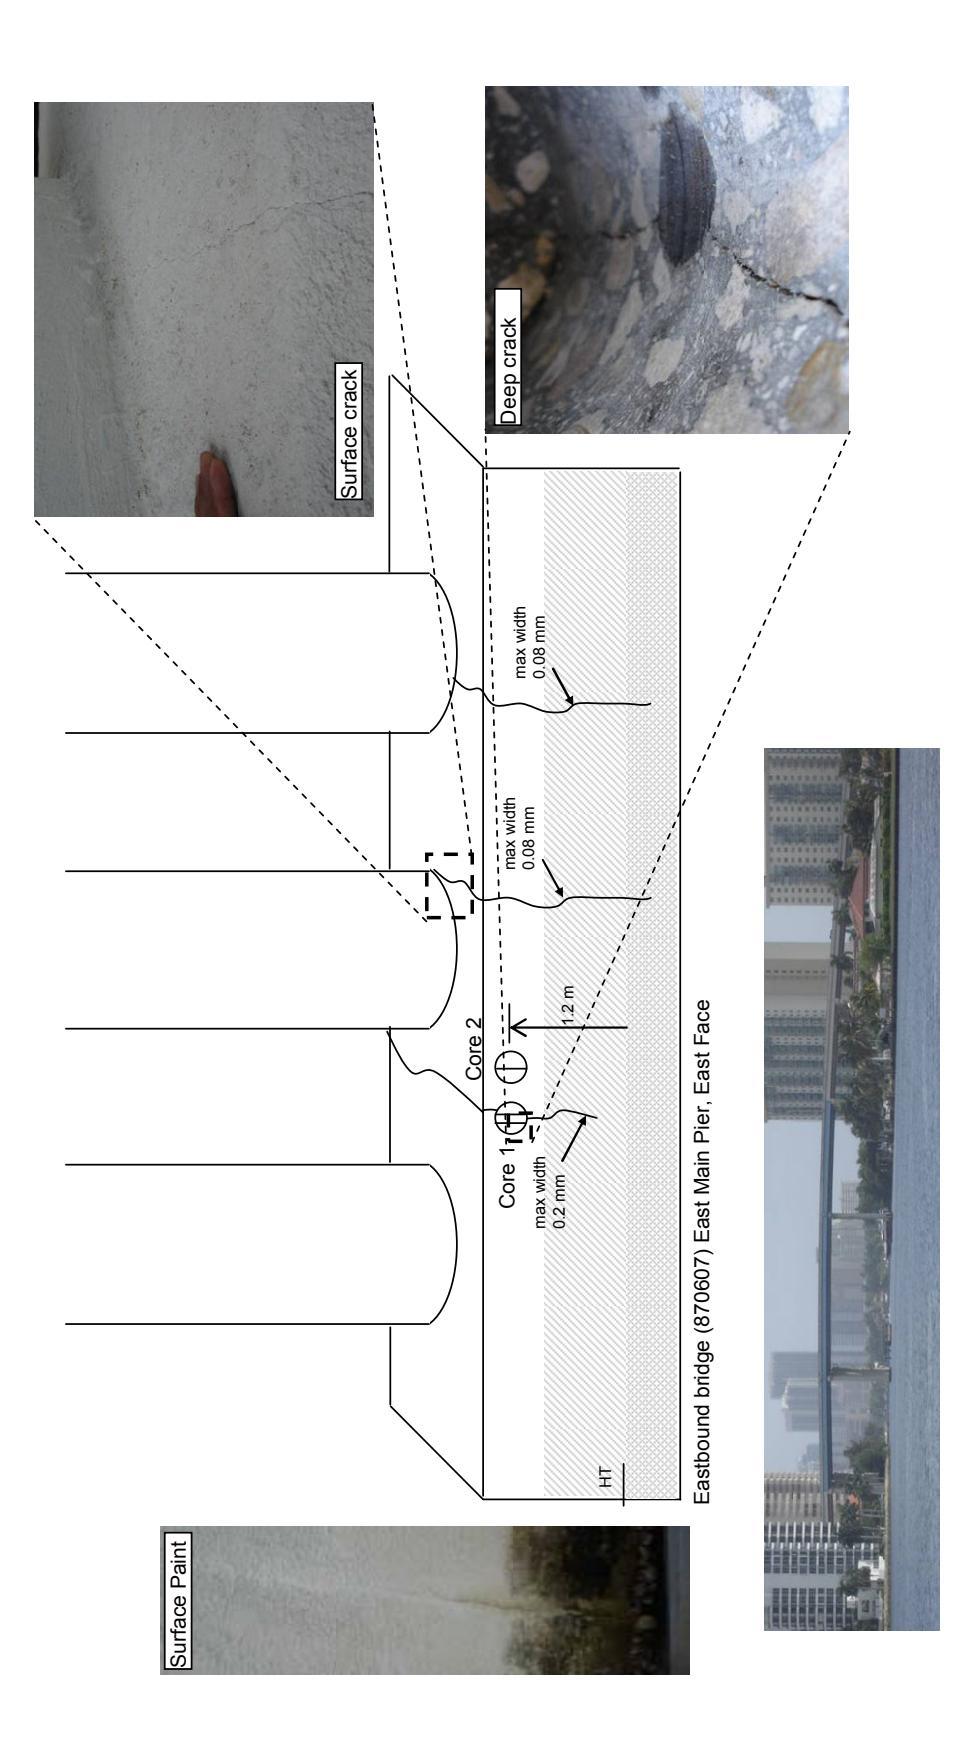
<u>Lehman Causeway (IT2/3).</u> Very little concrete deterioration was observed, although pre-existing damage prior to application of surface texture paint may have been obscured. Concrete cracks (typically ~0.08mm wide) were thin yet penetrated deep into the concrete. The cracks were often traced across the width of the footers and penetrated past reinforcement depths (Xc~7-10 cm). Concrete cores were extracted sampling ECR on and off crack locations ~50-120 cm AHT. Half-cell potentials ranged from -41 to -627 mV_{CSE} at tidal level to 1.2m AHT; low concrete resistivity was observed, 4 to 12 k Ω -cm at 0.1-1.2 m AHT (Figure 2b). The large aggregate consisted of limestone and river rock. The volumetric porosity of the concrete was ~20%. Only vestigial surface corrosion under defects of the epoxy coating was observed.

Figure A16. Lehman Causeway (IT2). Footer.
GROUP 4 BRIDGES
