**Report No. CDOT-2009-9
Final Report**

SHORT-TERM CRACK SEALANT PERFORMANCE AND REDUCING BUMPS AND TRANSVERSE CRACKING IN NEW HOT MIX ASPHALT OVERLAYS OVER CRACK SEALANTS

Scott Shuler

November 2009

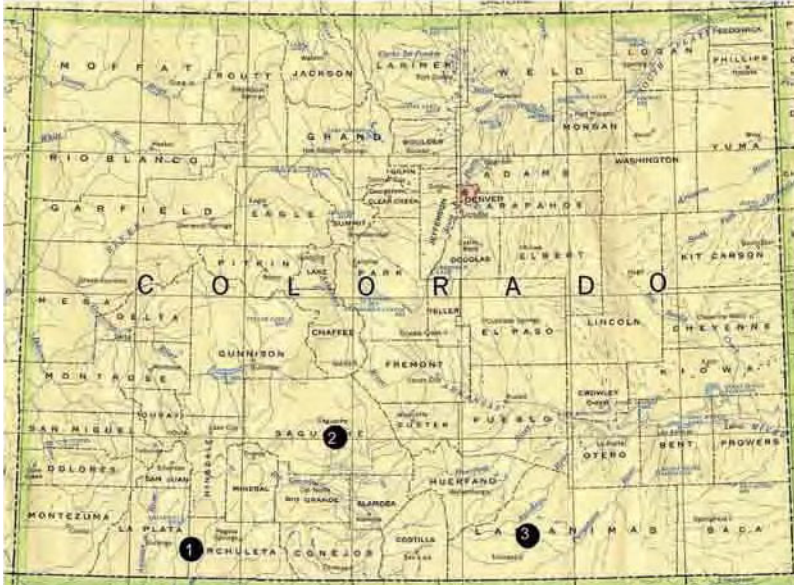
Figure 2. Experiment Site Locations

(location 1) from the intersection of US 160 south from milepost 30.02 to 32.70, on US 285 south of Saguache, CO from milepost 82.98 to 85.08 (location 2) and on US 350 northeast of Trinidad, CO from milepost 20.51 to 23.20 (location 3) as shown in Figure 2.

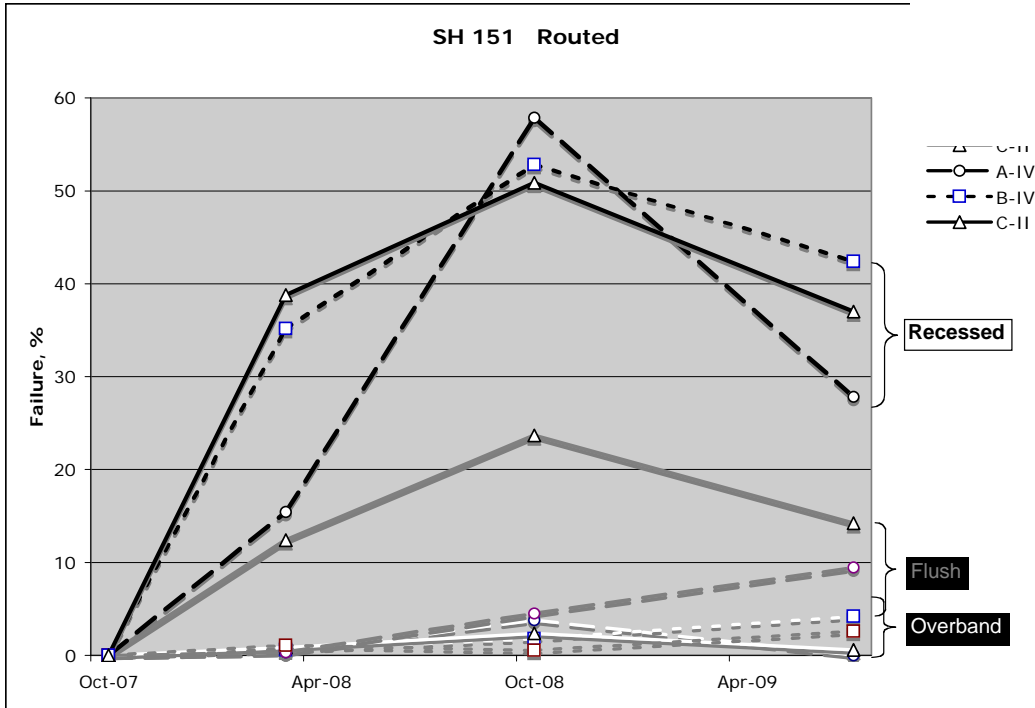
Figure 3. Sealant Performance on SH151-Cracks Prepared by Routing

Figures 3, 4, and 5 are the results from SH151 for routed, overbanded, and air blown cracks, respectively. Figures 6, 7 and 8 are the results from US285 for routed, overbanded and air blown cracks, respectively. And, Figures 9, 10 and 11 are the results from US350 for routed, overbanded and air blown cracks, respectively.
