# Investigation of the Dayton IR 75 Sign Truss Failure of 9/11/06

**Arthur Huckelbridge, D.Eng., P.E.  
&  
Andrew Metzger, P.E.**

**Department of Civil Engineering  
Case School of Engineering**

Report for the Ohio Department of Transportation  
Office of Traffic Engineering  
ODOT Agreement Number 14237

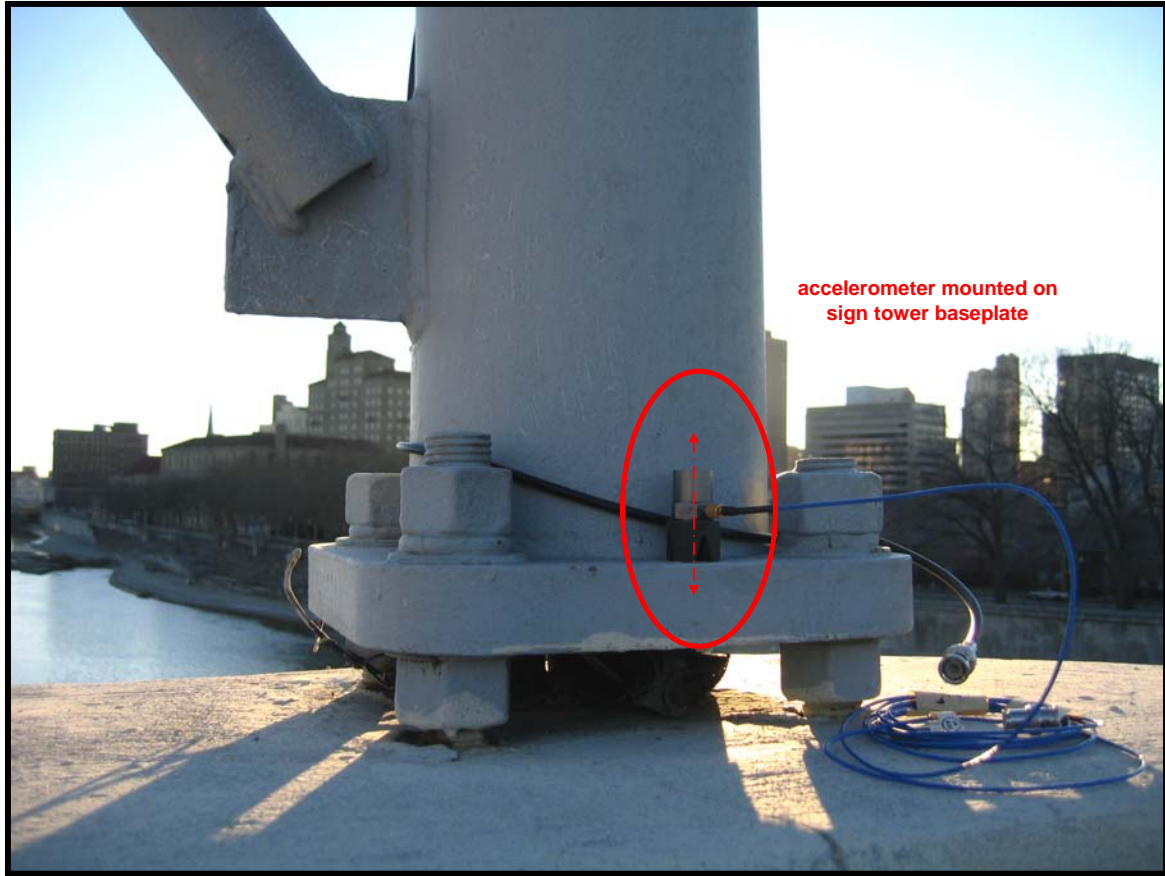
**Figure 9: Accelerometer Mounted on Tower Base**

On Sunday, December 10, 2006, traffic-induced vertical accelerations were measured at the bases of both of the towers (see Figure 9), where the sign support structure had previously been mounted, on the IR75 bridge over the Great Miami River in Dayton, OH. Accelerations were measured at a 100 hz sampling rate, and digitally recorded during passages of an ODOT tandem axle dump truck, weighing approximately 50 kips, as well as a number of other trucks of unknown weights, in the usual Sunday morning traffic stream. Accelerometers were mounted at both sign support towers, with an instrumentation cable temporarily suspended overhead from the west tower accelerometer to the data logger, located on the shoulder at the east tower (see Figure 10).

accelerometer mounted on  
sign tower baseplate

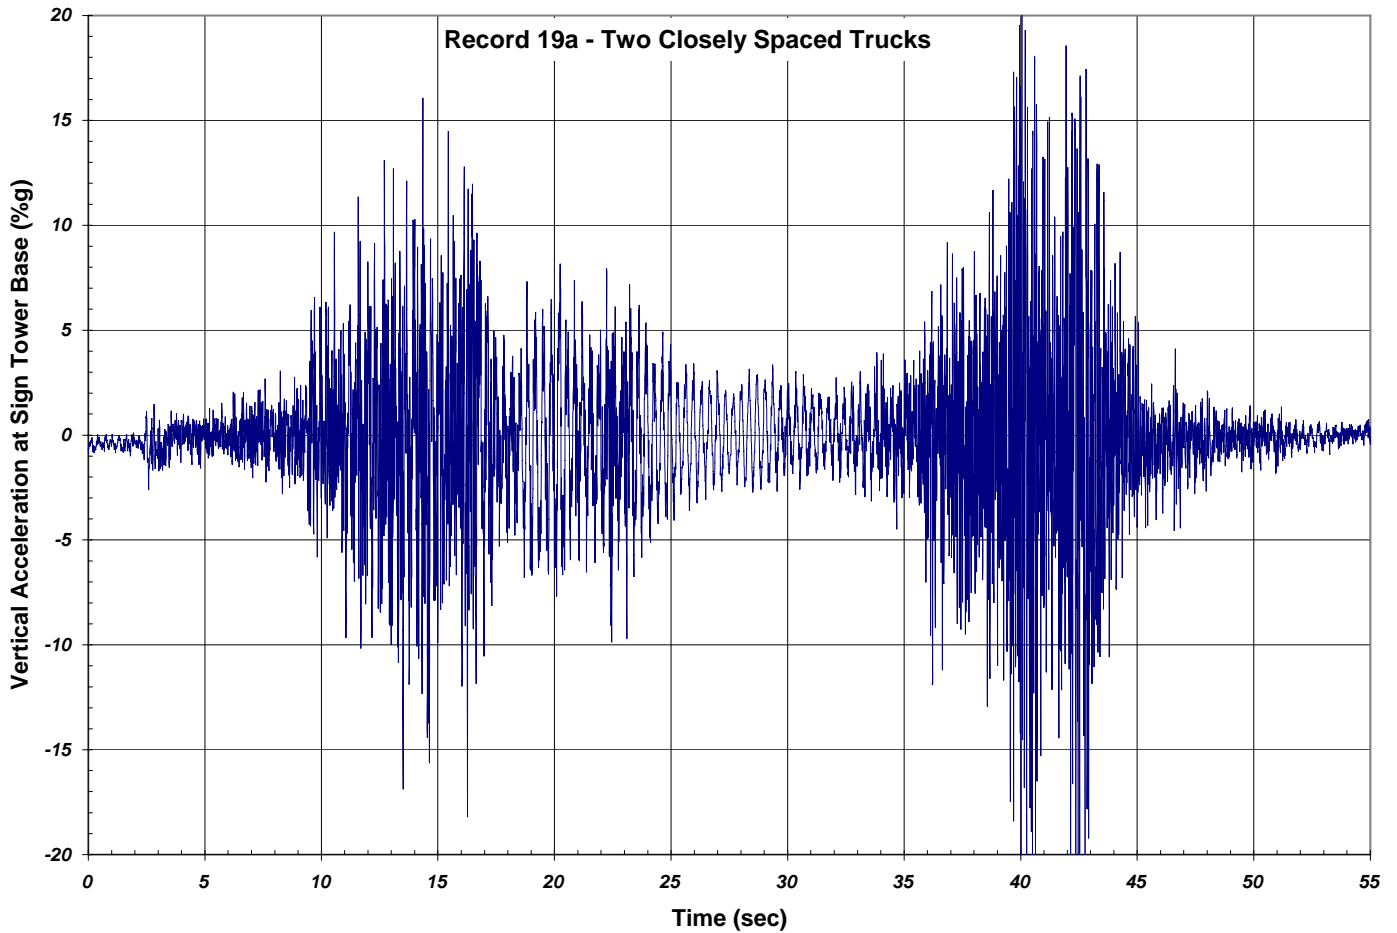
**Figure 11: Representative Traffic-Induced Bridge Acceleration Record**

As can be seen in Figure 11, measurable vertical vibrations produced by a single heavy truck passage can easily extend over a time interval on the order of 15 seconds or more in duration, and exhibit peak acceleration amplitudes from 10% to as high as 20% of gravity. The frequency content of this traffic-induced vibration will tend to be concentrated around the natural frequencies of the bridge in vibration modes excited by the traffic. Typically, the fundamental flexural and torsional modes will tend to dominate the traffic-induced response; vehicles in the center lanes will excite the flexural mode primarily, while vehicles in the outer lanes will have a greater tendency to excite the torsional mode. For a typical slab on girder bridge, these two response modes exhibit

very closely spaced natural frequencies. The frequency content of the vertical vibrations measured on this bridge were observed to be concentrated around a frequency of 3 hz. An ensemble of 19 separate truck passage records were preserved and utilized for the subsequent dynamic FE analysis of the failed sign structure.

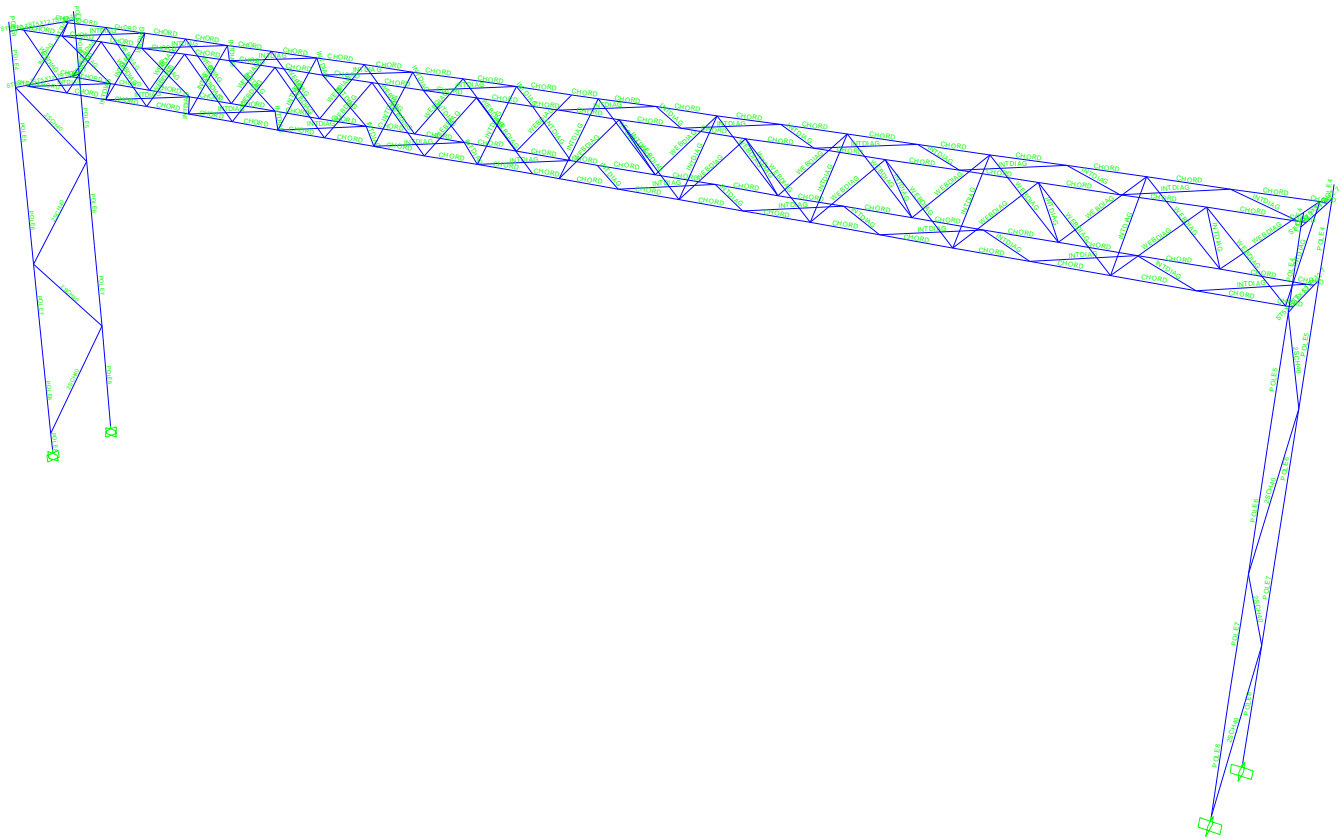
Figure 12: FE Model of Sign Truss

A finite element model of the failed sign structure was created utilizing the general purpose structural analysis software package SAP2000. The sign support structure, including the towers, was modeled with elastic 3D frame elements. Continuity was assumed for all structural connections; added mass totaling 1.5 kips of weight, representing signage, luminaires, wiring, etc., was distributed along the top and bottom chords of one vertical face of the truss. The aluminum truss members were assumed to have an elastic modulus of 10,000 ksi and a weight density of 0.10 lb/in<sup>3</sup>. The steel tower members were assumed to have an elastic modulus of 29,000 ksi and a weight density of 0.283 lb/in<sup>3</sup>. Nominal cross sections and dimensions were taken from the ODOT standard drawing (see Figure 2) as well as field measurements taken from the actual truss during the Dixie Outpost inspection of 11/16/06. The resulting FE model of the sign support structure is shown in Figure 12, and the first three natural modes of vibration are shown in Figure 13..

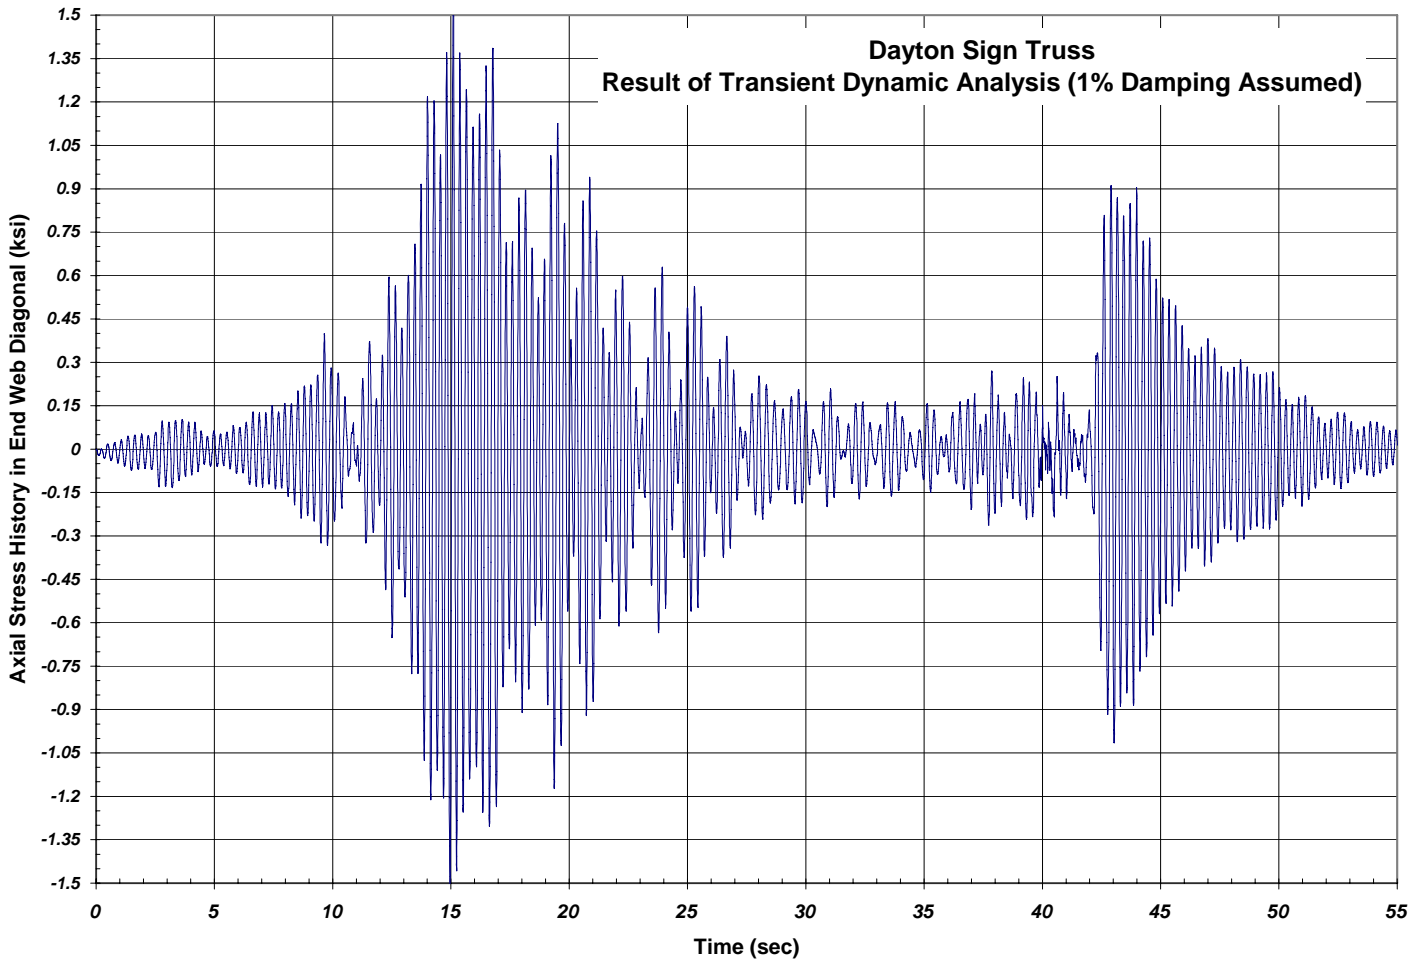
**Figure 14: Axial Stress Time History for End Web Diagonal**

The FE model depicted in Figure 12 was subjected to seismic excitation, consisting of vertical acceleration time histories applied to the support points at the tower bases. The acceleration time history records utilized were those recorded during the field tests of 12/10/06. A damping level of 1% of critical was assumed for all the dynamic analyses. The primary response quantities of interest were the axial stress levels in the web diagonals nearest the support towers, as they represent the most critical fatigue detail (AASHTO Category ET), subjected to the highest stress amplitudes. A sample record of such a response time history, computed for the tower acceleration record shown in Figure 11, is shown in Figure 14.

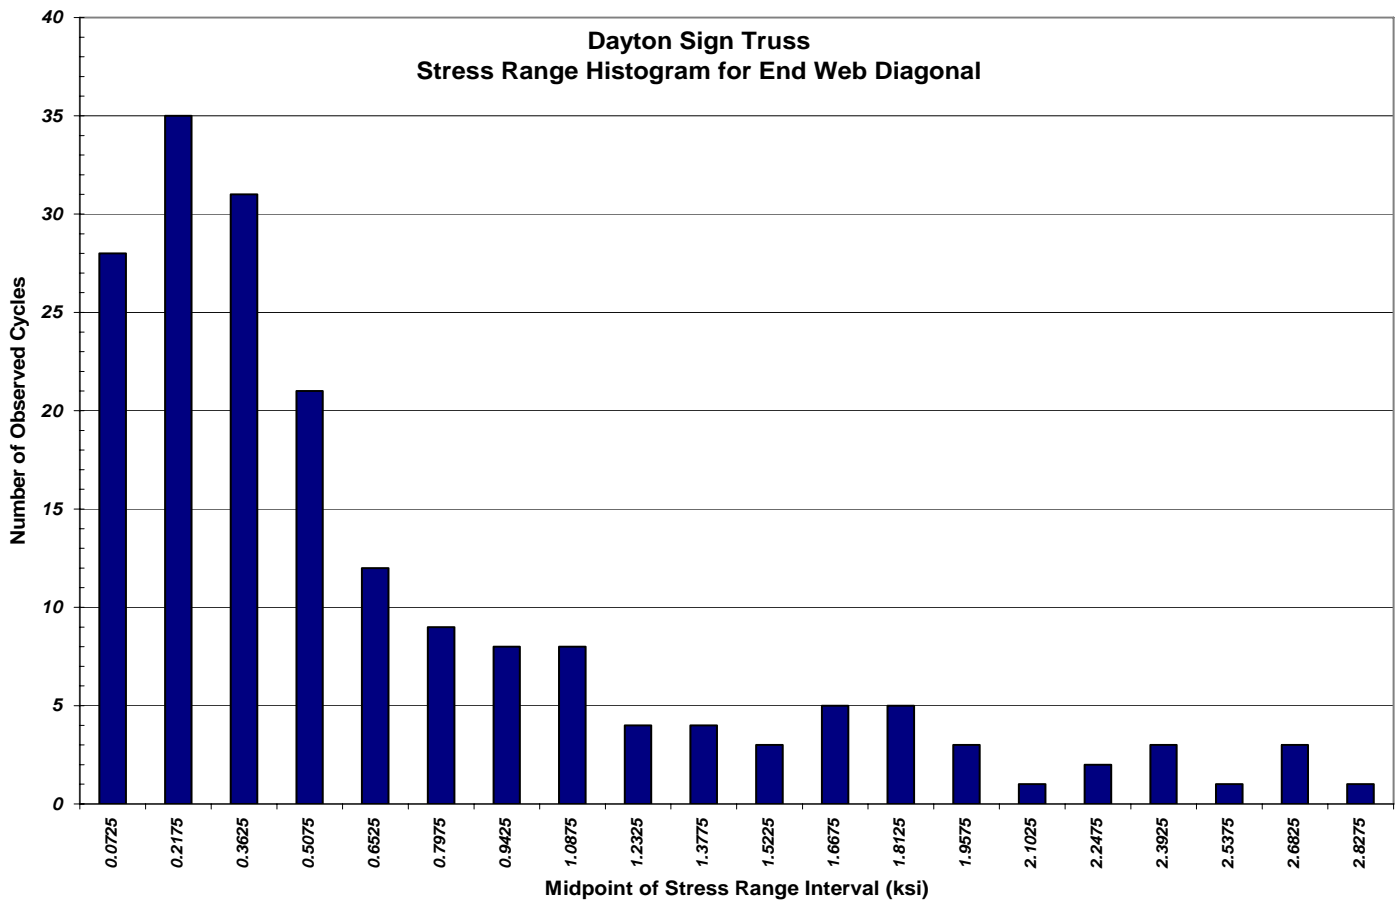
**Figure 15: Stress Range Histogram for the Response in Figure 13**

20 such “bins”, the sub-intervals would logically be  $< 0 \text{ to } .15 >$ ,  $< .15 \text{ to } .30 >$ ,  $< .30 \text{ to } .45 >$ , ..... ,  $< 2.85 \text{ to } 3.0 >$ . Each bin is then typically identified by its sub-interval midpoint value, i.e., the  $< 0 \text{ to } .15 >$  sub- interval is the .075 ksi bin, the  $< .15 \text{ to } .30 >$  sub-interval is the .225 ksi bin, etc. In processing a response time history into a stress range histogram, each time a particular cycle of response is “completed”, the current count in the appropriate stress sub-interval or “bin” for its peak-to-peak amplitude is incremented, until the entire response time history is processed. This type of data processing is known as “rainflow” cycle counting, and is a built-in “real-time” feature of many commercial dynamic data acquisition/processing software packages. A stress range histogram constructed for the response time history shown in Figure 14 is shown in Figure 15.

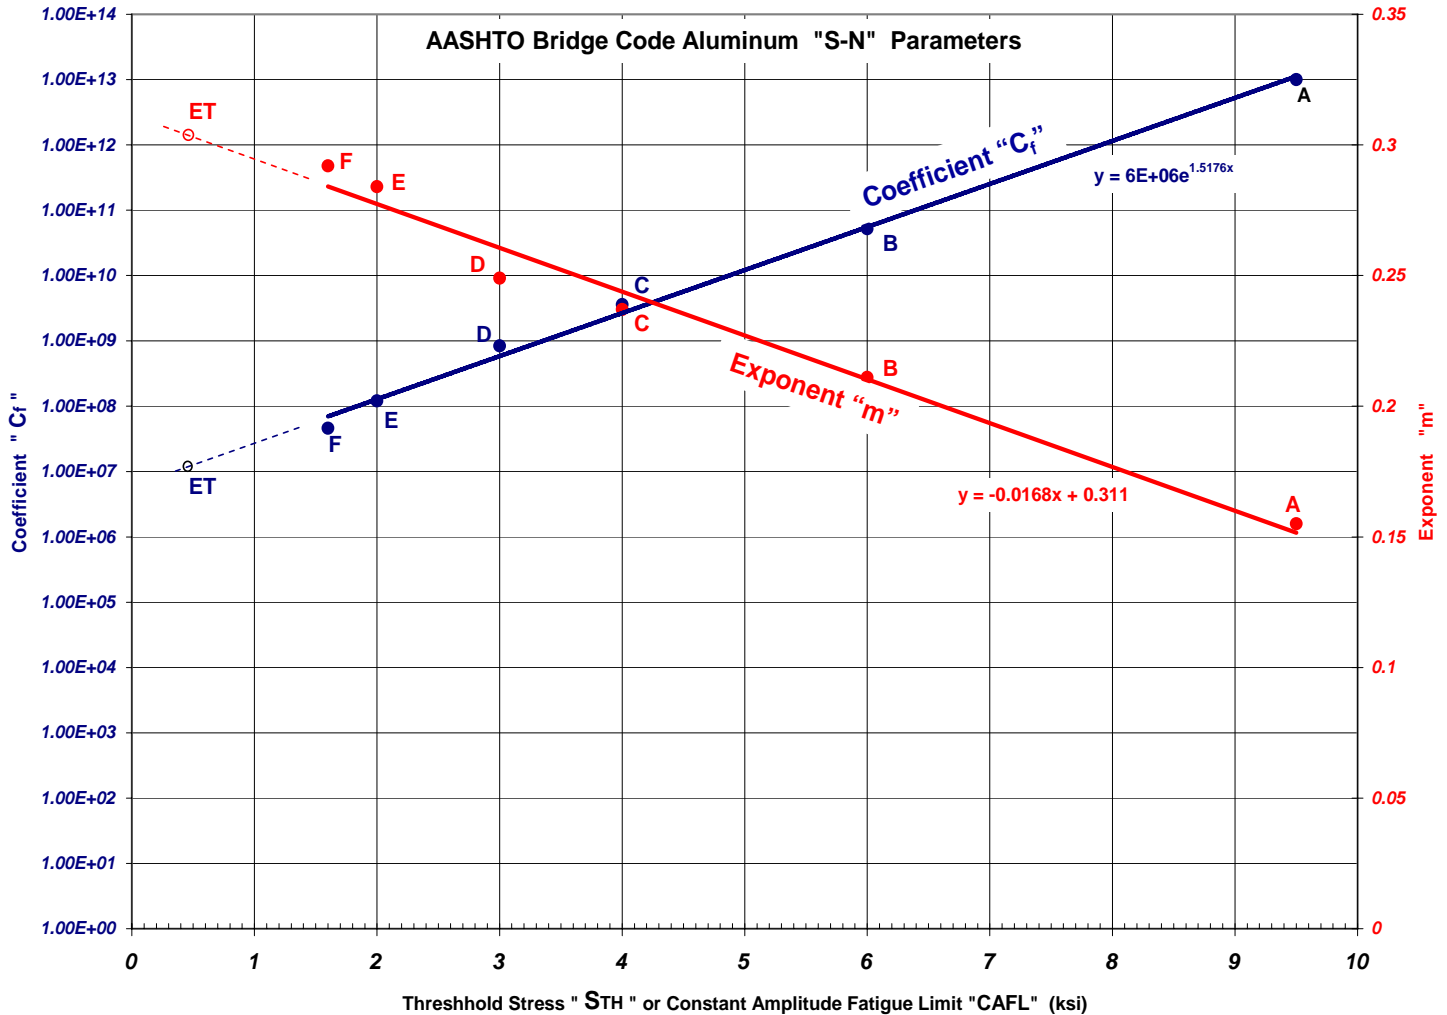
**Figure 16: Extrapolation of Category ET S-N Parameters**

These data were graphed and fit to analytical curves, utilizing the  $S_{TH}$  and CAFL as an independent variable, as shown in Figure 16. From these analytical curves the parameters of the ET fatigue lifetime curve were estimated as  $C_f = 1.17 \text{ E}+07$  (cycles /  $\text{ksi}^m$ ) and  $m = .304$ .

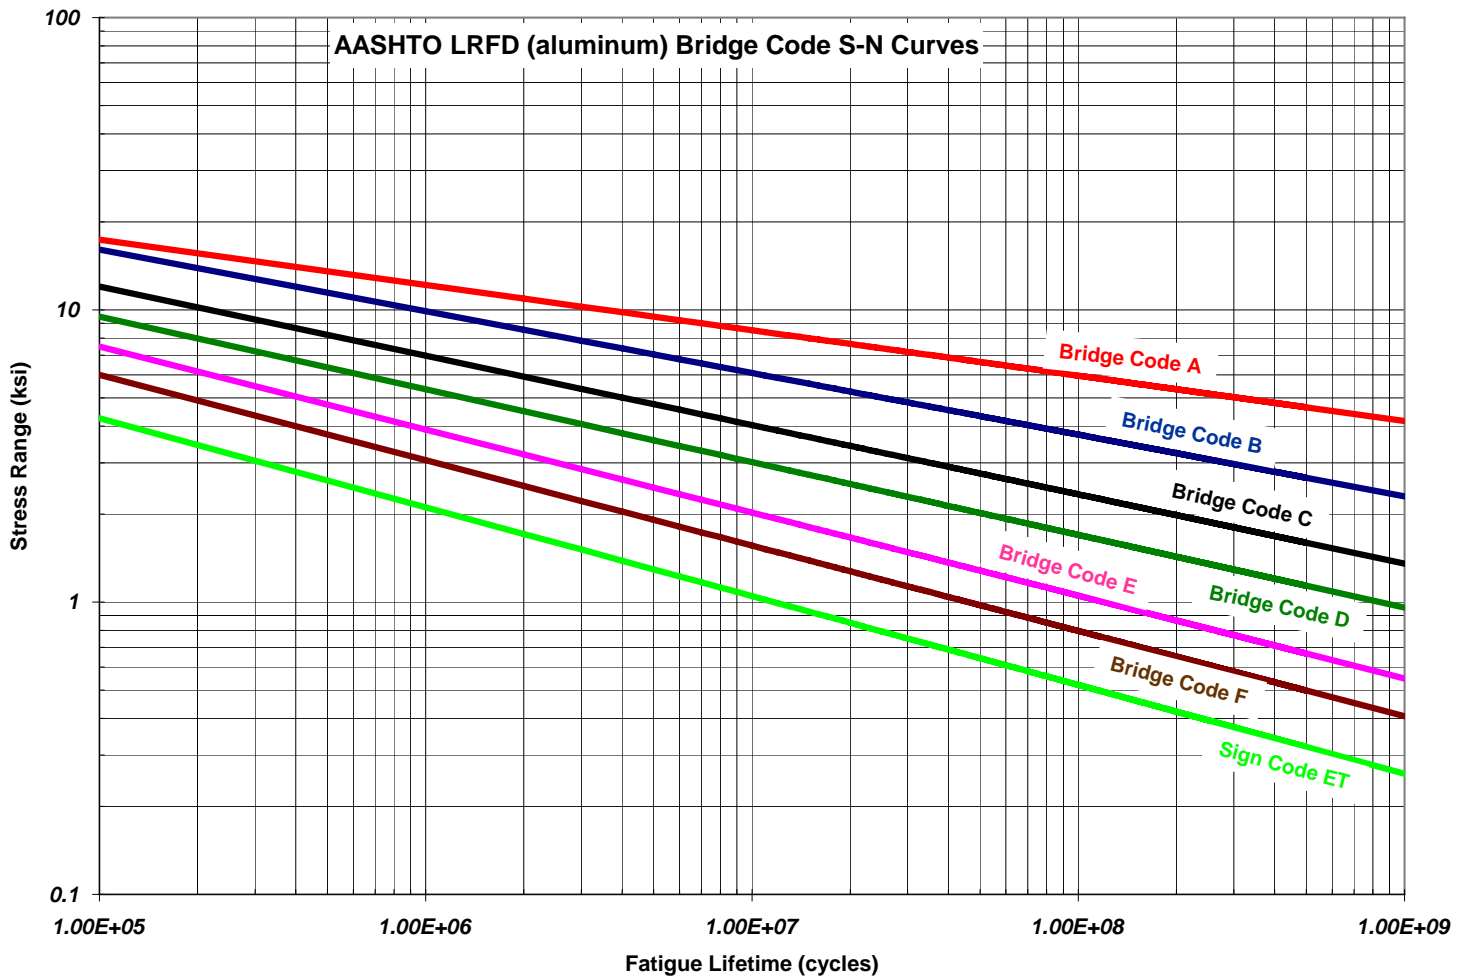
**Figure 17: Extrapolated S-N Curve for Fatigue Category ET**

The S-N curves for aluminum fatigue detail categories from the AASHTO LRFD Bridge code are plotted in Figure 17, along with the extrapolated curve assumed for the *Standard Specification for Structural Supports for Highway Sign, Luminaire and Traffic Signals* category ET fatigue detail. The cutoffs for threshold and CAFL stress values were intentionally not included in Figure 17 in order to illustrate the potential implications of very high cycle counts on a material lacking any apparent endurance limit.
