## **Investigation of Subsidence Along Segment of Missouri Route 65, Springfield, Missouri**

Neil L. Anderson and Evgeniy V. Torgashov

**NUTC  
R221**

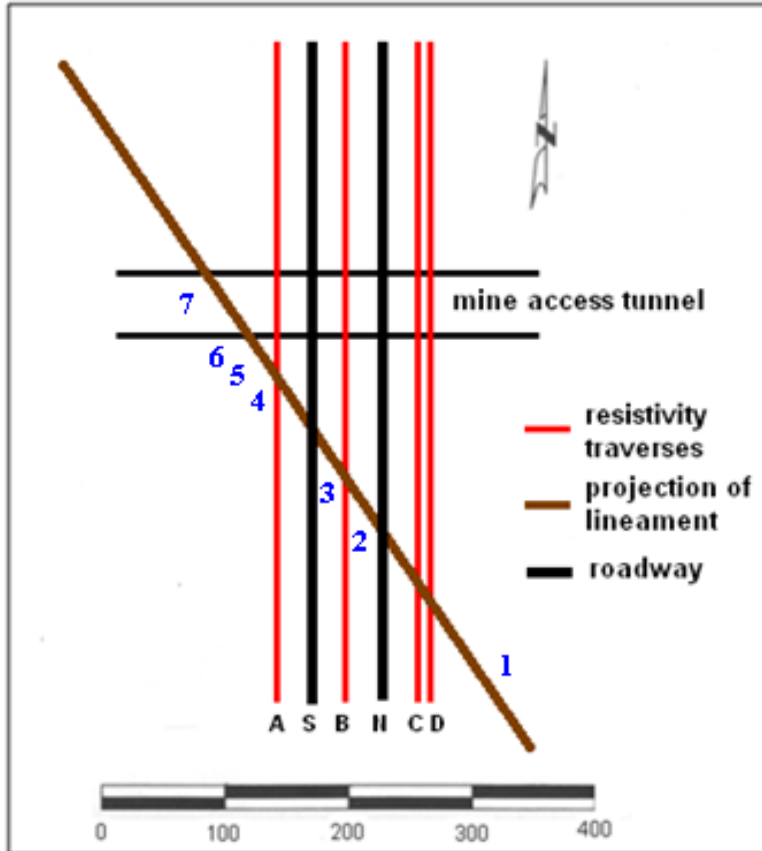
**Figure 1:** Map of study site showing locations of four north-south surface electrical resistivity tomography profiles (A, B, C and D). The centerlines of the northbound (N) and southbound (S) roadways, the mine access tunnel, the projected lineament and the approximate locations of seven boreholes are shown.

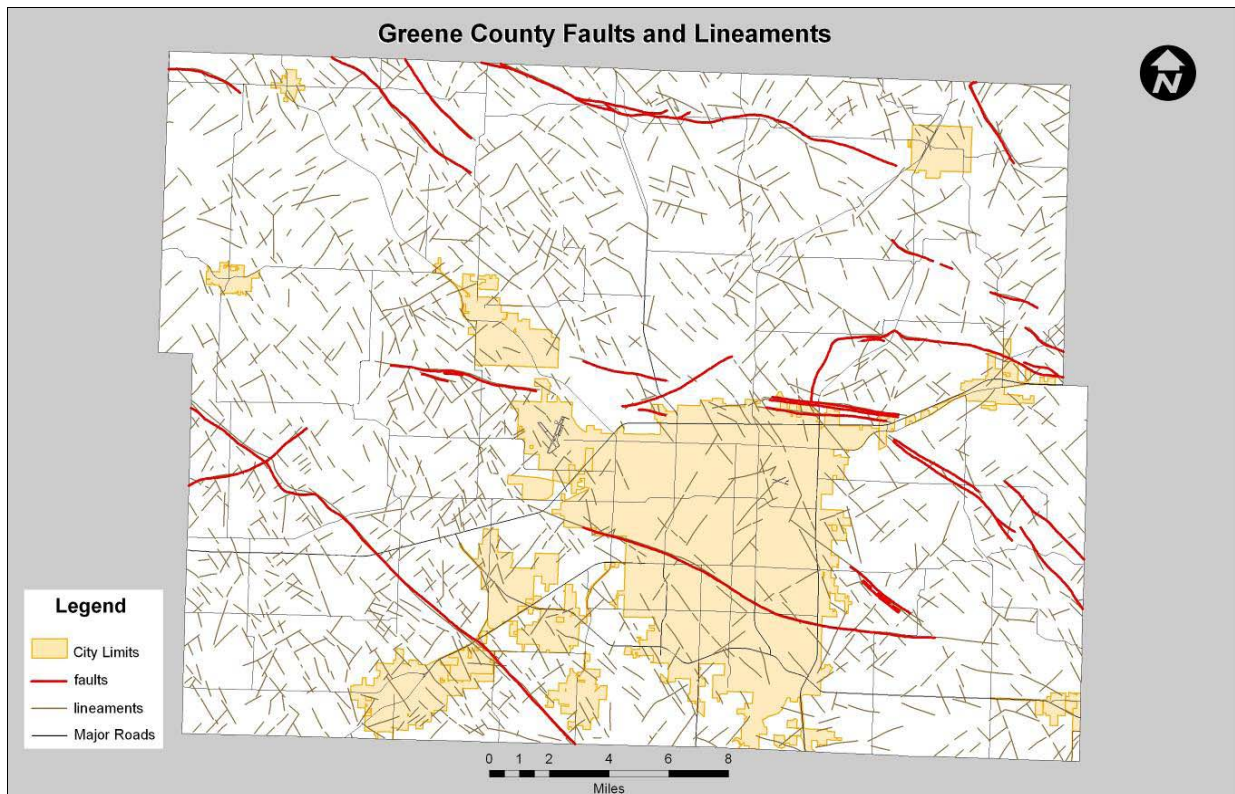
**Figure 6:** Locations and orientations of mapped faults and lineaments in Greene County (Coots, 2007). Faults and lineaments in the region tend to strike approximately northwest or northeast.
