1. Report No. FHWA/TX-10/5-4687-01-1		2. Government Accession No.		3. Recipient's Catalog No.	
4. Title and Subtitle RUBBLIZATION AND BASE OVERLAY OF FM 912 AND FM 1155		5. Report Date October 2009 Published: January 2010		6. Performing Organization Code

# **RUBBLIZATION AND BASE OVERLAY OF FM 912 AND FM 1155**

Report 5-4687-01-1  
Project 5-4687

Project Title: Pilot Implementation of Rubblization for Rehabilitation of Concrete Pavements

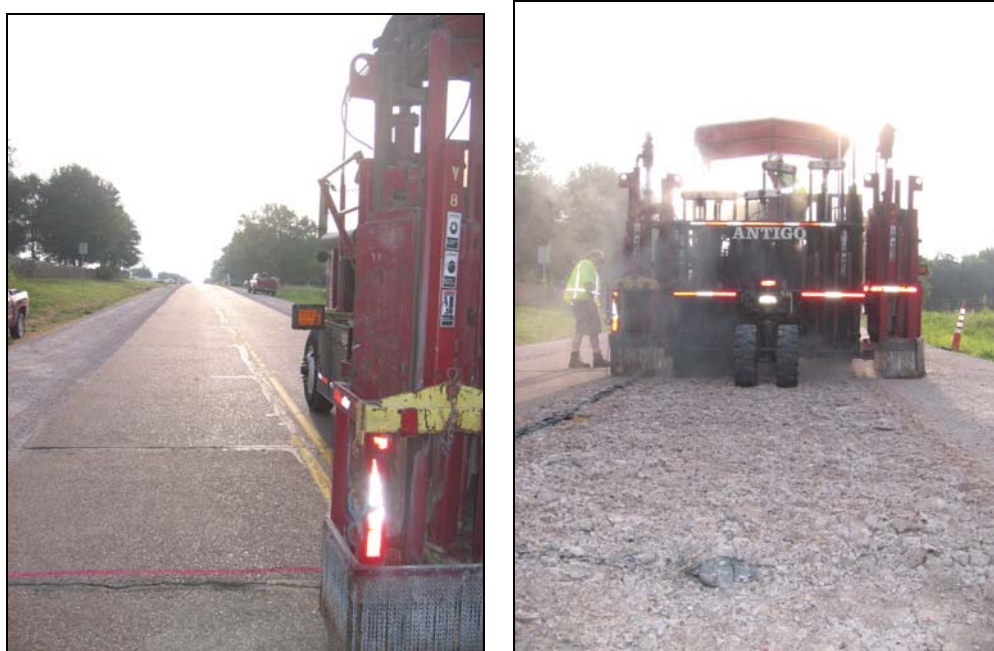
**Figure 2.1. Unfractured (Left) and Rubblized (Right) JCP during Type II Rubblization.**

Type II rubblization, employing a multiple head breaker, took place June 23–27, 2008. The Type II equipment rubblizes the entire lane width in one pass. Antigo Construction performed the Type II rubblization, with planned station limits from 105+00 to 169+00. Figure 2.1 shows the unfractured concrete ahead of the breaker, along with the surface view of the rubblized concrete after the operation.

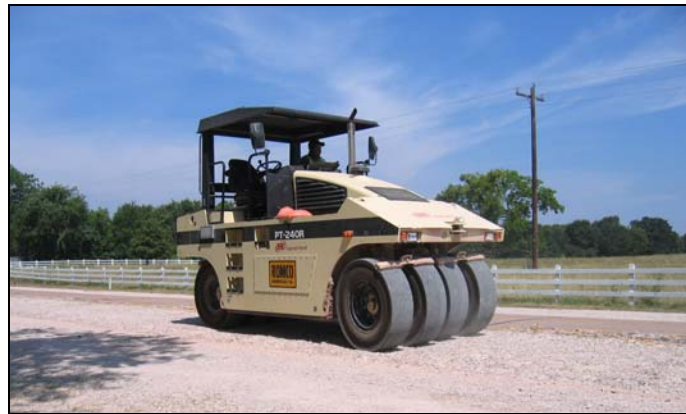
**Figure 2.4. Proof Rolling.**

To validate the locations of areas in need of full-depth repair, the contractor performed proof rolling with an IR PT-240R (see Figure 2.4), reportedly loaded to 30 tons. The location shown in Figure 2.3 indeed required full-depth repair. Per the specification, the contractor excavated unstable areas to a depth of 18 inches then repaired them with flexible base. Table 2.1 summarizes the locations on the project receiving full-depth repair within the limits of the Type II rubblization. Approximately 6 percent of the area rubblized required full-depth repair.

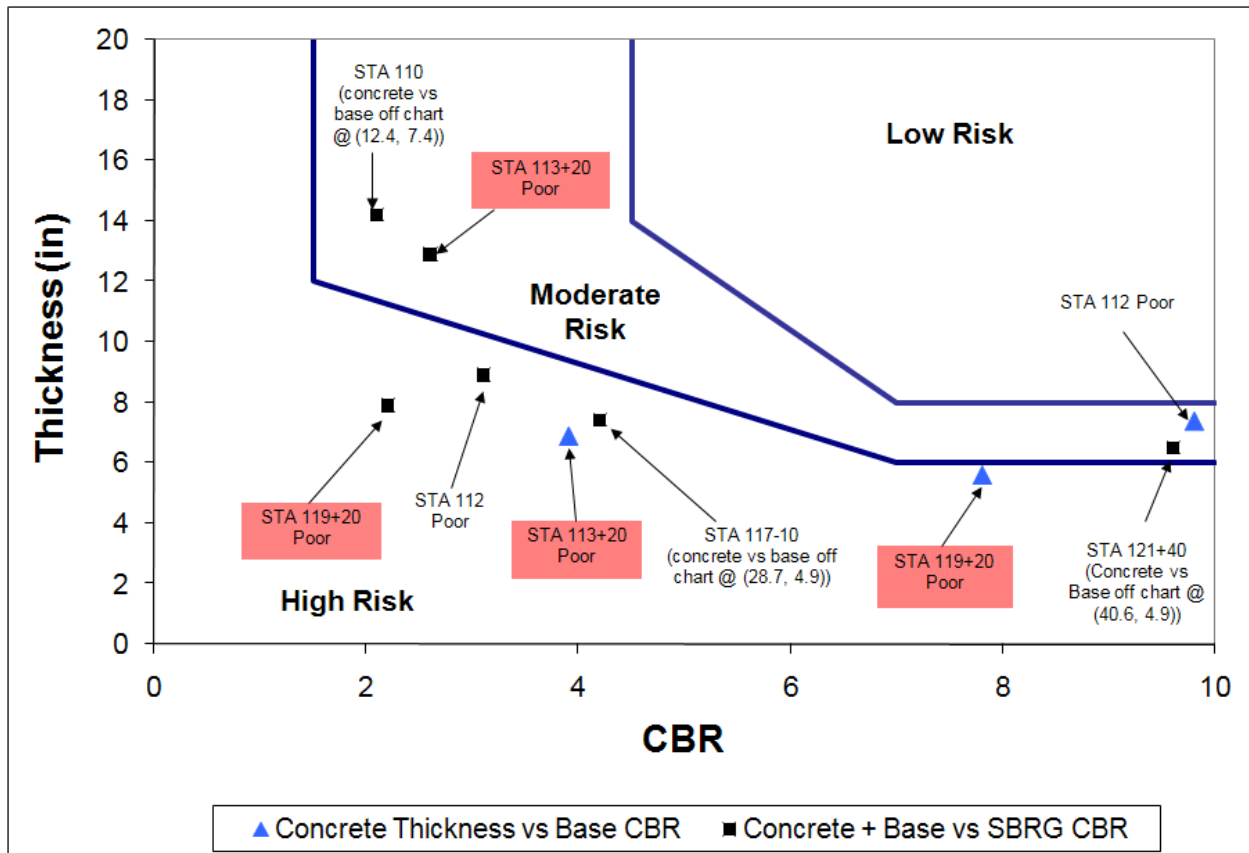
**Figure 2.6. Selection Chart Data from Construction for Type II Rubblization.**

validating the rubblization selection chart outlined in report 0-4687-2. Figure 2.6 shows these results plotted on the rubblization selection chart previously employed to evaluate the project’s suitability for rubblization. In Figure 2.6, locations showing a poor break pattern upon visual inspection are annotated as “poor.” Locations that proved unstable as determined by proof rolling are highlighted in red. The results indicate the rubblization selection chart matched well with field experience. Additionally, the results reiterate the importance of the support immediately beneath the slab; each measurement where the concrete thickness versus base California Bearing Ratio (CBR) plotted in the High Risk zone was found unstable during proof rolling and required removal. In contrast, two observations exist where only the concrete plus base thickness versus subgrade CBR plotted in the High Risk zone, and these locations remained stable upon proof rolling.

*Note: Locations highlighted in red required full-depth repair.*

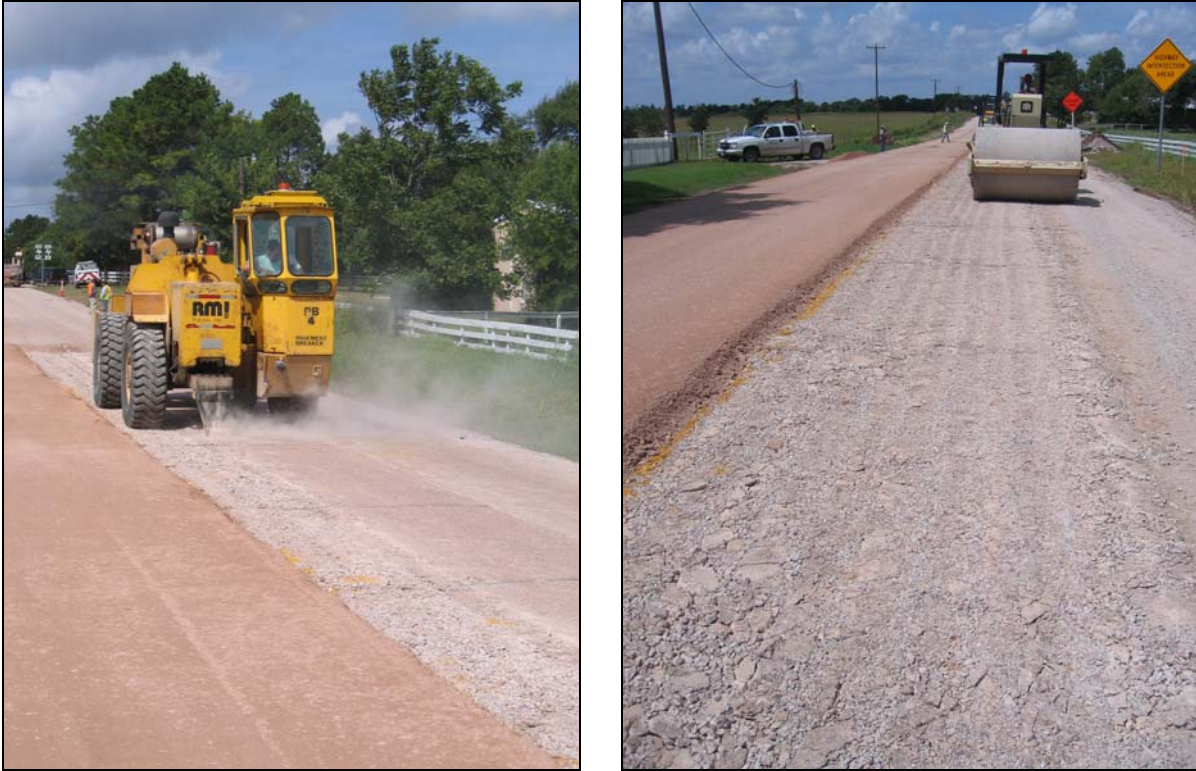
**Figure 2.7. Type I Rubblization in Progress and Completed Section.**

Type I rubblization, employing a resonant breaker, took place August 4–8, 2008. The Type I rubblizer uses a vibrating shoe to impact and fracture the concrete. RMI Worldwide performed the Type I rubblization, with planned station limits from 169+00 to 230+00. Figure 2.7 shows the Type I rubblization in progress along with a representative completed section.

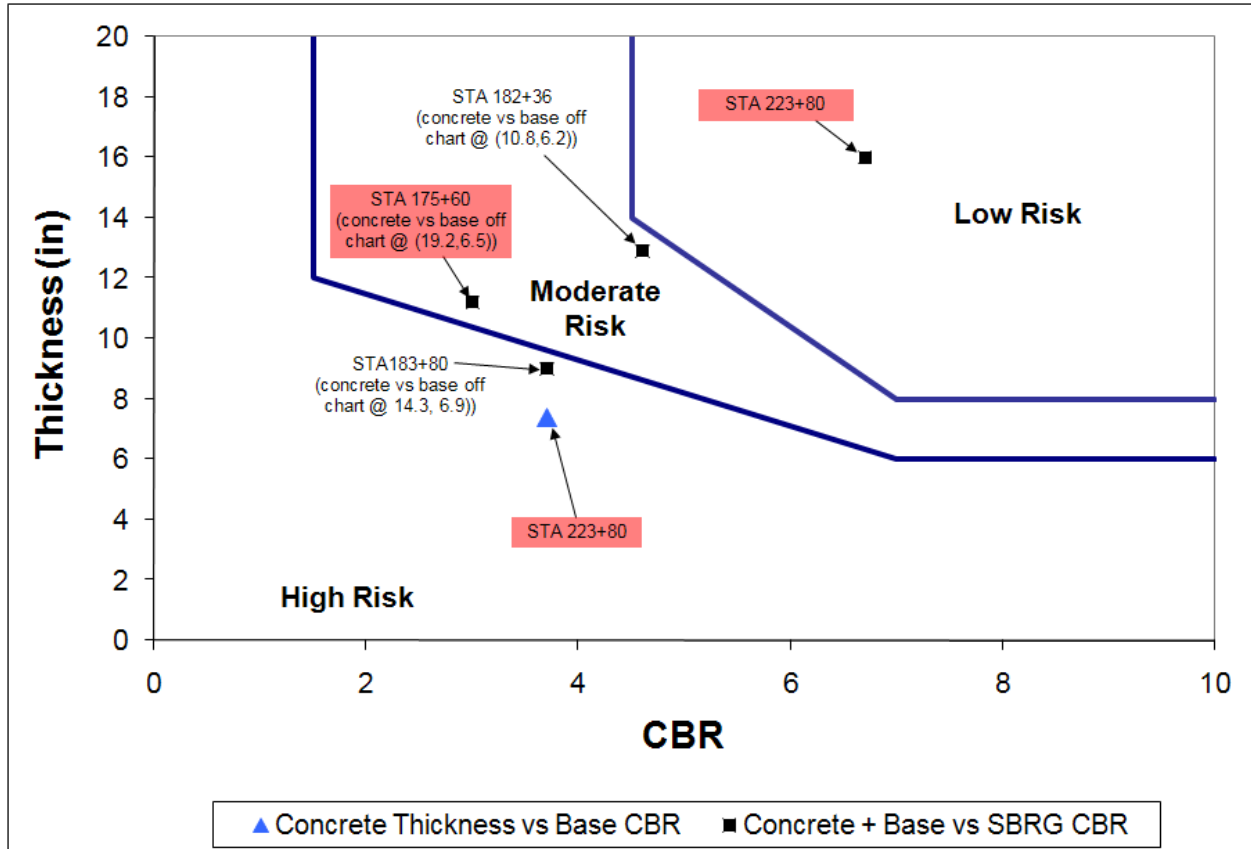
**Figure 2.11. Selection Chart Data from Construction for Type I Rubblization.**

TTI researchers sought to evaluate how the rubblization selection chart compared with field experience for the Type I rubblizer. Table 2.6 presents data collected at five locations, two of which required removal and replacement after proof rolling. Figure 2.11 plots these data on the rubblization selection chart. Locations noted in red required removal due to instability after rubblization. The field experiences match the chart reasonably well, with both locations requiring removal having at least one data point in the High Risk zone of the selection chart.

*Note: Locations highlighted in red required full-depth repair.*

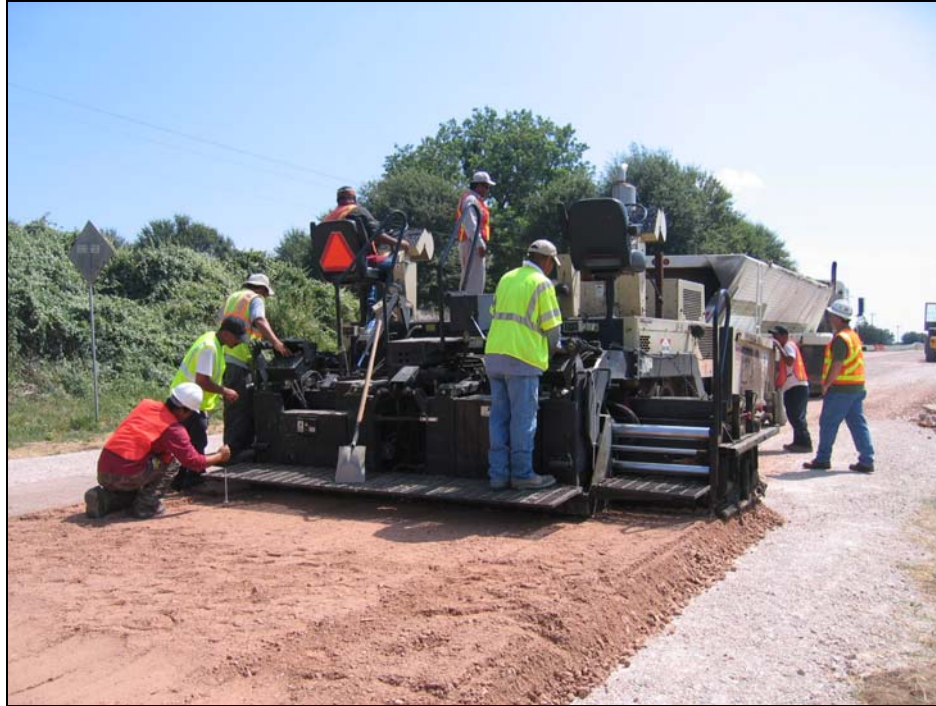
**Figure 2.12. Placing Base with Paver.**

Regardless of the type of rubblization employed, the flexible base was wetted in a pugmill then placed at the site with an asphalt paver, as Figure 2.12 shows. Instead of blade-spreading the base, a paver was used in attempts to minimize segregation of the base at the project site. A pneumatic and steel wheel roller compacted the base, as Figure 2.13 shows.

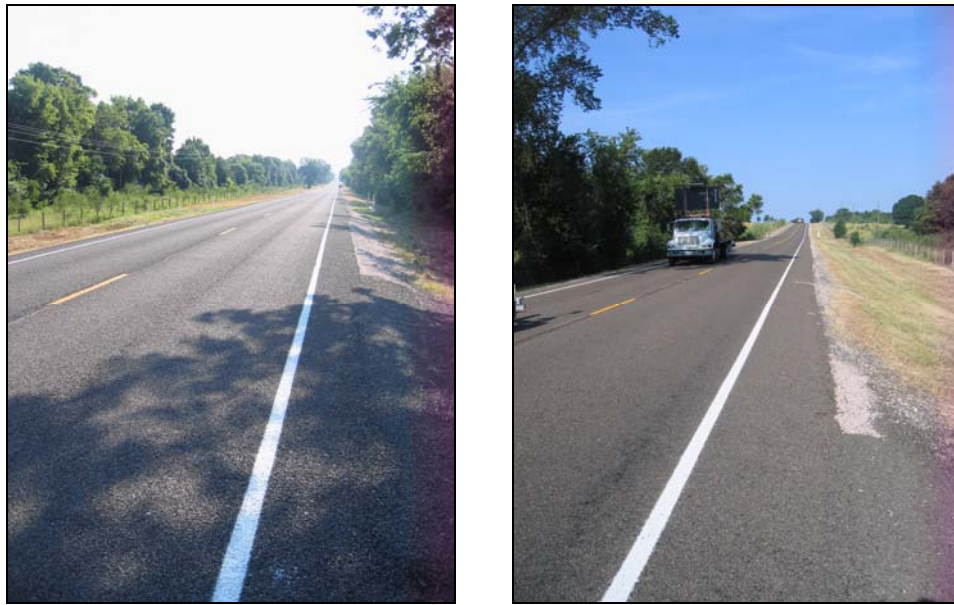
**Figure 3.1. Existing JCP with Grade 4 (Left) and Grade 2 (Right) Overlay.**

Figure 3.1 shows the sections receiving a flexible base overlay on top of the unrubblized existing JCP, and Figure 3.2 shows representative GPR data from these sections. The season leading up to the time of surveying had been unusually dry, and the strength of reflections from the layers was typically small. The most unusual reflections observed in these sections were the continued negative reflections indicative of voids underneath the concrete approximately 1.5 miles into the project as Figure 3.3 shows. TxDOT purposefully did not include the limits of this section in the rubblization plans due to the poor soil and history of voids and washouts underneath the concrete.

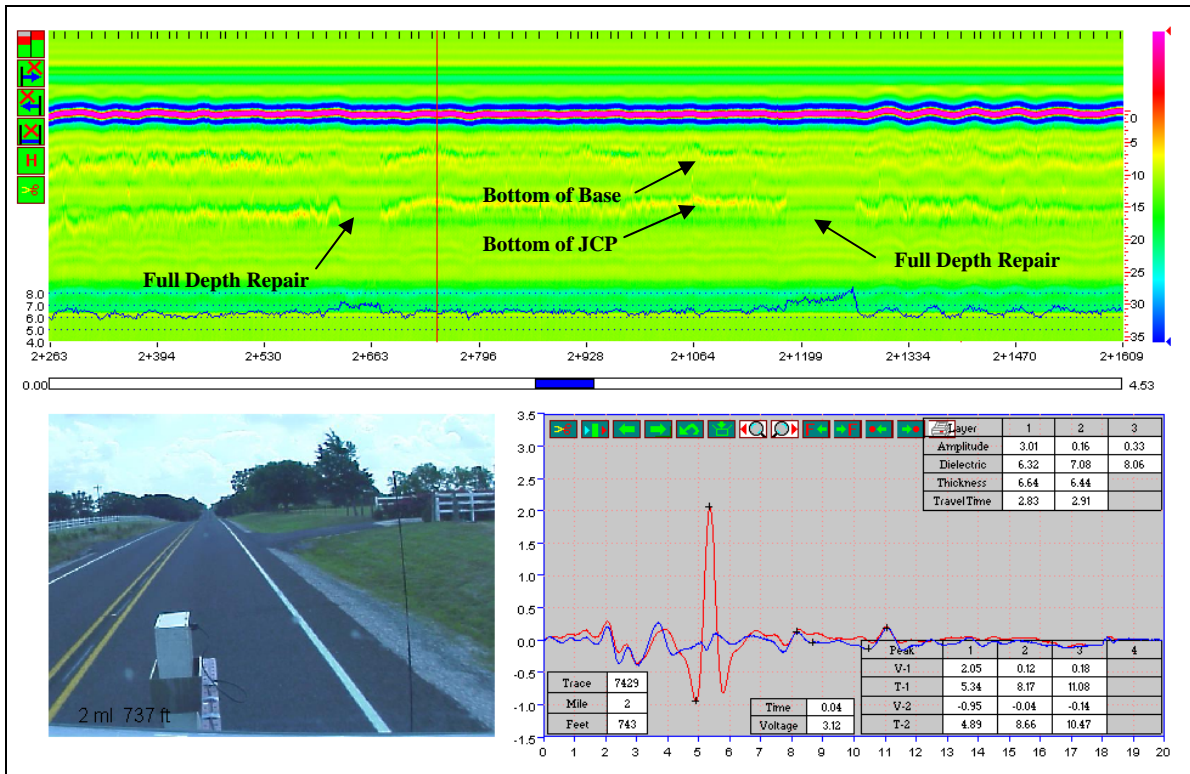
**Figure 3.5. Representative GPR from Type II Rubblization.**

Figure 3.4 shows the start of the section rubblized with Type II equipment looking northbound. The GPR data in this section, as Figure 3.5 represents, revealed nothing unusual. The waviness of the surface reflection indicates pavement roughness, and the locations of full-depth repairs are typically evident.

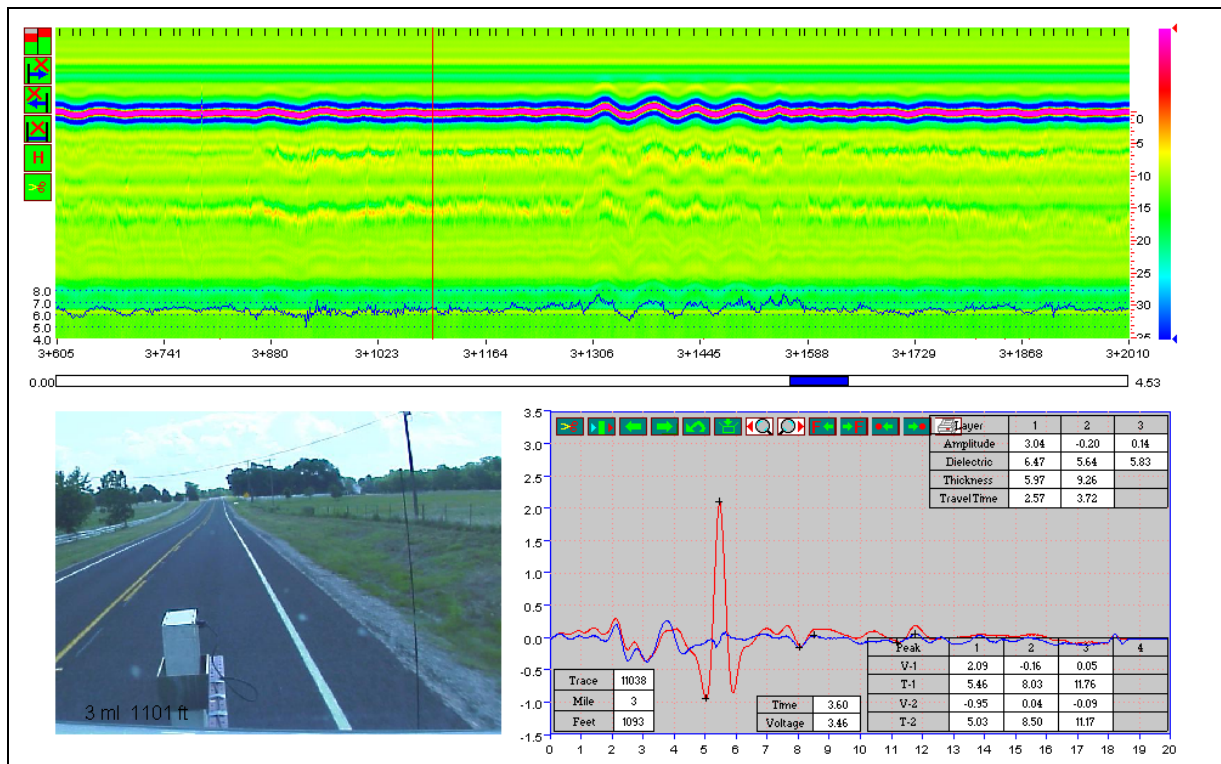
Figure 3.7. Example GPR from Type I Rubblization with Grade 2 Overlay.

Figure 3.6 shows the start of the section rubblized with Type I equipment looking northbound, and Figure 3.7 shows representative GPR from this section. Similar to the data from the section rubblized with Type II equipment, the GPR data are clean and do not indicate any problems within the pavement structure. Again, roughness in the surface reflection is evident and scrolling through the data reveals locations evident of full-depth repair.

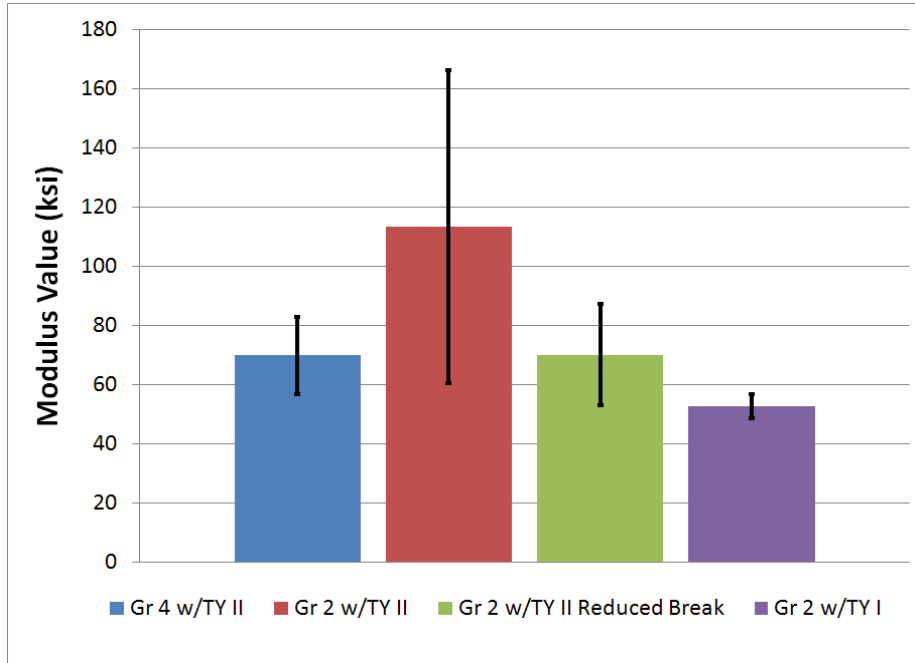
**Figure 3.10. Modulus Values of Rubblized JCP with 95 Percent Confidence Intervals.**

- The different sections of JCP rubblized with Type II equipment had statistically equivalent means, and Type II rubblization produced an average modulus value exceeding the value observed from Type I equipment, as Figure 3.10 shows. The average rubblized JCP modulus from Type II equipment was 79 ksi; from Type I equipment this value was 52 ksi. For design purposes, since the equipment to be used will not be known ahead of time, a rubblized concrete modulus value of 50 ksi would be recommended.

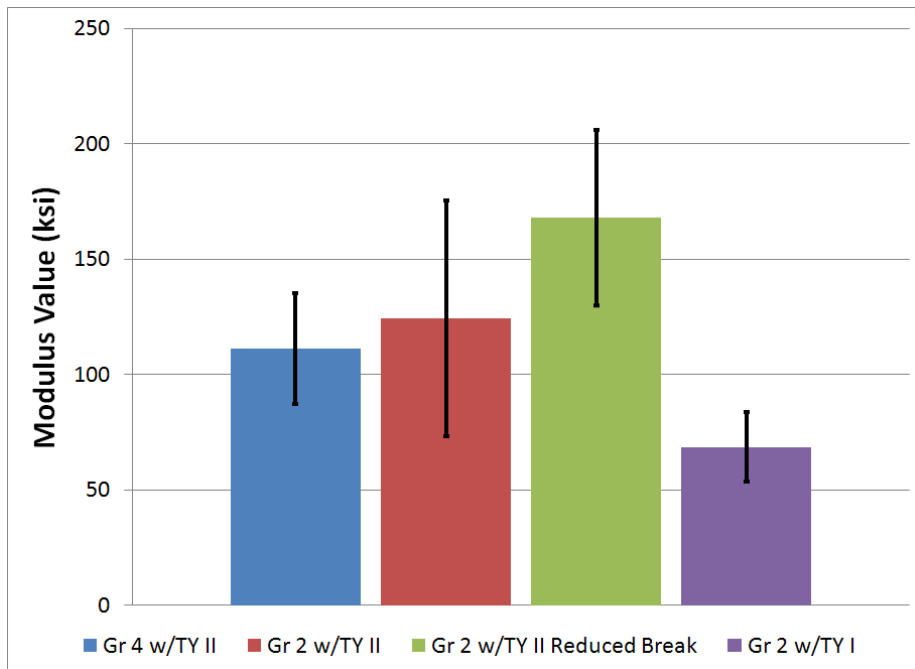
**Figure 3.11. Modulus Values of Flexible Base Overlays in Rubblized Sections with 95 Percent Confidence Intervals.**

- Within the sections rubblized with Type II equipment, the base modulus was higher in the section where the JCP received the reduced break pattern. In Type II sections receiving identical break patterns, the mean modulus value of the Grades 2 and 4 bases were statistically equivalent with an overall average value of 115 ksi. Additionally, the sections rubblized with Type II equipment exhibited higher base modulus values than the section where Type I equipment was used. This may be at least partially due to the fact that the section where Type I equipment was employed had an observed lower rubblized concrete modulus. The base overlay in the section rubblized with Type I equipment averaged 69 ksi. Figure 3.11 illustrates the base modulus results from these sections. For design purposes, since the equipment to be used will not be known ahead of time, a flexible base modulus value of 69 ksi would be recommended.

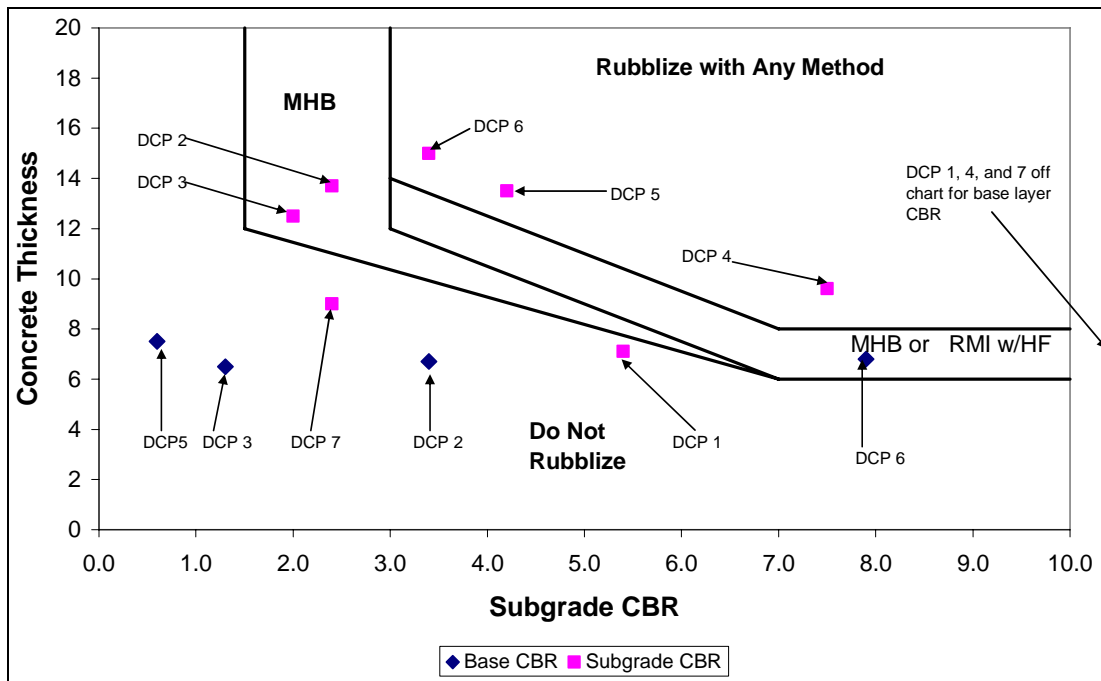
**Figure C.4. DCP Results from FM 912 on IDOT Rubblization Selection Chart.**

Figure C.4 shows this chart with the FM 912 data. Of particular attention in this graph are the data from DCP tests 1, 4, 6, and 7, because these are the only locations where the support immediately beneath the slab is sufficient to where rubblization may be feasible. The location represented by DCP 4 should not be rubblized because the section falls within the limits of the project where voids occur beneath the slab. Of the remaining locations 1, 6, and 7, the data show the portions of the project represented by tests 1 and 7 may not be suitable for rubblization because of the poor soil conditions a few inches below the bottom of the concrete. Only at location 6 do the data indicate the project is suitable for rubblization with minimal risk.

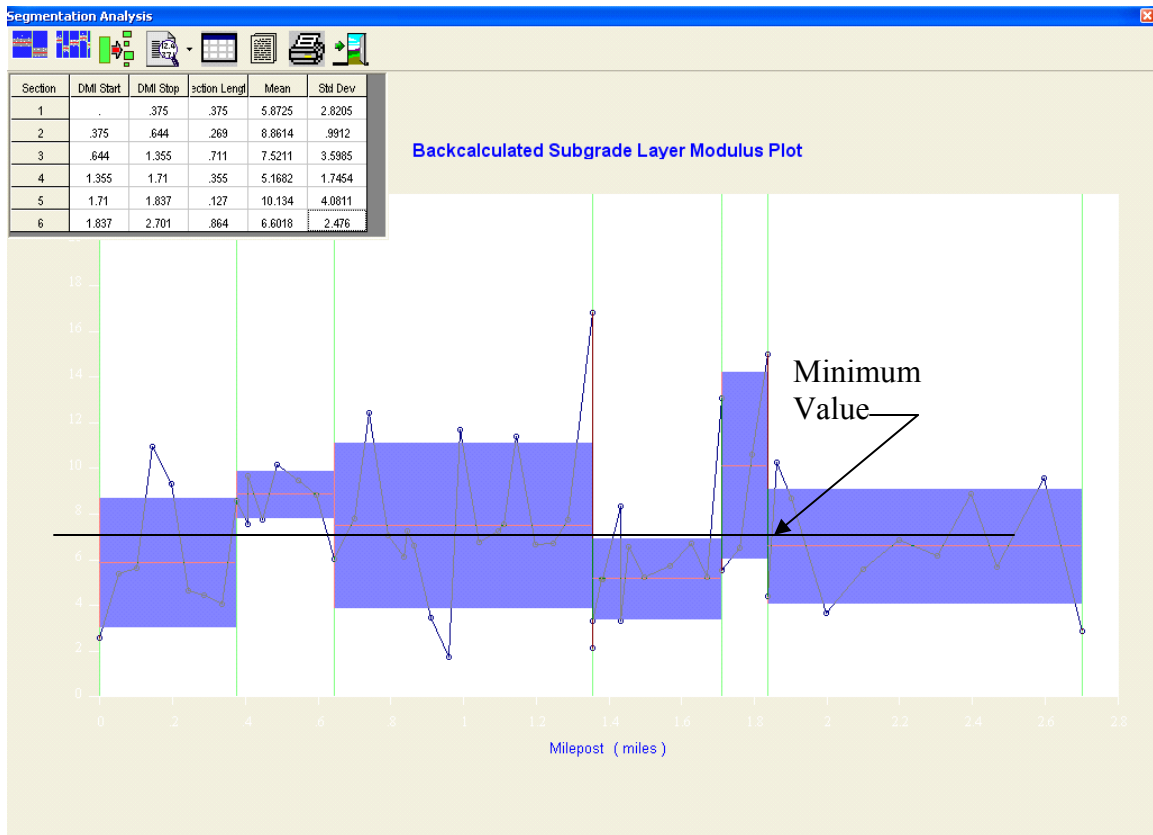
**Figure C.6. FM 912 Backcalculated Subgrade Modulus with Distance (SB Direction).**  
*Note: Milepost Zero is at RM 628 + 0.182*

To segment the project, the backcalculated subgrade modulus with distance is graphed in Figure C.6. Segments 2 and 6 are marginally suited for rubblization. The average subgrade value exceeds (segment 2) or nearly meets (segment 6) the required minimum value. The DCP data from within these sections indicate they are marginally suitable for rubblization. The limits of these sections are from RM 628.557 to 628.826 and 630.019 to 630.658.

The first segment is not suitable for rubblization because the subgrade modulus is less than the required minimum value. Segments 3 through 5 should not be rubblized due to their proximity to locations where voids have occurred beneath the slabs.

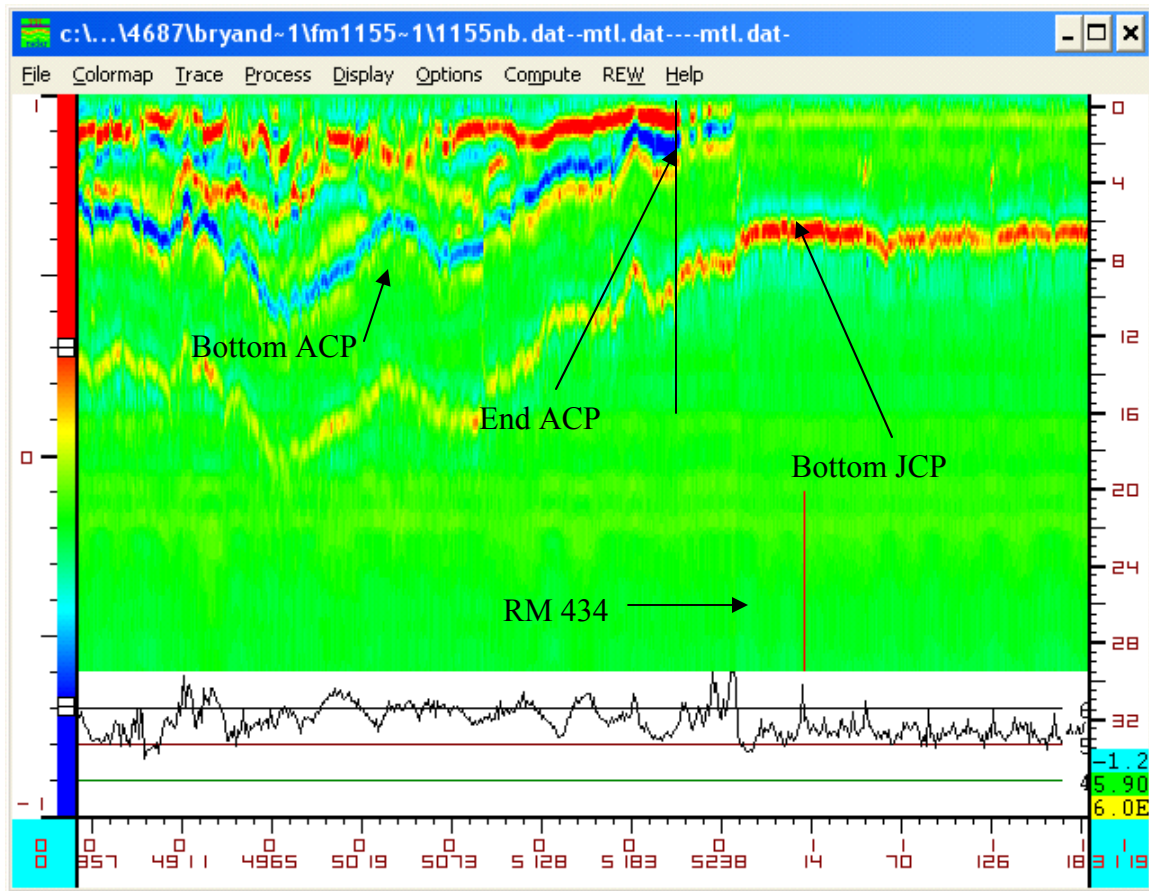
**Figure D.3. GPR Where ACP Exists over JCP on FM 912.**

To evaluate whether the project is suitable for rubblization, TTI performed a field analysis using GPR, FWD, and DCP testing. Several sections of the project have asphalt concrete patches over the concrete. Table D.1 shows the sections that exist based upon observation and GPR data. Figure D.2 illustrates representative GPR data from the project where the structure consists solely of JCP. Figure D.3 shows GPR data illustrating the transition from a location with asphalt concrete pavement (ACP) back to solely JCP.

The GPR survey serves two primary purposes. First, the survey can identify locations of excessively wet subgrade or trapped water, both of which hinder the rubblization process. Second, the GPR survey can identify section breaks or changes in structure. In the GPR data, no locations of excessively wet subgrade were identified. The highest subgrade dielectric value was 8.7 (values above 10 can indicate excessively wet material). The only changes in structure seen were at locations where ACP has been placed on top of the JCP.

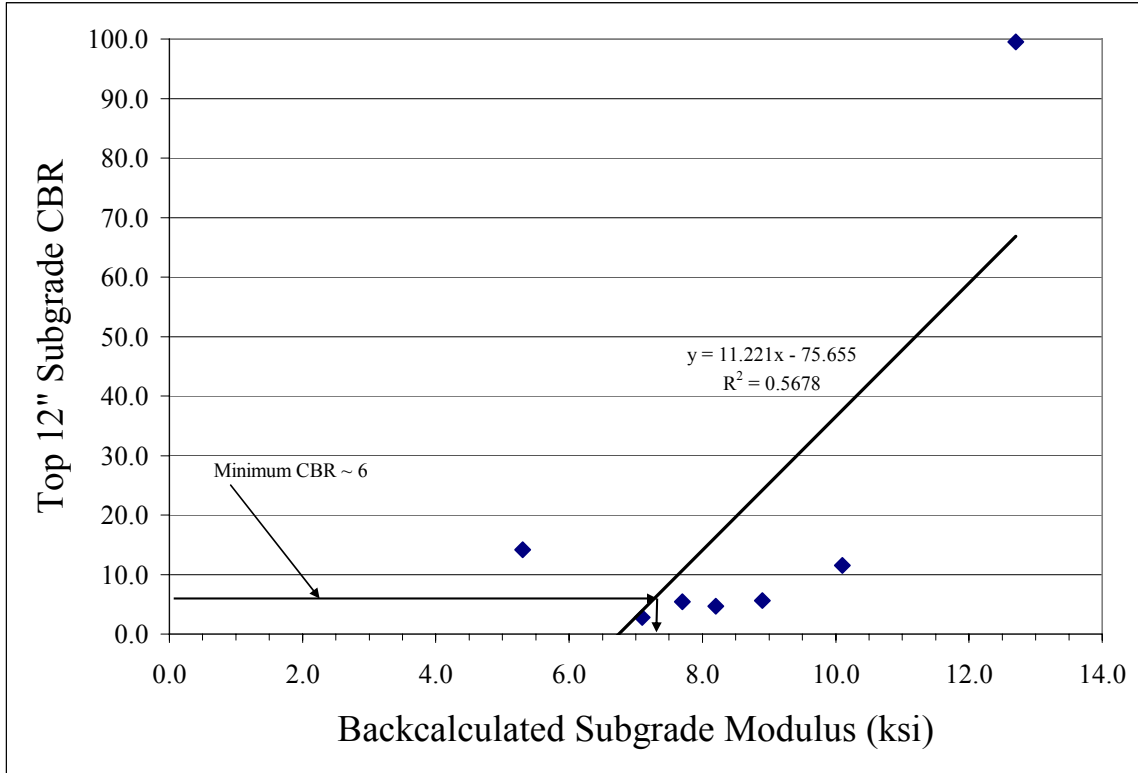
Figure D.5. Subgrade CBR vs. Subgrade Modulus for FM 1155.

Because the DCP testing is spot-specific, efforts were made to use the FWD data to better partition the project into limits where rubblization may be an option. To accomplish this segmenting, the minimum recommended subgrade CBR that would enable the concrete to be broken was read from Figure D.4. For the concrete thickness on FM 1155 (~7.5 inches), a subgrade CBR of approximately 6 would be required. Next, a relationship between the FWD and average CBR of the top 12 inches of subgrade was evaluated, as shown in Figure D.5. With all the data, a poor fit exists. When the two outliers are trimmed, as shown in Figure D.6, a better fit exists. The data in Figure D.5 indicate a minimum backcalculated modulus of approximately 7.5 is needed; the trimmed data in Figure D.6 indicate a backcalculated subgrade modulus of approximately 8.5 is necessary. The two methods of analysis are in reasonable agreement with each other, and it seems reasonable that for analysis purposes, the minimum required backcalculated subgrade modulus can be estimated as approximately 8.

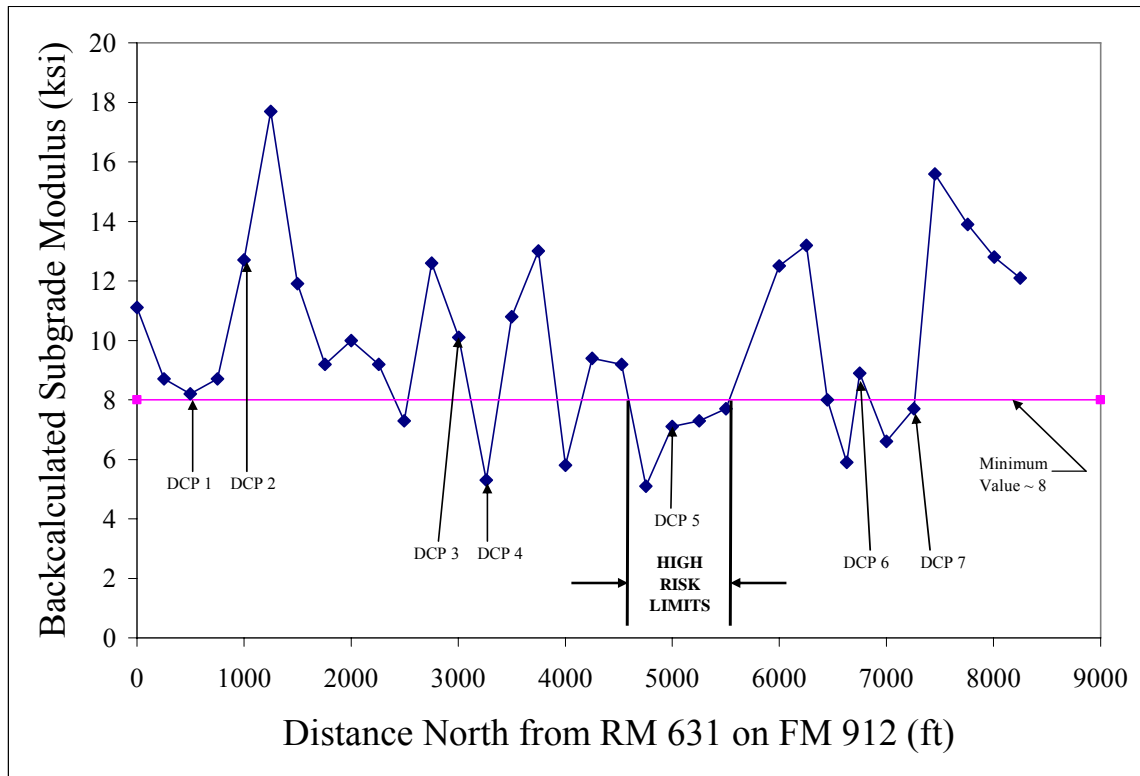
**Figure D.7. FM 1155 Backcalculated Subgrade Modulus with Distance (NB Direction).**  
*Note: Zero Distance is at RM 631 on FM 912.*

Figure D.7 shows the backcalculated subgrade modulus with distance for the project. Using the approximate minimum subgrade CBR of 8, rubblization may not be feasible for approximately one third of the project. With the FWD analysis in conjunction with the DCP analysis, the greatest risk of encountering problems if rubblization is attempted exists between 4580 to 5250 feet north of RM 631 on FM 912.

- The first 1000 feet are of questionable suitability for rubblization.
- From 1000 to 4550 feet, the project should be suitable for rubblization.
- From 4550 to 5250 feet, the subgrade support is likely too poor to support rubblization operations. A core should be taken at 5000 feet to verify the pavement structure.
- From 5250 feet to the end of the JCP, the project is marginally suitable for rubblization.
- Given the soil conditions, the multi-head breaker likely is the safest equipment to use if rubblization is attempted.
