Aggregate Distribution Investigation in Box Beams Fabricated With Self Consolidating Concrete

CTR Technical Report:	0-5197-01-1
Report Date:	October 2009
Project:	0-5197-01
Project Title:	Continuing Research on Allowable Design Release Stresses for Prestressed Concrete Beams
Sponsoring Agency:	Texas Department of Transportation
Performing Agency:	Center for Transportation Research at The University of Texas at Austin

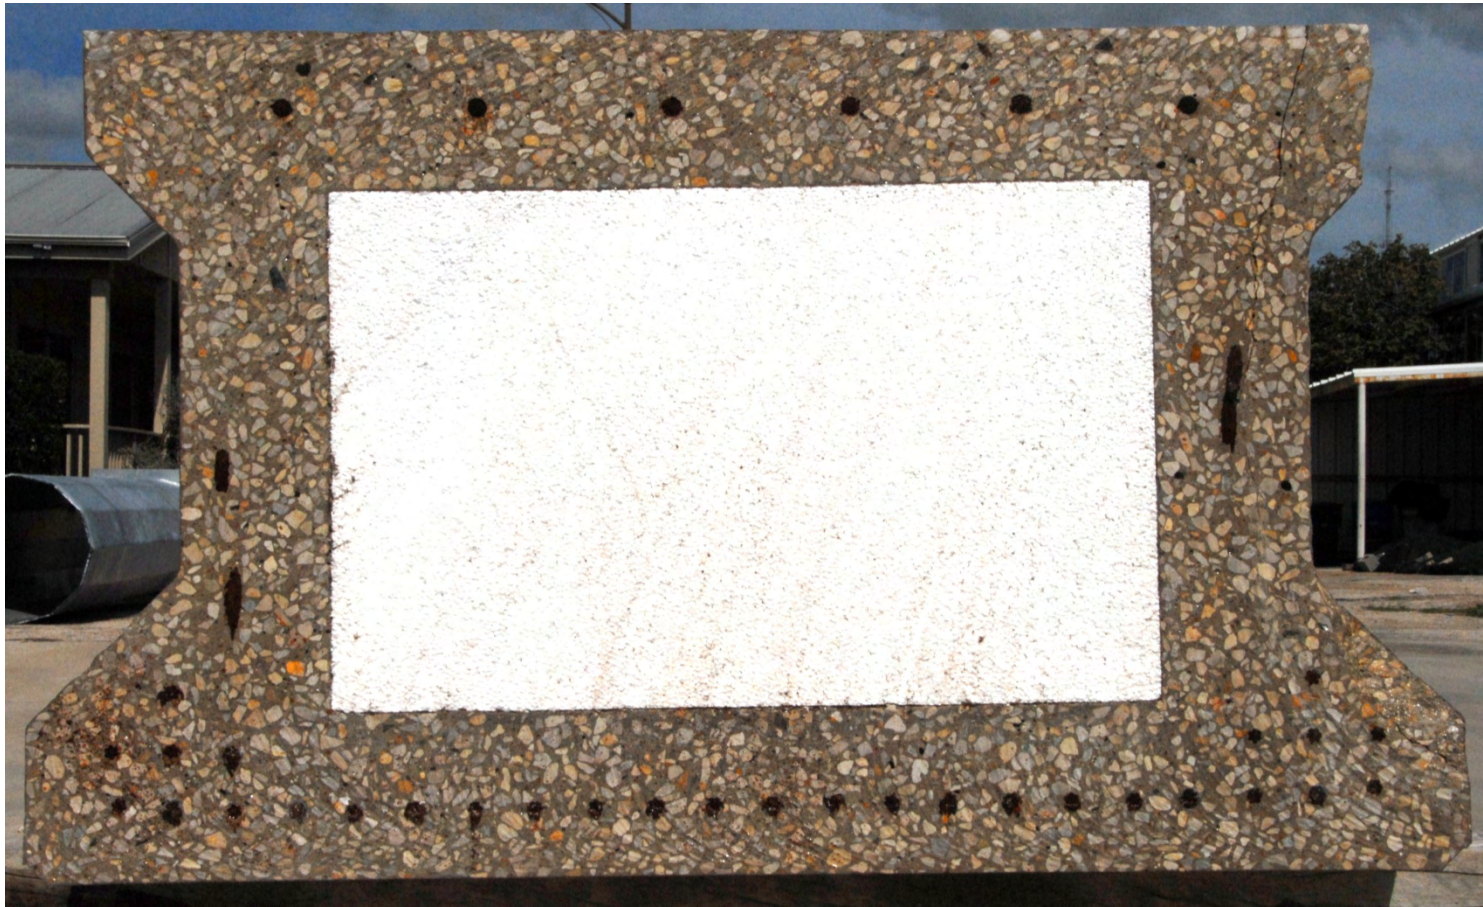
Figure A. 1: Picture BB02C1A

Beam Mark:	BB02	Cut Location and View:
Concrete Type:	Conventional Concrete	
Aggregate:	Limestone	
Cut ID:	BB02C1A

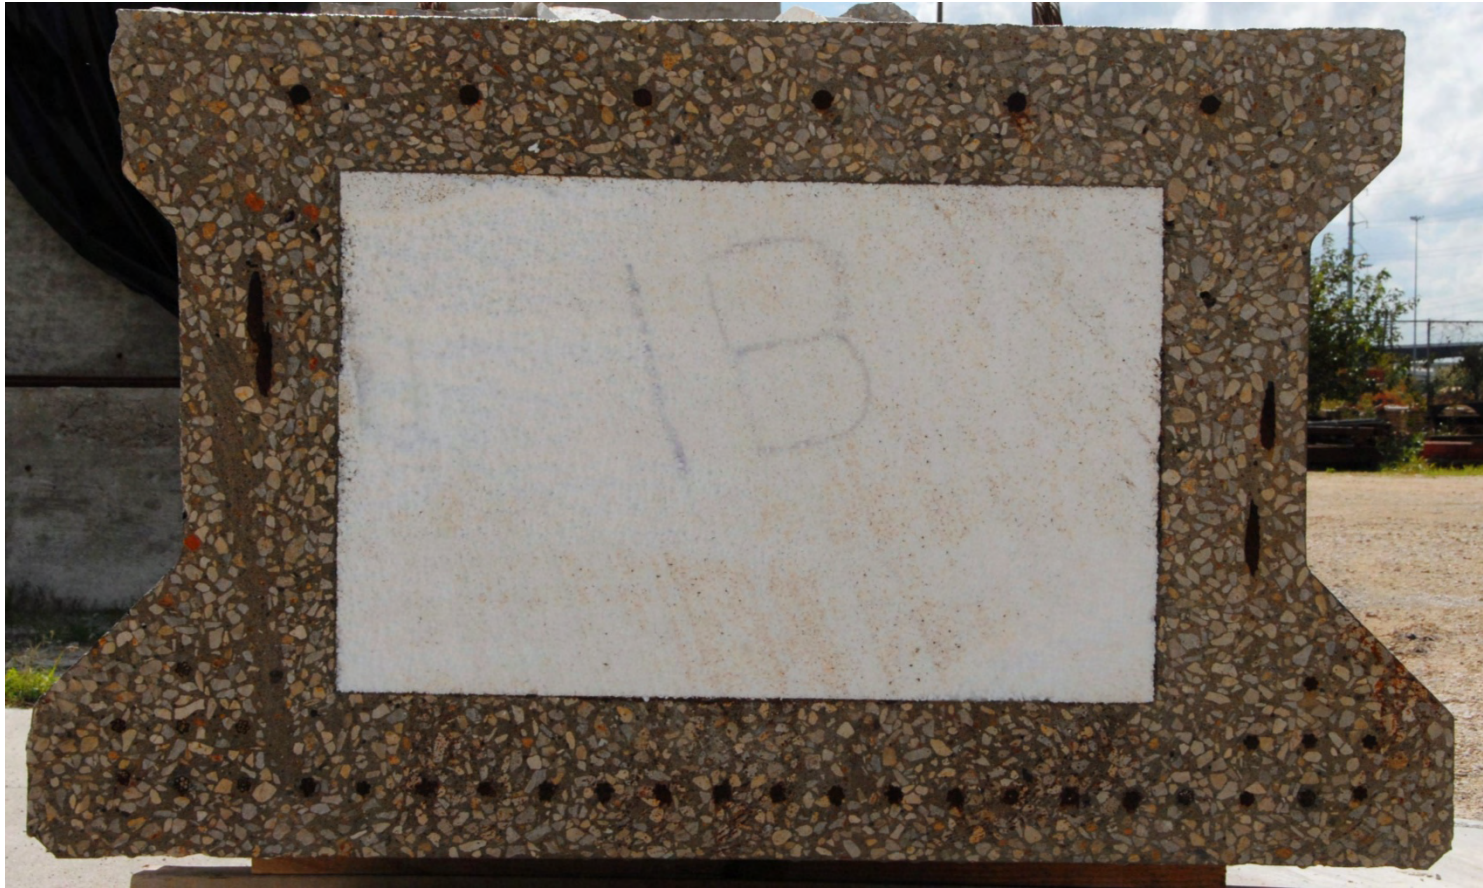
Figure A. 2: Picture BB02C1B

Beam Mark:	BB02	Cut Location and View:
Concrete Type:	Conventional Concrete	
Aggregate:	Limestone	
Cut ID:	BB02C1B

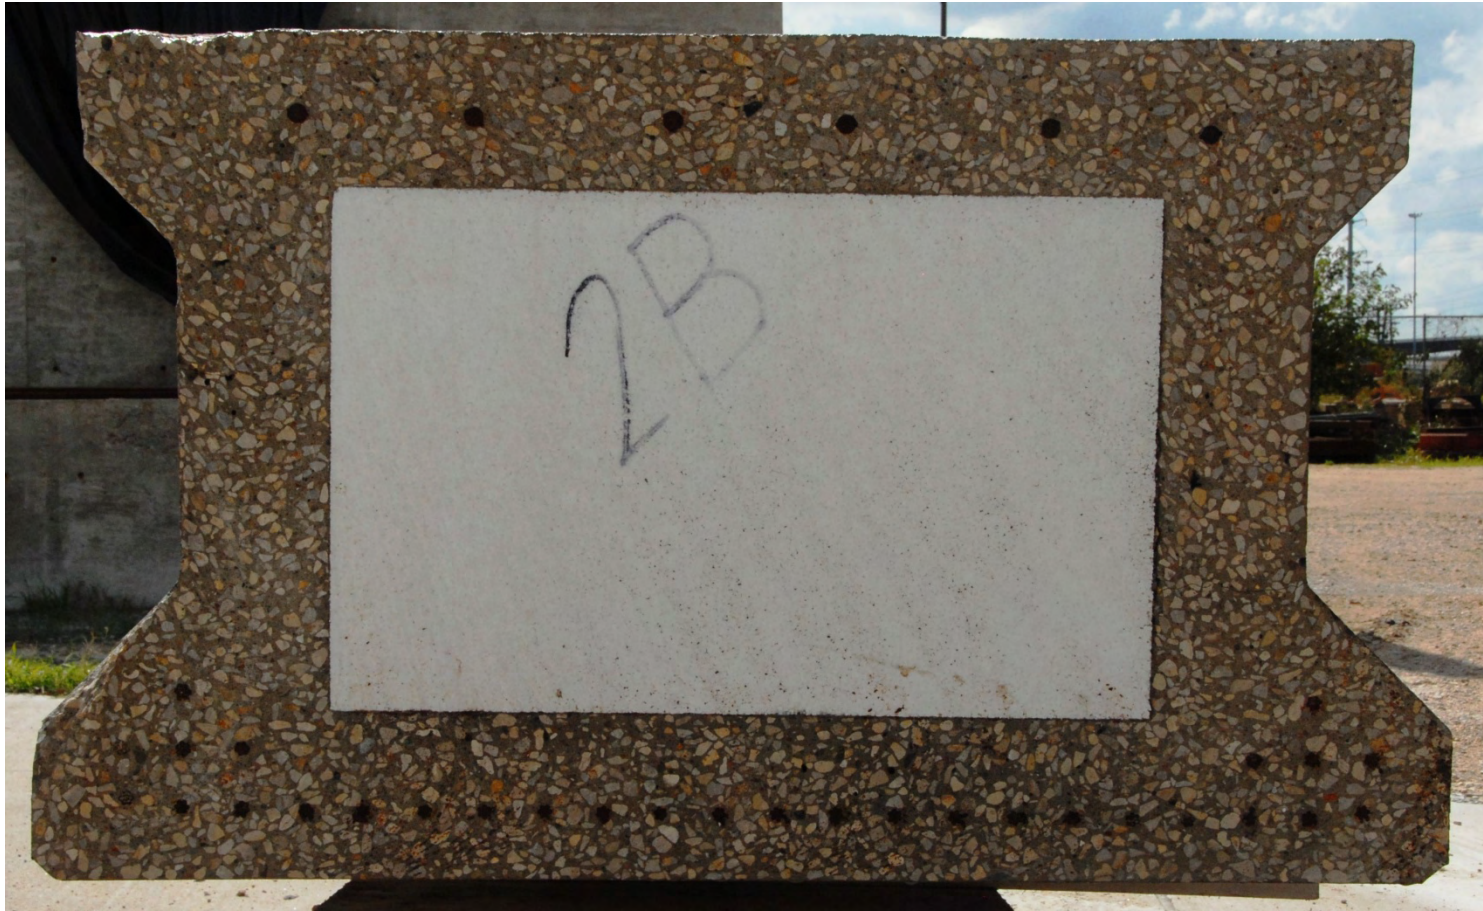
Figure A. 4: Picture BB02C2B

Beam Mark:	BB02	Cut Location and View:
Concrete Type:	Conventional Concrete	
Aggregate:	Limestone	
Cut ID:	BB02C2B

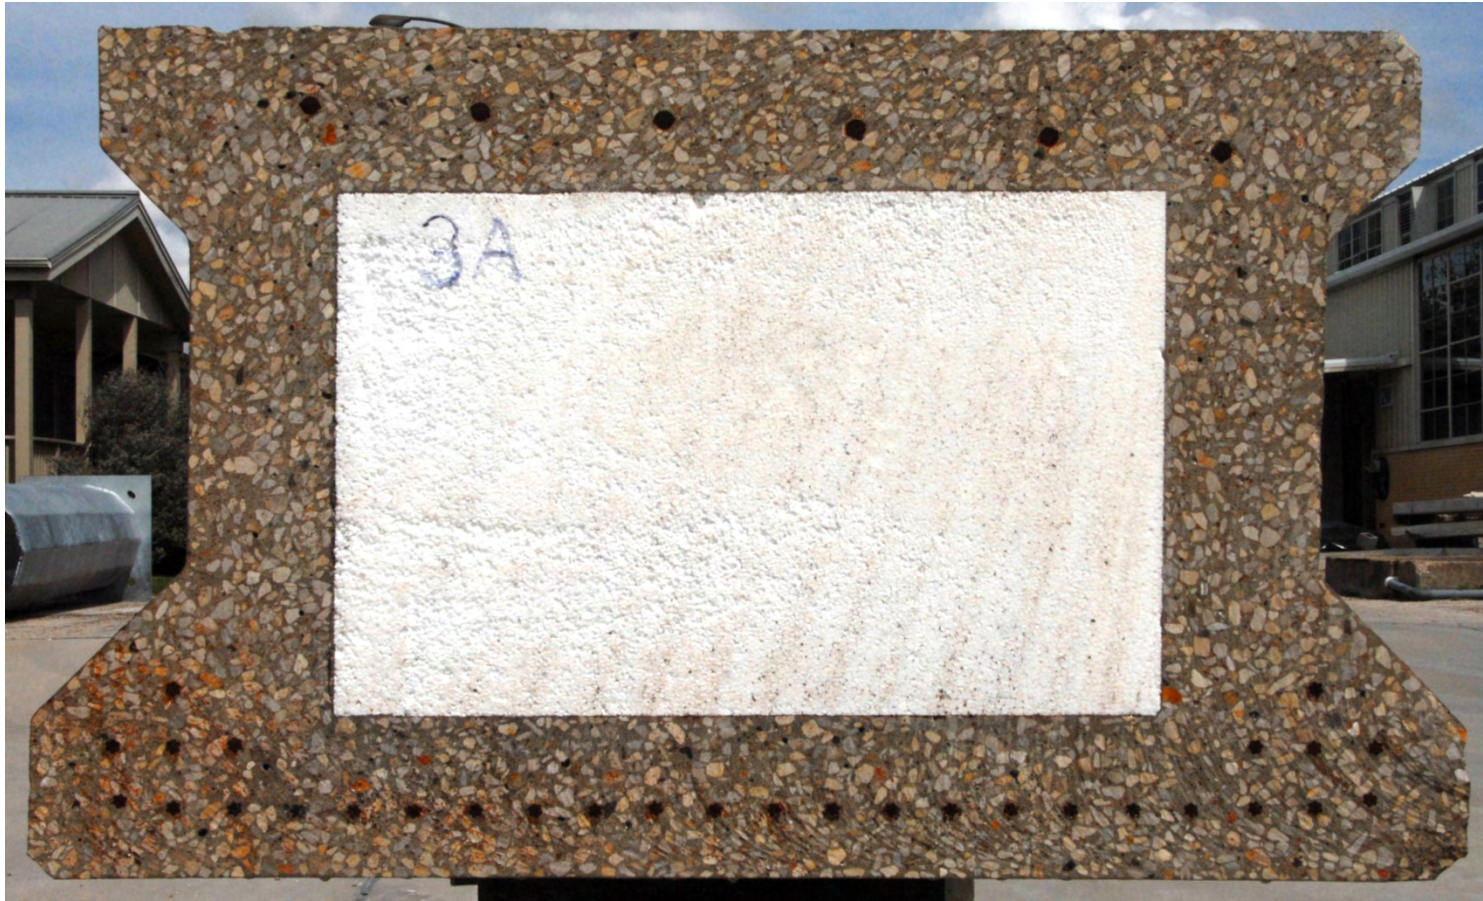
Figure A. 5: Picture BB02C3A

Beam Mark:	BB02	Cut Location and View:
Concrete Type:	Conventional Concrete	
Aggregate:	Limestone	
Cut ID:	BB02C3A

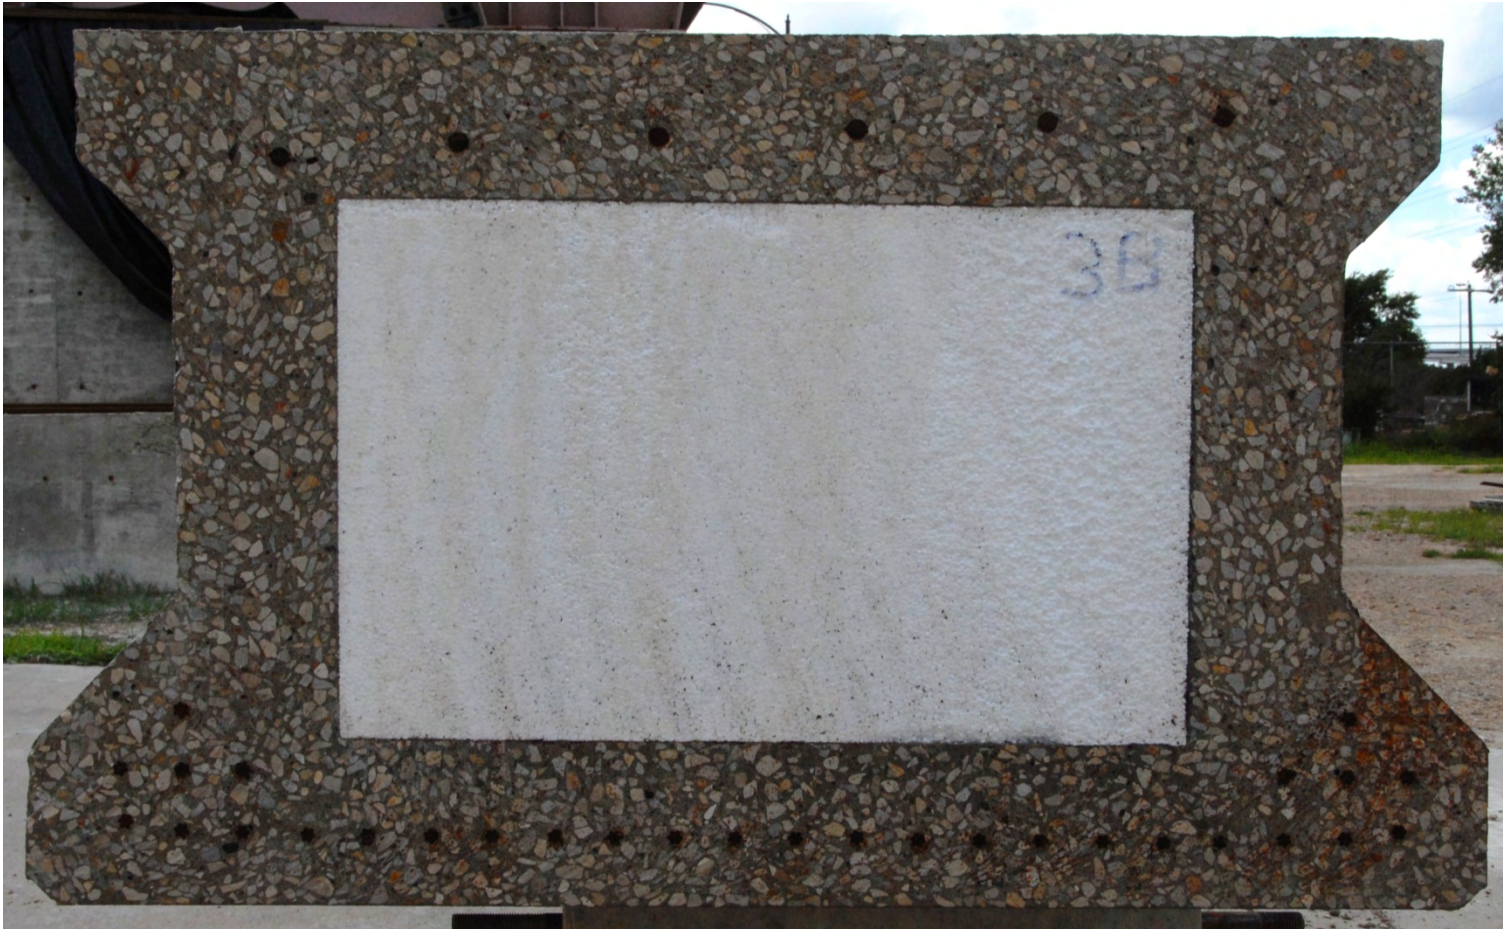
Figure A. 6: Picture BB02C3B

Beam Mark:	BB02	Cut Location and View:
Concrete Type:	Conventional Concrete	
Aggregate:	Limestone	
Cut ID:	BB02C3B

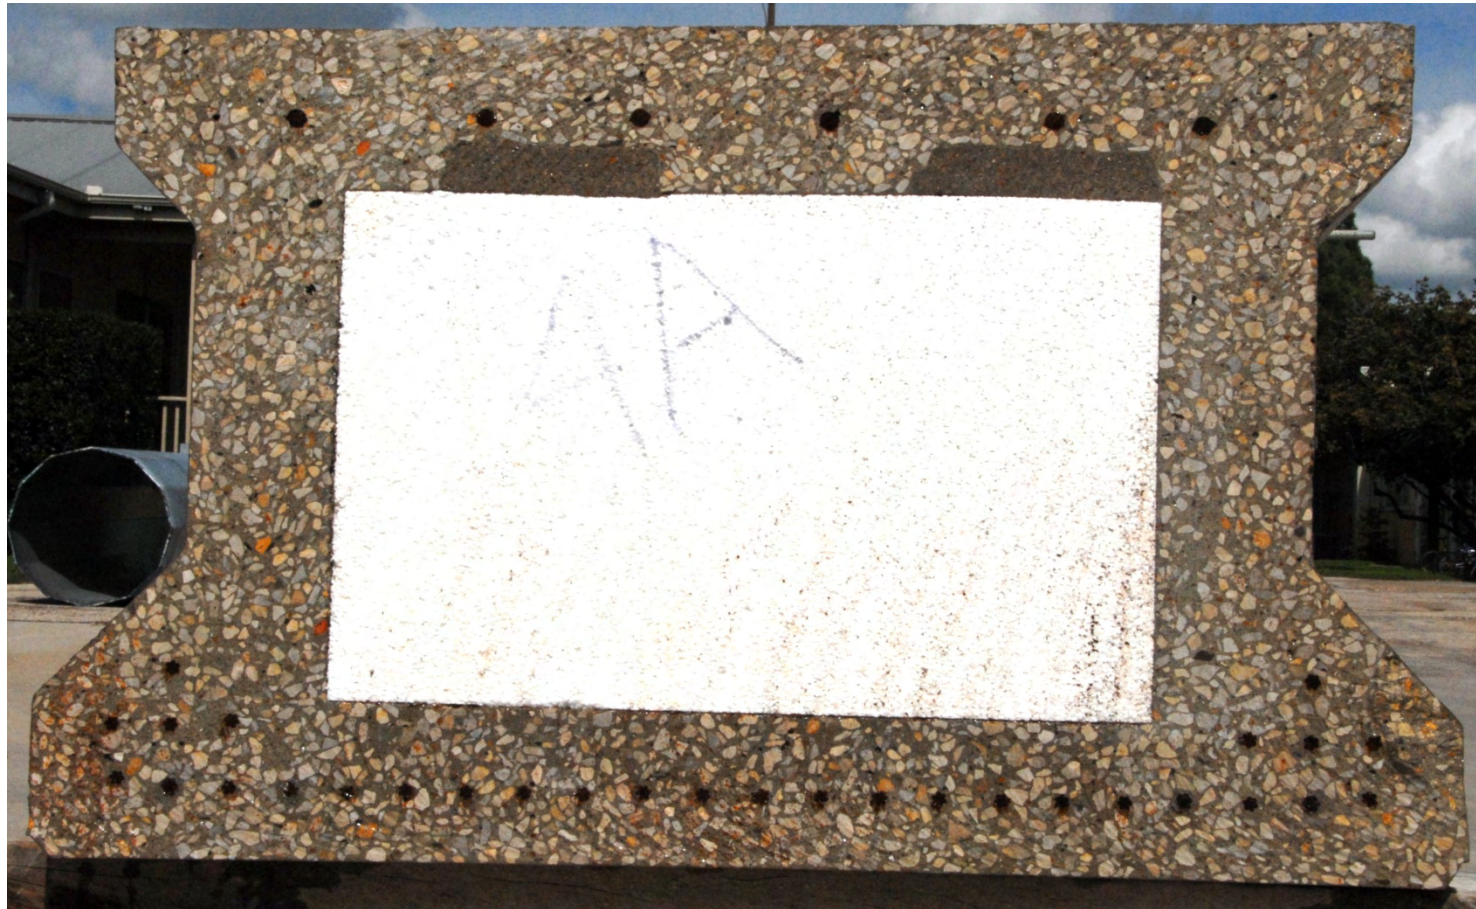
Figure A. 7: Picture BB02C4A

Beam Mark:	BB02	<p>Cut Location and View:</p>
Concrete Type:	Conventional Concrete	
Aggregate:	Limestone	
Cut ID:	BB02C4A

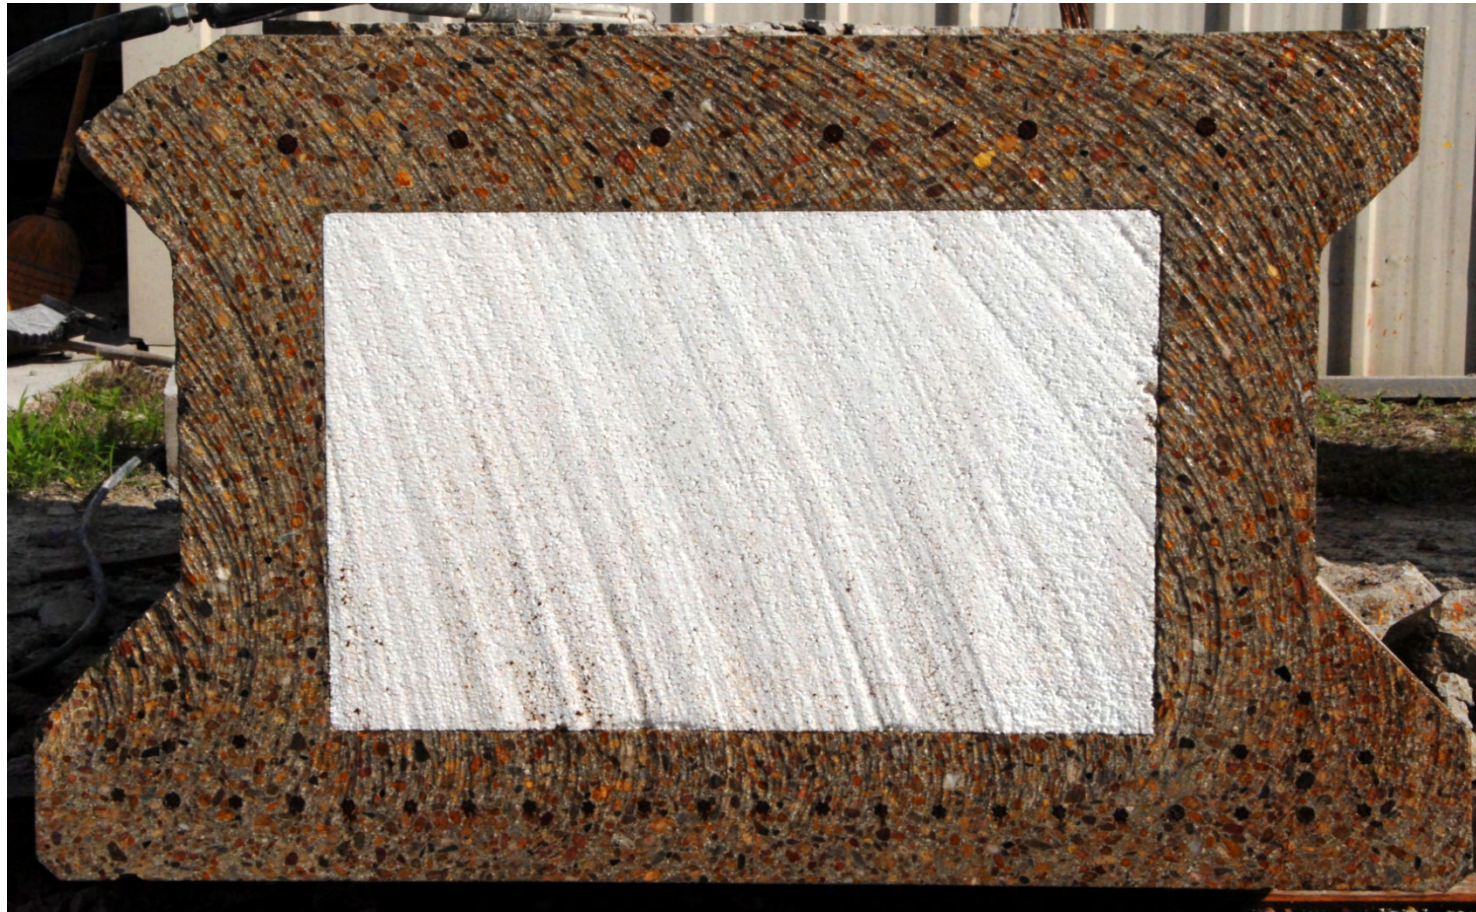
Figure A. 9: Picture BB07C1A

Beam Mark:	BB07	Cut Location and View:
Concrete Type:	Self consolidating	
Aggregate:	River Rock	
Cut ID:	BB07C1A

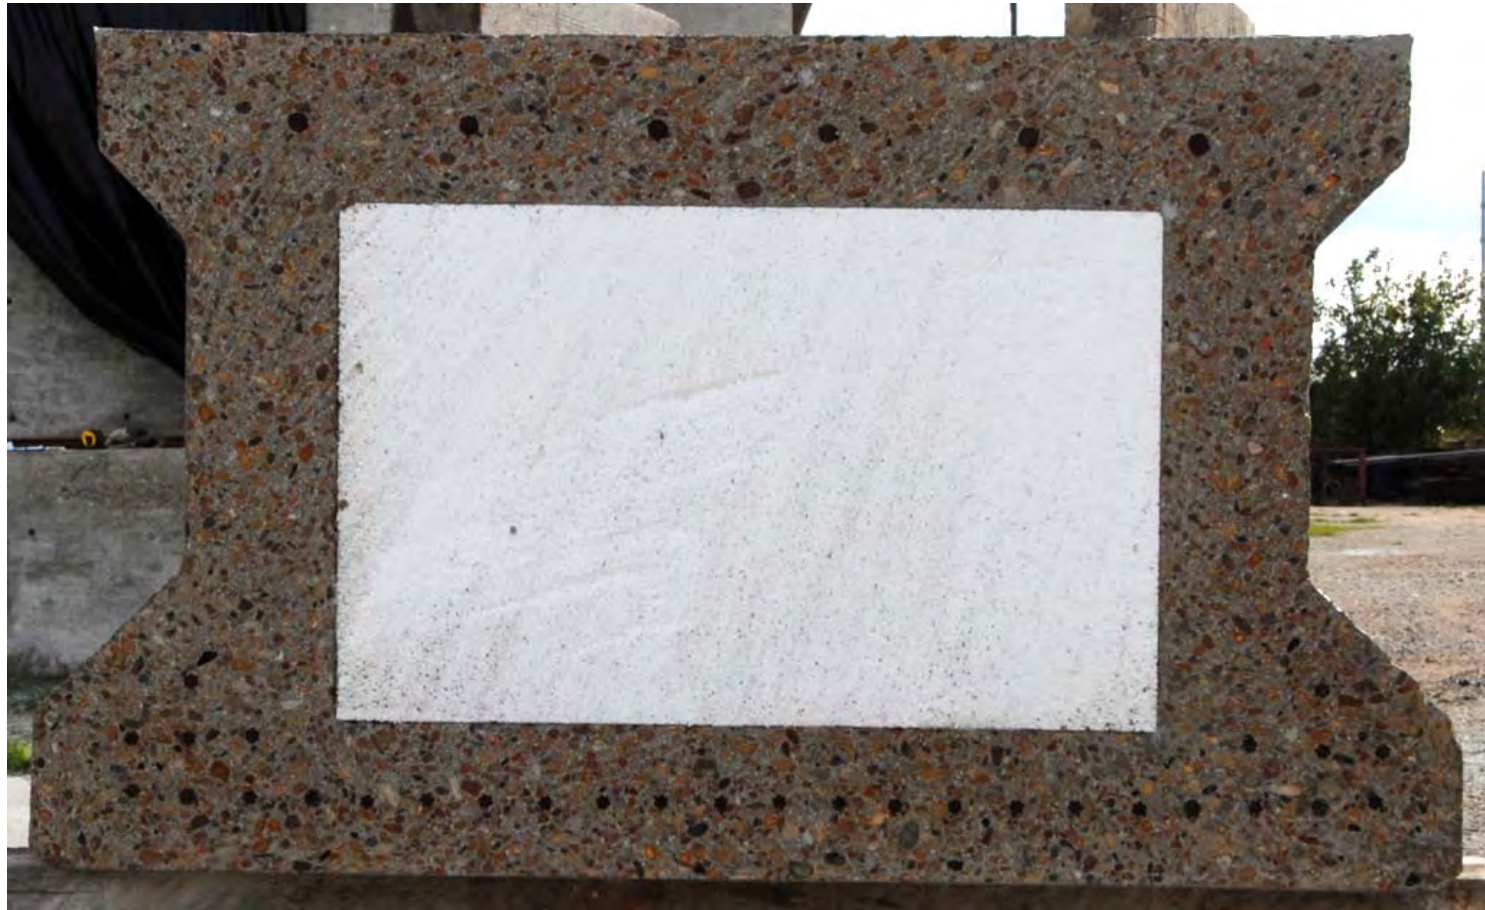
Figure A. 10: Picture BB07C1B

Beam Mark:	BB07	<p>Cut Location and View:</p>
Concrete Type:	Self consolidating	
Aggregate:	River Rock	
Cut ID:	BB07C1B

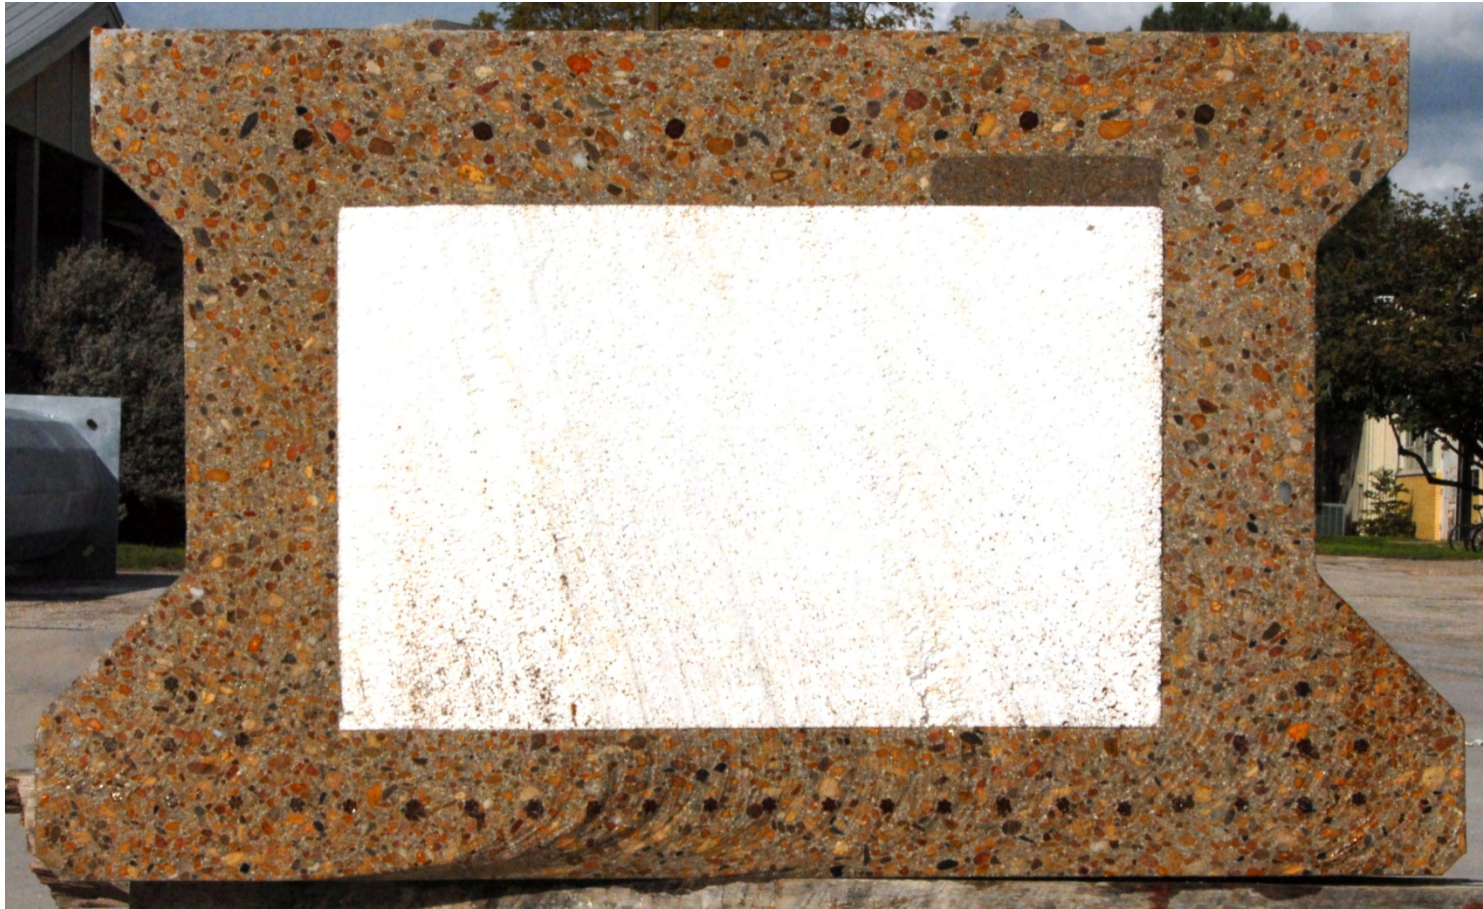
Figure A. 11: Picture BB07C2A

Beam Mark:	BB07	Cut Location and View:
Concrete Type:	Self consolidating	
Aggregate:	River Rock	
Cut ID:	BB07C2A

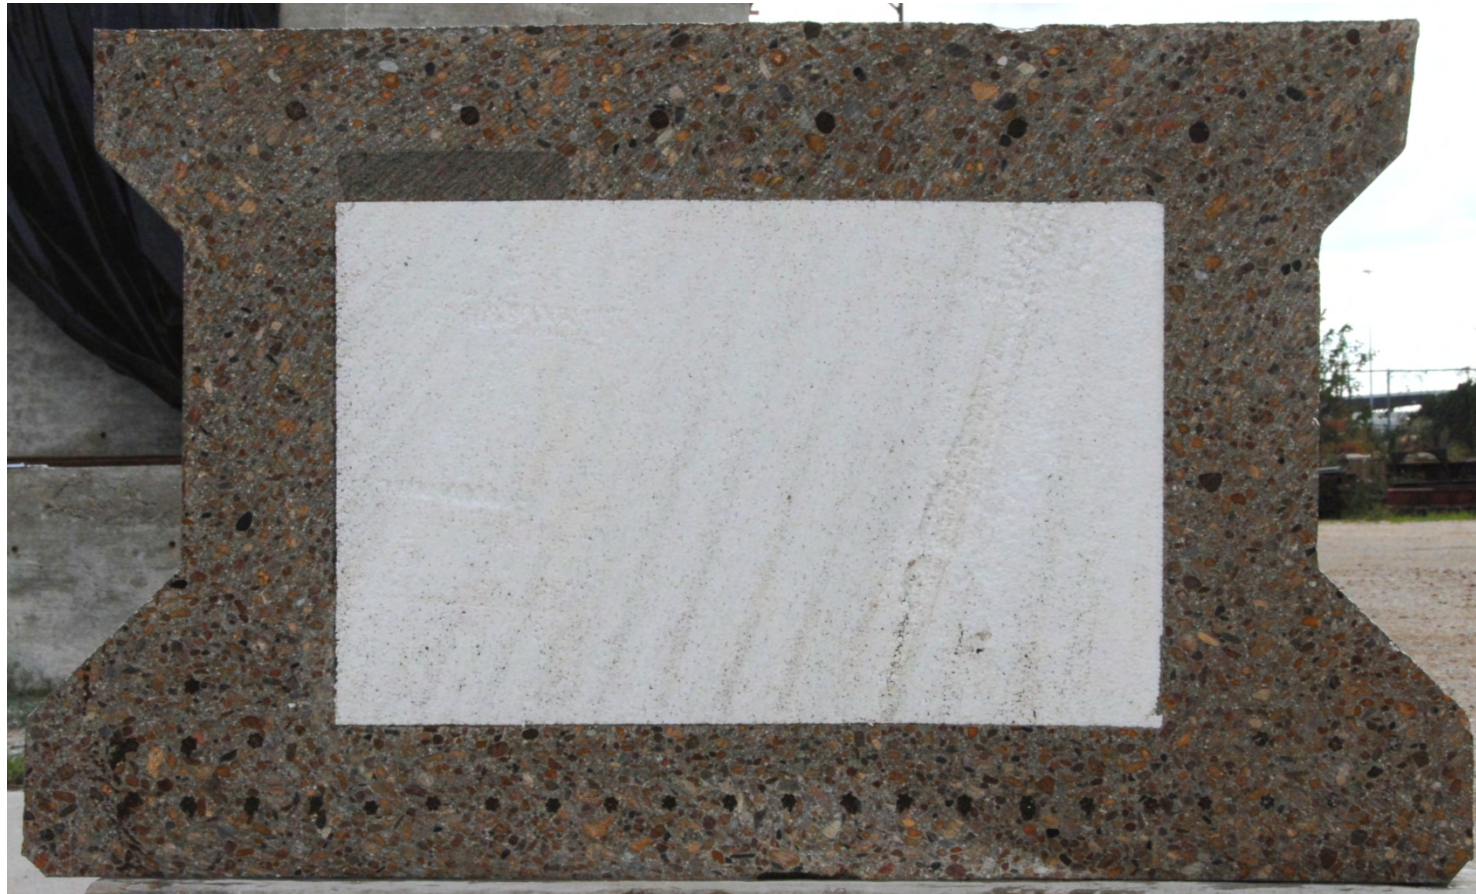
Figure A. 12: Picture BB07C2B

Beam Mark:	BB07	<p>Cut Location and View:</p>
Concrete Type:	Self consolidating	
Aggregate:	River Rock	
Cut ID:	BB07C2B

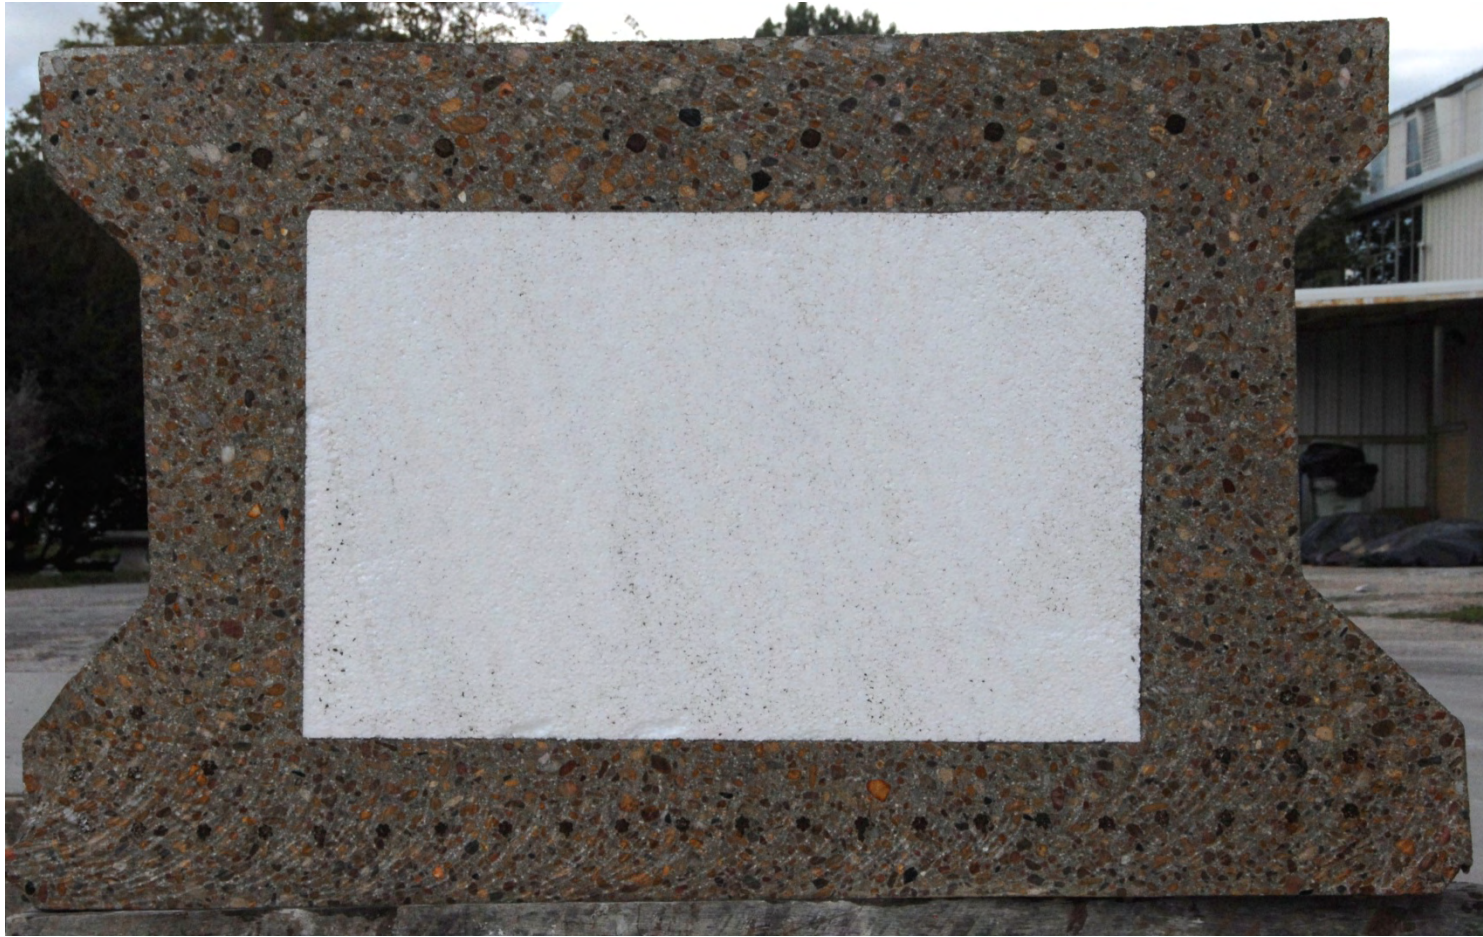
Figure A. 13: Picture BB07C3A

Beam Mark:	BB07	<p>Cut Location and View:</p>
Concrete Type:	Self consolidating	
Aggregate:	River Rock	
Cut ID:	BB07C3A

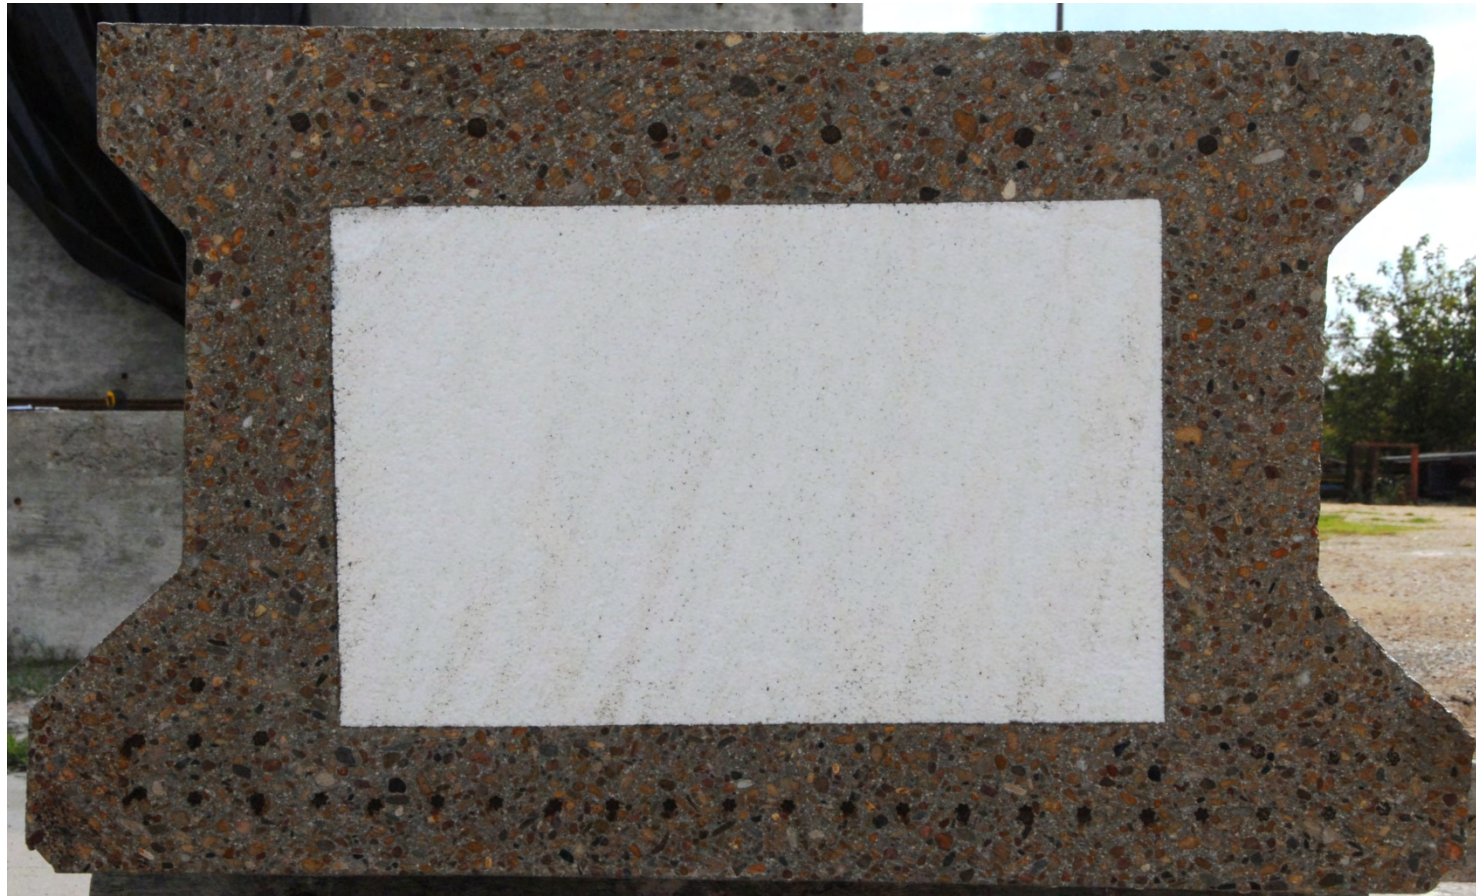
Figure A. 14: Picture BB07C3B

Beam Mark:	BB07	Cut Location and View:
Concrete Type:	Self consolidating	
Aggregate:	River Rock	
Cut ID:	BB07C3B

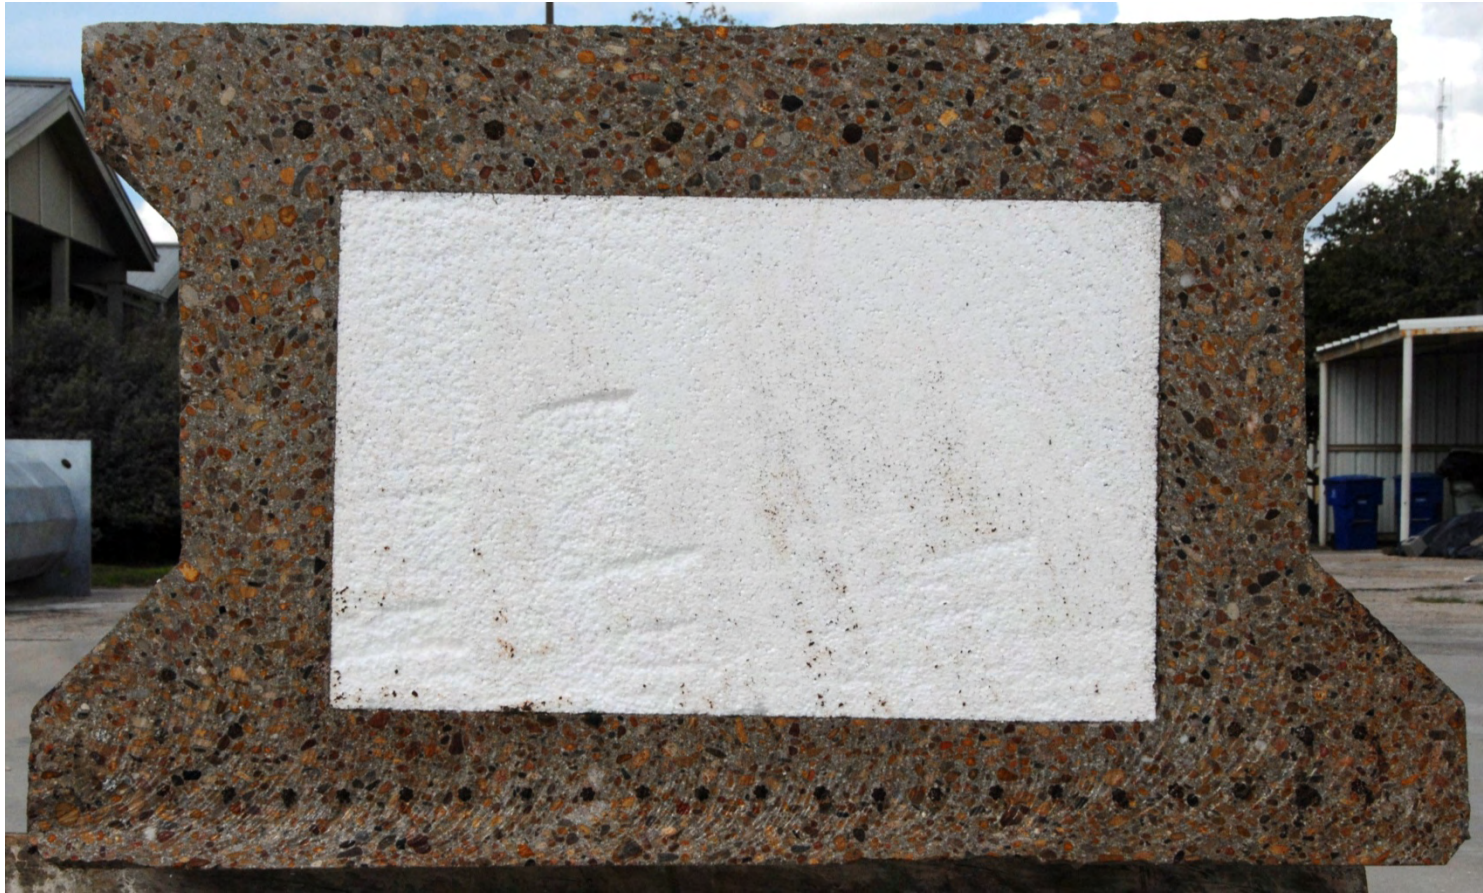
Figure A. 15: Picture BB07C4A

Beam Mark:	BB07	<p>Cut Location and View:</p>
Concrete Type:	Self consolidating	
Aggregate:	River Rock	
Cut ID:	BB07C4A

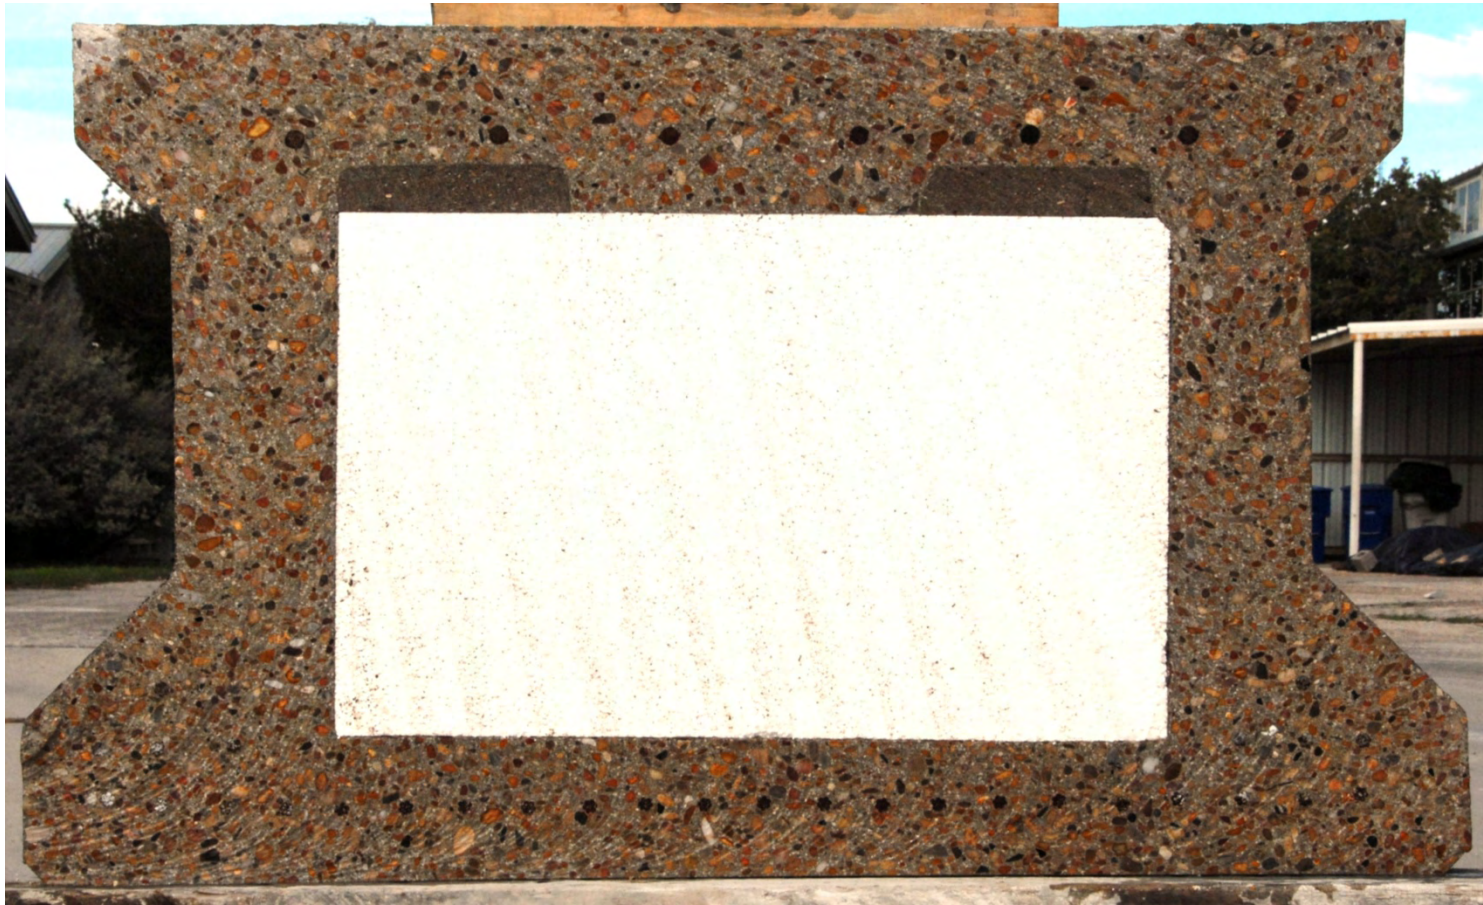
Figure A. 17: Picture BB07C5A

Beam Mark:	BB07	Cut Location and View:
Concrete Type:	Self consolidating	
Aggregate:	River Rock	
Cut ID:	BB07C5A

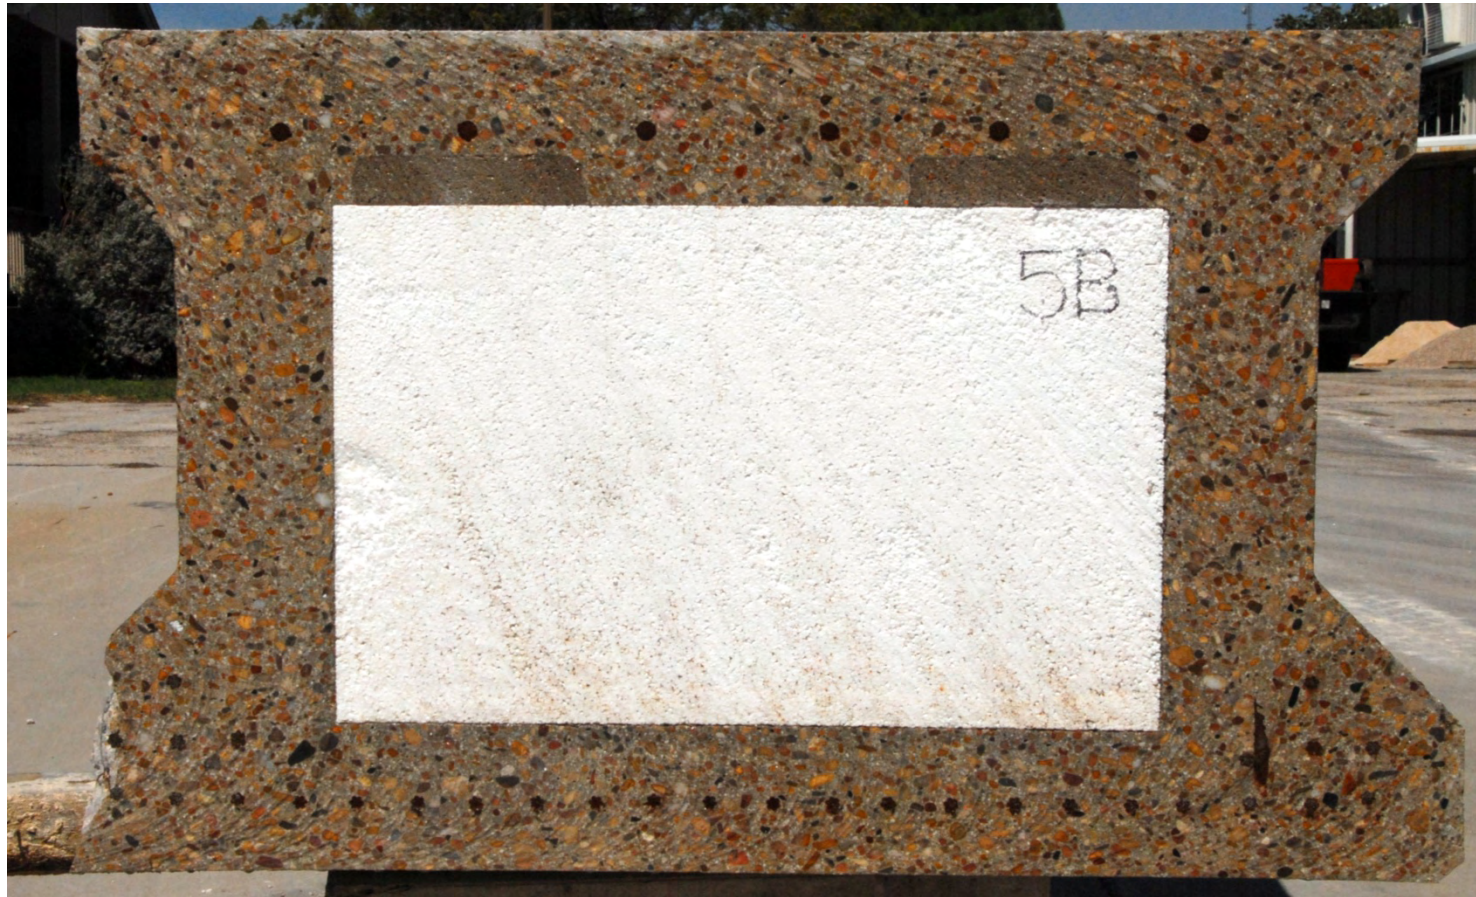
Figure A. 18: Picture BB07C5B

Beam Mark:	BB07	Cut Location and View:
Concrete Type:	Self consolidating	
Aggregate:	River Rock	
Cut ID:	BB07C5B

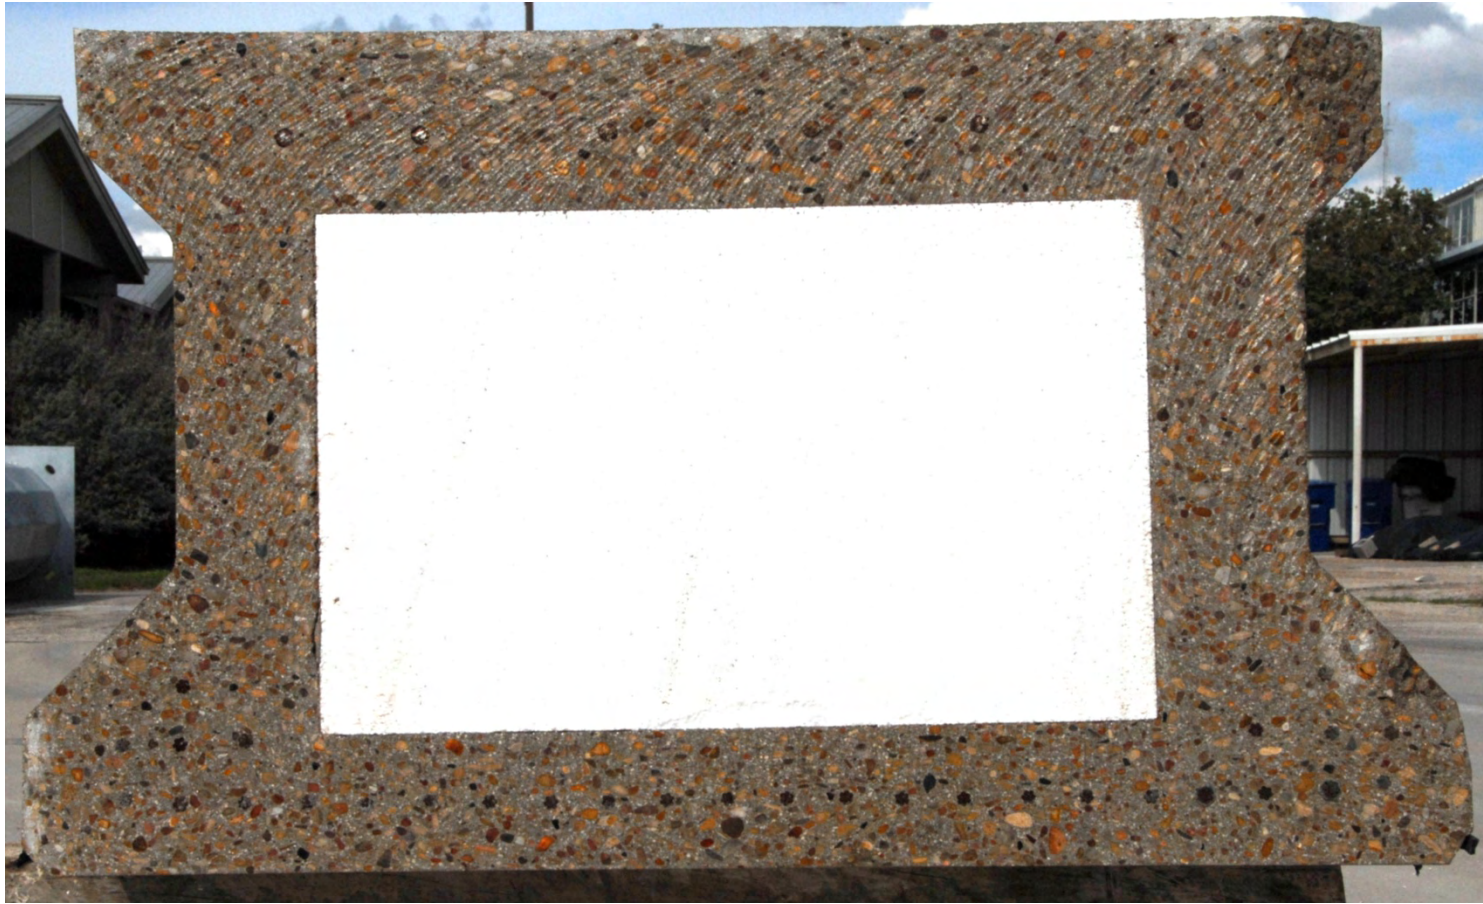
Figure A. 20: Picture BB07C6B

Beam Mark:	BB07	Cut Location and View:
Concrete Type:	Self consolidating	
Aggregate:	River Rock	
Cut ID:	BB07C6B
