Aggregate Distribution Investigation in Box Beams Fabricated With Self Consolidating Concrete

CTR Technical Report:	0-5197-01-1
Report Date:	October 2009
Project:	0-5197-01
Project Title:	Continuing Research on Allowable Design Release Stresses for Prestressed Concrete Beams
Sponsoring Agency:	Texas Department of Transportation
Performing Agency:	Center for Transportation Research at The University of Texas at Austin

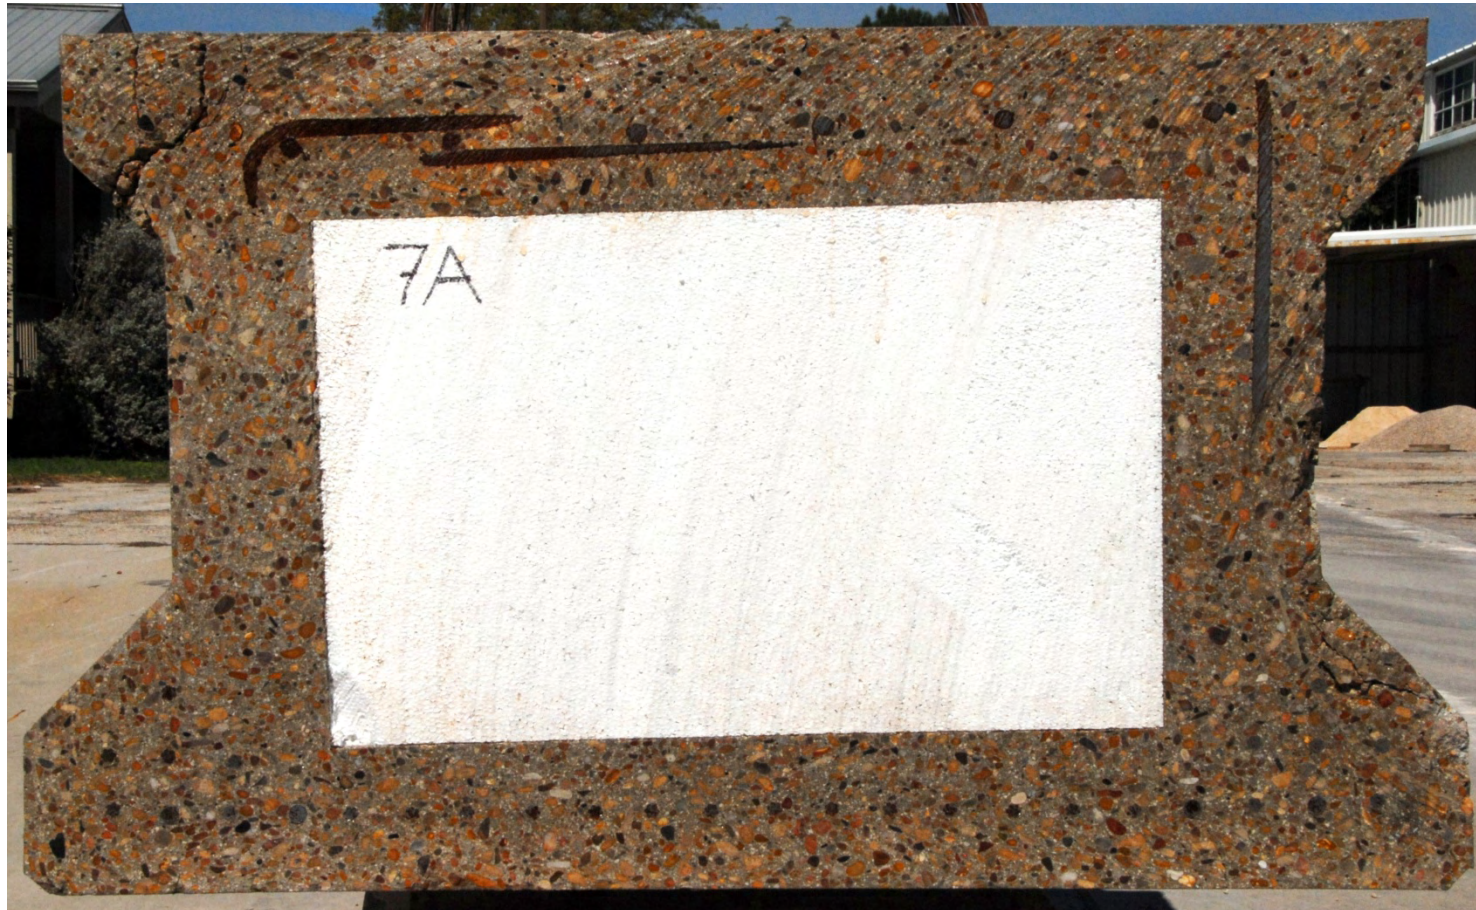
Figure A. 21: Picture BB07C7A

Beam Mark:	BB07	Cut Location and View:
Concrete Type:	Self consolidating	
Aggregate:	River Rock	
Cut ID:	BB07C7A

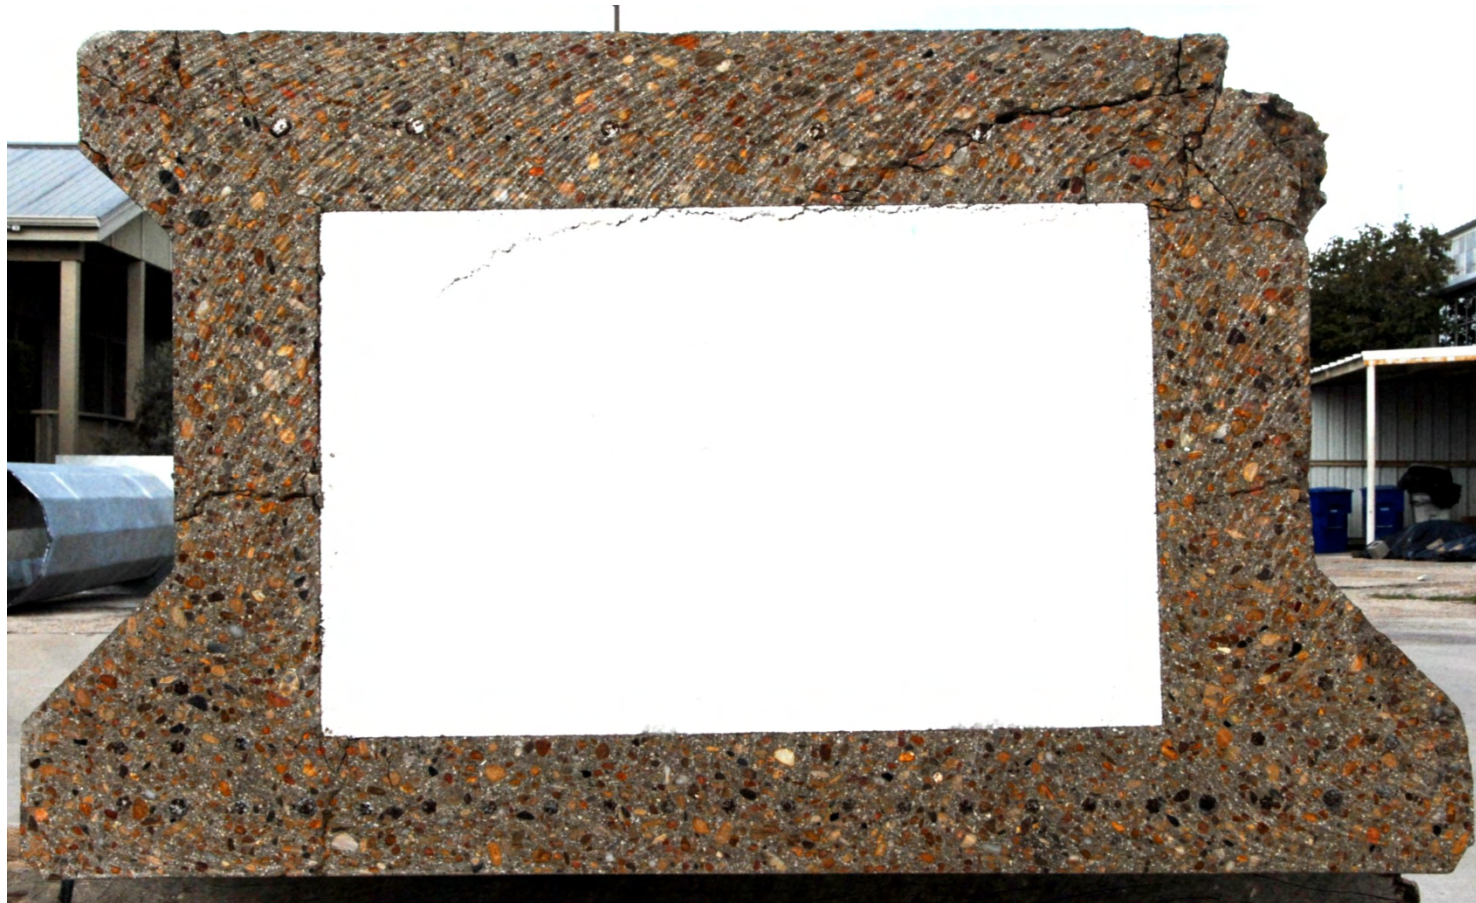
Figure A. 22: Picture BB07C7B

Beam Mark:	BB07	Cut Location and View:

Concrete Type:	Self consolidating	
Aggregate:	River Rock	
Cut ID:	BB07C7B

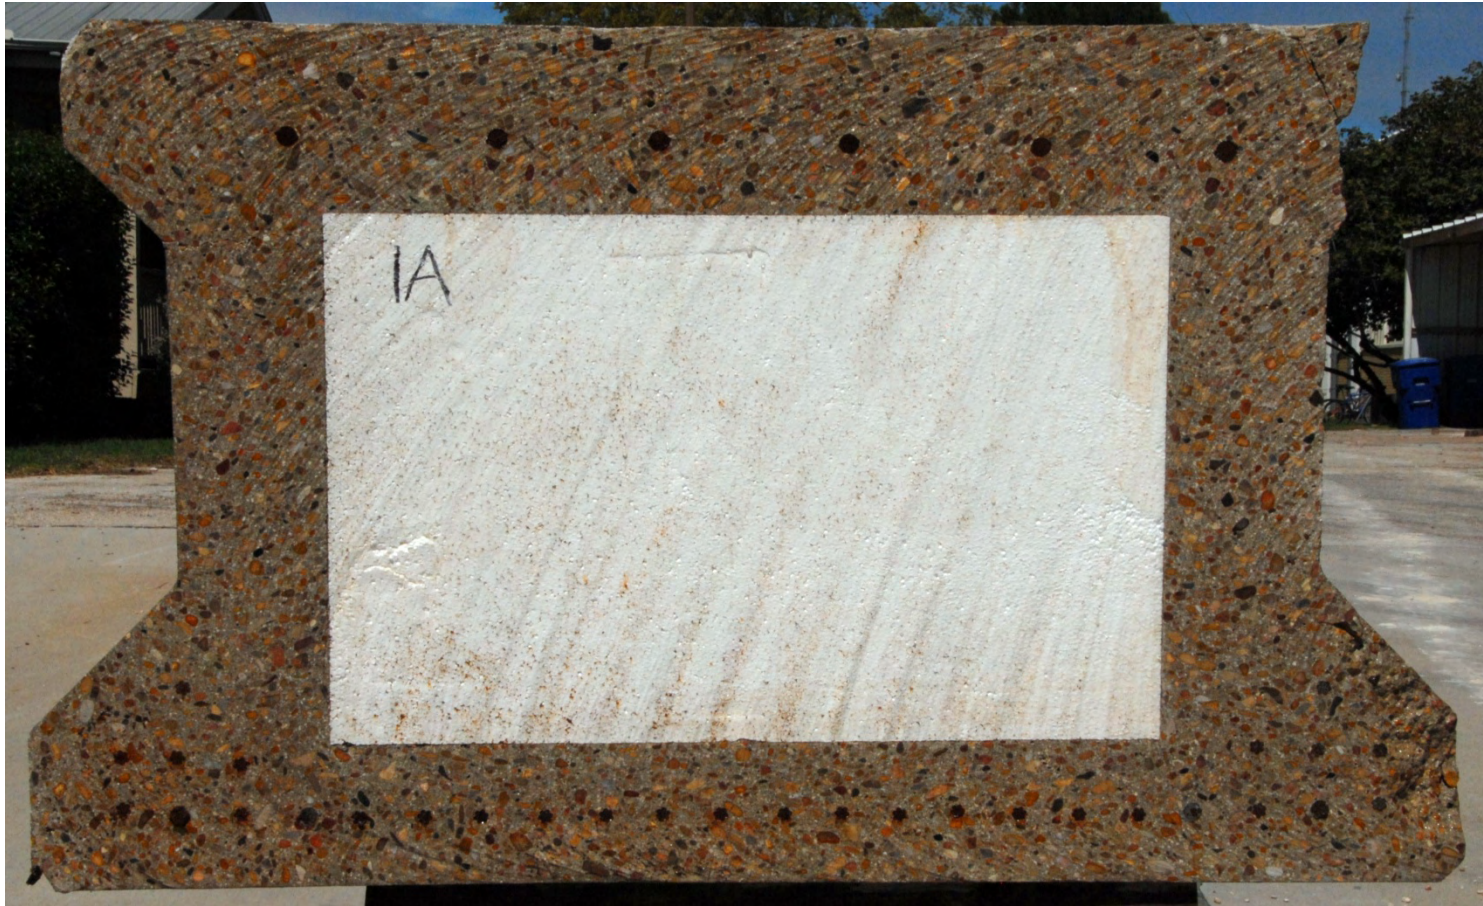
Figure A. 23: Picture BB08C1A

Beam Mark:	BB08	Cut Location and View:
Concrete Type:	Self consolidating	
Aggregate:	River Rock	
Cut ID:	BB08C1A

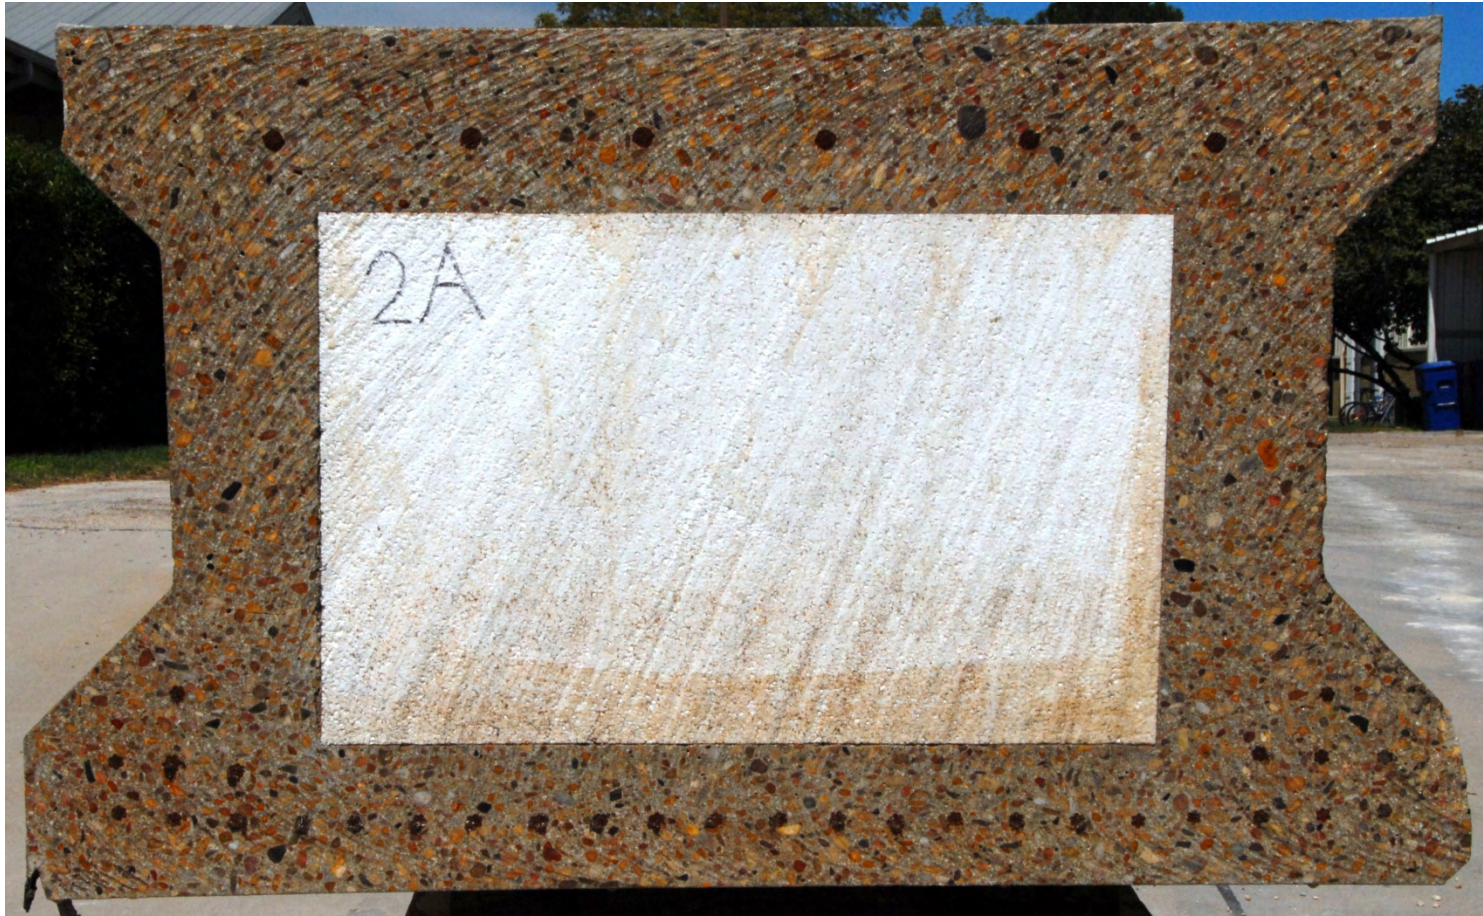
Figure A. 25: Picture BB08C2A

Beam Mark:	BB08	Cut Location and View:
Concrete Type:	Self consolidating	
Aggregate:	River Rock	
Cut ID:	BB08C2A

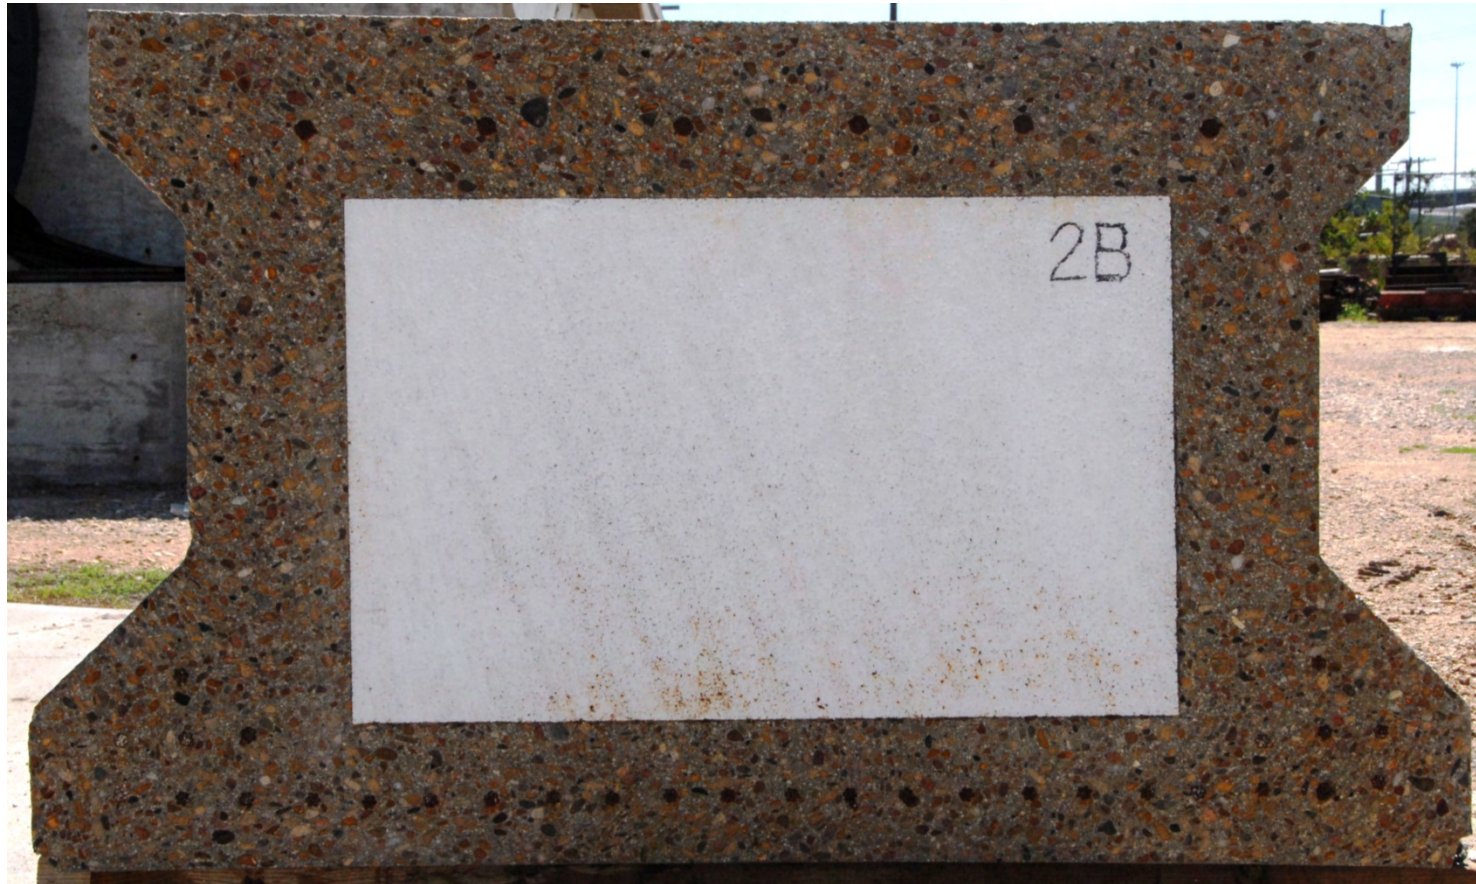
Figure A. 26: Picture BB08C2B

Beam Mark:	BB08	Cut Location and View:
Concrete Type:	Self consolidating	
Aggregate:	River Rock	
Cut ID:	BB08C2B

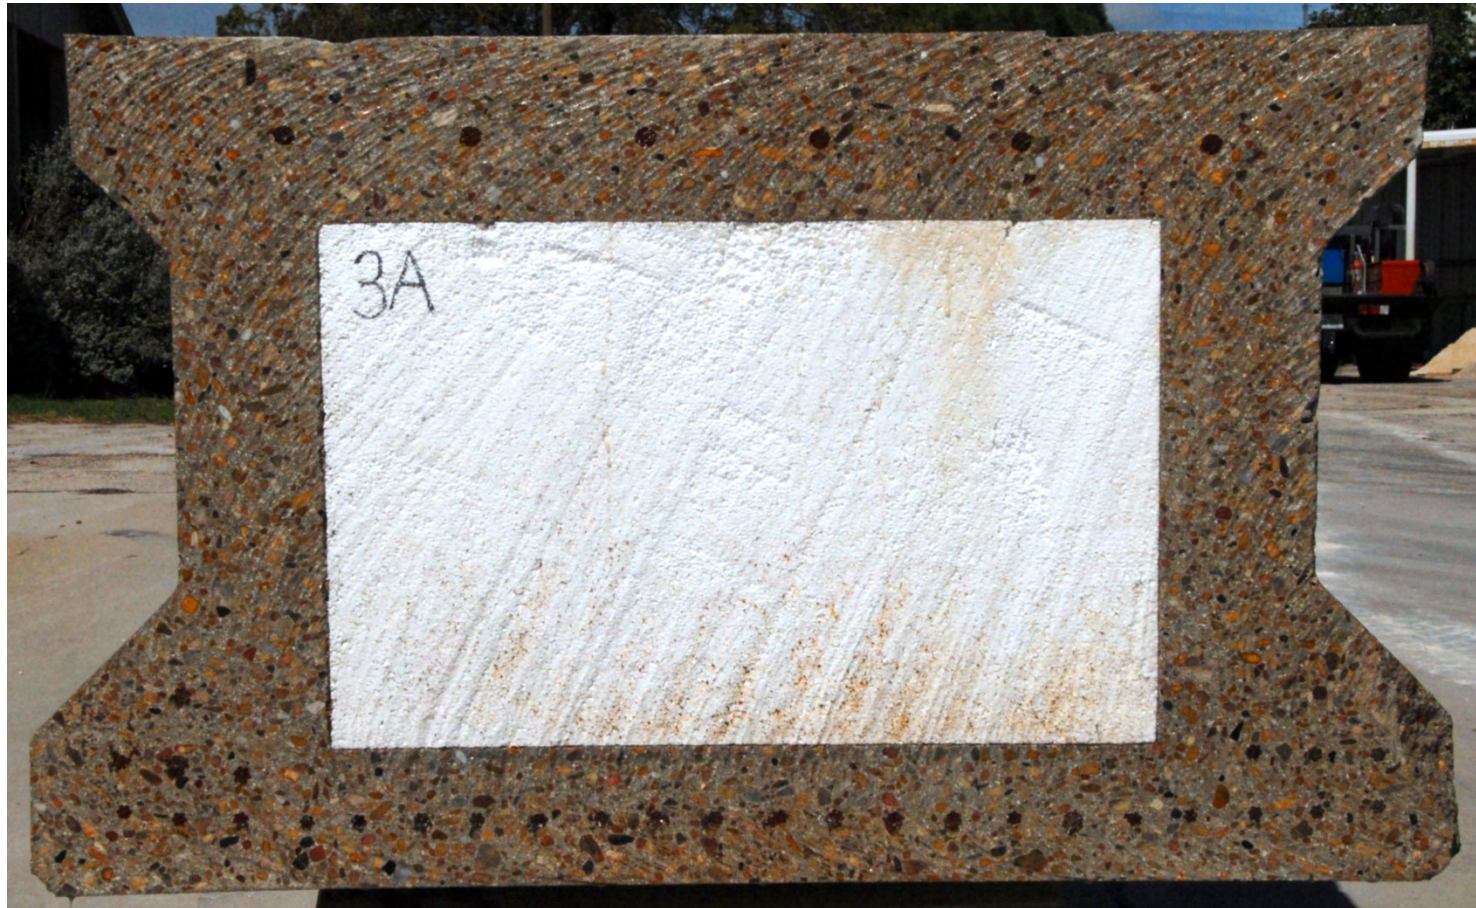
Figure A. 27: Picture BB08C3A

Beam Mark:	BB08	Cut Location and View:
Concrete Type:	Self consolidating	
Aggregate:	River Rock	
Cut ID:	BB08C3A

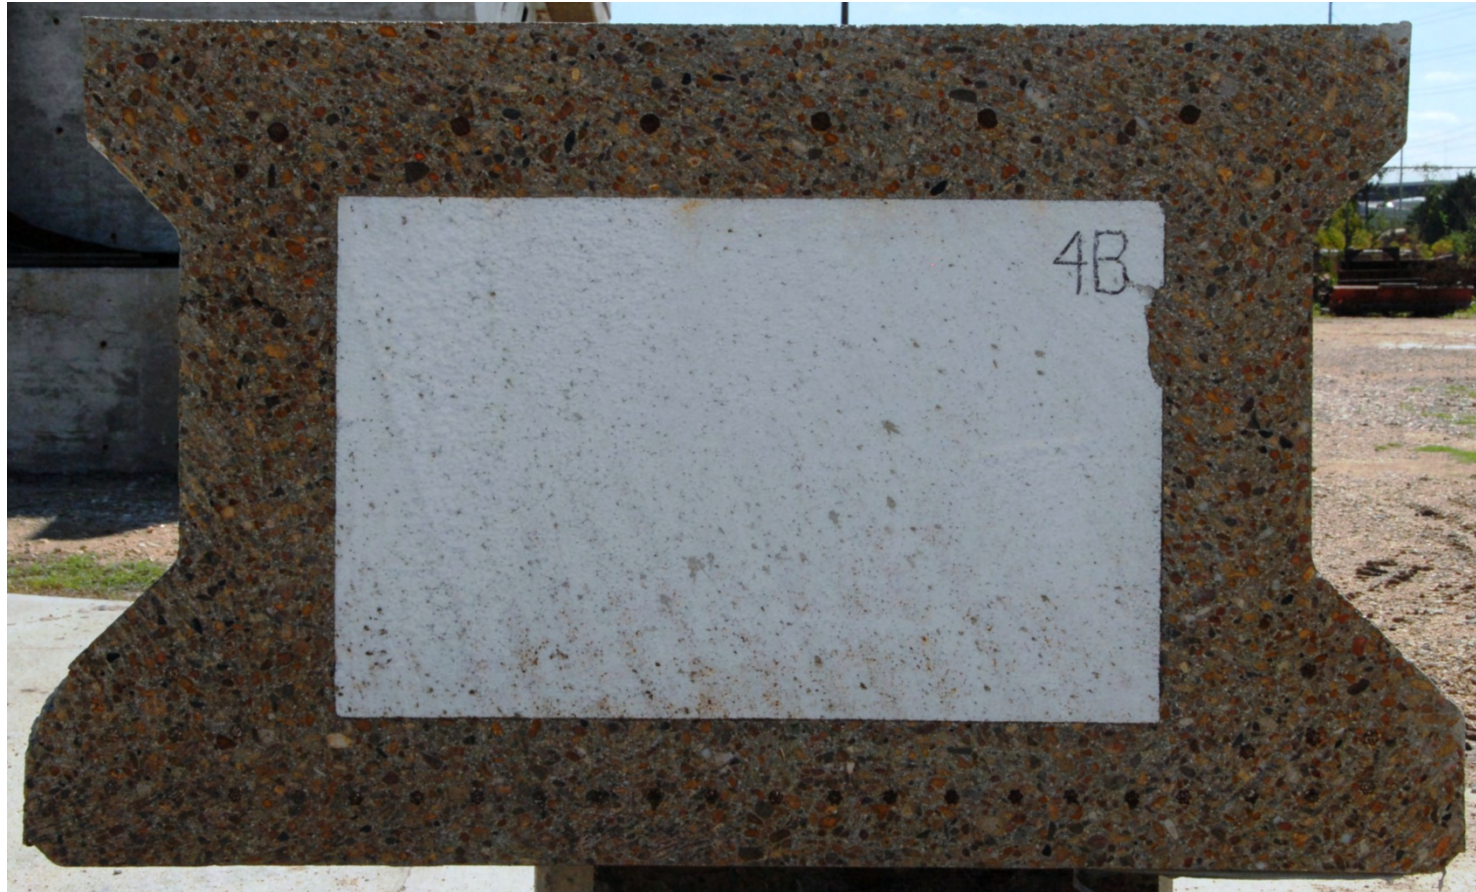
Figure A. 30: Picture BB08C4B

Beam Mark:	BB08	Cut Location and View:
Concrete Type:	Self consolidating	
Aggregate:	River Rock	
Cut ID:	BB08C4B

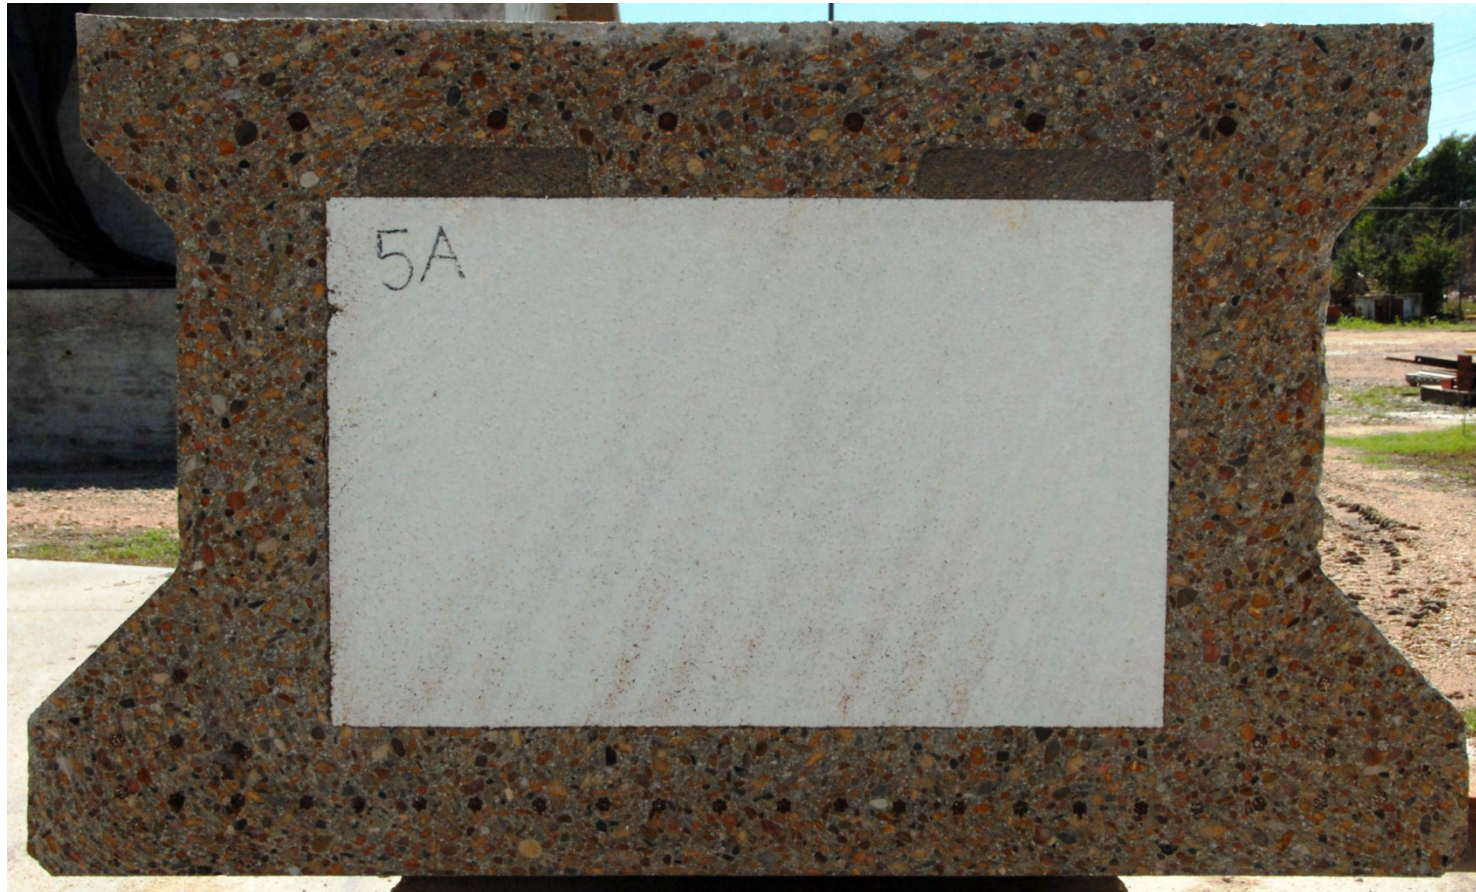
Figure A. 31: Picture BB08C5A

Beam Mark:	BB08	Cut Location and View:
Concrete Type:	Self consolidating	
Aggregate:	River Rock	
Cut ID:	BB08C5A

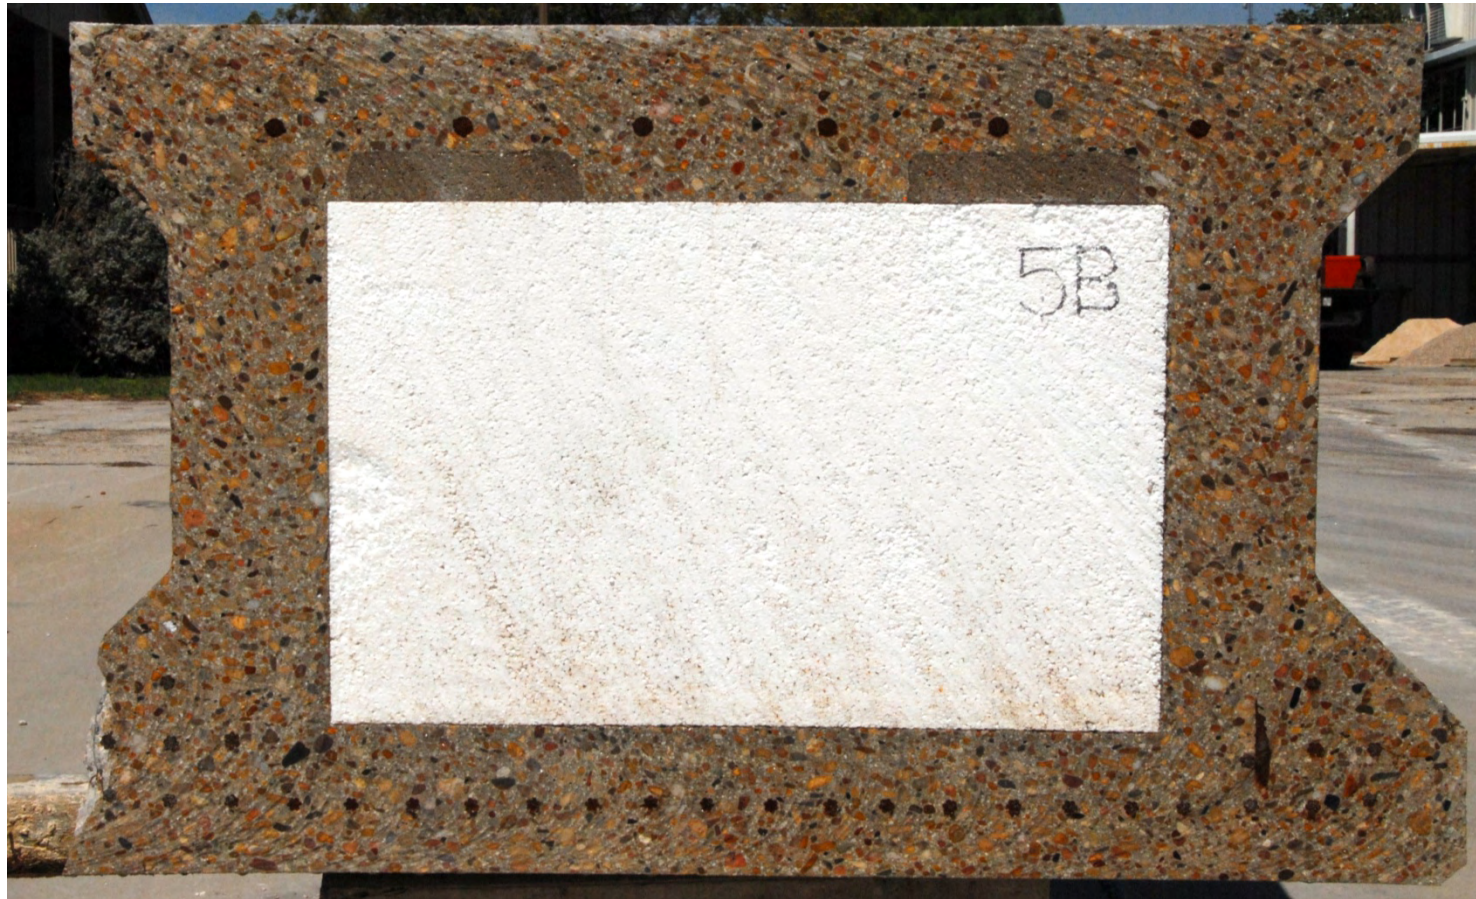
Figure A. 32: Picture BB08C5B

Beam Mark:	BB08	<p>Cut Location and View:</p>
Concrete Type:	Self consolidating	
Aggregate:	River Rock	
Cut ID:	BB08C5B

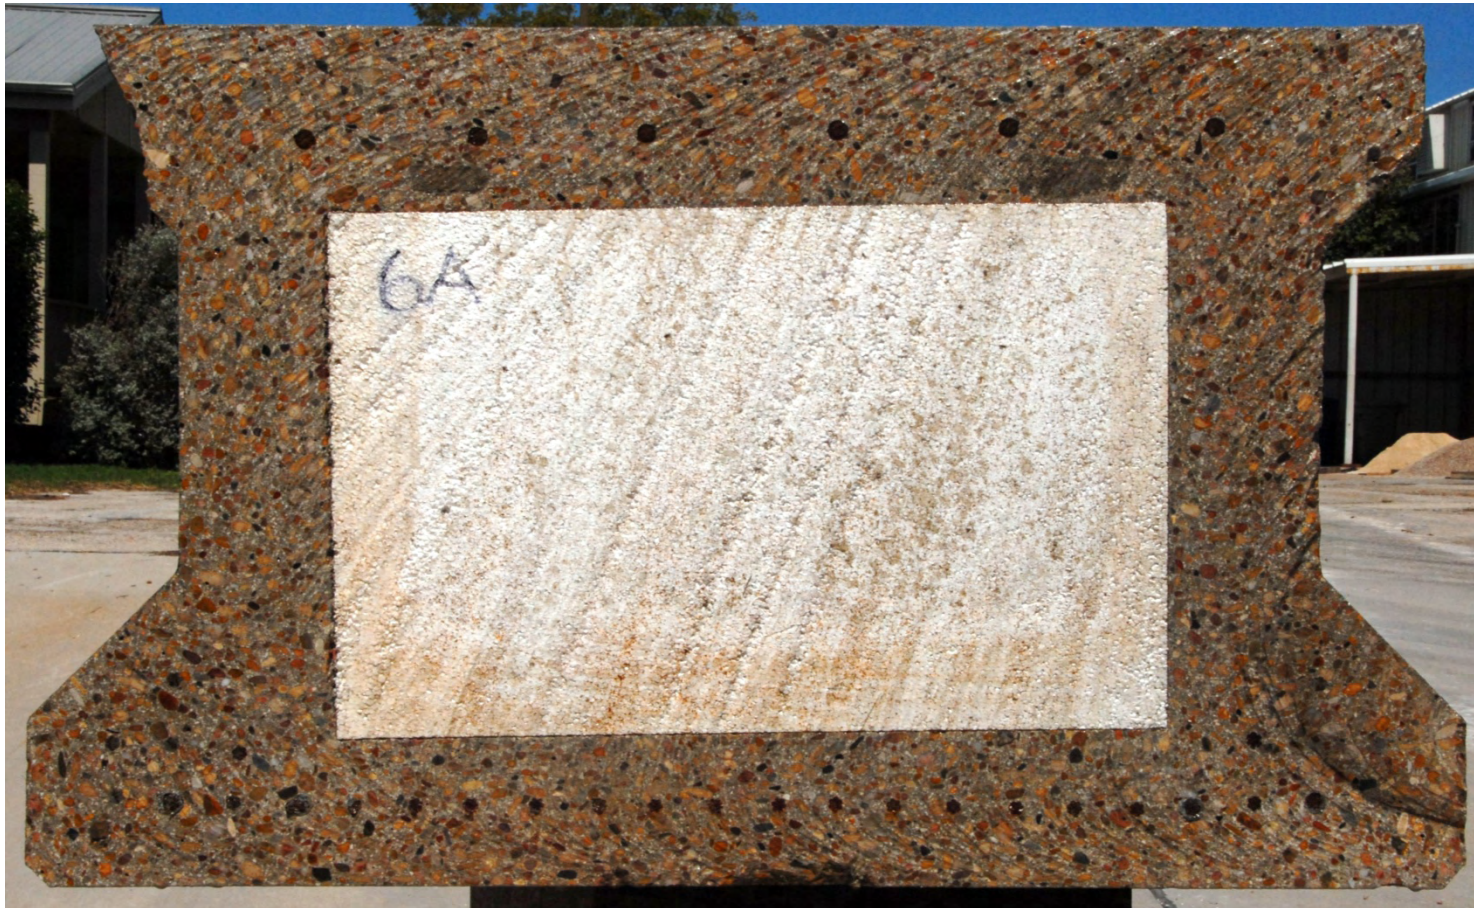
Figure A. 33: Picture BB08C6A

Beam Mark:	BB08	Cut Location and View:
Concrete Type:	Self consolidating	
Aggregate:	River Rock	
Cut ID:	BB08C6A

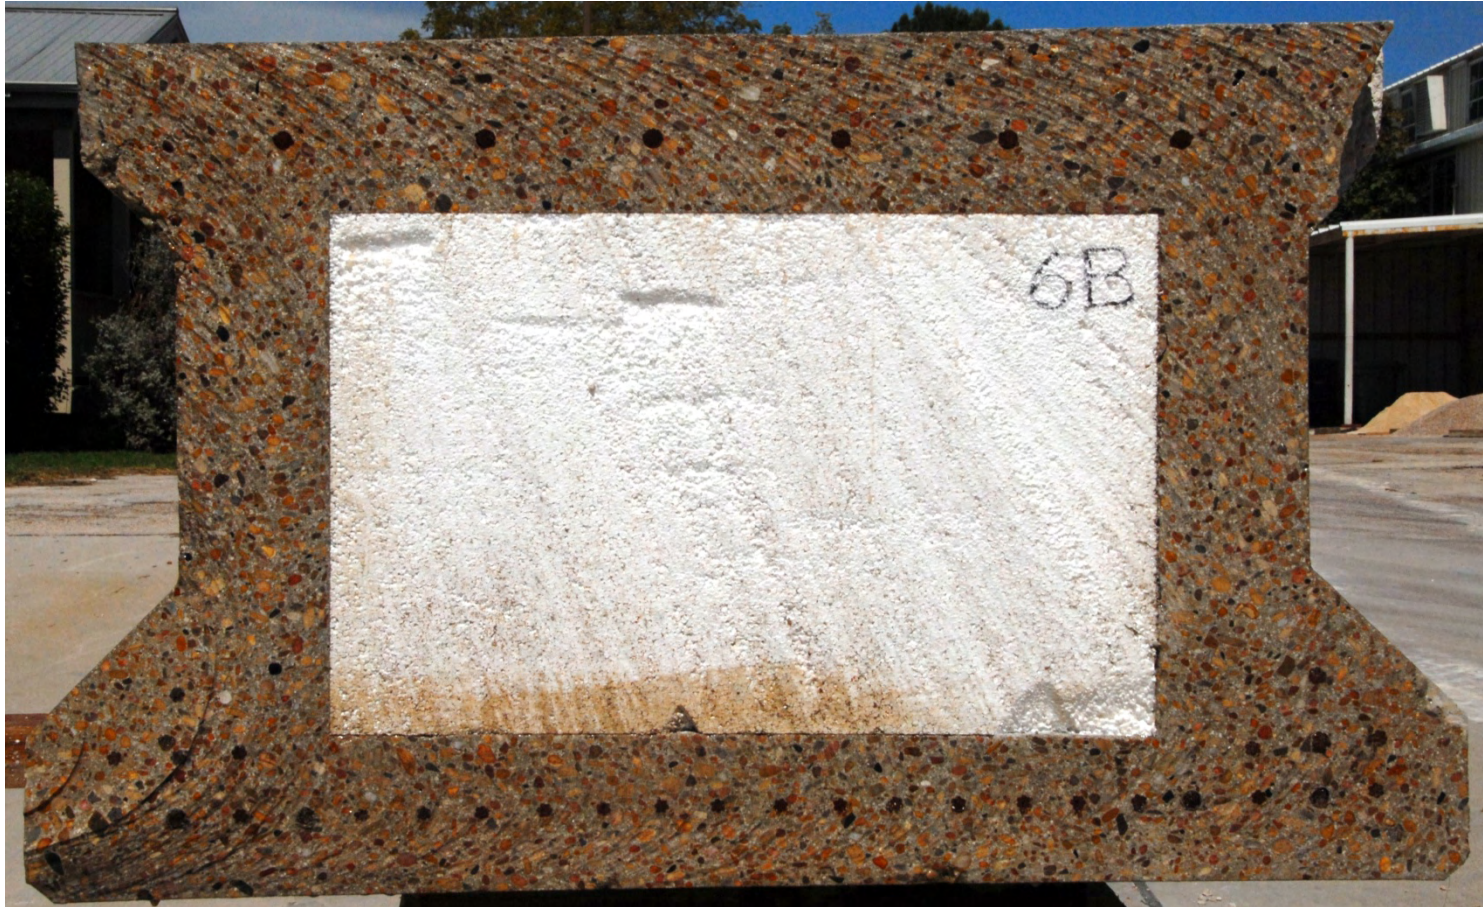
Figure A. 34: Picture BB08C6B

Beam Mark:	BB08	<p>Cut Location and View:</p>
Concrete Type:	Self consolidating	
Aggregate:	River Rock	
Cut ID:	BB08C6B

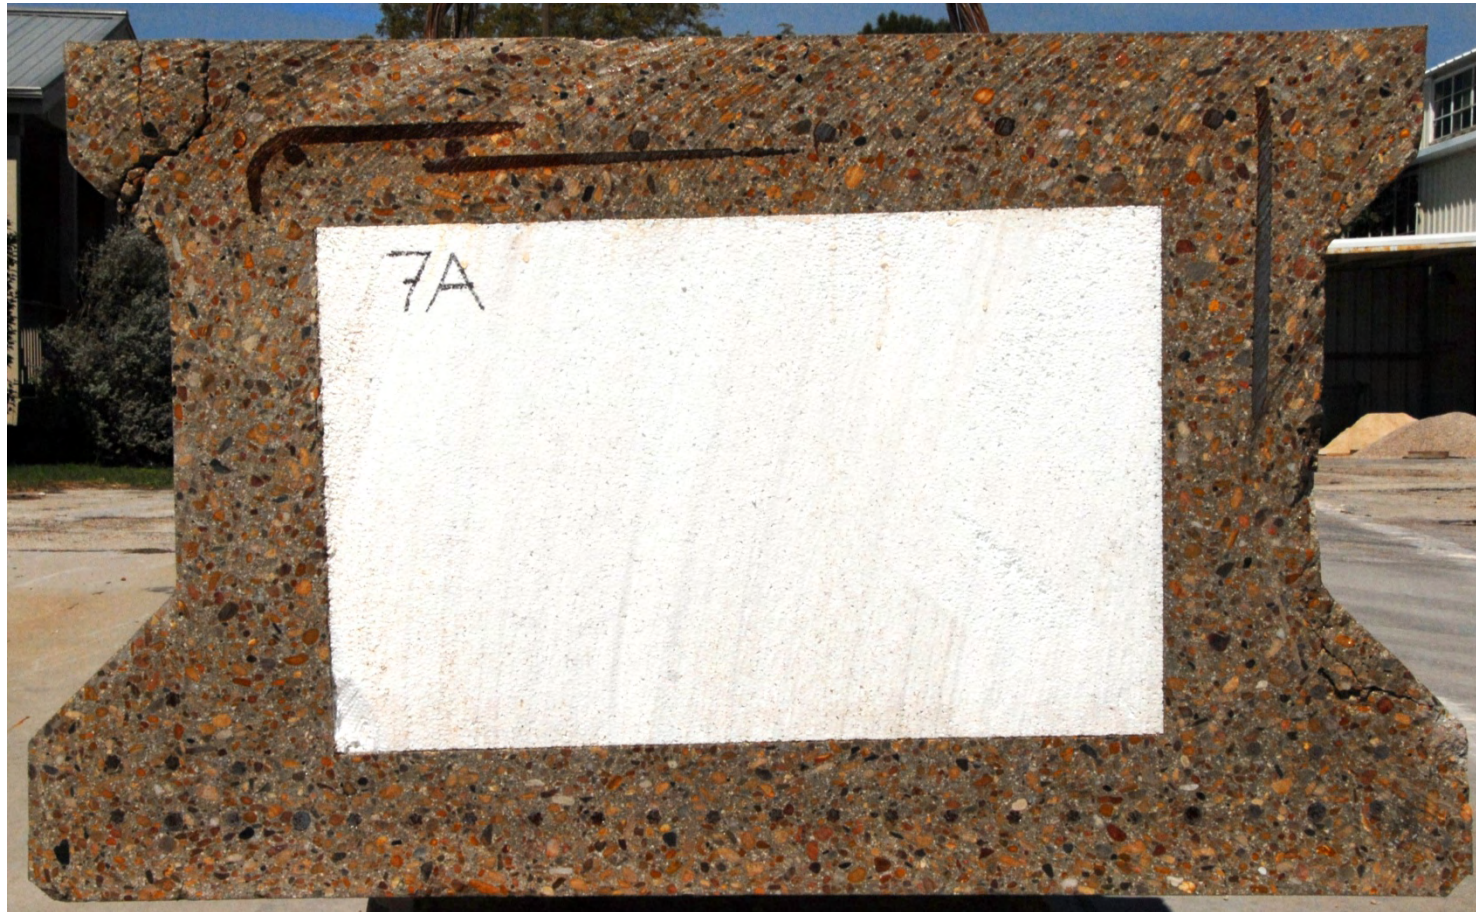
Figure A. 35: Picture BB08C7A

Beam Mark:	BB08	Cut Location and View:
Concrete Type:	Self consolidating	
Aggregate:	River Rock	
Cut ID:	BB08C7A

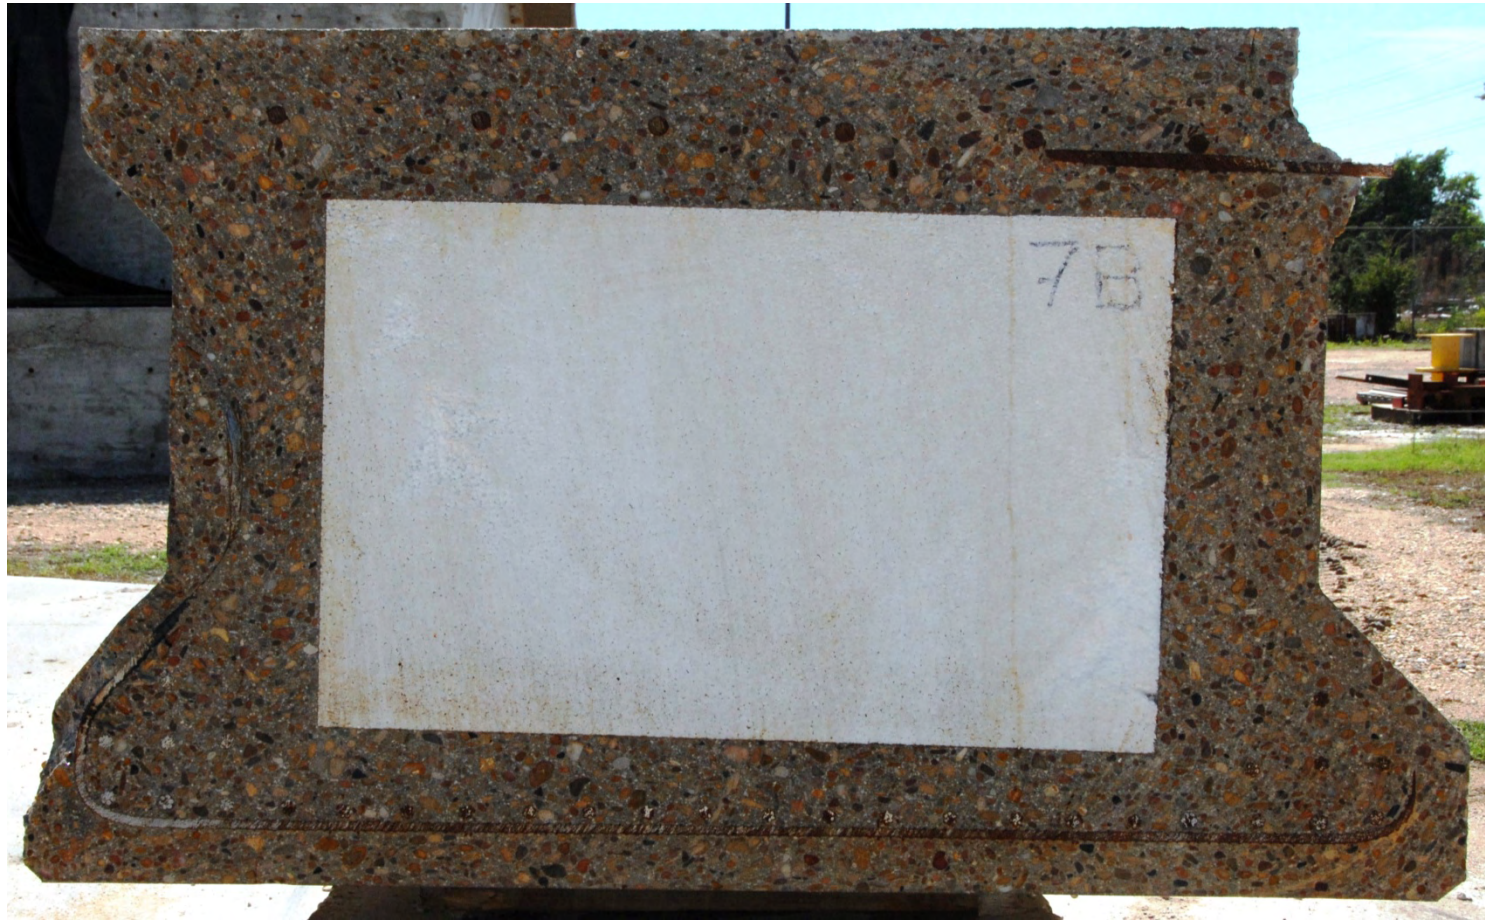
Figure A. 36: Picture BB08C7B

Beam Mark:	BB08	Cut Location and View:
Concrete Type:	Self consolidating	
Aggregate:	River Rock	
Cut ID:	BB08C7B

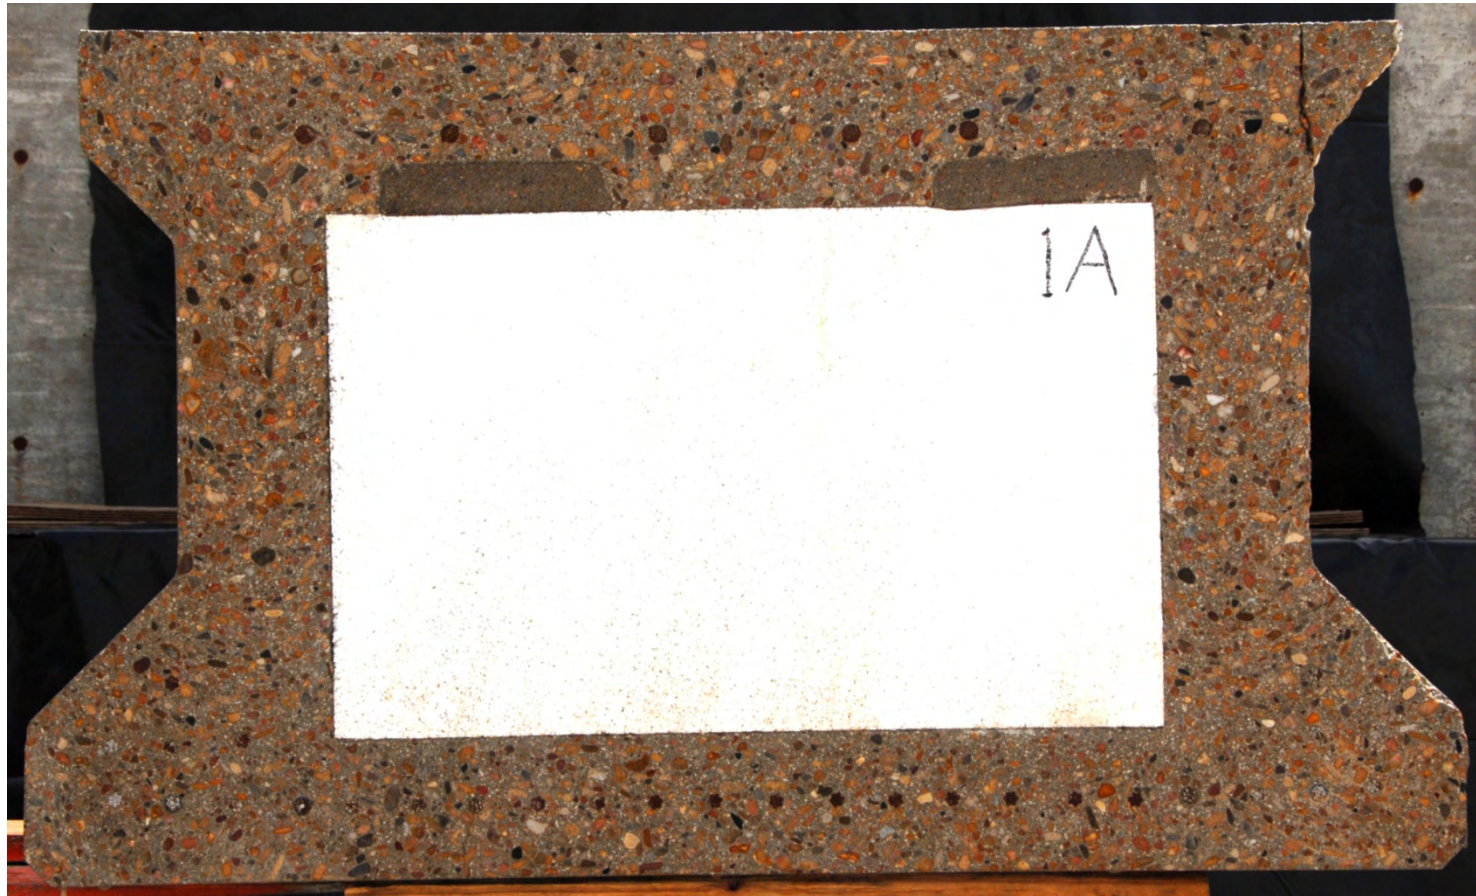
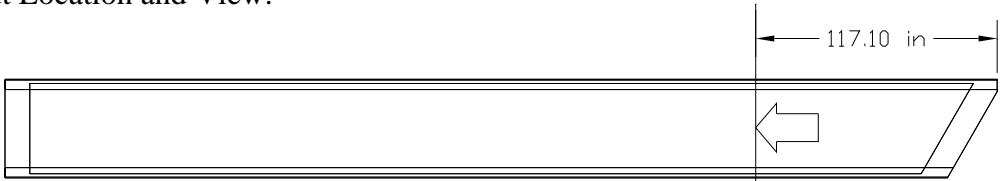
Figure A. 37: Picture BB09C1A

Beam Mark:	BB09	Cut Location and View:

Concrete Type:	Self consolidating	
Aggregate:	River Rock	
Cut ID:	BB09C1A

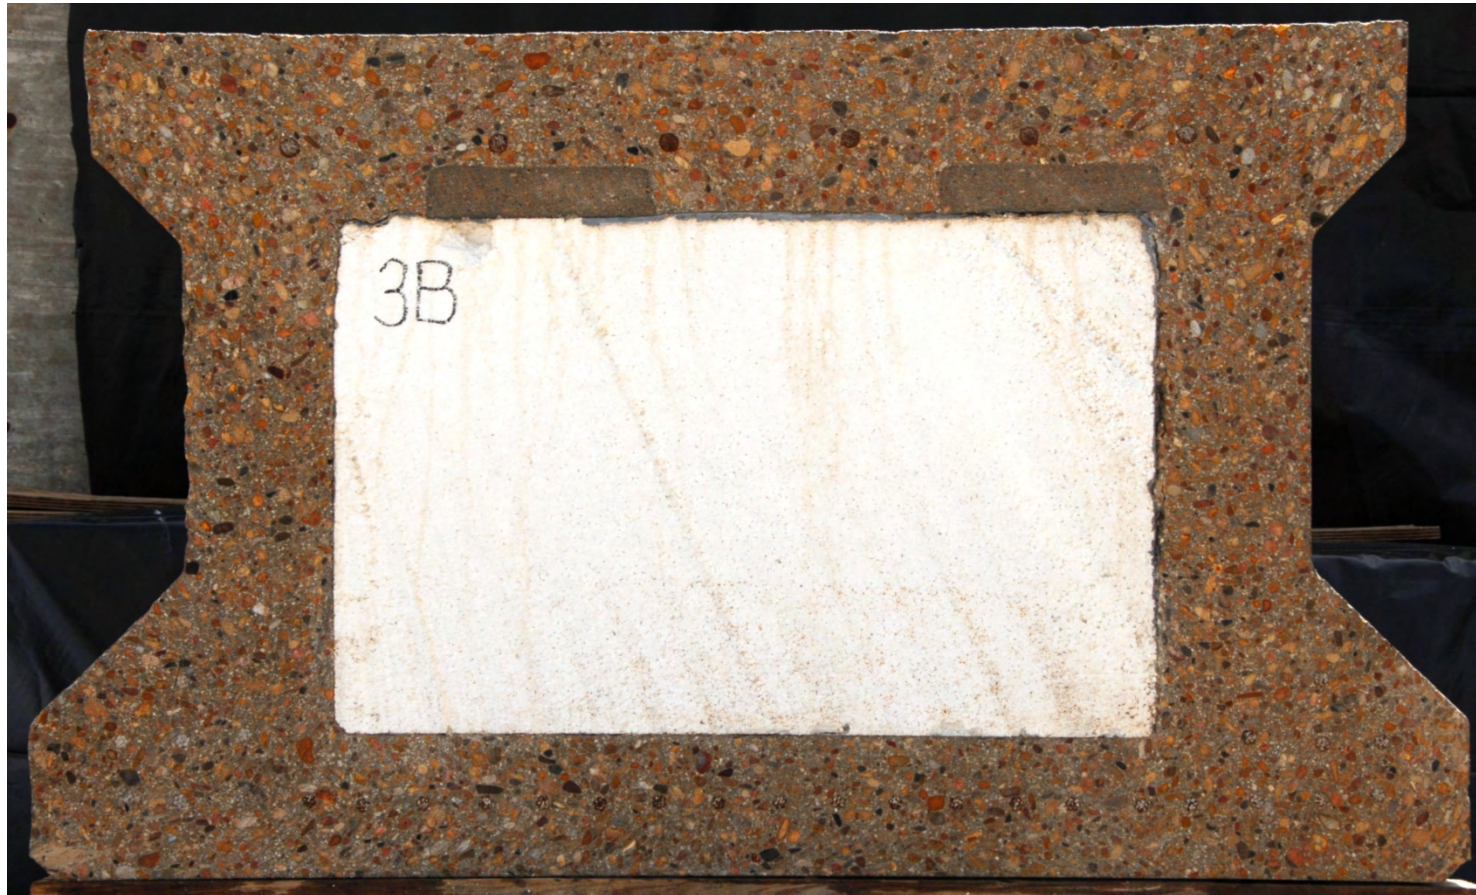
Figure A. 42: Picture BB09C3B

Beam Mark:	BB09	Cut Location and View:
Concrete Type:	Self consolidating	
Aggregate:	River Rock	
Cut ID:	BB09C3A	
Observations: This cut coincided with the joint between two Styrofoam blocks. The fabricator tapes together the top and sides of the blocks but since nothing is done to keep the bottom of the blocks together, concrete is able to flow up into the space between the blocks. This creates a thin layer of concrete (about 1/4 inch) as it is observed in this picture.
