Pennsylvania Department of Transportation Bureau of Planning and Research Project Contract No. 355I01 / Project No. 070202

Inspection Methods & Techniques to Determine Non Visible Corrosion of Prestressing Strands in Concrete Bridge Components

# Task 3 – Forensic Evaluation and Rating Methodology

ATLSS REPORT NO. 09-10

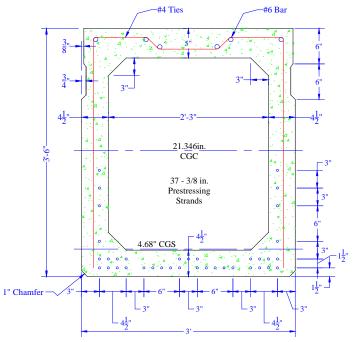
Figure 2-7: Span 1 Beam 3 of Clearfield Creek Bridge as per Structural Drawings

The structural drawings were supplied by PennDOT. This beam has a specified depth of 42 inches and a width of 36 inches. The prestressed steel reinforcement comprises thirty-seven (37) 3/8 in. diameter seven-wire strand with a minimum strand tensile strength of 250 ksi. The strands are pretensioned to an initial stress of 175 ksi with specified locations as shown in Figure 2-7. The strands have a nominal area of 0.0799 in<sup>2</sup> per strand. A minimum clear cover of 1 ½ inches was specified in the structural drawings. This requirement satisfies Section 1.6.16A of the 1965 Standard Specification for Highway Bridges wherein it states that 1 ½ inches should be used as clear cover for prestressing strands [AASHO 1965].

The beam is reinforced with #4 U-stirrups placed from the top of the beam. Matching U-stirrups from the bottom of the beam are not included. Furthermore, no horizontal transverse reinforcement is used in the bottom flange. The vertical legs of the stirrups are not properly developed with hooks and may not provide adequate development of the reinforcement if shear cracking were to occur. The beams were built in accordance with the design specifications of the time. Current bridge specifications have increased the requirements for U-stirrups in bridge sections as noted below:

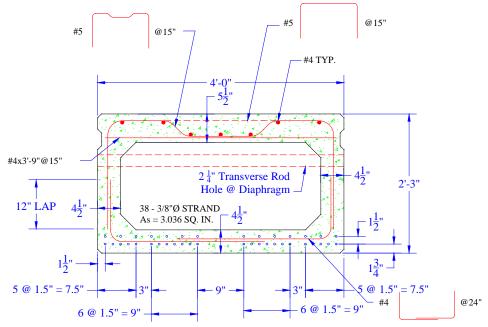
Figure 2-16: Span 1 Beam 7 of Lakeview Drive Bridge as per Structural Drawings

The structural drawings were supplied by PennDOT. The beam has a specified depth of 27 inches and a width of 48 inches. The prestressed steel reinforcement comprised thirty-eight (38) 3/8 in. diameter seven-wire strands with a minimum tensile strength of 250 ksi. The strands were pre-tensioned to an initial prestress of 14 kips per strand (175 ksi). Each strand had a nominal area of 0.0799 in<sup>2</sup>. The specified locations of the strand are shown in Figure 2-16. The beam has groupings of two #5 hairpin stirrups at the top and two #4 L shaped bars at the bottom. The bottom shear stirrups are located between the top and bottom layers of prestressing strand; common practice during 1960-era construction. This detail is no longer common practice. Current practice [AASHTO LRFD 2008, Sect. 5.10.3.1.5] dictates that longitudinal reinforcement shall be enclosed within stirrups and ties.

The spacing of the top and bottom transverse reinforcement was not the same along the length of the beam. The top flange shear reinforcement was to be spaced at 15 inches and the bottom shear reinforcement was to be spaced at 24 inches. As a result, the top and bottom stirrups are typically not in contact in the web. Since the stirrups are not adequately lapped the shear reinforcement may not be fully developed. Clear cover is called out as 1 ¾ inches in the structural drawings. This satisfies Section 1.6.16A of the 1965 Standard Specification for Highway Bridges wherein it states that 1 ½ inches should be used as clear cover for prestressing strands [AASHTO 1965].

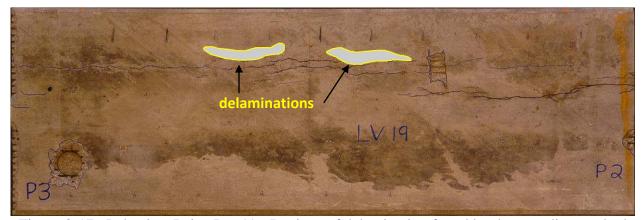
Figure 3-17: Lakeview Drive Bm.19 - Regions of delamination found by the sounding method

Only three of the seven beams were found to have delaminations according to the sounding method described. These beams are Main Street Beams 2 and 3, and Lakeview Drive Beam 19. Figure 3-15, Figure 3-16, and Figure 3-17 show the locations of delaminations found on the bottom flange of Main Street Beam 2, Main Street Beam 3, and Lakeview Drive Beam 19, respectively. It can be seen that the delaminated regions occurred over or adjacent to the primary longitudinal cracks. It should be noted that during the destructive evaluation, it was found that Lakeview Drive Beam 7 was almost fully delaminated. However, due to the fact that the delamination was fairly deep into the flange (approximately 2 to 3 in.) it was not detected by sounding. A comparison of the sounding results with in-situ damage is discussed in section 7.5.

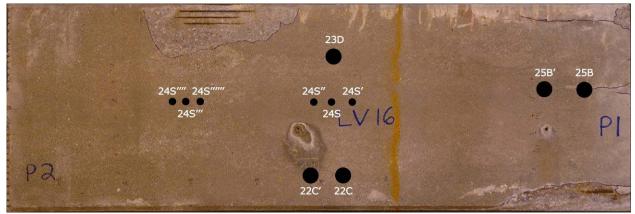
Figure 4-4: Core Locations for Beam LV16

Beam LV16 had 11 cores extracted overall, as shown in Figure 4-4. Six strength cores were extracted, 3 cores were sent to TEC for analysis, and 2 cores were designated for strand extraction. Core 23D was designated for petrographic testing. Core 25B was located along a longitudinal crack.

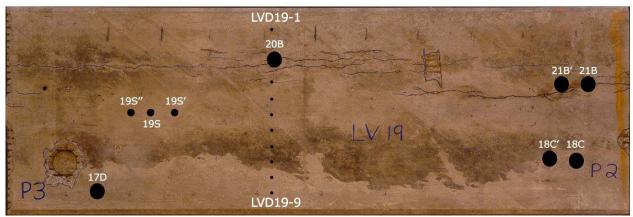
Figure 4-5: Core Locations for Beam LV19

Beam LV19 had 28 cores extracted overall, as shown in Figure 4-5. Three strength cores were extracted, 13 cores were sent to TEC for analysis, and 2 cores were designated for strand extraction. Core 17D was designated for petrographic testing. Cores 20 and 21 were located along a longitudinal crack.

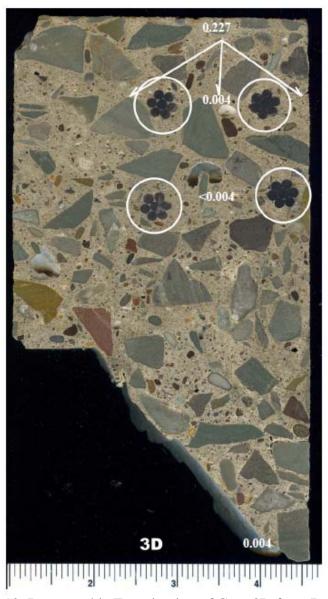
Figure 4-10: Petrographic Examination of Core 3D from Beam MS3

A cross-section of Core 3D showing relatively good grading and distribution of aggregates can be seen in Figure 4-10. Non-corroded seven-wire prestressing strands are circled. Arrows point to a crack at the top strand level. Aside from the crack there is no evidence of distress to the concrete. The core was taped to facilitate processing. The acid-soluble chloride contents are overlaid on the core section; the values shown are percent by concrete mass. The scale is in inches.

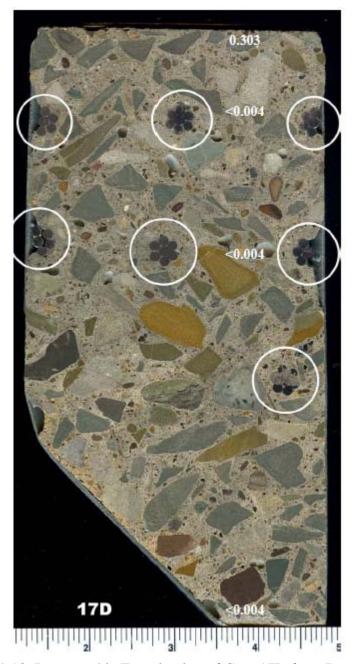
Figure 4-13: Petrographic Examination of Core 17D from Beam LV19

Cross-section of Core 17D showing relatively good grading and distribution of aggregates can be seen in Figure 4-13. Non-corroded seven-wire prestressing strands are circled. There is no evidence of distress to the concrete. The core was taped to facilitate processing. The acid-soluble chloride contents shown are percent by concrete mass. The scale is in inches.

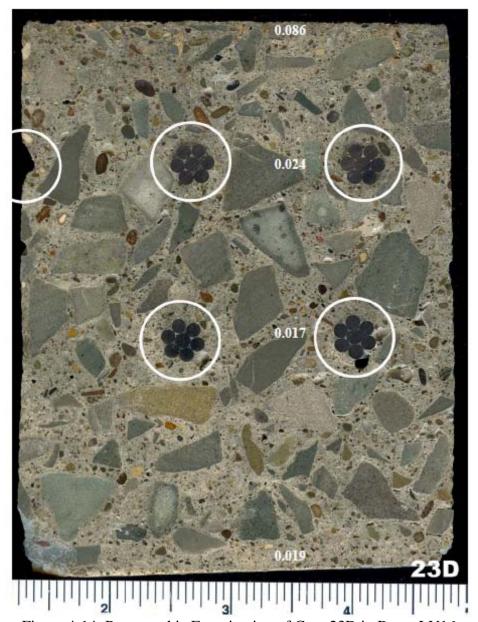
Figure 4-14: Petrographic Examination of Core 23D in Beam LV16

Cross-section of Core 23D showing relatively good grading and distribution of aggregates can be seen in Figure 4-14. Non-corroded seven-wire prestressing strands are circled. There is no evidence of distress to the concrete. The acid-soluble chloride contents shown are percent by concrete mass. The scale is in inches.

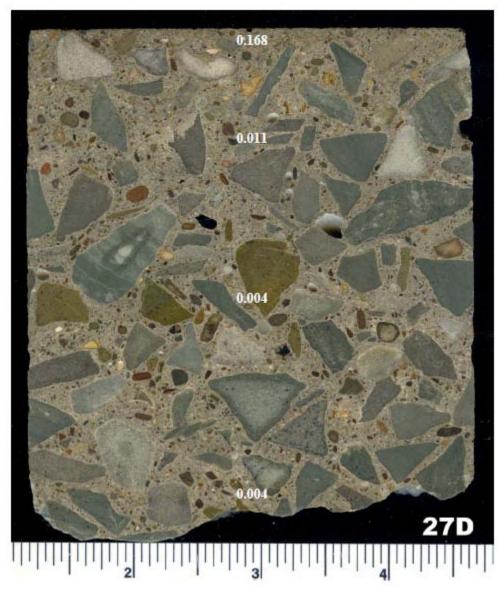
Figure 4-15: Petrographic Examination of Core 27D in Beam LV7

A cross-section of Core 27D showing relatively good grading and distribution of aggregates can be seen in Figure 4-15. There is no evidence of distress to the concrete. The acid-soluble chloride contents shown are percent by concrete mass. The scale is in inches.

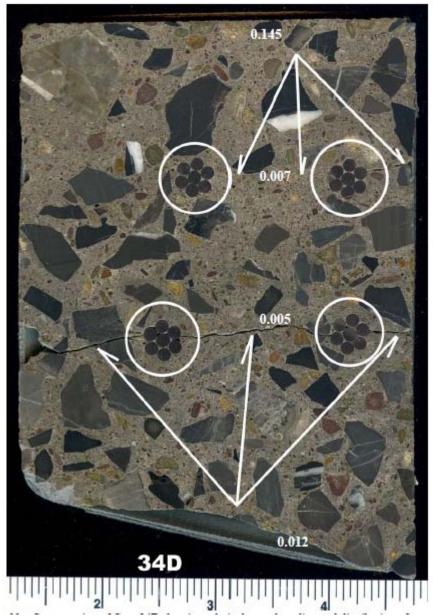
Figure 4-16: Petrographic Examination of Core 34D in Beam CC4

A cross-section of Core 34D showing relatively good grading and distribution of aggregates can be seen in Figure 4-16. Within the circles are non-corroded strands. The arrows point to cracks at strand levels. Aside from the cracks there is no evidence of distress to the concrete. The core was taped to facilitate processing. The acid-soluble chloride contents shown are percent by concrete mass. The scale is in inches.

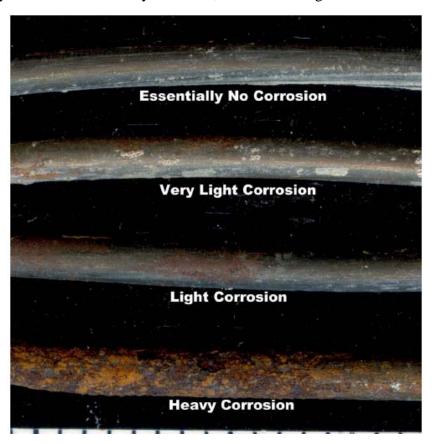
Figure 4-17: Degrees of Corrosion by TEC

Seven-wire prestressing strands having 3/8-inch diameters are present in Cores 3D, 10D, 14D, 17D, 23D, and 34D. Individual wire diameters are 1/8 inch. The degree of corrosion ranges from essentially no corrosion to heavy corrosion, as shown in Figure 4-17.

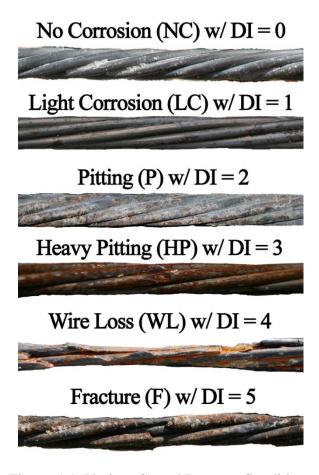
Figure 5-1: Various Strand Damage Conditions

- DI = 0. No Corrosion. No visible indications of corrosion product on the surface of the strand.
- DI = 1. Light Corrosion. Light corrosion product visible on the surface of the strand removable by light sanding with no associated section loss.
- DI = 2. Pitting. Corrosion present with section loss between 0 and 20% of the wire section area.
- DI = 3. Heavy Pitting. Corrosion present with section loss greater than 20% of the wire section area.
- DI = 4. Wire Loss. Corrosion present and complete 100% degradation of individual strand wires.
- DI = 5. Fracture. Corrosion present and localized fracture of individual wires.

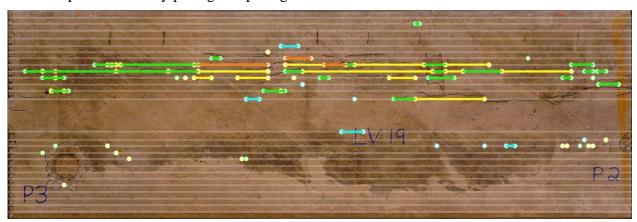
Figure 5-7: Damage Profile for Lakeview Drive Bridge Beam 19

As can be seen in Figure 5-7, most of the damage can be found on the upper half of the specimen. The visual inspection showed several cracks along this area. Even though there appears to be much damage on the beam, most of it is of the lighter nature; light corrosion and pitting. Wire loss was documented on strands six, seven, eight, and nine. The lower half of the beam is mostly undamaged, showing several spots with light corrosion damage and some isolated spots with heavy pitting and pitting.

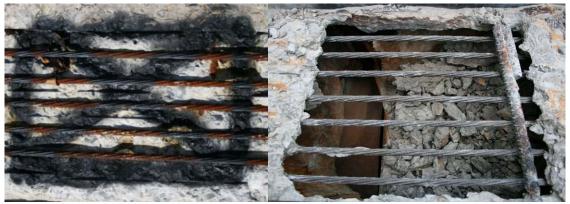
Figure 5-10: Before and After Deconstruction

At several spots throughout each beam, after the exposure of the first layer of strands had taken place, locations were determined where information about the second layer of strands was desired. The acquired data will aide in determining the relationship between the two levels of strands. A jackhammer was taken and punched through the remaining concrete in the bottom flange of the girder to fully reveal the 2<sup>nd</sup> level. For a before and after the concrete was punched-out image, see Figure 5-10.

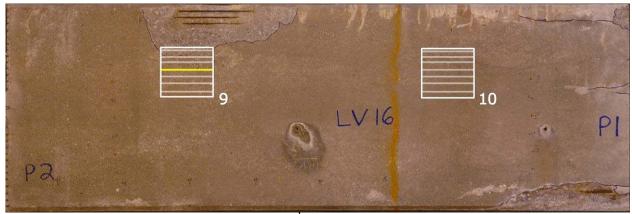
Figure 5-14: Location of 2<sup>nd</sup> Layer Punchouts on Beam LV16

As shown in Figure 5-14, two punch outs were taken for beam LV16. Punch out 9 is located near a spalled area where strand 10 had severe wire loss on the 1<sup>st</sup> strand level; the exposed 2<sup>nd</sup> strand level revealed heavy pitting on strand 10. Punch out 10 is taken over an area where no damage was found on the 1<sup>st</sup> level of strands; the exposed 2<sup>nd</sup> strand level revealed no corrosion damage.

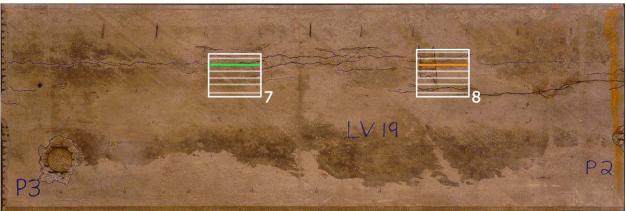
Figure 5-15: Location of 2<sup>nd</sup> Layer Punch outs on Beam LV19

As shown in Figure 5-15, two punch outs were taken for beam LV19. Punch out 7 is located along a longitudinal crack; exposed 2<sup>nd</sup> level strands revealed one case of pitting. Punch out 8 is located along a longitudinal crack; 2<sup>nd</sup> strand layer visual inspection revealed one case of wire loss.

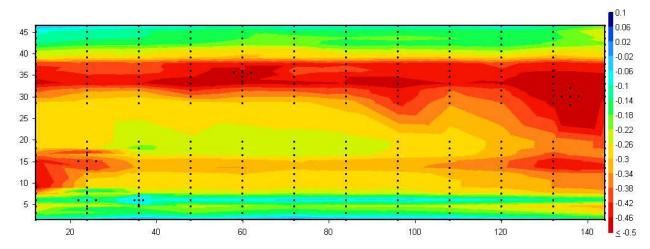
Figure 6-6: Half-Cell Potential Map of Lakeview Drive Span 3 Beam 19

These half-cell potential measurements were subsequently plotted as a color contour plot. An example of the plot for one beam segment is shown in Figure 6-6. It is important to note that the scale used in the following figure is used throughout the rest of this report. Dark blue through green shading represents a very small probability of corrosion, yellow through light orange shading represents an uncertain probability for corrosion, and dark orange through dark red shading is indicative of a very high probability of corrosion. The half-cell potential readings are discussed in more detail below.

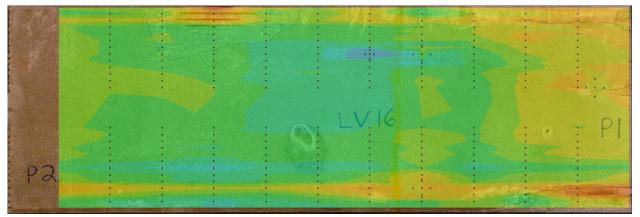
Figure 6-10: Bottom Flange Half-Cell Potential Map -- Lakeview Drive Beam 16

The half-cell potential map, as given in Figure 6-10, shows a band where corrosion is possible (indicated by yellow shading) above strands 25 and 26 near the bottom of the figure. The P1 side of the beam in this band seems to have an increased likelihood for corroded strands. The

spalled sections have half cell measurements indicating a high likelihood for corrosion potential. This has been verified through the visual inspection.

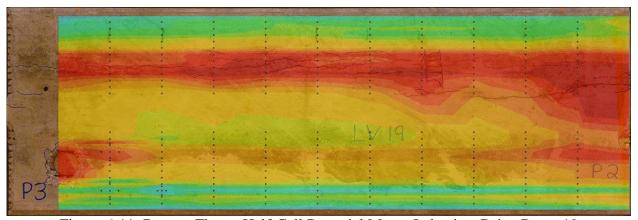
Figure 6-11: Bottom Flange Half-Cell Potential Map – Lakeview Drive Beam 19

The half-cell potential map, as given in Figure 6-11, indicates a potential for corrosion everywhere except along the top and bottom across the length of the beam. Under the longer crack, extending from the P3 side, corrosion is very likely.

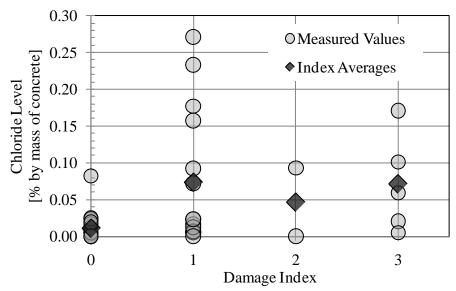
Figure 7-1: Chloride content relative to strand corrosion level

The standard deviations of the different corrosion levels were large. This is summarized in Table 7-1 and illustrated in Figure 7-1; the large variation was expected. Corrosion is often correlated with chloride levels, but it is also sensitive to the amount of moisture present in service. Since the samples were taken after the beams were taken out of service, the moisture condition of the samples could not be evaluated.

Based on the chloride measurements and corrosion levels determined, the following conclusions can be made: (1) on average the ACI limit of 0.026% divides the region between corrosion and no corrosion, (2) the average chloride readings for all cases with a damage index of 0 (no corrosion) was 0.0113 – under the ACI threshold – compared to 0.0704 for the cases with a damage index greater than 0, (3) the variability in the chloride levels at each corrosion state is very large making determination of chloride thresholds inappropriate for the data set, (4) it is possible to have heavy pitting of the strands with chloride levels of 0.005%, (5) it is possible to have no corrosion with chloride levels of 0.082%.

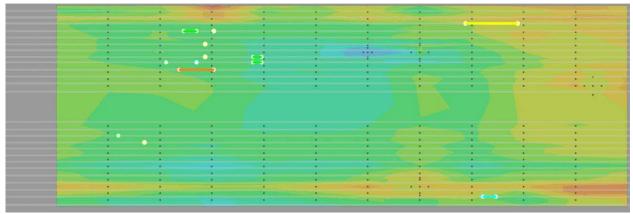
Figure 7-6: Overlay of Damage Profile on Half Cell Potential Map for Beam LV16

As shown in Figure 7-6, the detected damage found on beam LV16 was minimal. The half cell potential map shows an area of low voltage along the bottom of the beam spanning from end to end, however no damage was found in this area. Also, a large amount of wire loss was found on strand 10 (strands numbered starting with 1 at the top of the figure). The high half cell values indicate that it is unlikely that corrosion would exist at that location.

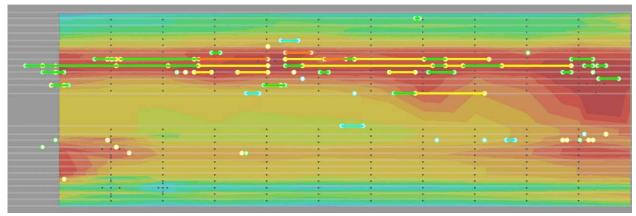
Figure 7-7: Overlay of Damage Profile on Half Cell Potential Map for Beam LV19

As shown in Figure 7-7, the detected damage found on beam LV19 was spread throughout a cracked region just above the centerline of the beam. This highly cracked region showed voltage readings which indicated corrosion.

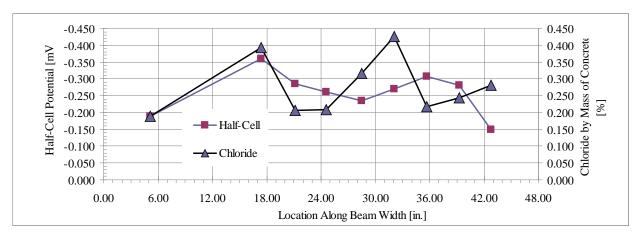
Figure 7-10: Voltage & Chloride Values along the Length of Beam LV19

From the four inch cores sent to The Erlin Company, the chloride percent by mass of concrete was obtained; half cell potential readings were also taken at these core locations. In addition to the four inch cores, 0.5 inch diameter plugs were taken along two of the beams widths; CC4 and LV19. The half cell potential readings at these locations are known as well. In comparing half-cell voltage readings and chlorides for the 0.5 inch diameter plugs, Figure 7-10 and Figure 7-11, it is clear that correlation does not exist.

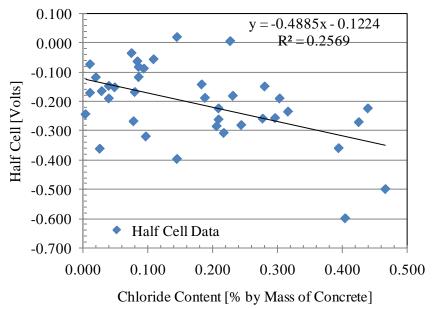
Figure 7-12: Correlation of Half-Cell Potential and Chloride Levels

The half cell voltage readings and chloride values from the 0.5 inch diameter plugs and the 4 inch diameter cores were compiled and analyzed together. The data is summarized in Figure 7-12. A low correlation exists between half cell potential and surface chloride level.

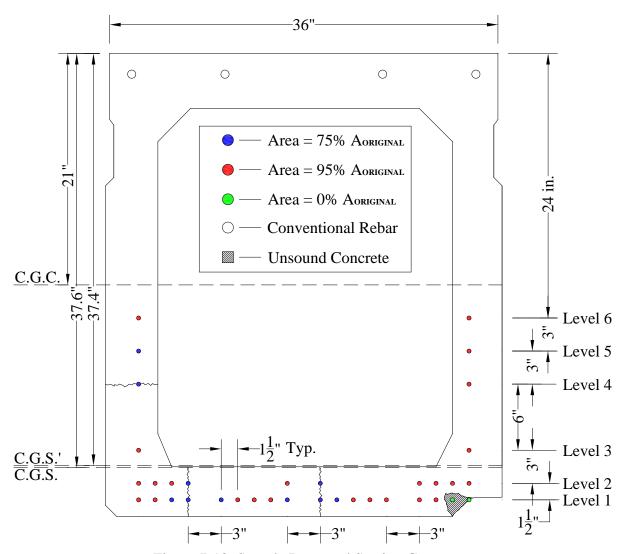
Figure 7-13: Sample Damaged Section Geometry

A prestressed concrete box beam section is illustrated in Figure 7-13. The damage within a region of one development length is included in the section image. Field inspection of the beam identified three longitudinal cracks, spalling and an area of unsound concrete. The construction documentation indicates that the beam is reinforced with 36 - 3/8 in. diameter seven-wire grade 270 prestressing strands. The spacing and arrangement of the strands is shown in Figure 1.

Using the recommended rating procedure the area reductions and reduced flexural strength is computed. This is conducted in the following stages: 1) the location of cracking, spalling and deteriorated concrete is used to determine a reduced area of prestressing steel (Figure 7-13), 2) a new center of gravity of steel and corresponding eccentricity is computed (Table 7-17), 3) a reduced nominal moment capacity is computed in accordance with ACI 318 recommendations.

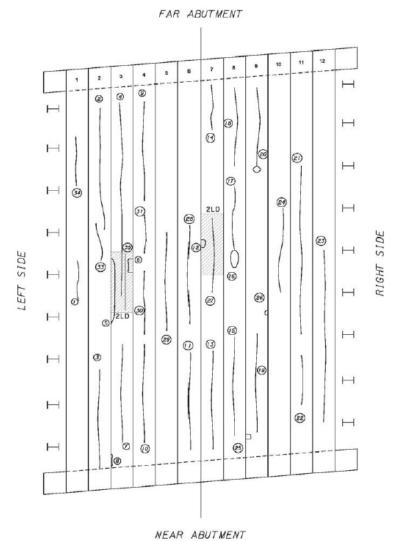
Figure 7-16: Field Sketch of Flaws from Visual Inspection

The visual inspection performed by SEI revealed many longitudinal cracks, areas of concrete spalling, exposed steel strand, and areas of delaminated concrete. A field sketch indicating the locations of these flaws along the bottom flanges of the members is shown below in Figure 7-16.

Due to the fact that no shop drawings were available for this particular bridge, the exact strand layout is unknown. Therefore, the PennDOT standard drawing ST-207 was used to recreate the strand layout most likely to have been used for this type of bridge built during this time period. It was determined to most likely be reinforced with twenty-two 7/16 in. diameter strands, having an initial tensile stress of 175 ksi and an ultimate tensile strength of 250 ksi. Due to the diameter of the reinforcement and as shown in Section 7.7.1, the inspection window to be used is 150 inches; this is shown as the shaded areas in Figure 7-16. The gross area of reinforcing steel is calculated to be 2.40 square inches.

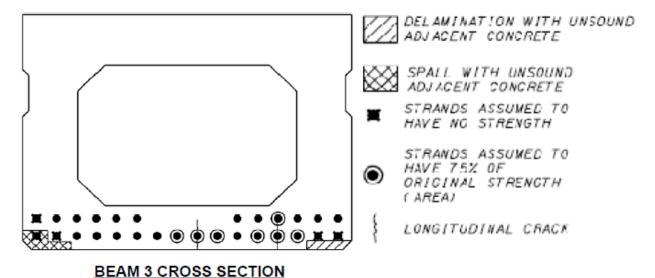
Figure 7-17: Strand Area Reductions by the Proposed Rating Method

It was determined by SEI that Beam 3 had the most damage for any given inspection window, therefore, this was the cross section in which the two rating method would be applied. In applying the proposed rating method to beam 3, Figure 7-17, the reduced area of steel due to flaws was determined to be 2.23 square inches. In applying the current PennDOT rating method to beam, Figure 7-18, the reduced area of steel due to flaws was determined to be 1.74 square inches.

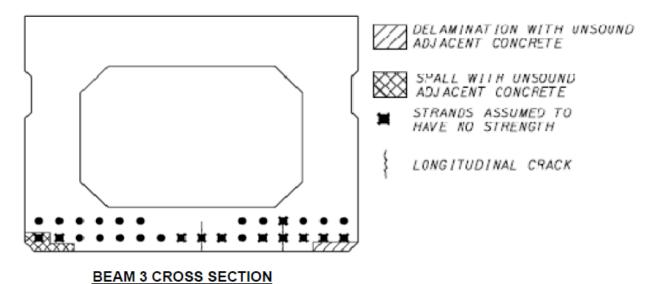
Figure 7-18: Strand Area Reductions by the Current PennDOT Rating Method

The strand areas and concrete properties were input into the PS3 program, which calculates the Inventory and Operating Ratings for bridge beams. As shown in Table 7-21, the average percent difference for an Inventory Rating between the two methods is 387.5%. As shown in Table 7-22, the average percent difference for an Operating Rating between the two methods is 75.9%. These results indicate that the current PennDOT rating method is much more conservative than the proposed method.

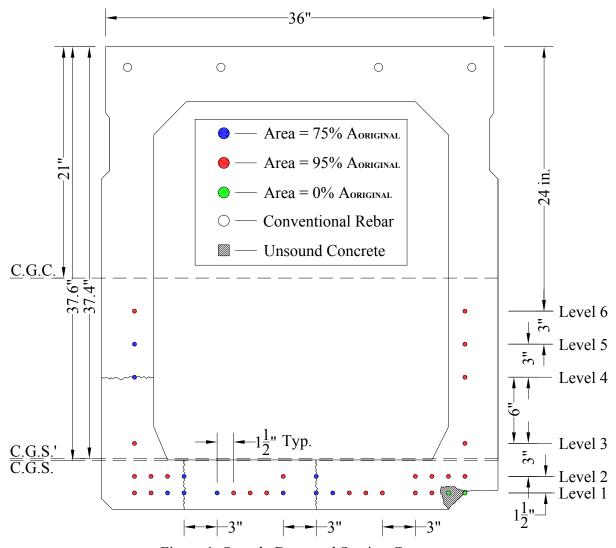
Figure 1: Sample Damaged Section Geometry

A prestressed concrete box beam section is illustrated in Figure 1. The damage within a region of one development length is included in the section image. Field inspection of the beam identified three longitudinal cracks, spalling and an area of unsound concrete. The construction documentation indicates that the beam is reinforced with 36 - 3/8 in. diameter seven-wire grade 270 prestressing strands. The spacing and arrangement of the strands is shown in Figure 1.

Level:	Original Area:	Depth from Top:	Reduced Area for Capacity Calculations:
1	$A_1 = 18 \times 0.085 \text{ in}^2$ = 1.53 in <sup>2</sup>	$d_1 = 40.5 \text{ in}$	$A'_1 = [(10 \times 95\%) + (6 \times 75\%) + (2 \times 0\%)]$ $\times 0.085 \text{ in}^2 = 1.19 \text{ in}^2$
2	$A_2 = 10 \times 0.085 \text{ in}^2$ = 0.85 in <sup>2</sup>	$d_2 = 39 \text{ in}$	$A'_2 = [(8 \times 95\%) + (2 \times 75\%)] \times 0.085 \text{ in}^2 = 0.77 \text{ in}^2$

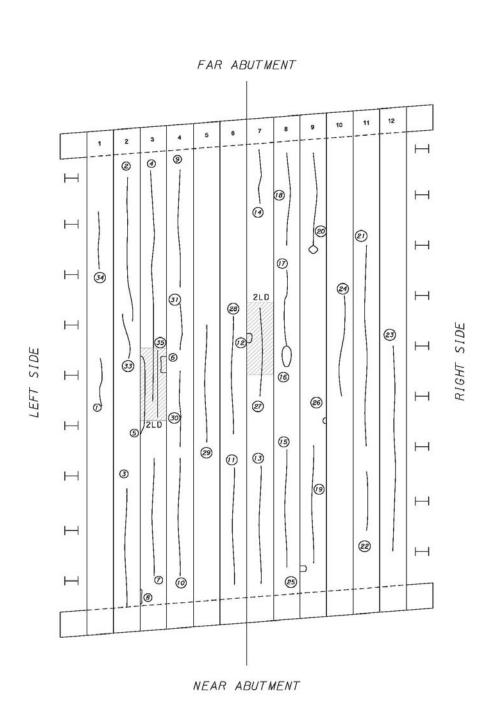
Figure 4a. Field sketch of cracks, spalls, and delamination on bridge.

A routine inspection has identified many longitudinal cracks and areas of spalls and delamination with exposed strands, as shown in Figure 3 and Figure 4a.

The shaded areas represent the inspection windows for load ratings. The window length is 150 in for this bridge.

(34) 10' FINE CRACK @ FAR ABUTMENT
(1) 4' FINE CRACK @ 0.5 SPAN
(33) 6' FINE CRACK @ 0.5 SPAN
(3) 10' FINE CRACK @ NEAR ABUTMENT
(2) 20' FINE CRACK @ FAR ABUTMENT

(8) 3' X 0.8' SPALL @ NEAR ABUTMENT - CORRODED SHEAR REINFORCEMENT
(7) 10' FINE CRACK @ NEAR ABUTMENT
(6) 3' X 0.5' AREA OF DELAMINATION @ 0.5 SPAN
(5) 15' X 0.5' SPALL @ 0.5 SPAN - [1] STRAND EXPOSED & BROKEN

(4) 13' FINE CRACK @ FAR ABUTMENT
(35) 3' FINE CRACK @ 0.5 SPAN
(31) 6' FINE CRACK @ 0.5 SPAN
(30) 10' FINE CRACK @ 0.5 SPAN
(10) 8' FINE CRACK @ NEAR ABUTMENT

(9) 10' FINE CRACK @ FAR ABUTMENT
(29) 15' FINE CRACK @ 0.5 SPAN
(28) 15' FINE CRACK @ 0.5 SPAN
(11) 8' FINE CRACK @ NEAR ABUTMENT
(27) 12' FINE CRACK @ 0.5 SPAN

(14) 6' FINE CRACK @ FAR ABUTMENT
(13) 8' FINE CRACK @ NEAR ABUTMENT
(12) 2' X 1' AREA OF DELAMINATION @ 0.5 SPAN
(18) 10' FINE CRACK @ FAR ABUTMENT
(17) 8' FINE CRACK @ 0.5 SPAN PROPOGATING FROM AREA OF DELAMINATION

(16) 4' X 1' AREA OF DELAMINATION @ 0.5 SPAN
(15) 8' FINE CRACK @ NEAR ABUTMENT
(26) 1' X 0.5' DELAMINATION @ 1/3 SPAN
(25) 1' X 1' DELAMINATION @ 0.1 SPAN

(20) 15' FINE CRACK @ FAR ABUTMENT
(19) 7' FINE CRACK @ NEAR ABUTMENT
(24) 17' FINE CRACK @ 0.5 SPAN
(22) 5' FINE CRACK @ NEAR ABUTMENT
(21) 25' FINE CRACK @ 0.5 SPAN

(23) 30' FINE CRACK @ 0.5 SPAN

Knowing the diameter of the strands (7/16") and the initial and ultimate tensile stress in the strands (175 ksi and 250 ksi respectively), the inspection window length is determined to be 150 in. The windows are shown as shaded areas in Figure 4a for Beams 3 and 7. The deterioration within this length is evaluated for all the beams at all locations to determine the location and reduction of strands for the rating.

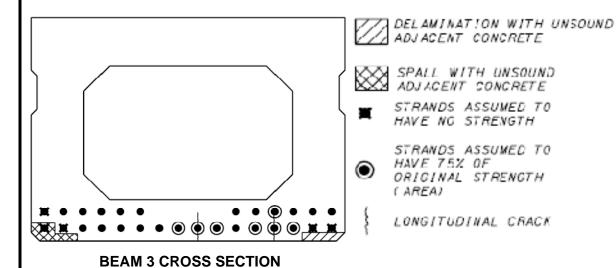
Through the inspection of the field notes, Beam 3 appears to have the most deterioration within the inspection window lenth at mid-span, where the beam has the greatest moment and will likely govern the rating. The bottom layer of strands that are at crack locations or within 3" from any crack is to be reduced to 75% of their original area. The strands at unsound concrete or are exposed are to be entirely discounted. All other strands will be reduced to 95% of their original area. The effective remaining strand area is then computed.

Beam 3 Total Area = (0.95\*16+7\*.75)\*.109 =
