Final Report RC-1526

Estimate of Cliff Recession Rates for the Baraga Cliffs

Michigan Department of Transportation

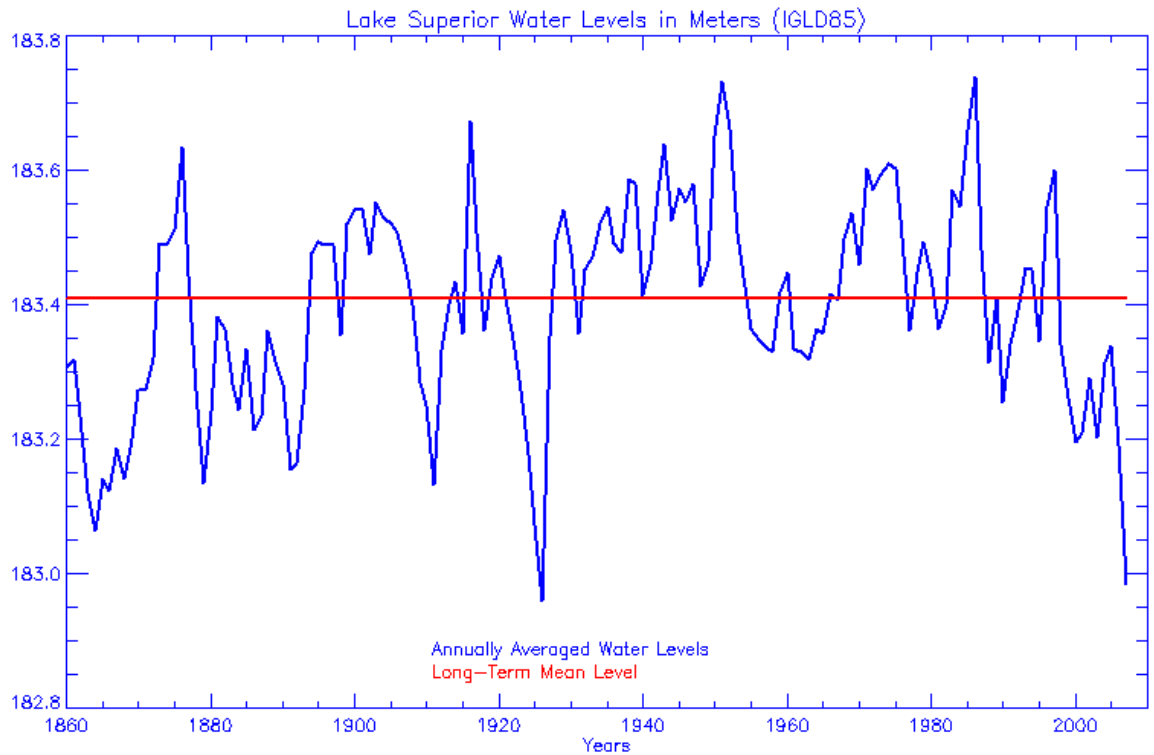
Figure 9 Lake Superior water levels from 1860 through 2005.

recession of the cliff face. The sequence of photos also shows how the lake level has changed over the past 50 years. For example, the lake levels for the year 1962, 1968, 1986, and 1997 were 601.5 ft, 601.9 ft, 602.8 ft, and 602.3 ft, respectively. Based on these lake levels, the 1986 photograph shows the high water level for the cliff for this period of time. Figure 9 shows the Lake Superior water levels for the past century and a half from 1860 to 2005. The mean lake level over this period was 601.7 ft.

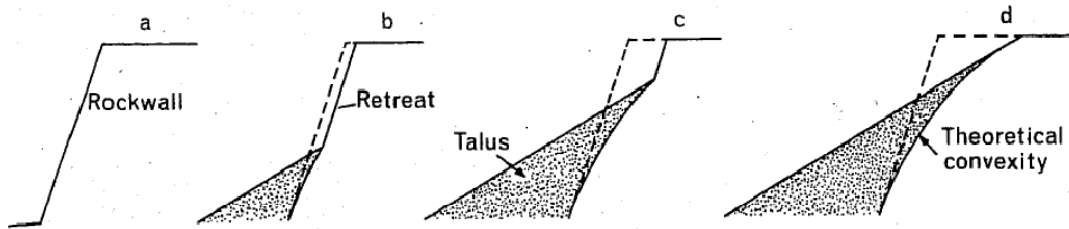
Figure 32: A theoretical cliff in which a convex rock slope forms under the talus slope. It is assumed that there is no talus removal from the base of the slope (After Selby, 1993).

As illustrated in Figure 32, the formation of a stable talus slope assumes that the talus slope base will remain and not be removed by wave action or long-shore currents. The slope just to the south of the Baraga Cliffs appears to have recessed to a stable slope, due in part to the large amount of stamp sand that was deposited in front of the cliff as clearly shown in Figure 21. The stable talus slope on the south side of the Baraga Cliffs is estimated to be between 30° and 35° and is vegetated with young deciduous trees and underbrush. Soil cover over the rubblized rock is relatively thin but appears to be resistant to erosion. Although recession of this slope has essentially stopped, some minor erosion still is occurring due to surface runoff directed over the slope via storm runoff collection and discharge over this slope.

Another solution would be to move the road back to a safe position and then allow the slope to naturally recess to a stable slope. However, this plan assumes that a natural stable slope will form, similar to that shown in Figure 32, and that Lake Superior will remain at its current level or lower.

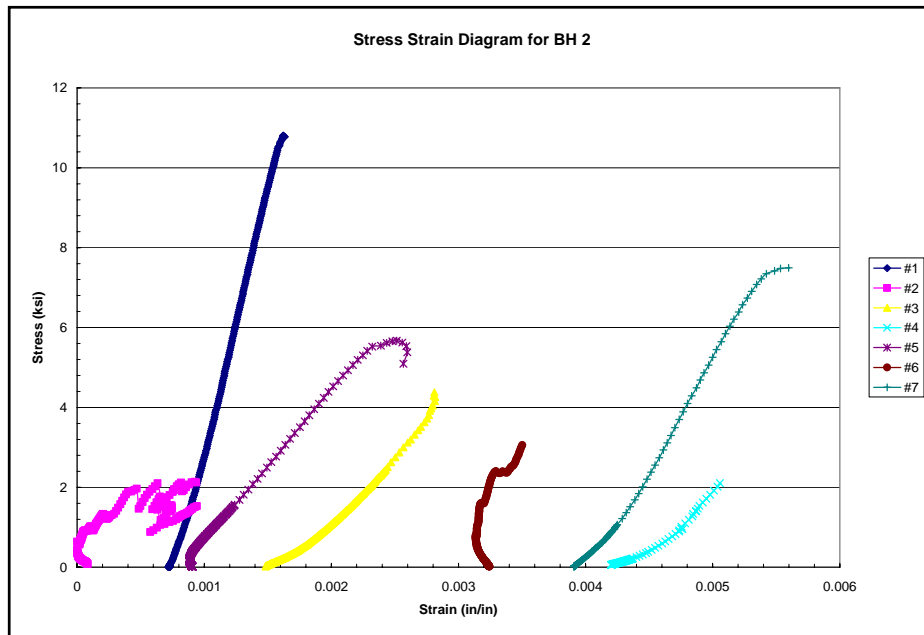
Figure 37: Stress –Strain test results for the core from borehole BH2. The test numbers are consistent with the data in Table 2.

BH 2		
Depth (ft)	Stress at Failure (ksi)	Young's Modulus (ksi)
10	10.7	13400
17	2.1	3700
25	4.4	3800
39	2.1	3700
46	5.7	3900
52	3.2	10500
57	7.5	5900
Average	5.1	6400

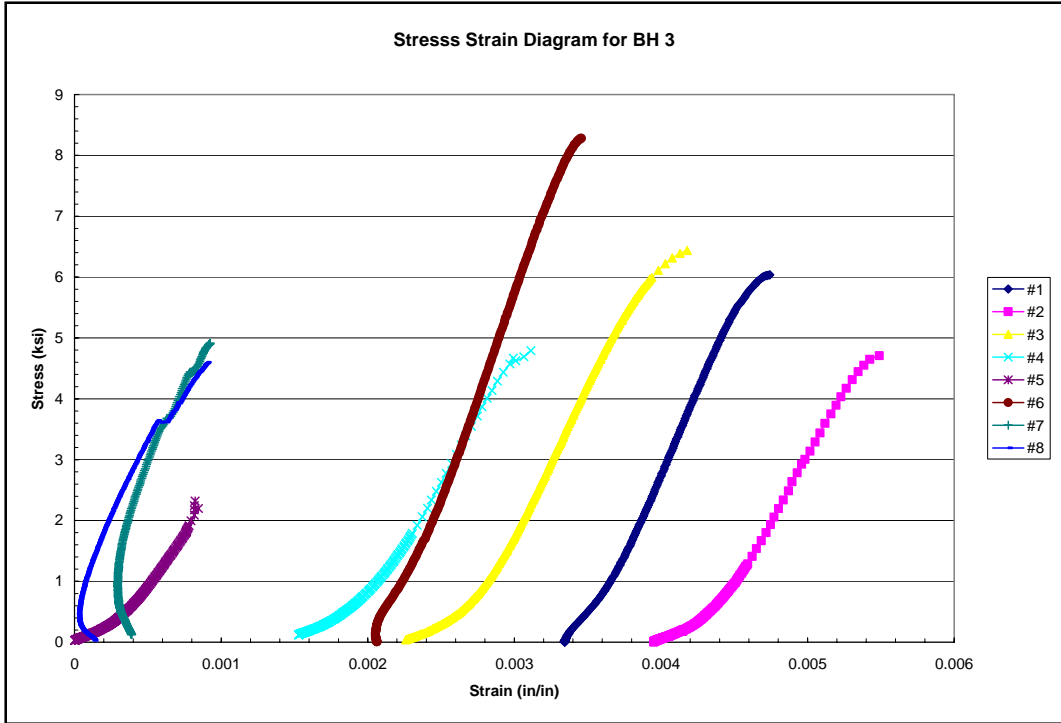
Figure 38: Stress –Strain test results for the core from borehole BH3. The test numbers are consistent with the data in Table 2.

BH 3		
Depth (ft)	Stress at Failure (ksi)	Young's Modulus (ksi)
13	6.1	5600
19	4.7	4300
25	6.4	5000
32	4.8	4400
40	2.7	3700
47	8.3	6900
52	4.9	4800
57	4.5	5000
Average	5.3	5000
