## **Field Test and Finite Element of I-345 Bridge in Dallas**

CTR Technical Report:	5-4124-01-2
Report Date:	July 10, 2009
Project:	5-4124-01
Project Title:	Field Test and Finite Element of I-345 Bridge in Dallas
Sponsoring Agency:	Texas Department of Transportation
Performing Agency:	Center for Transportation Research at The University of Texas at Austin

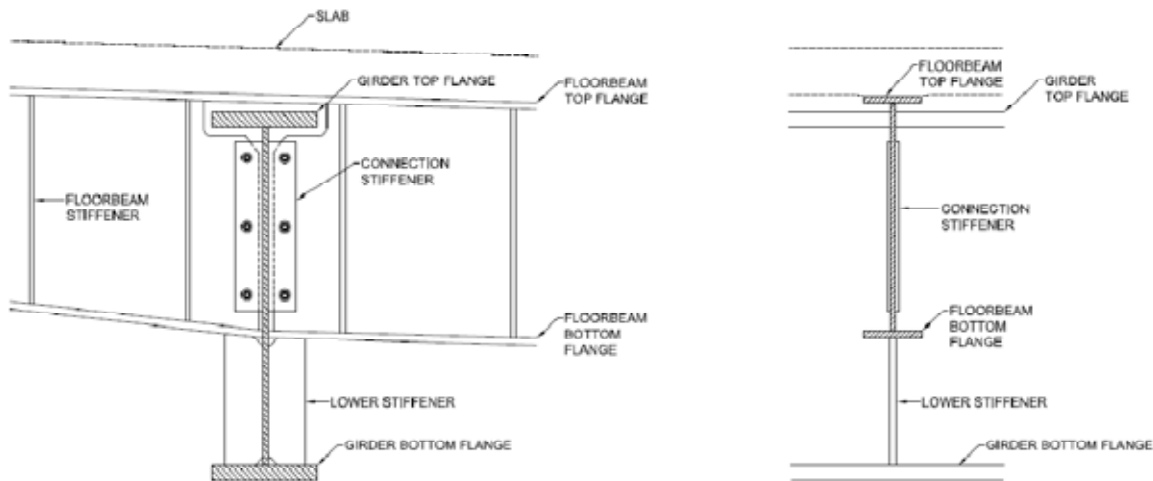
*Figure 1.1: Typical Connection of Floor Beam to Girder*

The original cracking on the bridge occurred at the connection of the floor beams to the girders. A detail of the connection is shown in Figure 1.1.

Cracking occurred in the girder web where the bottom floor beam flange is welded to the girder web. When the floor beam is at a pier the floor beam flanges frame into the web between the bearing stiffeners (Figure 1.2). The resulting small gap between the stiffener and flange welds causes high stresses to occur at the weld toes from displacement of the floor beam flange. These cracks typically formed an arc shape in the girder web around the edges of the bottom floor beam flange. Figure 1.3 shows the cracking that occurred at these locations. Cracking also occurred on the girder web in the gap between the top flange of the girder and the web of the connecting floor beam. The stiffener connecting the floor beam and girder webs is not attached to the top flange of the girder. This creates a small gap in the girder web where differential deflection between the two girders causes the floor beam to rotate creating very high stresses. Figure 1.4 shows an example of cracking at this location.

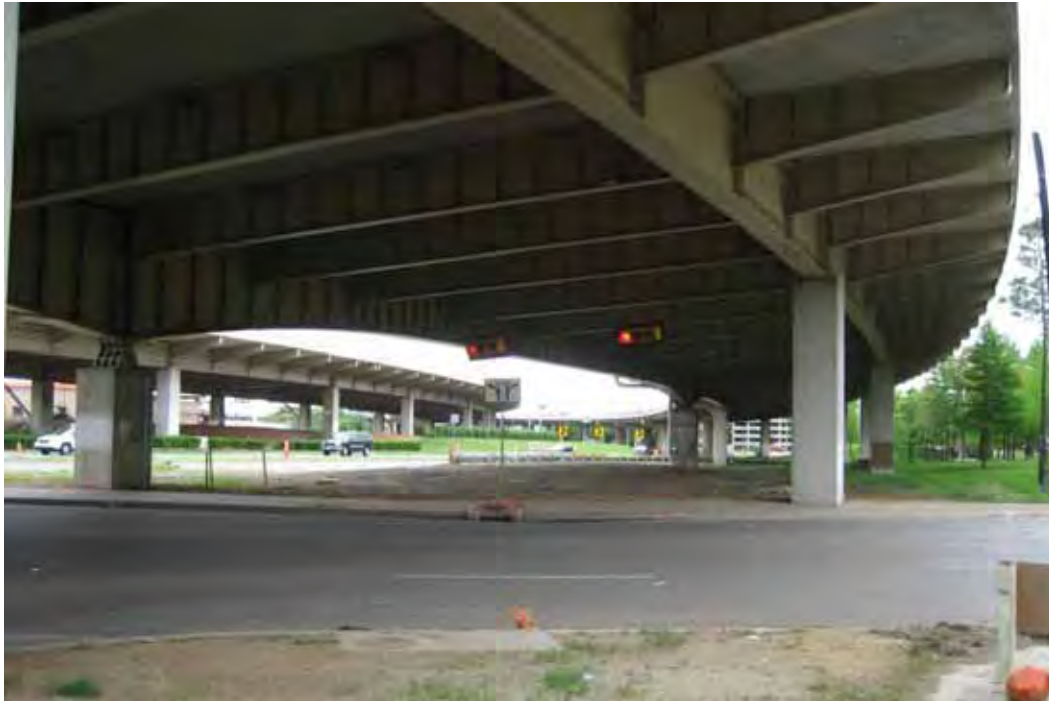
*Figure 1.14: Asymmetrical Columns and Haunches of Section F17S*

Section F17S is part of the southbound structure and is located just south of Live Oak Street. This section was chosen in part because of its asymmetrical support layout (see Figure 1.14). The support columns are placed in such a way as to accommodate the roadways underneath the bridge. This results in several locations where the girder at one end of a floor beam is supported by a column, but the girder at the other end is not. Girder two has two haunches as can be seen in Figure 1.14.

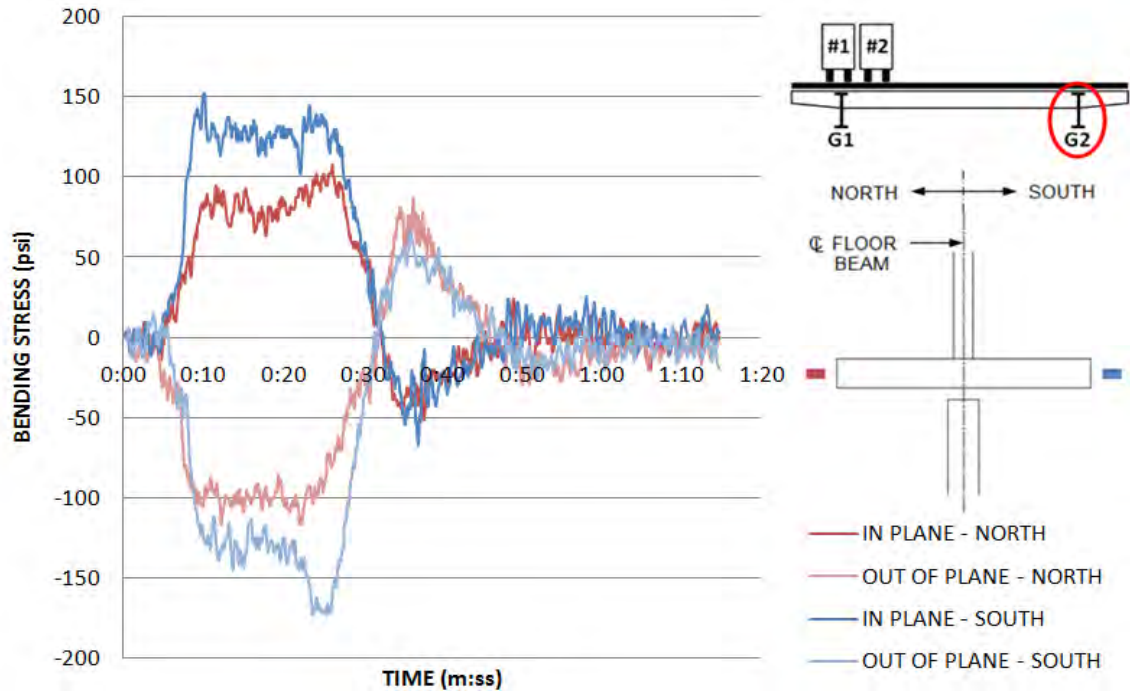
*Figure 4.31: In-Plane and Out-of-Plane Bending Stresses of Girder 2 Web due to two Trucks on the Left*

Figure 4.31 shows the stress in the bottom flange gages on the web of Girder 2 due to two trucks on the left side of the bridge. The in-plane stresses are positive, which means the girder is deflecting downward when the trucks are on the floor beam. The out-of-plane bending stresses are negative, which means the truck is bending outward toward the exterior of the bridge. These stresses reverse whenever the truck moves onto the next span.

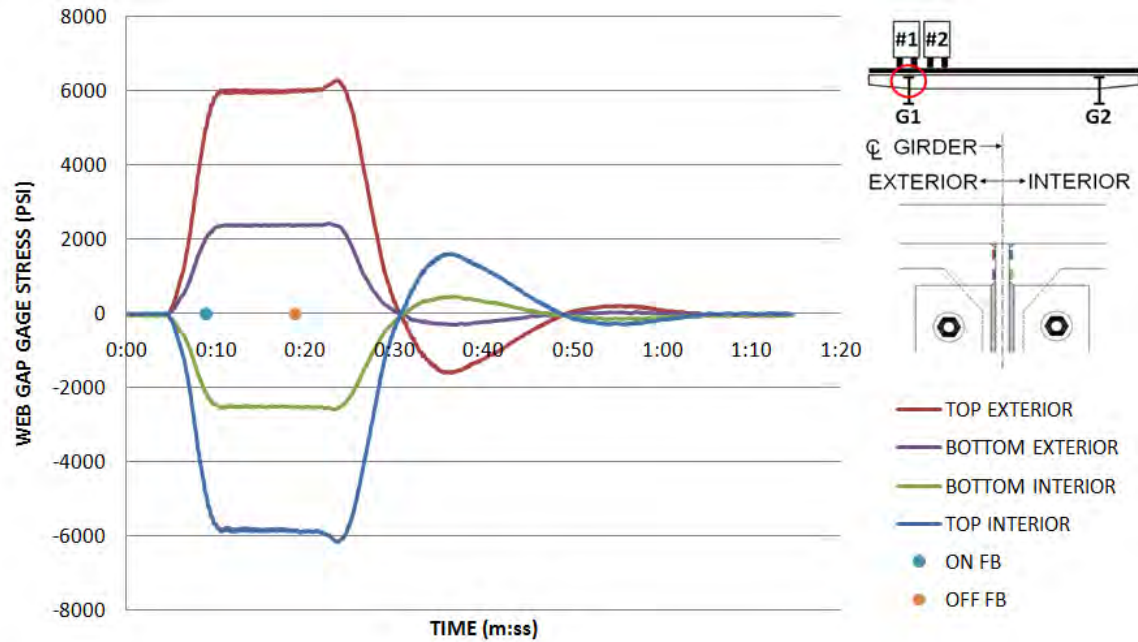
Figure 4.32: Stress in Web Gap Gages on Girder 1 due to 2 Trucks on the Left

Figure 4.32 is a plot of the stress in the web gap of Girder 1 due to two trucks on the left. The exterior gages show tensile stresses and the interior gages show compressive stresses. This indicates that the web gap is bending in single curvature toward the exterior of the bridge. When the truck is on the middle span, the web gap bends toward the interior of the bridge and bends back toward the exterior of the bridge on the last span. The stresses measured in the web gap of Girder 1 were the largest stresses measured anywhere along this floor beam and the girder connections.

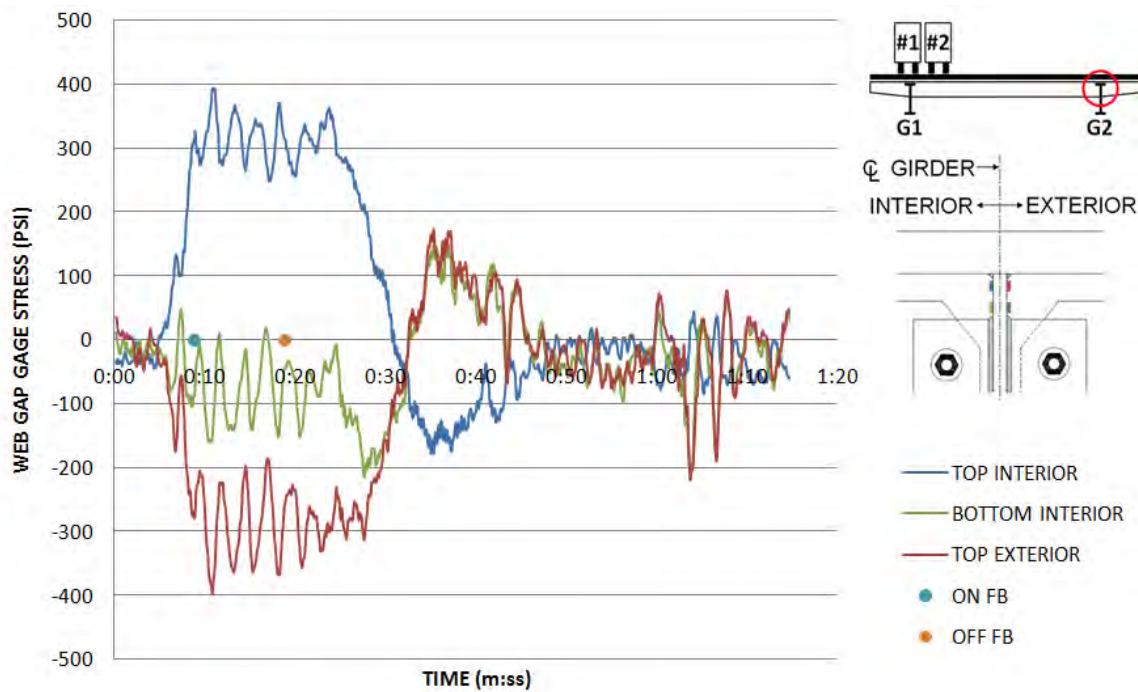
Figure 4.33: Stress in Web Gap Gages on Girder 2 due to 2 Trucks on the Left

Figure 4.33 shows the stresses in the web gap of Girder 2 due to two trucks on the left. The top gages show that the web gap is bending inward toward the center of the bridge. Again, the bending is reversed every time the trucks move onto the next span.

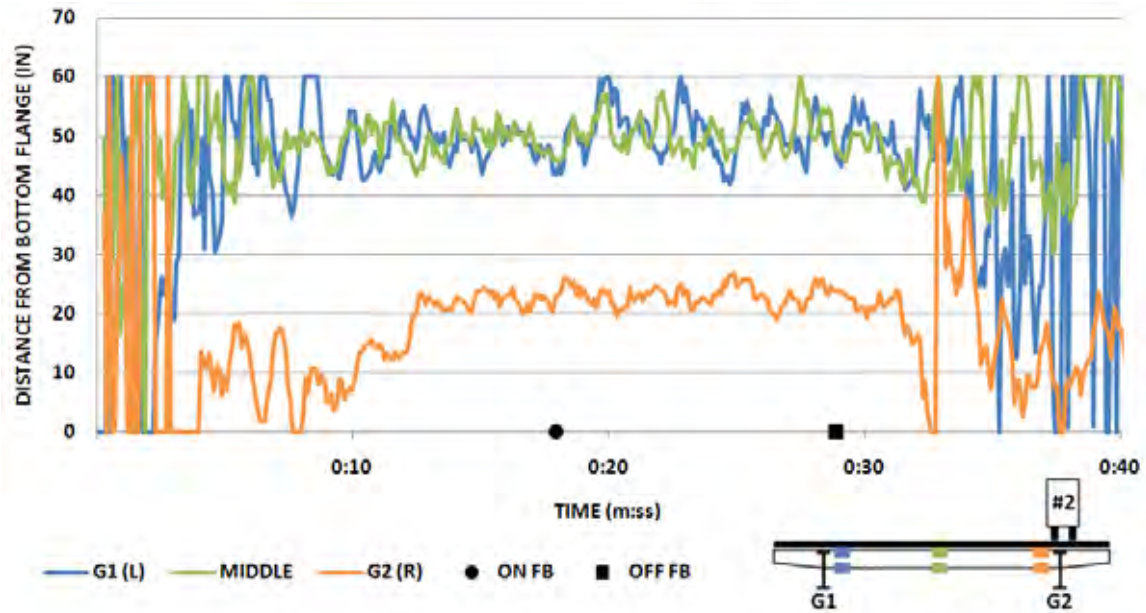
Figure 4.34: Axis of the Floor Beam versus Time due to One Truck on the Right

There are two anomalies in the data. The first is the location of the neutral axis on the right side of the floor beam when one truck is on the right (see Figure 4.34). The neutral axis was calculated to be about 23 inches above the bottom flange. This is slightly below the expected neutral axis if the floor beam and slab were to act non-compositely. In addition, the truck was very close to these gages. It would be expected that this would increase the friction force between the slab and floor beam, which would in turn increase the composite action between the two components. One explanation for this could be that when the truck came onto the floor beam, its weight caused the slab and floor beam to slip past one another, releasing the friction and causing non-composite action. Figure 4.4 shows that the in-plane bending stresses in the top and bottom flange on the right side of the floor beam are practically equal, which does suggest non-composite action as shown in Figure 3.8(a). The second anomaly occurred on the left side of the floor beam when two trucks are on the right (see Figure 4.35). The neutral axis at this location was calculated to be about ten inches above the bottom flange. The reason for this is that the stress measured in the top flange is much greater than the stress measured in the bottom flange (see Figure 4.12). This could be due to the fact that there was a lot of out-of-plane bending of Girder 1 during this run (see Figure 4.14), which may have decreased the stress in the bottom flange of the floor beam and caused the calculated neutral axis to be abnormally low.

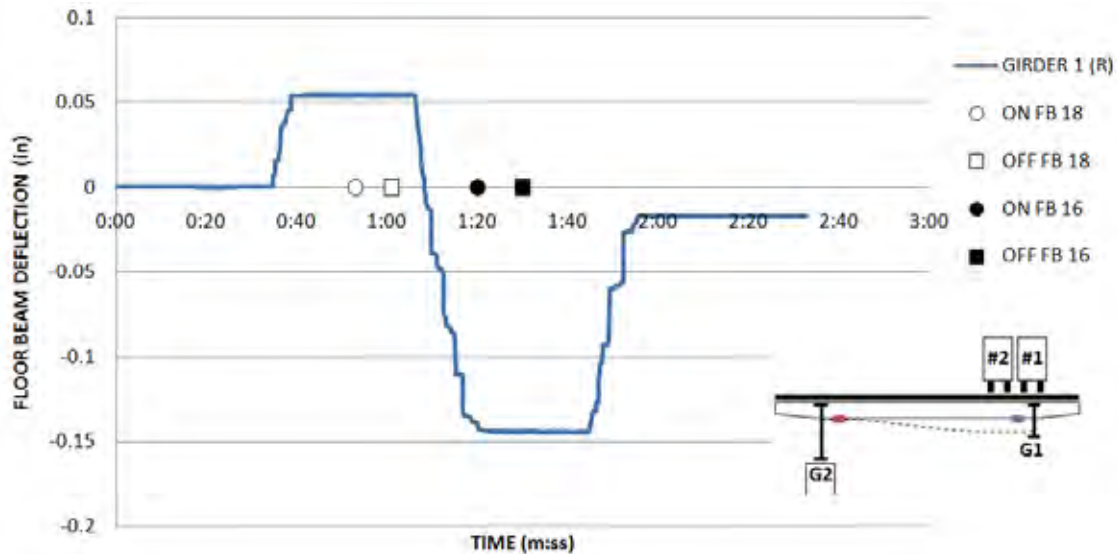
Figure 5.1: Deflection of Floor Beam due to Two Trucks on the Right

Deflection gages, also referred to as string potentiometers, were placed on the bottom flange of the floor beam at each end near the connection to the girder. These were used to determine how much the floor beam deflected under the weight of the trucks. The string pot that was placed near Girder 2 was determined to be defective. However, because this location was near the supported girder, it was not expected to deflect significantly. Figure 5.1 shows the deflection on the right side of the floor beam due to two trucks on the right side of the bridge. The right side of the floor beam deflected upward when the trucks were nearing Floor Beam 18 and deflected downward when the trucks were over Floor Beam 16. From this data, the deflected shape of Floor Beam 16 due to the stationary trucks can be determined and is represented by the dashed line in the detail of the floor beam within Figure 5.1. The right side of the floor beam deflects downward under the weight of the trucks while the left side is restrained from deflecting by the column.

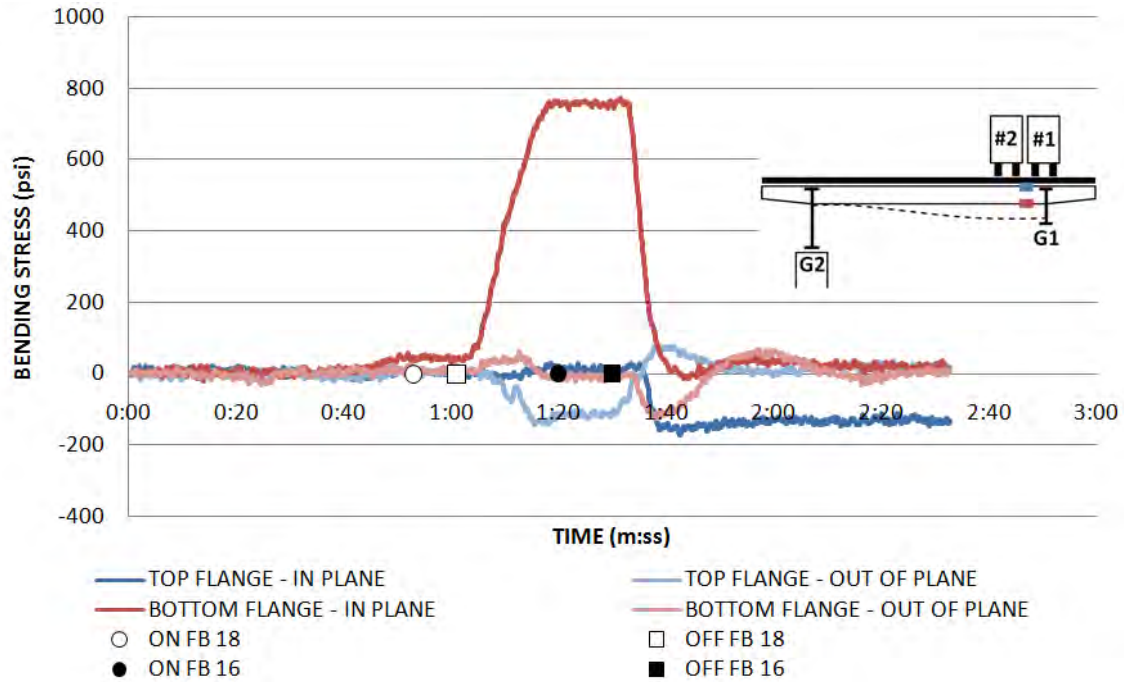
Figure 5.2: In-Plane and Out-of-Plane Stress of the Floor Beam near Girder 1 due to two Trucks on the Right

To determine how Floor Beam 16 responds to traffic loads, the stress in the floor beam gages was plotted versus time. Figure 5.2 shows the in-plane and out-of-plane bending stresses in the top and bottom flanges of the floor beam near Girder 1 due to two trucks on the right side of the bridge. When the trucks were over Floor Beam 18, there is very little stress in Floor Beam 16. This is because Girder 1 is supported by a column at Floor Beam 18. Therefore, the weight of the trucks was transferred through the girder to the column, not to the surrounding floor beams. When the trucks are over Floor Beam 16, it can be seen that the in-plane bending stress of the bottom flange is very large compared to the other stresses. The tensile stress in the bottom flange is a result of the weight of the trucks deflecting the right side of the floor beam downward. There is slight out-of-plane movement of the top flange when the trucks are over the floor beam and in both flanges when the trucks leave the floor beam. These stresses, however, are relatively small compared to the in-plane stress of the bottom flange.

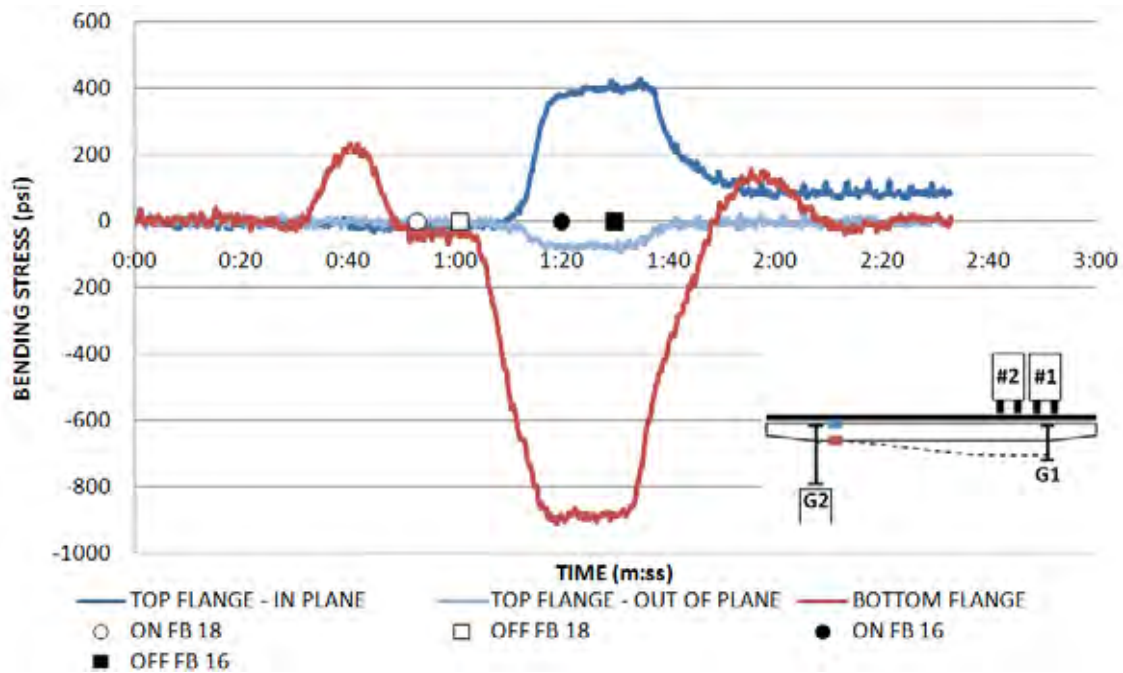
Figure 5.3: In-Plane and Out-of-Plane Stress of the Floor Beam near Girder 2 due to two Trucks on the Right

One of the gages placed on the bottom flange of the floor beam near Girder 2 was defective. Therefore, it is not possible to determine whether the stress in the floor beam flange at this location is in plane or out of plane. Figure 5.3 shows the in-plane and out-of-plane bending stresses in the top flange near Girder 2 as well as the stress on one side of the bottom flange due to two trucks on the right side of the bridge. Before the trucks reach Floor Beam 18, the bottom flange of Floor Beam 16 shows a slight tensile stress. The left side of the floor beam is restrained from deflecting due to the column. Therefore, this tensile stress is most likely caused by the right side deflecting upward from the weight of the trucks on the previous span. When the trucks are stationary over Floor Beam 16, there is tensile stress in the top flange and compressive stress in the bottom flange. This is consistent with the assumed deflected shape determined from Figure 5.1. The left side is restrained from deflecting due to the support from the column and the right side is deflecting downward under the weight of the trucks. This results in the floor beam bending in double curvature. After the trucks leave the floor beam, the bottom flange shows a slight tensile stress.

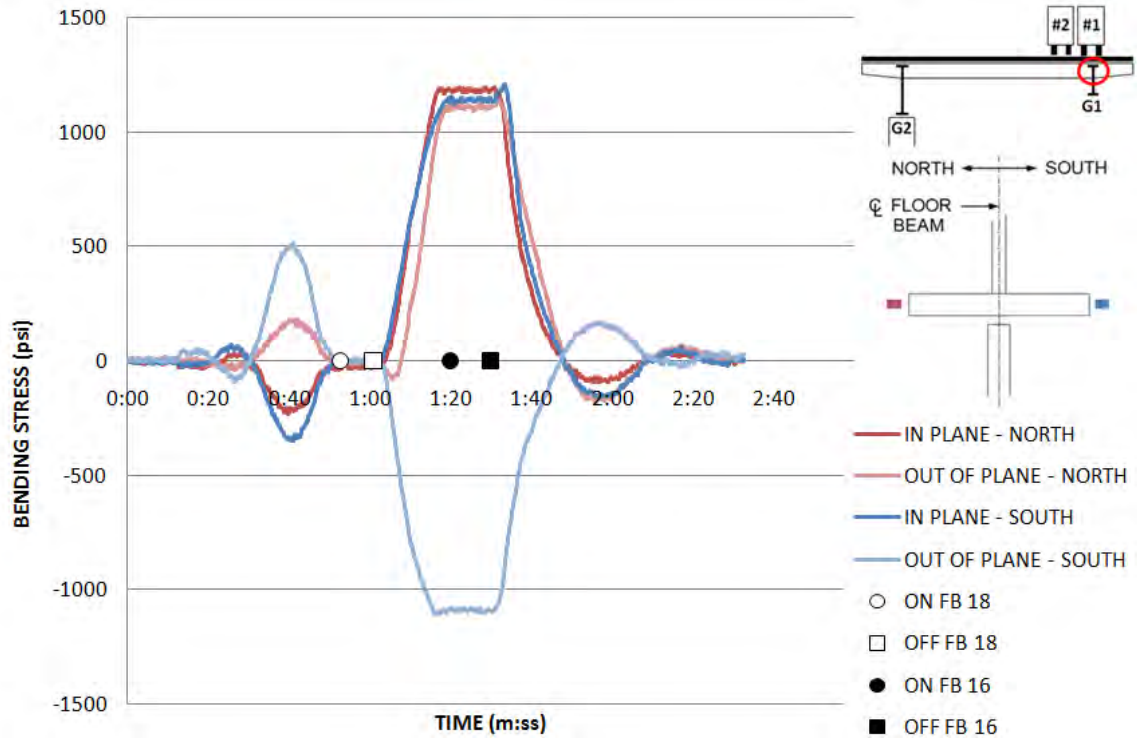
Figure 5.4: In-Plane and Out-of-Plane Bending Stresses of Girder 1 Web due to two Trucks on the Right

The stress recorded by the bottom flange gages can be plotted versus time to determine how the girder moves under live load. Figure 5.4 shows the in-plane and out-of-plane stress in Girder 1 adjacent to the bottom flange of the floor beam due to two trucks on the right side of the bridge. Before the trucks reach Floor Beam 18, Girder 1 experiences compressive in-plane stresses, which suggests that the girder is deflecting upward. When the trucks stop at Floor Beam 18, the stresses are zero. This is due to the fact that the trucks are over the connection of Floor Beam 18 to Girder 1, which is supported by a column. Therefore, no stress is being transferred to other floor beams. When the trucks stop over Floor Beam 16, the in-plane stresses in the girder are tensile due to the downward deflection of the girder under the weight of the trucks. The out-of-plane stresses are in different directions on either side of the floor beam. When the trucks leave the floor beam, the girder bends in the opposite direction.

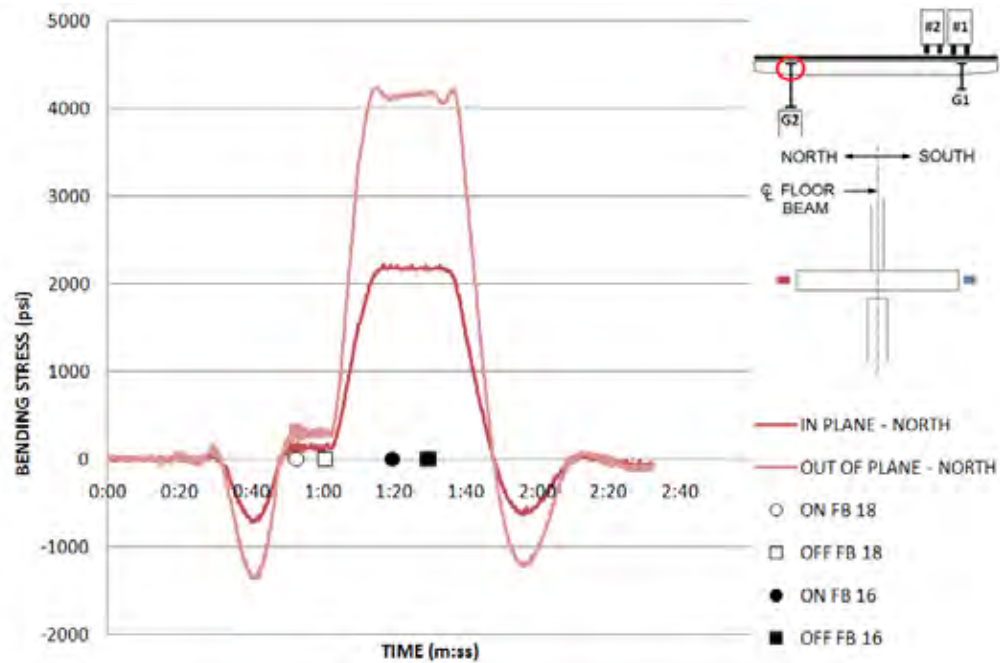
Figure 5.5: In-Plane and Out-of-Plane Bending Stresses of Girder 2 Web due to two Trucks on the Right

Figure 5.5 shows the stress in Girder 2 adjacent to the bottom flange of the floor beam due to two trucks in the right lanes. Girder 2 is haunched and supported by a column at this location. The girder has bearing stiffeners on either side of the floor beam that create a very small gap in which to place the strain gages. Because of this and the presence of repair welds, it was not possible to place gages on the interior or exterior side of the girder on the south side of the floor beam. The haunch of Girder 2 causes the bottom flange of the floor beam to frame into the girder above the girder's neutral axis. Figure 5.5 shows that the girder is experiencing in and out-of-plane stresses just before the trucks reach Floor Beam 18. Again, the stresses are practically zero when the trucks stop over Floor Beam 18. When the trucks stop over Floor Beam 16, the girder experiences tensile in-plane and out-of-plane stresses. This suggests that the girder is deflecting downward on either side of the column creating tension at the location where the floor beam frames into the girder above the column. The positive out-of-plane stress suggests that the girder is also bending inward toward the center of the bridge. The out-of-plane stress is significantly higher than the in-plane stress at this location. This is most likely due to the fact that the girder is supported by the column and is, therefore, restrained from deflecting vertically. The increased height of the girder due to the haunch creates a more slender web that may be more susceptible to out-of-plane bending. Comparing Figures 5.4 and 5.5, it can be seen that the stress in Girder 2 is much greater than the stress in Girder 1. This is due to the presence of bearing stiffeners on Girder 2. The bearing stiffeners create a very small gap next to the bottom flange of the floor beam, which results in very high stress concentrations in this area. These stress concentrations are most likely the cause of cracking at this location.

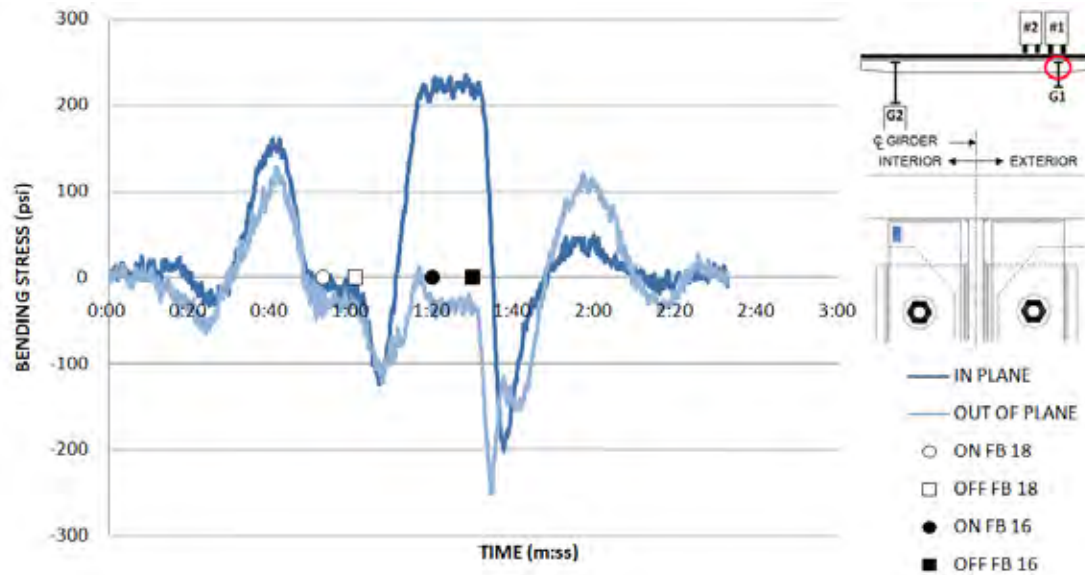
Figure 5.6: Stress in Girder 1 Retrofit Stiffeners due to two Trucks on the Right

Figure 5.6 shows the results from the retrofit stiffeners at Girder 1 for the live load test with two trucks on the right. It can be seen that the stiffeners experienced in-plane and out-of-plane bending prior to the trucks reaching Floor Beam 18. When the trucks stop at Floor Beam 18, the stresses are practically zero. Similar to the trends seen with the bottom flange gages, this is due to the fact that the trucks are over the connection of Floor Beam 18 to Girder 1, which is supported by a column. Therefore, no stress is being transferred to other floor beams. When the trucks stop on Floor Beam 16, the in-plane stresses are far greater than the out-of-plane stresses, which are practically zero. At this point, the trucks are directly over the connection and are causing no out-of-plane movement of the stiffeners.

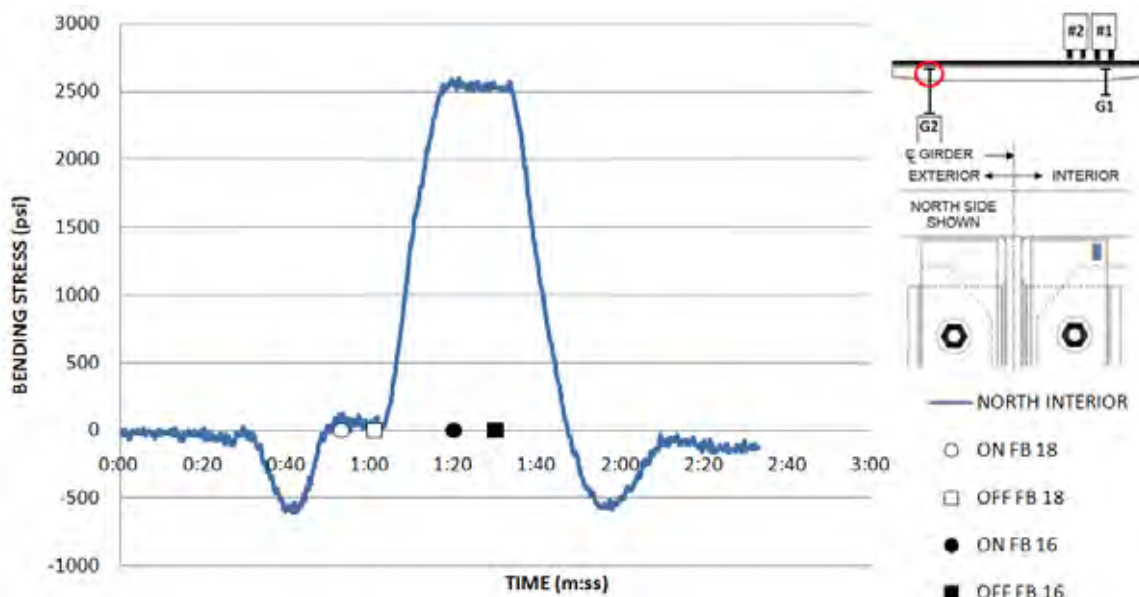
Figure 5.7: Stress in Girder 2 Retrofit Stiffeners due to two Trucks on the Right

Figure 5.7 shows the results from the retrofit stiffeners at the haunched Girder 2 for the live load test with two trucks on the right. The gage attached to the retrofit stiffener on the south side of the floor beam was found to be defective and is therefore not plotted in the figure. The plotted line corresponds to the stress recorded by the gage on the stiffener on the north side of the floor beam. There are compressive stresses in the girder prior to the trucks reaching Floor Beam 18, at which time the stress is zero. When the trucks are over Floor Beam 16, there are very high stresses in the stiffener. This is similar to what was seen in the bottom flange gages on Girder 2 when the trucks were on the right side (see Figure 5.5). Girder 2 seems to attract much of the stress due to its haunched section.

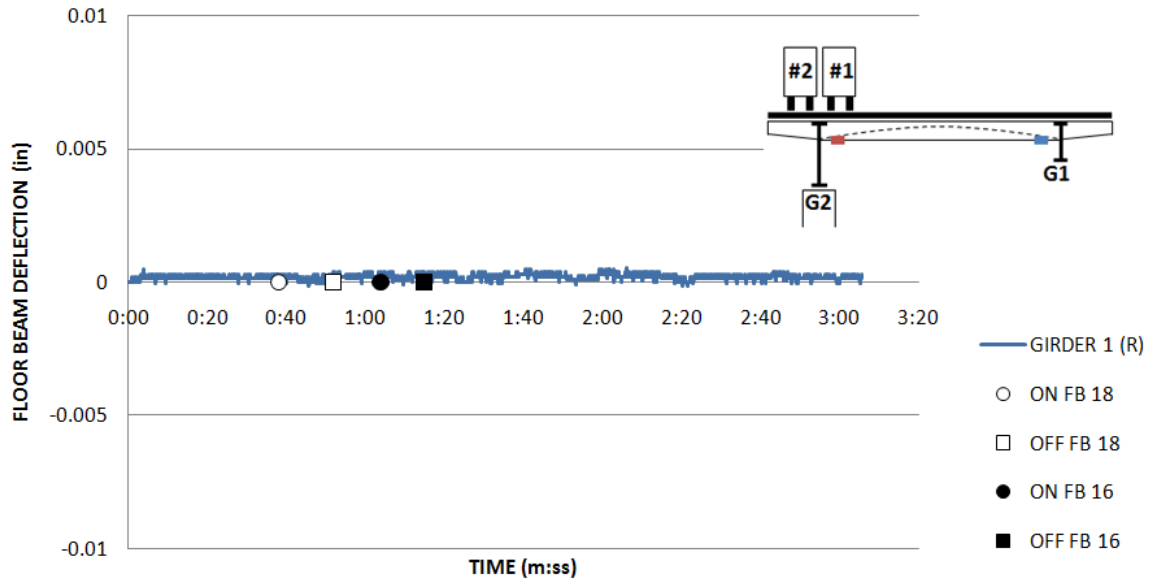
Figure 5.8: Deflection of Floor Beam due to Two Trucks on the Left

Figure 5.8 shows the deflections measured at the right side of the floor beam due to two trucks on the left side of the bridge. The string pot on the left side was defective, but it is assumed that the left side does not deflect due to the support of the column. The figure shows that the right side of the floor beam does not deflect. Because of the narrow shoulder on the left side of this bridge, the two trucks are centered over Girder 2 as can be seen in the detail within

Figure 5.8. Therefore, the trucks are completely supported by Girder 2 and do not cause the right side of the floor beam to deflect.

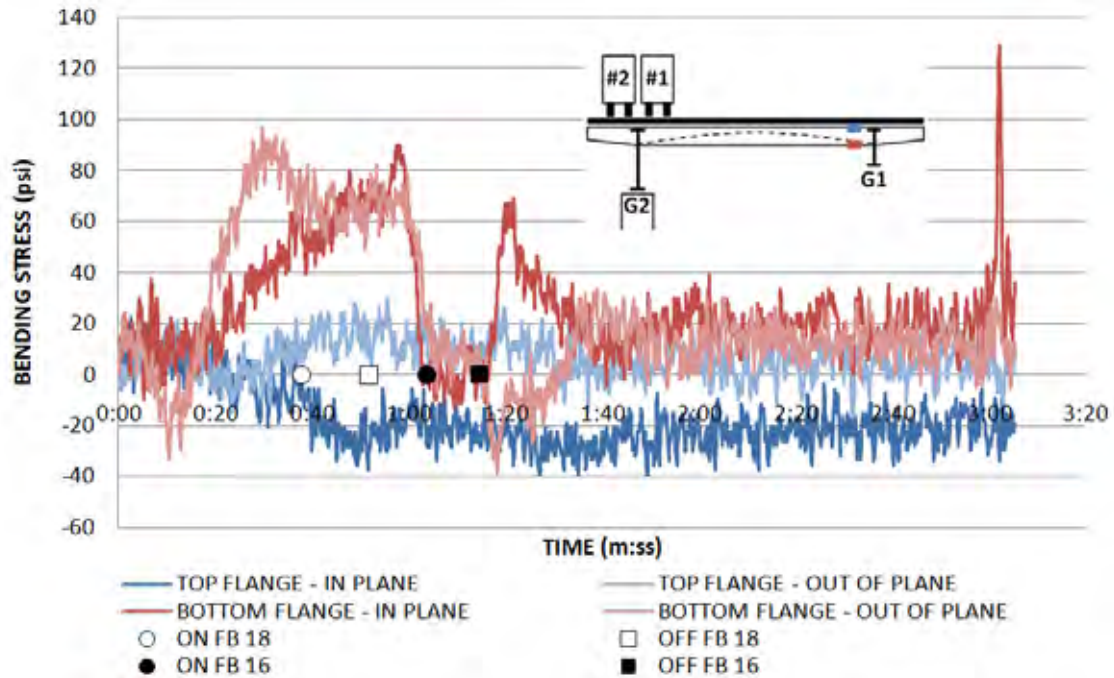
Figure 5.9: In-Plane and Out-of-Plane Stress of the Floor Beam near Girder 1 due to two Trucks on the Left

Figure 5.9 shows the in-plane and out-of-plane stresses in Floor Beam 16 near Girder 1 when two trucks were on the left side of the bridge. It can be seen that the stresses at this location are very low with the maximum recorded stress being only about 0.09 ksi. This is due to the fact that when the trucks are on the left side of Floor Beam 16, they are directly over the haunched girder, which is supported by a column. Therefore, the majority of the stress caused by the trucks is taken by the support and is not transmitted to the girder on the other side of the floor beam.

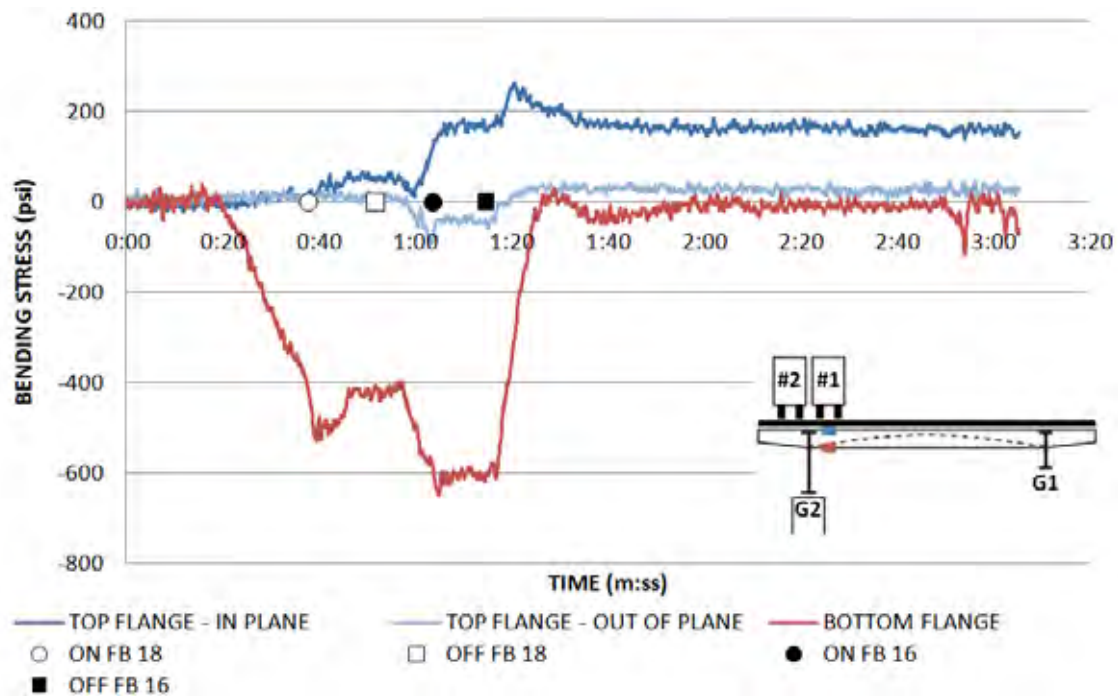
Figure 5.10: In-Plane and Out-of-Plane Stress of the Floor Beam near Girder 2 due to two Trucks on the Left

Figure 5.10 shows the in-plane and out-of-plane stresses in Floor Beam 16 near Girder 2 when two trucks were on the left side of the bridge. One of the gages placed on the bottom flange of the floor beam near Girder 2 was defective. Therefore, it is not possible to determine whether the stress in the floor beam flange at this location is in plane or out of plane. The top flange experiences very little stress until the trucks reach Floor Beam 16, at which point the flange experiences in-plane tensile stresses. The bottom flange recorded compressive stresses. This suggests that the floor beam is deflecting upward in between the two girders. This makes sense if the location of the trucks is considered. The left shoulder on Section F17S is narrow, measuring only four feet wide. Therefore, when the trucks are on the left side of the road, one of the trucks is actually driving on the overhang. This seems to create enough downward force on the overhang to cause the middle section of the floor beam to bend upward, as can be seen from the dashed line in the details of the previous figures.

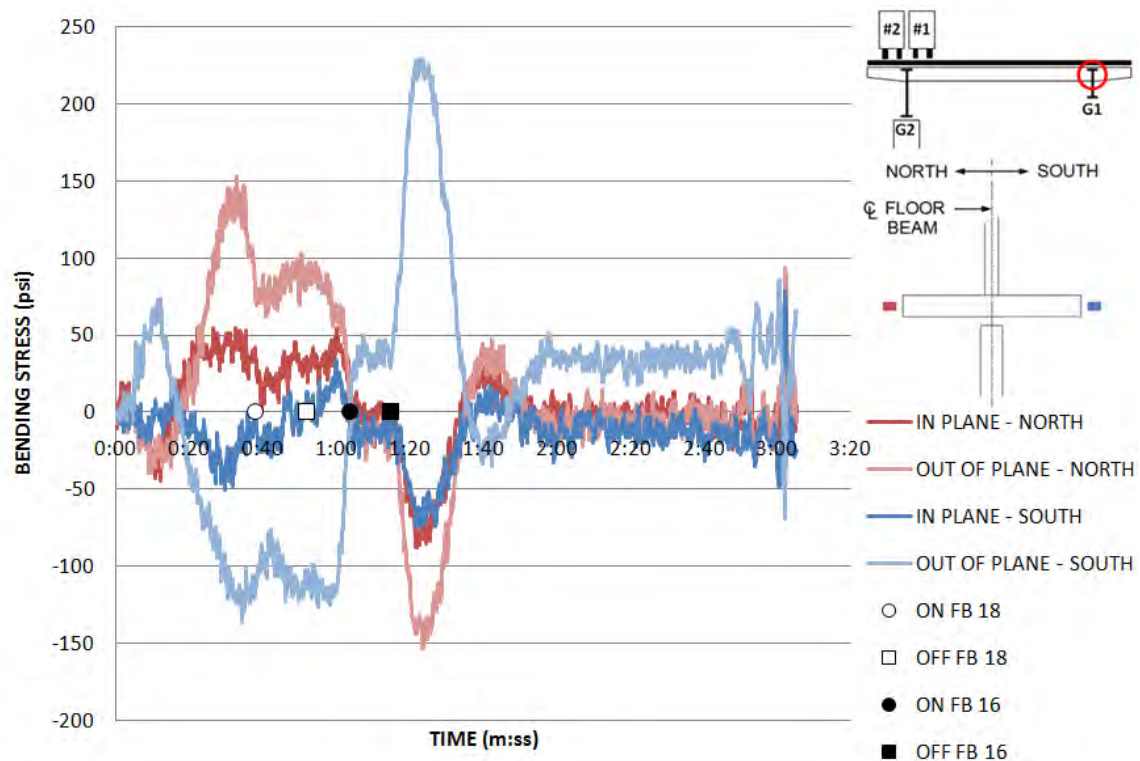
Figure 5.11: In-Plane and Out-of-Plane Bending Stresses of Girder 1 Web due to two Trucks on the Left

Figure 5.11 shows the stress in the web of Girder 1 due to two trucks on the left side of the bridge. Overall, the stresses are very low. This is because the trucks are directly over Girder 2, which is supported by a column. Therefore, no stress is being transferred to Girder 1. There is some out-of-plane bending of Girder 1 when the trucks are over Floor Beam 18 as well as when the trucks leave Floor Beam 16. The opposite signs of the out-of-plane stresses suggest that the girder web is bending in different directions on either side of the floor beam. These stresses, however, are all relatively low.

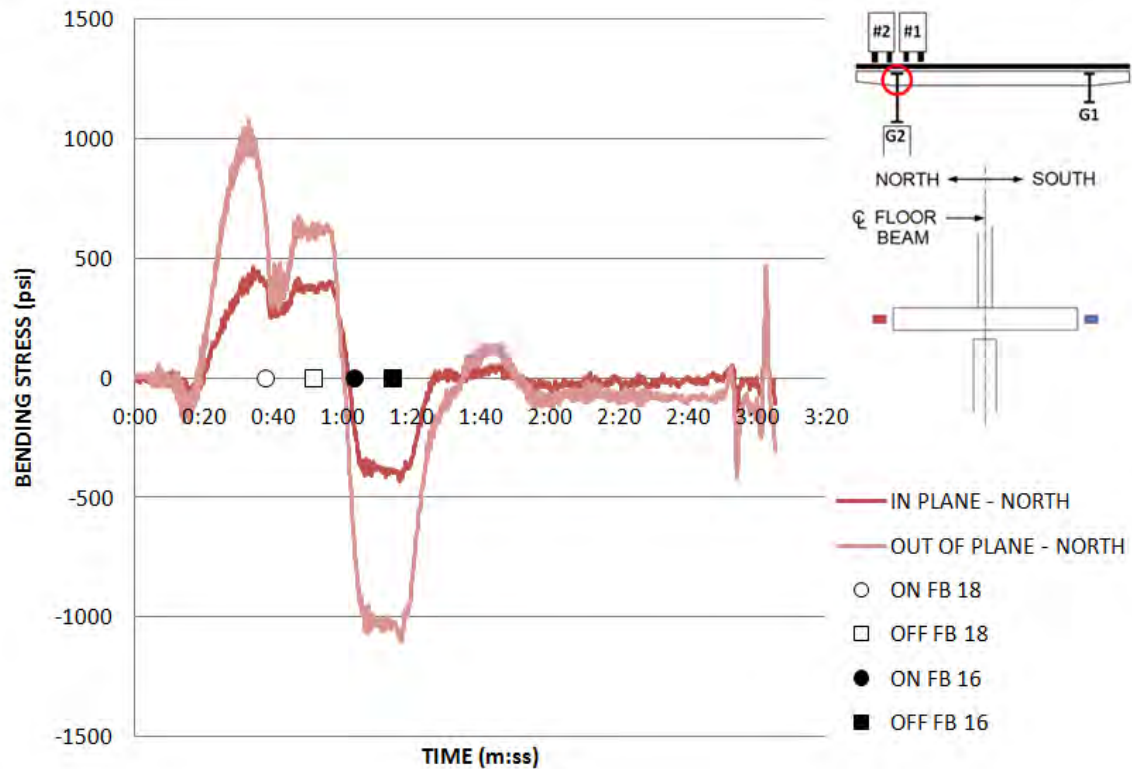
Figure 5.12: In-Plane and Out-of-Plane Bending Stresses of Girder 2 Web due to two Trucks on the Left

Figure 5.12 shows the stress in the web of Girder 2 due to two trucks on the left side of the bridge. Girder 2 is haunched and supported by a column at this location. The girder has bearing stiffeners on either side of the floor beam, which create a very small gap in which to place the strain gages. Because of this and the presence of repair welds, it was not possible to place gages on the interior or exterior side of the girder on the south side of the floor beam. Therefore, Figure 5.12 shows the in-plane and out-of-plane stresses in the girder web on the north side of Floor Beam 16. The haunch of Girder 2 causes the bottom flange of the floor beam to frame into the girder above the girder's neutral axis. Seeing as how the girder is supported by a column at this location, the in-plane stress would be expected to be tensile. This is true until the point when the trucks reach Floor Beam 16 where the in-plane stresses are negative. The girder bends out of plane toward the interior of the bridge when the trucks are over Floor Beam 18 and bends outward toward the exterior of the bridge when the trucks are over Floor Beam 16.

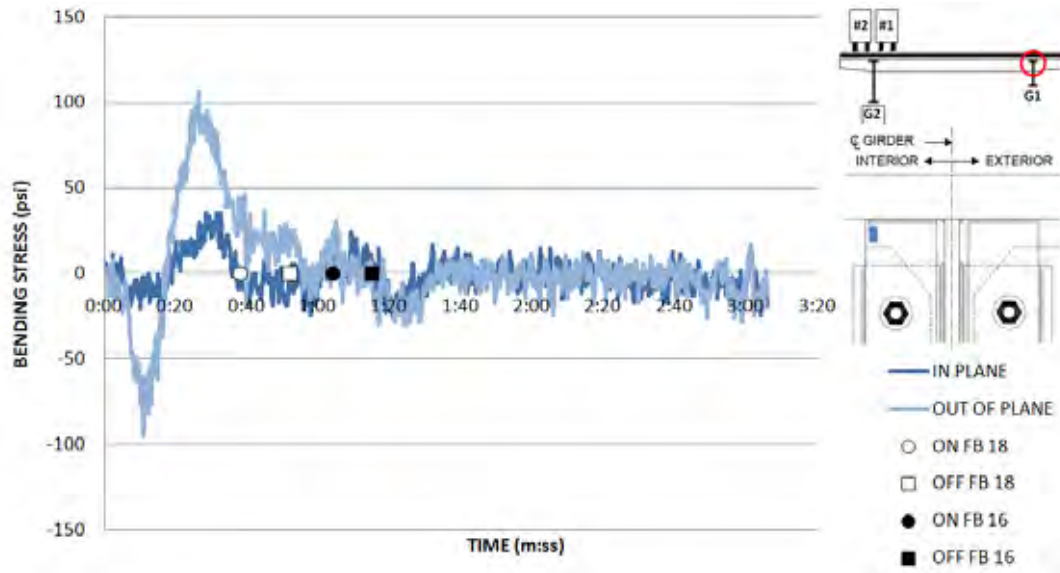
Figure 5.13: Stress in Girder 1 Retrofit Stiffeners due to two Trucks on the Left

Figure 5.13 is a plot of the in-plane and out-of-plane stresses in the retrofit stiffeners on Girder 1 due to two trucks on the left side of the bridge. The plot shows that the stress in the stiffeners is very low, with the maximum being about 0.1 ksi. This is due to the fact that when the trucks are on the left side of Floor Beam 16, they are directly over the haunched girder that is supported by a column. Therefore, the majority of the stress caused by the trucks is taken by the support and is not transmitted to the girder on the other side of the floor beam. This is similar to what was seen with the floor beam and bottom flange gages.

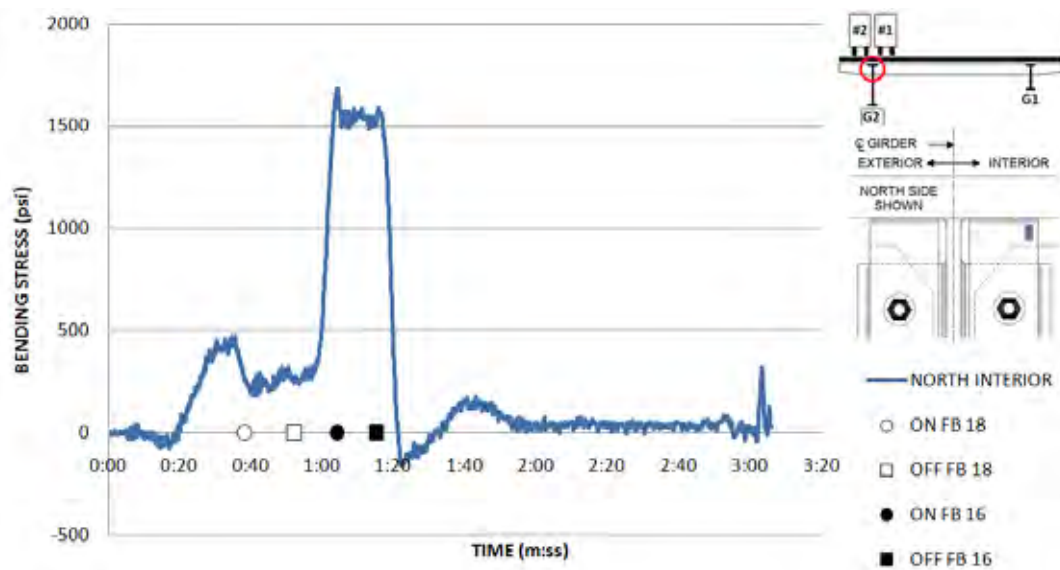
Figure 5.14: Stress in Girder 2 Retrofit Stiffeners due to two Trucks on the Left

Figure 5.14 shows a plot of the in-plane and out-of-plane bending stresses in the retrofit stiffeners on Girder 2 due to two trucks on the left side of the bridge. The gage attached to the retrofit stiffener on the south side of the floor beam was found to be defective and is therefore not plotted in the figure. The plotted line corresponds to the stress recorded by the gage on the stiffener on the north side of the floor beam. Because there was only one gage, it is not possible to determine whether the stress is due to in-plane or out-of-plane bending. The gage recorded tensile stresses when the trucks were over Floor Beam 18 and a greater tensile stress when the trucks were over Floor Beam 16.

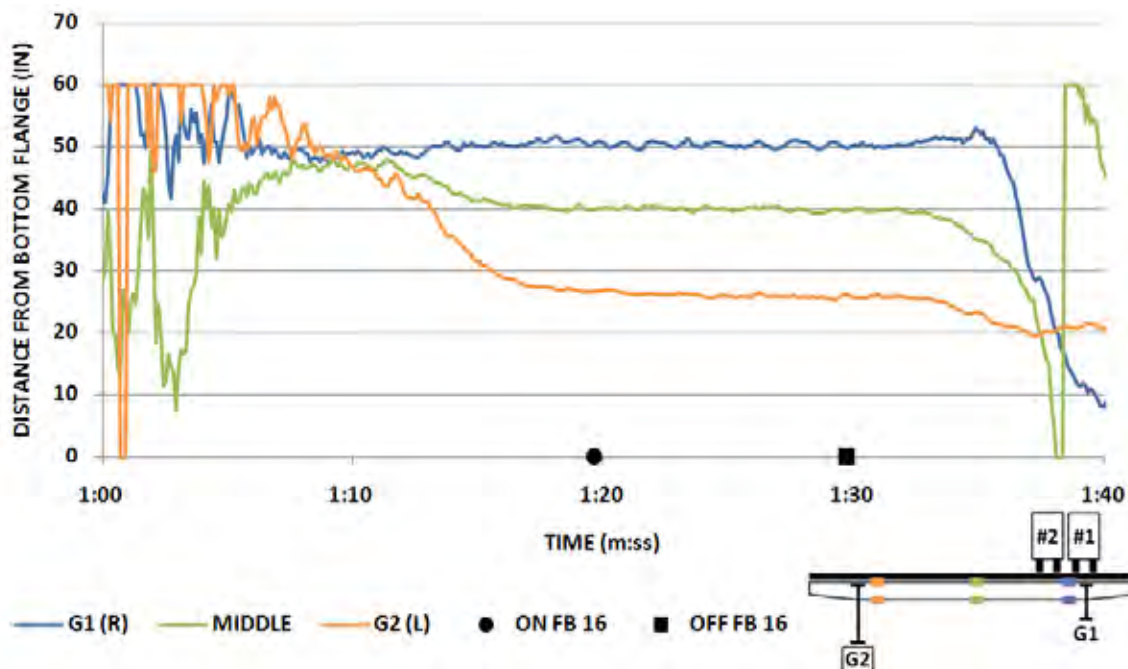
Figure 5.15: Neutral Axis of the Floor Beam versus Time due to Two Trucks on the Right

Figure 5.15 shows the location of the neutral axis versus time as two trucks move along the right side of the bridge. The figure shows that underneath the trucks, the neutral axis of the floor beam is about 50 inches above the bottom flange, which is in the top flange of the floor beam. Therefore, it would seem as though the floor beam and slab were acting compositely at that location. On the left side of the floor beam, the side opposite the trucks, the neutral axis is about 26 inches above the bottom flange of the floor beam, which is very near the center of the section. Therefore, it would seem as though the floor beam and slab were acting non-compositely at this location. In the middle of the floor beam, the neutral axis is located about 40 inches above the bottom flange which is in the top half of the web. It is believed that the weight of the trucks produces a friction force between the floor beams and slab, creating the composite action. On the side opposite the trucks, there is no weight to create friction between the floor beam and slab. As a result, they are free to slip past one another causing non-composite action.

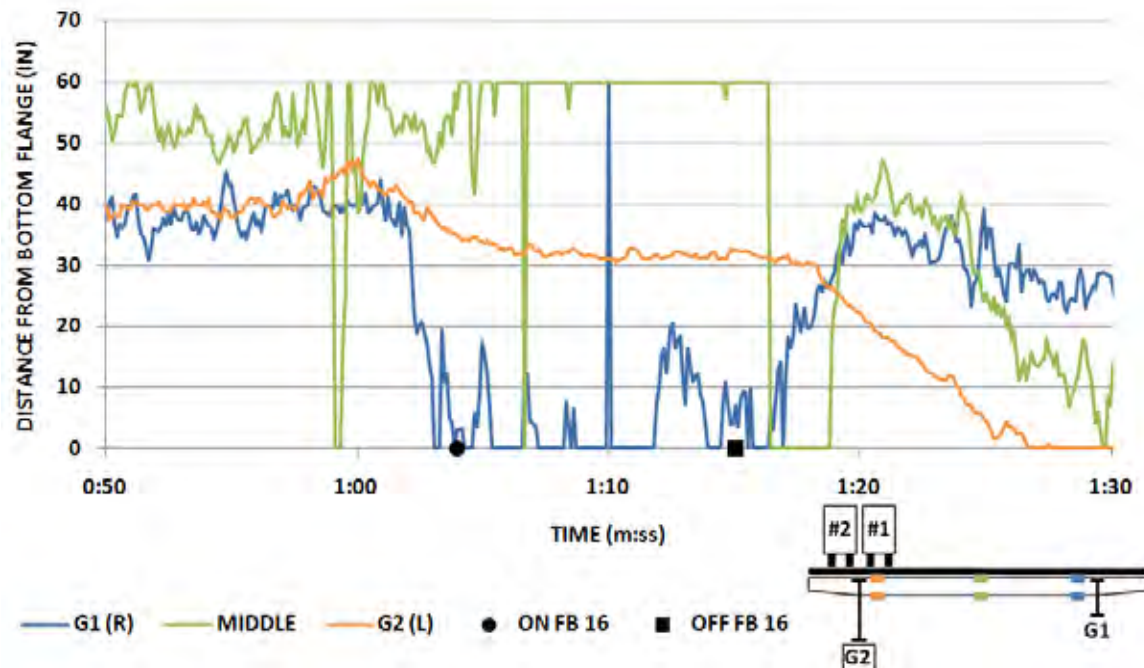
Figure 5.16: Neutral Axis of the Floor Beam versus Time due to Two Trucks on the Left

Figure 5.16 shows the location of the neutral axis of the floor beam versus time as two trucks move along the left side of the bridge. During this run, the two trucks were directly over Girder 2, which is supported by a column at Floor Beam 16. Due to the support of the column, there was very little stress transferred to the middle and right side of the floor beam. When the stress values are very small, the calculation of the neutral axis is very sensitive to any changes in stress. This makes the location of the neutral axis highly variable. This is the reason for the

scatter in the data of Figure 5.16 for the middle and right side of the floor beam. On the left side of the floor beam, directly under the trucks, the neutral axis was calculated to be about 32 inches above the bottom flange, which is slightly above the centroid. This suggests very minor composite action between the floor beam and slab. Because the supported girder is taking much of the stress from the trucks, there is little weight transferred to the floor beams. Therefore, there is very little friction to cause the floor beam and slab to act compositely.
