## **Field Test and Finite Element of I-345 Bridge in Dallas**

CTR Technical Report:	5-4124-01-2
Report Date:	July 10, 2009
Project:	5-4124-01
Project Title:	Field Test and Finite Element of I-345 Bridge in Dallas
Sponsoring Agency:	Texas Department of Transportation
Performing Agency:	Center for Transportation Research at The University of Texas at Austin

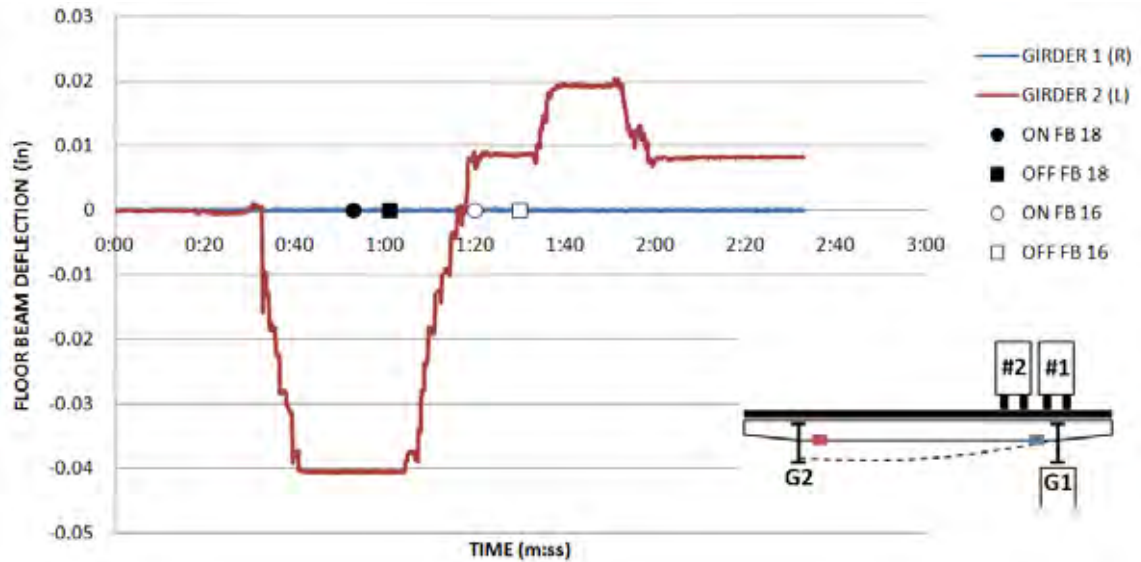
Figure 6.1: Deflection of Floor Beam due to Two Trucks on the Right

Deflection gages, also referred to as string potentiometers, were placed on the bottom flange of the floor beam at each end near the connection to the girder. These were used to determine how much the floor beam deflected under the weight of the trucks. Figure 6.1 shows the deflection on either side of the floor beam due to two trucks on the right side of the bridge. The right side of the floor beam was near Girder 1, which was supported by a column. Therefore, this side of the floor beam was restrained from deflecting. Due to the position of truck 2, which was on the interior side of Girder 1, the left side of the floor beam deflected downward 0.04 inches when the trucks were over the floor beam. When the trucks continue onto Floor Beam 16, the right side of the floor beam deflects upward 0.01 inches, which increases to 0.02 inches after the trucks leave Floor Beam 16. From these results, the deflected shape of the floor beam can be determined and is represented by the dashed line in the detail within Figure 6.1.

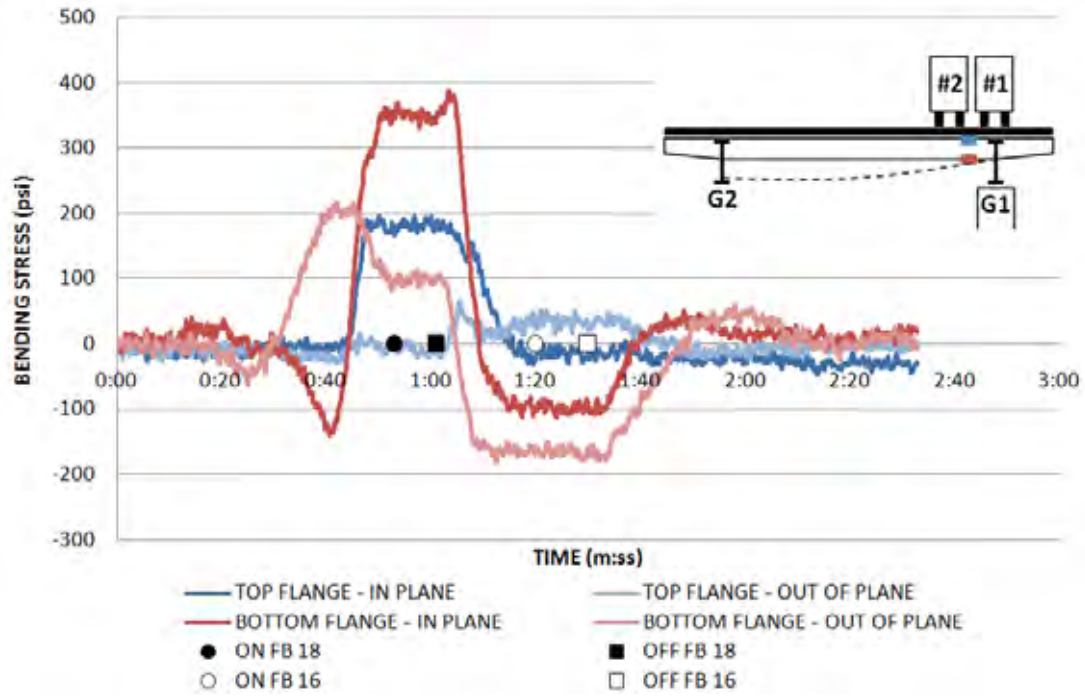
Figure 6.2: In-Plane and Out-of-Plane Stress of the Floor Beam near Girder 1 due to two Trucks on the Right

Figure 6.2 shows the in-plane and out-of-plane bending of the floor beam near Girder 1 due to two trucks on the right side of the bridge. The top and bottom flanges of the floor beam experienced tensile in-plane stresses where the stress in the bottom flange was almost twice that in the top flange. There is slight out-of-plane bending of the bottom flange when the trucks were over the floor beam. The top flange did not bend out of plane. These stresses changed direction when the trucks moved to Floor Beam 16. The in-plane stresses decreased while the out-of-plane bending of the bottom flange increased.

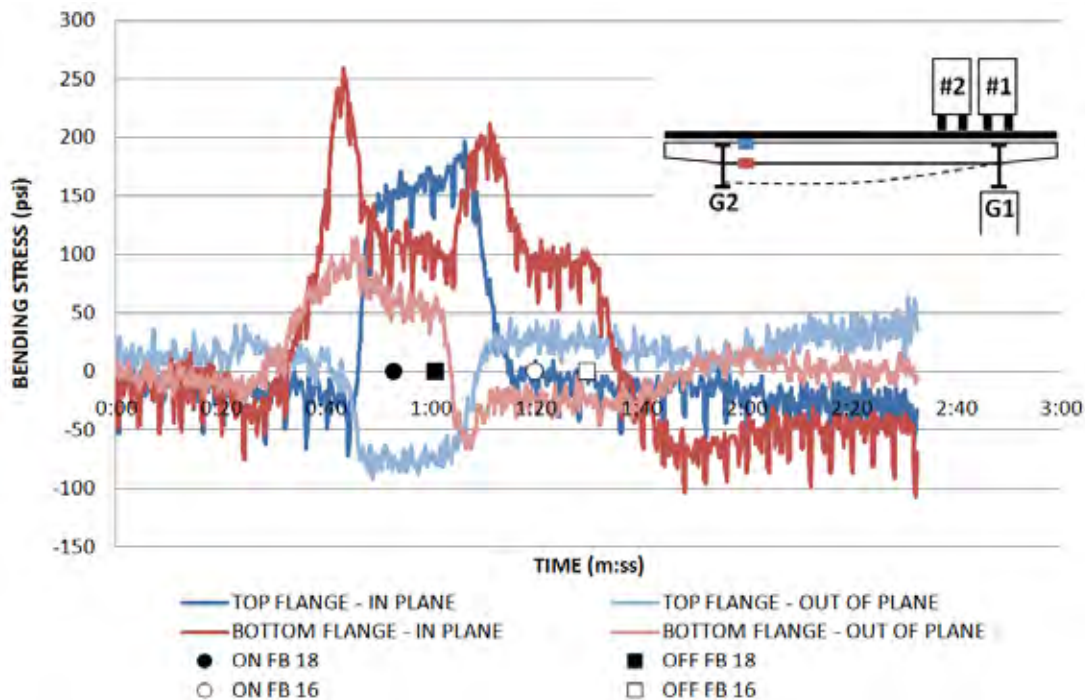
Figure 6.3: In-Plane and Out-of-Plane Stress of the Floor Beam near Girder 2 due to two Trucks on the Right

Figure 6.3 shows the in-plane and out-of-plane bending stresses of the floor beam near Girder 2 due to two trucks on the right side of the bridge. There is a lot of noise in this plot due to the small values of the stresses. With the trucks were over Girder 1, which was supported by a column, there was little stress transferred to the other side of the floor beam. The gages recorded small tensile in-plane stresses in the top and bottom flanges and out-of-plane stresses in different directions. The in-plane stress in the bottom flange is shown to be greater than that in the top flange except when it suddenly decreases when the trucks are over the floor beam. The reason for this could be that the stress on the left side of the floor beam is temporarily alleviated when the trucks are directly over the column on the right side. The stress then increases once the trucks leave the column. When the trucks moved onto Floor Beam 16, the stresses on this side of the floor beam generally went to zero.

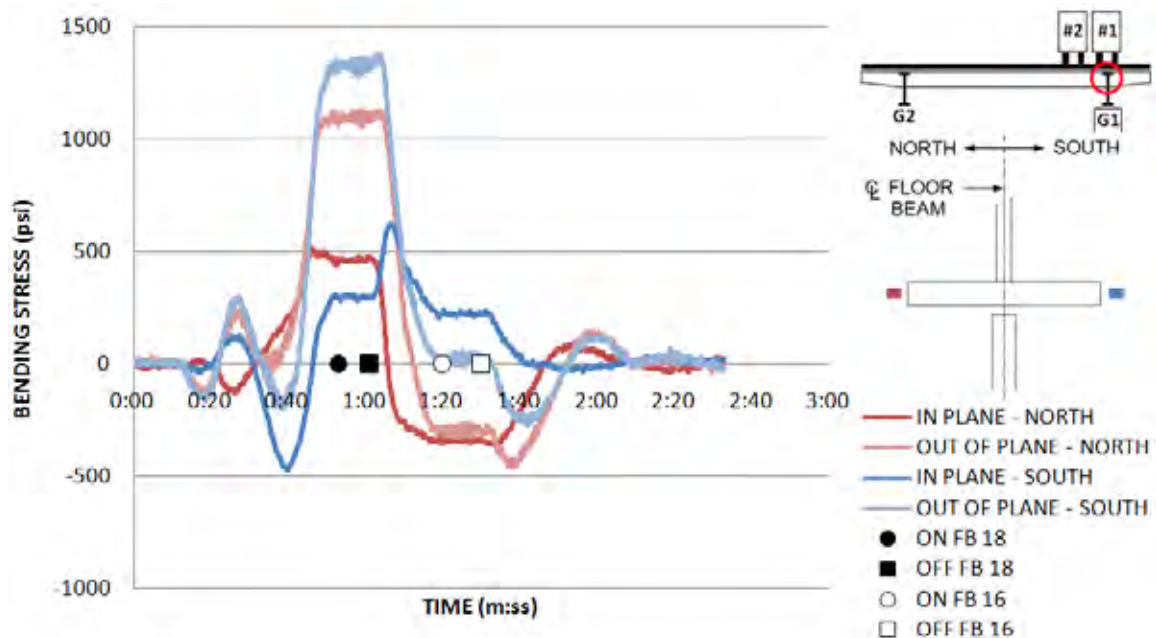
Figure 6.4: In-Plane and Out-of-Plane Bending Stresses of Girder 1 Web due to two Trucks on the Right

Figure 6.4 shows the in-plane and out-of-plane bending of the Girder 1 web adjacent to the bottom flange of the floor beam when two trucks were on the right side of the bridge. The bottom flange of the floor beam frames into the girder below the girder's neutral axis. Because Girder 1 is supported by a column at this location, the in-plane bending stress recorded by these gages was expected to be compressive. However, the figure shows that the in-plane stresses are tensile when the trucks are over the floor beam. The out-of-plane static stresses are very large and show that the girder is bending inward toward the interior of the bridge. When the truck is over Floor Beam 16, the in-plane stresses in the girder show different signs on either side of the floor beam. This suggests that the girder is deflecting upward on the north side of the floor beam and downward on the south side of the floor beam, which is the side closest to Floor Beam 16. There is also some out-of-plane bending of the girder on the north side of the floor beam when the trucks are over Floor Beam 16.

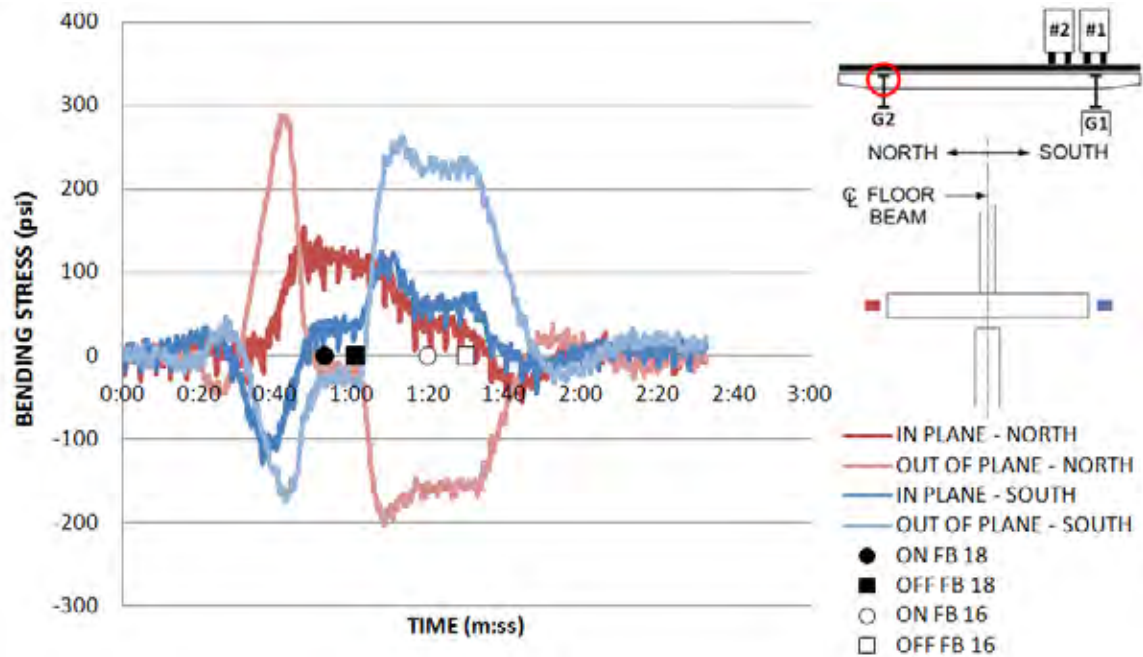
Figure 6.5: In-Plane and Out-of-Plane Bending Stresses of Girder 2 Web due to two Trucks on the Right

Figure 6.5 shows the in-plane and out-of-plane bending of the Girder 2 web adjacent to the bottom flange of the floor beam when two trucks were on the right side of the bridge. The stresses recorded in Girder 2 were relatively small due to the fact that the trucks were supported by a column on the right side. There is out-of-plane bending of the girder before the trucks reach Floor Beam 18 and when the trucks are over Floor Beam 16. In both of these cases, the girder is bending out of plane in different directions on either side of the floor beam.

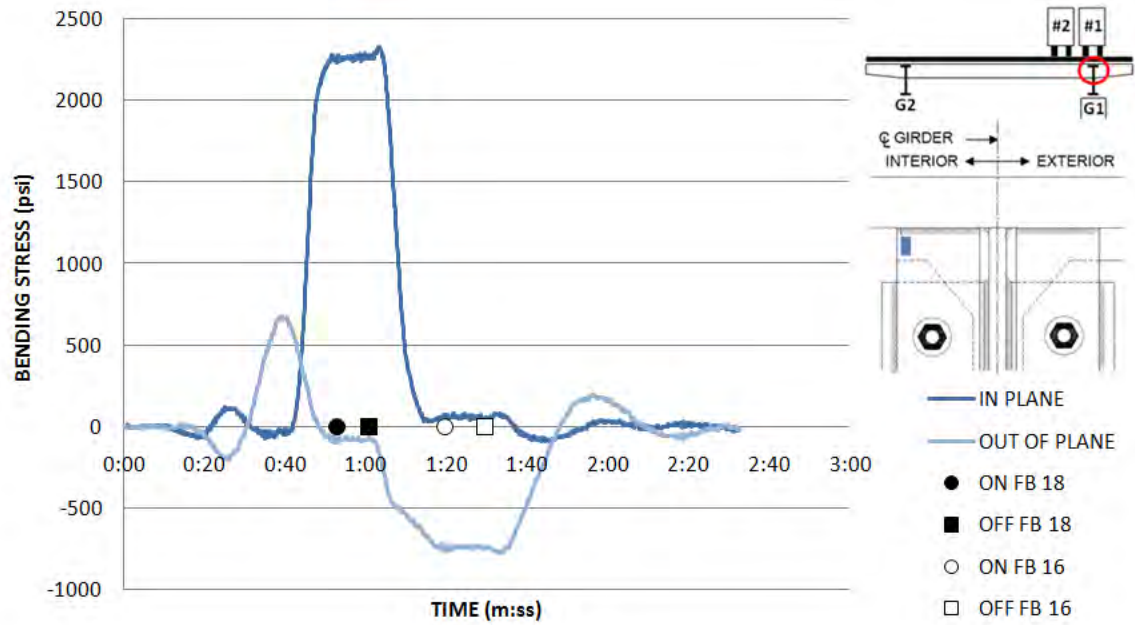
Figure 6.6: Stress in Girder 1 Retrofit Stiffeners due to two Trucks on the Right

Figure 6.6 shows the in-plane and out-of-plane bending stresses of the Girder 1 retrofit stiffeners due to two trucks on the right side of the bridge. The stiffeners bend out of plane prior to the trucks reaching the floor beam, but then bend completely in-plane when the trucks are on the floor beam. The static in-plane stress is relatively high due to the trucks location directly over the girder. Once the trucks leave the floor beam, the stiffeners bend out-of-plane.

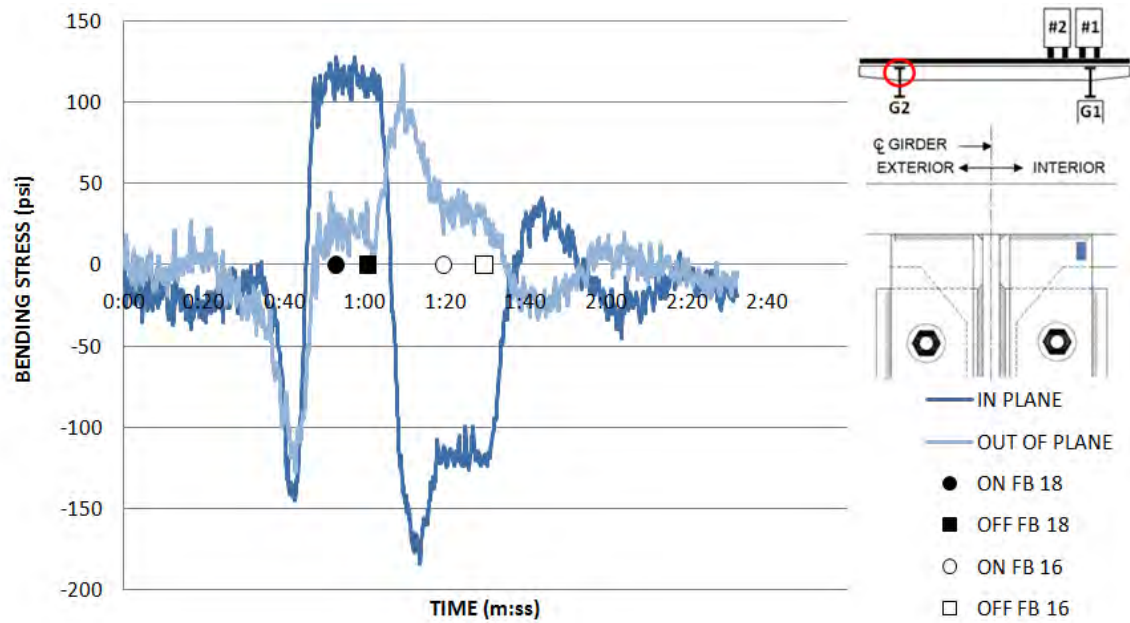
Figure 6.7: Stress in Girder 2 Retrofit Stiffeners due to two Trucks on the Right

Figure 6.7 shows the in-plane and out-of-plane bending stresses of the Girder 2 retrofit stiffeners due to two trucks on the right side of the bridge. The stiffeners bend both in and out of plane before the trucks reach the floor beam. When the trucks are on the floor beam, the stiffeners bend mostly in plane. When the trucks are over Floor Beam 16, the stiffeners bend in plane in the opposite direction with slight out-of-plane bending.

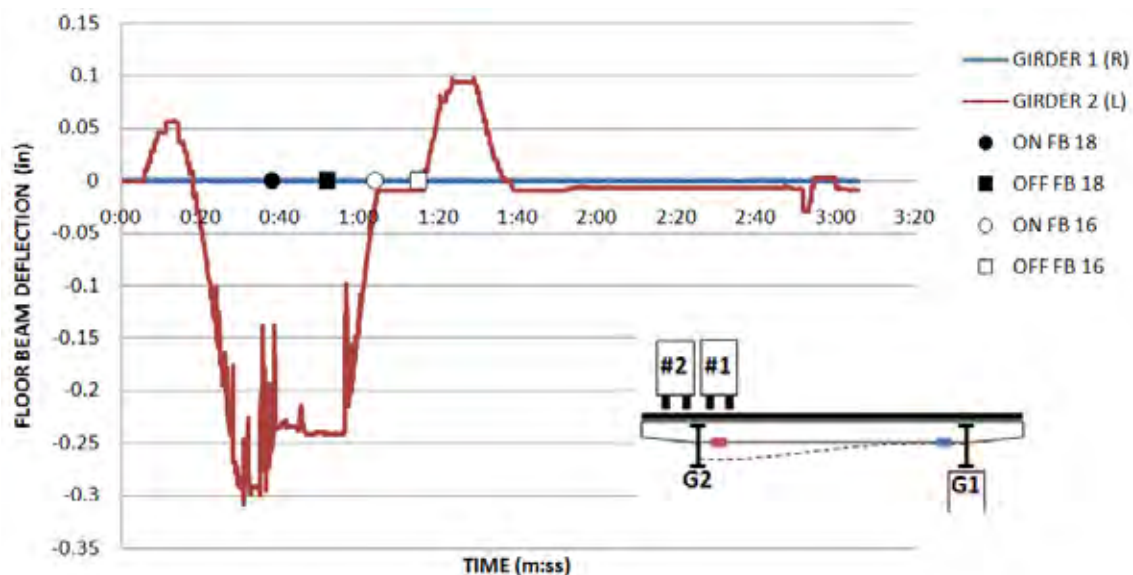
Figure 6.8: Deflection of Floor Beam due to Two Trucks on the Left

Figure 6.8 plots the deflection at both ends of the floor beam due to two trucks on the left side of the bridge. Girder 1 is restrained from deflecting due to the column. Therefore, the string pot on the right side of the floor beam shows no deflection. The left side of the floor beam deflects upward just before the trucks reach Floor Beam 18. When the trucks are on Floor Beam 18, the left side of the floor beam deflects downward under the weight of the trucks. The maximum deflection was recorded to be about 0.3 inches. When the trucks move onto Floor Beam 16, there is no deflection in Floor Beam 18. This is because the trucks are supported by the column at the connection of Girder 2 and Floor Beam 16. When the trucks leave Floor Beam 16, the left side of Floor Beam 18 deflects upward. From these results, the deflected shape of the floor beam due to static loading can be determined and is represented by the dashed line in the detail of the floor beam within Figure 6.8.

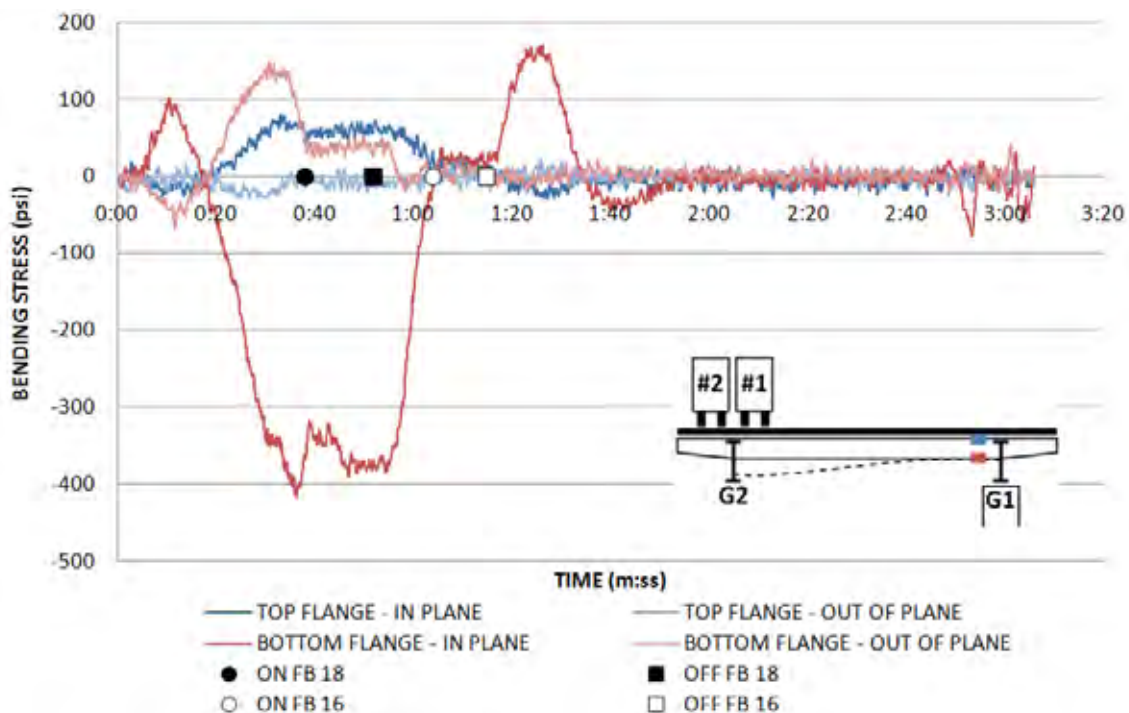
Figure 6.9: In-Plane and Out-of-Plane Stress of the Floor Beam near Girder 1 due to two Trucks on the Left

Figure 6.9 shows the in-plane and out-of-plane bending of the floor beam near Girder 1 due to two trucks on the left side of the bridge. There is slight in-plane and out-of-plane bending of the bottom flange before the trucks reach the floor beam. When the trucks are stationary over the floor beam, there is a relatively large in-plane compressive stress in the bottom flange with very little out-of-plane bending. The top flange has a small tensile in-plane stress. After the trucks leave Floor Beam 16, the bottom flange experiences tensile stresses. This data correlates with the deflection data from Figure 6.8, which shows that the left side of the bridge deflects downward under the weight of the trucks and causes compressive stresses in the bottom flange on the opposite side of the floor beam. When the trucks move past Floor Beam 16, the left side of Floor Beam 18 deflects upward as seen in Figure 6.8, which creates tensile stresses in the bottom flange on the opposite side of the floor beam.

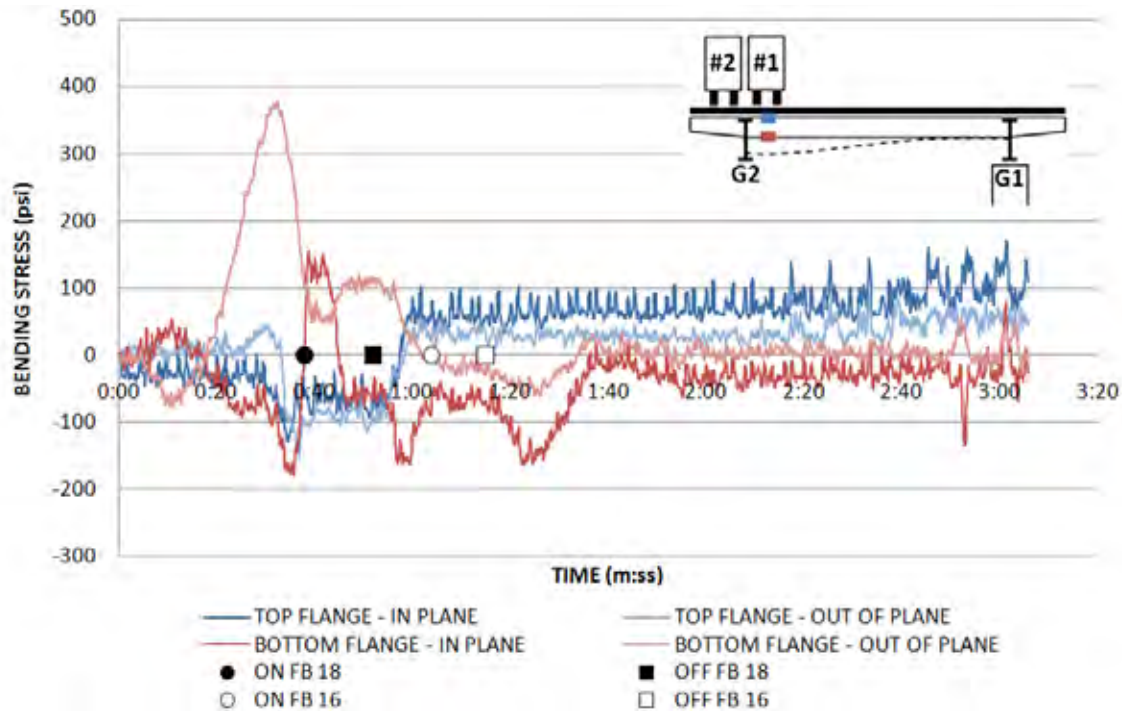
Figure 6.10: In-Plane and Out-of-Plane Stress of the Floor Beam near Girder 2 due to two Trucks on the Left

Figure 6.10 shows the in-plane and out-of-plane bending stresses in the floor beam near Girder 2 due to two trucks on the left. Before the trucks reach the floor beam, there are high out-of-plane bending stresses in the bottom flange, which suggest that the floor beam is deflecting laterally. When the trucks are over the floor beam, this out-of-plane stress is decreased as the in-plane bending stress increases. The in-plane stress is positive on the bottom flange when the trucks move onto the floor beam indicating that the floor beam is deflecting downward under the weight of the trucks. This data correlates well with the deflection data from Figure 6.8 that shows that the left side of the floor beam is deflecting downward due to the trucks. The stress in the bottom flange on the left side of the floor beam is generally less than that on the right side of the floor beam. This seems to suggest that the supporting column is attracting the majority of the stress caused by the trucks even when they are on the other side of the bridge.

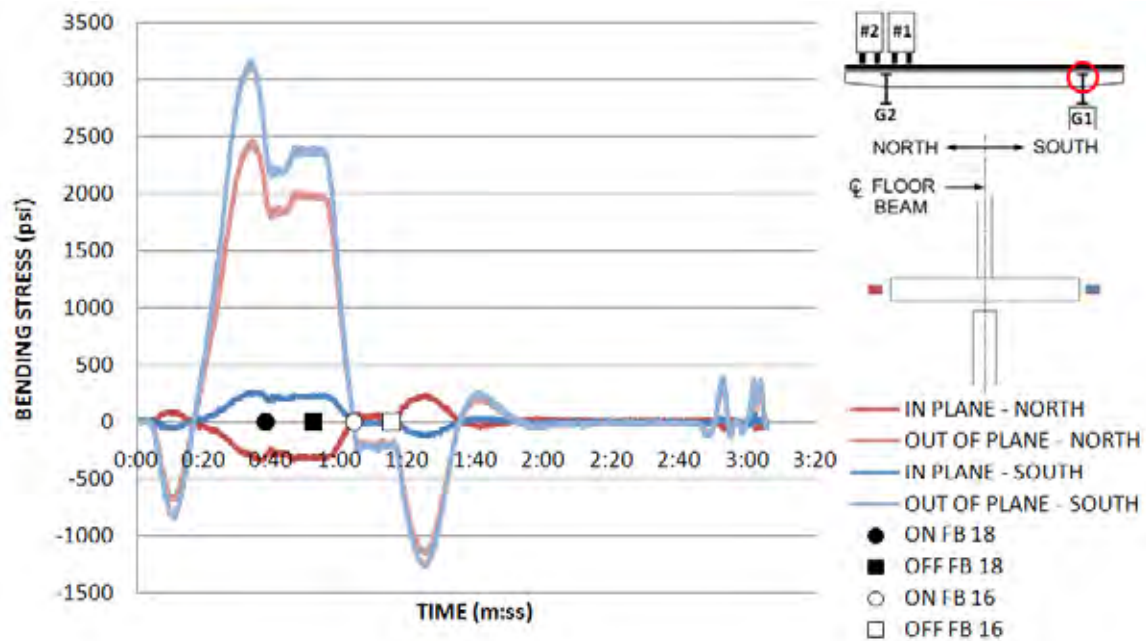
*Figure 6.11: In-Plane and Out-of-Plane Bending Stresses of Girder 1 Web due to two Trucks on the Left*

Figure 6.11 shows the in-plane and out-of-plane bending stresses in the web of Girder 1 adjacent to the bottom flange of Floor Beam 18 due to two trucks on the left side of the bridge. Because the girder at this location is supported by a column, it is assumed that the girder would not deflect vertically. This would cause the in-plane bending stresses to be very low. Figure 6.11 confirms this assumption. The figure shows that the in-plane bending stresses on either side of the floor beam flange are, in fact, small compared to the out-of-plane stresses. Before the trucks reach Floor Beam 18, the out-of-plane stresses are negative indicating that the girder is bending outward toward the exterior of the bridge. When the trucks are over the floor beam, the out-of-plane stresses are positive, which indicate that the girder is bending inward toward the center of the bridge. When the trucks are over Floor Beam 16, which is supported by a column on the left side, there is very little in-plane or out-of-plane stresses in the girder. After the trucks leave Floor Beam 16, the girder bends in the opposite direction, toward the exterior of the bridge.

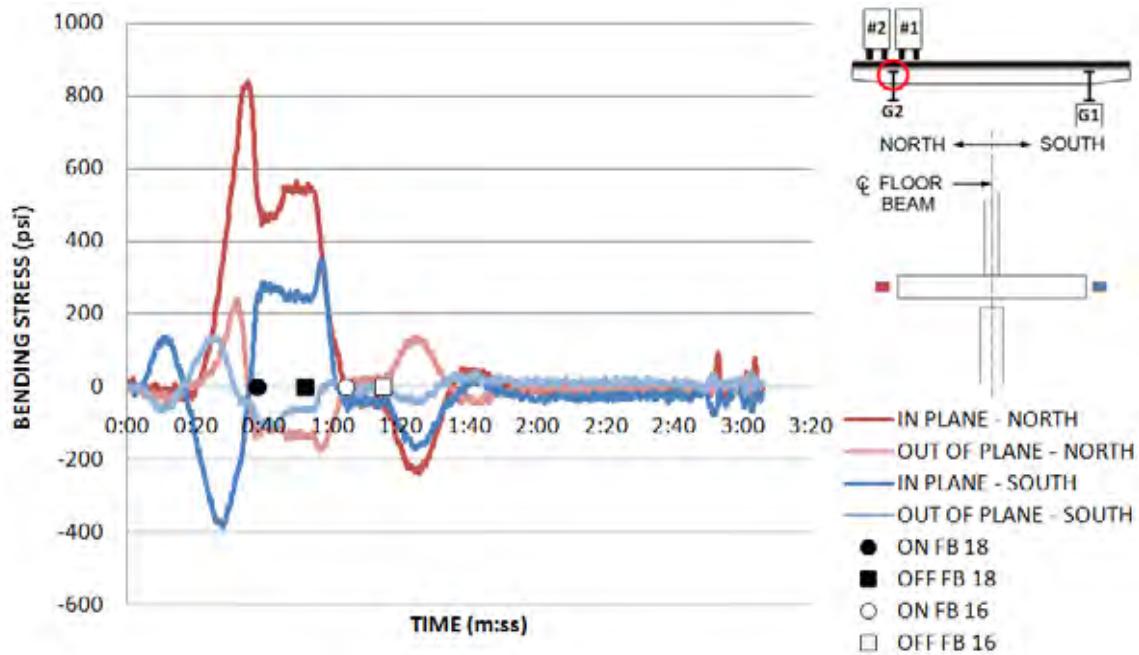
Figure 6.12: In-Plane and Out-of-Plane Bending Stresses of Girder 2 Web due to two Trucks on the Left

Figure 6.12 shows the in-plane and out-of-plane bending stresses in the web of Girder 2 adjacent to the bottom flange of Floor Beam 18 due to two trucks on the left side of the bridge. Girder 2 is not supported by a column at this location. Therefore, it is expected that the girder would deflect downward under the weight of the trucks. Figure 6.12 shows that the in-plane stresses on both sides of the floor beam are positive when the trucks are over Floor Beam 18, meaning that the bottom half of the girder is in tension. This confirms the assumption that the girder deflects downward, which would create tension in the bottom half of the girder. The out-of-plane stresses are small compared to the in-plane stresses, so there is very little lateral bending when the trucks are over the floor beam. Prior to the trucks reaching Floor Beam 18, the in-plane stresses on either side of the floor beam have different signs. On the north side of the floor beam,

which is the direction from which the trucks approach the floor beam, the tensile stress suggests that the girder is deflecting downward. On the south side of the floor beam, the compressive stress suggests that the girder is deflecting upward. When the trucks are on Floor Beam 16, which is supported by a column on the left side, the stress in the girder near Floor Beam 18 is very small. Once the trucks leave Floor Beam 16, the in-plane stresses are negative suggesting that the girder is deflecting upward. The small out-of-plane stresses are opposite in sign on either side of the floor beam, which means that it is deflecting laterally in different directions.

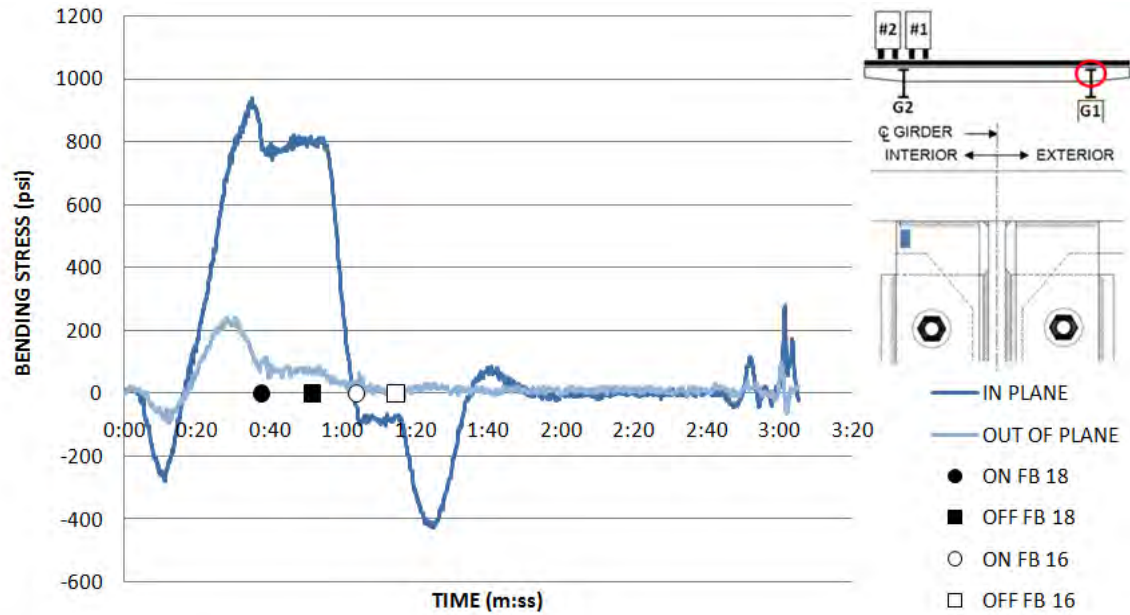
Figure 6.13: Stress in Girder 1 Retrofit Stiffeners due to two Trucks on the Left

Figure 6.13 shows the in-plane and out-of-plane bending stress in the retrofit stiffeners on Girder 1 due to two trucks in the left lanes. The figure shows that while the trucks are stationary over the girder, the stiffeners have a large positive in-plane stress, suggesting that they are bending in the plane of the stiffener. The trucks on the left side of the bridge are causing the floor beam-to-column connection on the right side of the bridge to bend out of the plane of the girder as seen in Figure 6.11. This is what is causing the in-plane bending of the stiffeners. When the trucks are over Floor Beam 16, which is supported by a column on the left side, there is very little stress in the stiffeners on Floor Beam 18. Once the trucks leave Floor Beam 16, the stiffeners experience compressive in-plane stress, which indicates they are bending in the opposite direction that they were bending when the trucks were over the floor beam. As the trucks continue to move along the bridge, the stress in the stiffeners goes to zero.

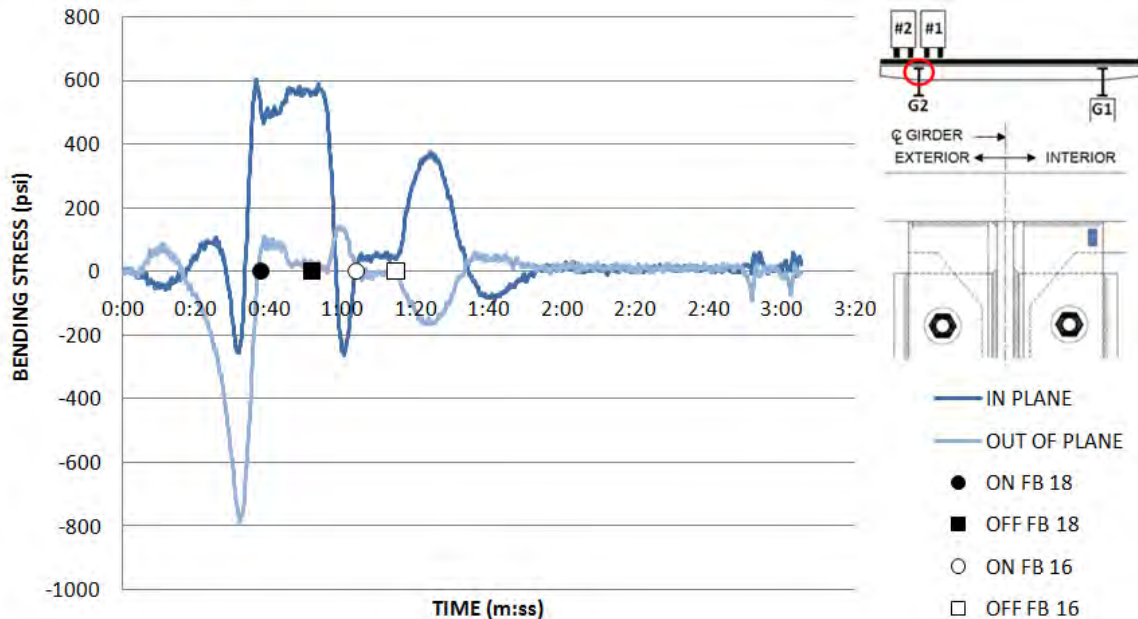
Figure 6.14: Stress in Girder 2 Retrofit Stiffeners due to two Trucks on the Left

Figure 6.14 shows the in-plane and out-of-plane bending stress in the retrofit stiffeners on Girder 2 due to two trucks in the left lanes. The figure shows that the stiffeners experience a very large out-of-plane bending stress before the trucks reach the floor beam. This suggests that they are bending out of the plane of the stiffener. The reason for this could be due to the movement of the girder, which bends vertically in different directions on either side of the floor beam, as seen in Figure 6.12. When the trucks are over the floor beam, the stiffeners experience only in-plane stresses due to the movement of the floor beam. When the trucks reach Floor Beam 16, the stress in the stiffeners is zero because the trucks are supported by a column at that location. Once the trucks leave Floor Beam 16, the stiffeners experience both in-plane and out-of-plane stress.

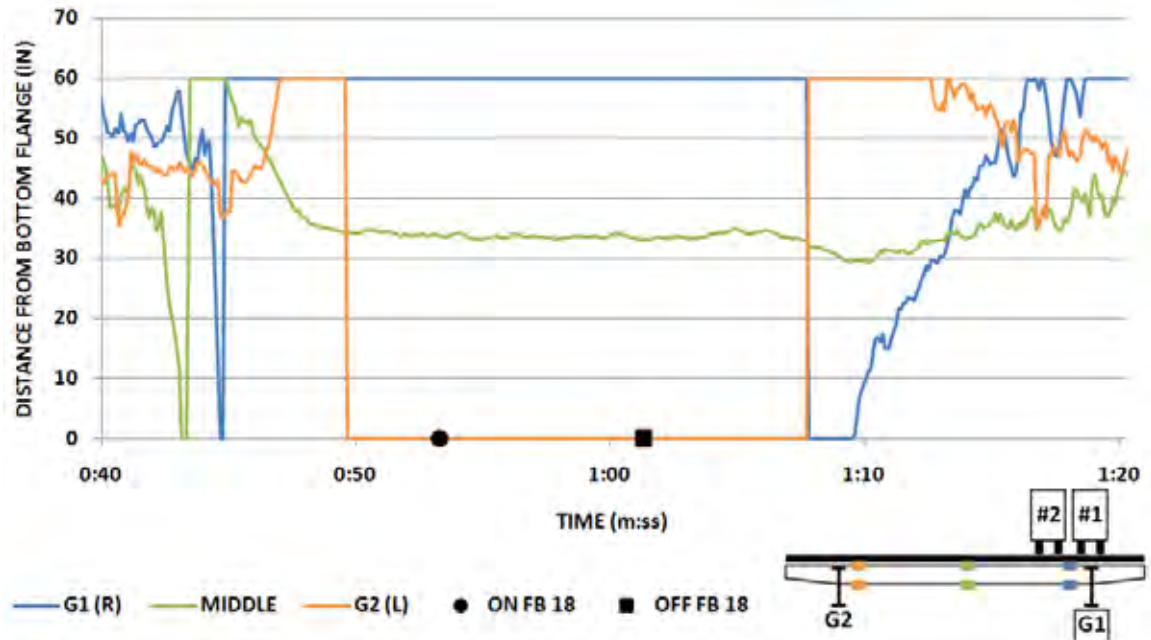
Figure 6.15: Neutral Axis of the Floor Beam versus Time due to Two Trucks on the Right

Figure 6.15 shows the location of the neutral axis versus time as two trucks move along the right side of the bridge. During this run, the trucks were directly over Girder 1, which is supported by a column at Floor Beam 18. Looking at the right side of the floor beam near the trucks, the figure shows that the neutral axis was calculated to be at the imposed limit of 60 inches from the bottom flange. This suggests that the stress in the bottom flange is much greater than the stress in the top flange. Figure 6.2 shows the stress in the flanges of the floor beam near the right side of the floor beam during this run. It can be seen that both the top and bottom flanges are experiencing tensile stress when the trucks are stationary, with the stress in the bottom flange greater than that in the top flange. Therefore, the neutral axis cannot be located within the floor beam and, therefore, must be in the slab, implying composite action.

In the middle of the floor beam, the neutral axis was calculated to be at about 33 inches from the bottom flange, which is slightly above the centroid. This suggests that there is slight composite action between the floor beam and slab. On the left side of the floor beam, opposite the trucks, the figure shows the neutral axis to be above the centroid of the section except for the time around when the trucks were stationary over the floor beam at which time the neutral axis drops suddenly to the bottom of the section. Figure 6.3 shows the stresses in the top and bottom flanges on the left side of the floor beam. Both the top and bottom flanges are experiencing tensile stresses when the trucks are near the floor beam. The stress in the bottom flange is shown to be greater than that in the top flange except when it suddenly decreases when the trucks are over the floor beam. This is the cause for the sudden jump in the location of the neutral axis in Figure 6.15. The reason for this could be that the stress on the left side of the floor beam is temporarily alleviated when the trucks are directly over the column on the right side. The stress then increases once the trucks leave the column.

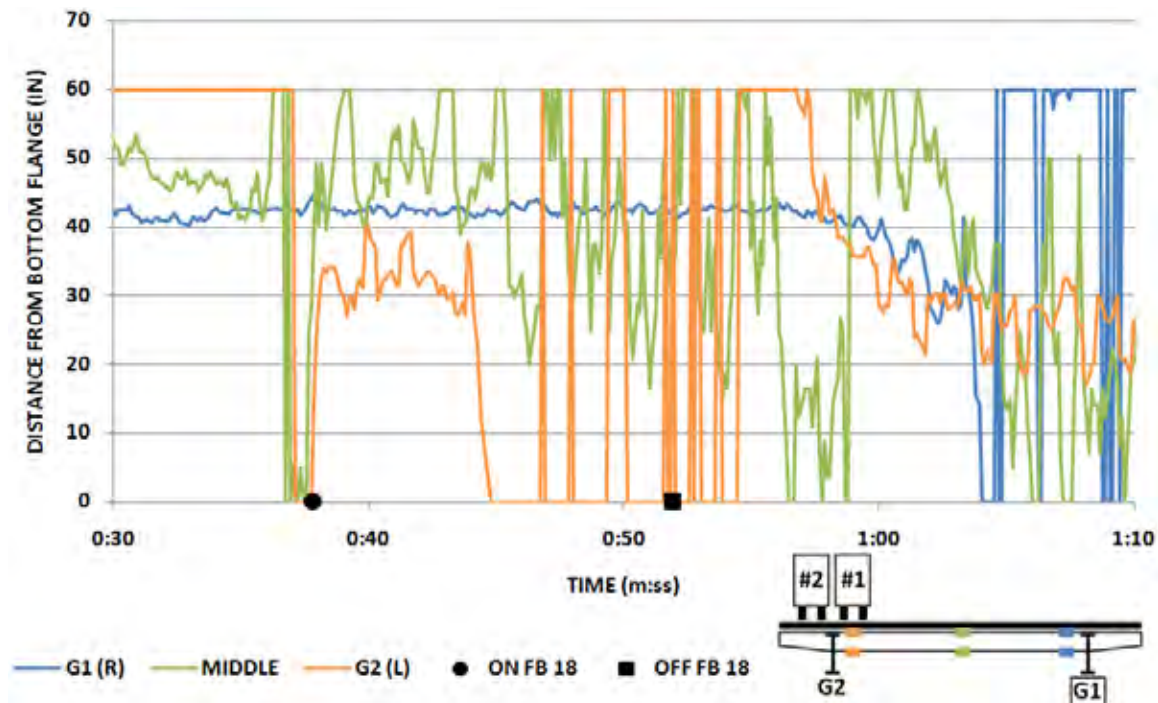
Figure 6.16: Neutral Axis of the Floor Beam versus Time due to Two Trucks on the Left

Figure 6.16 shows the location of the neutral axis versus time as two trucks move along the left side of the bridge. The figure shows that the location of the neutral axis at the middle and left side of the floor beam is somewhat steady when the trucks stop on the floor beam, but then becomes highly variable. Figure 6.10 shows the stress in the left side of the floor beam during this run. It can be seen that the in-plane stress in the bottom flange is positive when the trucks first stop on the floor beam and the stress in the top flange is slightly negative. Then the stress in the bottom flange suddenly becomes negative even though the trucks are stationary. At this point, the stresses in the top and bottom flanges are essentially equal in sign and magnitude, which makes calculating the neutral axis impossible and is the cause of the variability in the plot shown in Figure 6.16. However, prior to this point, the neutral axis was calculated to be above the centroid for each of the three gage locations and, therefore, suggests composite action between the floor beam and slab.

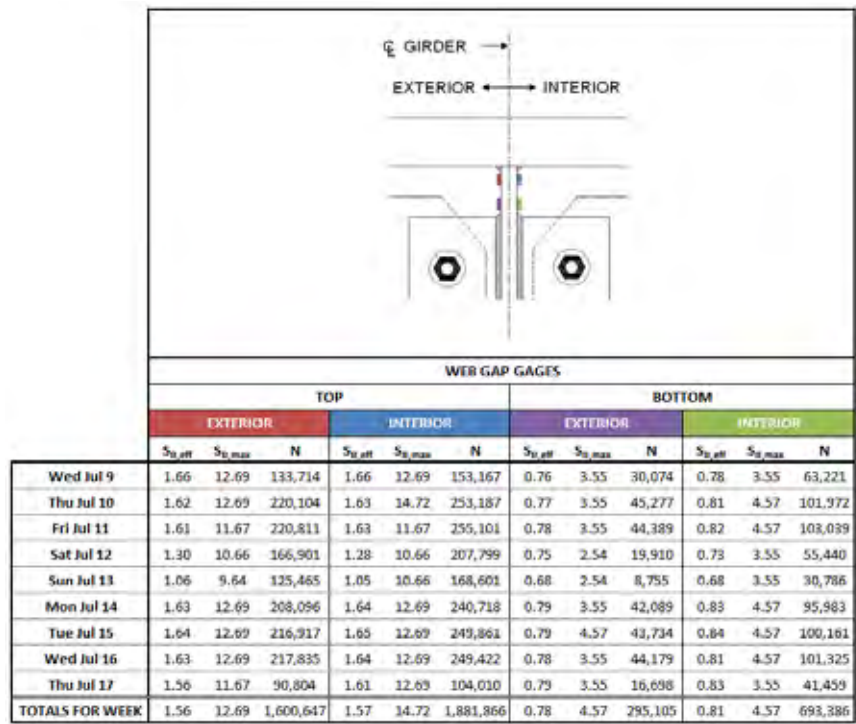
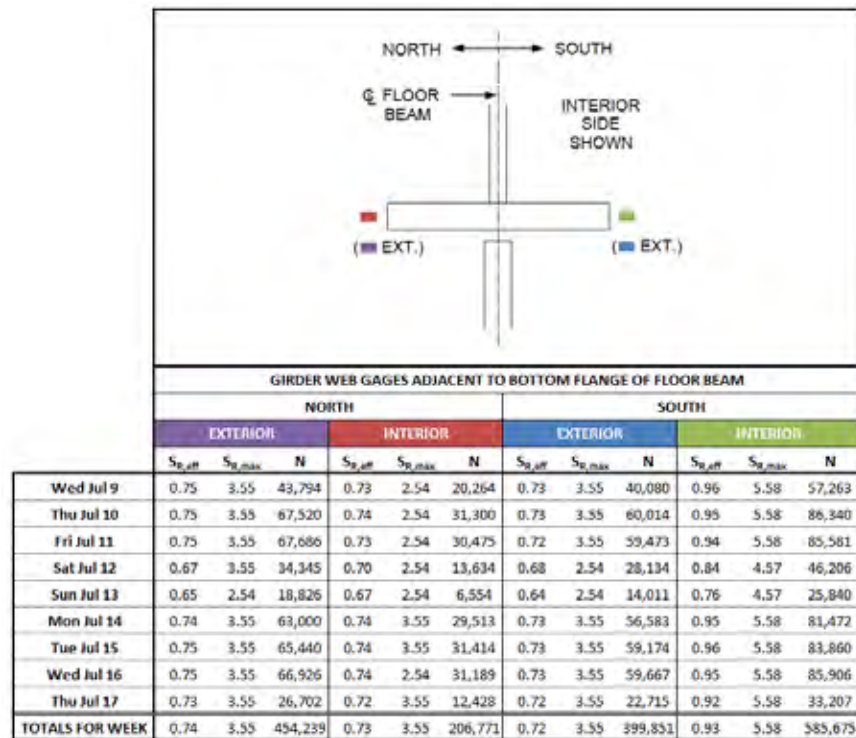
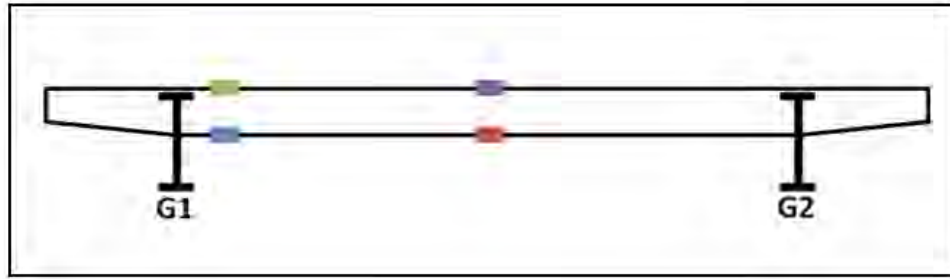
Figure 7.1: Stress Range Summary for Gages Near Connection of Floor Beam 2 to Girder 1

Figures 7.1 and 7.2 show a summary of the effective stress range, maximum stress range, and number of cycles for each of the gages on Floor Beam 2. The first group of gages shown is the web gap gages. The calculations show that the gages at the top of the gap experienced the highest stress ranges. The maximum stress ranges recorded were between 12 and 15 ksi. However, the effective stress range was calculated to be only about 1.5 ksi. This is because there were only a few cycles in the very high stress ranges while the majority of the cycles were in very low stress ranges. The gages on the bottom of the gap recorded lower stress ranges with the maximum recorded around 4.5 ksi and the effective stress range around 0.8 ksi.

The bottom flange gages are summarized next. Three of the four gages recorded very similar numbers. The maximum stress range for these gages was 3.55 ksi and the effective stress range was around 0.73 ksi. The interior gage on the south side of the floor beam recorded slightly higher stresses at 5.58 ksi and 0.93 ksi for the maximum and effective stress ranges, respectively.

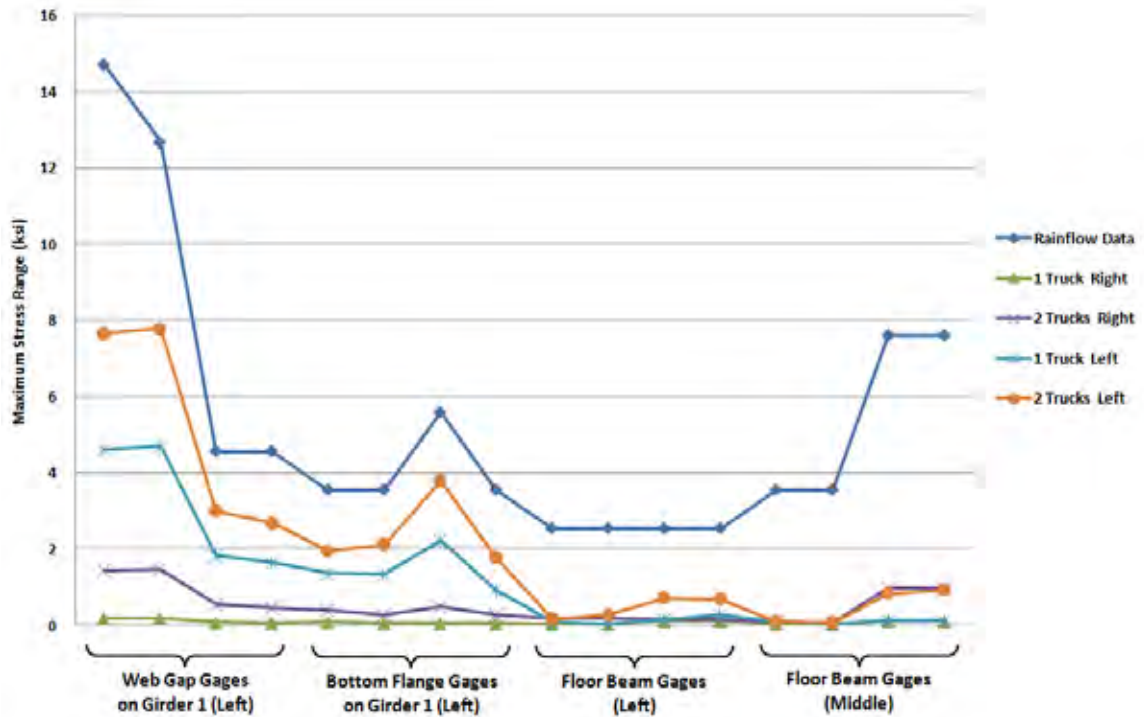
Figure 7.3: Comparison of Rainflow Data to Live Load Test Data for Floor Beam 2

Figure 7.3 shows the maximum stress ranges recorded for each gage from both the rainflow counting program as well as the four controlled live load tests. It can be seen that the stress ranges from each of the tests are different, but the general trends in the stress ranges for the gages are similar for all of the tests. All of the tests found that the top web gap gages experienced the highest stress ranges.

For the gages located near the left side of the bridge, it would be expected that the highest stress ranges recorded during the live load tests would occur during the test where there were two trucks on the left side of the road. Figure 7.3 confirms this expectation. The two trucks left test is followed by the single truck left, two trucks right, and single truck right tests.

The stress ranges recorded by the rainflow counting program are significantly higher than the stress ranges calculated from the live load tests. It is important to remember that the trucks were moving very slowly during the live load tests and were, in fact, stationary when over the instrumented floor beams. Therefore, the stresses that were recorded during these tests were essentially static stresses. Conversely, during the fatigue test, the traffic was moving at its normal pace. The fast-moving vehicles create a dynamic effect that amplifies the stresses felt by the bridge members.

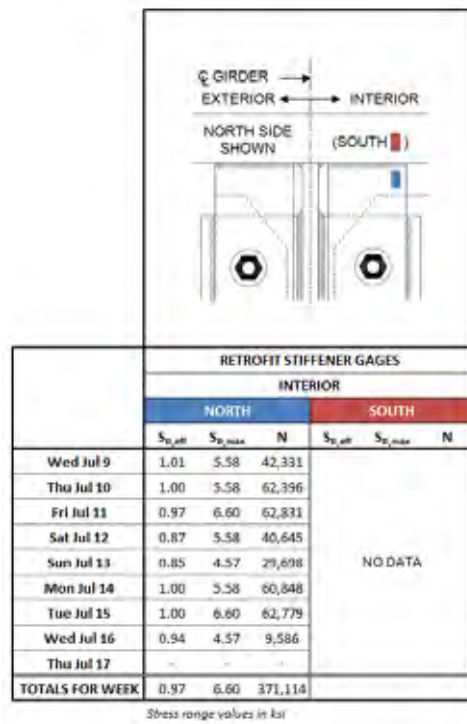
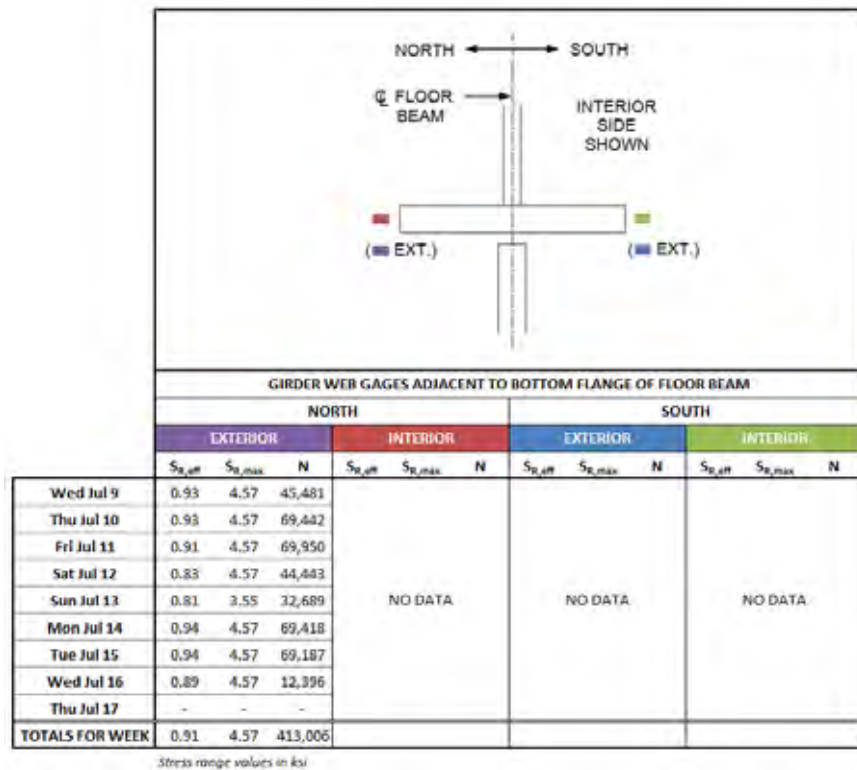
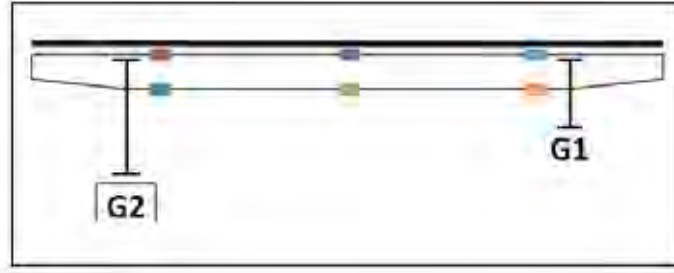
Figure 7.4: Stress Range Summary for Gages Near Connection of Floor Beam 16 to Girder 2

Figures 7.4 through 7.6 show a summary of the effective stress range, maximum stress range, and number of cycles for each of the gages on Floor Beam 16. Figure 7.4 shows the gages located at the connection of Floor Beam 16 to Girder 2, which is on the left side of the bridge. There were only two working gages at this connection. The first is the retrofit stiffener gage. This gage recorded a maximum stress range of 6.6 ksi and an effective stress range of 0.97 ksi. If compared to the retrofit stiffeners on Girder 1, which is shown in Figure 7.6, it can be seen that the stiffeners on Girder 2 experienced higher stress ranges. This is due to the fact that Girder 2 is haunched and was shown in Chapter 5 to attract greater stress than Girder 1.

The bottom flange gage on Girder 1 (Figure 7.4) experienced an effective stress range of 0.91ksi. This is higher than the bottom flange gages on Girder 2 (Figure 7.6), whose effective stress ranges average 0.64 ksi. Again, this is due to the haunch of Girder 2 attracting high stresses.

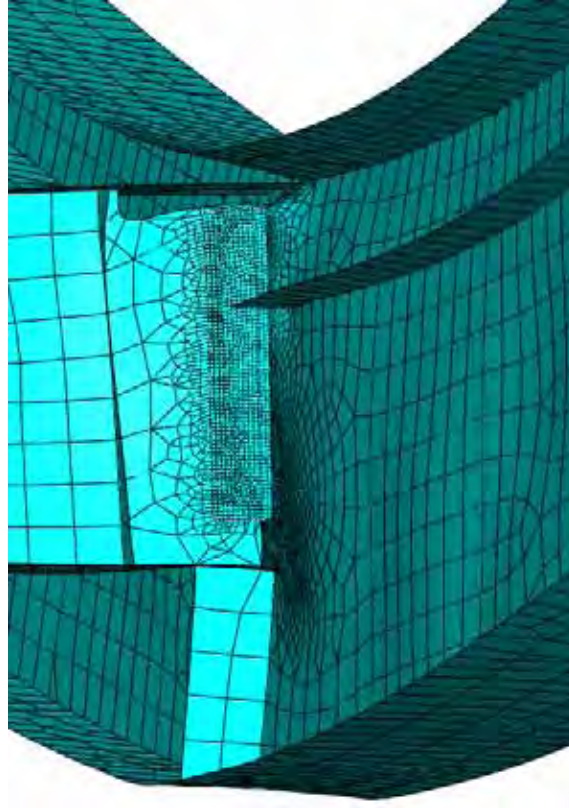
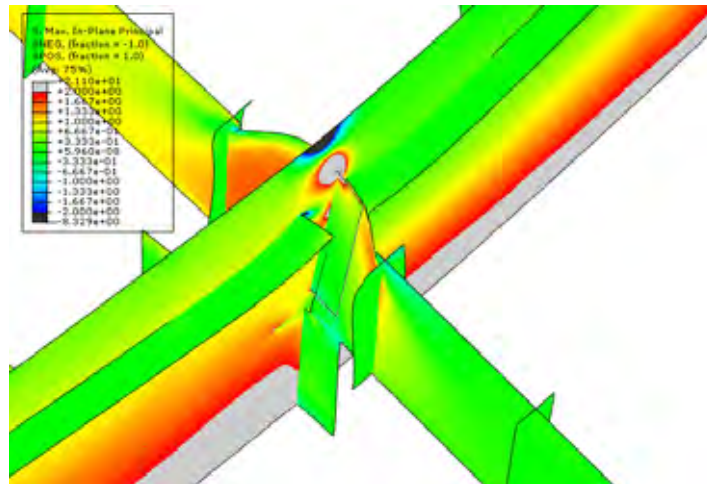
*Figure 8.10: View of Connection in Deformed State*

Figure 8.9 shows the deformed state of the entire bridge due to the weight of two trucks over girder 2. The slab has been removed from this image to provide a better view of the deformed shape of the girders and floor beams. The deformations have been magnified by a factor of 1500. Figure 8.10 shows a view of the connection in the deformed state. The double curvature of the web gap can be seen in this figure as well as the lack of significant out-of-plane bending in the girder web near the connection of the bottom flange of the floor beam. The high stress concentration at the web gap is shown in the figure (the top and bottom flanges are removed from the image to provide a better view).
