## **Field Test and Finite Element of I-345 Bridge in Dallas**

CTR Technical Report:	5-4124-01-2
Report Date:	July 10, 2009
Project:	5-4124-01
Project Title:	Field Test and Finite Element of I-345 Bridge in Dallas
Sponsoring Agency:	Texas Department of Transportation
Performing Agency:	Center for Transportation Research at The University of Texas at Austin

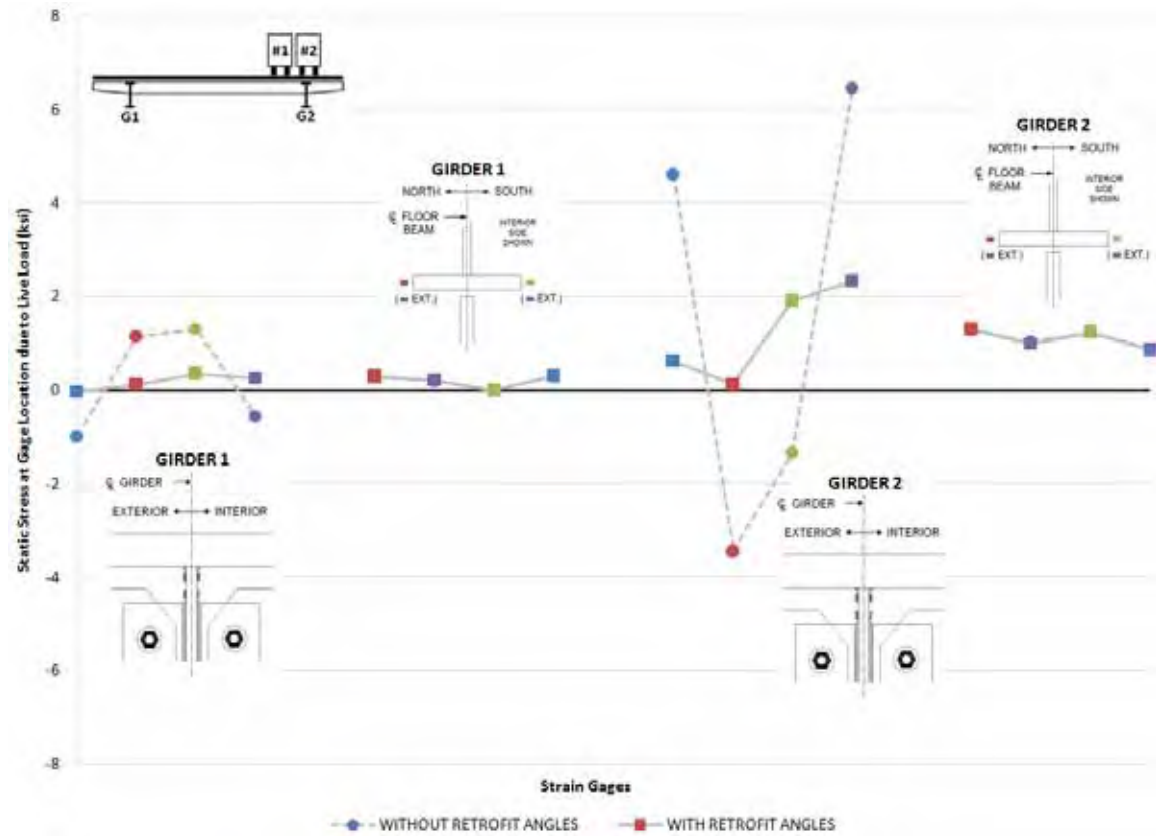
Figure 8.12: Comparison of Model Results with and without Retrofit Angles for Load Case with 2 Trucks on the Right

The results from the composite model before and after adding the retrofit angles will be compared to determine if this retrofit is effective in reducing the stress at the connection. Figures 8.12 and 8.13 show the results for the test with two trucks on the right and two trucks on the left, respectively. As can be seen from both figures, the retrofit angles are effective in reducing the stress in the web gaps. However, the stress in the girder web near the bottom flange of the floor beam is not affected by the angles.

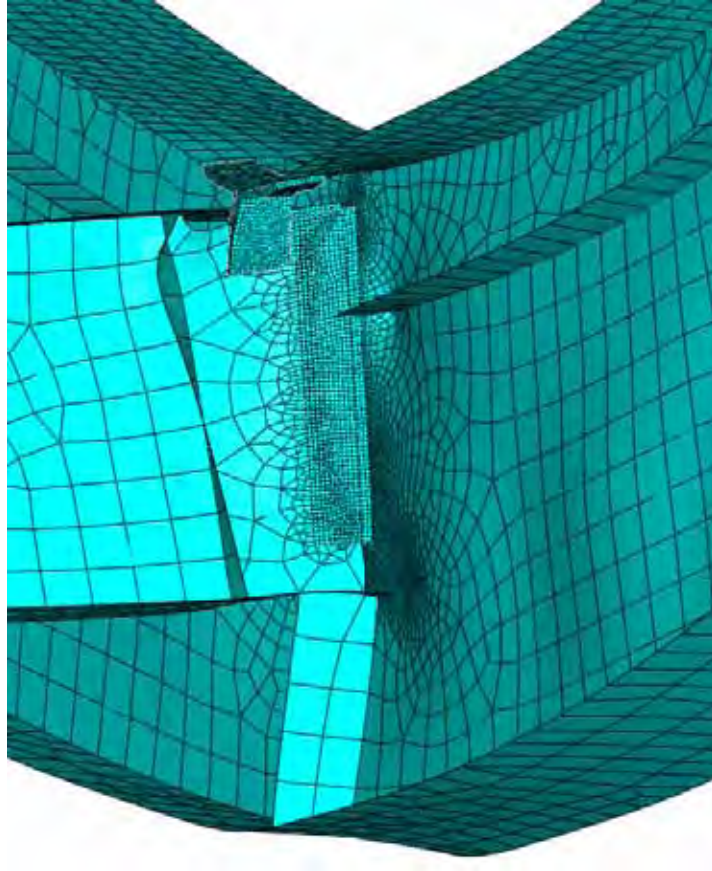
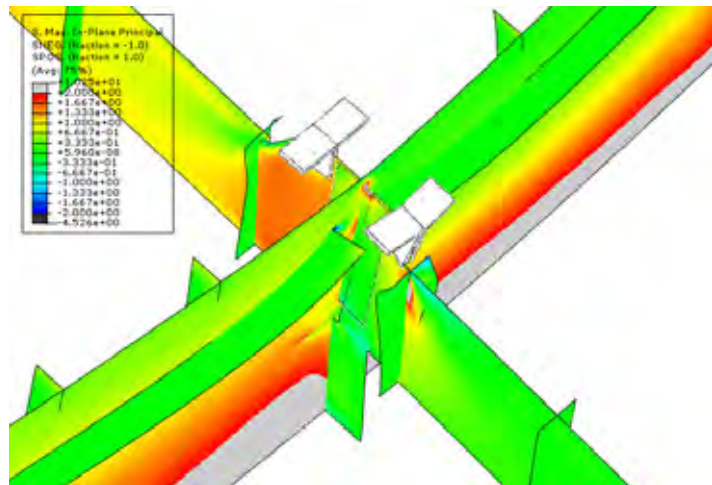
*Figure 8.14: View of Connection in Deformed State with Retrofit Angles*

Figure 8.14 shows a view of the connection in the deformed state with the retrofit angles. If this figure is compared to Figure 8.10, which does not include the retrofit angles, it can be seen that the angles significantly reduce bending in the web gap, thus reducing the stress in that area.

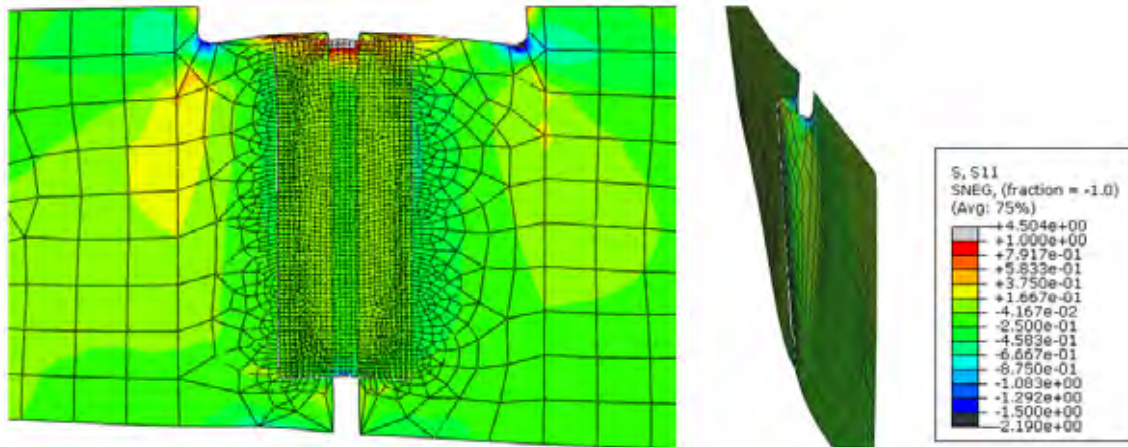
Figure 8.15: Stress Contours and Deformation near Floor Beam Cope with no Retrofit Angles

The following two figures show stress contours and the deformed shape of the floor beam web near the floor beam cope. Figure 8.15 shows the floor beam before the retrofit angles and Figure 8.16 shows the floor beam with the retrofit angles. Although the retrofit angles decrease the bending in the web gap, it can be seen by comparing Figures 8.15 and 8.16 that the angles increase stresses in the floor beam web around the coped area, which is close to the area where the transverse stiffeners are attached to the floor beam. The increase in stress at the cope and at the transverse stiffener welds may lead to cracking at this location.

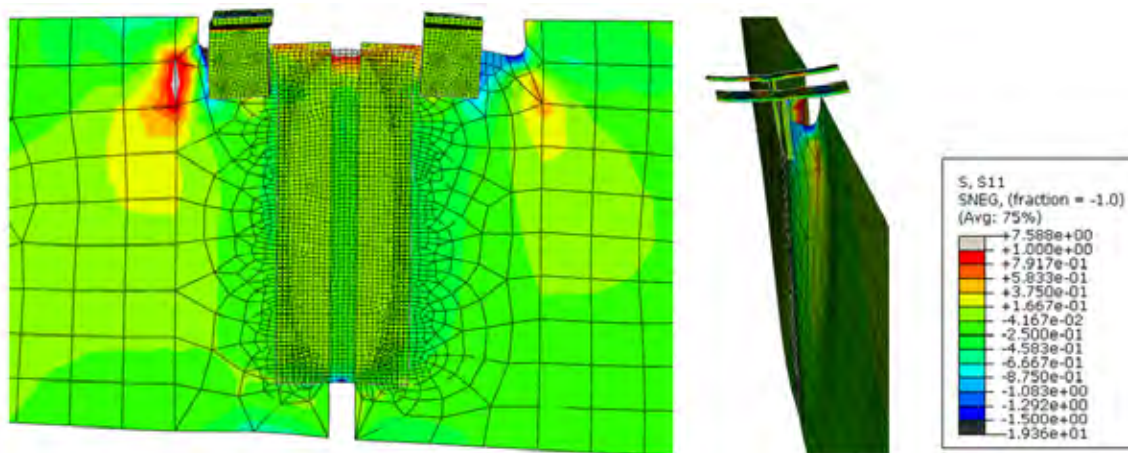
Figure 8.16: Stress Contours and Deformation near Floor Beam Cope with Retrofit Angles

Retrofit angles, one of the retrofit plans being considered for this bridge, were incorporated into the model to determine their effectiveness. The purpose of these angles is to connect the web of the floor beam to the top flange of the girder. The model shows that the angles decreased the bending stress in the web gap but increased the stress in the floor beam web around the coped area. This increase in stress at the cope and at the transverse stiffener welds may lead to cracking at this location.

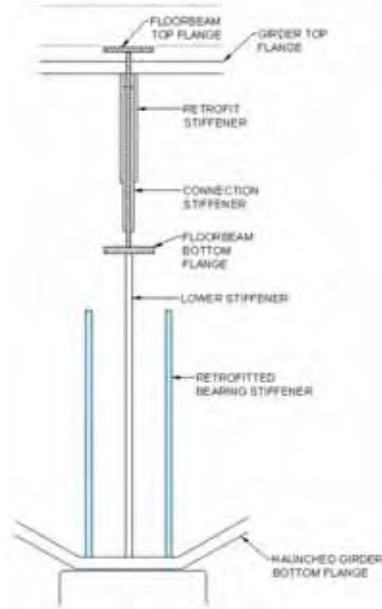
*Figure 9.5: Detail Showing Proposed Retrofit Bearing Stiffeners*

The second retrofit incorporated into the model involves cutting the bearing stiffeners at the connection of floor beam 16 to girder 2 in half. This eliminates the small gap that exists between the bearing stiffeners and the bottom flange of the connecting floor beam, which was shown to have relatively high stresses. A detail of this retrofit can be seen in Figure 9.5. The lower stiffener directly under the floor beam was left at its original height. Figure 9.6 shows this retrofit incorporated into the sub model.

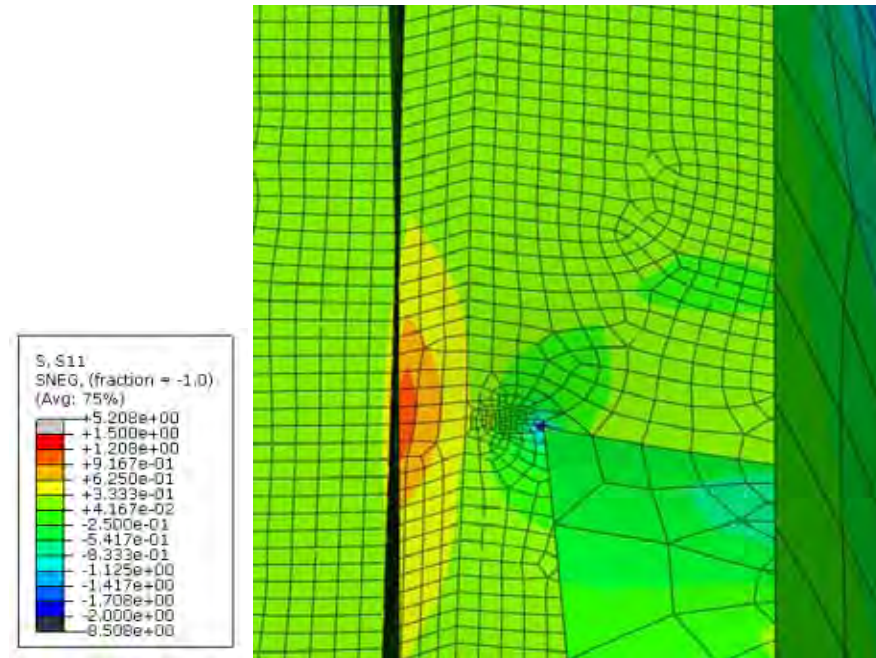
It can be seen from the figure that the stress values recorded by the retrofit stiffener gages and the floor beam gages correlate well with the computer model results. The main difference between the field and model data is shown by the girder web gages. The field data shows out-of-plane bending of the girder web toward the interior of the bridge while the computer model shows the web bending in the other direction. The reason for this can be seen in Figure 9.9, which shows stress contours on the girder web in the gap between the bearing stiffeners and bottom flange of the floor beam. Near the vertical bearing stiffener, the stress contours in the gap are red, which signifies tension. Near the bottom flange of the floor beam, the contours are blue, which signifies compression. The change from tension to compression means that the web is bending in double curvature within this gap. Because the gap is so small, this creates a very high stress gradient and any slight change in the location of the strain gage could result in a change in the sign of the stress recorded by the gage. Therefore, it is possible that the locations of the strain gages that were placed in this gap during the field testing do not exactly match the points where stress values were measured in the computer model. This would account for the difference in the direction of bending of the web between the field and model data. Thus, these discrepancies are likely to be the result of slight differences in the locations of the points used to compare the field data and computer model results.

*Figure 9.9: Stress Contours Showing Double Curvature in Web Gap*

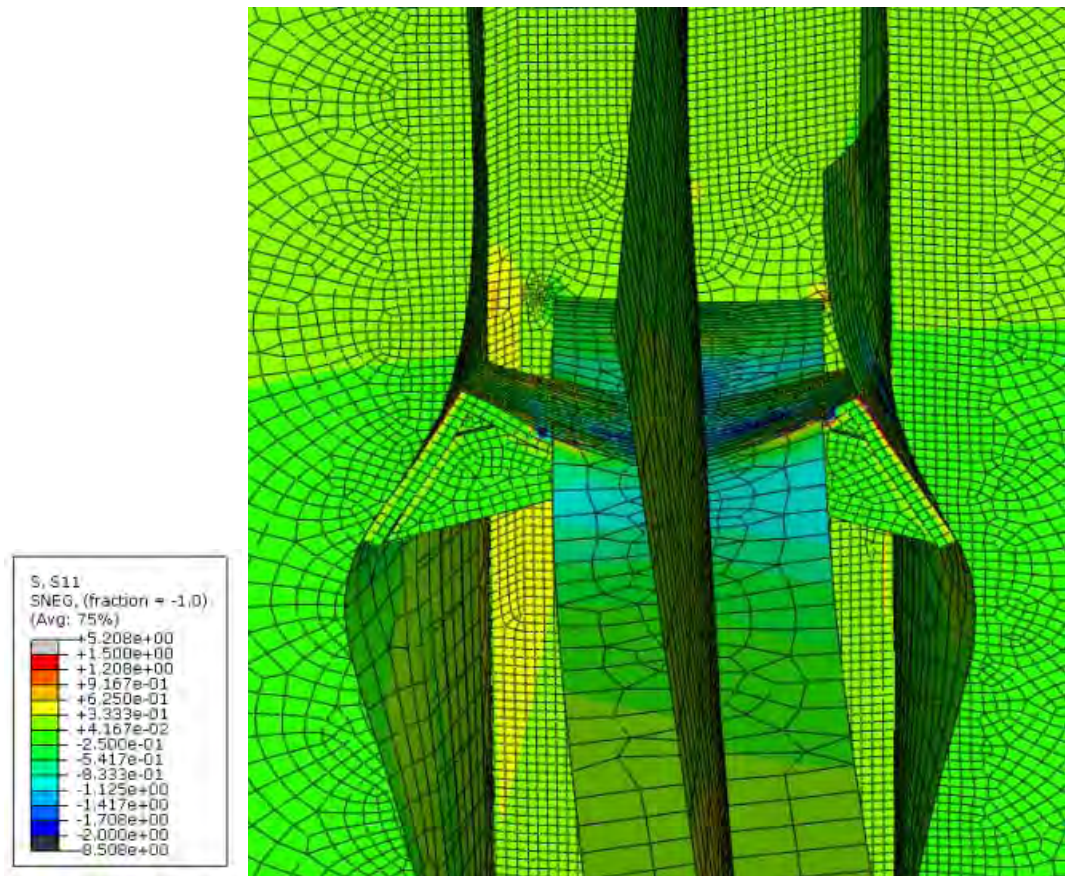
Figure 9.13 shows a view of the connection in the deformed state with the retrofit braces and brackets. The stress contours in the gap between the bearing stiffeners and the bottom flange of the floor beam show that the magnitude of the stress in this area has decreased compared to Figure 9.9, which shows the connection without the retrofit. There are increased stresses in the bottom flange of the floor beam where the brackets are connected. These stresses are a result of the truck loads rotating the floor beam downward and the brackets pushing back up on the bottom flange. One possible way to reduce these stresses would be to place a continuous plate above both angle brackets between the brackets and the bottom floor beam flange. This would spread the stresses out and reduce the distortion that is seen in the bottom flange.

*Figure 9.13: View of Connection in Deformed State with Retrofit Braces*

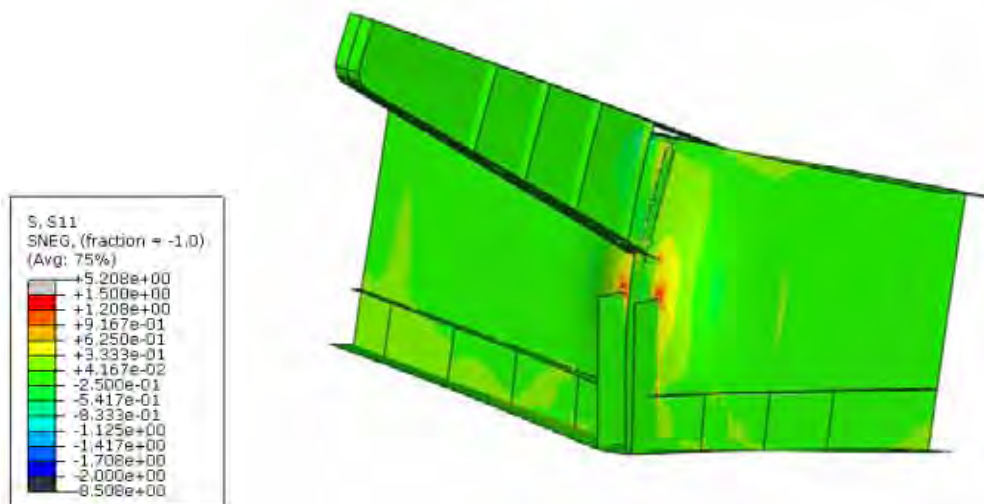
*Figure 9.14: View of Connection in Deformed State with Retrofit Bearing Stiffeners*

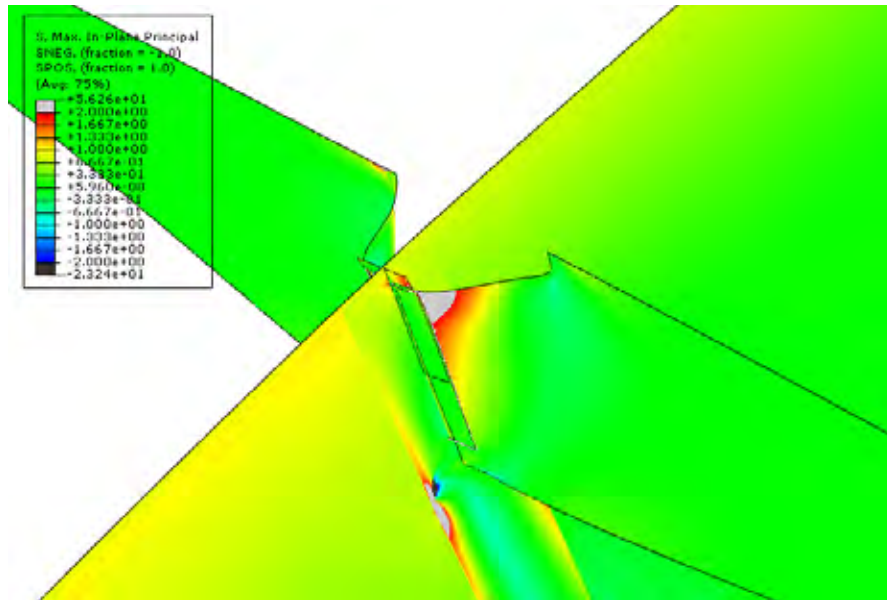
It is important to note that the finite element model results show that there is also significant bending of the web of the floor beam near where the web is coped to go around the top girder flange. This bending is caused by rotation of the girder. Figure 9.15 shows the bending in the floor beam web near the cope without retrofits and Figure 9.16 shows similar bending in the floor beam web with the brace plate retrofit. The magnitude of the stresses near the cope is not reduced with the retrofit. Therefore, while the previously mentioned retrofits are effective in reducing the girder web stresses near the bottom flange of the floor beam, they do not help to reduce the stresses near the top of this connection when the distortion in the floor beam web is caused by the rotation of the girder.

*Figure 9.15: Floor Beam Web Bending due to Girder Rotation without Retrofits*

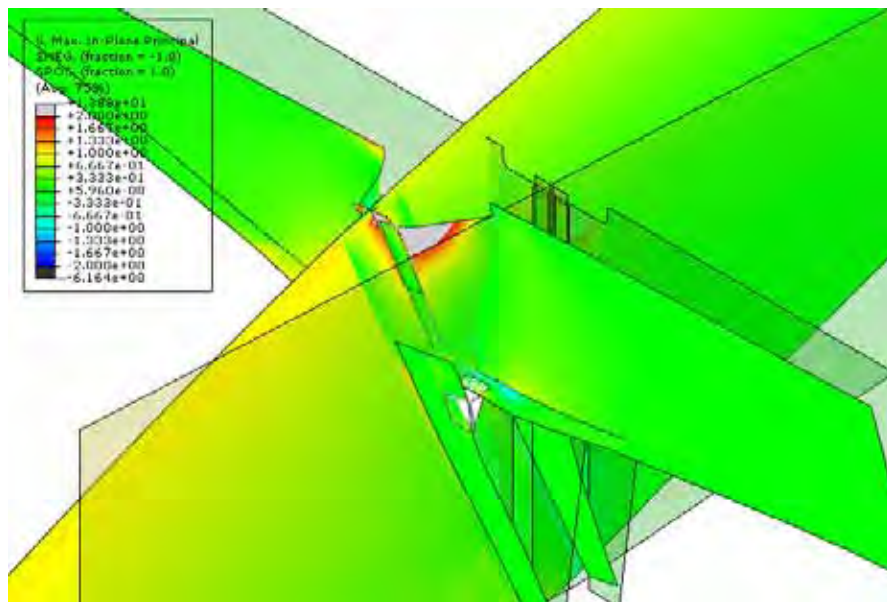
*Figure 9.16: Floor Beam Web Bending due to Girder Rotation with Brace Plate Retrofit*
