CENTER FOR TRANSPORTATION INFRASTRUCTURE AND SAFETY

Spalling Solution of Precast -Prestressed Bridge Deck Panels

Lesley Sneed, Ph.D., P.E. Abdeldjelil "DJ" Belarbi, Ph.D., P.E. Young-Min You, Ph.D., P.E.

FINAL REPORT

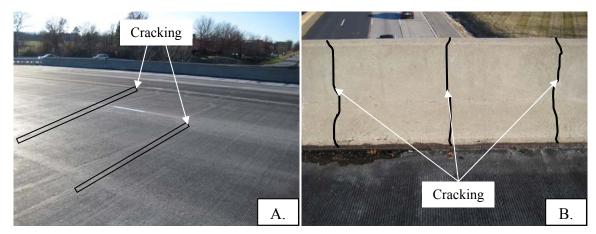
Deterioration conditions observed were similar in nature in each bridge deck. Transverse cracking extended over the entire bridge deck in a "zigzag" fashion and in many cases extended through the concrete barriers. Transverse cracks appear to be reflective cracks that formed directly over the panel joints. Figure 4-1 shows examples of the cracking observed in the bridge decks. Observed water stains, efflorescence, rust seepage and spalling at the bottom surface of many panels indicate deterioration and corrosion of steel is occurring. Its main cause is most likely due to the ingress of carbonation and chlorides into the concrete. Figure 4-2 shows three different panel joints with water staining and efflorescence surrounding the spalled area, which exposes much of the panel reinforcement at the panel edge. The transverse cracks above provide a direct route for chlorides to reach prestressing tendons embedded in the prestressed panel. No

Figure 4-1 Crack Propagation in Bridge Deck (A. Cracking in the CIP topping, B. Cracking from the CIP topping extending to the concrete barrier (highlighted for clarity)) (Bridge A4704)

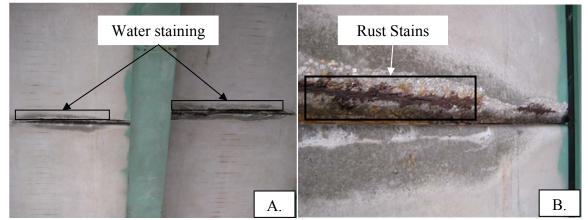
Figure 4-2 Spalling, Efflorescence, Water Staining and Rust Stains Observed in PPC panels (A. Adjacent panel joints, B. Close-up shot of panel joint) (Bridge A4704)

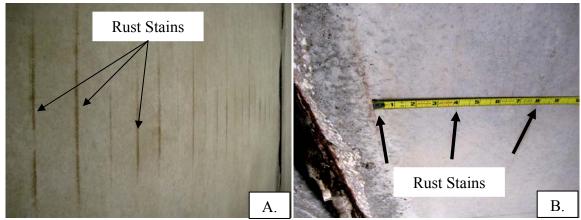
Rust colored stains were also observed on the surface of many panels as shown in Figure 4-3. The spacing of these stains is approximately 4 in. and is consistent with tendon spacing. No cracking was observed in the panels at or near the discoloration lines.

Figure 4-3 Rust Stains Observed on the Panel Surface (A. Rust stains along the entire width of the panel, B. Rust stain spacing at 4 in. on center) (Bridge A4704)

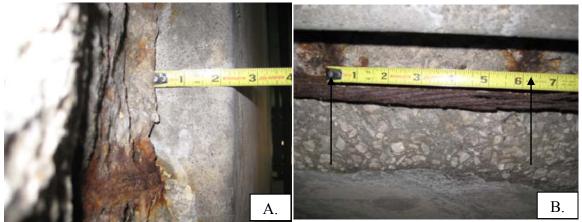
Figure 4-4 and Figure 4-5 show exposed tendons and spalled concrete sections. In Figure 4-4, the spall thickness is approximately 2.5 in. deep. The spalling not only exposes the prestressing but also the mild reinforcement spaced at 6 in. on center. Partially or completely ruptured tendons, shown in Figure 4-5, indicate the extent of corrosion in these systems.

Figure 4-4 Spalled Sections of PPC Panels (A. Depth of a spalled section, B. Exposed mild reinforcement in a spalled section) (Bridge A4067)

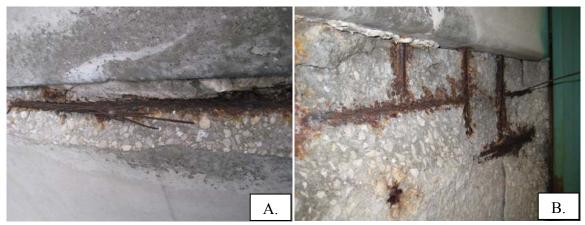
Figure 4-5 Ruptured Tendons in Spalled Section (A. Partially ruptured tendon, B. Completely ruptured tendon) (Bridge A4067)

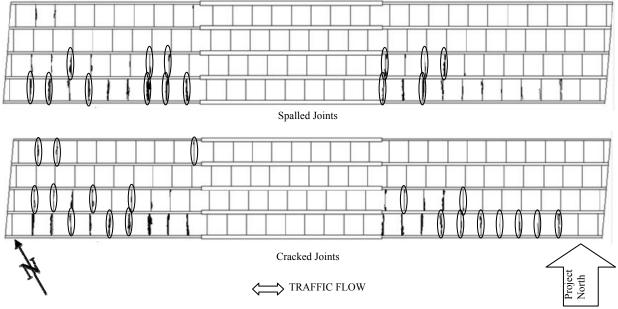
At the time of this investigation, 15 of the 116 total panel joints (13%) have started to spall, and an additional 19 joints have begun cracking at the edges, an early stage of spalling. Spalling was limited to the south side of the bridge, Panel Lines C and D. Panel Line D included nine of the spalled joints, and Panel Line C included six spalled joints. The extent of the spalling in Panel Line C is not as advanced as that found in Panel Line D. Figure 4-7 shows a full bridge deck bottom surface view of the spalled panel joints. Of the 15 spalled joints, tendons were exposed in 14 joints. Measurements at spalled sections showed edge distance to tendon ranged from 1.5 to 2.0 in. (center of tendon to edge of concrete). Cracking in the panels was limited to Panel Line A, C and D at the panel joint locations. Figure 4-7 also shows the locations of panel joints with cracking but no spalling. No additional cracking was observed in the other portions of the panels. Efflorescence observed in 88 panel joints tended to be less prevalent in the panels placed in the middle and at the ends of the bridge deck. The same is true for water stains observed at the panels joints with the exception of panel joints located in Panel Line B. Only four of the 29 panel joints in Panel Line B contained water stains. Of the 116 full size panels, 96 included discoloration lines in the middle of the panels that had a spacing of 4 in. on center. Most of these lines had a grayish or rust colored tint to them. No cracking was observed along these lines.

Figure 4-7 Panel Spalling and Cracking Locations

Visual inspection findings indicated a nonuniform distribution of deterioration occuring in the panels of the bridge decks. Spalling was limited to Panel Lines D and C (Figure 4-7), and more importantly, panels located in the middle of the bridge deck (in the longitudinal direction) had little to no signs of deterioration. GPR and rebound hammer data confirm this relationship as explained below. All data indicate that panels located in the region of the deck with increased longitudinal reinforcement in the CIP slab are less deteriorated, which is likely the result of a lesser amount of chlorides because the additional reinforcement provides improved transverse crack control.

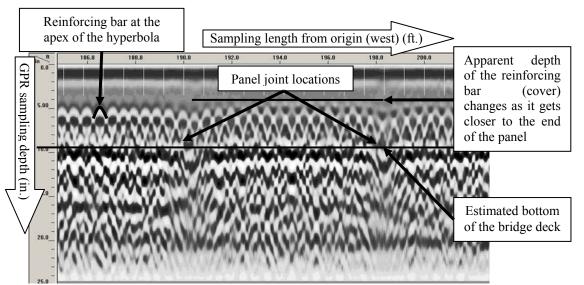
Panel joints could be located accurately on the longitudinal GPR profiles obtained from the top surface of the bridge deck, in large part because they are characterized by deteriorated concrete and propagate in the transverse direction across the bridge deck. Figure 4-8 shows GPR data acquired along the top surface of the deck along Panel Line D; the locations of two joints are highlighted in the figure. Anomalously high travel times (large apparent depths) and anomalously low amplitudes characterize the GPR image of reinforcing bar in immediate proximity to the panel joints. Both features are normally indicative of concrete degradation. In addition, the arrival time (apparent depth) of the reflection from the base of the concrete slab is anomalously high, presumably because of deterioration of the concrete. These interpretations are consistent with the visual inspection data. As described in Section 4.3.2, reflective cracking was observed in the CIP portion of the bridge deck, and water stains and cracking were observed in the PPC panels of the bridge deck in these locations.

Figure 4-8 GPR Data Acquired on the Top Surface of the Deck Along Panel Line D During the Longitudinal Scan

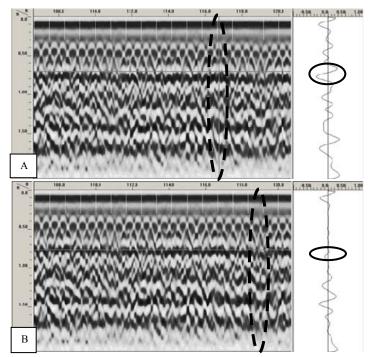
Pulse magnitudes were also reviewed at key segments of the data profile. The pulse magnitude indicates the amount by which dielectric properties differ. The larger the pulse magnitude is the greater the difference in dielectric permittivity of the two materials. Figure 4-9 depicts GPR data acquired in the longitudinal direction from the top surface of the bridge deck over Panel Line C. The graph to the right of the profile depicts pulse magnitude along the horizontal axis versus travel time along the vertical axis. The wavelet encircled by the solid line in Figure 4-9A is the reflected signal from the bottom of the bridge deck in the middle of a panel where there is little to no visual evidence of degradation. It has maximum amplitude of ± 0.4 . In comparison, Figure 4-9B shows the GPR reflection from the bottom of the bridge deck near a panel joint where there is visual evidence of degradation. The relatively low pulse amplitude supports the hypothesis that degradation is occurring in proximity to the joint.

Figure 4-9 GPR Data Obtained During the Longitudinal Scan, and Graph Showing Pulse Magnitude vs. Travel Time (A. Non-degraded or non-delaminated area, B. Degraded or delaminated area)

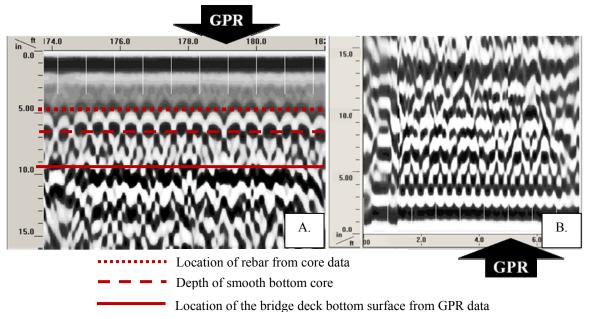
Figure 4-10 GPR Data Acquired on August 11, 2009 (A. Data acquired from the top surface of the bridge deck, B. Data acquired from the bottom surface of the bridge deck)

In an attempt to examine deterioration within the thickness of the bridge deck, data acquired from the top and bottom surfaces of the bridge deck were compared. Figure 4-10 shows data acquired from both the top and bottom surfaces of the bridge deck on August 11, 2009. Figure 4-10A shows data acquired from the top surface of the bridge deck in the longitudinal direction

over a length of 8 ft. Figure 4-10B shows data acquired from the bottom surface of the bridge deck of the 8 ft. wide panel located in the area corresponding to Figure 4-10A. Both figures show increasing depths to reinforcement near the edges of the data (panel joint locations) indicating degradation at the panel joints.

GPR data obtained in the longitudinal direction from the top and bottom surface of the bridge decks were also correlated with findings from core C-7. The location of core C-7 with respect to the GPR data is shown in Figure 4-10 from the upper and lower deck views. This core had a

smooth bottom surface and included reinforcement. The depth of the reinforcement and core were mapped on the GPR data obtained from the top of the bridge deck. This core, taken in the middle of a spalled panel, contained a measured chloride ion content suggesting corrosion was not probable in the CIP portion of the bridge deck; however, some delamination was most likely occurring in the area because of the smooth bottom surface of the core. Figure 4-10A shows GPR data acquired from the top surface, and Figure 4-10B shows GPR data acquired from the bottom surface of the bridge deck in this region. Apparent depth of reinforcement and slab thickness shown on the GPR data obtained on the top surface of the bridge deck correlates well with the core data, which indicates little to no delaminations; however, little information pertaining to the cross-section of the bridge deck could be obtained from the bottom surface GPR data due to the close spacing of the tendons (4 in. spacing).

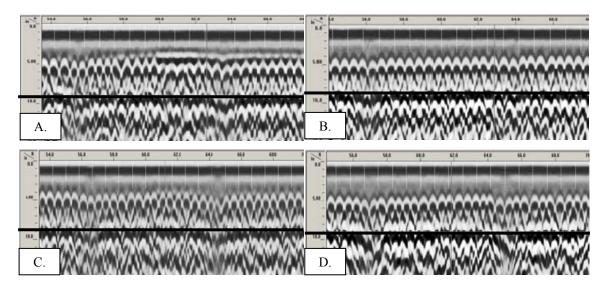
The varying degree of degradation from one panel line to the next can be seen in Figure 4-11. This figure shows GPR data taken in the longitudinal direction from the top of the bridge deck in the four different panel lines at the same location measured along the length of the bridge. The solid lines indicate the GPR representation (apparent location) of the bottom of the bridge deck in that area. When the data for the four panel lines are compared, varying (apparent) reinforcing bar depths and concrete thicknesses are observed. As expected, apparent reinforcing depths and concrete thicknesses are greatest on Panel Line D because it is the most deteriorated based on the visual inspection data.

Figure 4-11 Apparent Depth of Deck from GPR Shots Obtained on Top of the Bridge Deck in the Longitudinal Direction Over Varying Panel Lines (A. Panel Line A = 9.2 in, B. Panel Line B = 8.7 in., C. Panel Line C = 8.8 in., D. Panel Line D = 9.3 in.)

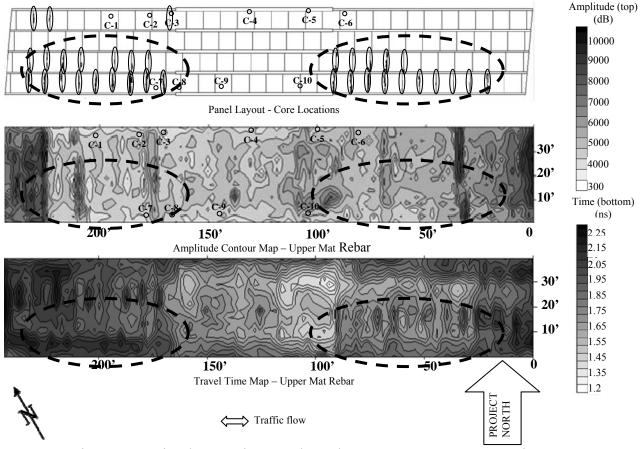
Additional graphical representation of relative deterioration was depicted in contour maps using RADAN interpretation software (GSSI 2007). The contour map of the rebar reflection amplitudes from the upper mat of rebar is shown in Figure 4-12. Once the EM energy is emitted into the concrete, the energy can be absorbed, refracted or reflected back to the antenna. The amount by which the energy is absorbed, reflected or refracted depends greatly on the complex permittivity of the material. The permittivity of the material is influenced by the temperature, moisture content and salt content of the material as well as the material pore structure and the EM energy pulse frequency (Maierhofer 2003). This map, based on data obtained in the transverse direction, shows that relatively higher amplitude signals exist in the ends of the bridge deck. The amplitude of the signal is a measurement of dielectric permittivity contrasts between the concrete and the rebar and is recorded in decibels (dB). Smaller amplitudes indicate areas of increased deterioration. According to the contour map, less deterioration is occurring at the ends and middle portions of the bridge deck.

A contour map of the travel times to the upper mat of rebar is also presented in Figure 4-12 that shows the signal travel times to the upper mat of rebar in nanoseconds (ns). The velocity at which EM energy travels through a material is dependent upon the material dielectric constant, or dielectric permittivity. As the dielectric constant of the material increases, the velocity at which EM energy propagates through the given material decreases. Normally, the longer travel times would indicate more deterioration in the system.

Figure 4-12 Visual Inspection Results and GPR Contour Map Comparison

Two contour maps were created from the GPR data to display possible areas of deterioration and delaminations (Figure 4-12). Visual inspection results are also shown in the figure for comparison. Figure 4-12 shows the GPR interpretation of deterioration in the bridge deck through the reinforcement reflection amplitude and signal travel time contour maps versus the visual inspection results from the bottom side of the bridge deck. The circled portions of each diagram correspond to the locations with the worst case of spalling and cracking observed in the panels on the bridge deck. These areas should presumably correspond to the worst delaminating areas in the CIP topping slab because the CIP topping slab is the concrete through which the chlorides are progressing to allow tendon corrosion.

GPR data gathered in the area of the dashed circles located on the east side of the bridge correlates well with the visual inspection data for both contour maps. The amplitude map shows lower areas of reinforcement reflection amplitudes (lighter sections), and the travel time map shows longer travel times (darker sections) in the circled area especially close to the east end of the bridge deck. There is, however, a "strip" of darker area in the reinforcement reflection amplitude map located inside of the circle, indicating less deteriorated concrete. This area is directly over the mid-width of a panel and not near a panel joint. This confirms that most of the deteriorated concrete is concentrated over the panel joints alone, and that there are no additional delaminations occurring between the panel joints in the CIP topping.

GPR data on the west side of the bridge deck show excessively long travel times in the signal travel time map, indicating deterioration, and some areas of lower reinforcement reflection amplitudes in the amplitude map. Again, the amplitude map includes "strips" of relatively high amplitudes. The "sinkhole" areas of longer travel times in the signal travel time map likely correspond to the reflective cracking in the CIP topping over the panel joints observed during the visual inspection. The scan lines in the west portion of the deck appear to have acquired data over the reflective cracking occurring over Panel Lines B and D, and the scan lines acquired in the east portion of the bridge deck appear to have acquired data over the reflective cracking occurring over Panel Lines B and D.

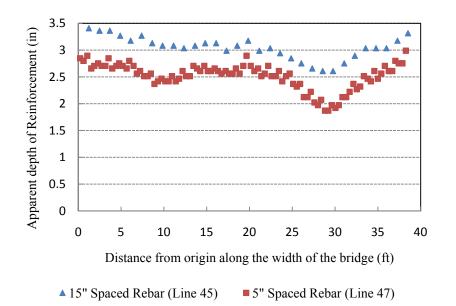
Lesser degredation of concrete within the anomoly region is confirmed with the GPR scan in the transverse direction. Figure 4-13 shows the variation in apparent reinforcement depths in two scan lines, Lines 45 and 47, in the transverse scan. Line 45 is located just outside the anomoly region, and Line 47 is located just inside the anomoly region. The figure shows a decrease in apparent reinforcement depth as the spacing of the reinforcement decreases. Since the actual depth of reinforcement is the same in both cases, the decrease in apparent reinforcement depths indicates less deteriorated concrete.

Figure 4-13 Apparent Reinforcement Depth - Transverse GPR Scan Lines 45 and 47

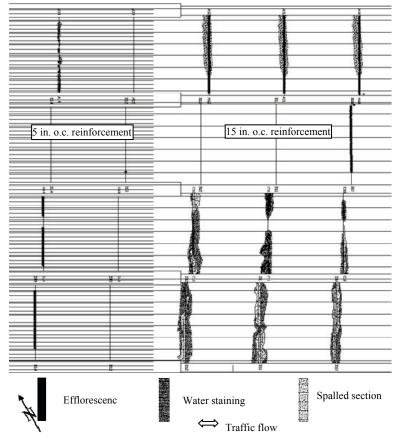
The location of the GPR anomoly (additional reinforcement) was mapped along with the spalling, cracking, efflorescence and water staining visual inspection results. Figure 4-14 shows a portion of the bottom surface of the bridge deck at the transition between 15 in. spaced reinforcement, located on the right side figure, and 5 in. spaced reinforcement, located on the left side of the figure. The CIP reinforcement overlays the panel mapping for visual aid. Note the spalled and waterstained joints in Panel Line D. The area with the closer spaced reinforcement shows less signs of water stains and no spalling or cracking. The locations of spalled and water stained joints clearly show that more deterioration is occurring in areas with decreased reinforcement.

Figure 4-14 Relationship Between Longitudinal Reinforcement Spacing in CIP topping and PPC Panel Deterioration (A. 5 in. spacing, B. 15 in. spacing)

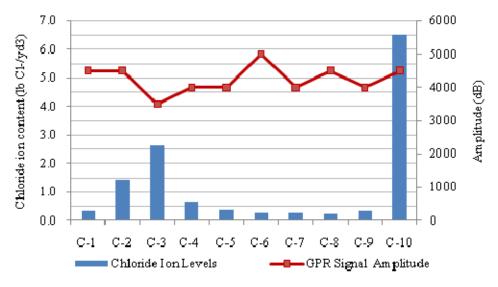
For additional comparison, each core was plotted on the amplitude contour map. Figure 4-12 shows the locations of the cores with respect to the amplitude contour map created from the transverse scan GPR data. The amplitude values for each core location were then compared with the amplitude values with the highest chloride ion content found in each core (Figure 4-16). GPR data yielded results that did not always correlate with the chloride ion values measured in each

core. For example, core C-10 had the highest chloride ion value, but was not in an area of the lowest amplitude. Core C-10, taken directly over a reflective crack in the CIP topping, is a spot measurement, and the crack would allow more chlorides to ingress into the concrete at that spot. GPR data, however, indicates the concrete integrity in a given area and the concrete area around core C-10 may be very sound.

Figure 4-16 Chloride Ion Levels of Each Core Versus the Amplitude Measurement of Each Core

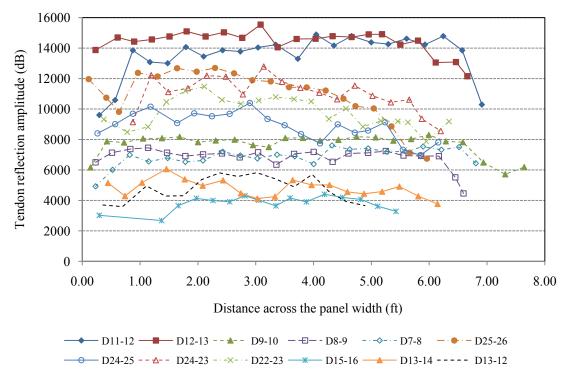
GPR data were obtained on the bottom surface of the bridge deck in an attempt to determine the relative condition of the prestressing tendons. Unfortunately, because of the apparatus used and difficulty in maneuvering in the lifts, the antenna was not always directly coupled to the surface of the panel resulting in changes of the angle of the antenna with respect to the panel. As a result, much of the data obtained was unusable in comparing relative panel-to-panel deterioration, but the general relationship of the data proved useful. Through the use of the reinforcement reflection-picking tool in RADAN, the amplitude of each tendon reflection was acquired for all panels selected for the GPR data acquisition located in Panel Line D, which exhibited the worst case of spalling. Figure 4-18 shows the average amplitudes recorded for each tendon reflection acquired on selected panels. As shown in the graph, many of the panels had varying amplitudes, but most had the general relationship of lower amplitudes at the panel ends, near the joints, and higher amplitudes in the middle of the panels. Lower amplitudes at the joints indicate that more deterioration is occurring in tendons at the edges than within the middle of the panels.

Figure 4-18 Average Tendon Reflection Amplitudes on Panels Located in Panel Line D

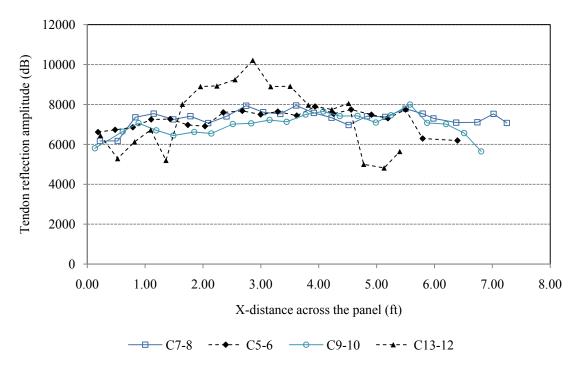
All of the panels shown in Figure 4-18 have discoloration lines on the bottom surface, so an additional plot of tendon reflection amplitude data from panels in Panel Line C is shown in Figure 4-19. Dotted lines were used to connect the data points acquired on panels without the discoloration lines (Panels C5-6 and C13-12), and solid lines were used to connect the data points acquired on panels with discoloration lines (Panels C7-8 and C9-10). The figure shows similar relationships between plots of data acquired from panels with the discoloration lines and the panels without the lines. This indicates that no additional corrosion is occurring in panels with the discoloration lines; therefore, there is no evidence supporting the assumption that the discoloration lines are indicative of corrosion occurring in the tendons.

Figure 4-19 Average Tendon Reflection Amplitudes on Panels Located in Panel Line C

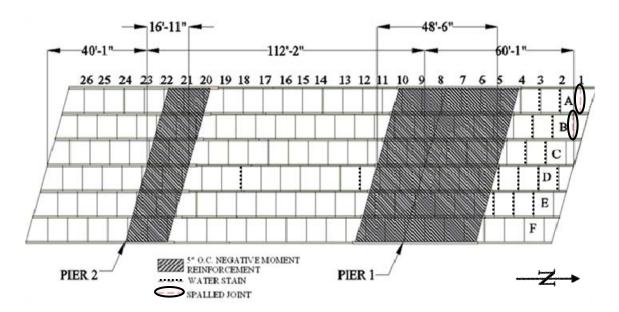
The objective of the bridge investigation was accomplished by viewing as many panels as possible from behind the guardrail or from one lane closure. These positions allowed a clear viewing of all of the panels within 50 feet of each pier. Figure 4-20 shows the panel layout of Bridge A4067 with the labeling rubric used for the investigation. Figure 4-21 shows the panel

layout for Bridge A4705. The figures also highlight locations of additional reinforcement in the CIP bridge deck topping as specified in the bridge drawings. Span length dimensions as well as lengths of areas with extra reinforcement are also shown. Due to the limited number of spalled panel joints observed, joints with water staining deterioration were dually observed and recorded. on each of the figures. Observed spalled joints are circled, and water stained joints are marked with a dotted line. Only two spalled panel joints were identified in Bridge A4067 and three in Bridge A4705. No spalled or water stained joints were observed in panel joints located under the areas containing the additional negative moment reinforcement in the CIP topping.

Figure 4-20 Visual Inspection Results for Bridge A4067

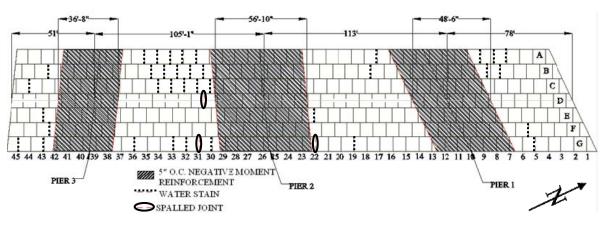
Figure 4-21 Visual Inspection Results for Bridge A4705

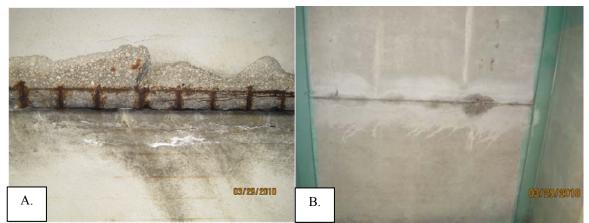
Figure 4-22 shows the worst case spalling found in Bridge A4067. The outermost tendon is completely ruptured, and several sections of rebar are fully exposed. The worst deterioration on this bridge deck occurred at the edge of the west abutment. The bridge deck slopes downward from west to east at a grade of -5.00%. Given this slope, it is logical to conclude that the excess deterioration is not caused by the ponding of water in this area.

Figure 4-22: Images of Bridge Deterioration from St. Louis Bridge Investigations (A. Worst case spalling found in Bridge A4067, B. Panel joint experiencing waterstaining and efflorescence in Bridge A4705)

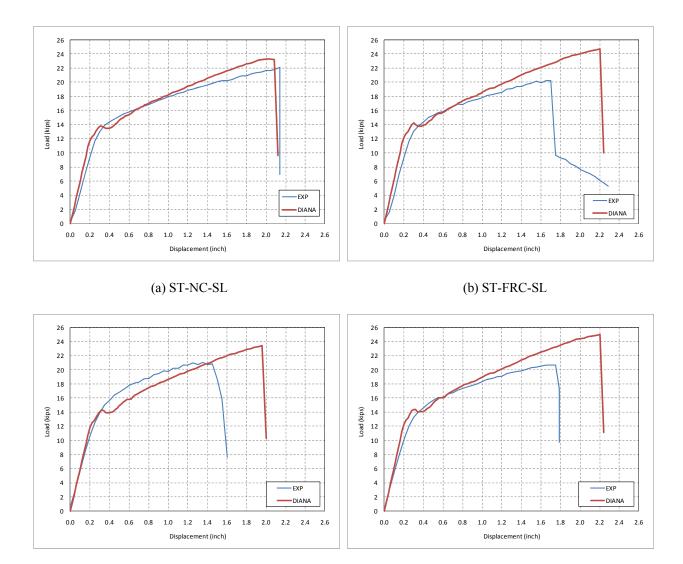
(c) CFRPT-NC-SL (d) CFRPT-FRC-SL Figure 6-14 Comparison of Load-Displacement Relationships at Loading Point Location

The experimental load-displacement relationships at the point of application of the load (E-2 in Figure 5-2) are compared with FE analysis results as shown in Figure 6-14. Ultimate strengths and corresponding displacements are summarized in Table 6-3.

FE analytical results shown in Figure 6-14 show reasonable agreement with test results regarding the overall behavior. Most of the experimental results, however, show less ductile behavior than FE analytical results with the exception of the control panel, ST-NC-SL. There are several reasons for this phenomenon. First, this phenomenon is mainly attributed to different material properties of concrete between the experiments and FE analysis. As observed in the experiments, most test specimens failed by concrete crushing at the top fiber at the ultimate state (ref. Section 5.2). Thus, the failure mode is governed substantially by the compressive strength of concrete. In particular, significant differences between test and analytical results for specimens using FRC, Figure 6-14 (b) and (d), can be explained by this reason. As mentioned above, concrete material properties adopted in the FE models were based on the manufacturer's recommendation, which indicated a 10% and 2% increase in compressive and flexural strength, respectively, from that of corresponding concrete without fibers. These differences make a large difference between experimental and analytical results as shown in the graphs. As observed in Figure 6-14 (a),

As a result, FE analysis was found to overestimate the ultimate strengths and corresponding displacements of the unit panel specimens. As shown in Table 6-3, the average ratio of ultimate strength (P_{EXP}/P_{FE}) is 0.87 with a maximum ratio of 0.95 and a minimum ratio of 0.82. FE analyses for both FRC specimens significantly overestimate both ultimate strengths and displacements. If the exact stress-strain relationship of FRC were available, this discrepancy would most likely be resolved. Good agreement (5%) between experimental and FE results of panel ST-NC-SL is explicit evidence for this explanation.

Although FE analysis somewhat overestimated the ultimate strengths and corresponding displacements, good agreement was found in the behavior before the ultimate state including cracking load, initial (uncracked) stiffness, and post-cracking behavior. The following discussions on crack patterns and stress variations on each component further address the efficiency and limitations of these analyses.

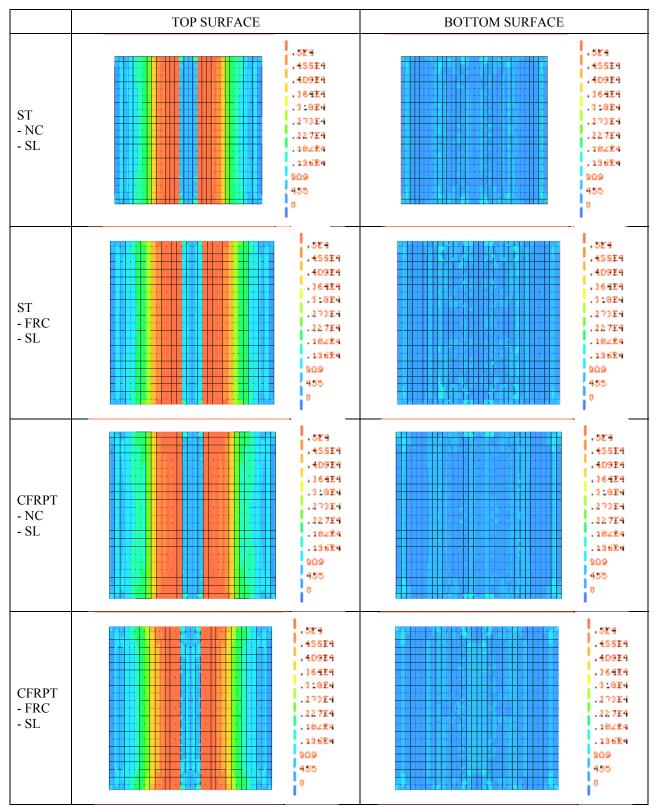
Figure 6-15 Von Mises Stress Variations on Concrete Surfaces at Ultimate State

Figure 6-15 illustrates Von Mises Stress variations on concrete on both bottom and top surfaces. Usually Von Mises stress variations are used to determine the critical local region under severe conditions. As shown in the figure, all analytical results show stress concentrations at both edge regions of the loading beam. Normal stress variations along the tendon direction are presented in Figure 6-16 with respect to the top and bottom surface. Stress values of these variations range from compressive strength on the top surface to tensile strength of concrete on the bottom surface. Thus, the failure mode of each specimen can be clearly observed from these variations. 6-17 shows strain variations across the section at midspan at ultimate state. This data can be used to compare with measured test data as well as to calculate panel curvature.

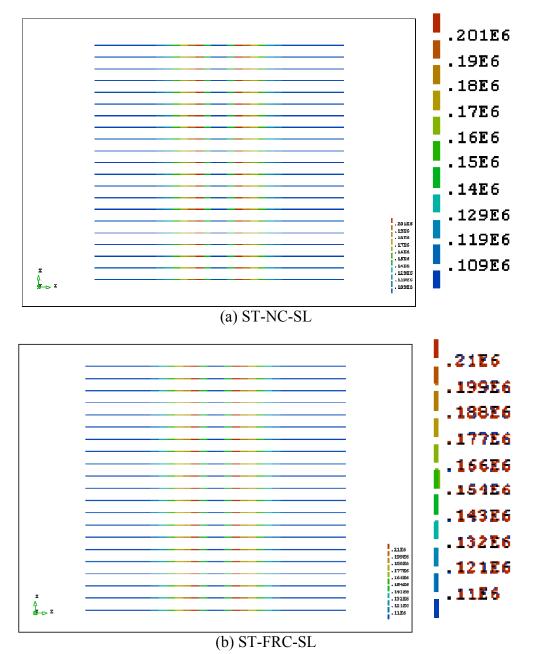
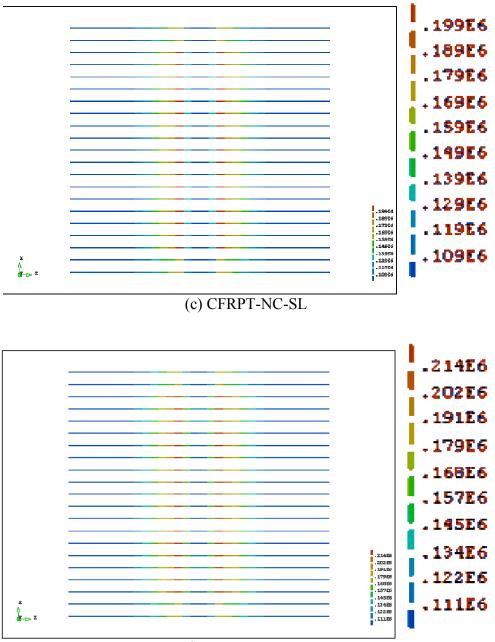
(d) CFRPT-FRC-SL Figure 6-18 Principal Tensile Stress Variations on Tendons at Ultimate State

Stress variations of reinforcement are important to determine which material governs the final failure mode and investigate the effects of using different materials. Figure 6-18 illustrates the principal tensile stress variations on tendons at ultimate state with detailed values depicted in legend. Although stress levels are somewhat different for a given panel, all values are below the tendon yield strength. From this observation, it is clear that failure is governed by concrete crushing and not by yielding of reinforcement. In addition, comparison between normal and fiber reinforced concrete reveals that relatively higher stress values are observed in FRC specimens due to higher loading capacity of these members. CFRP tendons participate less in the load-carrying capacity than steel tendons. Accordingly, CFRP tendons can have more reserve to withstand further loading increase than steel tendons with respect to their strengths.

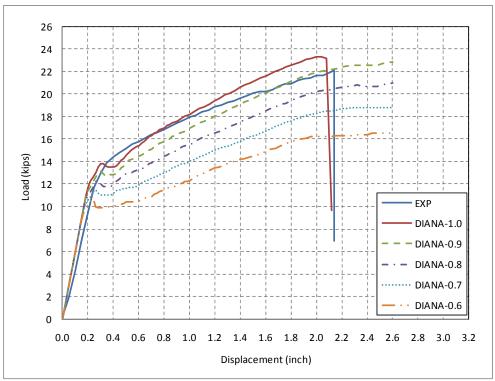
Figure 6-19 Load-Displacement Relationships of Corroded Panels

Figure 6-19 shows load-displacement relationships for all analytical models. As shown in the figure, cracking and ultimate strengths are significantly decreased with decreasing reduction factors (corresponding to decreasing cross-section). Especially, a marked decrease in ultimate strength is observed in reduction factor, 0.7, with respect to test results as indicated in Table 6-5. Therefore, it is necessary to investigate failure modes from stress variations on concrete and reinforcement.

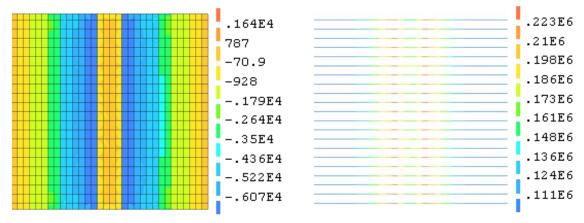
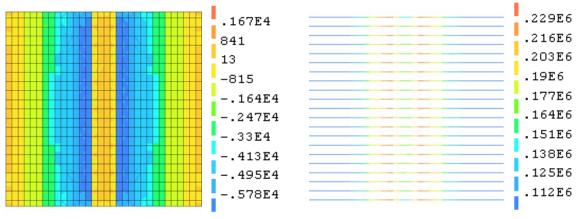
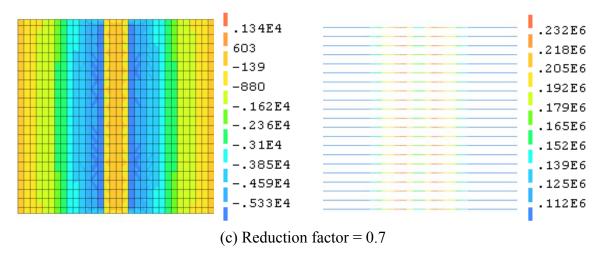
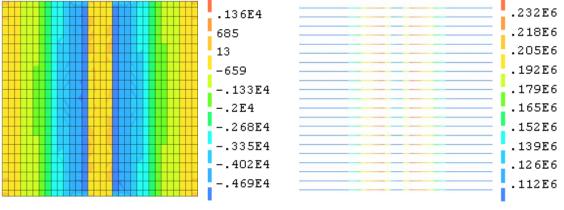
Figure 6-20 Stress Variations for Corroded Panels

Figure 6-20 shows normal stress variations at the top surface of the concrete and principal tensile stress variations on the tendons at ultimate state. Significant stress changes are observed in both concrete and tendons between reduction factors 0.8 and 0.7. After reduction factor 0.8, prestressing tendons start to yield and concrete does not reach its compressive strength. That is, yielding of the prestressing tendons governs the failure mode. Therefore, severe corrosion levels of prestressing tendons, with reduction in cross-section roughly estimated between 0.8 and 0.7, can cause substantial degradation of the ultimate capacity of the SIP panel as well as alter the failure mode.

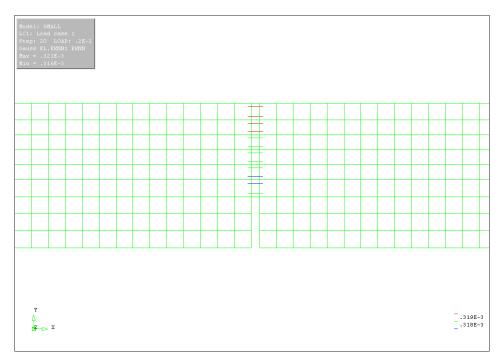
Figure 6-33 Crack Patterns on FE Models with Positive Moment Region Reinforcement at 3 Years

Von Mises stresses and crack patterns at representative times are summarized in Table 6-7. No shrinkage cracks are observed in either of the FE models at the period of 3 months, however, differences can be seen in the stress variations at this time. For the model with the positive moment reinforcement condition, different amounts of reinforcement tend to induce more stress participation from the bottom reinforcement due to the larger amount of bottom reinforcement. The model with the negative moment reinforcement condition, shows similar stress participation by both top and bottom reinforcement due to similar amounts of both reinforcement. Moreover, discontinuity at the panel joints induces a stress concentration at the bottom of the CIP topping concrete in both models. This phenomenon is observed in all analytical results regardless of time. Shrinkage cracks are observed in the model with the positive moment reinforcement condition in three years at the joint location, while no cracks are observed in the model with the negative moment reinforcement condition. Crack patterns at this time are highlighted in Figure 6-33. As shown in the figure, cracks in the top portion of the CIP concrete are wider than cracks in the bottom portion resulting in stress relief on the top portion of the concrete. These crack patterns remain the same until fifteen years with increasing crack width. In contrast, the model with the negative moment reinforcement condition finally shows shrinkage cracks at fifteen years. These crack patterns are also highlighted in Figure 6-34. As opposed to the crack patterns in the model with the positive moment reinforcement condition, cracks at the bottom portion of the CIP concrete are wider than those at the top portion. Crack widths of this model are very small, however, compared to those of the positive moment reinforcement condition model.

found that increased CIP topping reinforcement can at least retard the shrinkage cracking and change the mechanism of crack propagation.

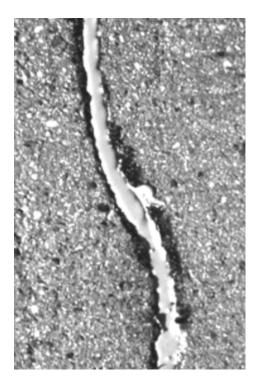
Figure 7-1 Crack Repaired by Routing and Sealing (ACI 345.1R 2006)

This treatment reduces the ability of moisture to reach the reinforcing steel or pass through the concrete. Findings from the Chapter 4 field investigations, including evidence of water staining and deterioration at the panel joint locations, indicates the consequences of moisture penetration through the concrete at the panel joint locations is a critical problem for this deck system. Thus, this treatment would be beneficial in reducing this mode of moisture transmission.

Crack routing and sealing is an appropriate choice for non-structural repair of cracks of width ranging from 0.2 - 1.0 in. as shown in Table 7-1. Much of the transverse reflective cracking observed at the panel joint locations fall into this category. Using this technique, the crack is essentially treated as a joint. Sealant materials can be epoxies, urethanes, silicones, polysulfide, asphaltic materials, or polymer mortar materials with a high elongation capacity. Surface preparation is critical in this technique, since bond failure can occur at edges of the groove.
