# **Bathymetric Surveys at Highway Bridges Crossing the Missouri River in Kansas City, Missouri, using a Multibeam Echo Sounder, 2010**

Scientific Investigations Report 2010–5207

By Richard J. Huizinga

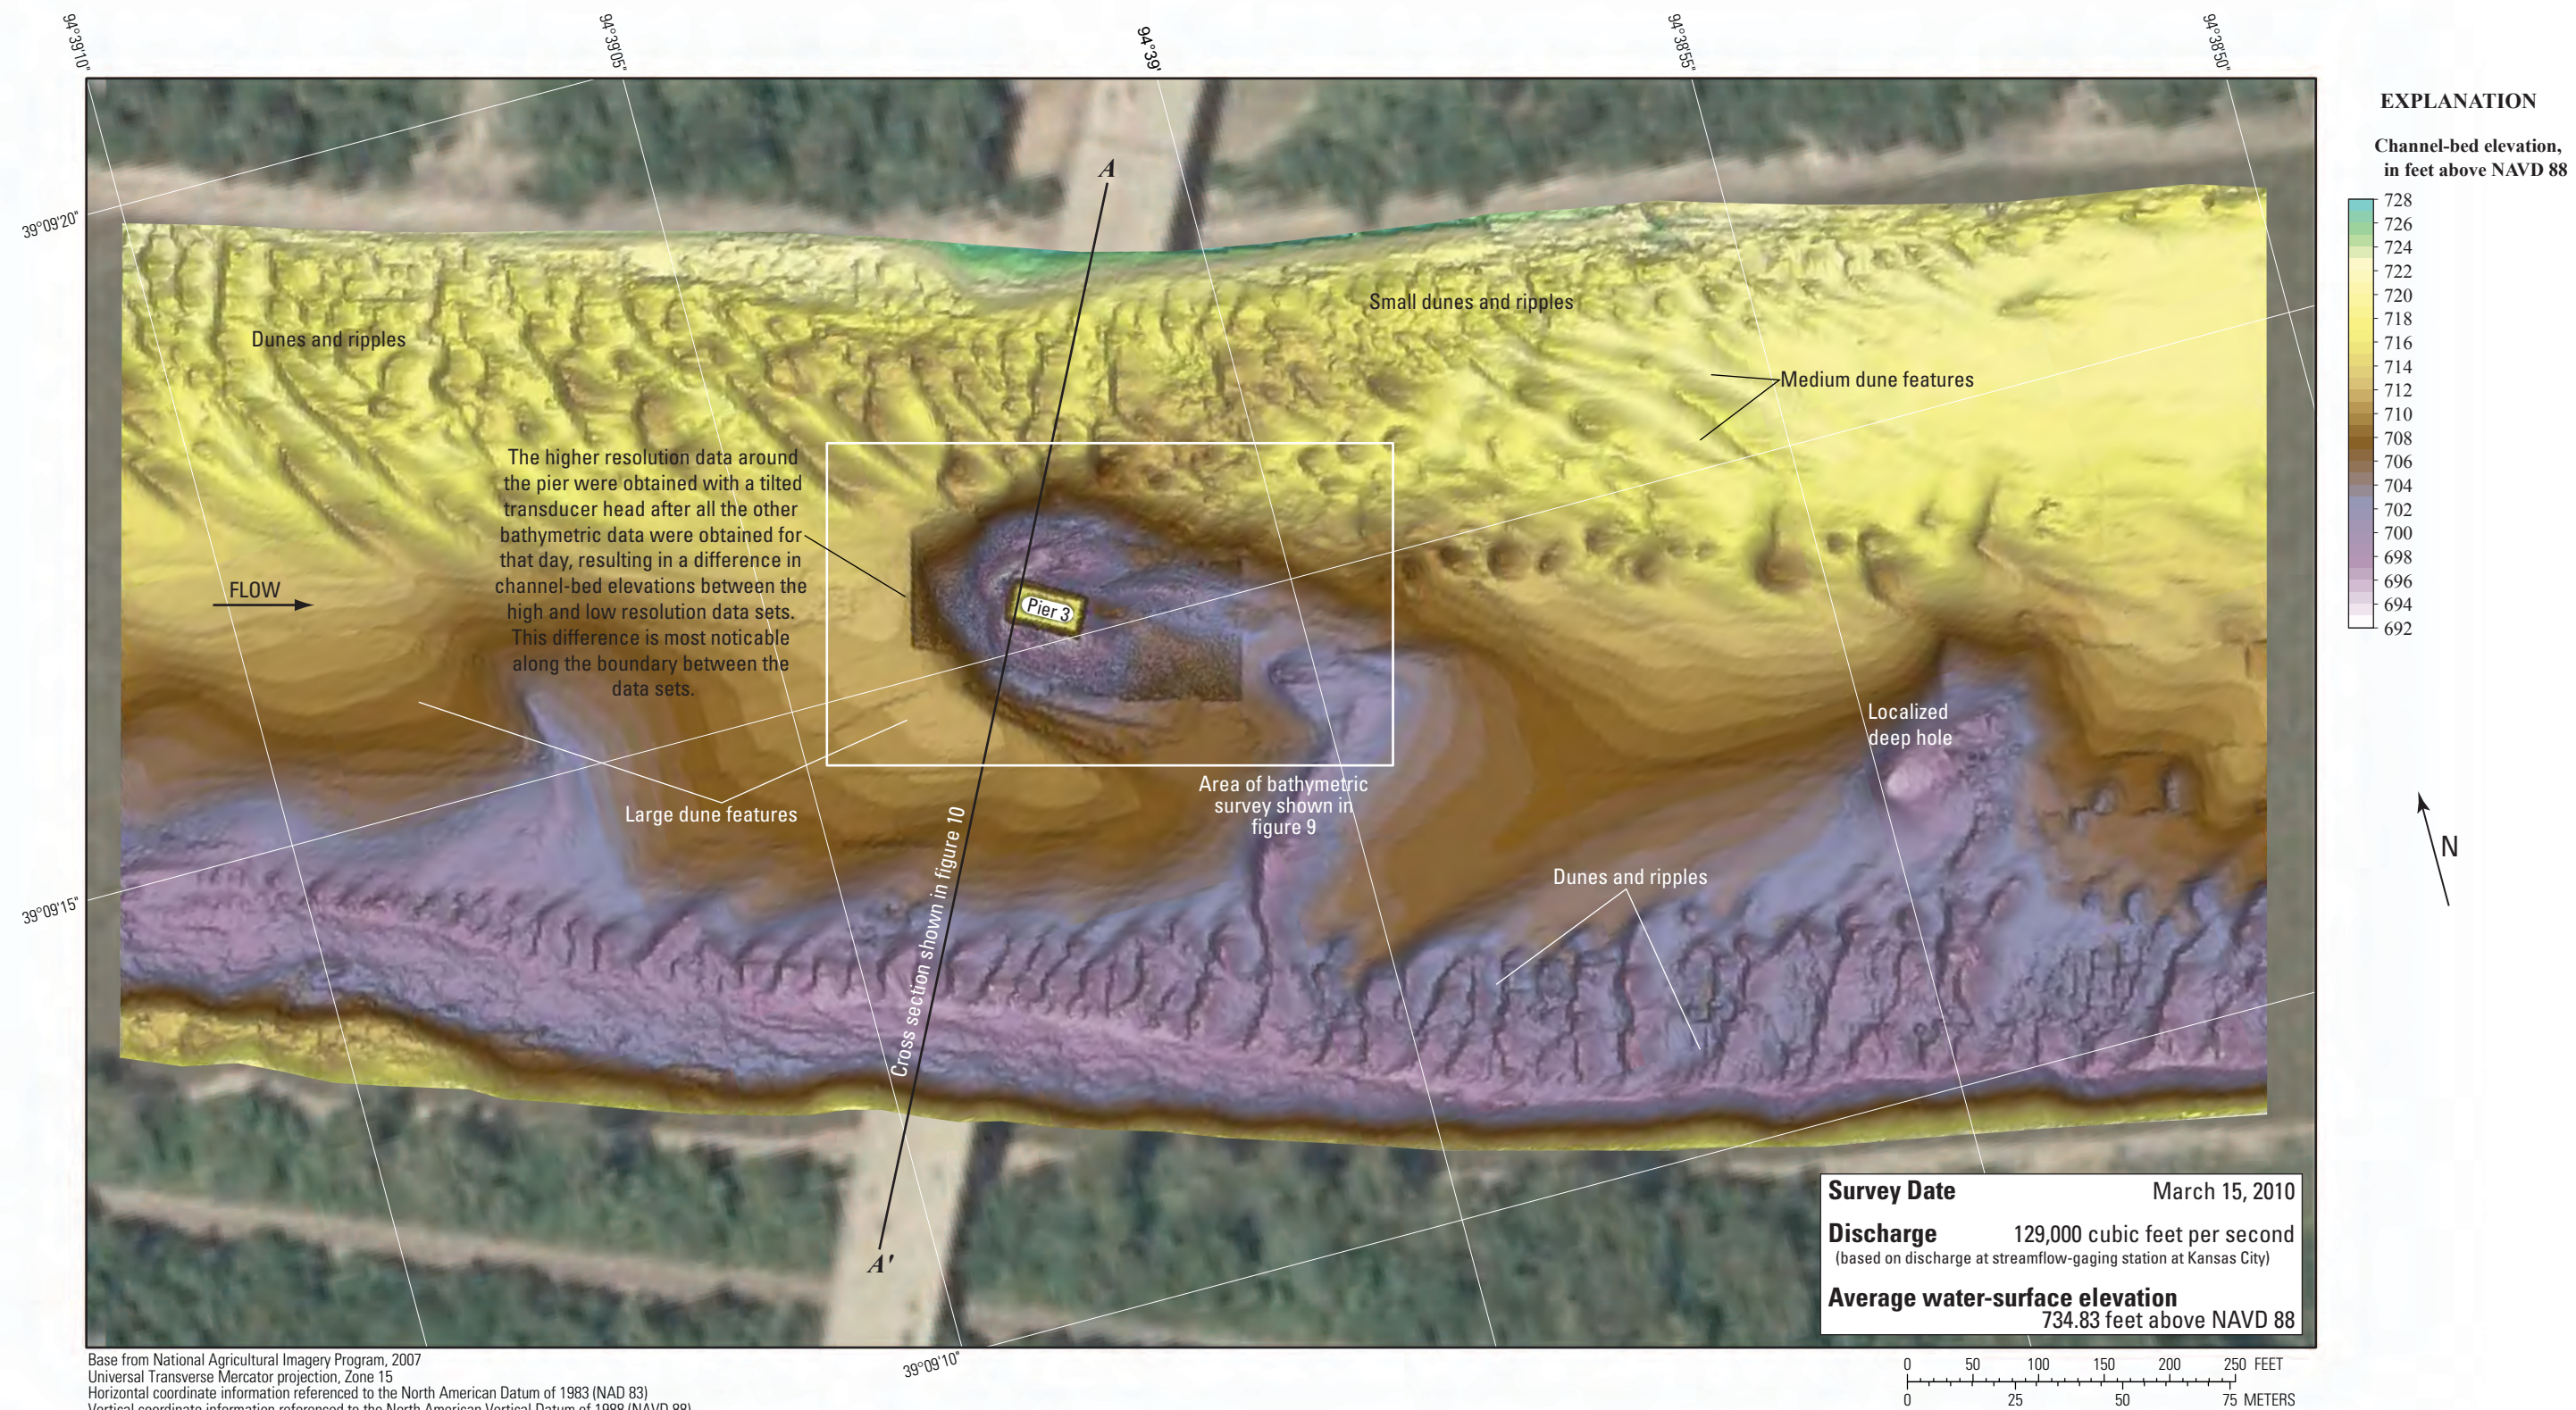
large dune features were detected in the middle of the channel, as well as a localized deep hole in the middle of the downstream channel (fig. 8). Numerous smaller dunes and ripples were along the left (north) bank on the inside of the river bend and in the channel thalweg on the right (south) side (fig. 8).

Figure 8. Bathymetric survey of the Missouri River channel in the vicinity of structure A1800 on Interstate 635 in Kansas City, Missouri.

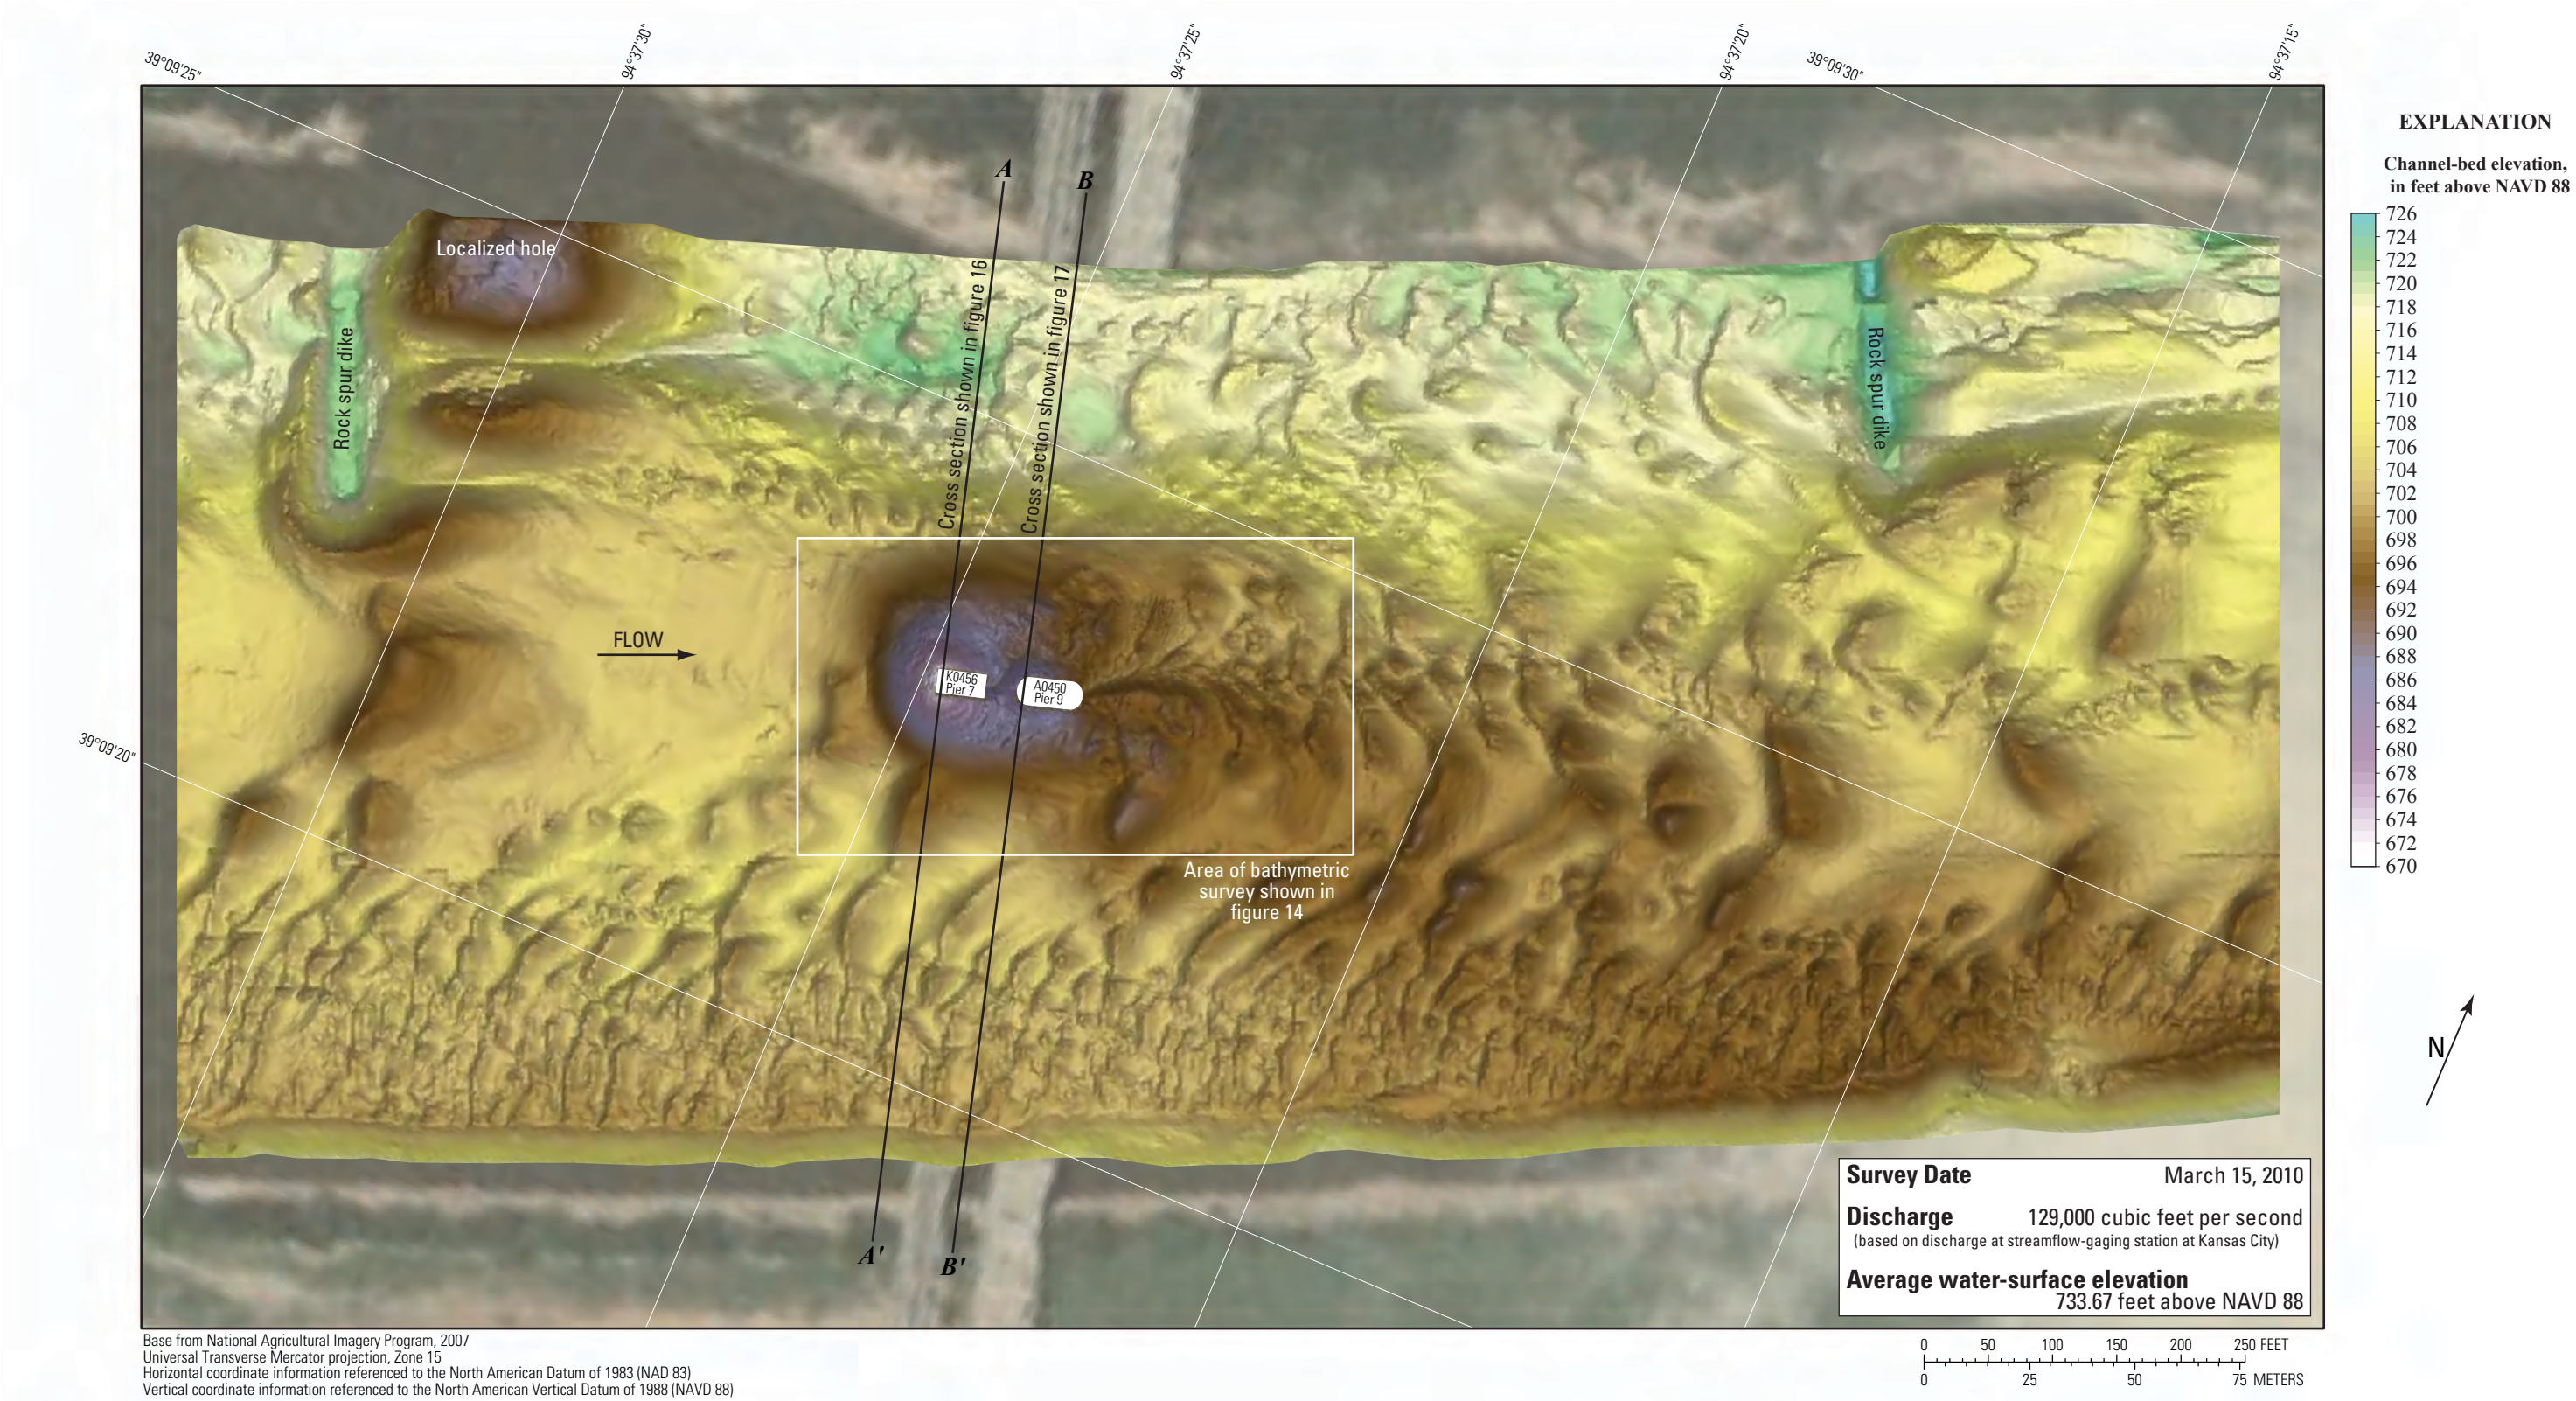
The survey area was about 1,640 ft long and about 710 ft wide, extending from bank to bank in the main channel (fig. 13). The upstream end of the survey area was about 640 ft upstream from the centerline between structures K0456 and A0450 (figs. 12, 13). The channel-bed elevations ranged from about 688 to 720 ft for most of the channel bed, except near the main channel piers. A broad, shallow thalweg along the outside of the river bend on the right (south) bank was about 5 ft deeper than the channel bed in the middle of the channel (fig. 13). Between the rock spur dikes on the inside of the bend on the left (north) bank, deposits reached an elevation of about 722 ft (fig. 13).

A localized deep hole was downstream from the upstream spur dike (fig. 13). Several large dune features were detected in the middle of the channel, as well as numerous smaller dunes and ripples throughout the channel, particularly downstream from the rock spur dikes and the main channel piers (fig. 13).

Figure 13. Bathymetric survey of the Missouri River channel in the vicinity of structures K0456 and A0450 on U.S. Highway 69 in Kansas City, Missouri.

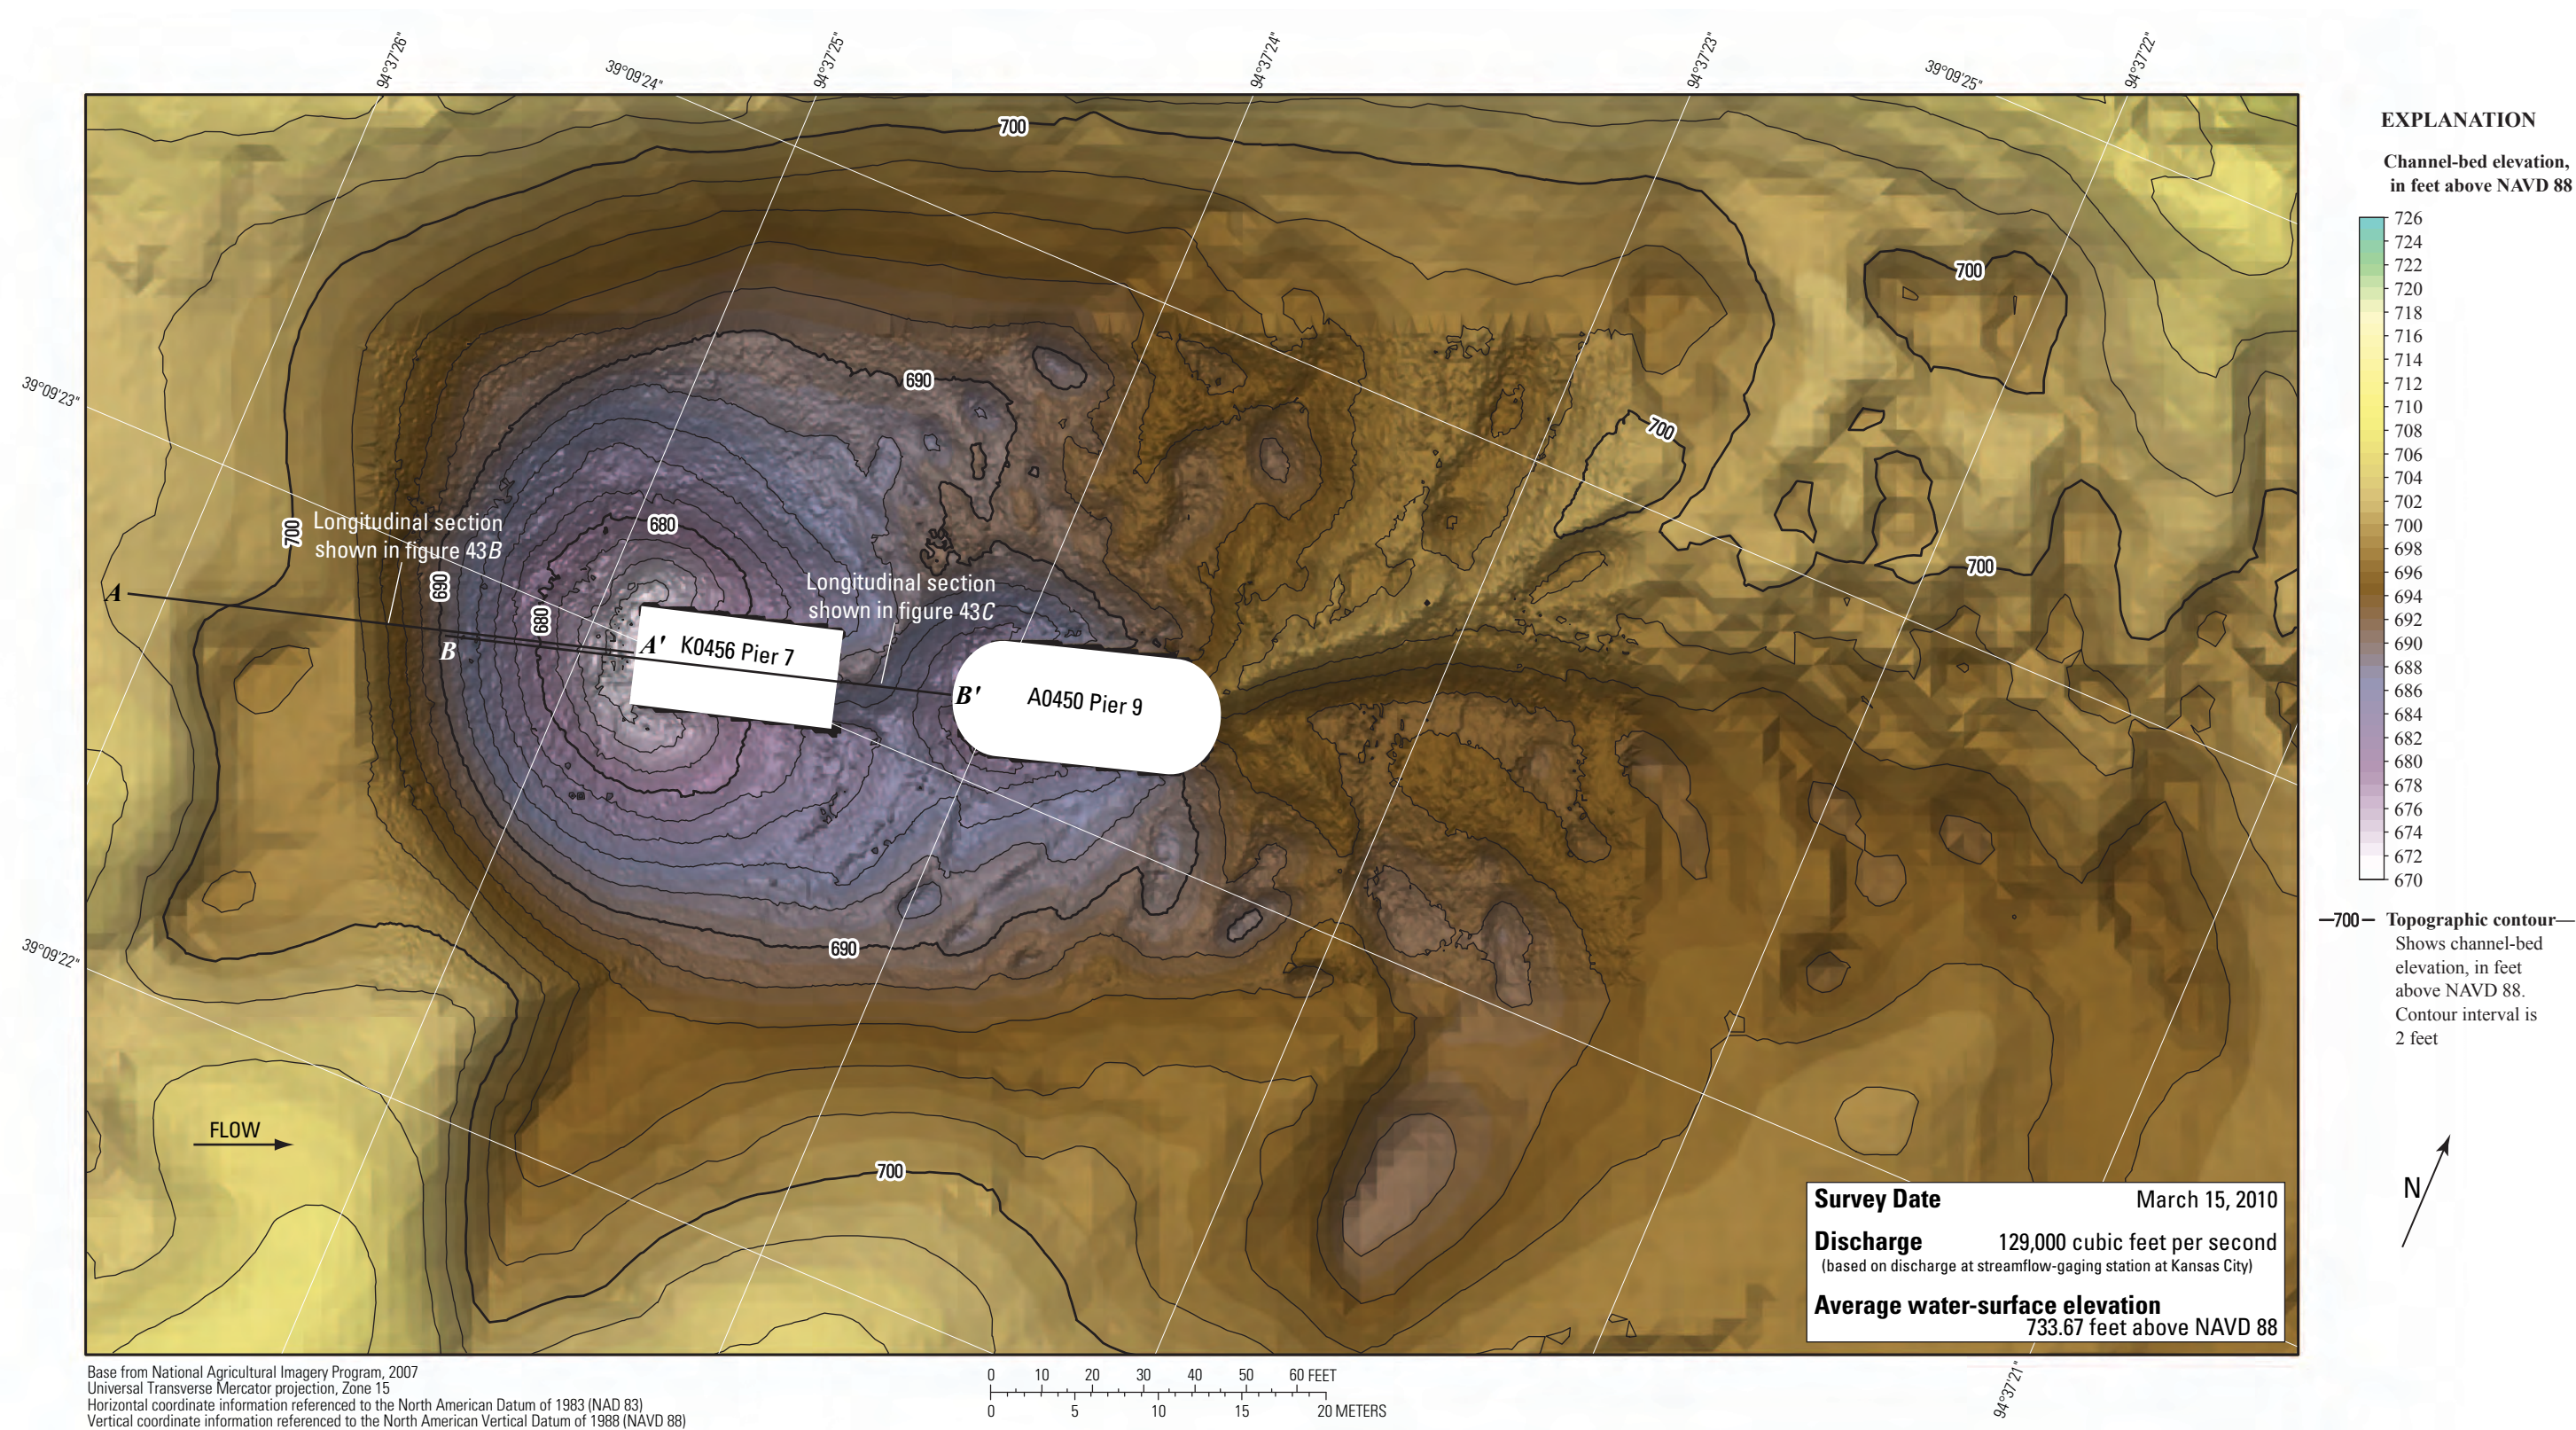
In the vicinity of the main channel pier of upstream structure K0456 (pier 7; fig. 14), a scour hole had a minimum elevation of about 672 ft (table 4), about 28 ft below the average channel bed immediately upstream from the pier. The scour hole upstream from pier 7 of upstream structure K0456 was about 9 ft deeper than the scour hole upstream from pier 9 of downstream structure A0450 (table 5).

Figure 14. Bathymetric survey of the Missouri River channel in the vicinity of the main channel piers of structures K0456 and A0450 on U.S. Highway 69 in Kansas City, Missouri.

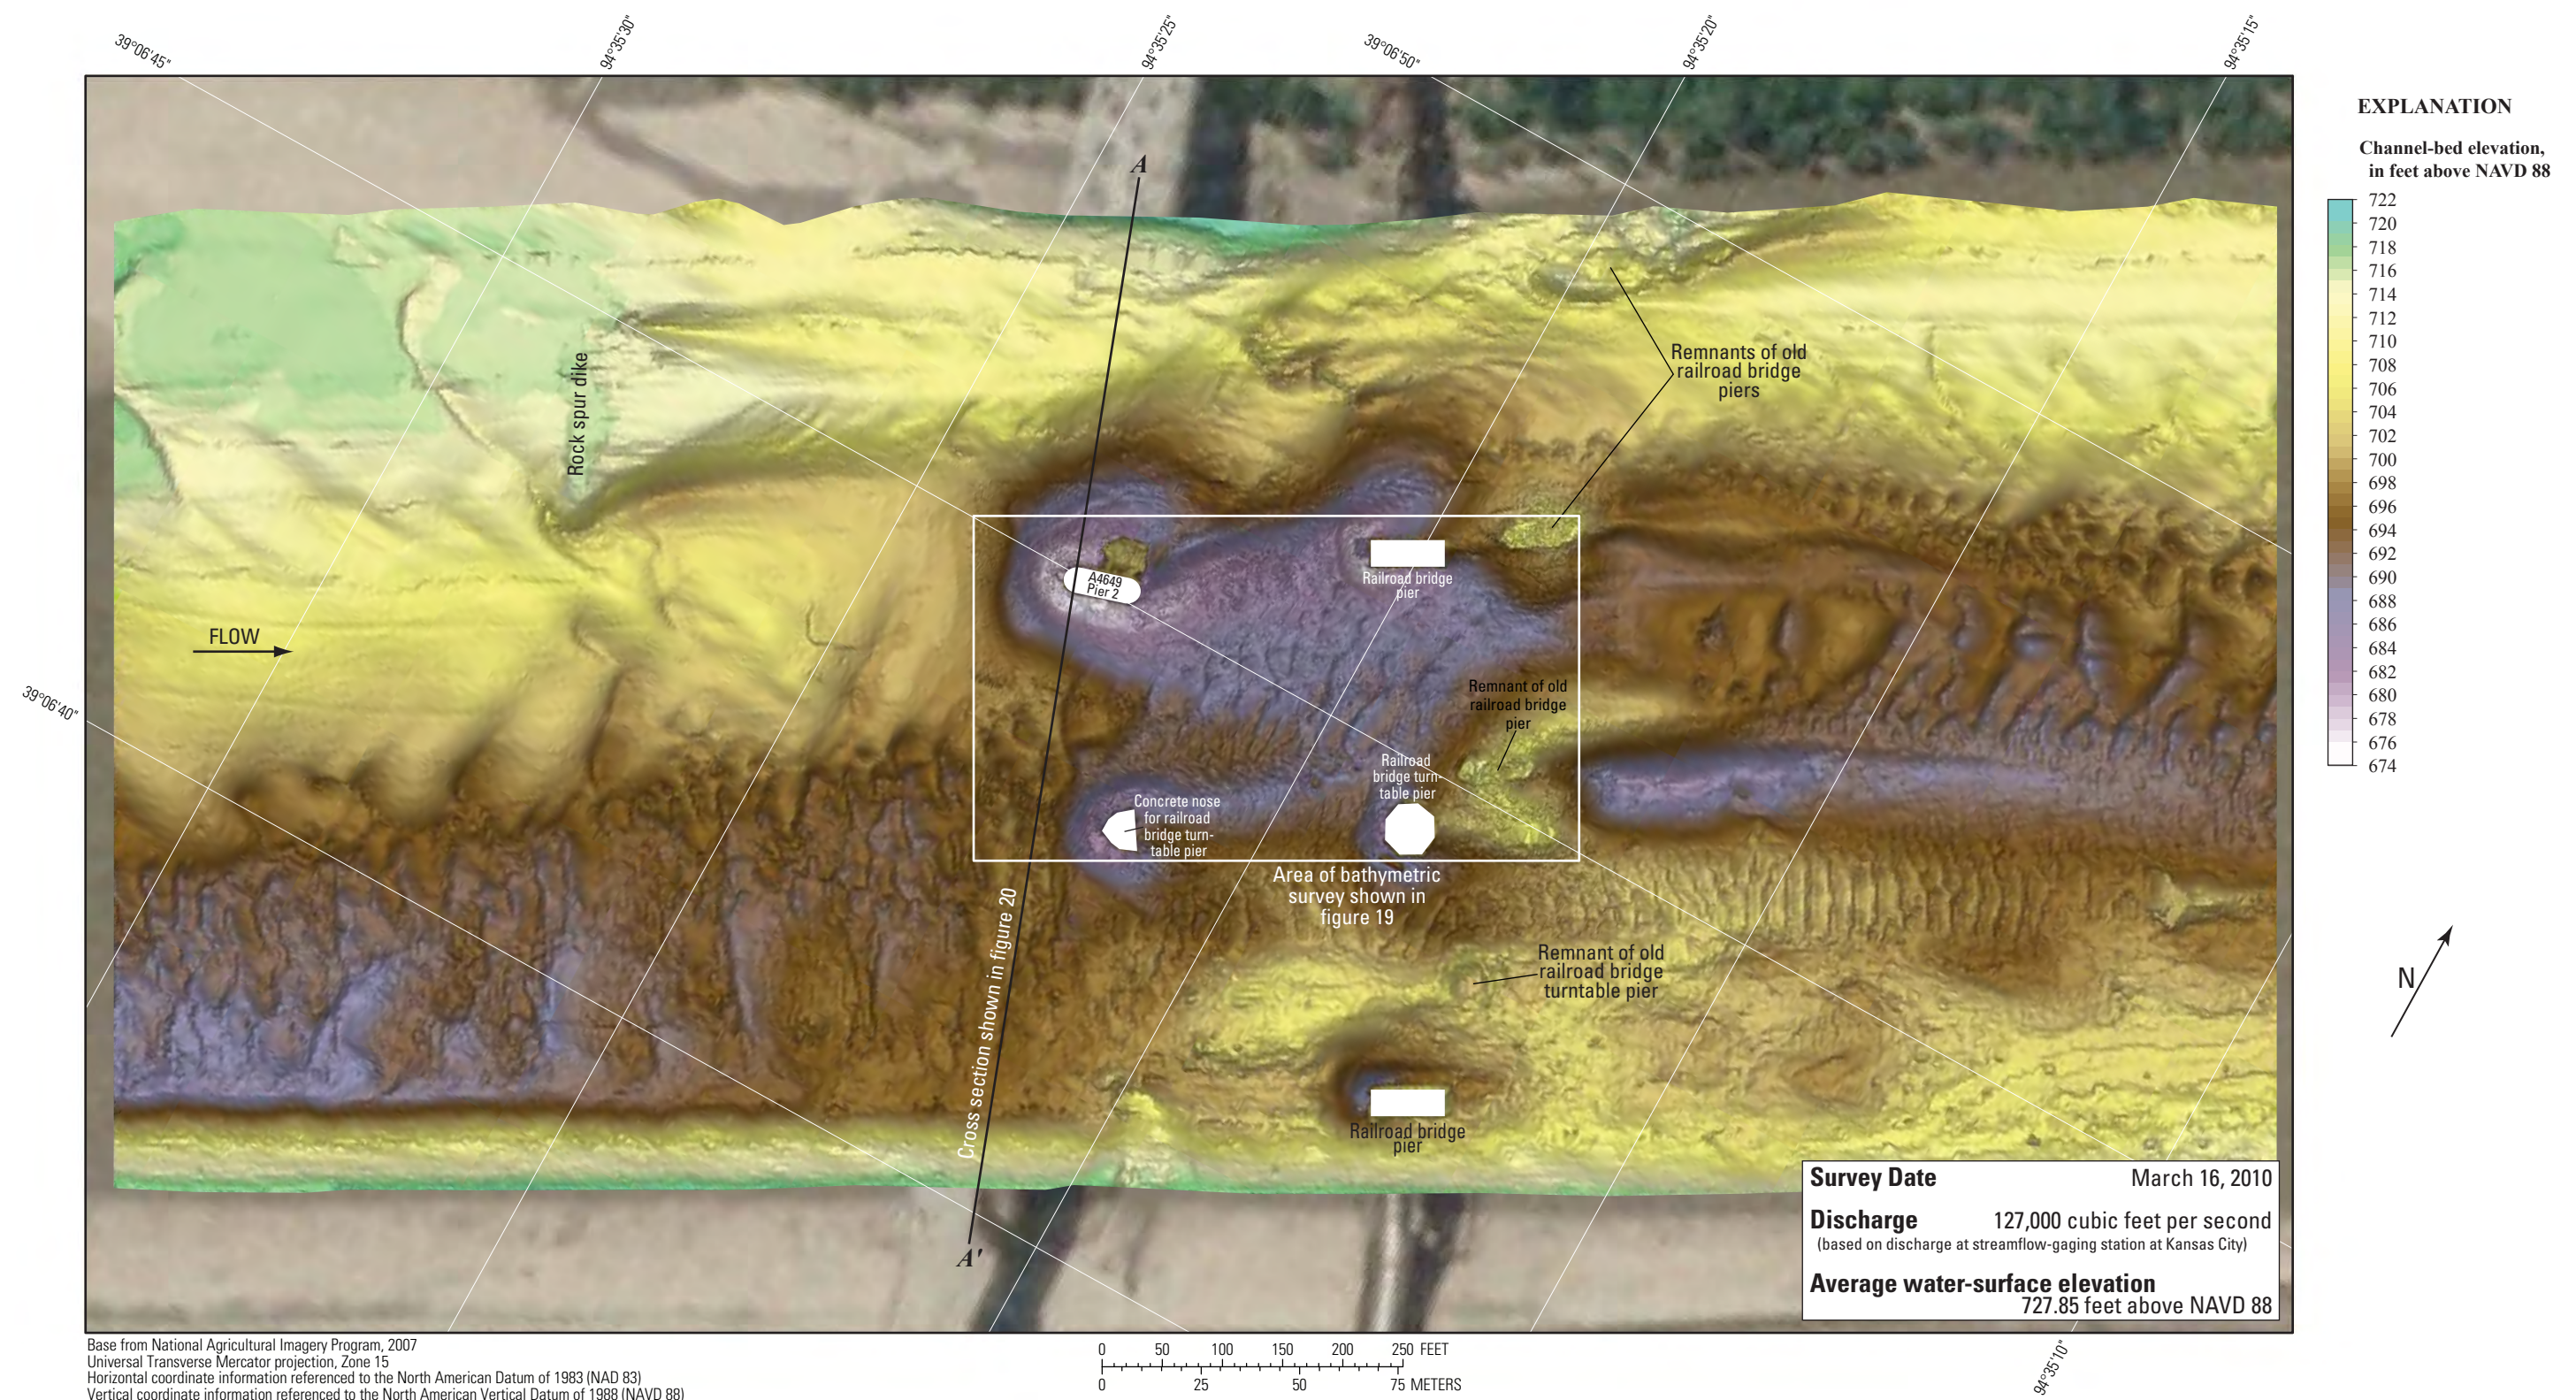
The survey area was about 1,800 ft long and about 820 ft wide, extending from bank to bank in the main channel (fig. 18). The upstream end of the survey area was about 820 ft upstream from the centerline of structure A4649 at pier 2 (figs. 17, 18). The channel-bed elevations ranged from about 685 to 708 ft for most of the channel bed, except near the main channel pier of structure A4649 and the various railroad bridge piers and concrete noses upstream from them (figs. 18, 19). A deep thalweg on the right (south) bank on the upstream end of the surveyed area was about 20 ft deeper than the channel bed in the middle of the channel (fig. 18). The thalweg was shallower and shifted to the middle of the channel at the bridges and downstream (fig. 18). Upstream from the rock spur dike on the inside of the bend on the upstream left (north) bank, deposits reached an elevation of about 720 ft (fig. 18). Remnants of piers from an old bridge (presumably the first Hannibal railroad bridge) were evident downstream from the existing Second Hannibal railroad bridge (fig. 18). Unlike the two upstream sites (structure A1800 and structures K0456 and A0450), large dune features were not detected in the channel at this site; however, numerous medium

and small dunes and ripples were detected throughout the channel, particularly in the channel thalweg upstream and downstream from structure A4649 and between the highway bridge and the railroad bridge (fig. 18).

Figure 18. Bathymetric survey of the Missouri River channel in the vicinity of structure A4649 on U.S. Highway 169 in Kansas City, Missouri.

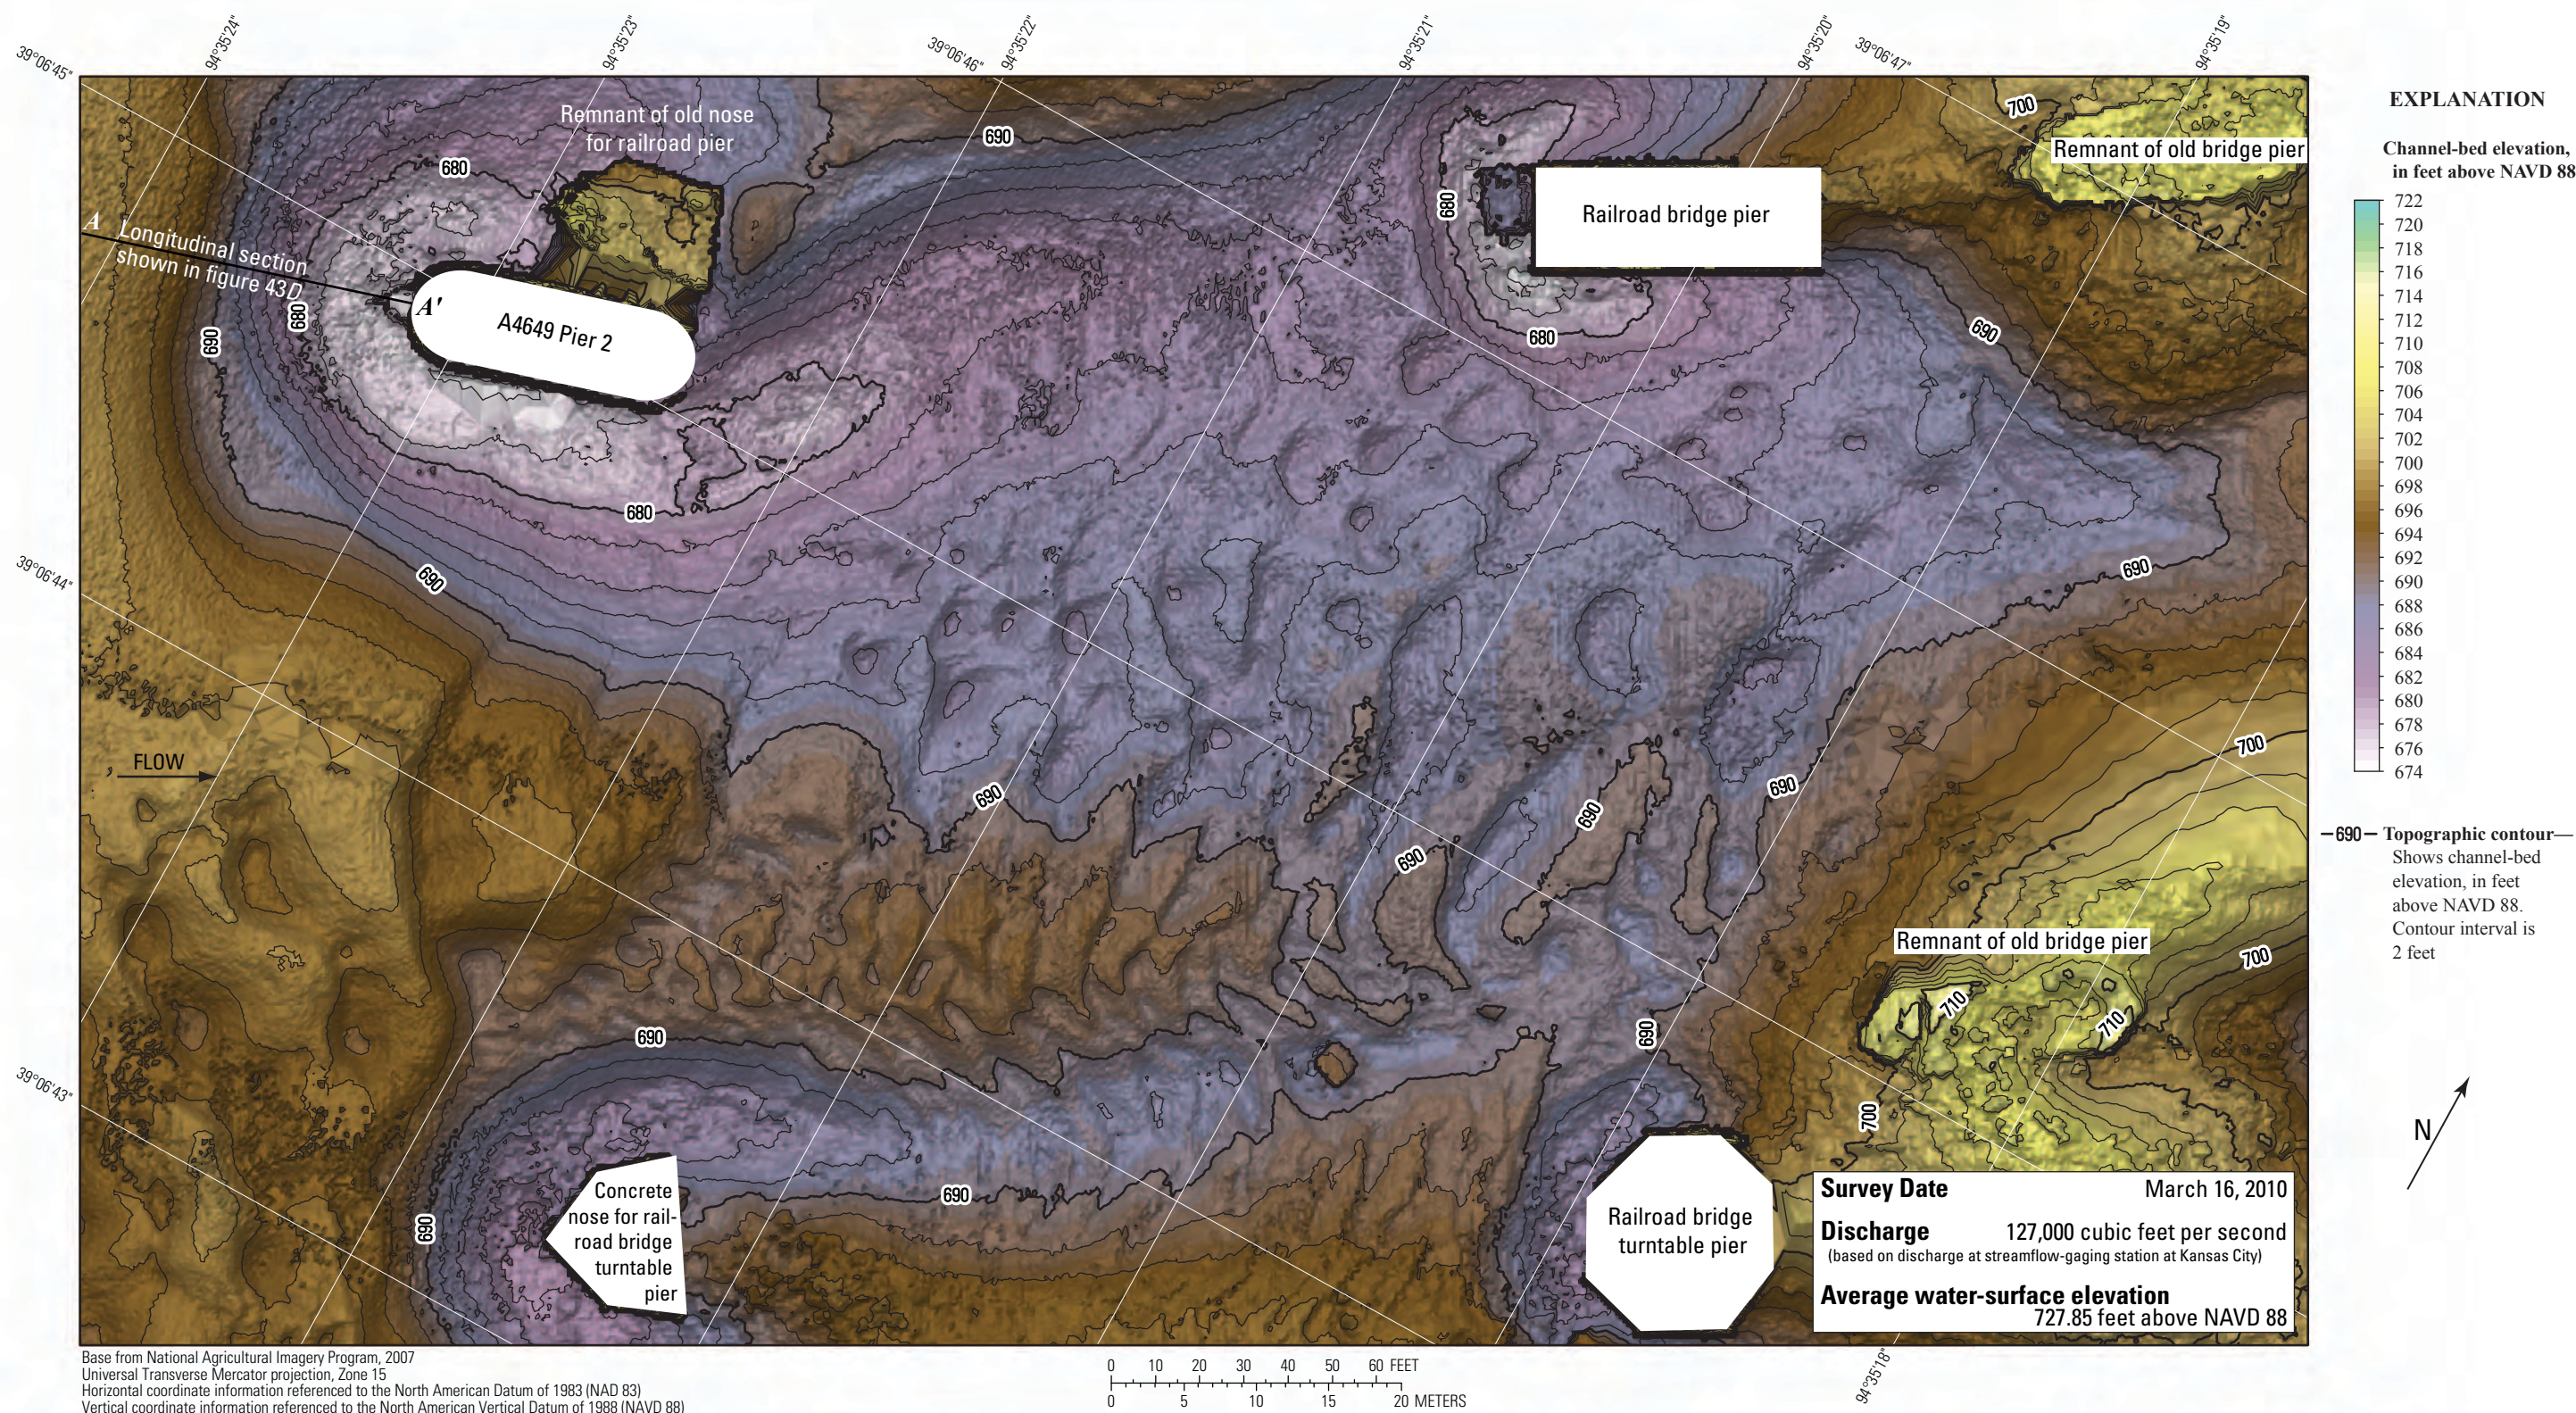
In the vicinity of the main channel pier (pier 2; fig. 19), a scour hole had a minimum elevation of about 675 ft (table 4), about 24 ft below the average channel bed immediately upstream from the pier (table 5). The scour hole was about 2 ft deeper on the right (south) side than the north side, and the hole extended further around on the right side (fig. 19). A submerged remnant of a structure near the left downstream side of the pier (fig. 19) was presumably a nose for the railroad bridge downstream similar to the concrete nose upstream from the railroad bridge turntable pier. The remnants of the old bridge piers were clearly defined, as were the piles of cobble-size debris around them. The remnant downstream from the existing railroad bridge turntable pier had a maximum elevation of over 710 ft (fig. 19), which was only 17 ft below the water surface on the day of the survey. Avoiding this pier remnant would be difficult in lower flow conditions than those on the day of the survey.

Figure 19. Bathymetric survey of the Missouri River channel in the vicinity of the main channel pier of structure A4649 on U.S. Highway 169 in Kansas City, Missouri.

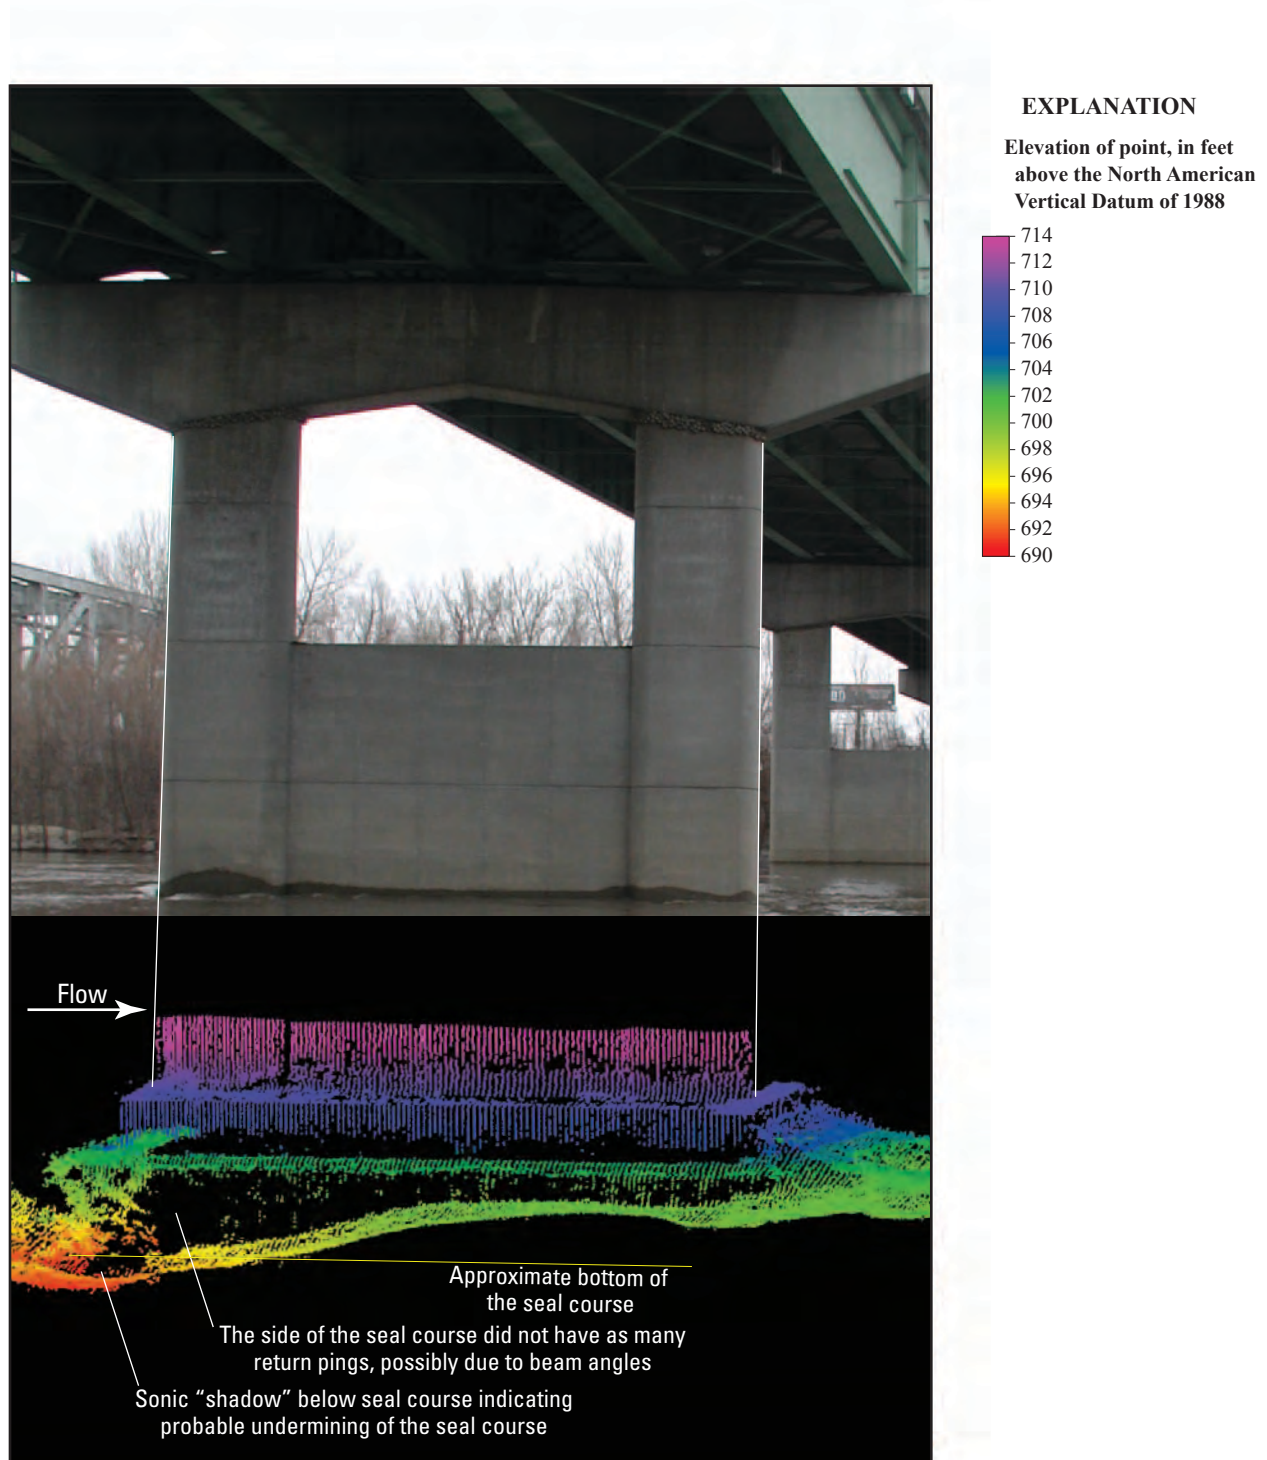
In the immediate vicinity of the left main channel pier (pier 5; fig. 26), a scour hole had a minimum elevation of about 691 ft (table 4), about 5 ft below the elevation of the bottom of the pier seal course of 696.26 ft (fig. 24; table 5). Information from bridge plans indicates that pier 5 also is founded on shafts drilled 20 ft into bedrock, with about 24 ft of bed material between the bottom of the scour hole and bedrock (fig. 24; table 5). The point cloud visualization of the multibeam depth points obtained during the survey does not clearly indicate the bottom of the seal course as a sonic “shadow” because the side of the seal course did not have as many return pings, resulting in poor point coverage. However, the difference in elevation between the top of the seal course and bed can be seen, and is greater than the depth of the seal course (fig. 27). Several beams or piles protruded from the channel bed immediately upstream from pier 5 (fig. 26).

**Figure 27.** Point cloud visualization of the channel bed and right (south) side of the left main channel pier (pier 5) of structure A4060 on State Highway 9 over the Missouri River in Kansas City, Missouri.
