# **Bathymetric Surveys at Highway Bridges Crossing the Missouri River in Kansas City, Missouri, using a Multibeam Echo Sounder, 2010**

Scientific Investigations Report 2010–5207

By Richard J. Huizinga

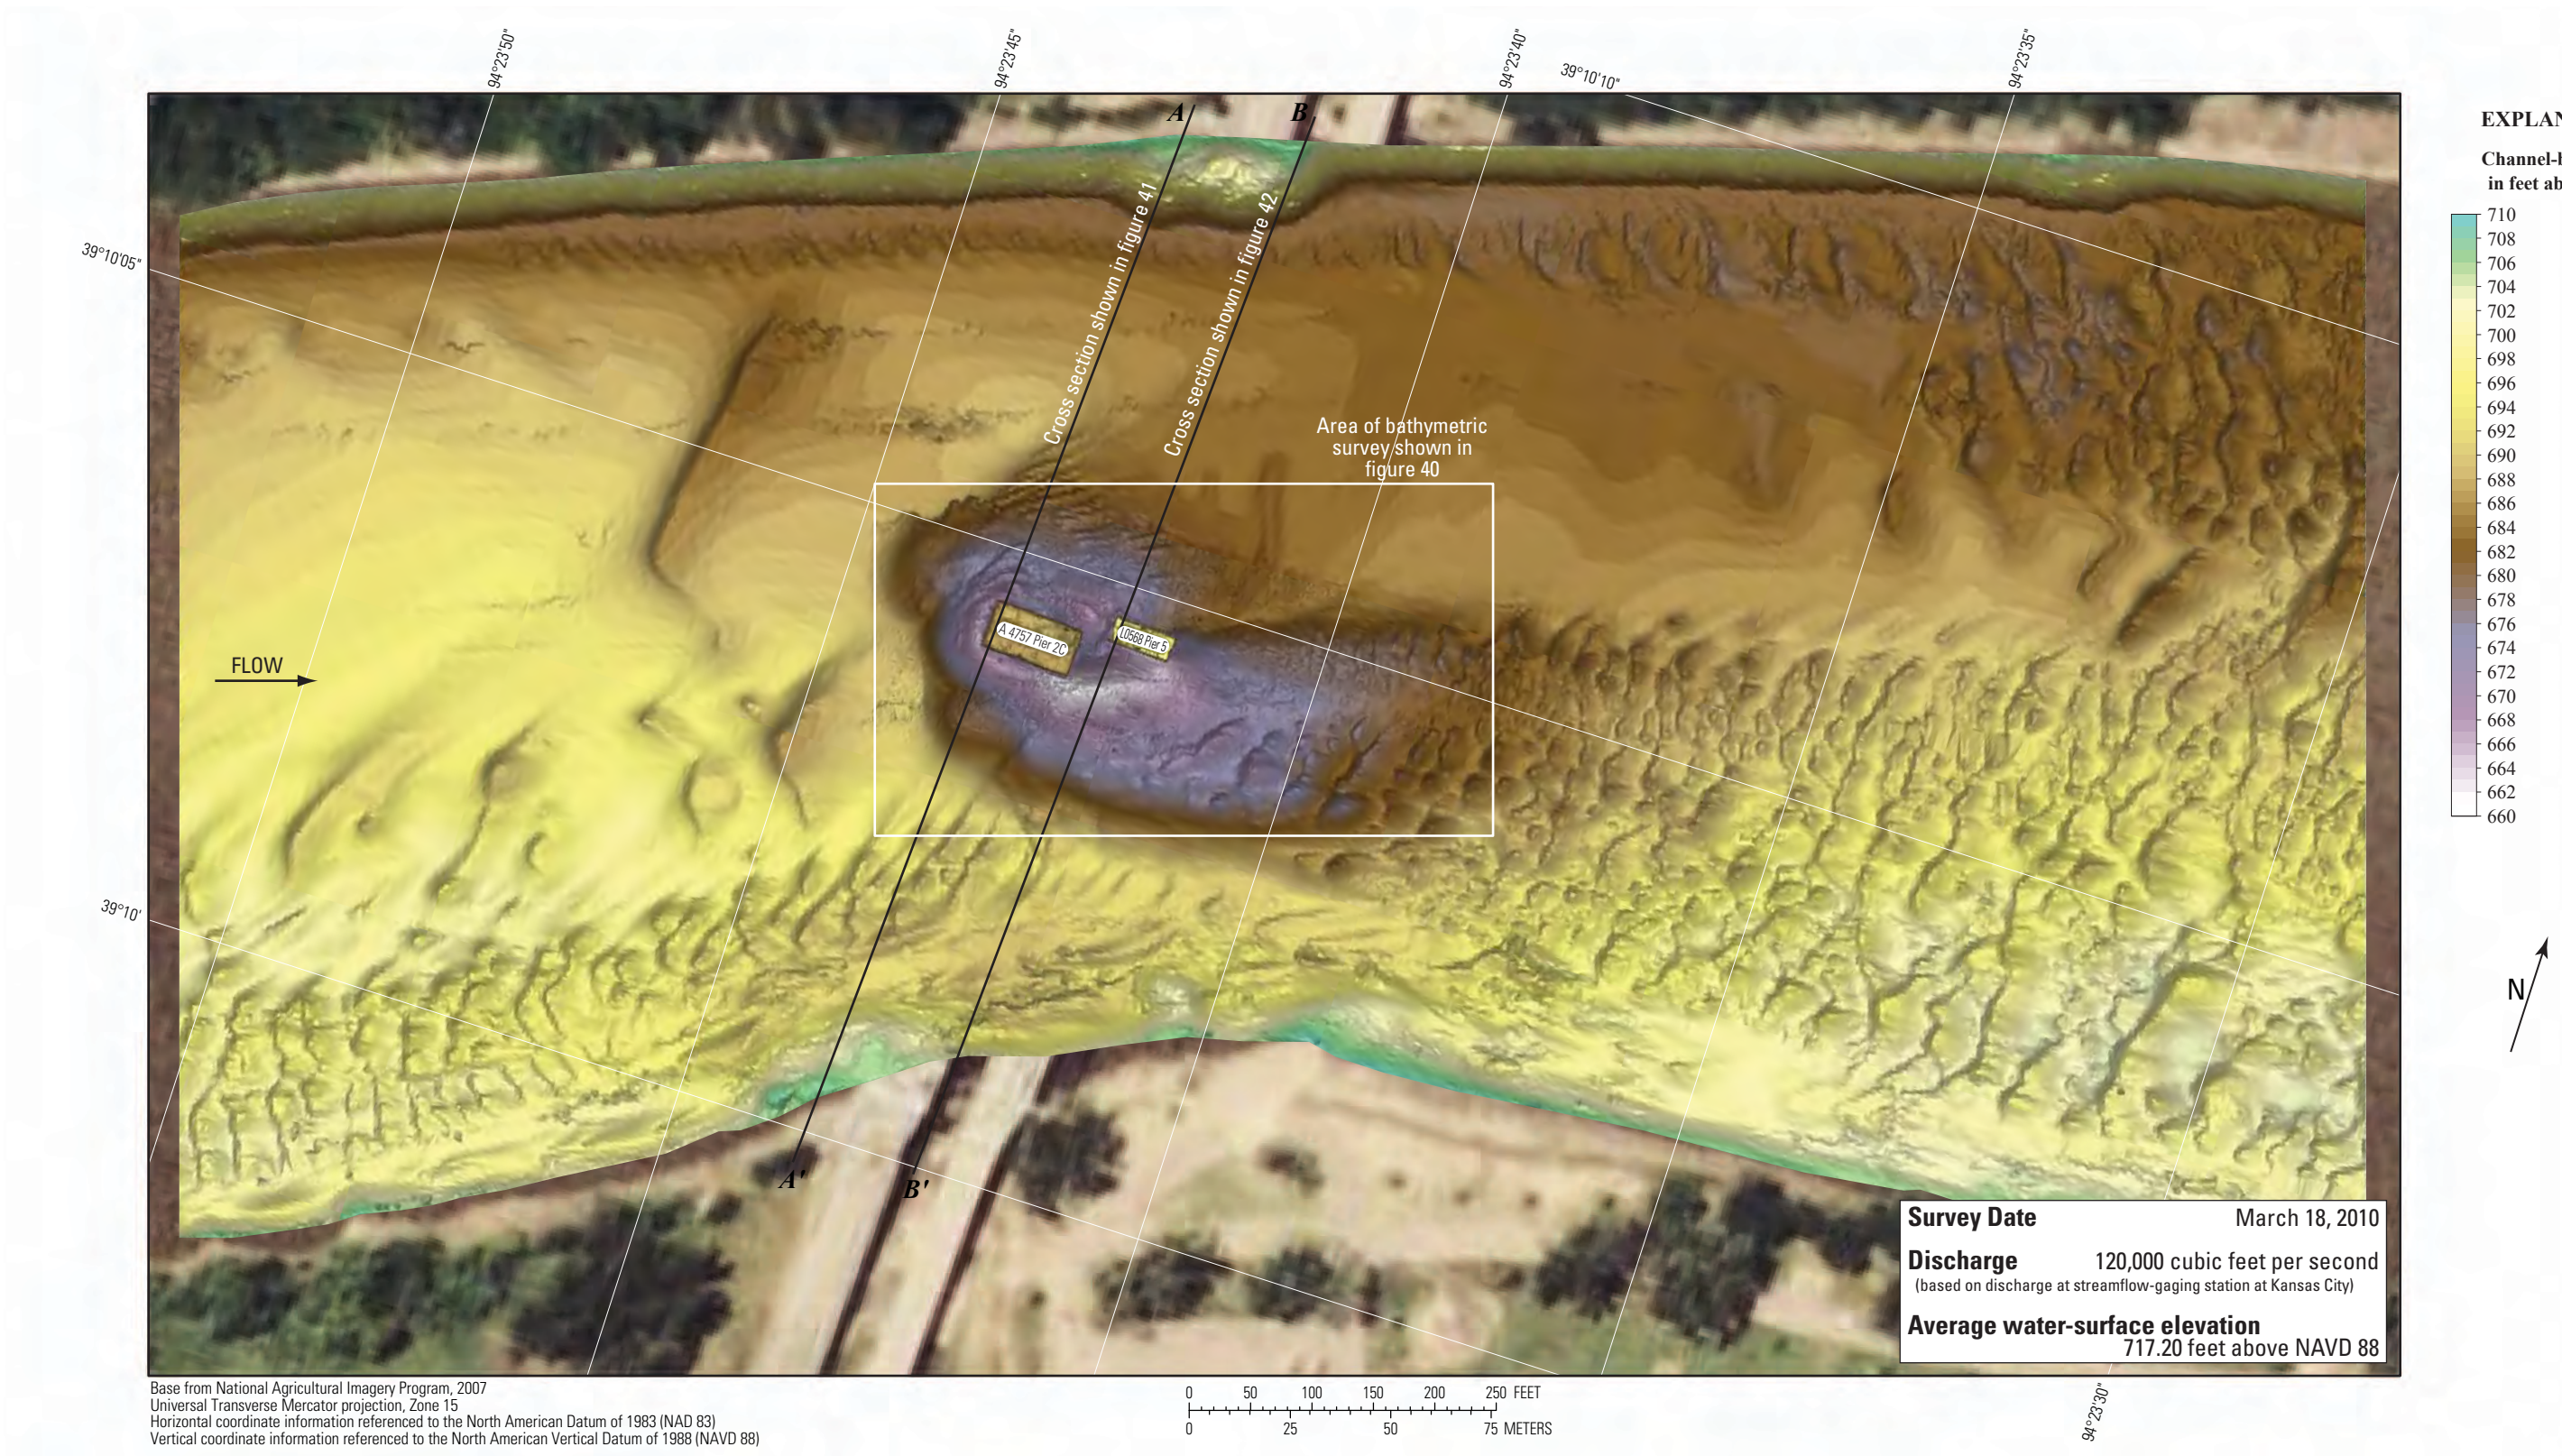
The survey area was about 1,780 ft long and about 810 ft wide, extending from bank to bank in the main channel (fig. 39). The upstream end of the survey area was about 740 ft upstream from the centerline between structures A4757 and L0568 (figs. 38, 39). The channel-bed elevations ranged from about 676 to 702 ft for most of the channel bed, except near the main channel piers of structures A4757 and L0568. A narrow channel thalweg was along the left (north) bank at the upstream end of the surveyed area that widened throughout the surveyed area (fig. 39). A few large dune features were detected in the channel upstream from the bridges, as well as numerous smaller dunes and ripples along the right (south) bank upstream from the bridge and across the channel downstream from the bridges (fig. 39). A noticeable channel constriction was at and immediately downstream from the bridges.

**Figure 39.** Bathymetric survey of the Missouri River channel in the vicinity of structures A4757 and L0568 on State Highway 291 in Kansas City, Missouri.

hole that nearly encompassed the main channel piers of both bridges (figs. 39, 40). Although the piers of structure A4060 were aligned to the flow, the railroad bridge piers upstream from structure A4060 were skewed to flow (figs. 22, 23, 26), and the effects of the asymmetric scour hole upstream from the right main channel pier (pier 6) affected the shape and size of the hole at that pier (fig. 23).

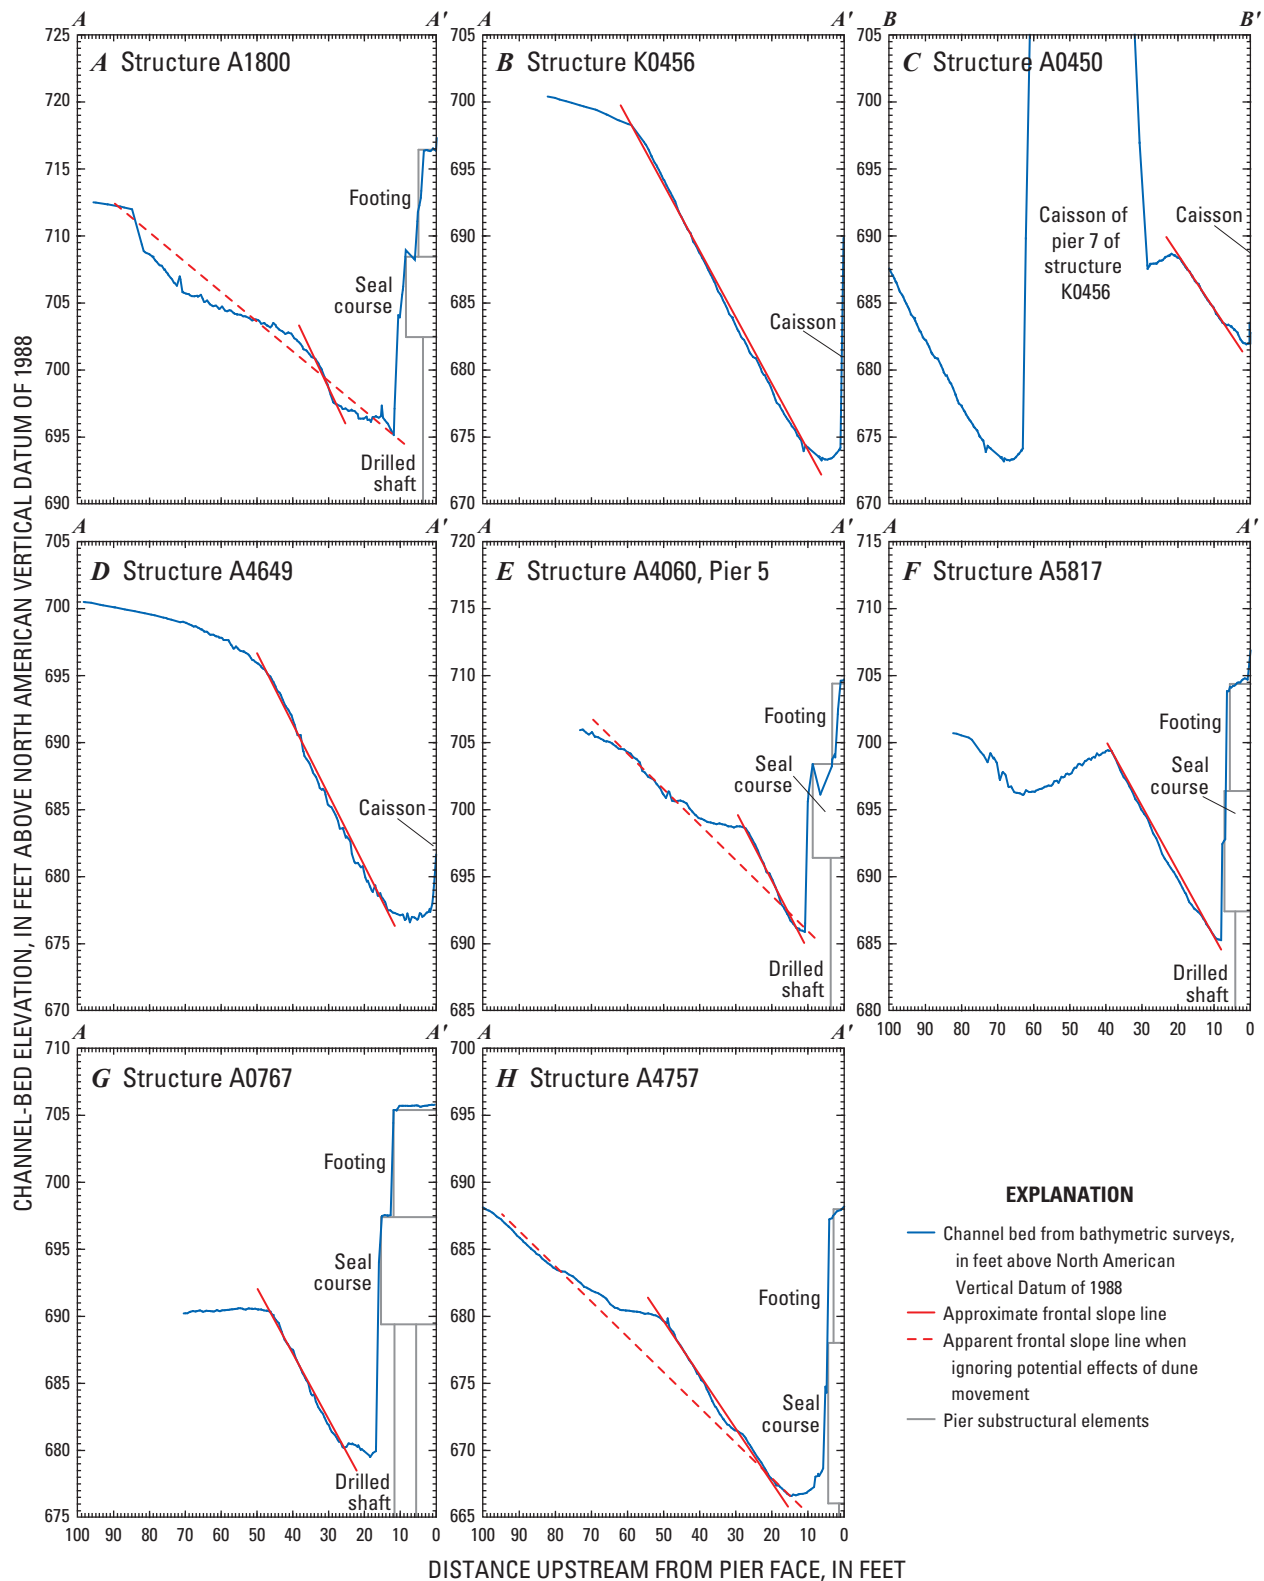
A scour hole was present at every pier for which bathymetry could be obtained and varied in depth relative to the upstream channel bed. A longitudinal profile was drawn upstream from the nose of each pier with a well-defined scour hole (fig. 43), and the approximate frontal slope determined for each hole (table 5). The frontal slope was not determined for the poorly defined scour hole at the right main channel pier (pier 6) of structure A4060 (fig. 23) or the main channel pier at structure L0568, which had no scour hole specific to it (fig. 40). The approximate frontal slope of the scour holes at each of the remaining piers ranged from 1.77 to 2.49 (table 5). Richardson and Davis (2001) noted that the side slope of a scour hole in cohesionless sand could range from 1.0 to 1.8, depending on the composition of the bed material and its wet angle of repose. The slope values determined in the Kansas City area are somewhat greater than the range of values noted in Richardson and Davis (2001), except for structure A1800.

As noted in the previous site-specific data, the movement of bed material manifested as dune features affected the bathymetric data at several of the bridges where a tilted transducer head was used to obtain depth points at the pier after the general channel bathymetric data had been collected. However, the shape of the scour holes at several of the bridges displayed the effects of these dune movements as well. The scour hole upstream from structure K0456 has a squarish upstream edge, which likely is the result of dunes moving into and around the hole (figs. 13, 14). A similar squarish upstream edge was observed at structure A4649 (figs. 18, 19) and structure A4757 (figs. 39, 40). The scour hole at structure A1800 also was affected by dune movement, displayed by subtle “steps” and waves present along the sides of the hole (fig. 9) and in the longitudinal profile (fig. 43A). Other profiles displayed similar, but more subtle “steps” in the longitudinal profiles (figs. 40, 43E, 43H).

**Figure 43.** Longitudinal profiles upstream from piers at the structures surveyed on the Missouri River at Kansas City, Missouri.

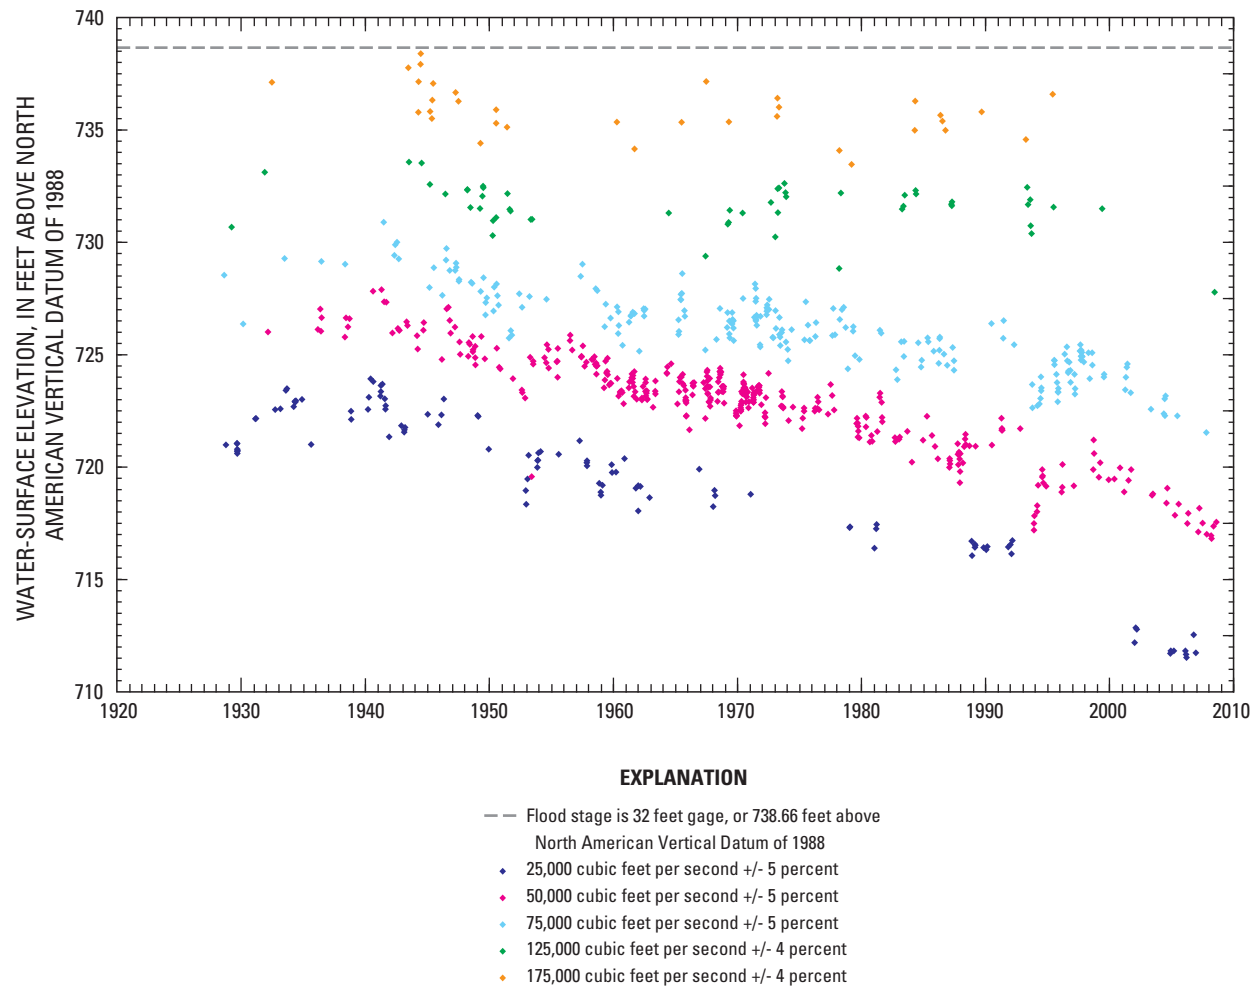
With the exception of structure A0767, all of the bridges for which a Level II scour assessment was completed had a lower channel-bed elevation during the bathymetric surveys than during the Level II survey in 2002, and all of the bridges had a lower channel-bed elevation during the 2010 surveys than when the bridge had been built. Researchers have stated that water stage appears to be decreasing with time on the Mississippi River for discharges less than flood stage (Brauer, 2009; Huizinga, 2009). Huizinga (2009) stated that this likely is caused by a combination of channel deepening caused by rock spur dikes in the channel and a decrease in the overall sediment load on the Missouri and Mississippi Rivers caused by upstream reservoirs. A similar but more limited analysis to that in Huizinga (2009) was completed using data from discharge measurements at the streamgage on the Missouri River at Kansas City, Missouri, where water-surface elevations for a variety of discharge ranges from measurements at the streamgage were plotted (fig. 44). Water-surface elevations were used instead of stage to remove the effects of a 10 ft datum shift in 1989. A decrease in the water-surface elevations with time at the Kansas City streamgage was similar to that observed on the Mississippi River at St. Louis, Missouri, and Chester, Illinois (Huizinga, 2009), which implies a similar decrease in the channel-bed elevations with time at the Kansas City streamgage. The decrease with time appears to be greater for lower discharges than for higher discharges (fig. 44). The range of discharges observed during the bathymetric surveys was 120,000 to 129,000 ft<sup>3</sup>/s, which corresponds to the 125,000 ft<sup>3</sup>/s  $\pm$  4 percent discharge range in figure 44.

**Figure 44.** Water-surface elevation for a given discharge range with time from measurements made at the streamflow-gaging station on the Missouri River at Kansas City, Missouri (station number 06893000).

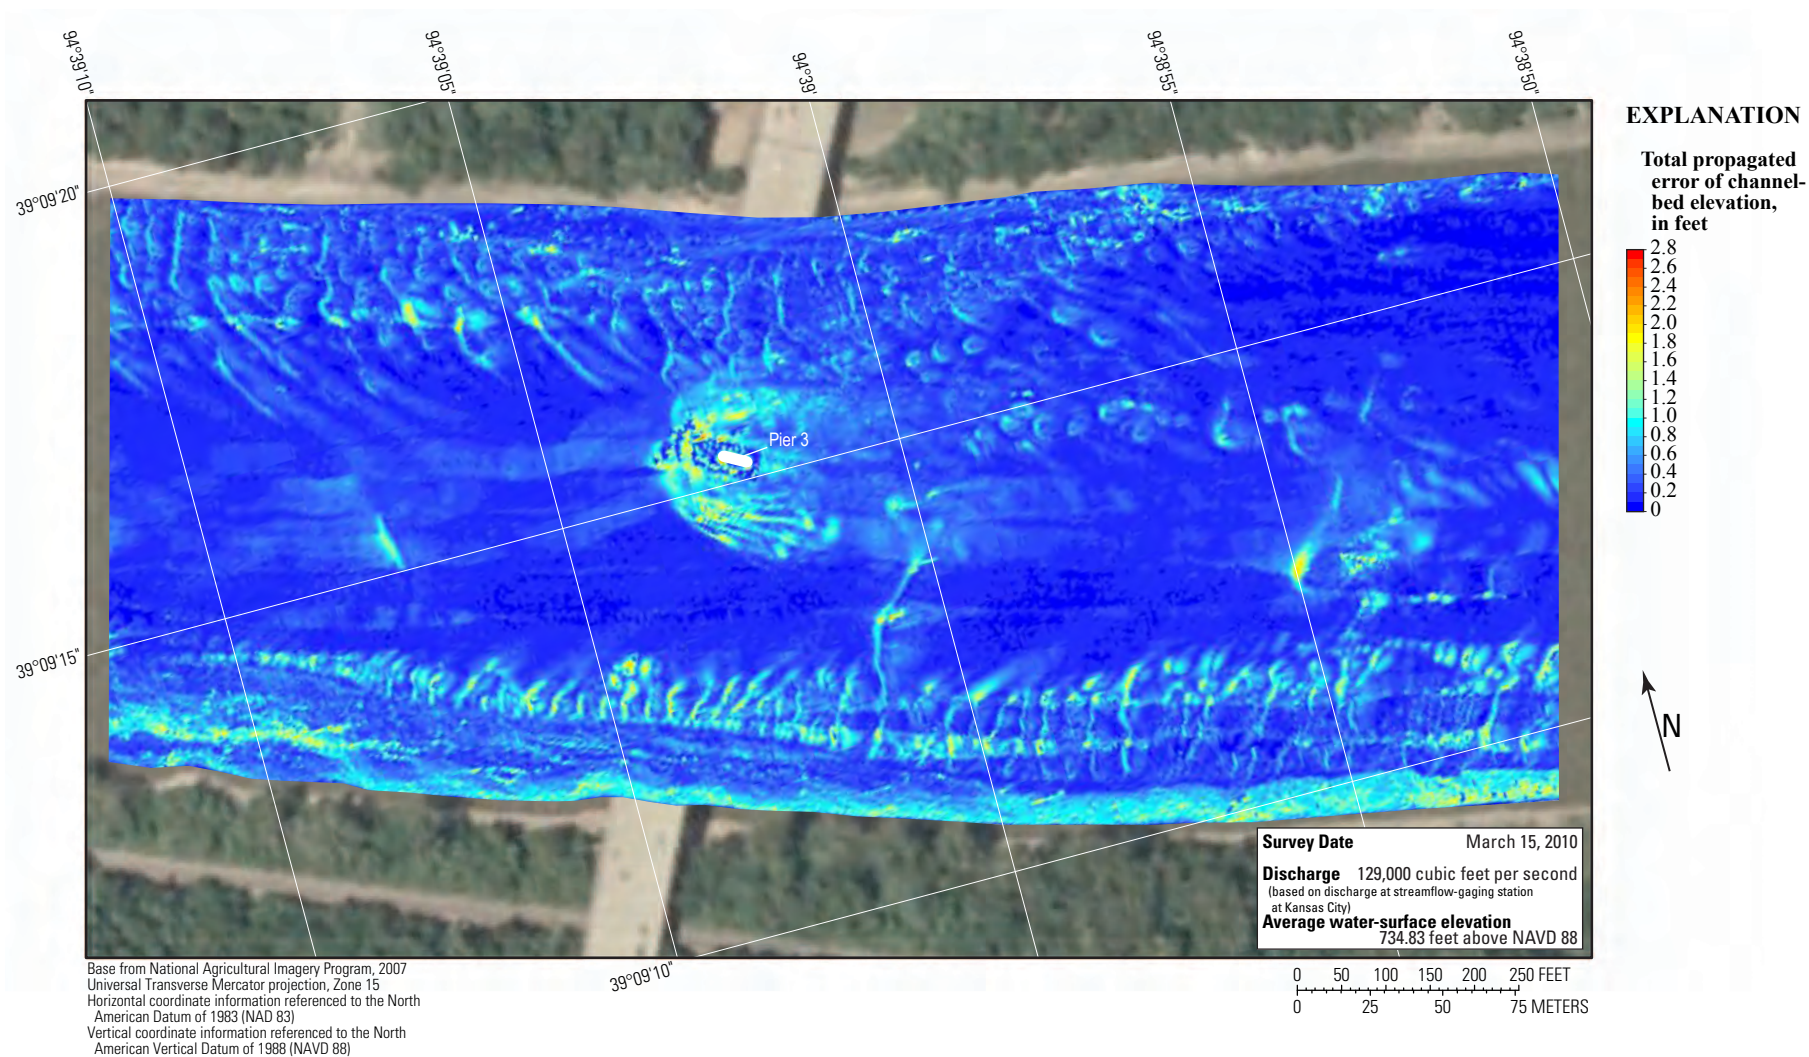
relevant error sources are taken into account (Kevin Oberg, written commun., 2010). A representative example of the spatial distribution of TPE typically observed in the survey data is shown in figure 46 for the bathymetric data at structure A1800.

The largest TPE in the Kansas City surveys was about 2.8 ft; however, TPE values of this magnitude typically occurred near high-relief features, such as the front or side of a pier footing or large submerged object (fig. 46). More typically, TPE values were less than 1.5 ft, with larger values occurring near moderate-relief features (banks, dune faces, and scour holes; fig. 46). Occasionally, these larger TPE values also occurred in the outermost beam portions of the multibeam swath in the overlap with an adjacent swath, typically in the channel thalweg where substantial bed movement would occur between survey passes (fig. 46). Substantial parts of the channel bed at all of the surveyed sites had TPE values of 0.5 ft or less, and the tops of bridge substructural elements (pier footings and seal courses) typically had TPE values of 0.2 ft or less (fig. 46).

**Figure 46.** Total propagated error of bathymetric data from the Missouri River channel in the vicinity of structure A1800 on Interstate 635 in Kansas City, Missouri.
