Report No. UT-10.20

ASSESSING CORROSION OF MSE WALL REINFORCEMENT

Utah Department of Transportation
Research Division

September 2010

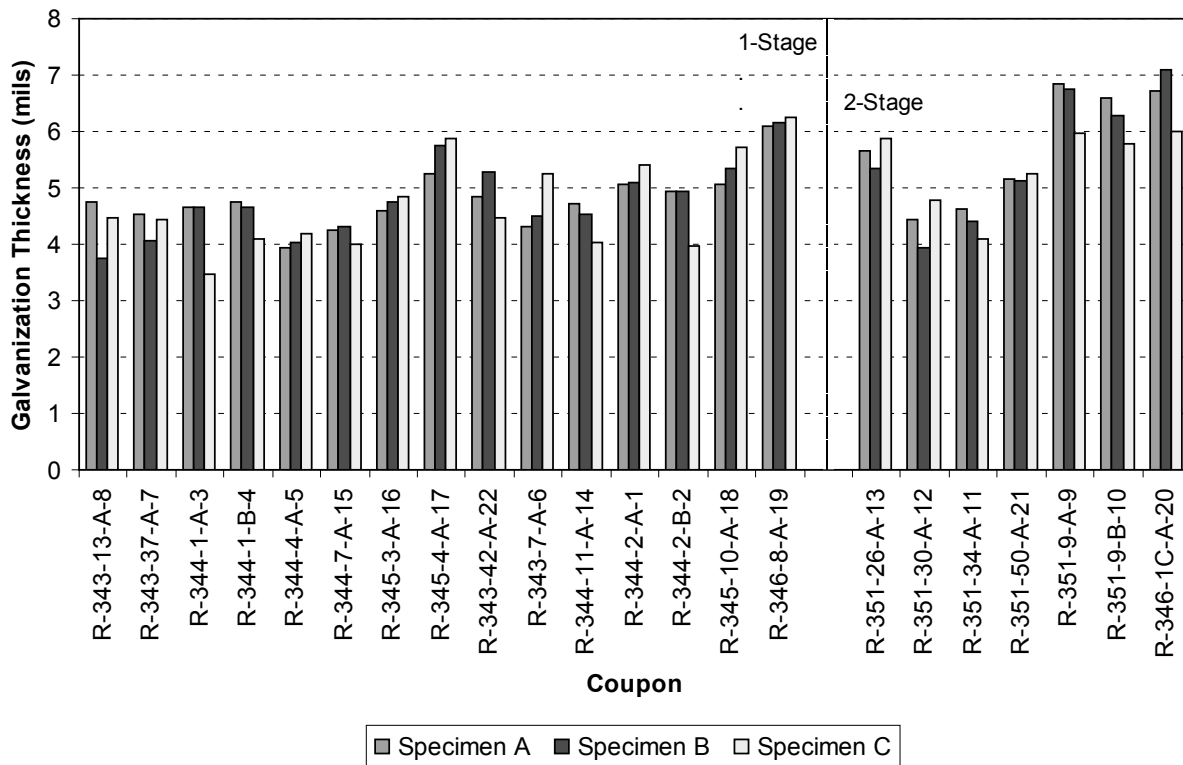
Figure 10 Variation in coupon galvanization thickness

The thickness of the coupon galvanization based on acid stripping as shown in Table 6 is presented graphically in Figure 10. In this figure, one-stage MSE walls are grouped on the left and placed in order of decreasing age from left to right, and two-stage MSE walls are grouped on the right and again placed in order of decreasing age from left to right. It should be noted that the maximum time differential between all of the walls is less than two years (although they all are approximately eleven to twelve years old), and construction dates more precise than the year built are not available.

It can be seen from the data that in all instances the amount of galvanization currently present on the specimens exceeds the amount specified at installation (3.4 mil or 2.0 oz/ft²). Based on AASHTO's design corrosion rate, 3.4 mil of galvanization should be consumed after sixteen years or about 0.5 mil remaining after eleven years. Even after acknowledging that the AASHTO design rates are conservative, it is still surprising that after eleven to twelve years so much galvanization is present (even exceeding the initially specified amount). Unfortunately, because the initial galvanization thickness is unknown, we are unable to estimate a reliable corrosion rate prior to the present time. However, the data describing current conditions can be used as baseline information going forward to compute corrosion rates in the future.

In an attempt to roughly approximate a corrosion rate, one might utilize the apparent trend in bar height from left to right (i.e., older to younger) in Figure 10 for the two different types of MSE walls. Unfortunately, since there is only one data point in 1999 for the two-stage MSE walls, any estimated rate for two-stage walls would be tenuous at best. A linear regression with respect to year built for the one-stage MSE walls indicates a corrosion rate of about 0.55 mil/year/surface. While this rate is similar to the AASHTO design rate for galvanization for the first two years after installation, the corrosion rate at this point in the walls' design life with galvanization still present is expected to be much less (consistent with the change in design corrosion rate for zinc after two years as shown previously in Table 1), leading us to doubt the accuracy of the calculated rate. Greater reliability could be realized if the time interval over which the regression was performed were greater than the nominal one-year time frame and more data points were available. It is also possible that the elevated rate partially reflects a seasonal or longer-duration variation in metal loss, the existence of which has been recognized by previous investigators (e.g., Fishman and Withiam (in press)).

Examining the data in Figure 10 to identify other corrosion trends, taken as a group, there seems to be little appreciable or consistent difference in galvanization thickness among the specimens located at different distances back from the face of the MSE wall. There may be a slightly elevated rate away from the wall face (which is the opposite of what we would initially suspect given the greater potential access to oxygen and moisture variations near the wall face). As indicated previously in Table 6, the average thickness of the 22 innermost specimens (specimens “C”) is 4.9 mil whereas the average thickness of the 22 outermost specimens near the wall face (specimens “A”) is 5.1 mil, a difference of about 0.2 mil. Since this difference represents about 3% of the overall average of the galvanization thickness for the 22 coupons (and recognizing that the trend is not discernable when considering median values rather than average values), any spatial differences seem to be materially negligible.

When examined with respect to wall type (recognizing that there is limited data with only 15 and 7 one- and two-stage MSE walls, respectively), the spatial pattern of decreasing thickness with increasing distance away from the one-stage walls is slightly more pronounced when considering median values (which may be more representative of “typical” conditions than average values because outlying data points can have greater effect when the sample number is small). In this case, the thickness of the innermost specimens is 4.5 mil whereas the thickness of the outermost specimens is 4.8 mil, a difference of about 0.3 mil (or about 2 years of galvanic corrosion based on AASHTO design rates). For the two-stage MSE walls, spatial trend is irregular, with the average and median values suggesting differing trends. Consequently, we are left to conclude that there is no readily discernable difference in corrosion rate as a function of distance away from the wall face.

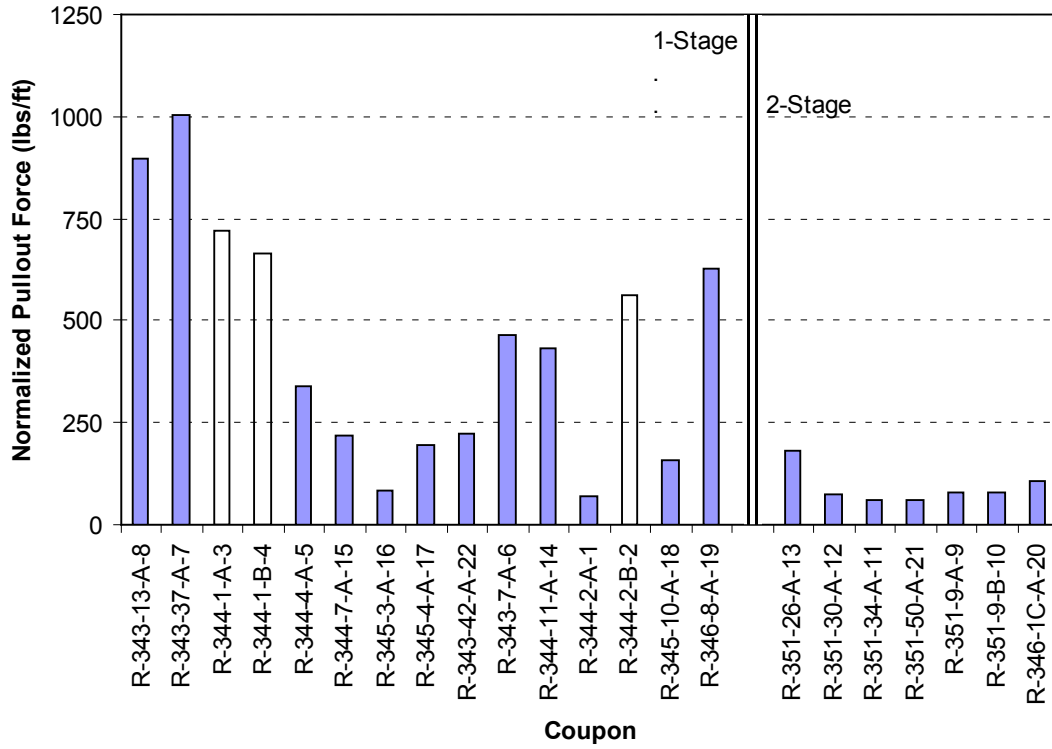
Figure 19 Coupon pullout resistance normalized by embedded length

In an effort to facilitate comparisons between coupons, the coupon pullout force can be normalized in two ways. First, the pullout force can be divided by the embedded length. Second, the pullout force can be divided by the embedded length as well as by the height of the wall above the coupon (i.e., the distance from the coupon to the top of the wall or the “overburden height”) which is a proxy for effective vertical stress. These normalized resistances are shown in Figure 19 and Figure 20. In these figures, one-stage MSE walls are grouped on the left and placed in order of increasing overburden height from left to right, and two-stage MSE walls are grouped on the right and again placed in order of increasing overburden height from left to right. In the graphs, the shading of bars has been removed for coupons which the pullout resistance is suspected to be artificially high due to friction against the edge of the access hole.

In these figures, it is readily apparent that peak pullout resistance for the coupons is typically much larger for one-stage MSE walls than for two-stage MSE walls. After discounting those coupons which appeared to rub on the back/side of the access hole during extraction, the average and median peak pullout resistance normalized by embedded coupon length and overburden height for the one-stage walls is about 34 and 23 lb/ft/ft, respectively; for two-stage walls, the average and median values are about 7 and 6 lb/ft/ft, respectively (a difference of about four to five times between the two wall types). We suspect that the difference in peak pullout resistance between the two types of MSE wall is attributable to an inherently lower degree of compaction near the face of the two-stage walls. Because the welded wire mesh facing is flexible relative to the standard concrete panel, it is difficult to apply a large amount of compactive energy near the wall face. In fact, many early MSE wall specifications specifically excluded compaction testing within a meter or so of the wall face because of this difficulty. In addition to affecting the compacted density of the soil near the wall face, the flexibility of the wall facing also provides less constraint on the failure surface, thus lessening the amount of shear resistance that develops prior to pullout.

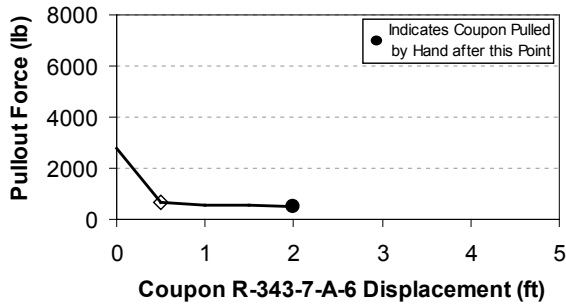
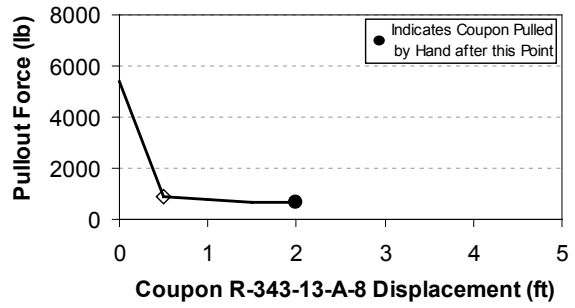
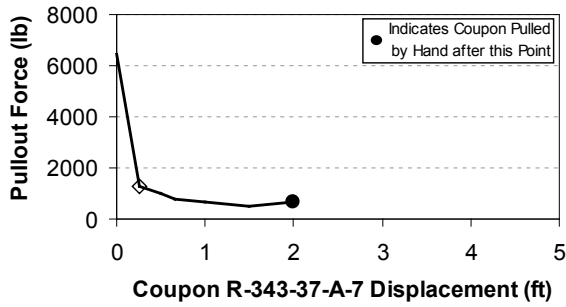
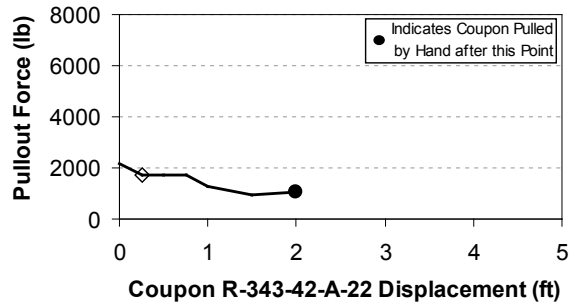
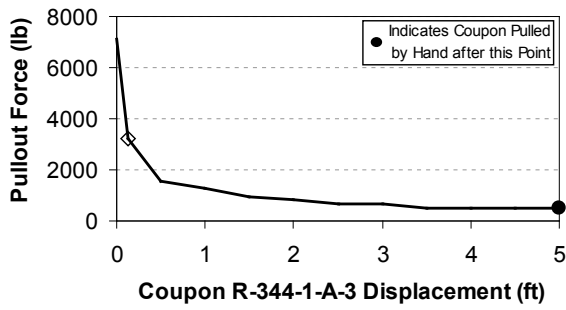
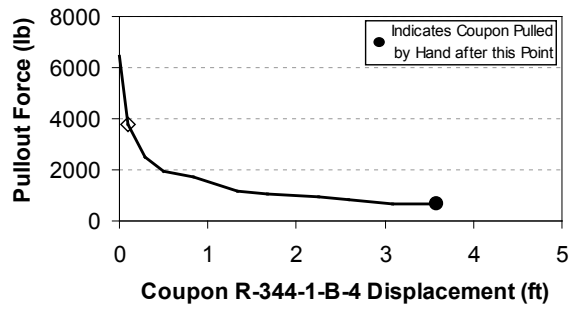
Figure 21 Coupon pullout resistance versus displacement
(continued on next page)

Plots showing the pullout resistance of coupons at displacement intervals of approximately 3 or 6 in are presented in Figure 21. The end of the first displacement interval is shown in the figures by a hollow diamond, and the portion of the curve to the left of it might have been steeper than that shown (i.e., the peak resistance may have decreased more rapidly) had jack pressures been recorded at smaller displacement intervals. From the plots, one can see a pronounced decrease in resistance once the coupons start to move and are pulled out of the wall. While completion of the extraction process by hand prevented minimum values from being reached (values which should trend to zero as the full length of the coupon exits the wall), the pullout resistances appeared to typically approach some type of ultimate or “residual” value after several inches of displacement. The residual values ranged from about 10 to nearly 100% of the measured peak force. (The nearly 100% values correspond to coupons R-344-2-A-1 and R-351-50-A-21 which spun around in-place when trying to attach an extraction coupler).
