1. Report No. FHWA/TX-11/5-5833-01-1		2. Government Accession No.		3. Recipient's Catalog No.	
4. Title and Subtitle IMPLEMENTATION OF TRANSVERSE VARIABLE ASPHALT RATE SEAL COAT PRACTICES IN TEXAS				5. Report Date December 2010 Published: January 2011

IMPLEMENTATION OF TRANSVERSE VARIABLE ASPHALT RATE SEAL COAT PRACTICES IN TEXAS

Report 5-5833-01-1
Project 5-5833-01
Project Title: Statewide Implementation of TVAR Seal Coat Methods

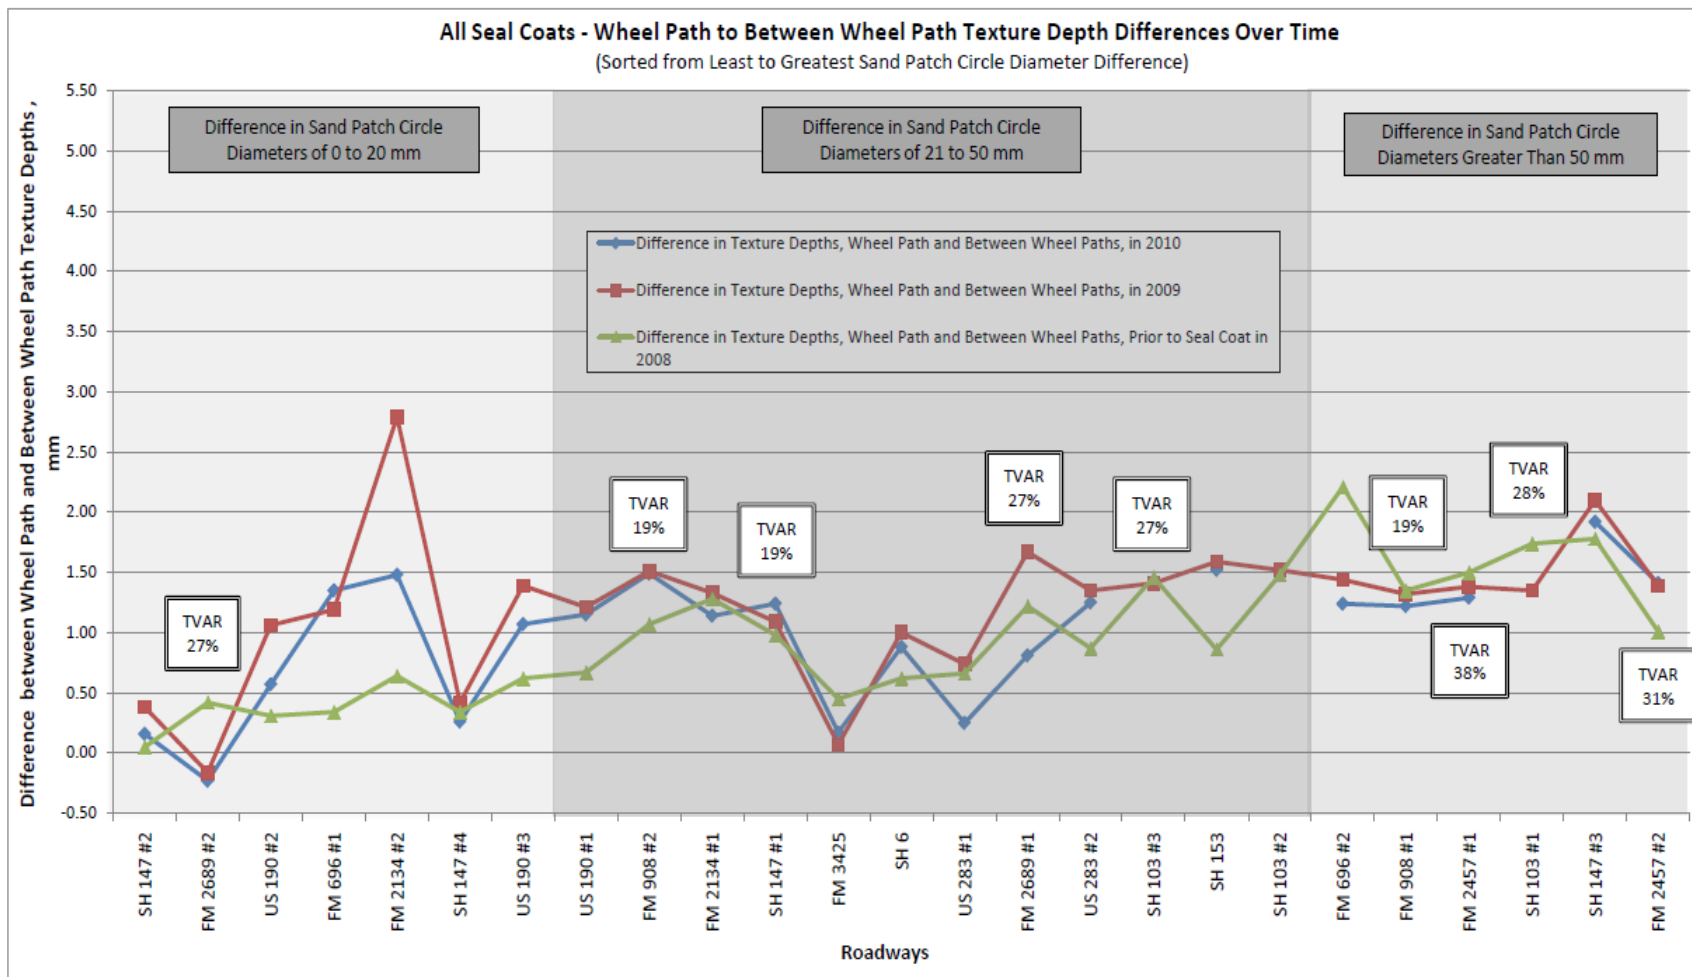
Figure 10. Transverse Difference in Texture Depth over Time Sorted by Difference in Sand Patch Test Circle Diameters.

Figure 10 displays differences in texture depth test results across the lane over the two-year period of the study for all pavements included in the post-seal coat texture test study. The pavements are sequenced from left to right on the chart from least to greatest pre-seal coat texture depth difference across the lane. In other words, pavements with the most uniform textures across the lane are displayed on the left portion of the chart. These more uniform

textures in some cases resulted from the pavement being uniformly low in texture across the lane and in others cases from the texture being more uniformly deep across the lane. In either scenario resulting in a relatively high degree of texture uniformity across the lane, the TVAR Field Guide recommends use of a transversely uniform asphalt application rate instead of TVAR. Shading is used on the figure to show which pavements fell into the two categories for recommended use of TVAR seal coats as determined by the pre-seal coat texture depth differences across the lane. The double-frame text boxes indicate which pavement locations actually received a TVAR treatment and the percentage difference in the asphalt application rate.

Several observations may be made from Figure 10. District decisions to use TVAR are in general agreement with field guide recommendations. There is, however, an indication that the three districts involved in this study tend to use TVAR less often than indicated by the current field guide recommendations. Another observation is that when a district did choose to use TVAR, and a higher TVAR percentage was selected for use, these pavements were among the group of pavements meeting field guide criteria for higher percentage TVAR applications. The single location where field guide criteria recommended uniform asphalt application and the district instead used TVAR was on FM 2689 location 2. While location 2 had a relatively uniform texture location, it was not believed to be the most common texture situation found throughout the FM 2689 pavement length to be sealed. The texture difference found at FM 2689 location 1 was considerably greater and in all likelihood better represents the condition of the entire pavement length to be sealed. Pavement locations 1 and 2 were within 600 ft of each other. A final observation is the uniquely high textures found in 2009 and 2010 on FM 2134 at location 2. This location is on a short dead-end length of pavement just past a park entrance. There are only two or three residences past the park entrance on FM 2134, and it was uncertain if these homes were inhabited. So traffic level on this pavement location is extremely low.

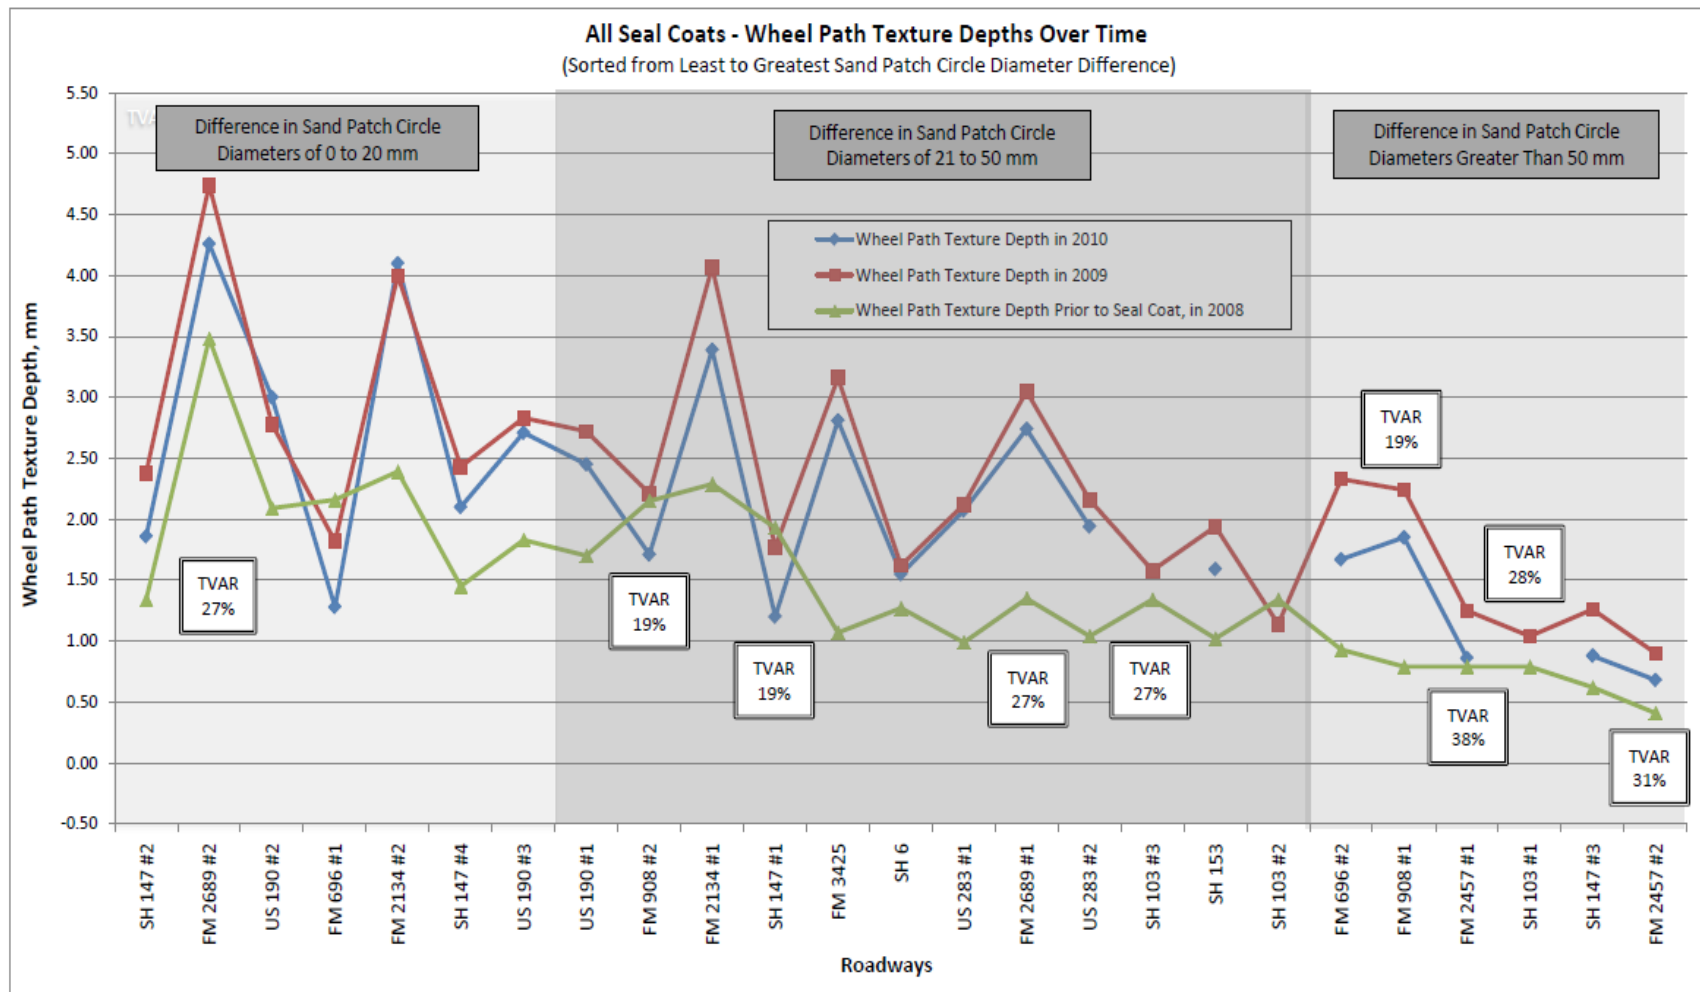
Figure 11. Wheel Path Texture Depth over Time Sorted by Difference in Sand Patch Test Circle Diameters.

Similarly, Figure 11 displays the wheel path texture depths found in the outside wheel paths over the two-year period of the study. Observing the change in wheel path texture alone is another method of studying degree of success in mitigating return of wheel path flushing when TVAR is used during seal coat construction. The pavements are sequenced in the same manner as in Figure 10, facilitating comparison of displayed information.

Observations to be made from Figure 11 include that wheel path textures varied widely among pavement locations selected for study. It is evident on the left portion of the chart that

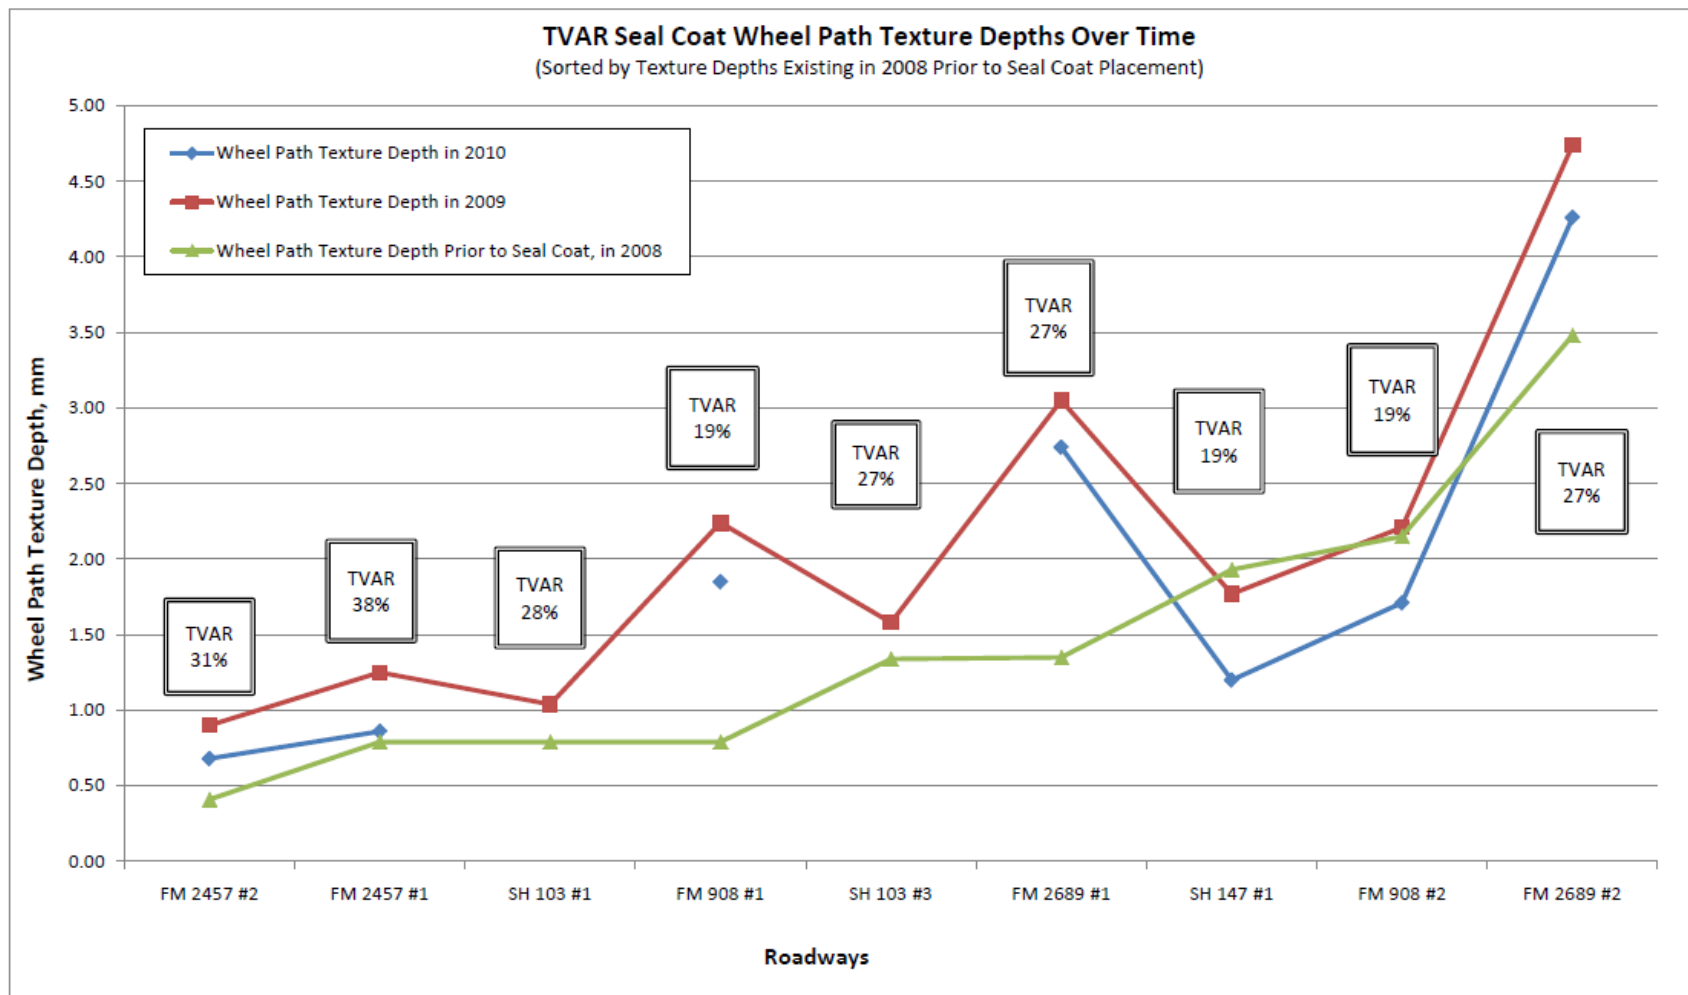
Figure 12. Wheel Path Texture Depth over Time for Pavements Using TVAR Asphalt Application Rates.

Figure 12 shows that after two years of traffic two of the pavement locations were found to have wheel path textures less than respective wheel path textures prior to the TVAR seal coat placement. These two TVAR locations were the lowest percentage TVARs included in the study, both at 19 percent. Similarly to one of the observations made on Figure 10, the districts frequently chose high TVAR percentages at locations where wheel path texture depths were the lowest. These pavements are those displayed on the left portion of the chart. Also note there are no 2010 texture data displayed for SH 103 locations. SH 103 was microsurfaced earlier in 2010. The district determined that microsurfacing was necessary to ensure long lasting adequacy of pavement textures. This pavement had been the worst flushing condition included in the original research project.

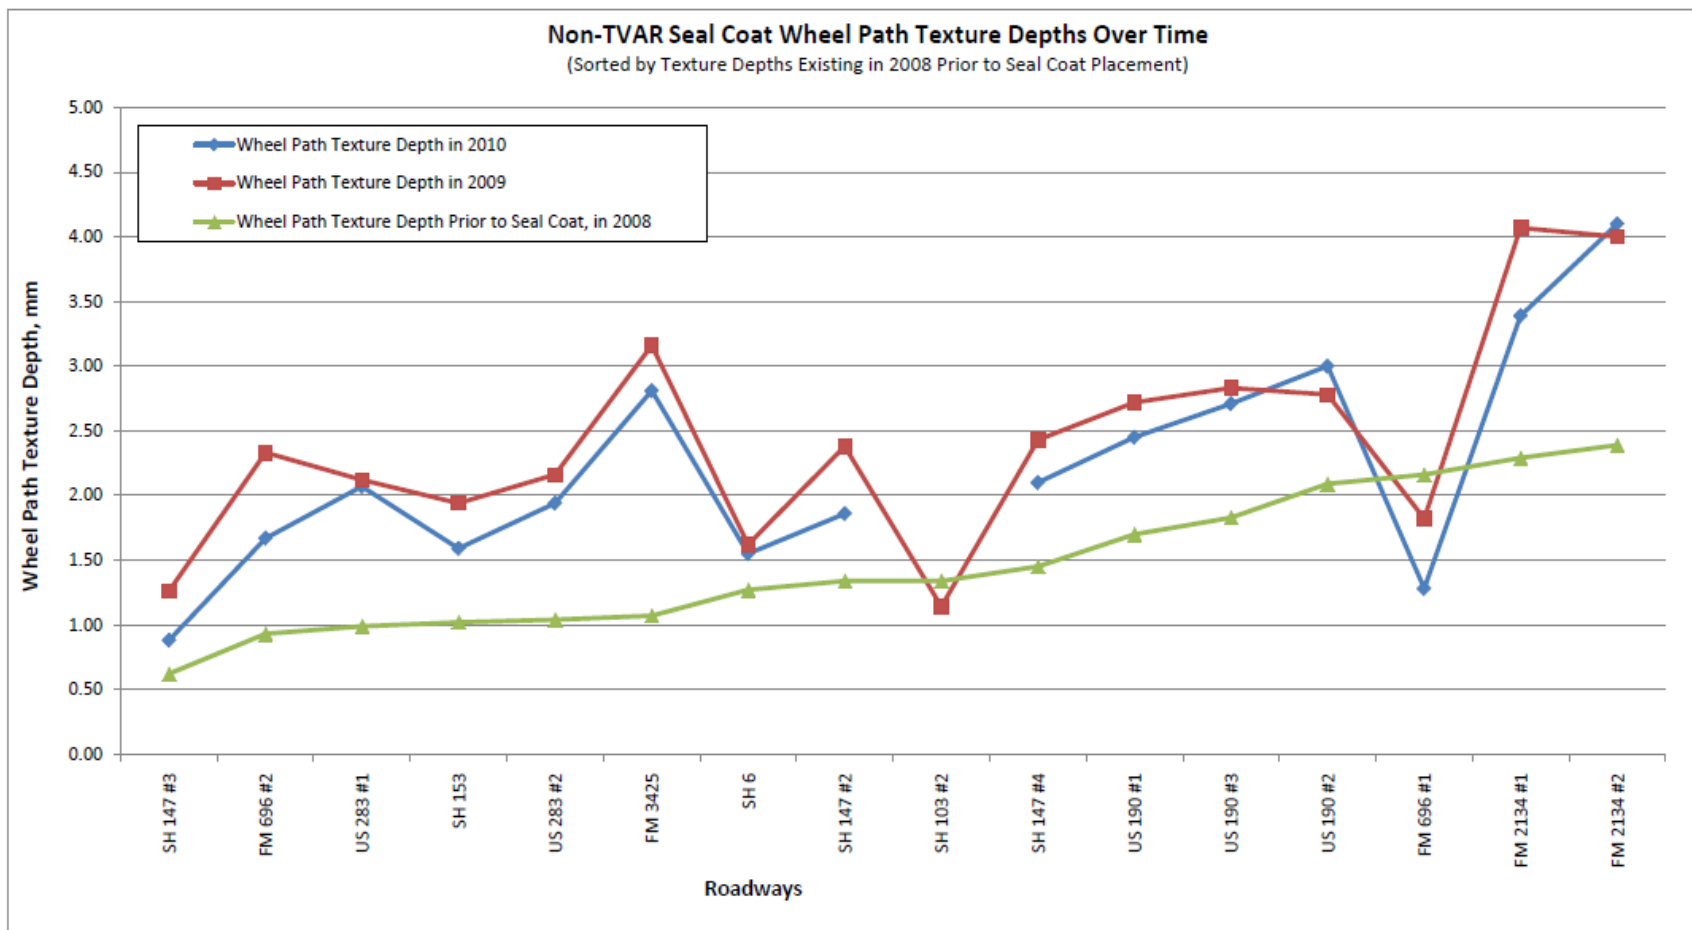
Figure 13. Wheel Path Texture Depth over Time for Pavements Using Uniform Asphalt Application Rates.

Figure 13 displays wheel path texture depth test results for the pavement locations where TVAR methods were not used when the seal coat was constructed. Only two of the 16 locations were found to have wheel path texture depths lower after two years of traffic than those existing prior to seal coat placement. Besides these two exceptions, wheel path texture depths two years later were usually considerably higher than pre-existing texture depths.

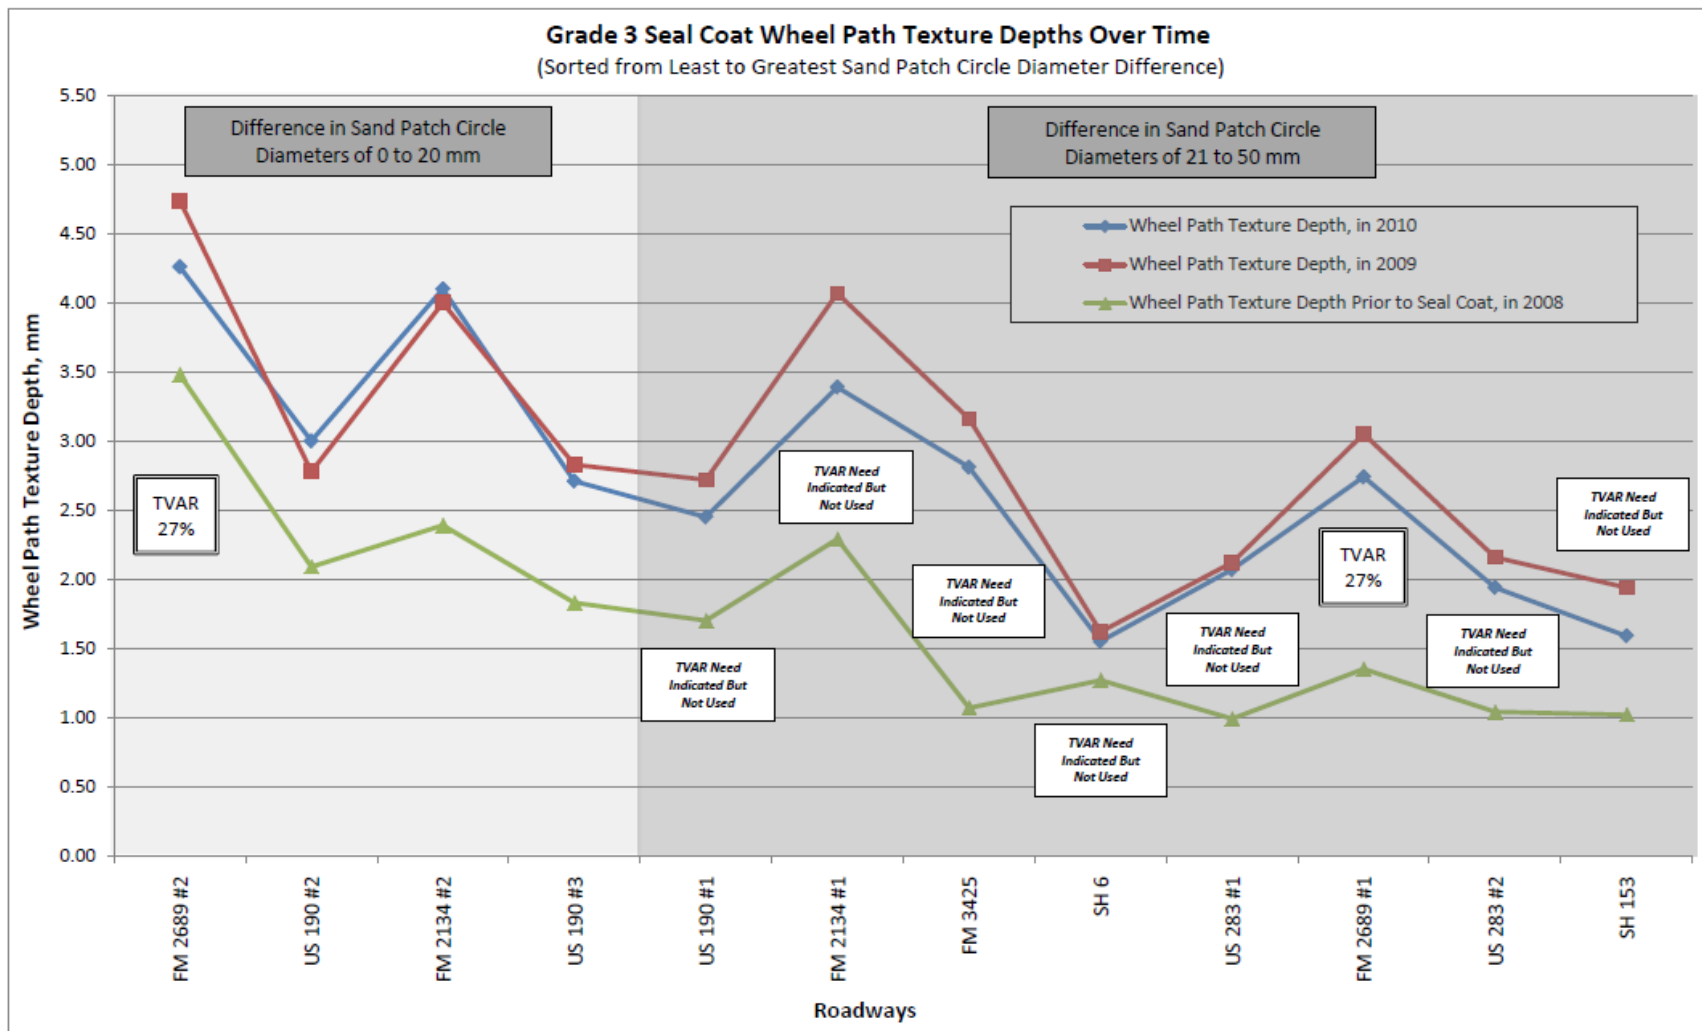
Figure 14. Grade 3 Seal Coat Wheel Path Texture Depth over Time.

A comparison of Figures 14 and 15 clearly indicates, as expected, the greater texture depths resulting when Grade 3 aggregate seal coats were placed. What was somewhat of a surprise was the extent to which the Grade 3 seal coats outperformed the Grade 4 seal coats, even those using TVAR methods, in retaining wheel path texture depth improvements over the two year period of observation. Based on the limited information displayed in these two figures, it may be that use of Grade 3 seal coat aggregate is just as effective as and possibly more effective in mitigating return of flushed wheel paths than use of Grade 4 aggregate in conjunction with TVAR asphalt application methods. Additional data points and study would be required to confidently compare relative performance of Grade 3 and Grade 4 aggregate seal coats, with and without use of the TVAR method.

3. Districts should consider increased use of Grade 3 aggregate seal coats when the existing pavements exhibit easily visible wheel path flushing.
4. Seal coat asphalt rate determination methods for pavements with flushed wheel paths should be reviewed for possible revision to provide reduced asphalt application rates in these situations. Construction of carefully controlled test sections is recommended to determine if adjustments in design procedures are required and magnitudes of those adjustments.

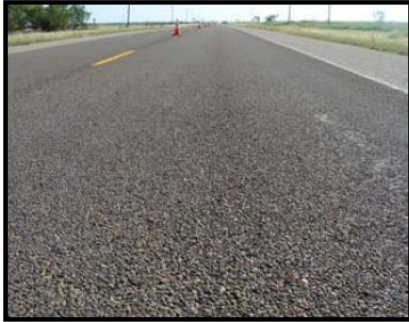
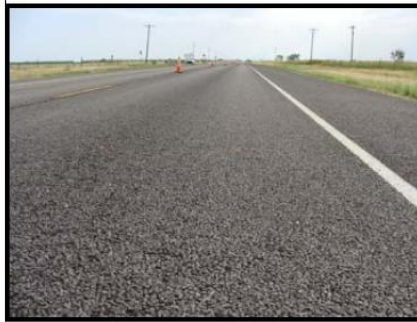
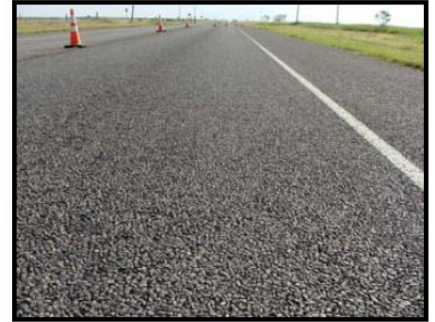
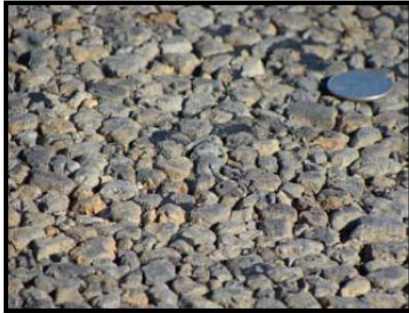
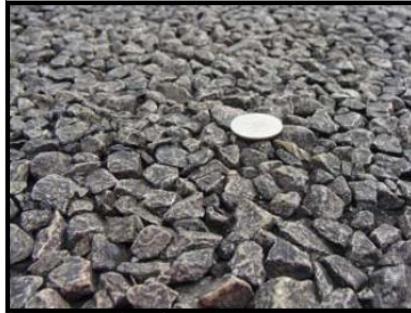
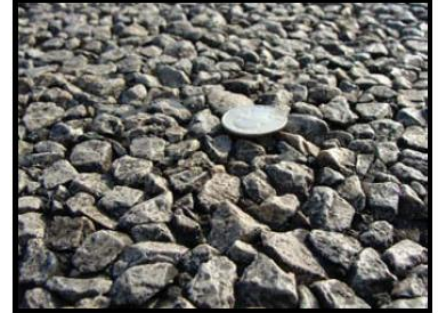
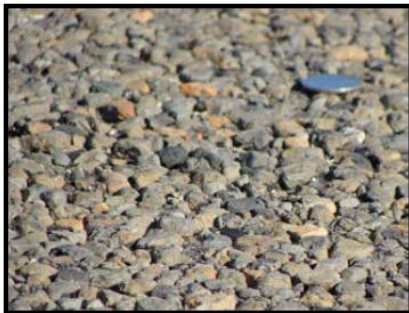
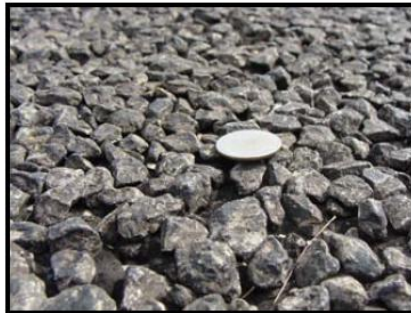
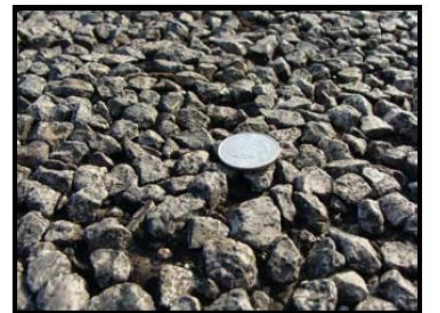
US 190 (Location 1) – McCullough County Grade 3 Aggregate with Straight AC-20XP at 0.45 gal/SY

Sand Patch Mean Texture Depth, mm			
	Old Pavement in 2008	New Seal in 2009	New Seal in 2010
Wheel Path	1.70	2.72	2.45
Between WP	2.37	3.93	3.60
Difference	0.67	1.21	1.15

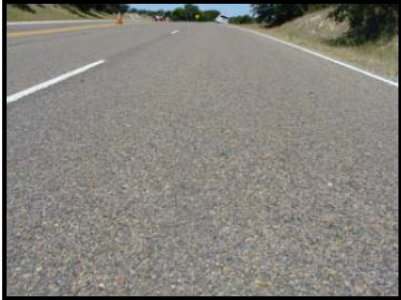
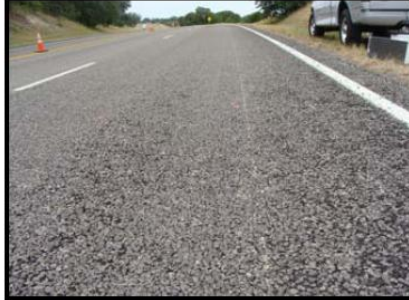
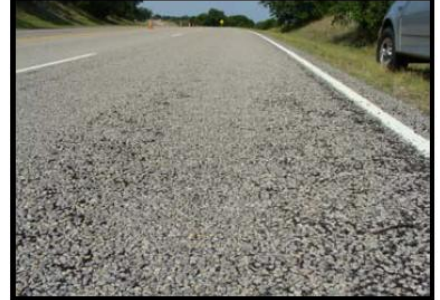
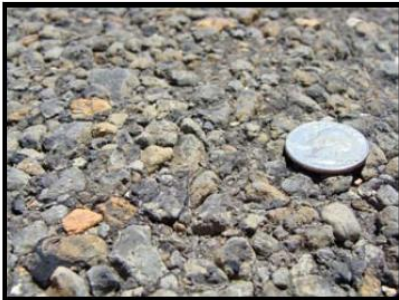
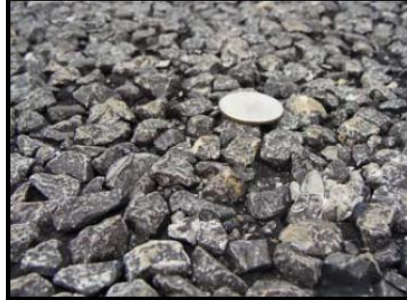
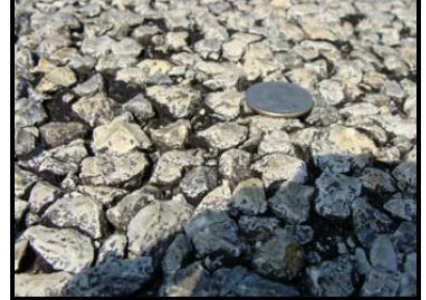
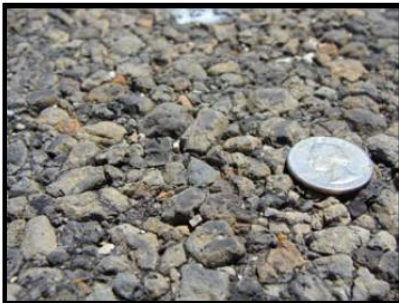
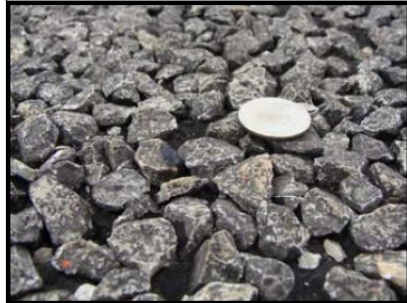
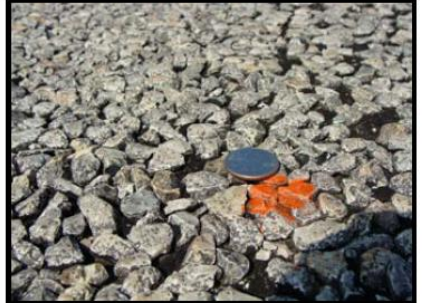
US 190 (Location 2) – McCullough County
Grade 3 Aggregate with Straight AC-20XP at 0.48 gal/SY

Sand Patch Mean Texture Depth, mm			
	Old Pavement in 2008	New Seal in 2009	New Seal in 2010
Wheel Path	2.09	2.78	3.00
Between WP	2.40	3.83	3.57
Difference	0.31	1.06	0.57

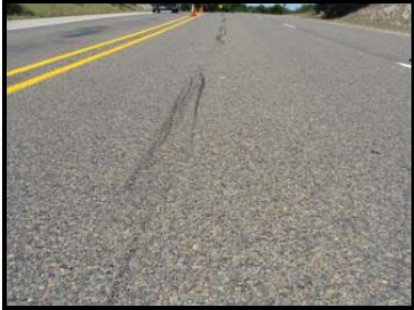
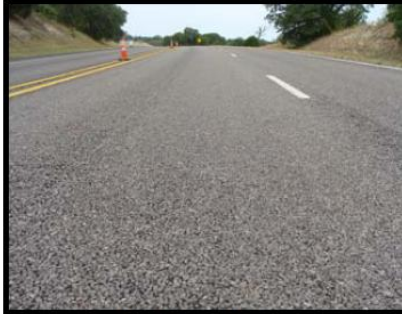
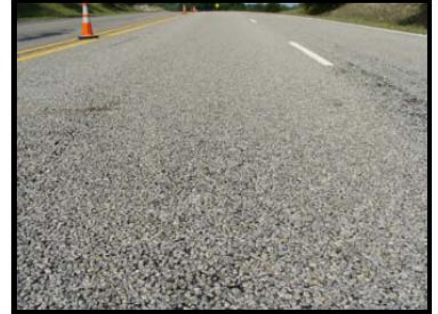
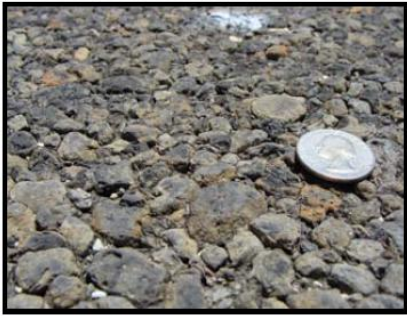
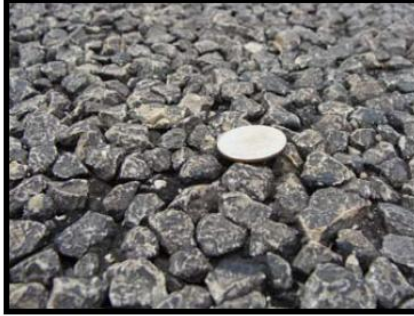
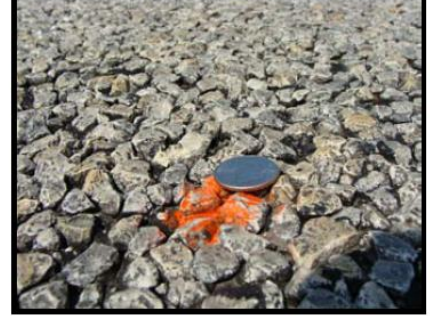
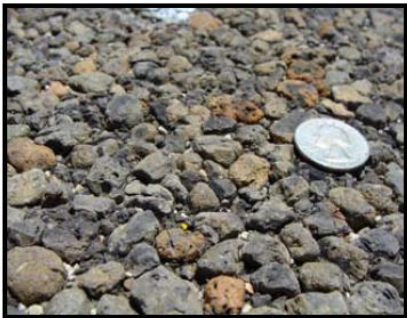
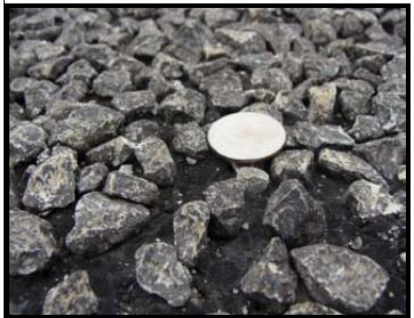
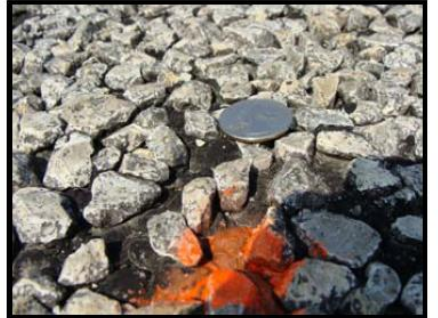
US 190 (Location 3) – McCullough County
 Grade 3 Aggregate with Straight AC-20XP at 0.50 gal/SY

Sand Patch Mean Texture Depth, mm			
	Old Pavement in 2008	New Seal in 2009	New Seal in 2010
Wheel Path	1.83	2.83	2.71
Between WP	2.45	4.22	3.78
Difference	0.62	1.39	1.07

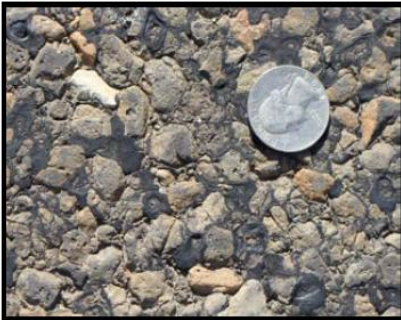
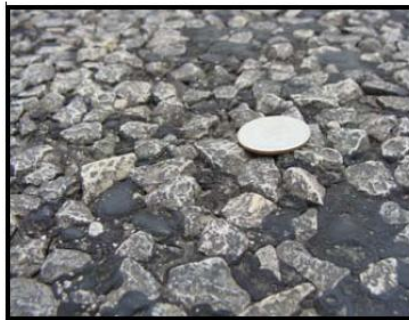
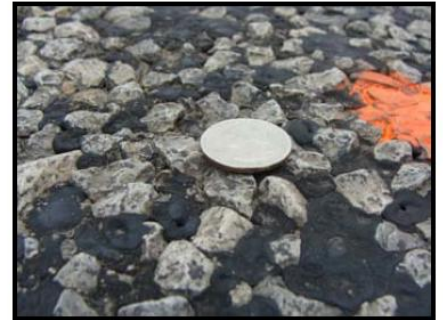
Wheel Path Texture

Sand Patch Mean Texture Depth, mm			
	Old Pavement in 2008	New Seal in 2009	New Seal in 2010
Wheel Path	1.02	1.94	1.59
Between WP	1.88	3.53	3.11
Difference	0.86	1.59	1.52

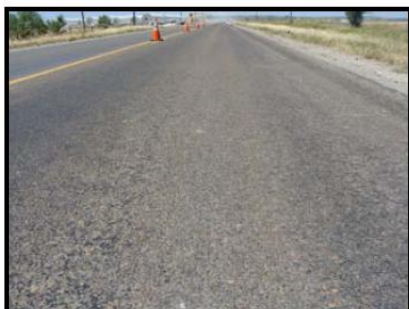
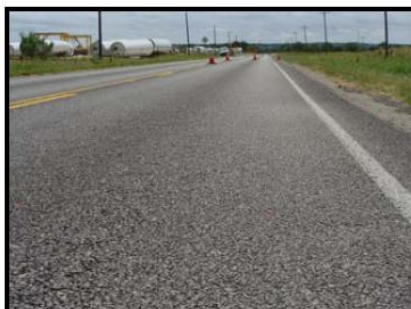
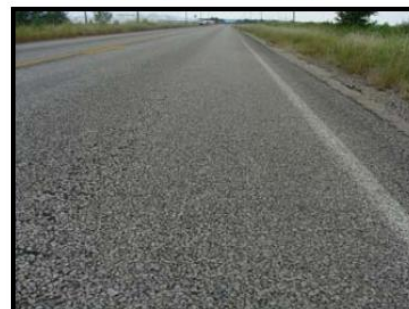
Southbound View

Sand Patch Mean Texture Depth, mm			
	Old Pavement in 2008	New Seal in 2009	New Seal in 2010
Wheel Path	1.07	3.16	2.81
Between WP	1.52	3.23	2.98
Difference	0.45	0.07	0.17

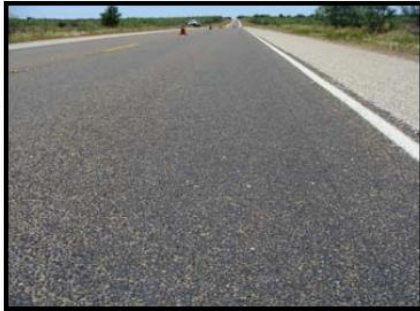
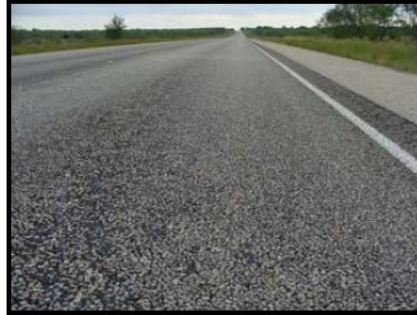
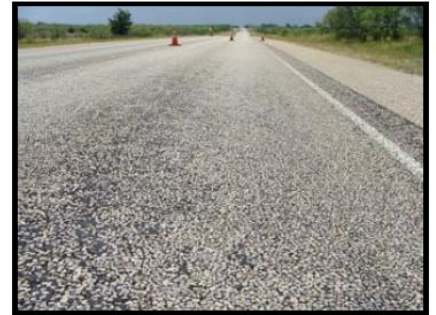
Southbound View

Sand Patch Mean Texture Depth, mm			
	Old Pavement in 2008	New Seal in 2009	New Seal in 2010
Wheel Path	0.99	2.12	2.07
Between WP	1.65	2.86	2.32
Difference	0.66	0.74	0.25

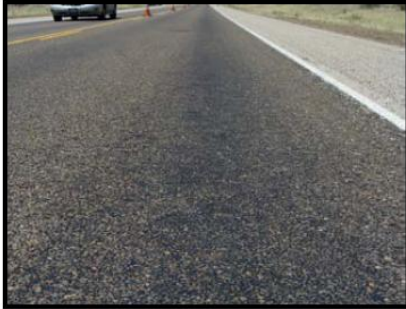
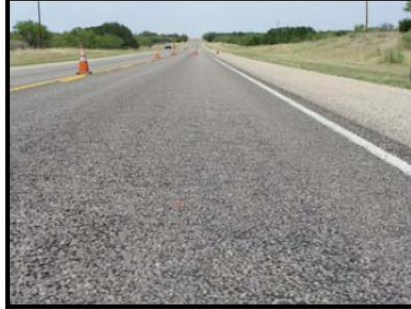
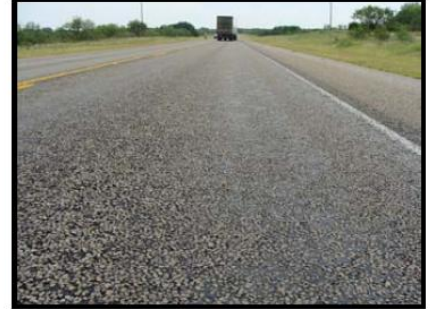
Northbound View

Sand Patch Mean Texture Depth, mm			
	Old Pavement in 2008	New Seal in 2009	New Seal in 2010
Wheel Path	1.04	2.16	1.94
Between WP	1.91	3.51	3.19
Difference	0.87	1.35	1.25

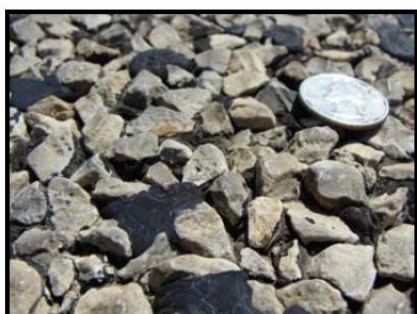
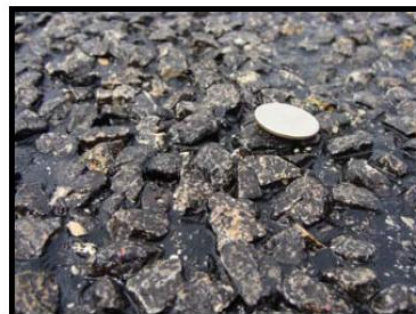
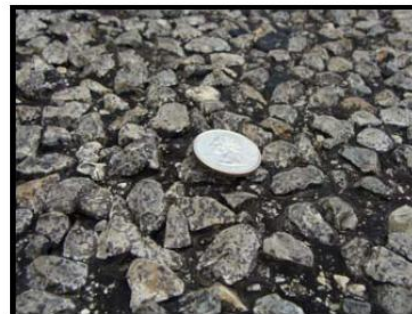
Westbound View

Sand Patch Mean Texture Depth, mm			
	Old Pavement in 2008	New Seal in 2009	New Seal in 2010
Wheel Path	2.29	4.07	3.39
Between WP	3.57	5.40	4.53
Difference	1.28	1.33	1.14

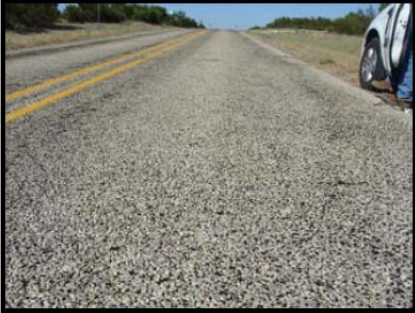
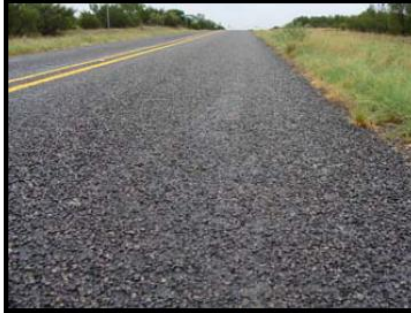
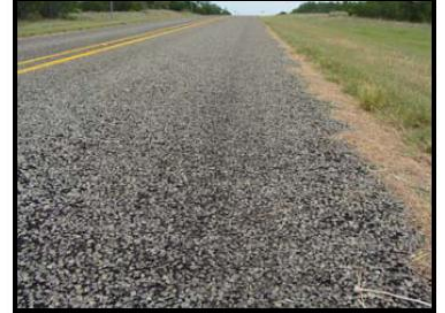
Old Pavement – 2008

FM 2134 (Location 2) – Coleman County
 Grade 3 Aggregate with Straight AC-20XP at 0.52 gal/SY

Sand Patch Mean Texture Depth, mm			
	Old Pavement in 2008	New Seal in 2009	New Seal in 2010
Wheel Path	2.39	4.00	4.10
Between WP	3.03	6.79	5.58
Difference	0.64	2.79	1.48

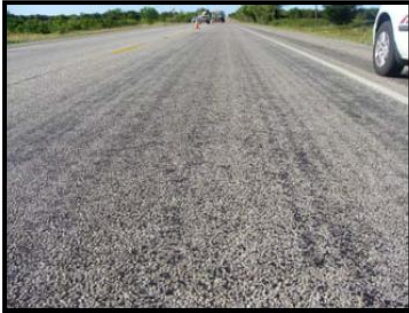
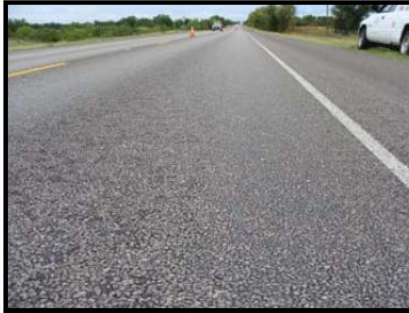
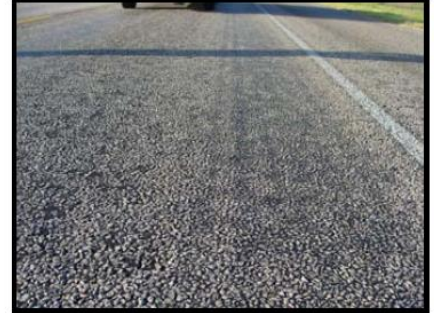
Old Pavement – 2008

SH 6 – Eastland County
Grade 3 Aggregate with Straight AC-20XP at 0.45 gal/SY

Sand Patch Mean Texture Depth, mm			
	Old Pavement in 2008	New Seal in 2009	New Seal in 2010
Wheel Path	1.27	1.62	1.55
Between WP	1.89	2.61	2.43
Difference	0.62	1.00	0.88

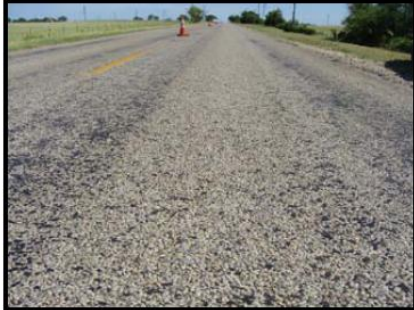
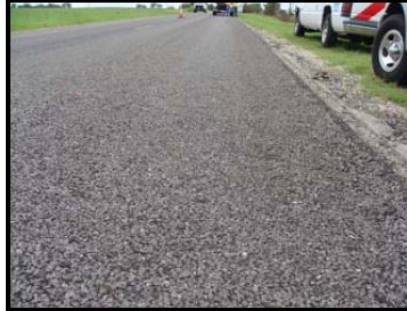
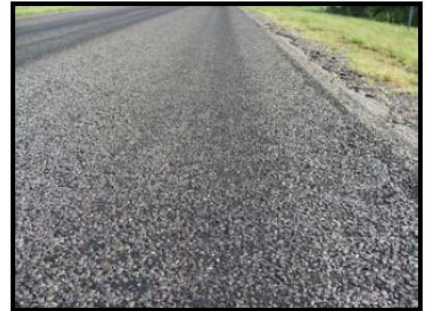
Old Pavement – 2008

The second pair of pavement locations was on FM 2689 in Eastland County. They were located in the same lane, within approximately 600 ft of each other, and may be seen in Figure 17. Yet, location 1 had limited pre-existing wheel path texture depth, 1.35 mm, compared to the pre-existing wheel path texture depth of 3.48 mm at location 2. These wheel path texture depths and those found after one year and two years of traffic are shown in Table 12. Both locations received a TVAR seal coat, at asphalt application rates of 0.30 and 0.38 gal/SY, as the bulk of the pavement length called for a TVAR seal coat. Both locations have retained excellent textures over the two-year period of the study. Location 2, which did not require a TVAR method seal coat, has not lost aggregate from the wheel path even though a relatively low asphalt rate was applied.

FM 2689 (Location 1) – Eastland County
 Grade 3 Aggregate with TVAR AC-20XP at 0.30/0.38 gal/SY

Sand Patch Mean Texture Depth, mm			
	Old Pavement in 2008	New Seal in 2009	New Seal in 2010
Wheel Path	1.35	3.05	2.74
Between WP	2.57	4.72	3.55
Difference	1.22	1.67	0.81

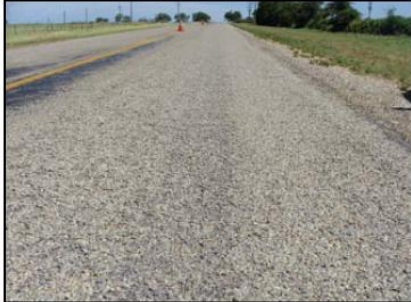
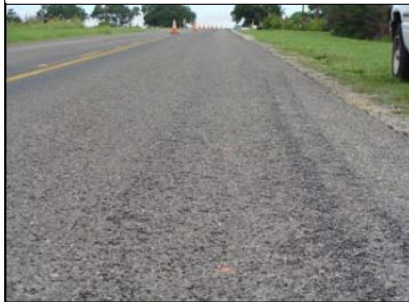
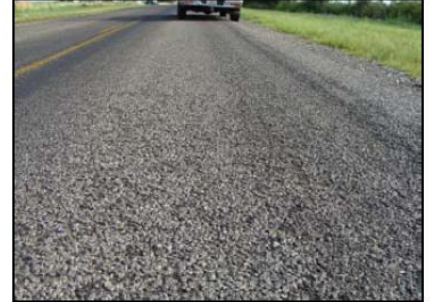
Old Pavement – 2008

FM 2689 (Location 2) – Eastland County
 Grade 3 Aggregate with TVAR AC-20XP at 0.30/0.38 gal/SY

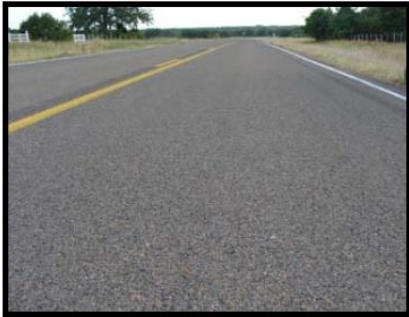
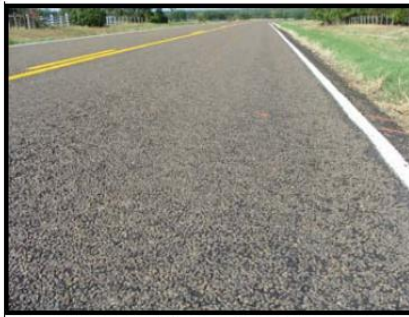
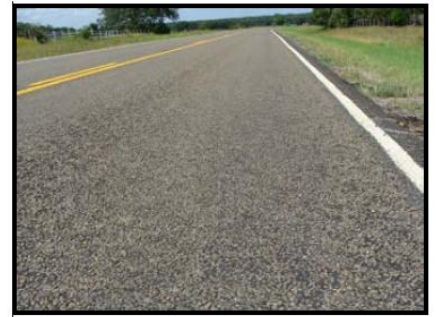
FM 696 (Location 1) – Burleson County
Grade 4 Aggregate with Straight AC-20XP at 0.36 gal/SY

Sand Patch Mean Texture Depth, mm			
	Old Pavement in 2008	New Seal in 2009	New Seal in 2010
Wheel Path	3.48	4.74	4.26
Between WP	3.90	4.58	4.04
Difference	0.42	-0.16	-0.22

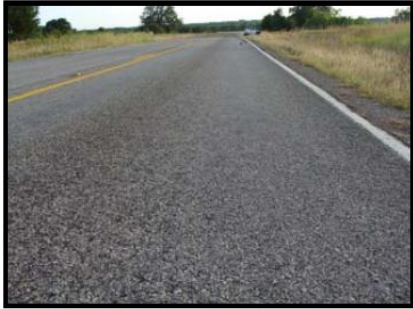
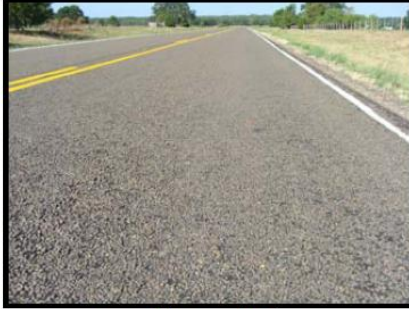
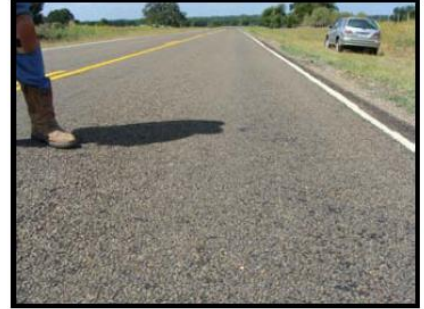
FM 696 (Location 2) – Burleson County
Grade 4 Aggregate with Straight AC-20XP at 0.36 gal/SY

Sand Patch Mean Texture Depth, mm			
	Old Pavement in 2008	New Seal in 2009	New Seal in 2010
Wheel Path	2.16	1.82	1.28
Between WP	2.50	3.02	2.62
Difference	0.34	1.19	1.34

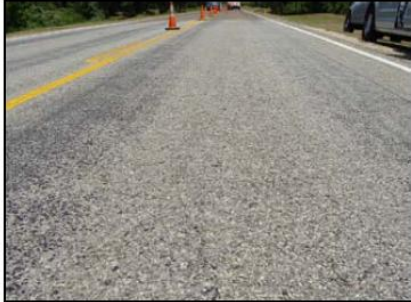
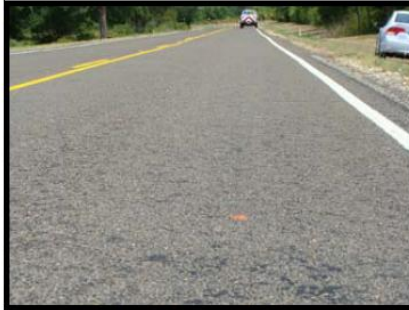
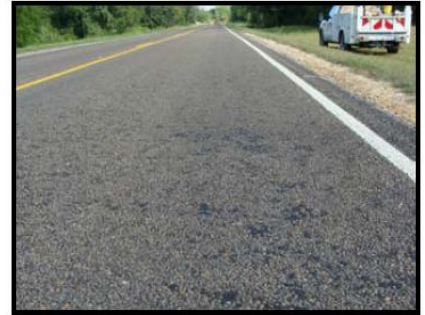
FM 908 (Location 1) – Burleson County
 Grade 4 Aggregate with TVAR AC-20XP at 0.32/0.38 gal/SY

Sand Patch Mean Texture Depth, mm			
	Old Pavement in 2008	New Seal in 2009	New Seal in 2010
Wheel Path	0.93	2.33	1.67
Between WP	2.14	3.78	2.92
Difference	1.21	1.44	1.25

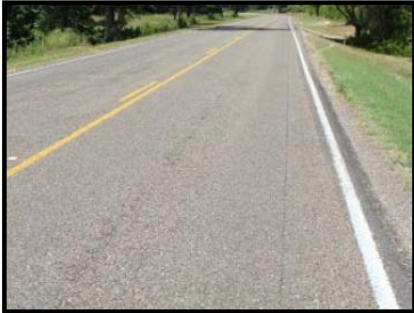
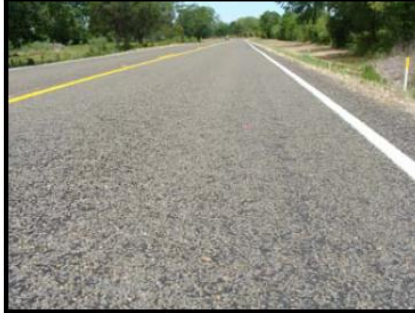
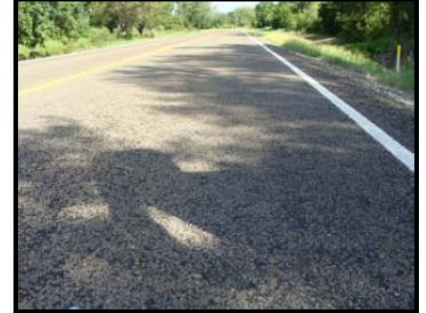
FM 908 (Location 2) – Burleson County
Grade 4 Aggregate with TVAR AC-20XP at 0.32/0.38 gal/SY

Several pairs of pavements merit individual comparison. The first is a pair of pavement locations in Burleson County. FM 696 and FM 908 are parallel north-south roads which carry similar traffic. FM 696 location 1 and FM 908 location 2 had both been sealed by maintenance the prior year with a fine Grade 4 seal coat. These maintenance seals were short in length, leaving the majority of these pavement surfaces to be sealed in 2008 in an aged condition. The appearance and texture depth test results in 2008 for these two test locations were virtually identical, as seen in Table 11 and Figure 16. However, since the textures of these two pavements otherwise differed, FM 908 location 2 received a TVAR seal coat, with asphalt rates at 0.32 and

Sand Patch Mean Texture Depth, mm			
	Old Pavement in 2008	New Seal in 2009	New Seal in 2010
Wheel Path	0.79	2.24	1.85
Between WP	2.14	3.55	3.07
Difference	1.35	1.32	1.22

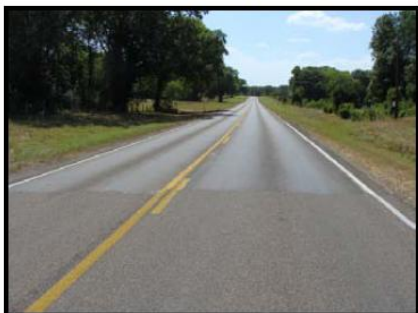
FM 908 (Location 3) – Burleson County
 Grade 4 Aggregate with TVAR AC-20XP at 0.39/0.45 gal/SY

Sand Patch Mean Texture Depth, mm			
	Old Pavement in 2008	New Seal in 2009	New Seal in 2010
Wheel Path	2.15	2.21	1.71
Between WP	3.22	3.72	3.21
Difference	1.07	1.51	1.50

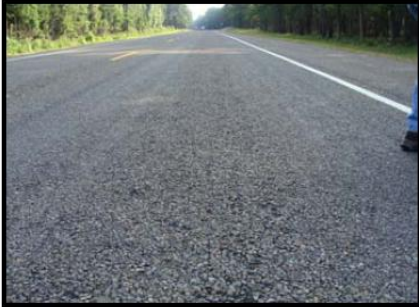
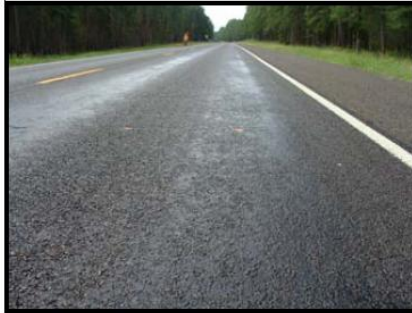
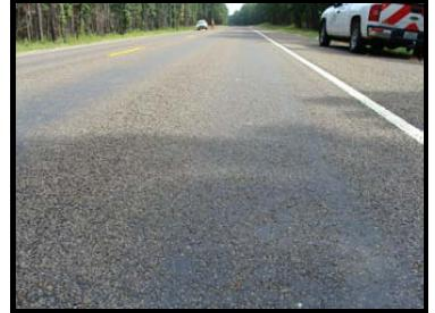
SH 147 (Location 1) – San Augustine County
 Grade 4 Aggregate with TVAR AC-15P at 0.32/0.38 gal/SY

The third pair of locations is on SH 147 in San Augustine County. Location 1 is in the northbound lane and location 3 is in the southbound lane, approximately three miles apart. Because of predominantly differing texture conditions around these test locations, location 1 with reasonably good pre-existing wheel path textures received a TVAR seal coat at 0.32 and 0.38 gal/SY and location 3, which was a considerably flushed wheel path location, received a uniform asphalt application at 0.34 gal/SY. The visual appearances of these locations may be seen in Figure 18, and Table 13 contains pre-existing and post-seal coat wheel path texture depths. Location 3 has lost virtually all texture improvement provided by the new seal coat within two years of construction. Location 1 now has *less* wheel path texture than existed prior to seal coat construction two years prior, although the texture depth is superior to that in location 3. The appearance is that both of these locations still have an excess of asphalt at the surface and both would have benefited from a lesser asphalt application in the wheel paths provided that the lesser asphalt amount would have held the aggregate over the first winter.

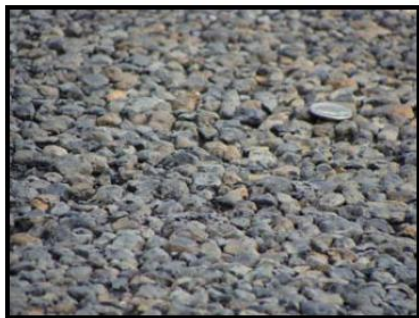
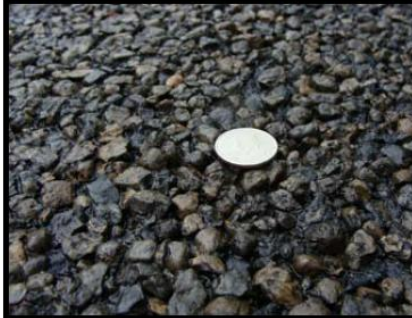
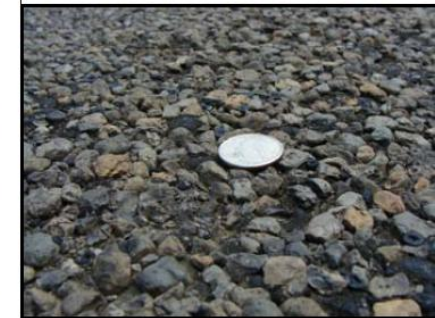
Sand Patch Mean Texture Depth, mm			
	Old Pavement in 2008	New Seal in 2009	New Seal in 2010
Wheel Path	1.93	1.77	1.20
Between WP	2.91	2.86	2.44
Difference	0.98	1.09	1.24
