1. Report No. FHWA/TX-11/5-5833-01-1		2. Government Accession No.		3. Recipient's Catalog No.	
4. Title and Subtitle IMPLEMENTATION OF TRANSVERSE VARIABLE ASPHALT RATE SEAL COAT PRACTICES IN TEXAS				5. Report Date December 2010 Published: January 2011

IMPLEMENTATION OF TRANSVERSE VARIABLE ASPHALT RATE SEAL COAT PRACTICES IN TEXAS

Report 5-5833-01-1
Project 5-5833-01
Project Title: Statewide Implementation of TVAR Seal Coat Methods

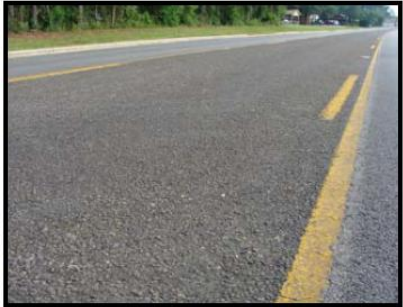
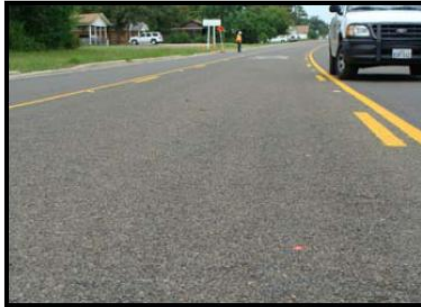
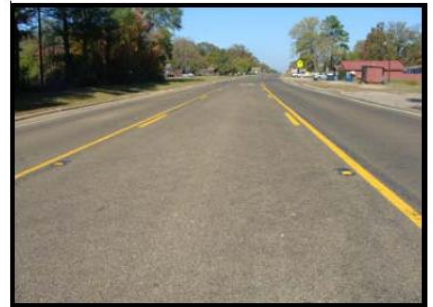
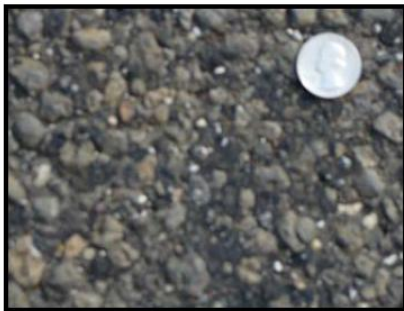
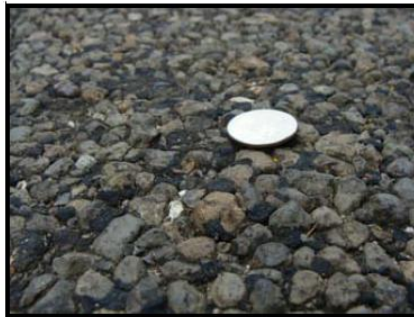
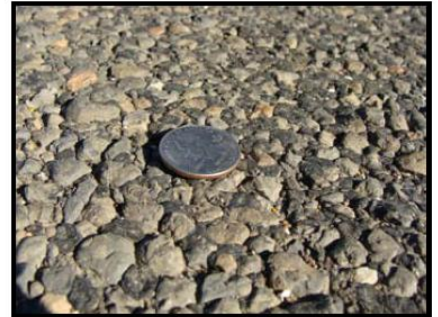
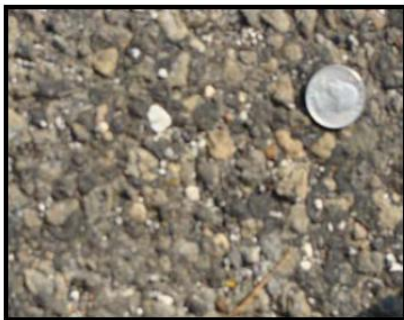
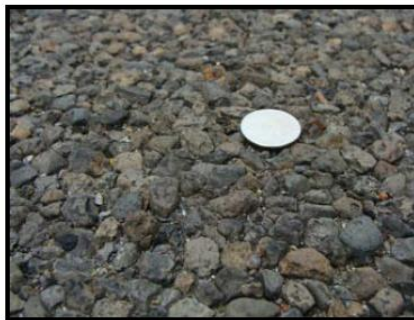
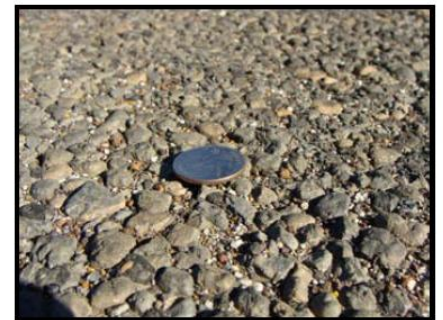
SH 147 (Location 2) – San Augustine County
 Grade 4 Aggregate with Straight AC-15P at 0.33 gal/SY

Sand Patch Mean Texture Depth, mm			
	Old Pavement in 2008	New Seal in 2009	New Seal in 2010
Wheel Path	1.34	2.38	1.86
Between WP	1.39	2.76	2.02
Difference	0.05	0.38	0.16

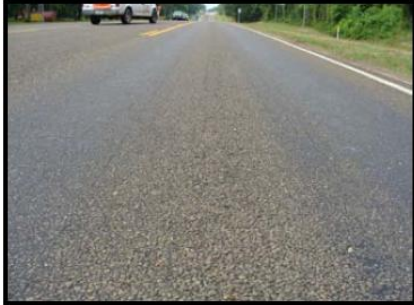
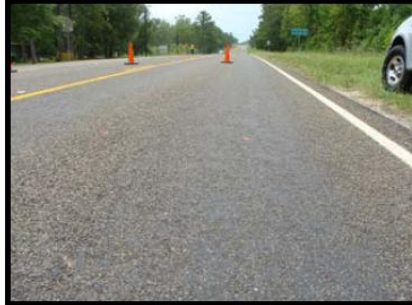
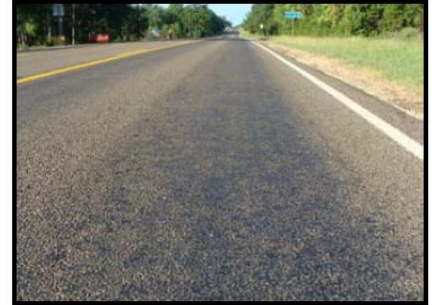
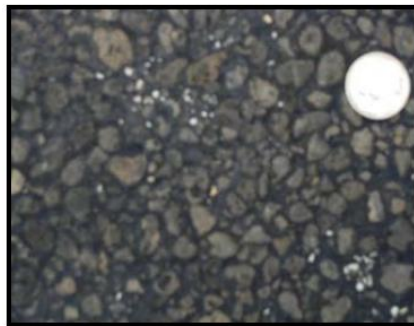
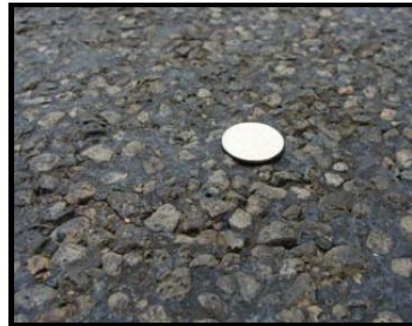
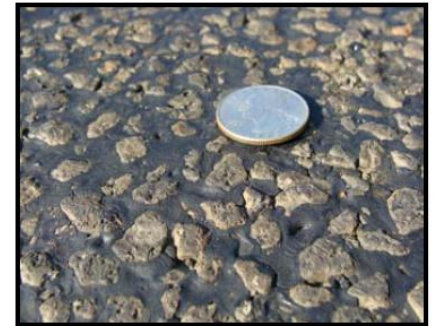
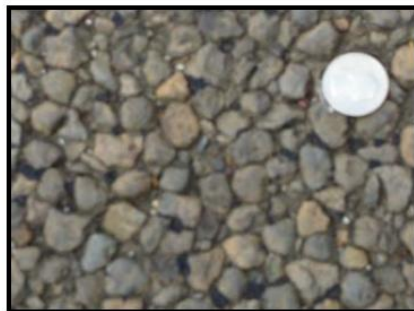
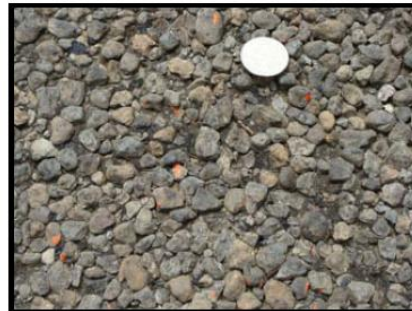
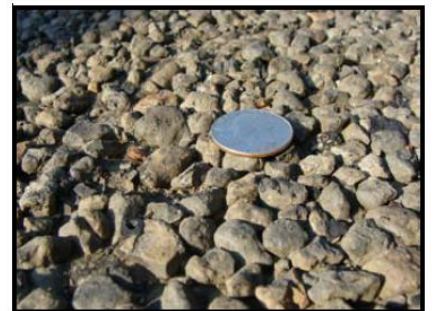
SH 147 (Location 3) – San Augustine County
 Grade 4 Aggregate with Straight AC-15P at 0.34 gal/SY

The third pair of locations is on SH 147 in San Augustine County. Location 1 is in the northbound lane and location 3 is in the southbound lane, approximately three miles apart. Because of predominantly differing texture conditions around these test locations, location 1 with reasonably good pre-existing wheel path textures received a TVAR seal coat at 0.32 and 0.38 gal/SY and location 3, which was a considerably flushed wheel path location, received a uniform asphalt application at 0.34 gal/SY. The visual appearances of these locations may be seen in Figure 18, and Table 13 contains pre-existing and post-seal coat wheel path texture depths. Location 3 has lost virtually all texture improvement provided by the new seal coat within two years of construction. Location 1 now has *less* wheel path texture than existed prior to seal coat construction two years prior, although the texture depth is superior to that in location 3. The appearance is that both of these locations still have an excess of asphalt at the surface and both would have benefited from a lesser asphalt application in the wheel paths provided that the lesser asphalt amount would have held the aggregate over the first winter.

Sand Patch Mean Texture Depth, mm			
	Old Pavement in 2008	New Seal in 2009	New Seal in 2010
Wheel Path	0.62	1.26	0.88
Between WP	2.40	3.36	2.80
Difference	1.78	2.10	1.92

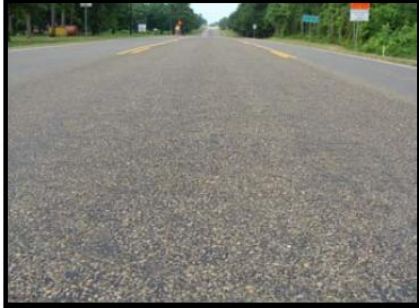
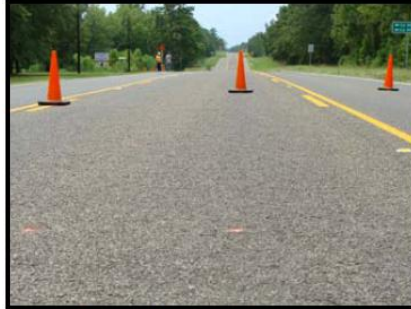
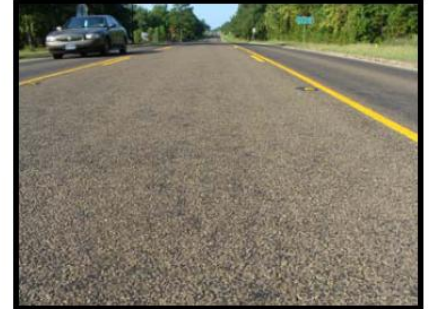
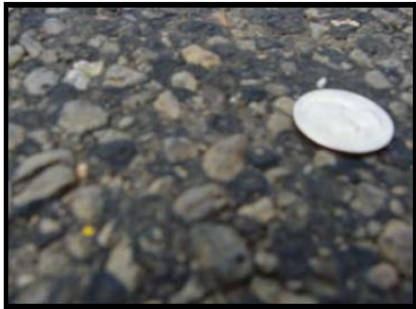
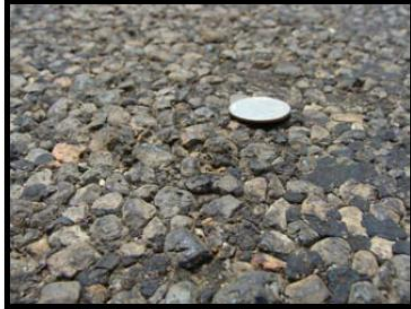
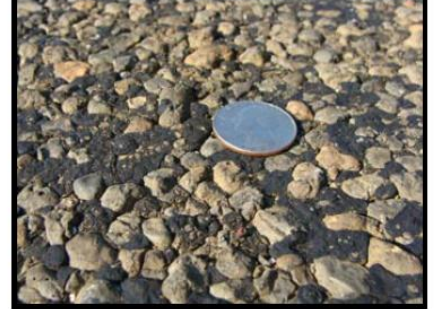
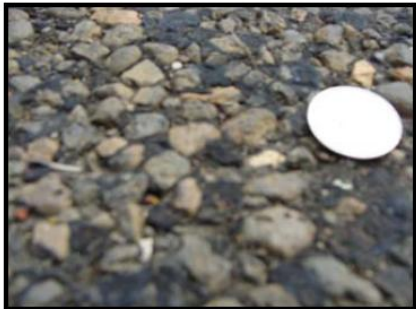
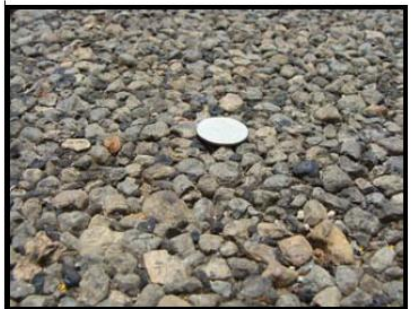
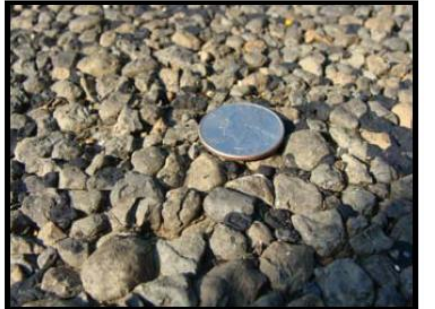
SH 147 (Location 4) – San Augustine County
 Grade 4 Aggregate with Straight AC-15P at 0.38 gal/SY

Sand Patch Mean Texture Depth, mm			
	Old Pavement in 2008	New Seal in 2009	New Seal in 2010
Wheel Path	1.45	2.43	2.10
Between WP	1.79	2.86	2.36
Difference	0.34	0.42	0.26

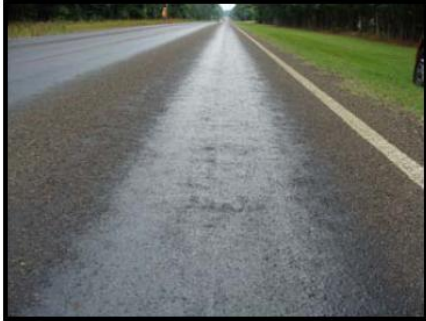
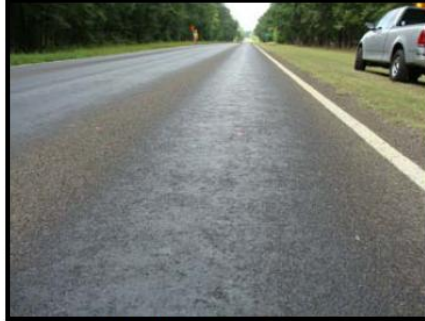
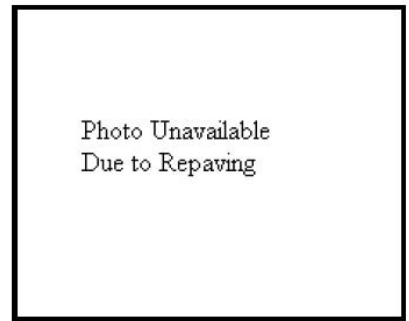
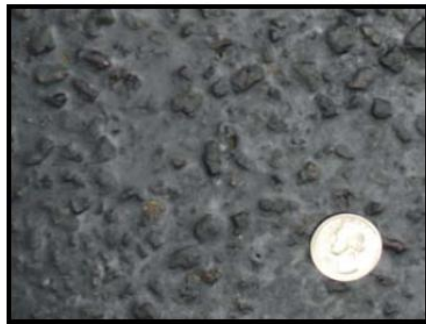
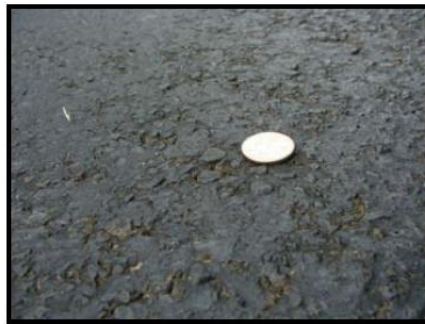
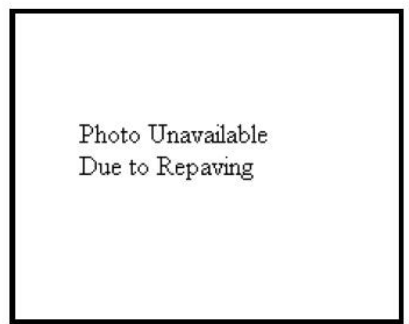
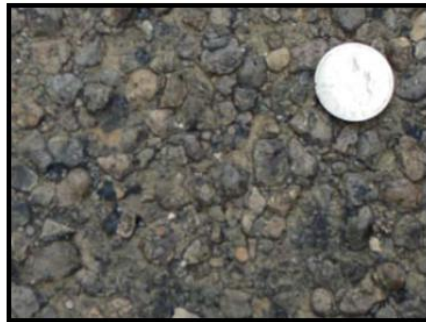
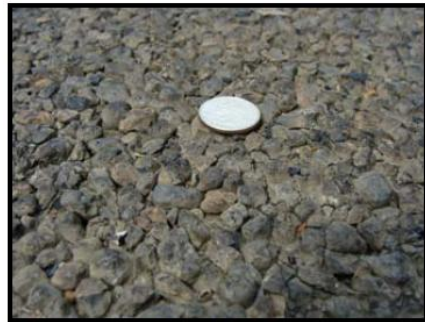
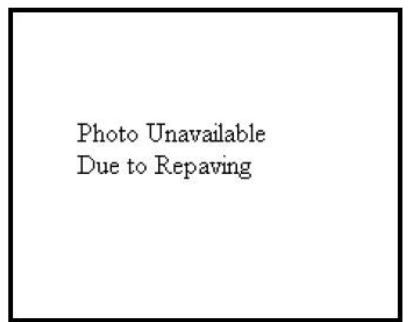
SH 103 (Location 1) – San Augustine County
 Grade 4 Aggregate with TVAR AC-15P at 0.25/0.32 gal/SY

Sand Patch Mean Texture Depth, mm			
	Old Pavement in 2008	New Seal in 2009	New Seal in 2010
Wheel Path	0.79	1.04	N/A
Between WP	2.53	2.39	N/A
Difference	1.74	1.35	N/A

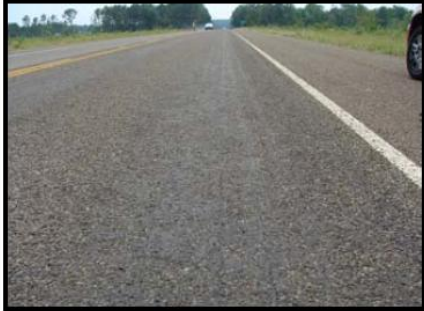
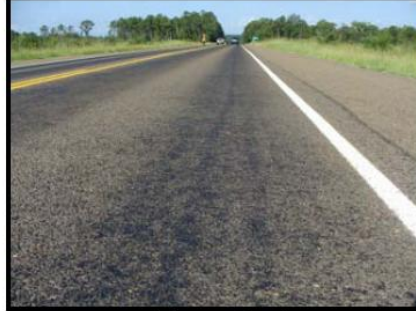
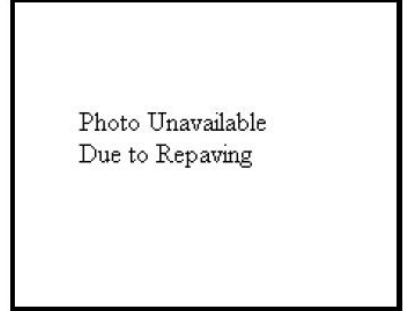
Old Pavement – 2008

SH 103 (Location 3) – San Augustine County
 Grade 4 Aggregate with TVAR AC-15P at 0.30/0.38 gal/SY

Sand Patch Mean Texture Depth, mm			
	Old Pavement in 2008	New Seal in 2009	New Seal in 2010
Wheel Path	1.34	1.58	N/A
Between WP	2.80	2.99	N/A
Difference	1.46	1.41	N/A

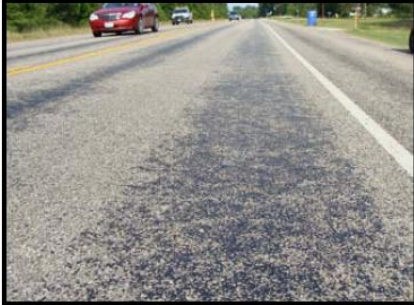
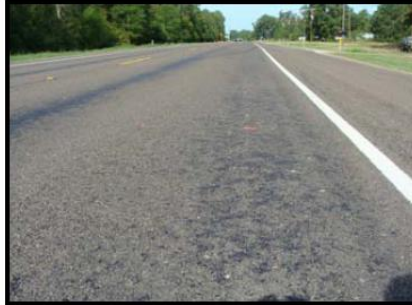
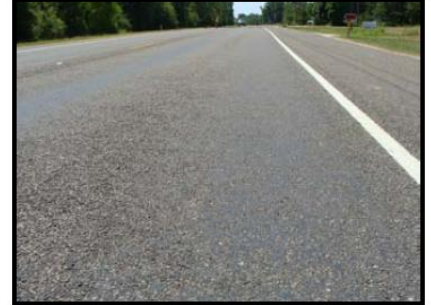
Old Pavement – 2008

FM 2457 (Location 1) – Polk County
 Grade 4 Aggregate with TVAR AC-20-5TR at 0.24/0.33 gal/SY

Sand Patch Mean Texture Depth, mm			
	Old Pavement in 2008	New Seal in 2009	New Seal in 2010
Wheel Path	0.79	1.25	0.86
Between WP	2.29	2.63	2.15
Difference	1.50	1.38	1.29

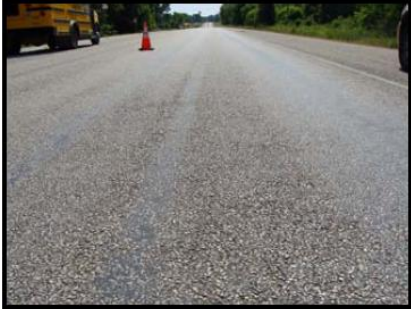
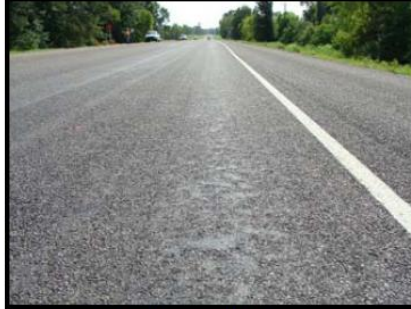
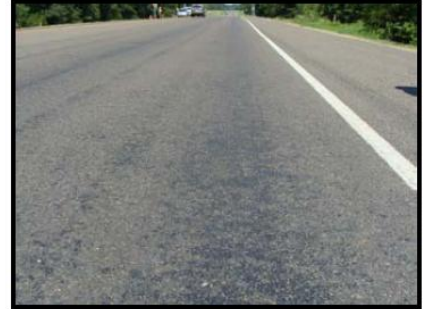
Old Pavement – 2008

FM 2457 (Location 2) – Polk County
 Grade 4 Aggregate with TVAR AC-20-5TR at 0.26/0.34 gal/SY

Sand Patch Mean Texture Depth, mm			
	Old Pavement in 2008	New Seal in 2009	New Seal in 2010
Wheel Path	0.41	0.90	0.68
Between WP	1.42	2.29	2.09
Difference	1.01	1.39	1.47
