Identification and Evaluation of Pavement-Bridge Interface Ride Quality Improvement and Corrective Strategies

Institute for Transportation

Report Number FHWA/OH-2011/1

January 2011

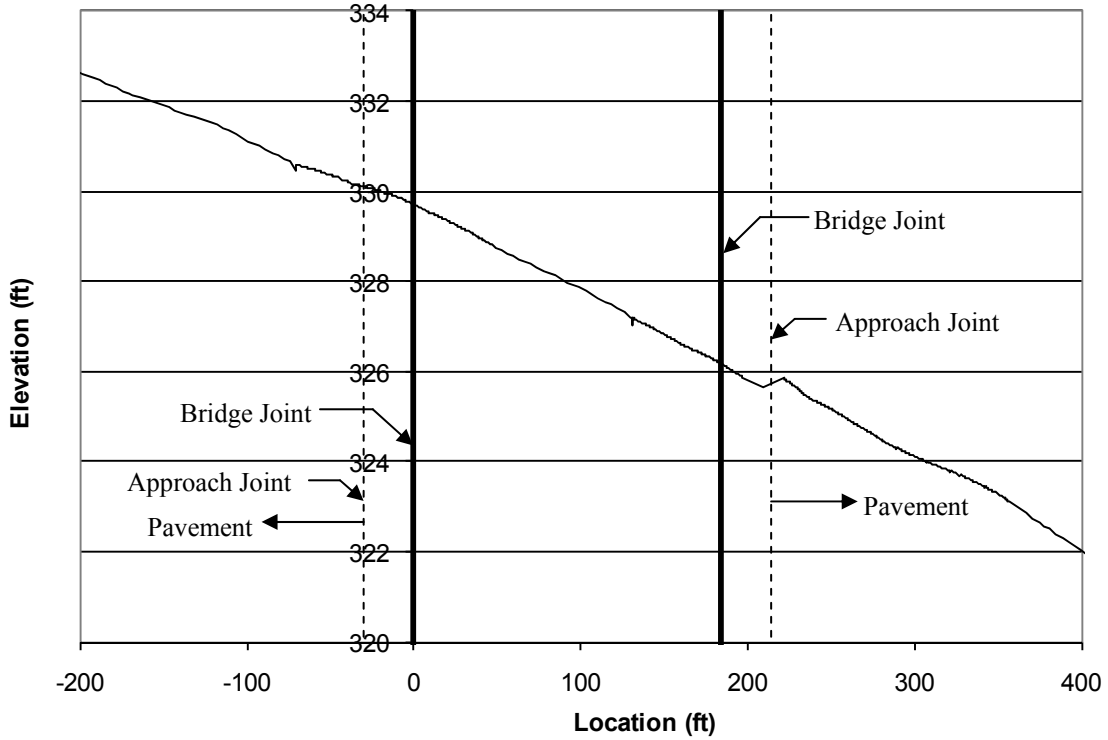
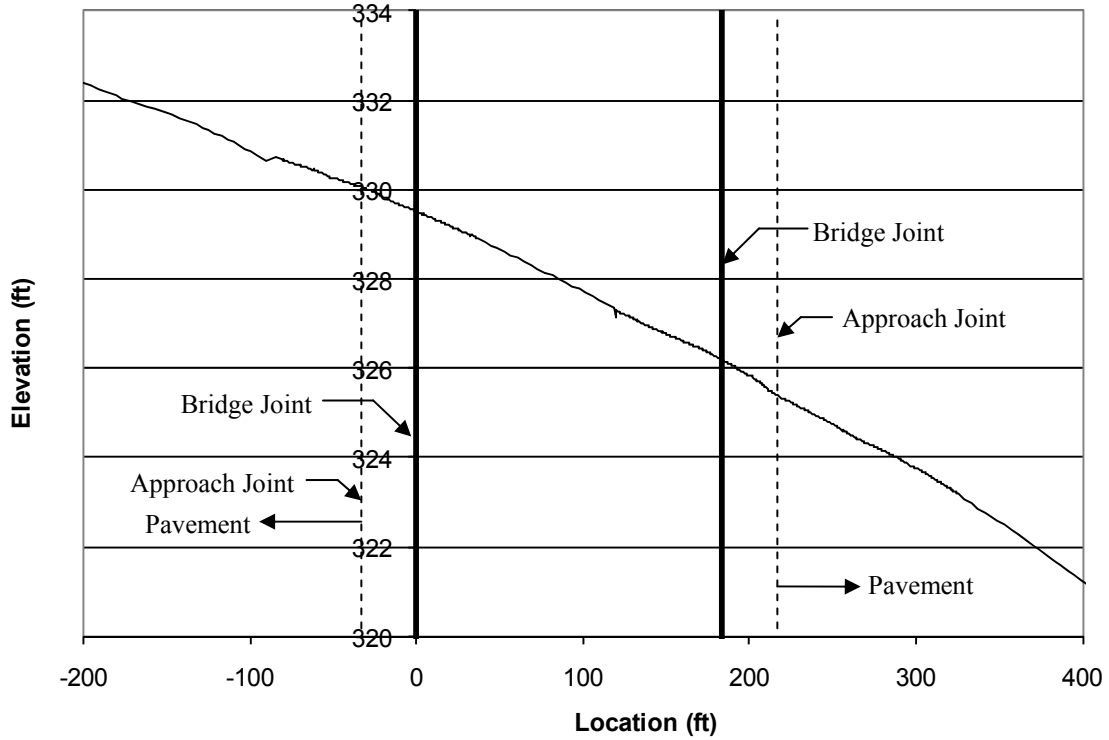
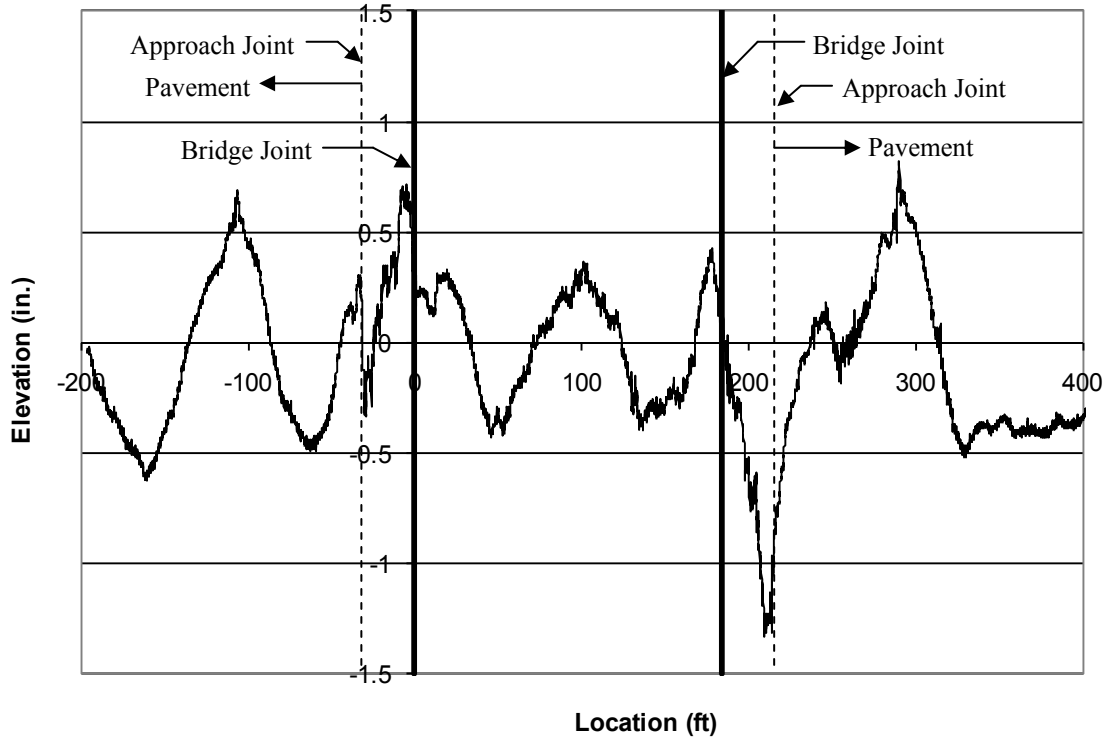
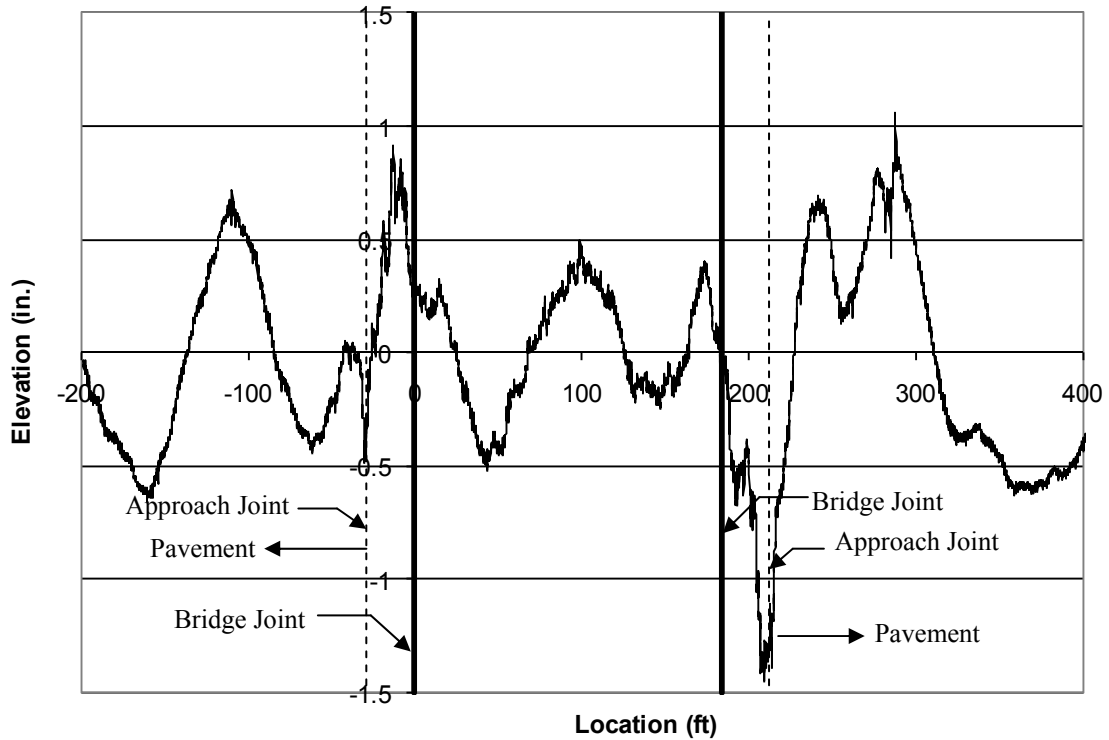
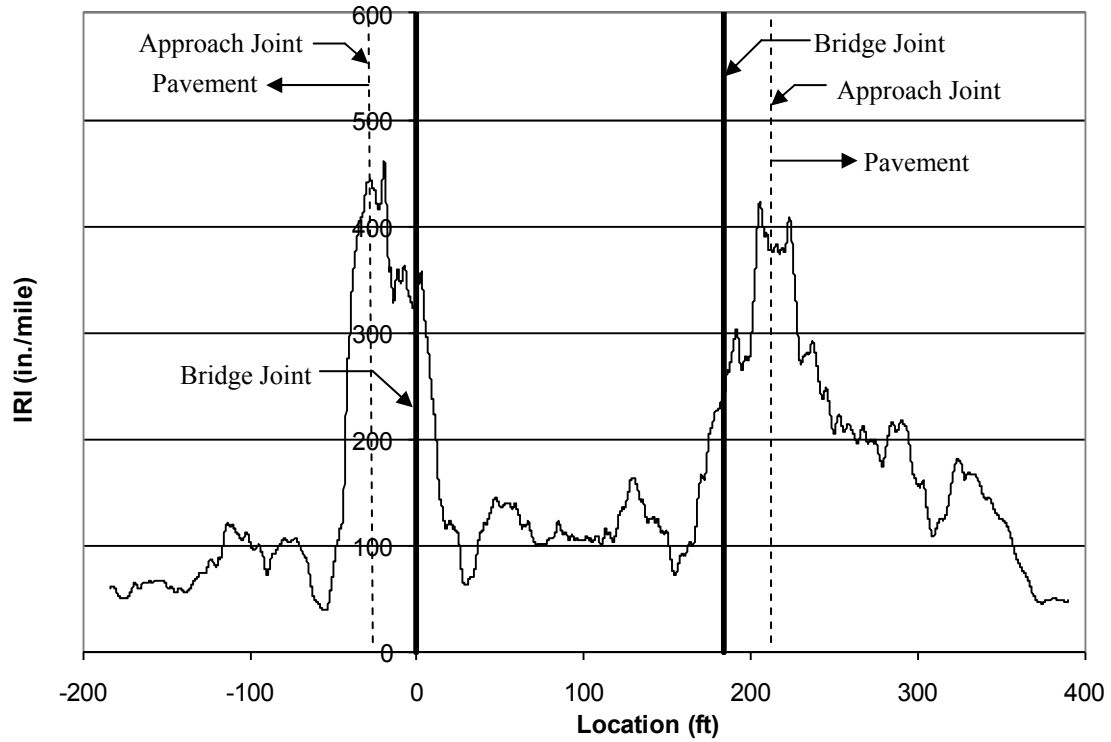
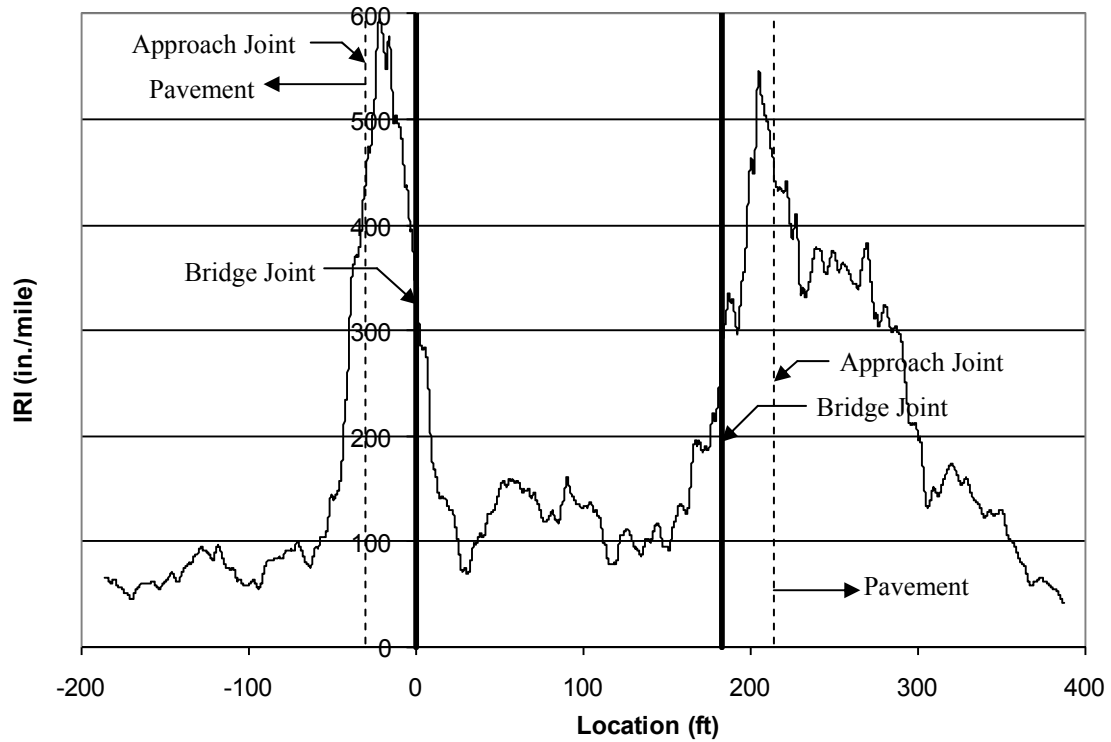
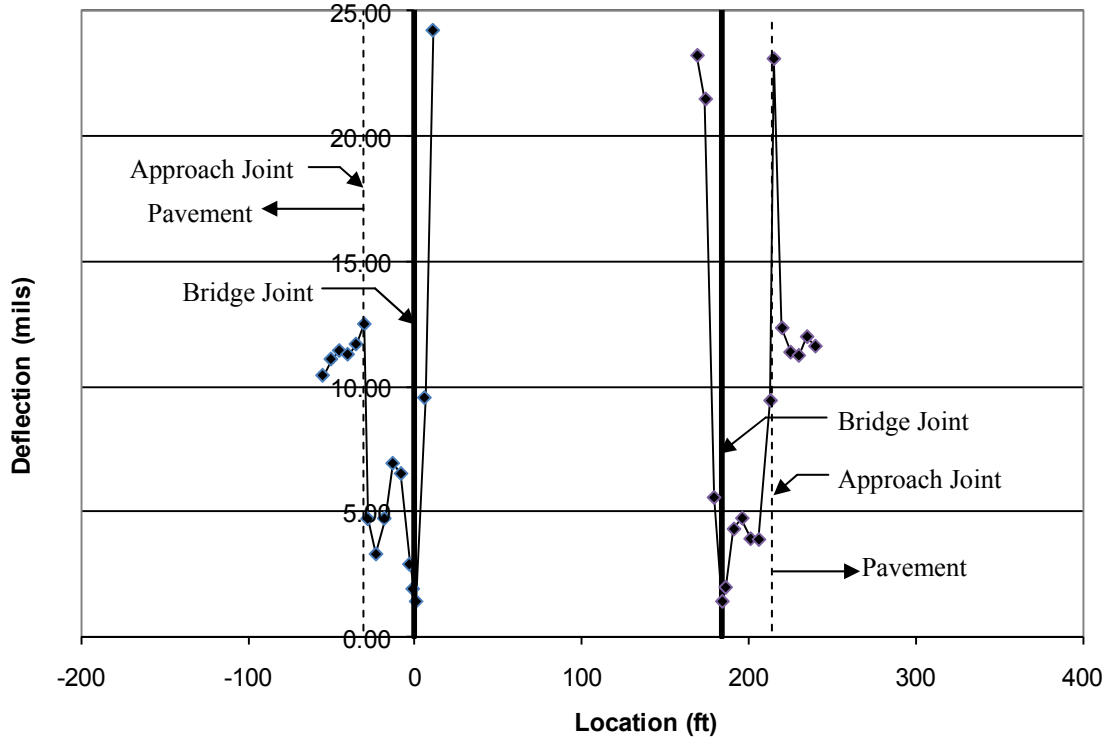
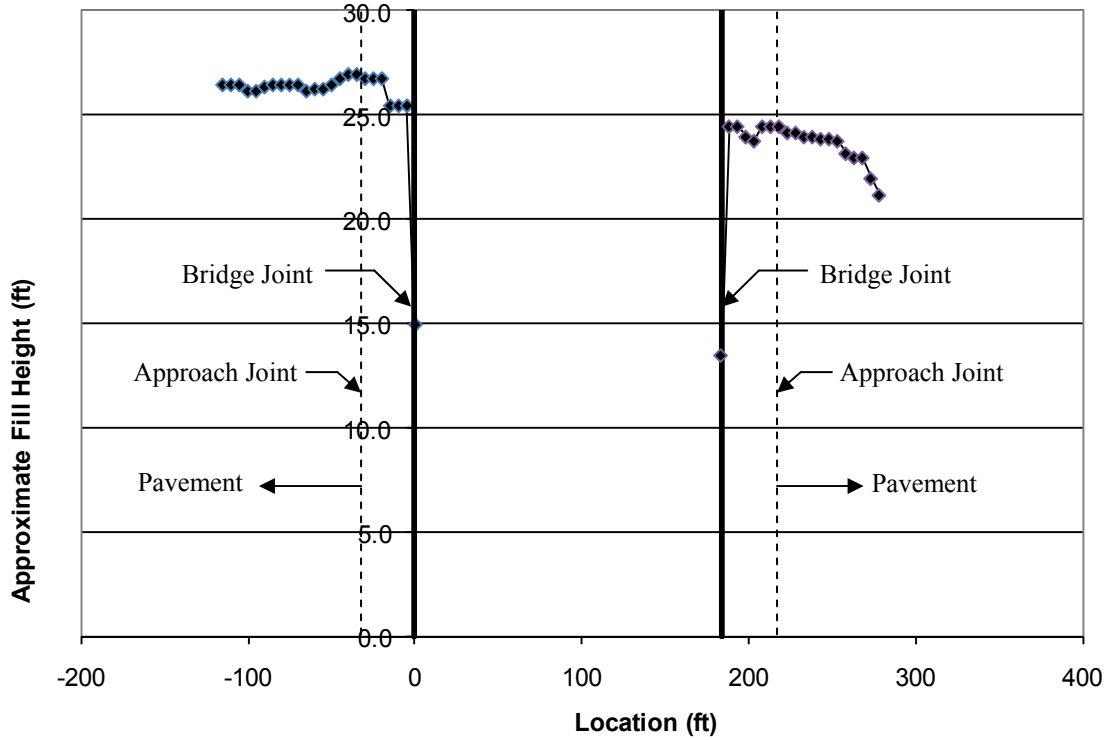
Figure 5.11. FAI 33-14.17 bridge geometric testing results

Figures 5.11a and 5.11b show the results of the laser-based survey. As can be seen, there is an overall slope of the bridge with three global geometric discontinuities observed. The first global discontinuity occurs at the entry end of the bridge and can be observed in both the right and left wheel lines. The location of the discontinuity relative to the bridge indicates that the discontinuity may be at the end of the approach slab system. The second discontinuity occurs on the bridge and can, again, be seen in both wheel lines. This discontinuity may be occurring at an on-bridge joint. The third and final discontinuity occurs only in the right wheel line after the exit end of the bridge. This discontinuity is a noticeable “ramp” occurring in the region of the approach slab.

The raw profiler data are shown in Figures 5.11c and 5.11d. From these data it can be observed that both left and right wheel lines tend to track well together before/after the approach slabs. A general agreement in measurements can also be seen on the bridge itself. However, the approach slab regions show differing profiler data in the approach slab regions. The difference is most marked on the exit end of the bridge—possibly related to the right wheel line global geometric discontinuity noted above. The IRI results continue to corroborate the findings noted above. Further, the IRI results in the approach slab regions show IRI values approaching 600 in./mile. It should be noted that here, and in subsequent similar discussions, that maximum, instantaneous values will be cited. It is important to note that these represent the worst measurement for the site and not the site average. These instantaneous values speak to localized roughness, which usually occurs at the bridge-pavement interface.

Observations from the FWD test results show a very stiff support system close to the bridge ends and that this support system seems to soften moving away from the bridge ends. The approximate fill heights, however, indicate only a minimal difference in the fill depths moving away from the bridge ends. Collectively, this would indicate that the stiffness differences are derived from differences in construction (e.g., soil compaction levels).

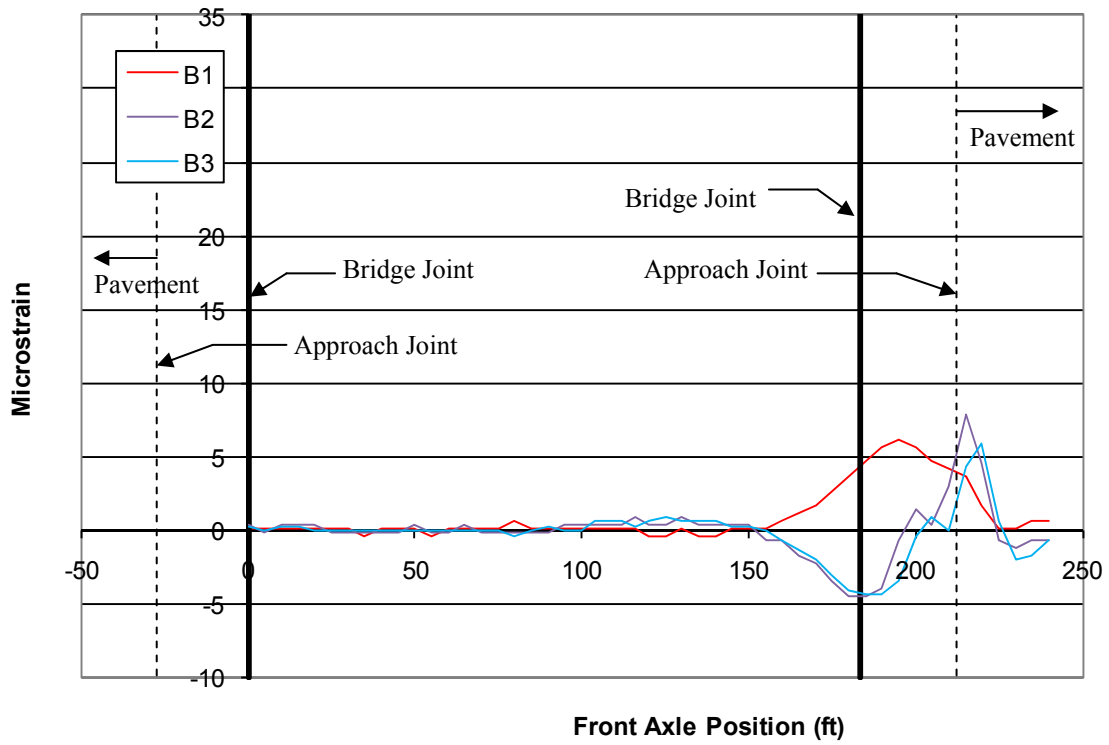
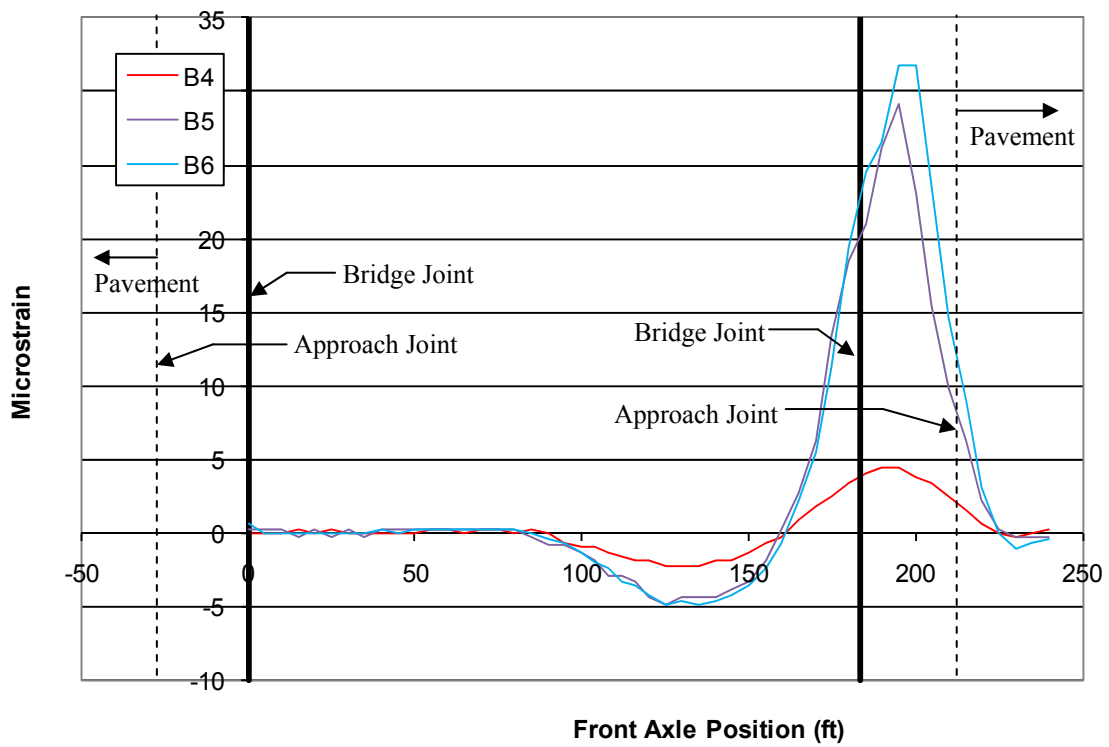
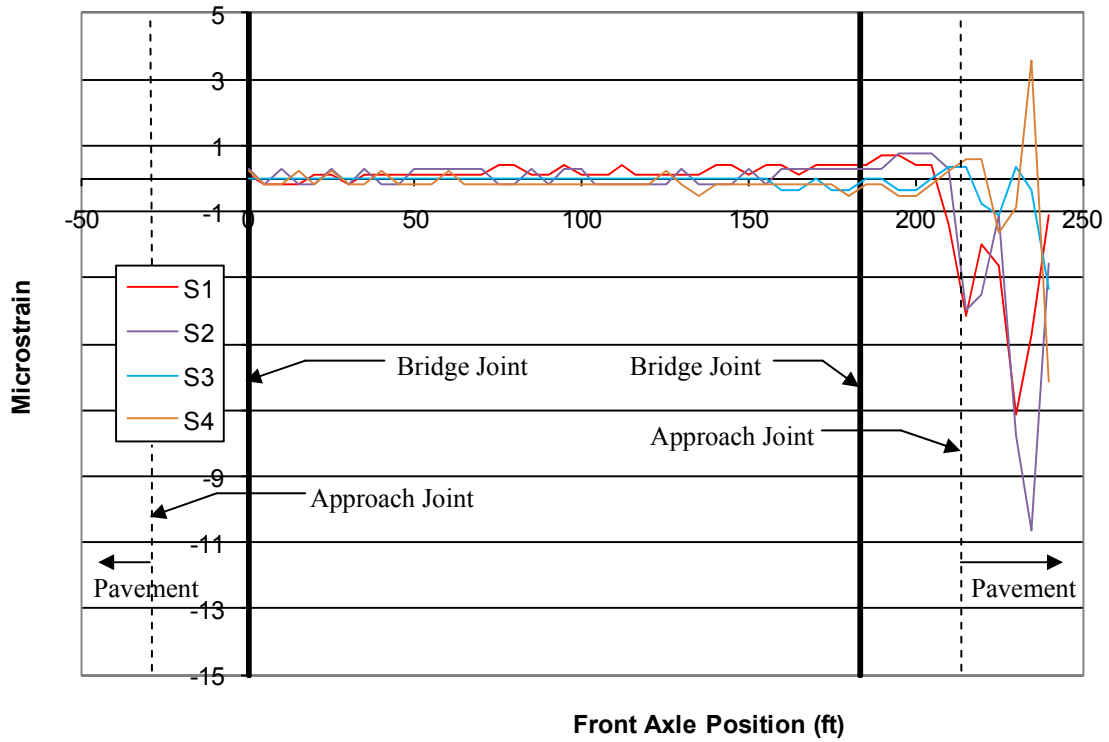
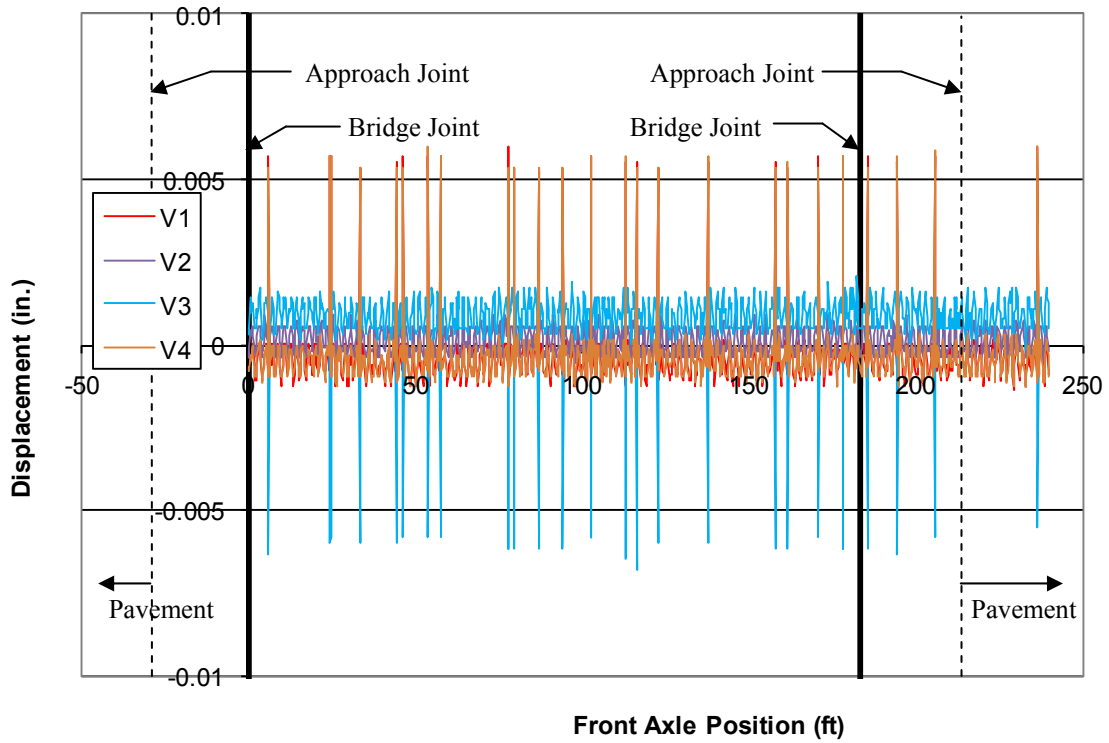
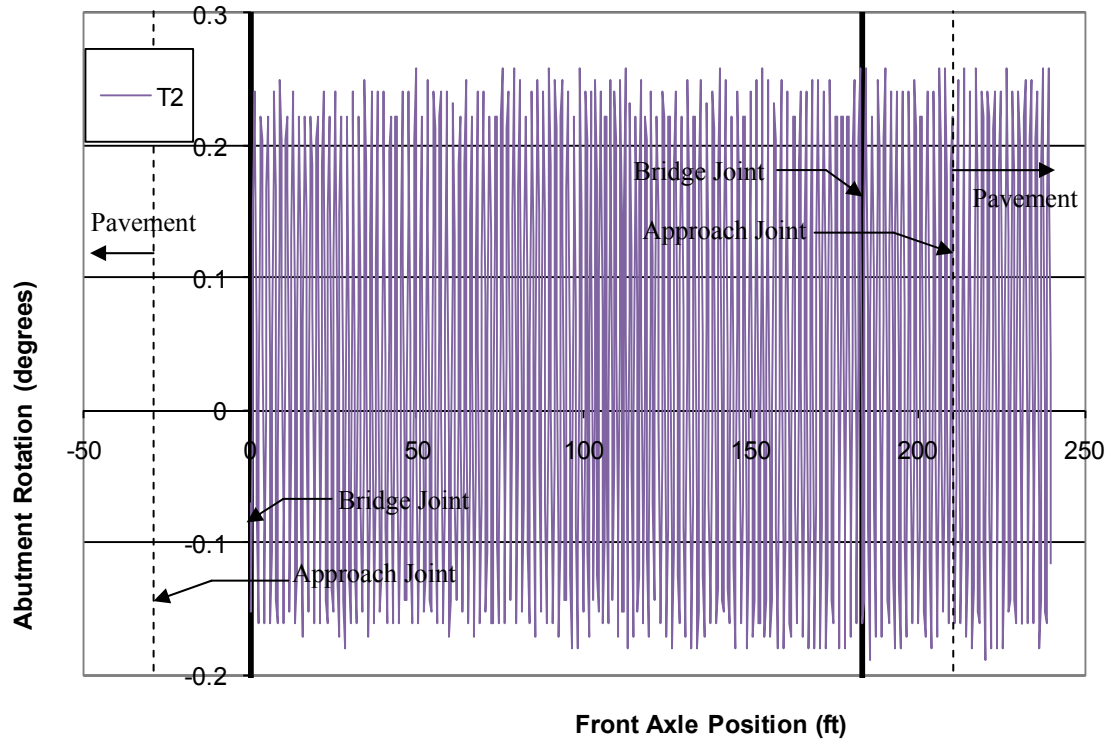
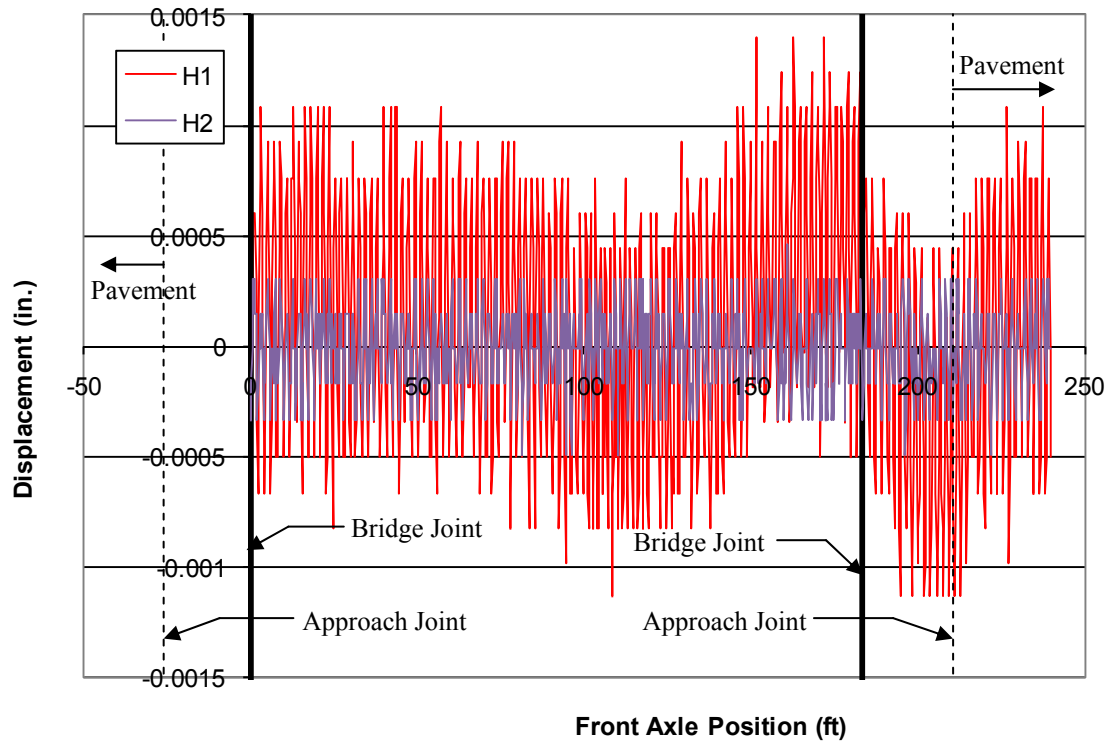
Figure 5.13. FAI 33-14.17 bridge live load testing results

From the end of the girder strain gages, relatively low strain levels were observed (See Figure 5.13a). However, the reversal of strain sign at this location indicates some unintended end restraint. It also appears that there may be some bending transferred from the approach slab to the bridge. The girder strain response near midspan further shows the unintended end restraint and load transfer from the approach slab to the bridge. Also evident from these data is the overall continuity within the entire bridge. From Figure 5.13d, the approach slab does not appear to be deflecting independently (e.g., it is well connected to the adjoining elements resulting in negligible differential displacement). Note that the “spikes” in the data are likely from outside electromagnetic (EM) interference.

From Figure 5.13e, the abutment does not appear to be rotating under live load (and this is likely the intended behavior). However, Figure 5.13f shows that the abutment is translating. Furthermore, a reversal of movements is apparent—indicating that the abutment is moving both into and away from the supporting soil. This is likely an unintended behavior and potentially could cause for the formation of voids behind the abutment if the support material was not properly designed and installed.

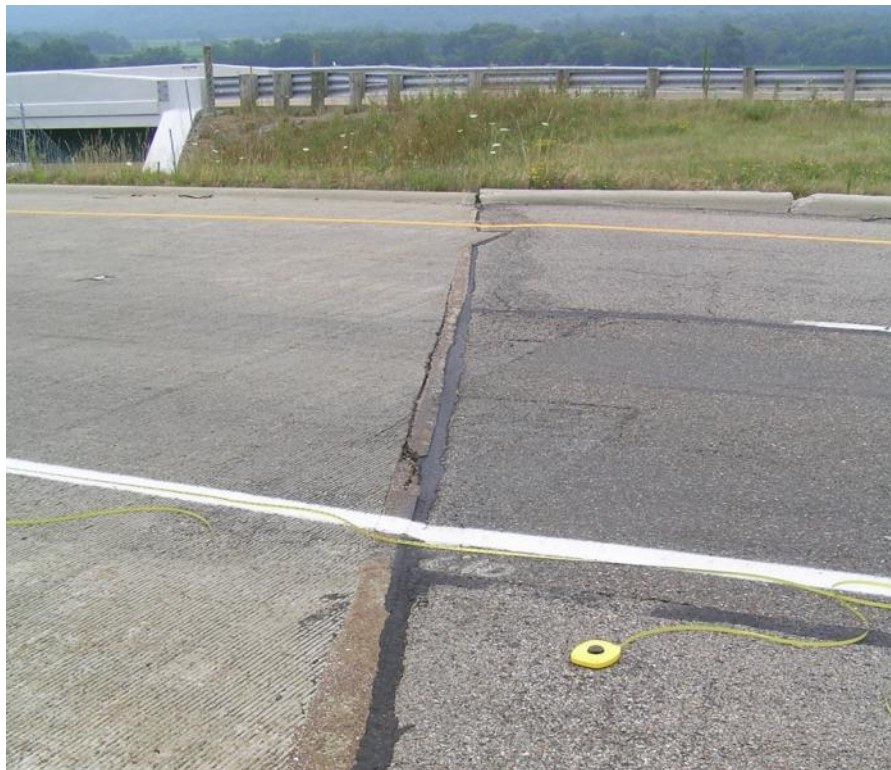
The MUS 16-7.69 bridge had multiple signs of distress causing ride quality issues. On the entrance side of the bridge, an 81 ft long asphalt wedge was located over both the mainline pavement and the approach slab. A small dip was located in the mainline pavement approximately 60 ft away from the bridge abutment. At some point, the joint had been filled with grout, which exacerbated the bump problem. The entrance edge of the bridge approach slab was also noted to have approximately 1.5 in. of differential settlement relative to the pavement, as shown in Figure 5.15. Similar issues were present on the exit end of the bridge. A 150 ft long asphalt wedge had been placed starting at the approach slab on the mainline pavement. The joint between the pavement and the approach slab did not allow for bridge or pavement expansion. The joint, at some point, was filled with grout causing a hump as seen in Figure 5.16. The approach joint, in combination with a large dip located just past the approach slab (seen in Figure 5.17), was causing oil staining and what appeared to be scrape marks from cars bottoming out.

Figure 5.16. Approach to pavement joint filled with grout causing a hump

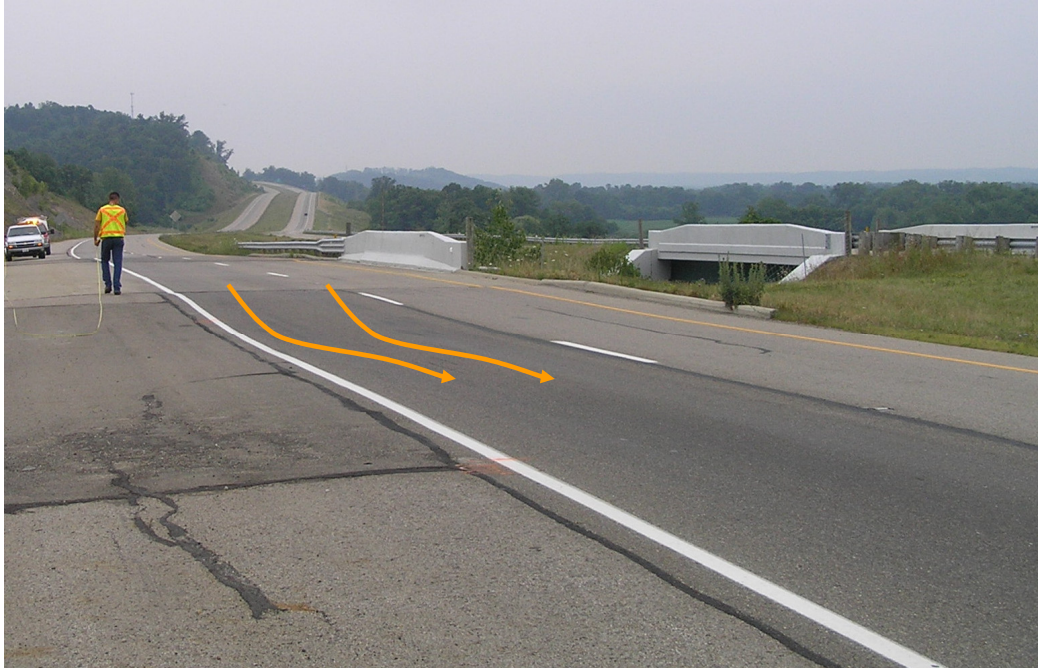
Figure 5.17 Dip in pavement when exiting the bridge

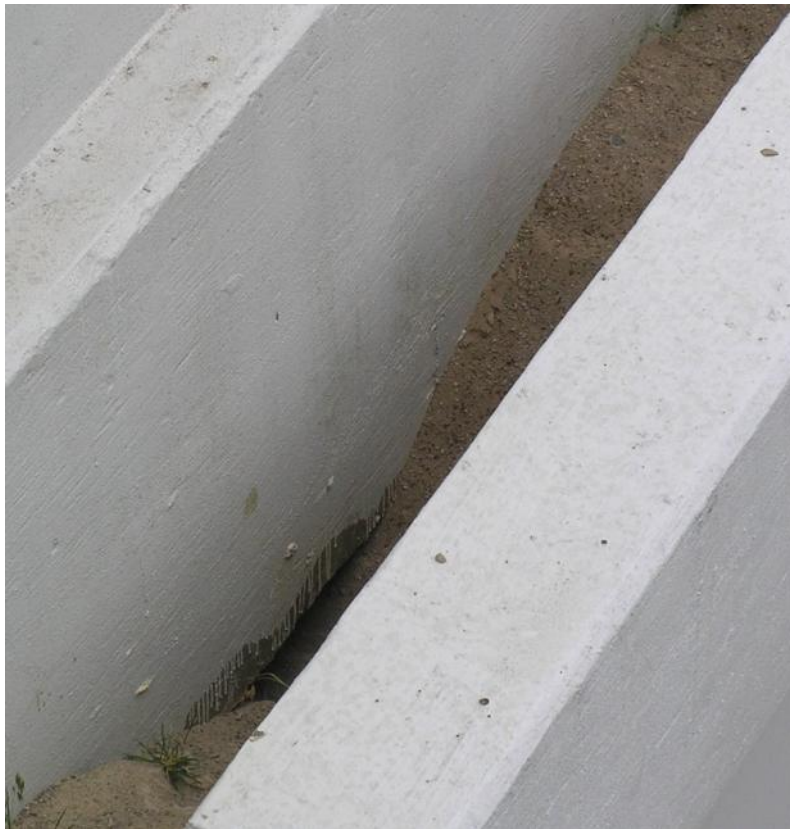
Some loss of fill was also evident at locations between the abutment and the MSE as shown in Figure 5.18.

Figure 5.18. Fill loss between the MSE wall and the bridge abutment

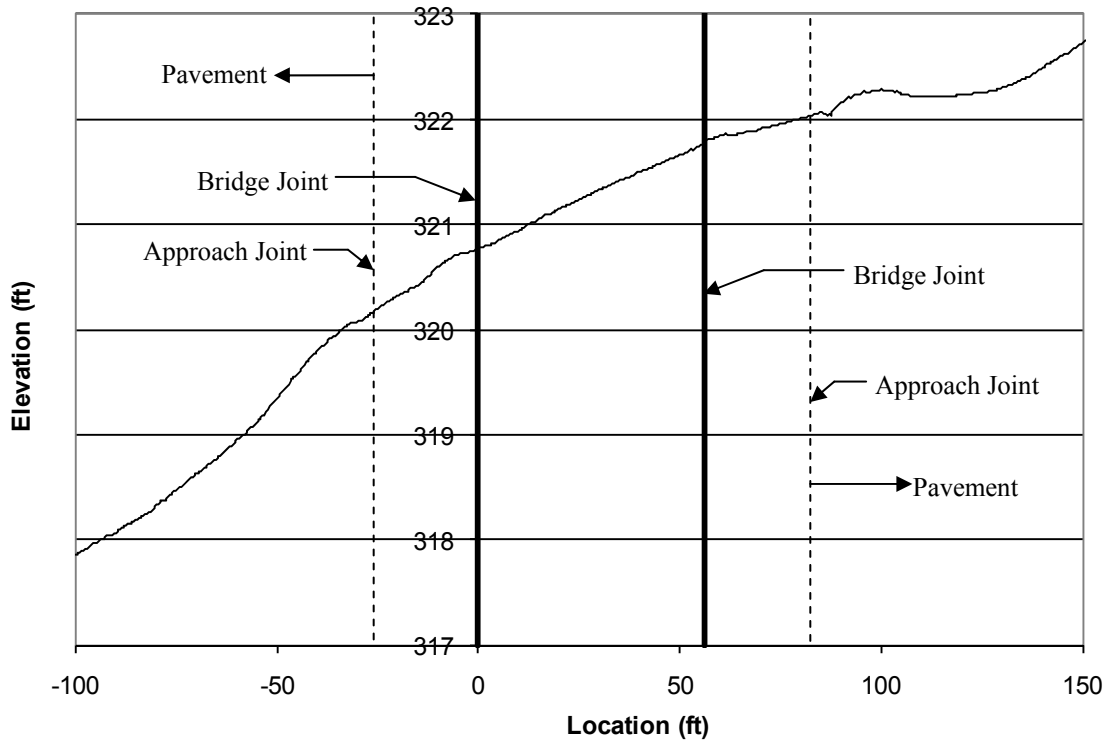
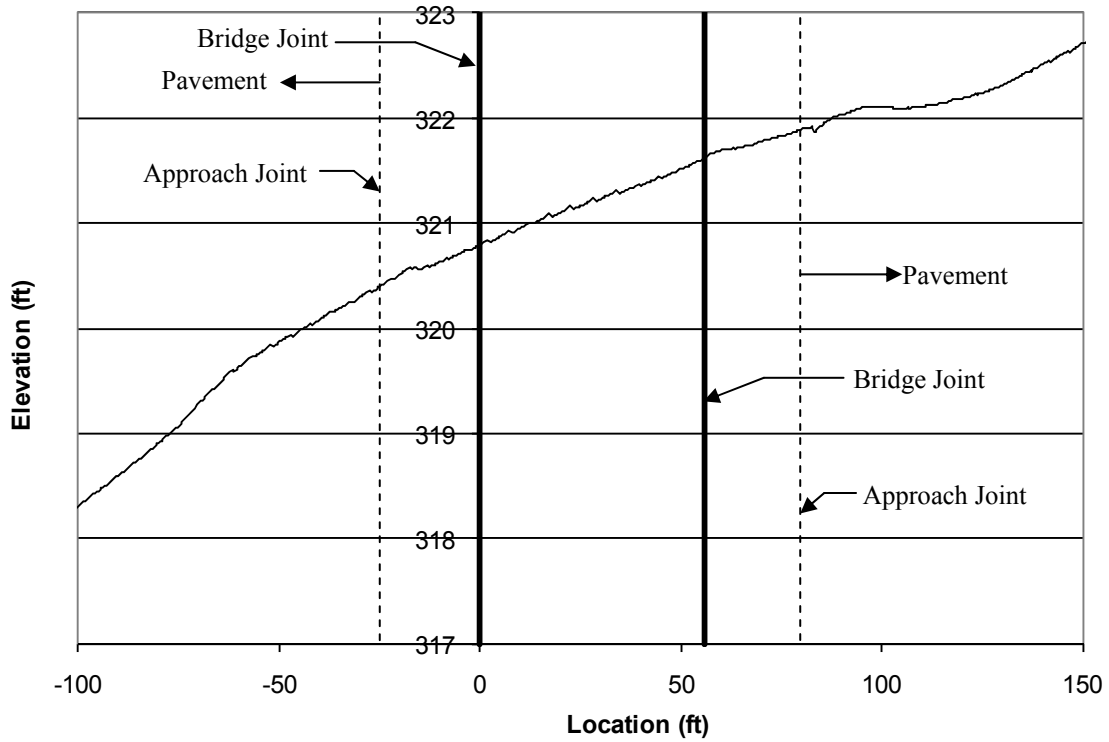
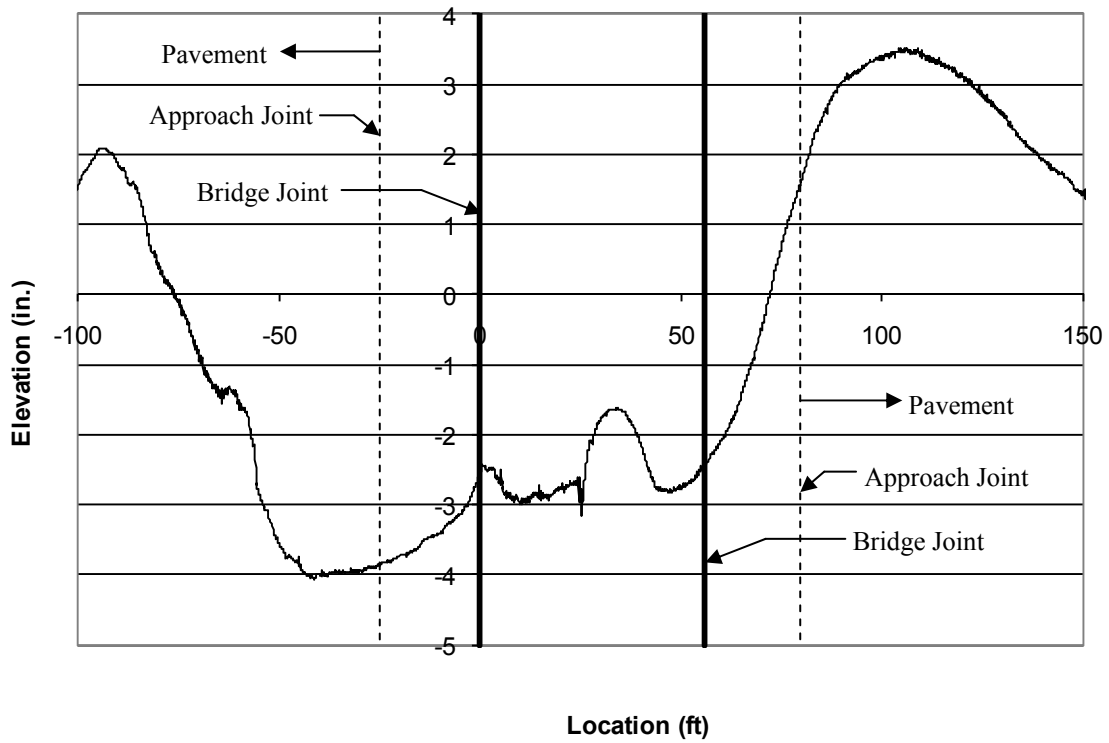
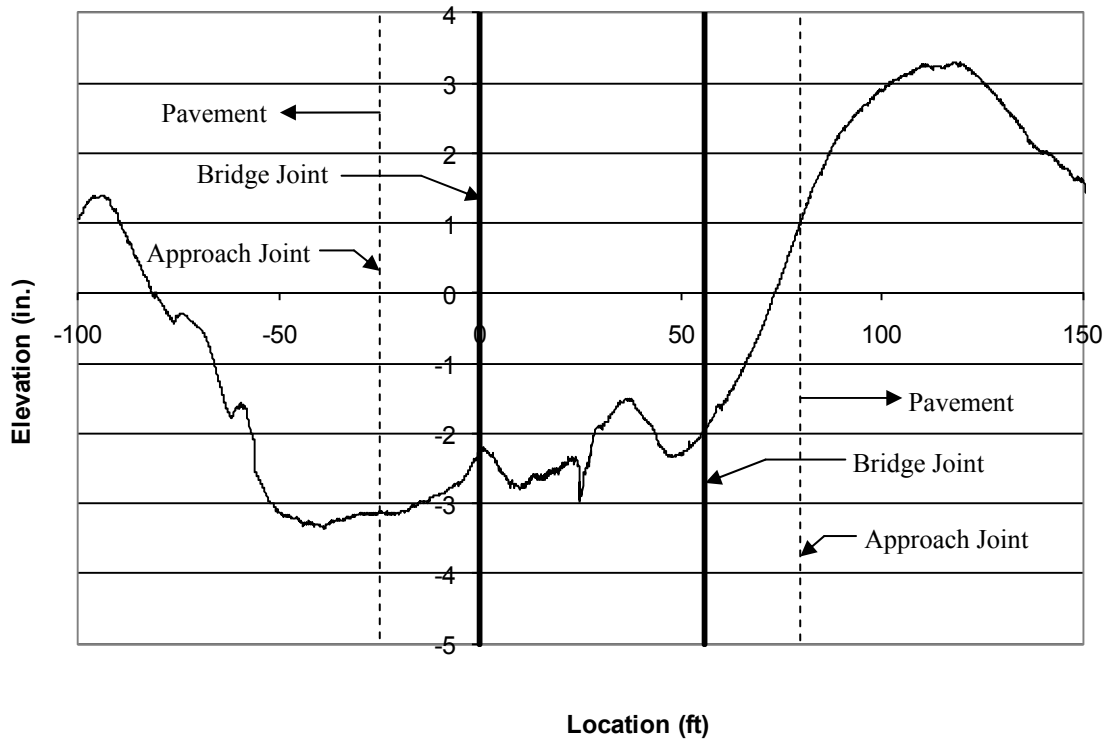
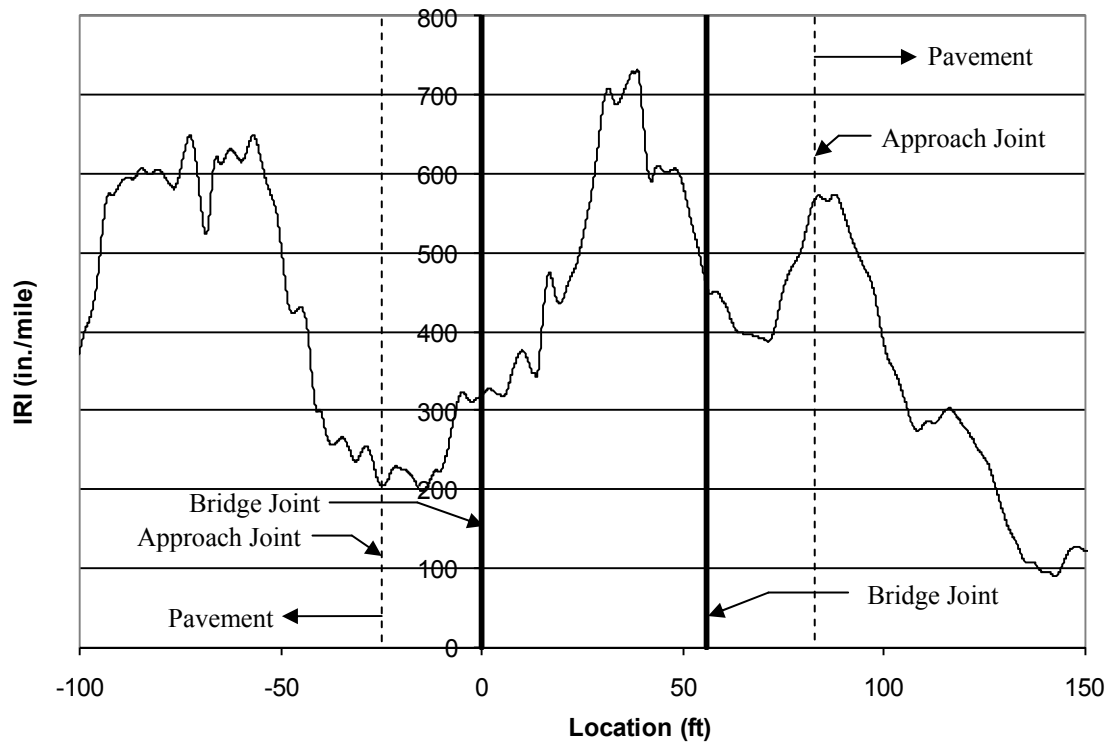
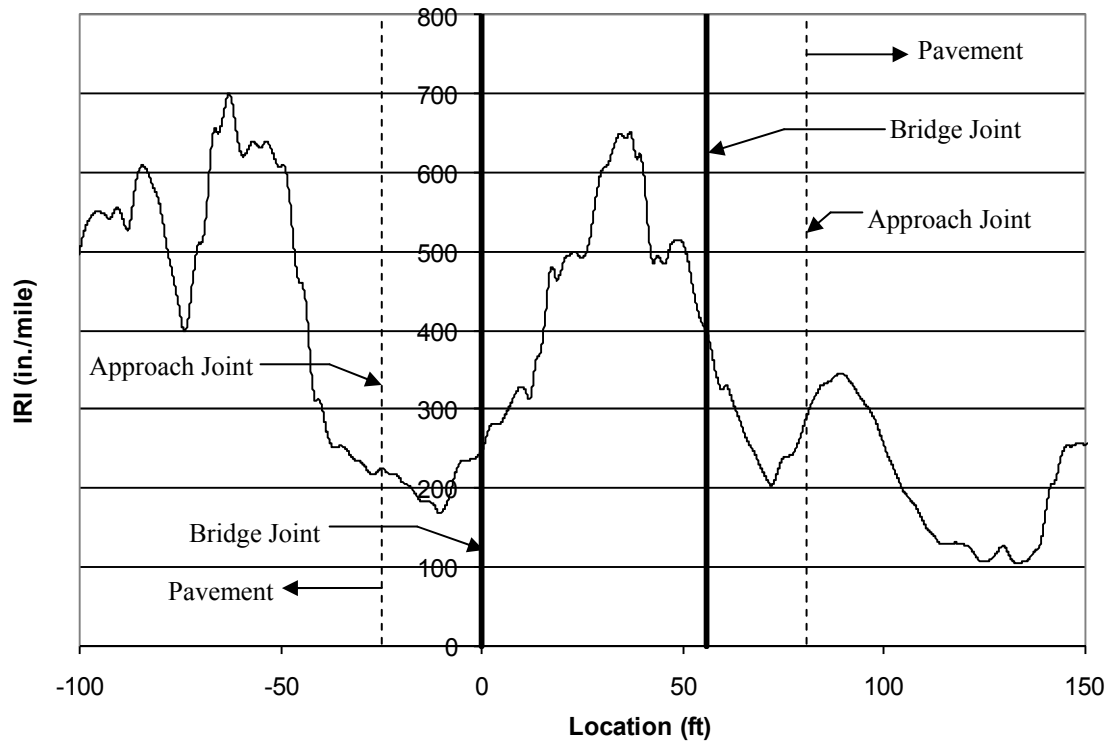
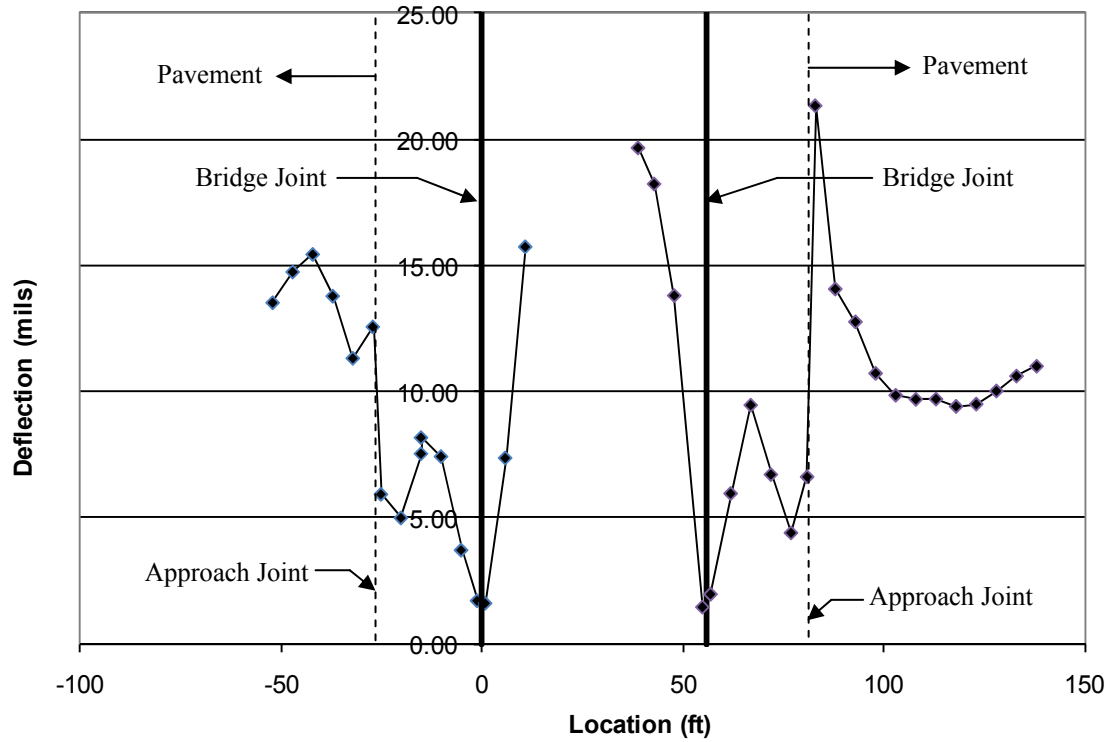
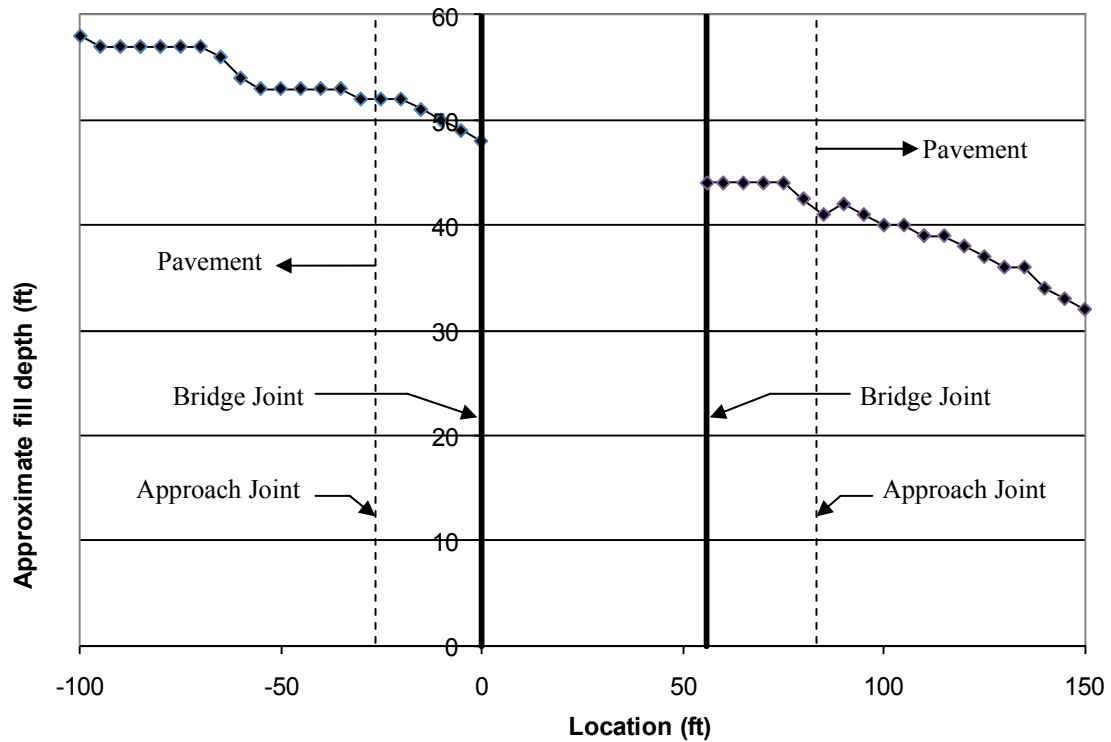
Figure 5.19. MUS 16-7.69 bridge geometric testing results

The profiler data (both in raw form and in computed IRI form) indicate that the bridge geometry at the local level is widely varying. Furthermore, the variances are consistent between the left and right wheel lines. The computed IRI data indicate that both wheel lines have IRI values approaching 800 in. per mile. Interestingly, the IRI data are not the “worst” in the area of the dip and hump mentioned previously (which might seem to be the worst from a driver perspective). Rather, the worst IRI values are on either the entrance end or on the bridge itself. These data indicate multiple factors may be impacting the ride quality.

The FWD test results show that, again, the support system stiffness is widely variable. Immediately at the bridge abutment, the support system is very stiff (as expected). The support system consistently softens away from the bridge. At the exit end of the bridge is a gain in stiffness. The location of this stiffness again coincides with the dip and hump mentioned previously. The fill height is quite large with a consistent variation. Such large fill depths give greater opportunity for less than optimum post-construction soil compaction.

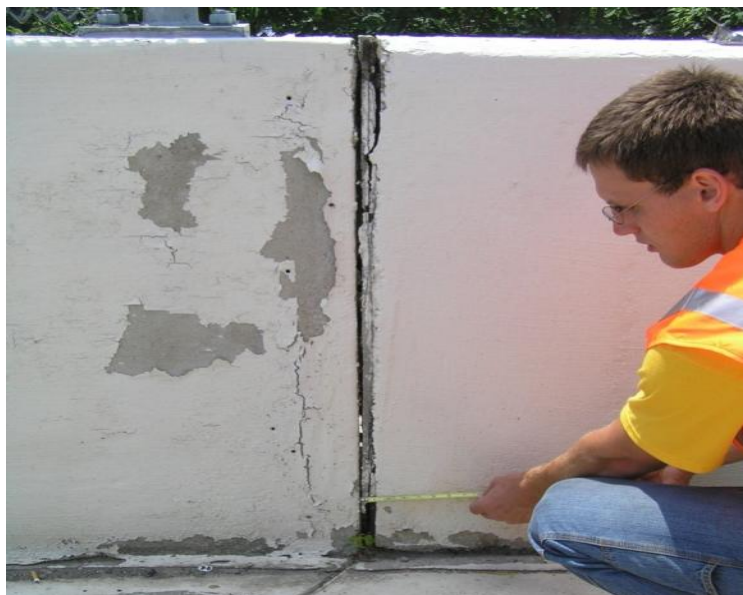
About a month prior to conducting the field test, the bridge approach slabs were mud-jacked, a 50 ft long asphalt wedge was placed on the pavement leading up to the approach slab, and the approach pavement was ground. Figure 5.22 shows the newly surfaced approach on the bridge. Upon investigation, the approach slab has settled causing the parapet's vertical joint at the bridge to be wider at the top than at the bottom, as shown in Figure 5.23. A 20 in. deep void was found between the wing wall and approach slab, as shown in Figure 5.24.

Figure 5.23. Tapered vertical gap at bridge to approach slab joint indicating settlement
