Identification and Evaluation of Pavement-Bridge Interface Ride Quality Improvement and Corrective Strategies

Institute for Transportation

Report Number FHWA/OH-2011/1

January 2011

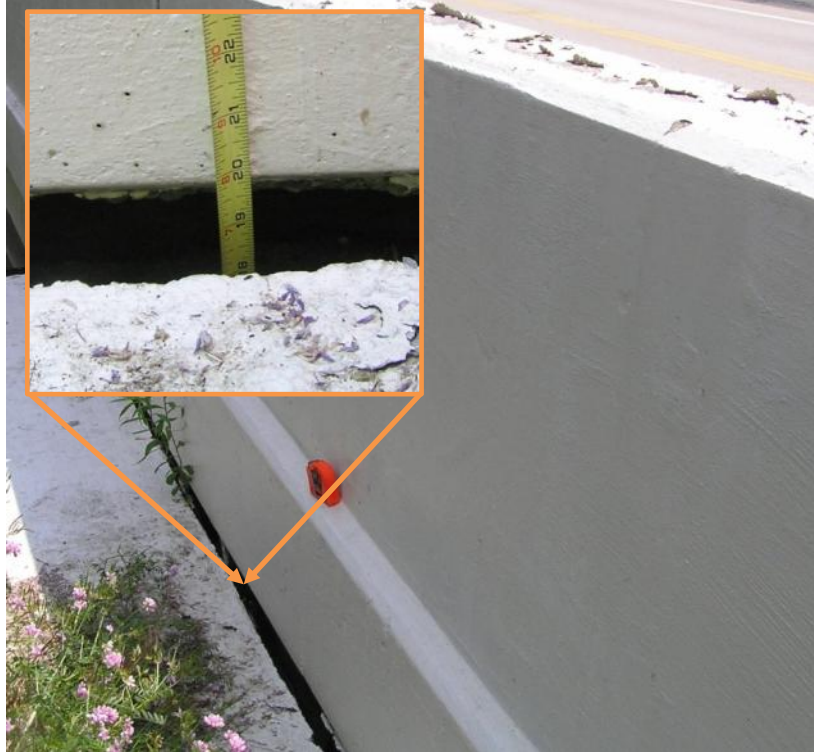
About a month prior to conducting the field test, the bridge approach slabs were mud-jacked, a 50 ft long asphalt wedge was placed on the pavement leading up to the approach slab, and the approach pavement was ground. Figure 5.22 shows the newly surfaced approach on the bridge. Upon investigation, the approach slab has settled causing the parapet's vertical joint at the bridge to be wider at the top than at the bottom, as shown in Figure 5.23. A 20 in. deep void was found between the wing wall and approach slab, as shown in Figure 5.24.

Figure 5.24. Void under approach

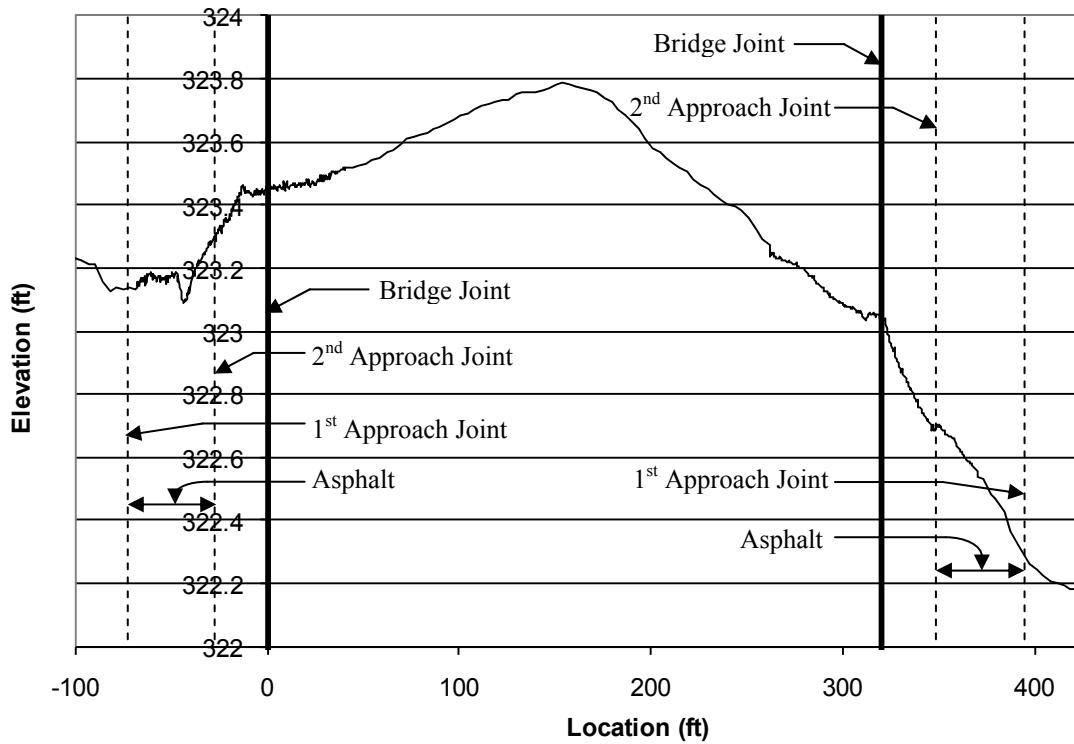
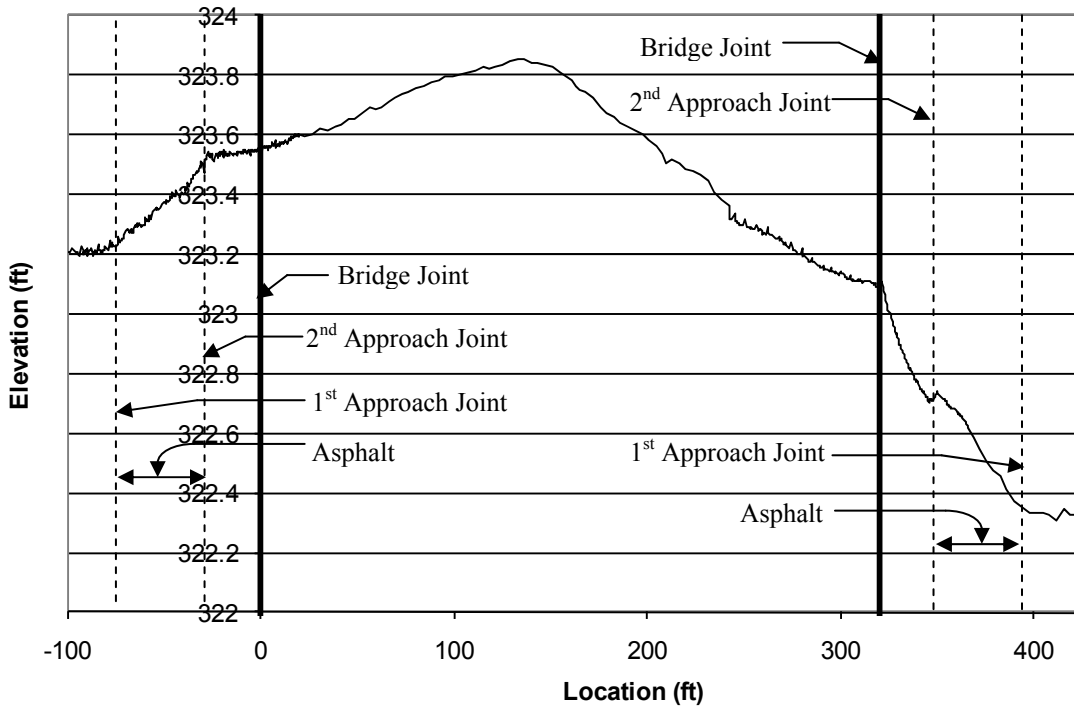
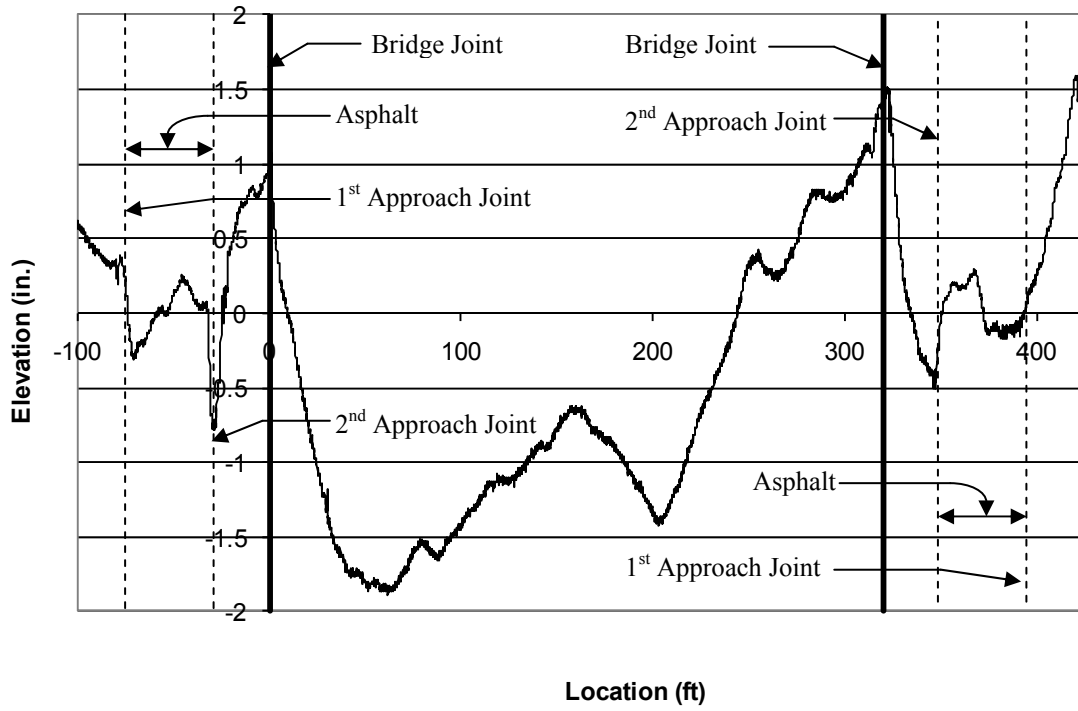
Figure 5.25. RIC 430-9.98 bridge geometric testing results

Figures 5.25a and 5.25b show the results of the laser-based survey. Generally, consistency is good between the survey data from the left and right wheel lines. The one exception is on the entrance end of the bridge, where it the right wheel line has greater variability. This variability will also be evident in the calculated IRI data. Overall, the bridge has a sweeping vertical geometry that, in Figures 5.25a and 5.25b, appears relatively smooth—a fact that is again corroborated with the IRI measurements.

The raw profiler data indicates that, with the exception of the entrance end of the bridge, the two wheel lines show similar characteristics. The difference is even more obvious upon seeing the calculated IRI data, where the right wheel line has IRI values of more than 600 at the entrance. Consistent with the global measurements, the calculated IRI values on the bridge indicate a generally smooth and consistent surface. The problem areas seem to be concentrated at the approach pavement and the bridge joint. The FWD test results indicate a rapid degradation in the support system stiffness on the entrance end. The speculation is that this rapid change in support stiffness may be a source of the entrance conditions mentioned previously.

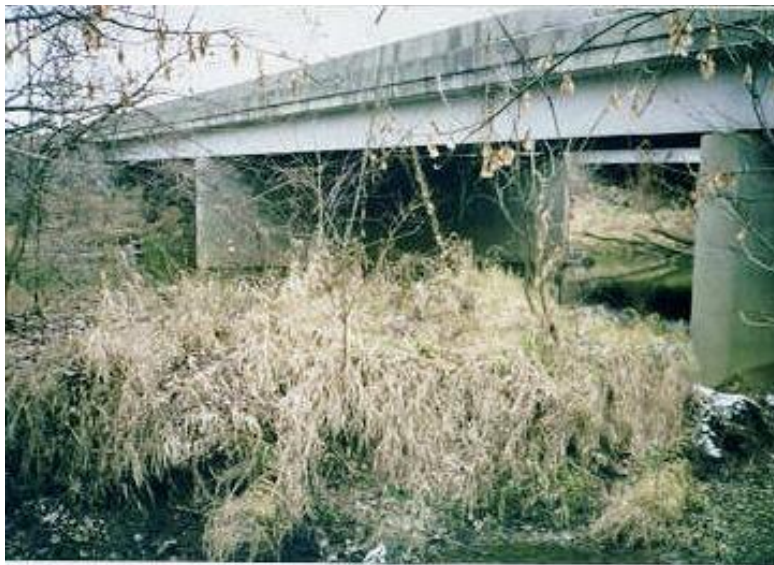
Figure 5.26. Profile view of FRA 317-8.09

FRA 317-8.09 is a 170 ft three-span bridge built circa 1970 at an existing bridge location. The bridge investigated is a two-lane bridge carrying northbound traffic over Blacklick Creek. The bridge is constructed of six rolled W36x135 steel beams with a non-composite reinforced concrete deck. The abutments consist of piles with concrete caps. The girders are attached to the pile cap as an ODOT typical integral abutment. The bridge plans show a 25 ft approach slab unattached on a 6 in. paving notch; however, during the site investigation, no approach slab was evident. Figure 5.26 shows a profile of the bridge.

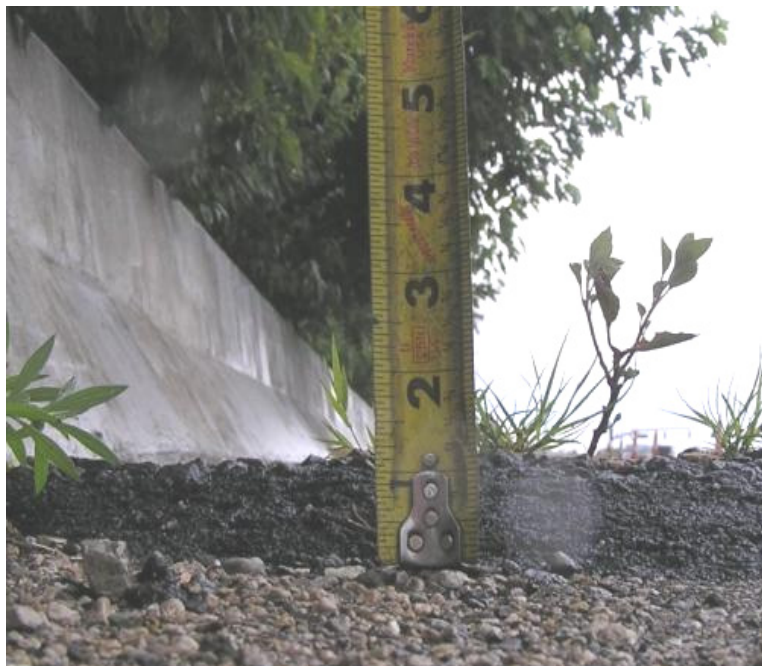
The site investigation of the FRA 317-8.09 bridge showed two asphalt wedges placed up to each bridge abutment. The first asphalt wedge was 2 ft wide in the longitudinal direction and located at the abutment as shown in Figure 5.27. The next asphalt wedge, which appeared to be placed several years after the first, was 50 ft long and extended over the 2 ft wedge up to the abutment. Cracking at the pavement-to-bridge abutment joint was also evident and can be seen in Figure 5.27. Evidence of the pavement settling at the bridge abutment was seen at the shoulder of the bridge. Figure 5.28 shows more than a 1 in. difference in the elevation of the pavement and the bridge. The expansion joint material located around the integral abutment bridge has deteriorated allowing soil on the back side of the abutment to erode through the joints.

Figure 5.28. Differential settlement at pavement and bridge abutment

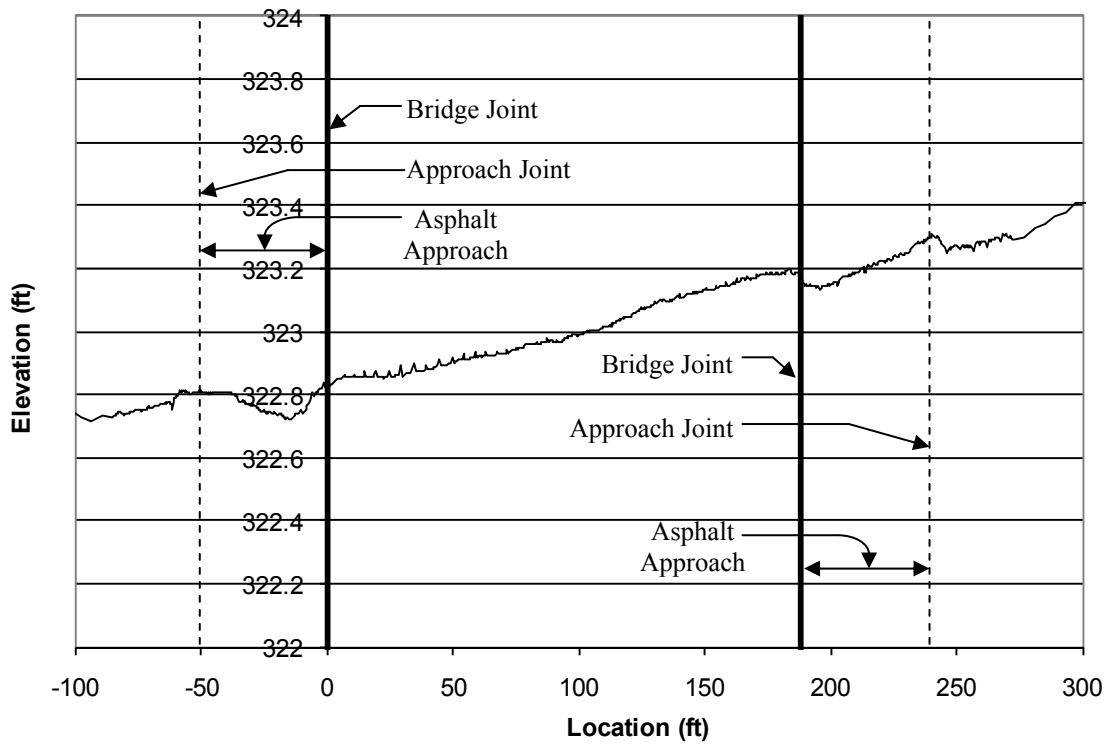
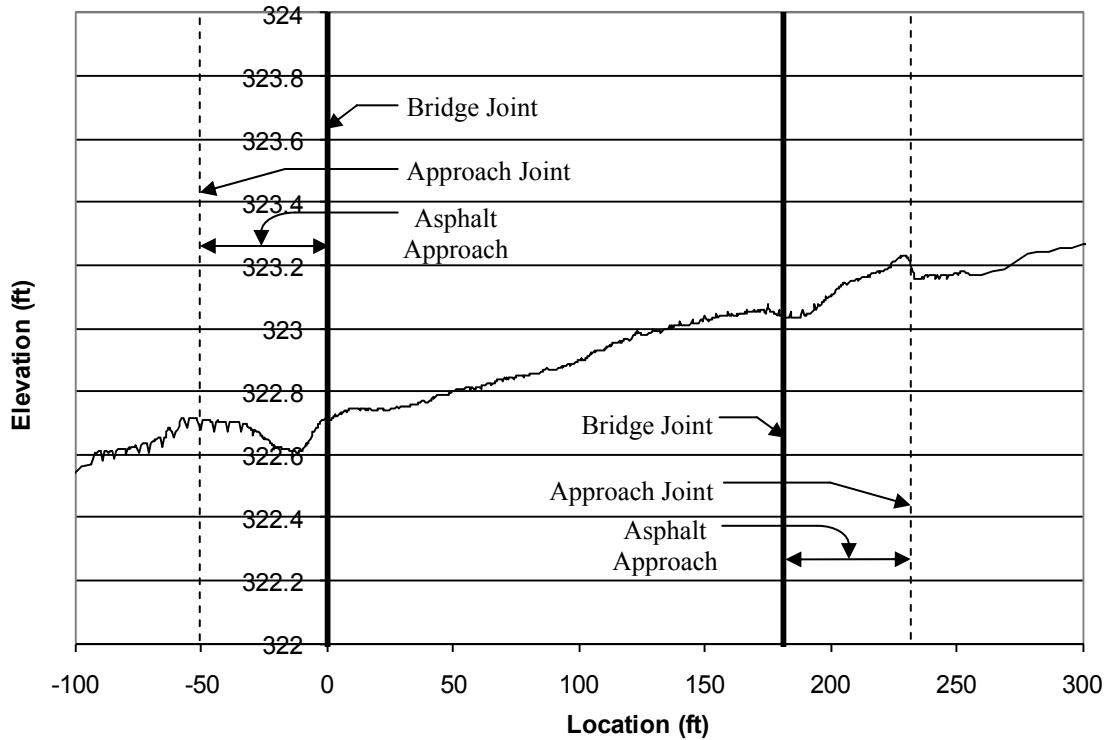
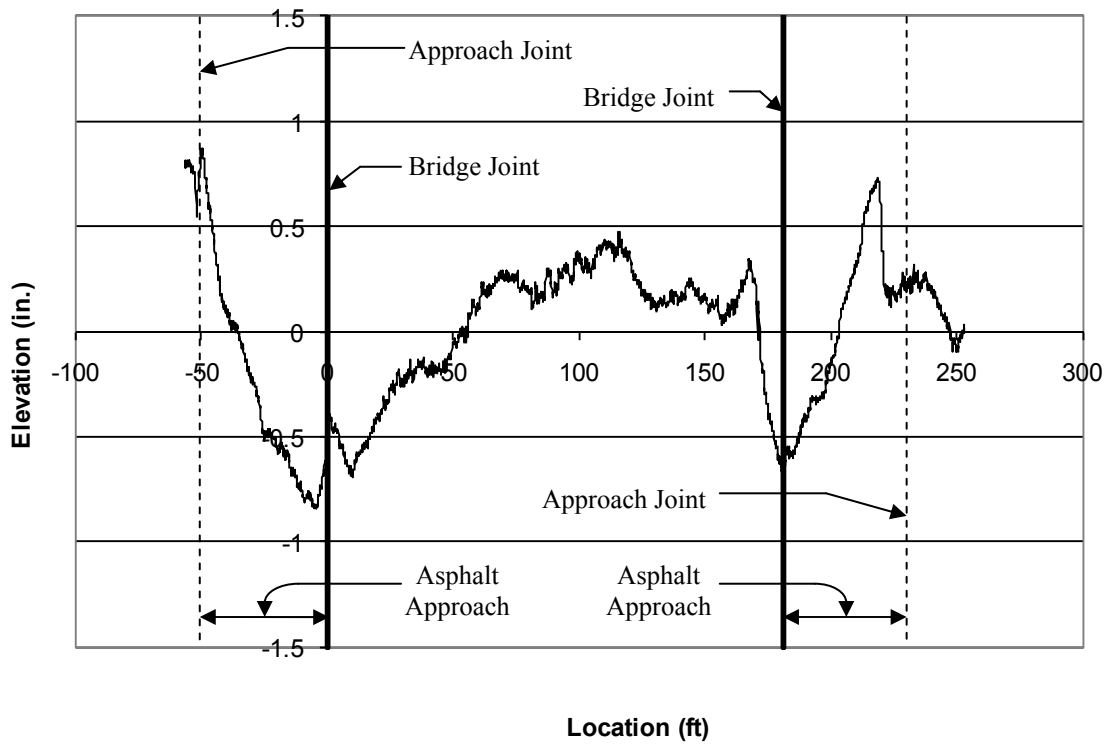
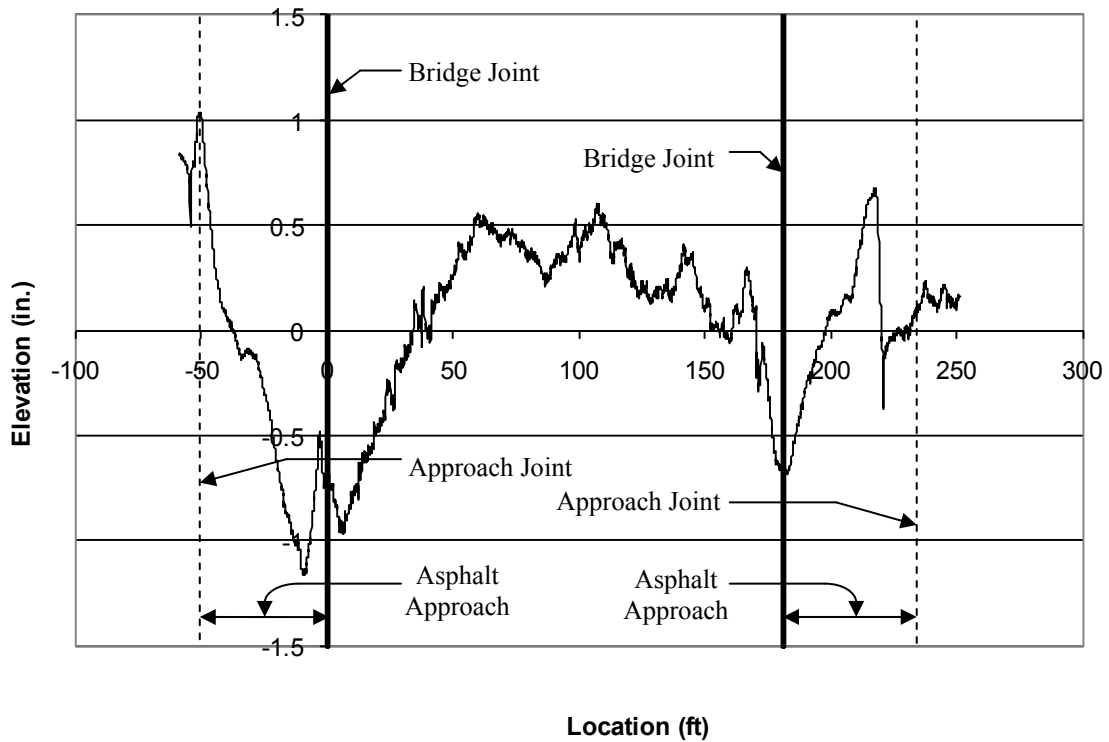
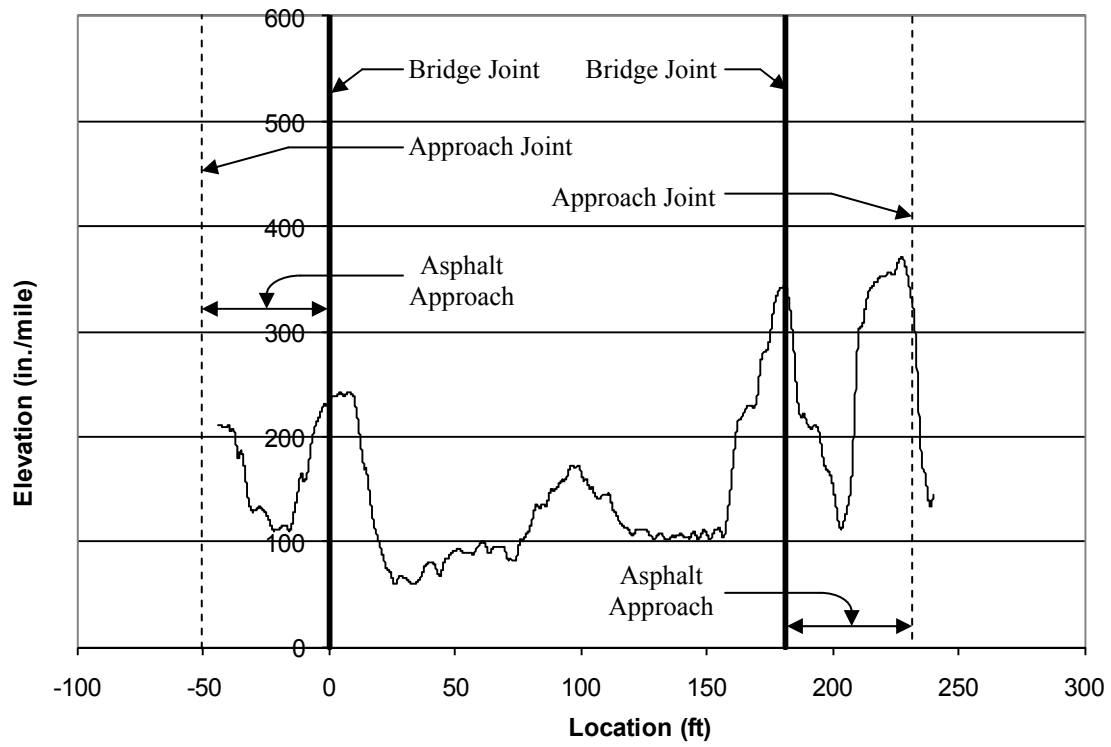
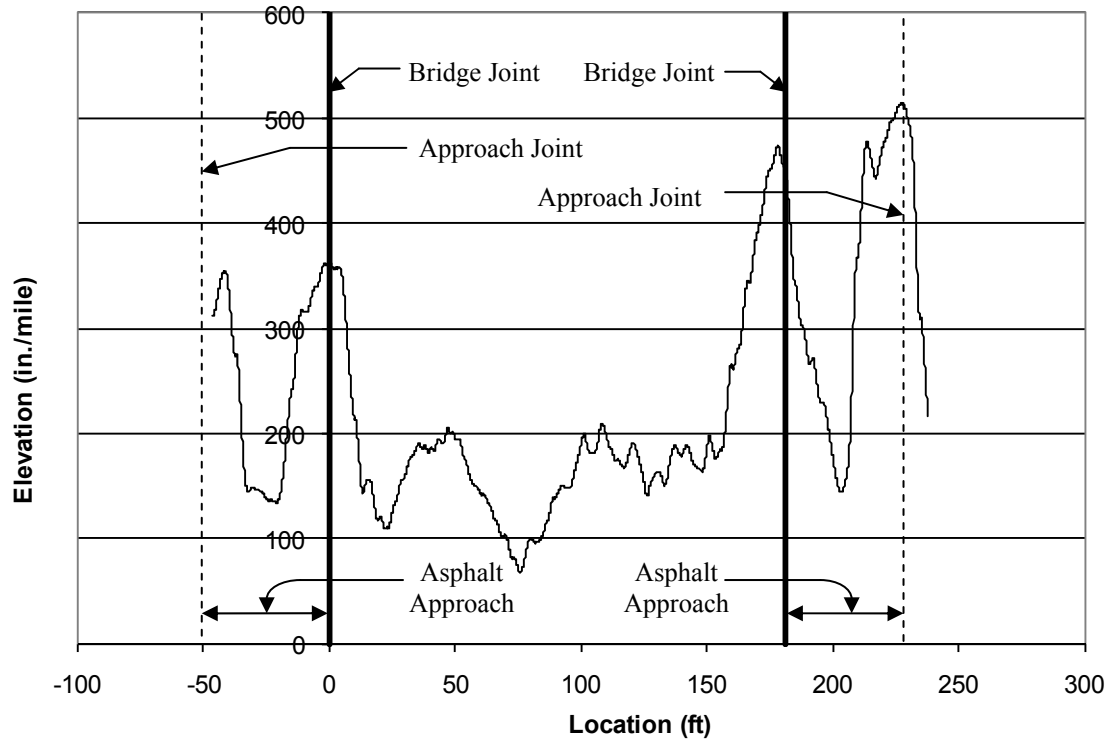
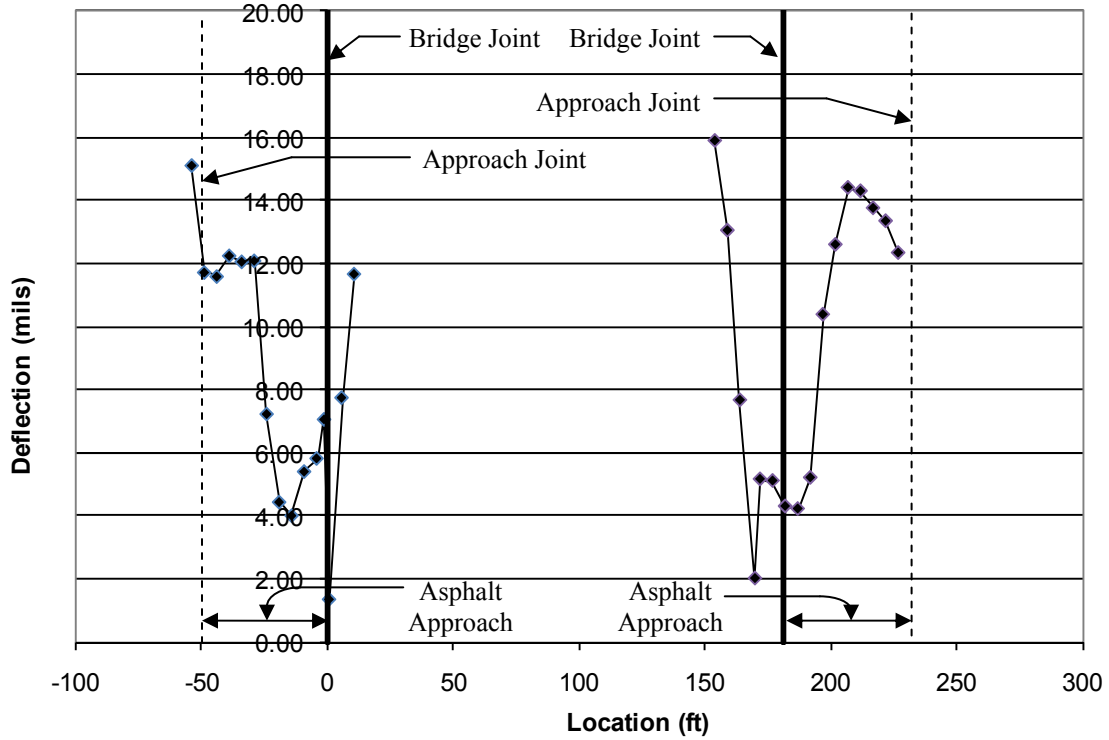
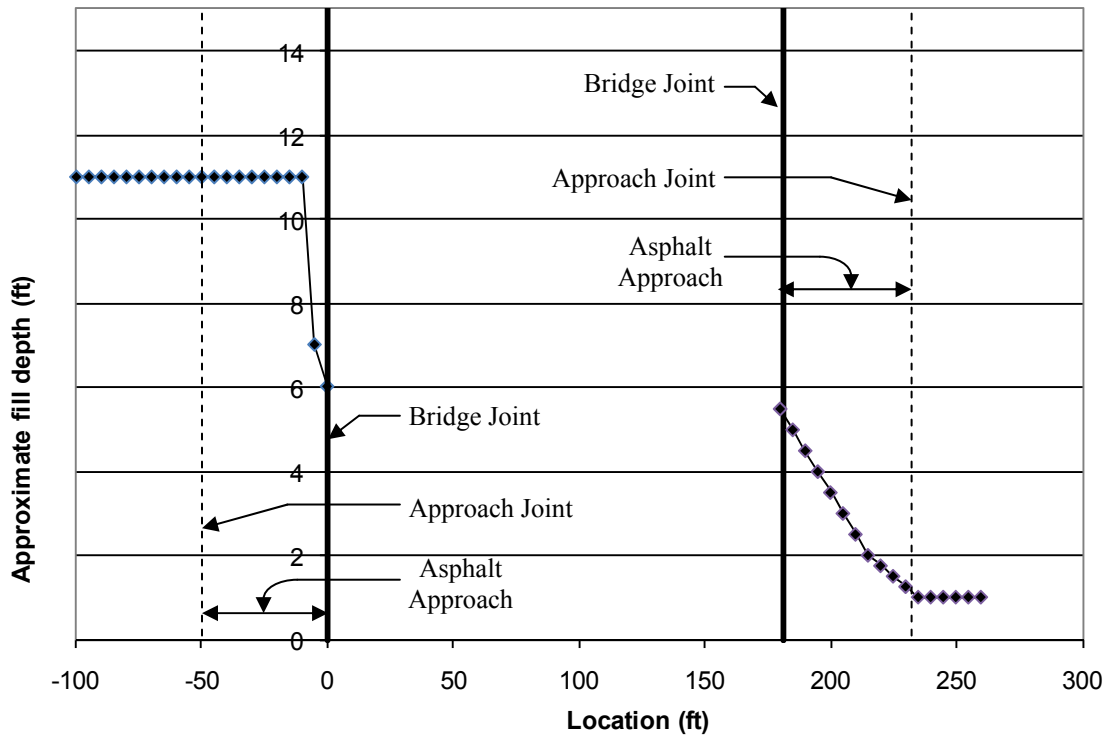
Figure 5.29. FRA 317-8.09 bridge geometric testing results

Figures 5.29a and 5.29b show the results of the laser-based survey. The data from the two wheel paths indicate that, generally, the two wheel paths are geometrically similar. Further observation of the data does not show a smoothly flowing geometry. In both wheel lines, prominent dips can be observed at both the entrance and exit ends and also a large hump on the exit. Note that the “fuzzy” appearance of the data is not believed to be real; rather, it is believed to be a remnant of errors propagating through the process of stitching together multiple data sets.

The profiler and IRI data shown in Figures 5.29c through 5.29f show that the local geometry of the bridge is comparable in each wheel path and that there is significant local variation. The calculated IRI data indicate that the worst ride characteristics are on the exit end of the bridge. This fact compares well with the findings from the global geometric measurements.

The FWD test results indicate that there is general similarity in the stiffness on and off the bridge. However, it can clearly be seen that the support system stiffness is extremely high in the immediate vicinity of the bridge abutment. The approximate fill heights vary significantly from the entrance to the exit bridge ends. These differences may contribute to the difference in observed roadway geometry (both local and global).

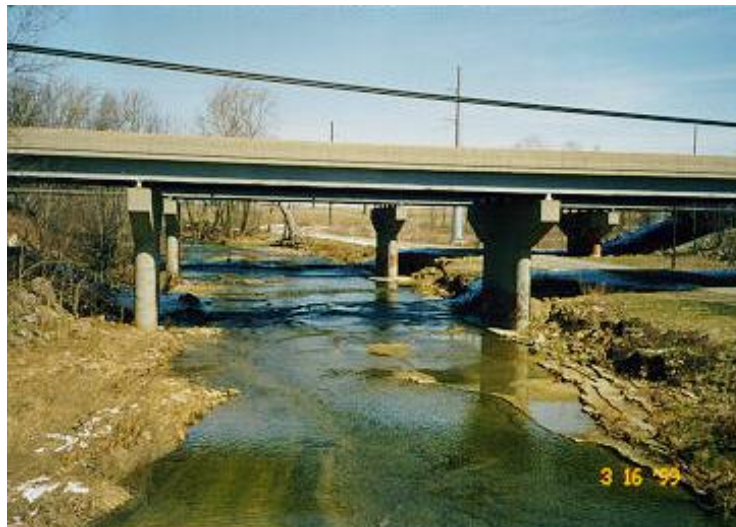
The original PRE 70-12.49 bridge was built in about 1962 at a new bridge site. The bridge crosses over Price Creek and Price Creek Road as shown in Figure 5.30. The eastbound bridge was investigated and consists of four spans with a total length of 220 ft and the longest span being 63 ft. In the past decade, the bridge was widened, adding three more steel beams and changing the abutments to an integral or semi-integral type abutment. Figure 5.31 shows the bridge beams and abutments. The abutments consist of vertical and battered steel piles with concrete caps. The bridge has no skew. The approach slabs are 25 ft long concrete and are supported on a 6 in. paving notch. No reinforcing attachment of the approach to the abutment is noted on the plans. The approach slabs appear to be relatively new.

Figure 5.30. Profile of PRE 70-12.49 prior to widening

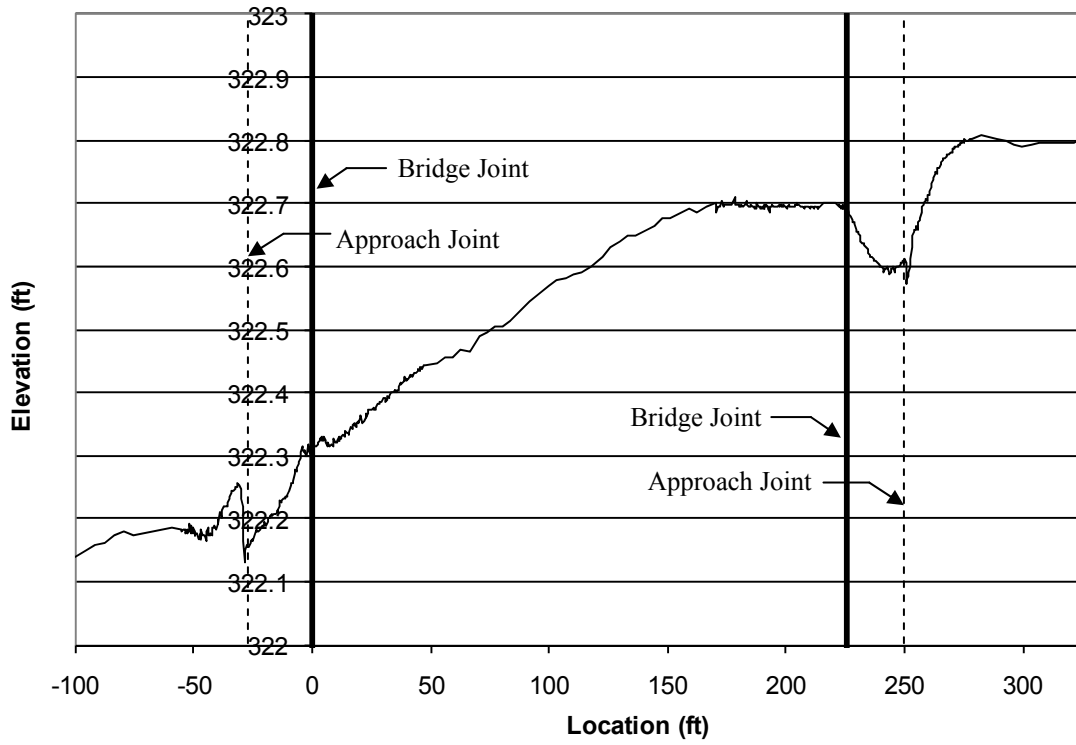
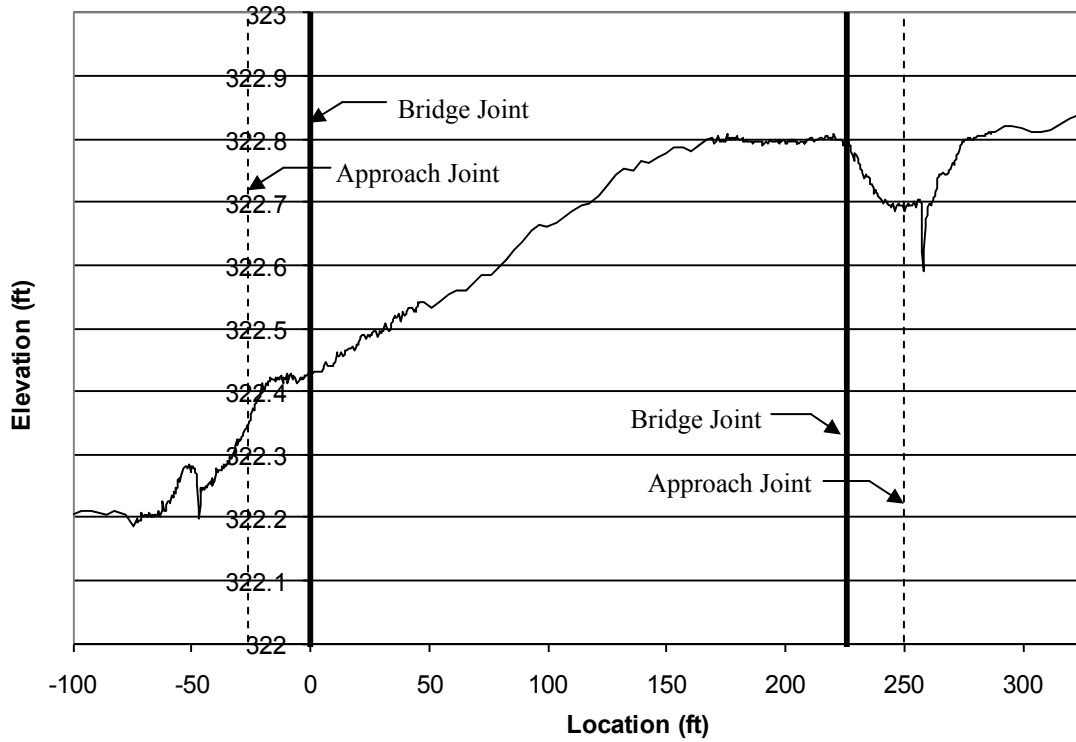
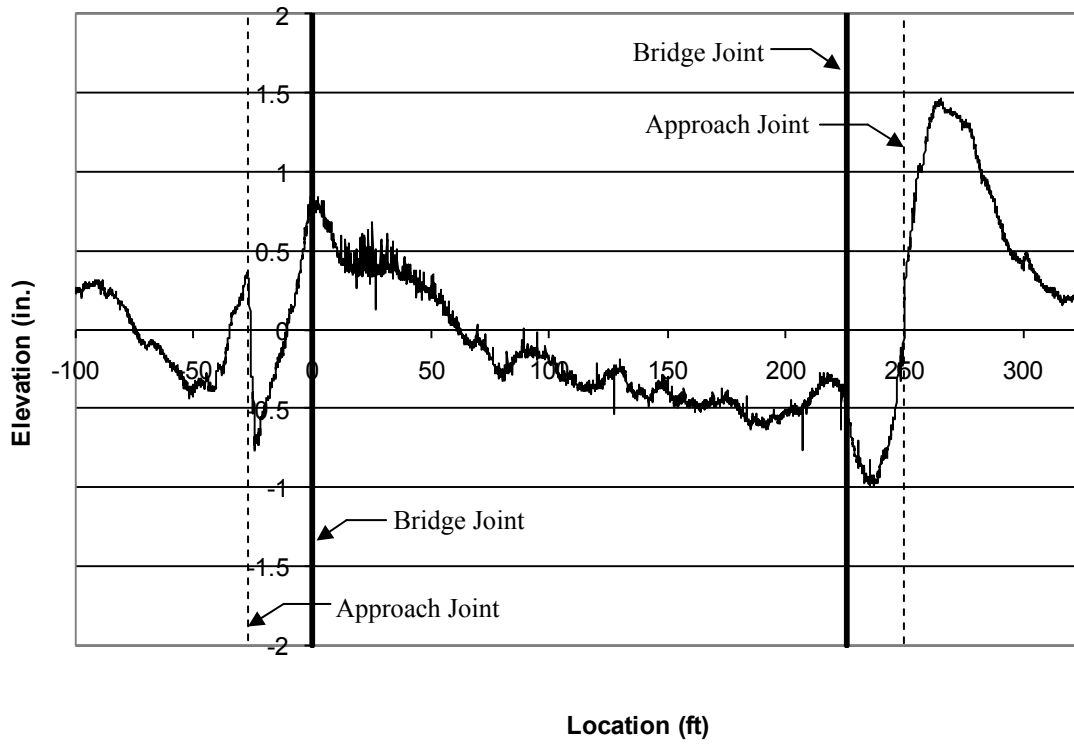
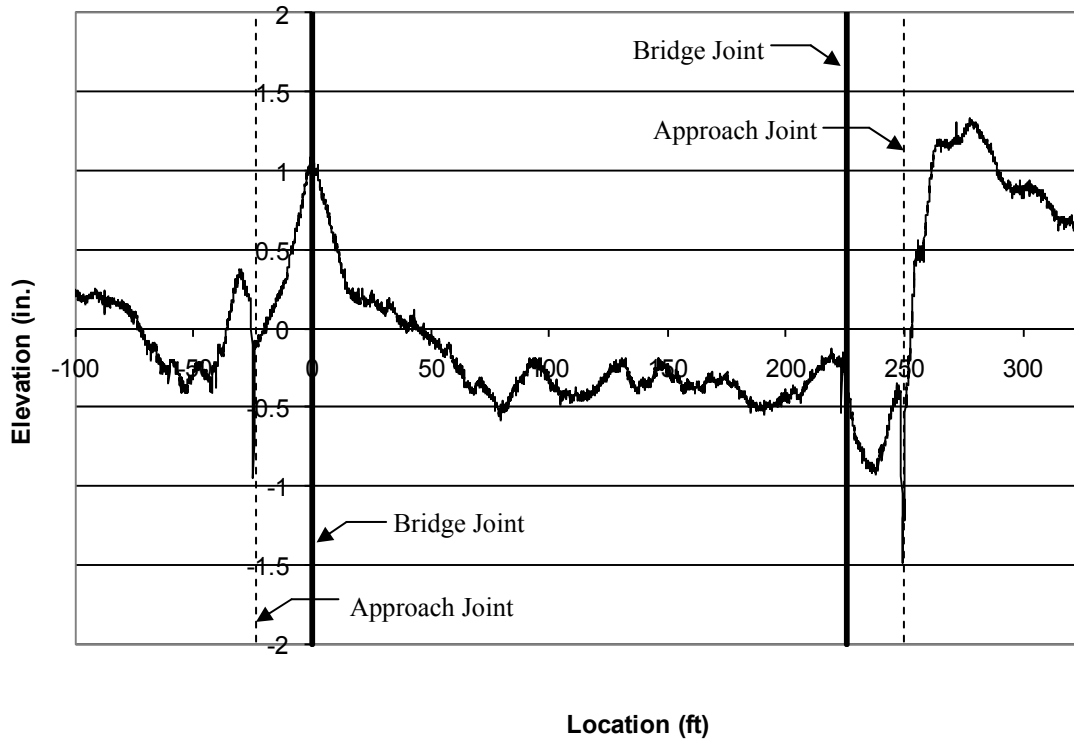
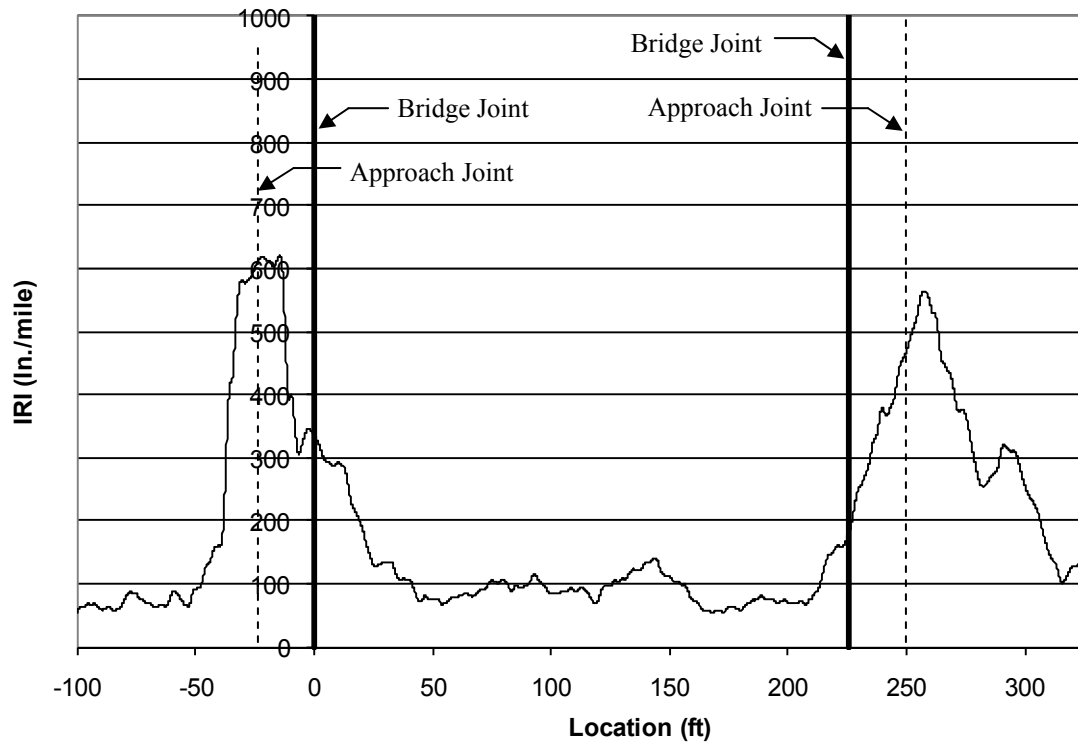
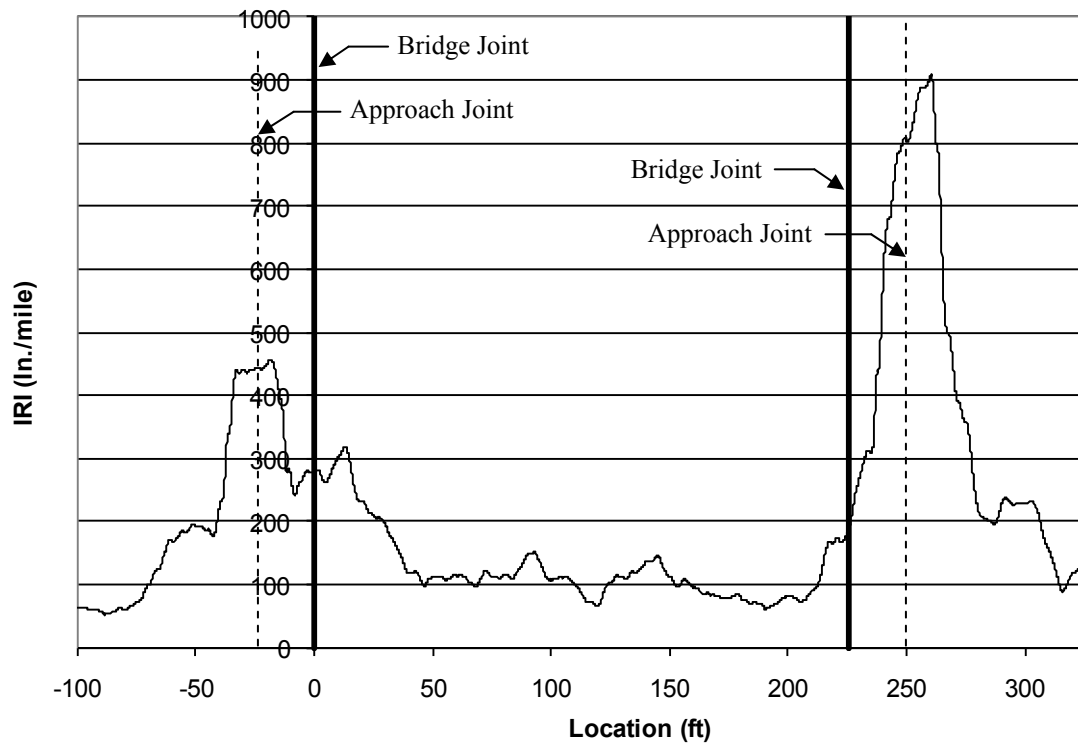
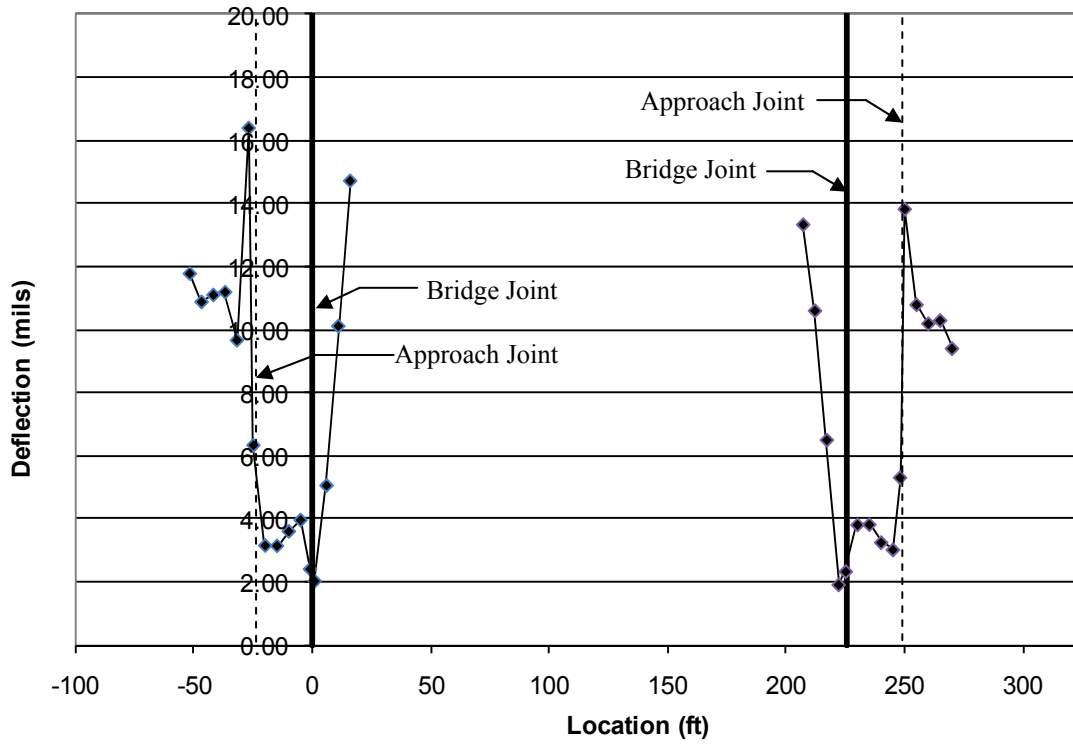
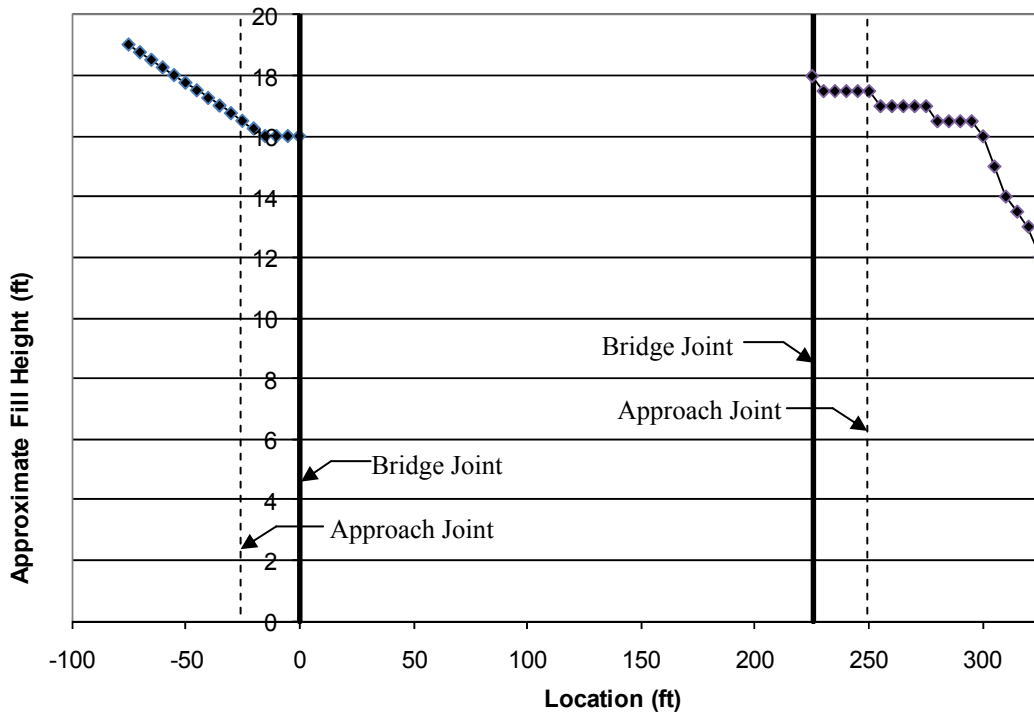
Figure 5.35. PRE 70-12.49 bridge geometric testing results

Figures 5.35a and 5.35b show the results of the laser-based survey. These data show that the surface of the bridge itself is relatively consistent (a fact also shown in the IRI data). However, the regions around the approach slabs show global geometries that change rapidly with numerous dips and humps evident. Note the consistency in the measurements from the left and right wheel lines is relatively good.

The profiler data (and the IRI data) show, as does the survey data, consistency in the profile of the bridge itself, with reduced consistency off the bridge. In fact, the IRI is more than 900in. per mile in one of these areas. When considering both the survey data and the profiler data, it seems as though some type of degradation in behavior/performance of the approach slab-to-bridge and/or approach slab-to-pavement connection may be contributing to the poor ride quality.

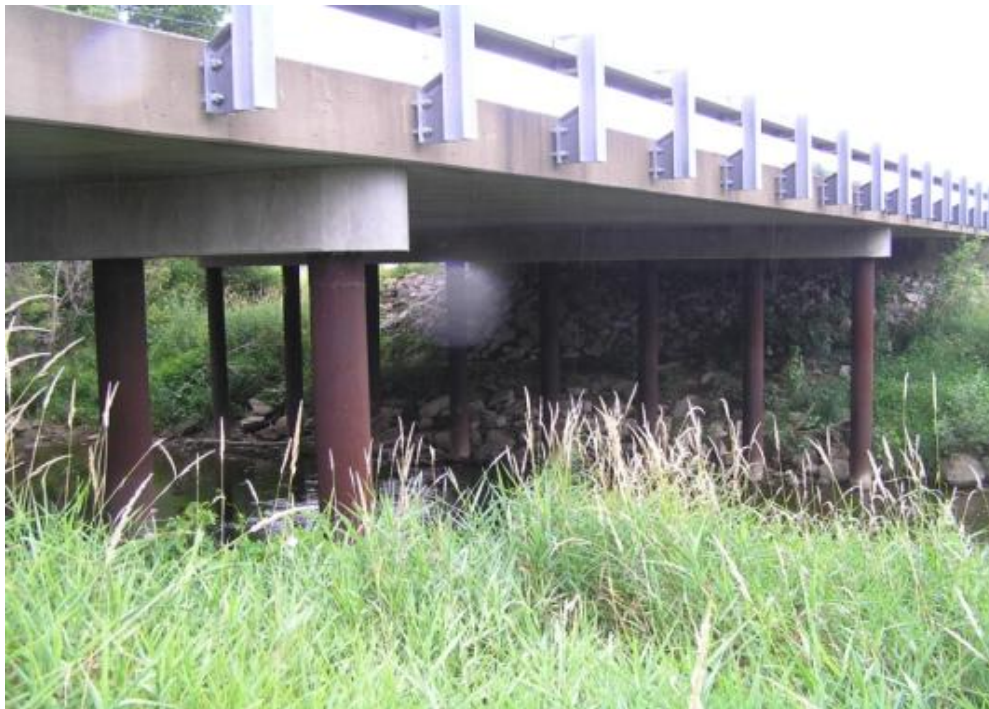
Figure 5.36. LIC 40-12.53 profile view

The LIC 40-12.53 bridge was built in 1994 at an existing bridge site. The bridge carries two lanes of bi-directional traffic and has a turning lane. The bridge crosses South Fork Licking River with a three-span 21.5 in. thick continuous concrete slab. The total length of the bridge is 130 ft with a longest span of 49 ft. The bridge has a 10 degree skew with cast-in-place concrete columns and a concrete pile cap at the abutments. The approach slab is 25 ft long and bears on a 9 in. paving notch. The slab is attached to the pile cap with #8 diagonal bars. The bridge is shown in Figure 5.36. The joint at the pavement-to-approach interface did not allow for expansion, as shown in Figure 5.37.
