Identification and Evaluation of Pavement-Bridge Interface Ride Quality Improvement and Corrective Strategies

Institute for Transportation

Report Number FHWA/OH-2011/1

January 2011

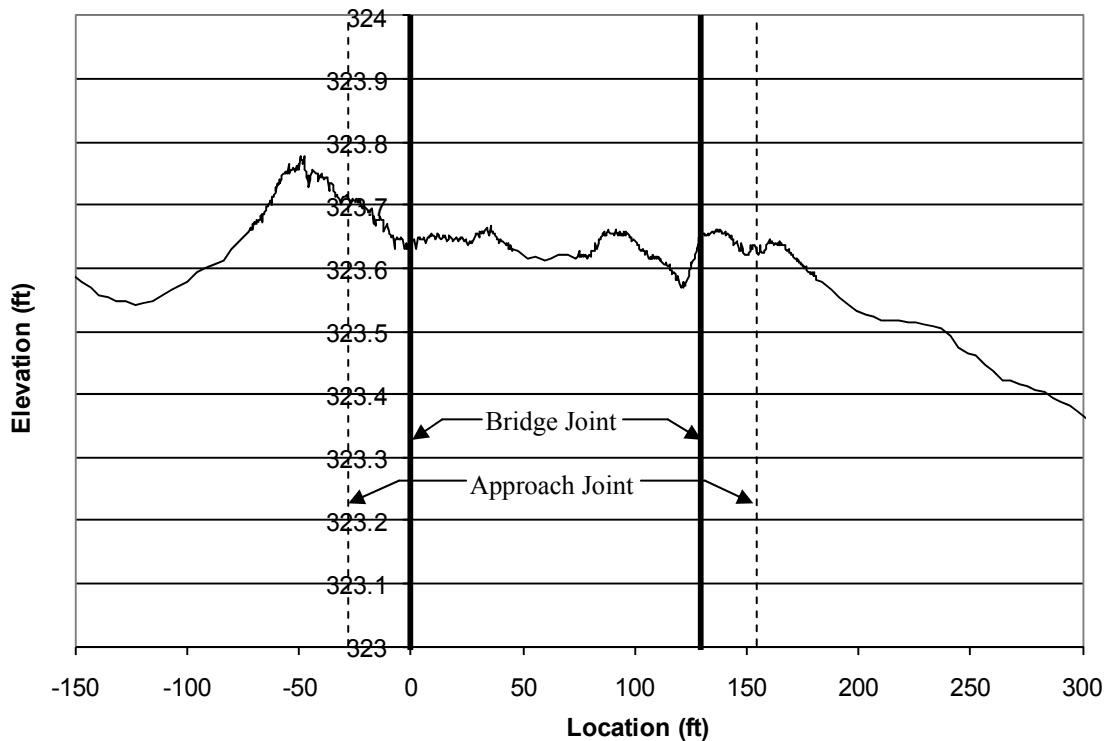
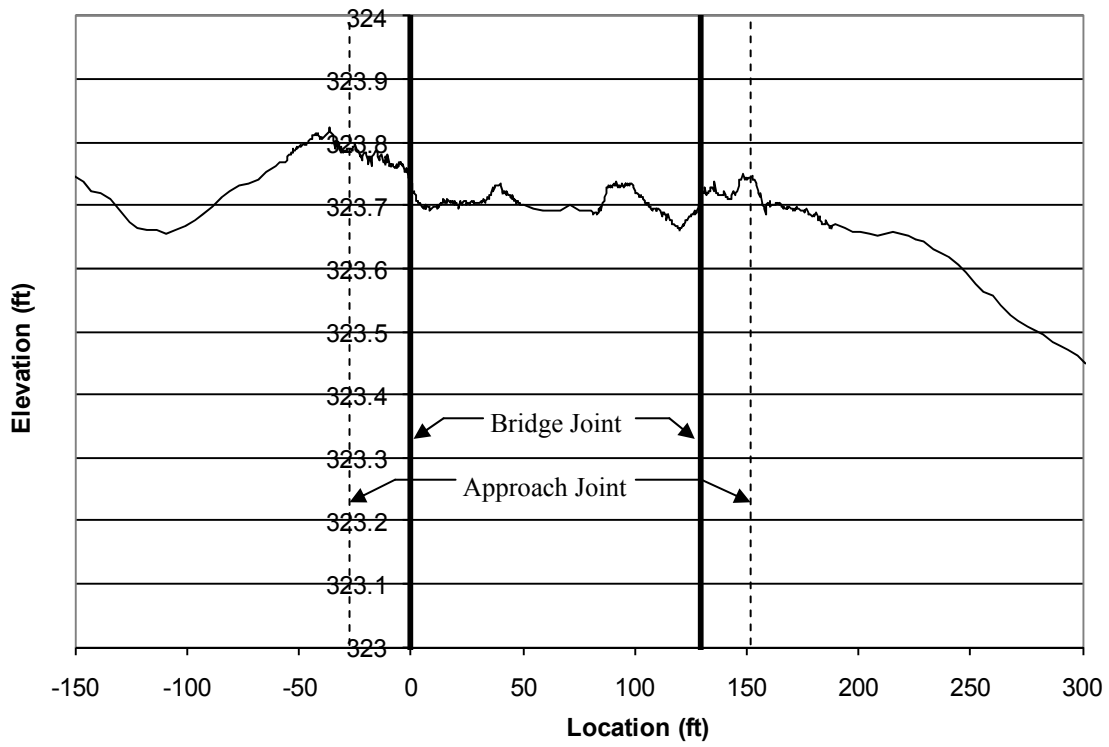
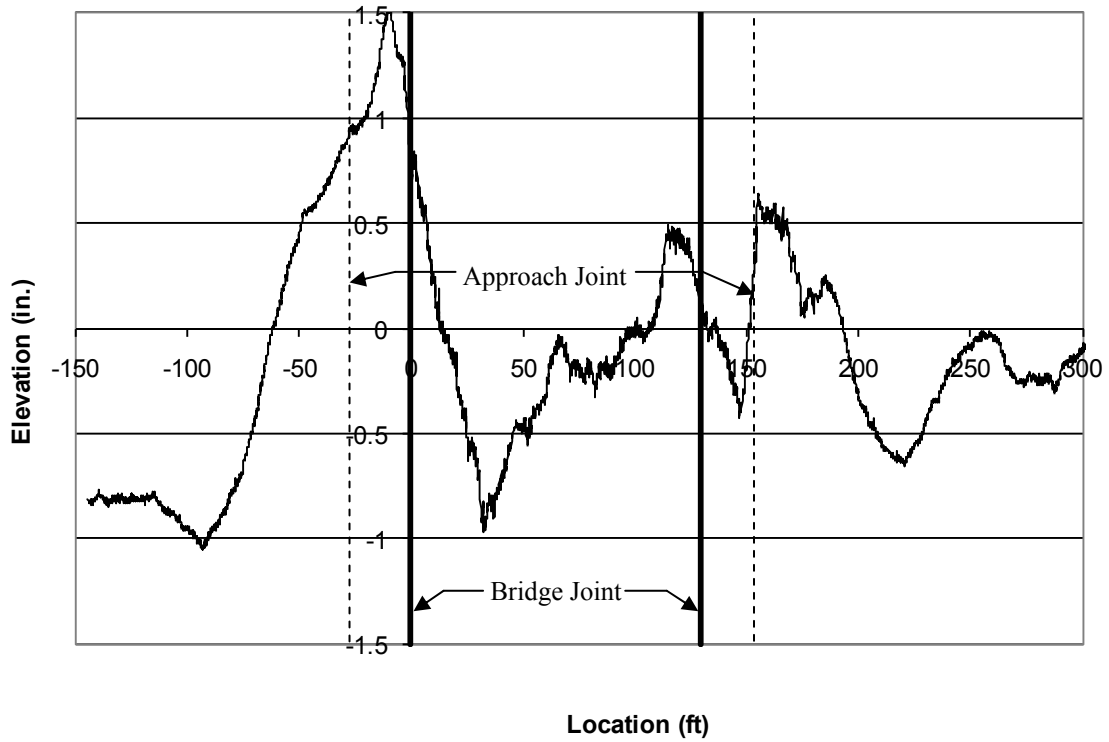
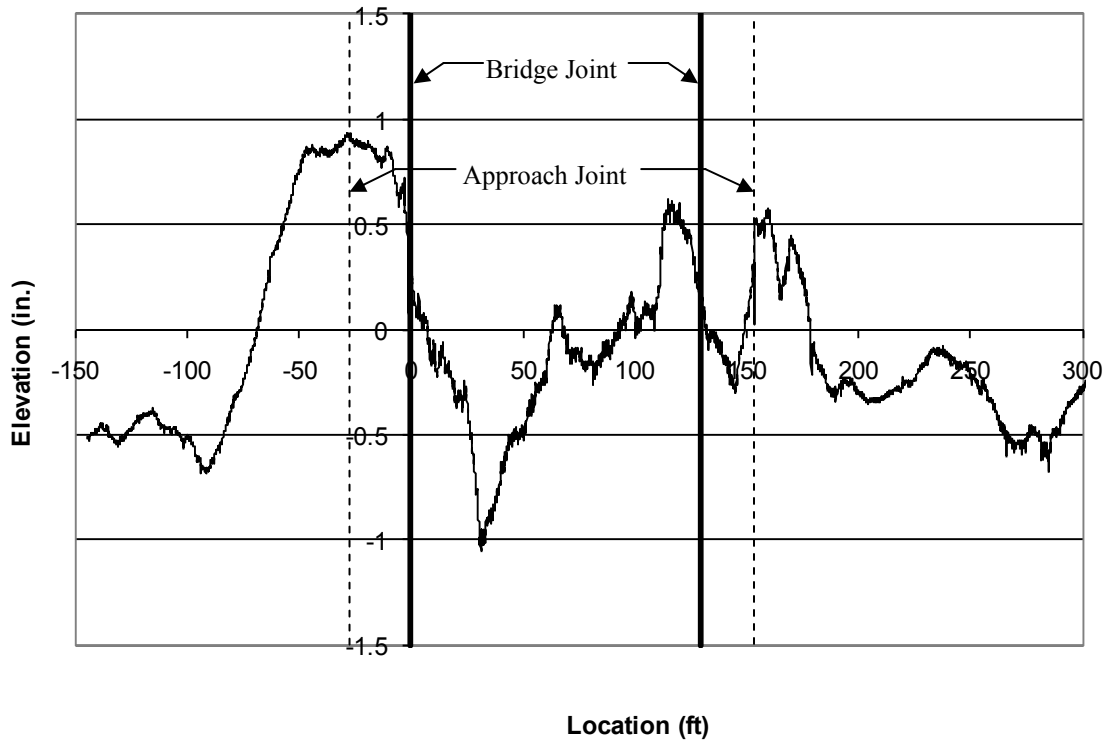
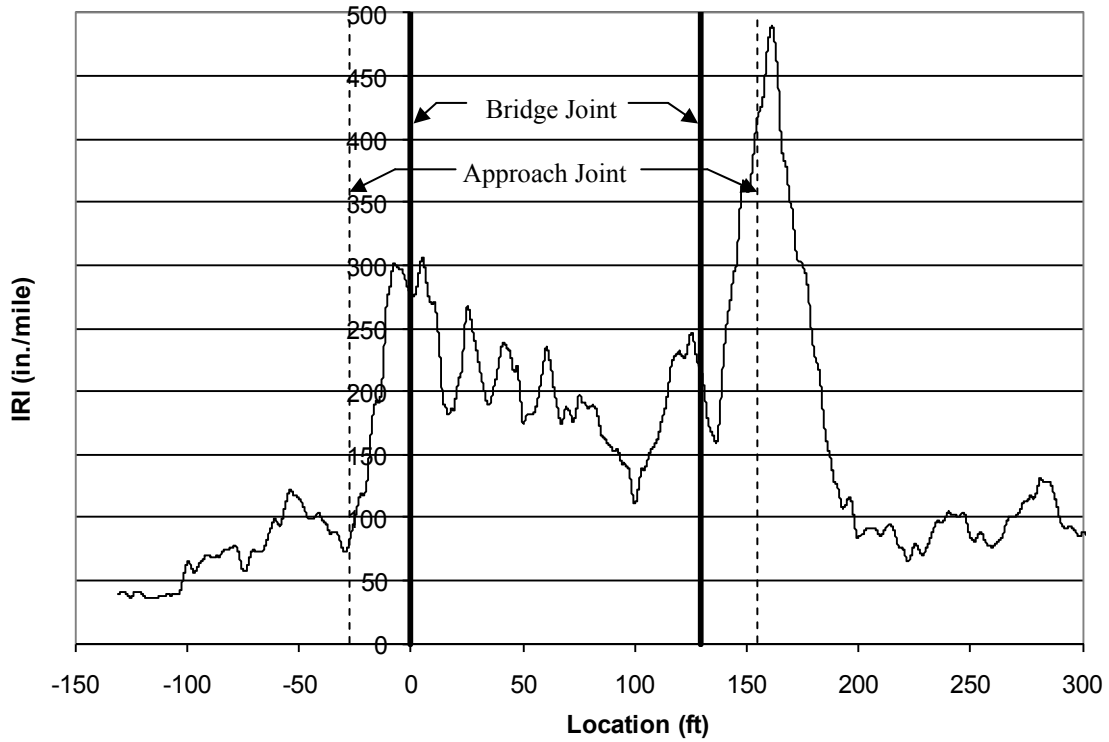
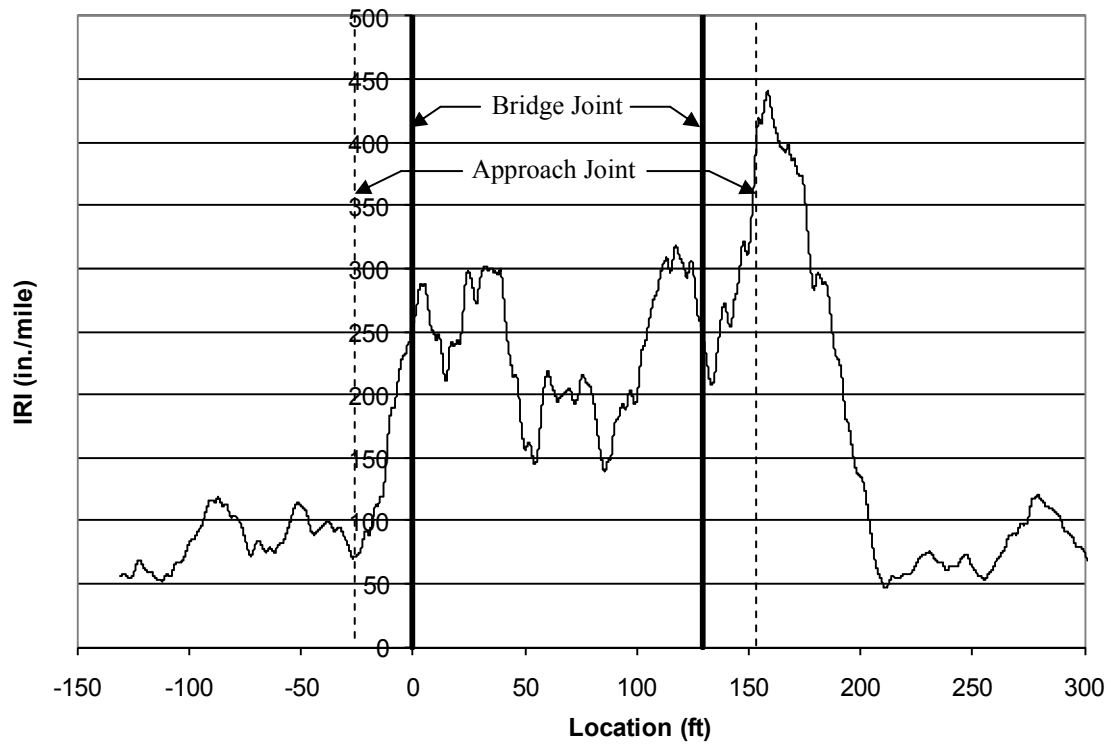
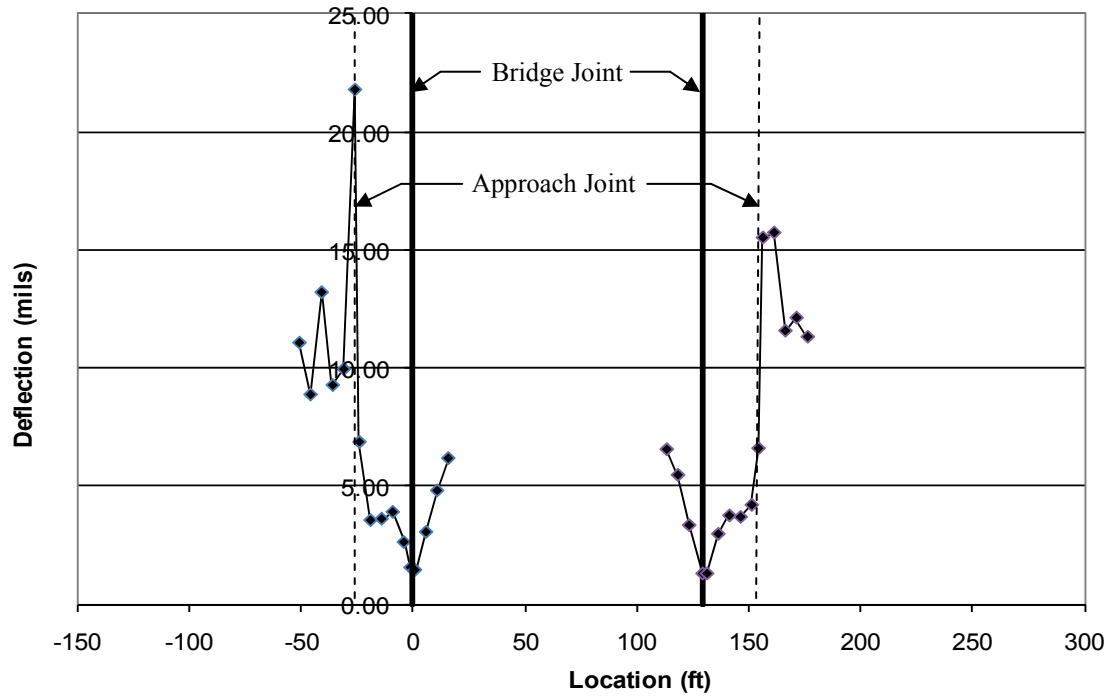
Figure 5.39. LIC 40-12.53 bridge geometric testing results

Figures 5.39a and 5.39b show the results of the laser-based survey. This bridge shows a consistent geometry from left to right. It further appears that the bridge consists of three distinct “regions,” both physically and in terms of data consistency. The entrance end of the bridge shows some variability that changes gradually. The bridge itself shows less overall variability in magnitude but that the variability changes quickly. The exit end of the bridge shows some instances of rapid, marked changes, indicating the potential for ride quality degradation.

In general, the above-mentioned observations are reified in the raw profiler and IRI data. Of greatest concern is the high spike in IRI data at the exit end on an otherwise acceptable bridge.

The FWD test results do not offer an explanation to the above-mentioned features. Specifically, the lowest stiffness is at the end of the bridge with the best ride quality. This may indicate approach slab connection problems.

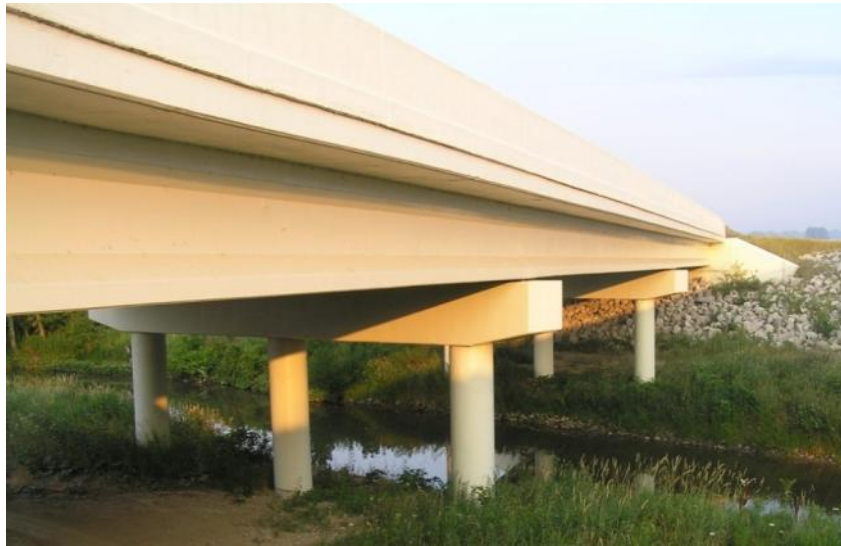
Figure 5.40. WYA 30-22.40 profile view

The WYA 30-22.40 bridge, shown in Figure 5.40, was built circa 2000 over Broken Sword Creek. The bridge has a 20 degree skew and is two lanes wide carrying eastbound traffic. The bridge is three spans with a total length of 233 ft. Six 54 in. deep pre-stressed concrete I-beams, with a composite concrete deck, make up the three spans. The abutments consist of one row of H-piles oriented with their strong axis parallel to the direction of travel. The piles have a concrete cap that connects to the girders to create an ODOT integral abutment. The approach slabs are 30 ft long and rest on a 6 in. paving notch. The approach slab is connected to the abutment with diagonal # 8 bars. The joint between the concrete pavement and approach slab has a 50 in. asphalt pressure relief joint.

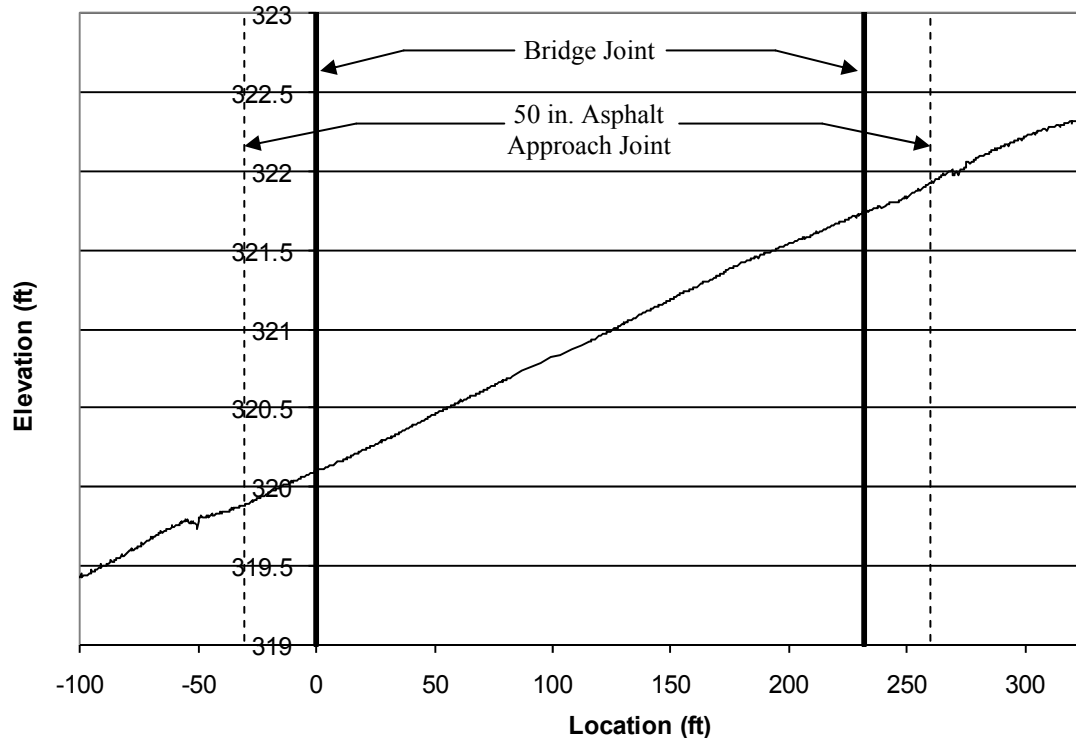
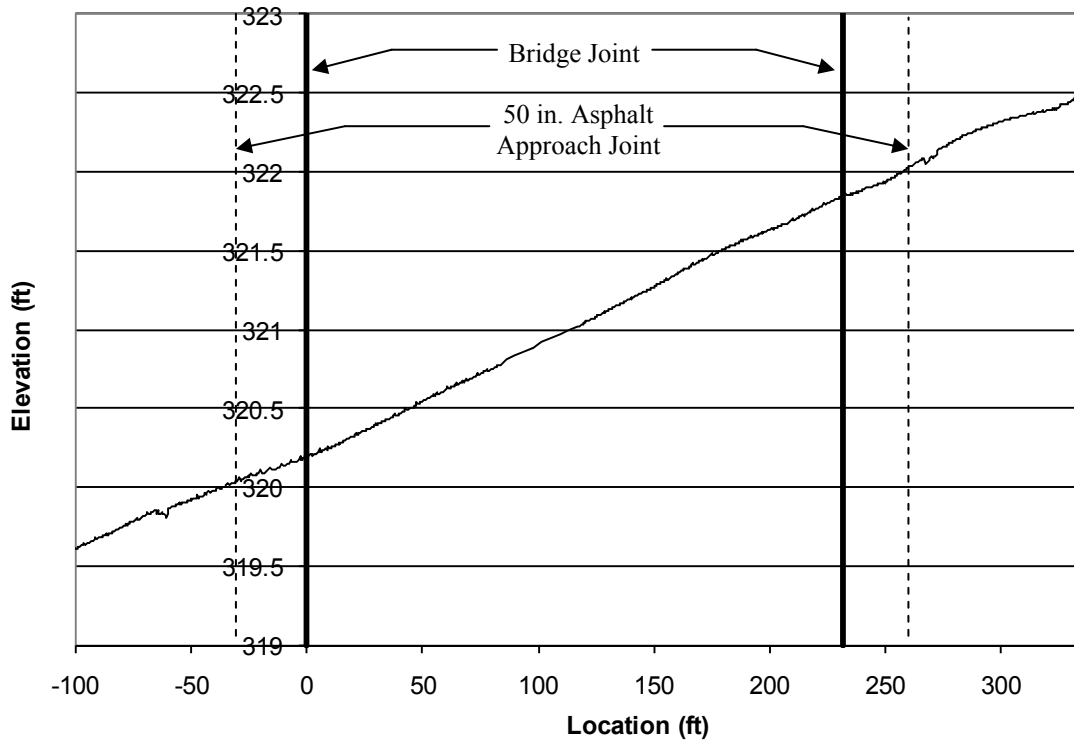
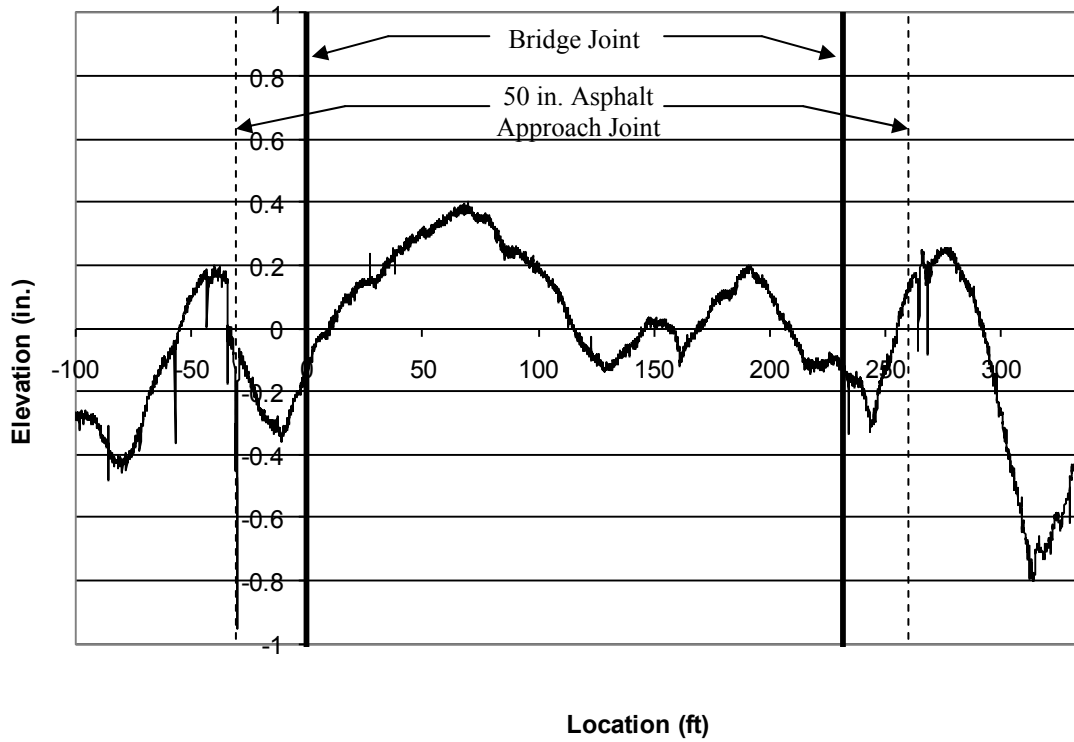
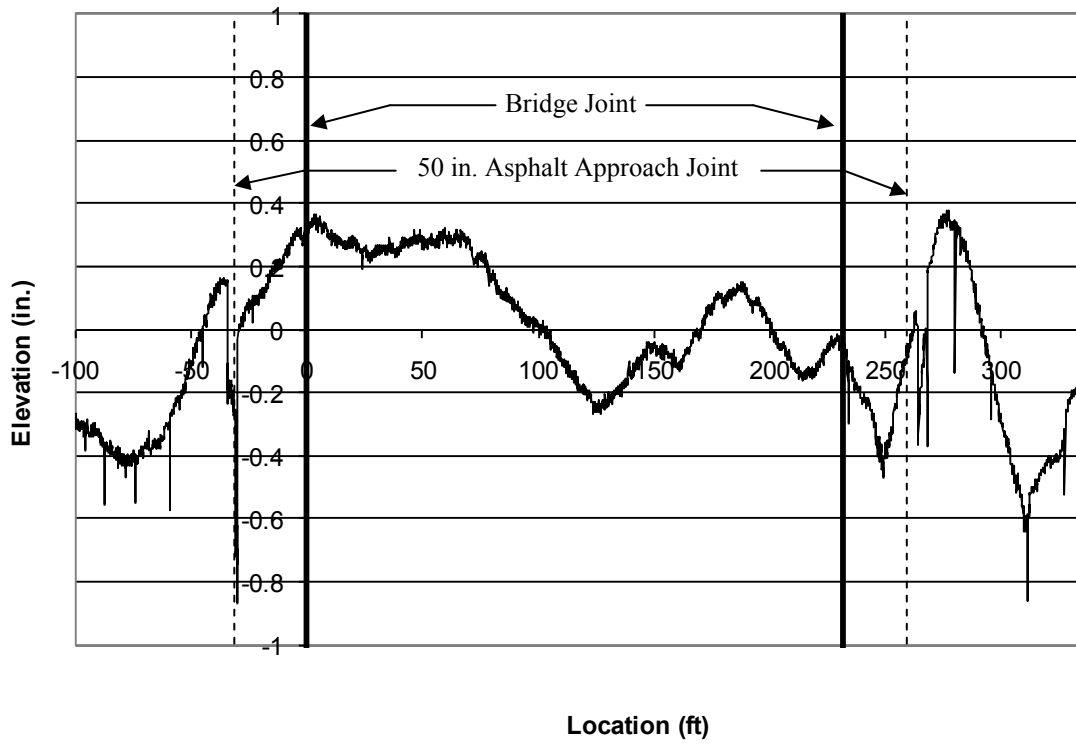
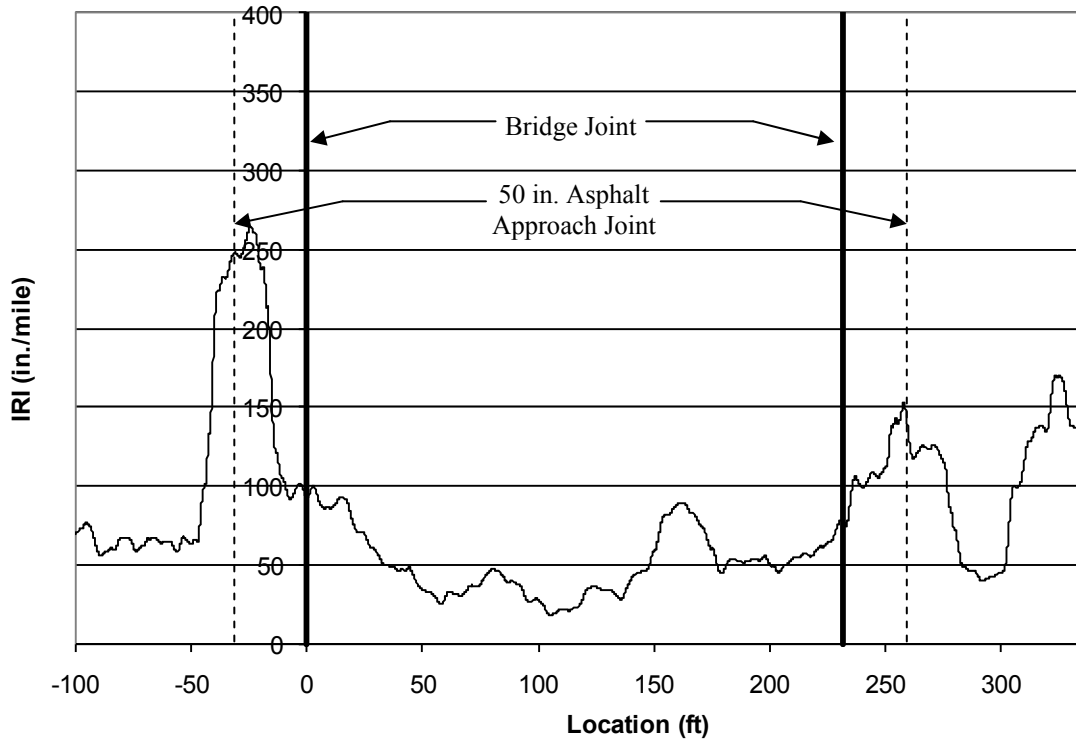
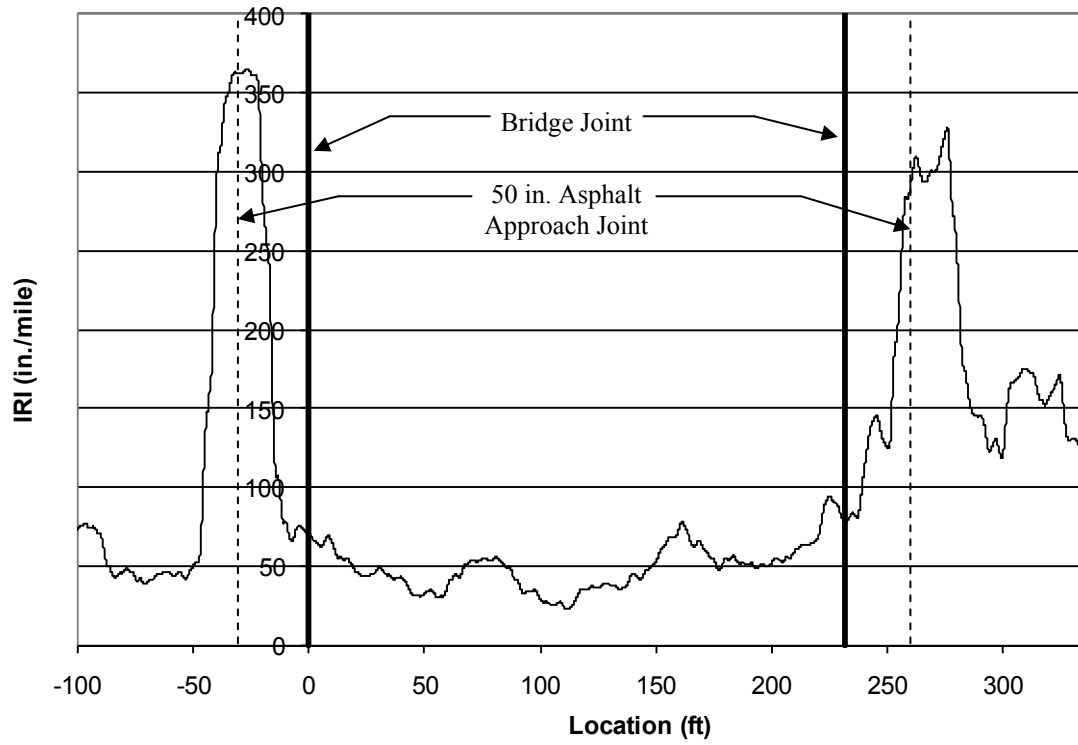
The profiler data (both raw and IRI) further confirm the observations made with respect to the survey data. With the exceptions of the area in the vicinity of the approach slab-to-pavement connection, this appears to be a bridge with very good rideability characteristics.

Unlike some of the previously-discussed FWD results, the WYA 30-22.40 bridge shows greater consistency in support system stiffness. Like the previously-discussed bridges, the greatest stiffness is at the abutment (as expected). However, the change in system stiffness with this bridge was less than that observed for other bridges.

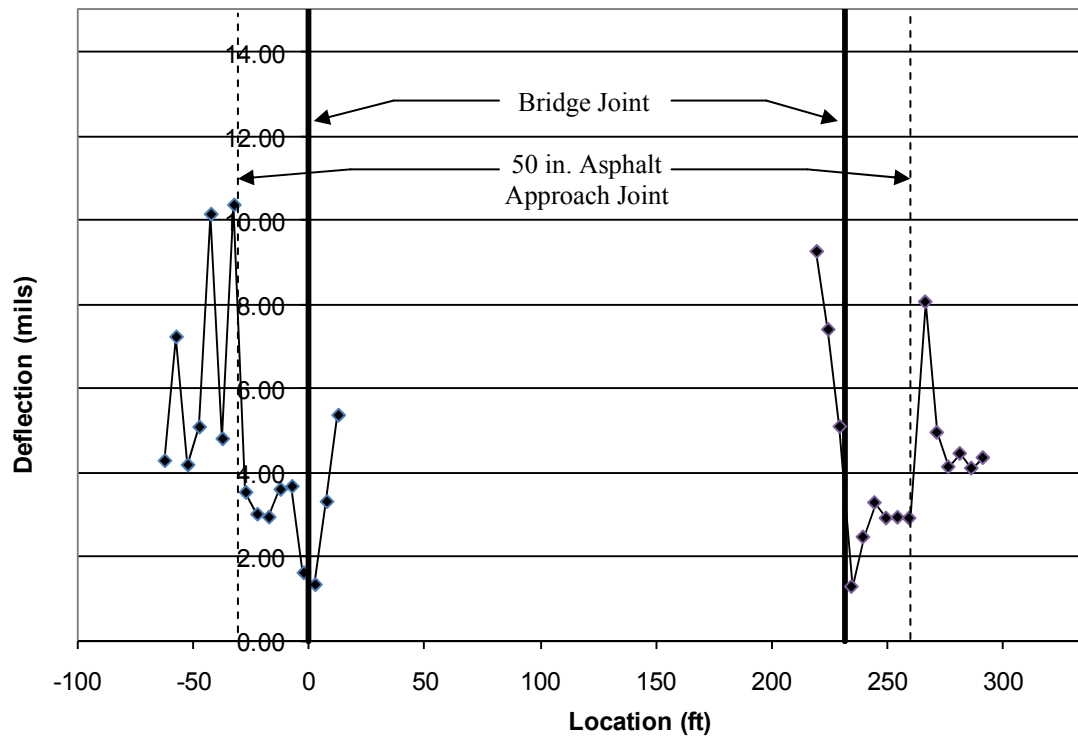
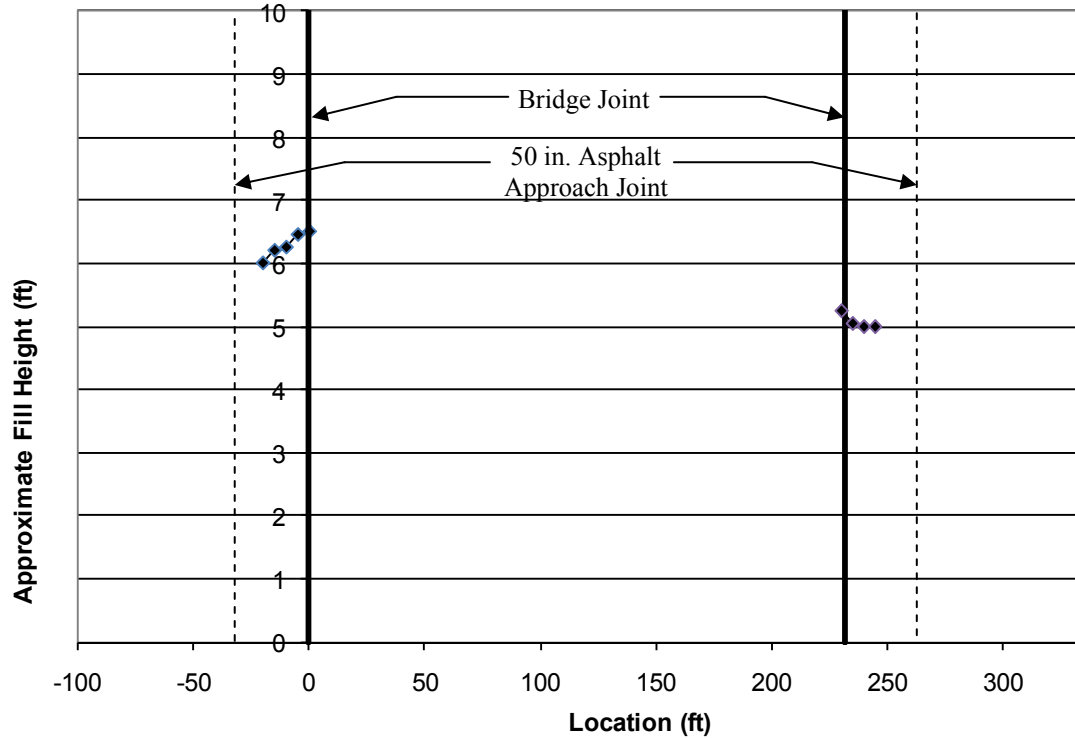
Figure 5.43. WYA 30-22.40 bridge geometric testing results

Figures 5.43a and 5.43b show the results of the laser-based survey. With only minor exceptions at both the entrance and exits of the bridge the global survey results indicate a bridge with few discontinuities. The discontinuities at both ends and in both wheel lines likely coincide with the approach slab-to-pavement joint. It would appear, then, that these areas would be the only locations where rideability may be less than desired.

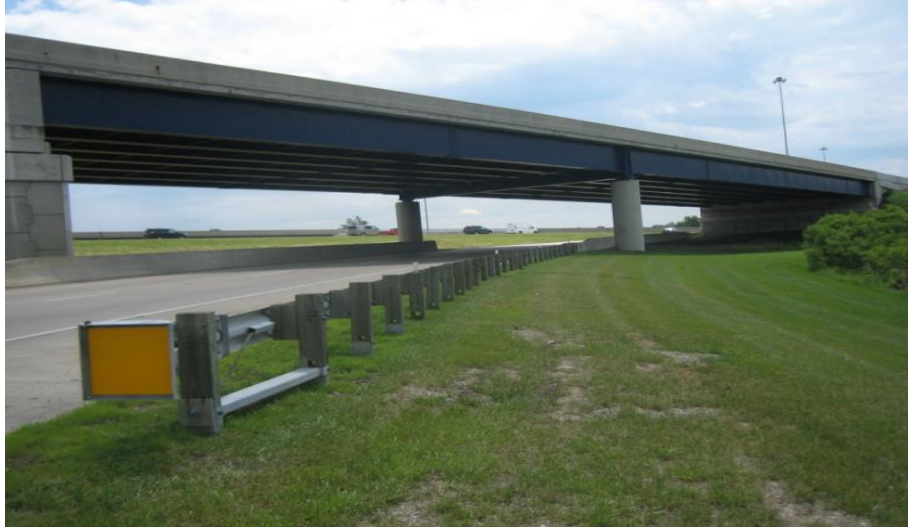
Figure 5.44. FRA 270-32.36 profile view

The FRA 270-32.36 bridge was built circa 1995 and carries three southbound lanes of traffic over an on ramp to Interstate 270. The bridge is a 304 ft long two-span bridge with the longest span being 173 ft, as shown in Figure 5.44. The bridge has seven 84 in. deep continuous steel plate girders with composite concrete decking. The abutments are semi-integral, which bear pile caps of two rows of vertical steel H-piles with their weak axis oriented parallel to the travel direction. Each abutment has 20 ft of MSE wall retaining the bridge embankments. The bridge, during the time of testing, had 30 ft concrete approach slabs. The highway pavement is concrete; therefore, a 12 in. pressure relief joint was placed at the end of each approach slab. In the past this bridge had experienced a severe erosion problem at the entrance abutment. Specifically, water began infiltrating the MSE wall, creating a large void under the approach slab. Subsequently, the void was filled with grout.

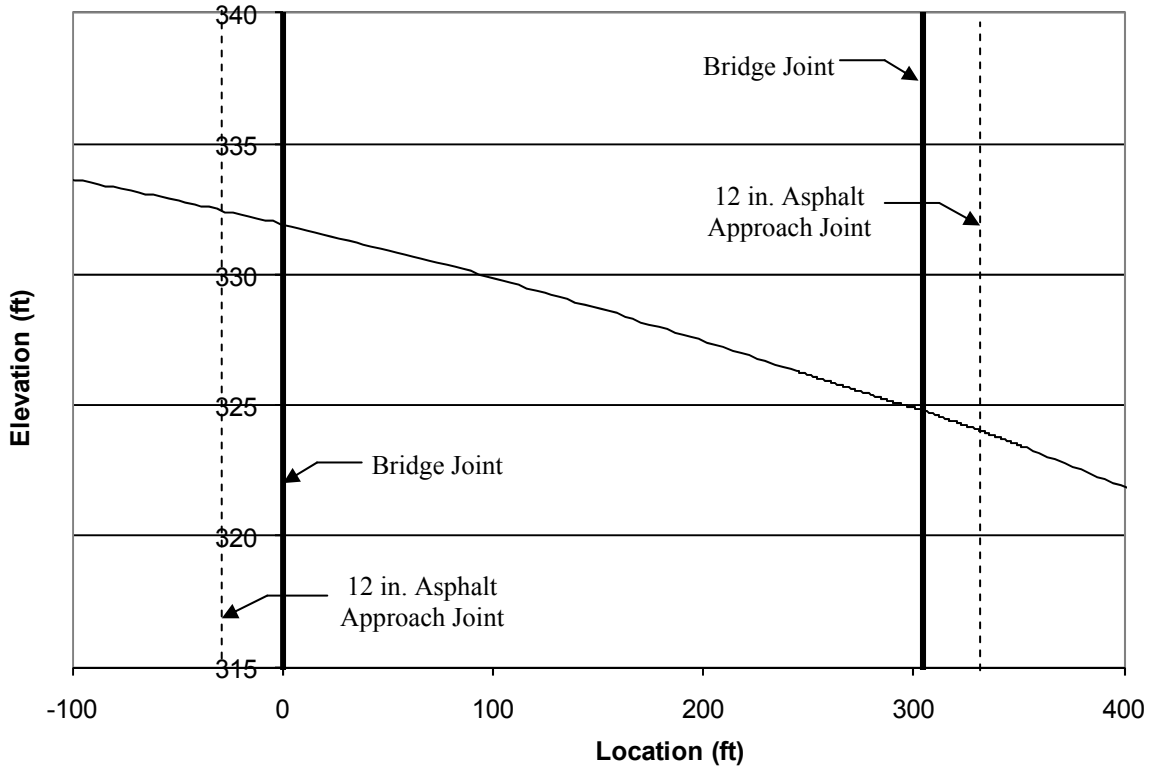
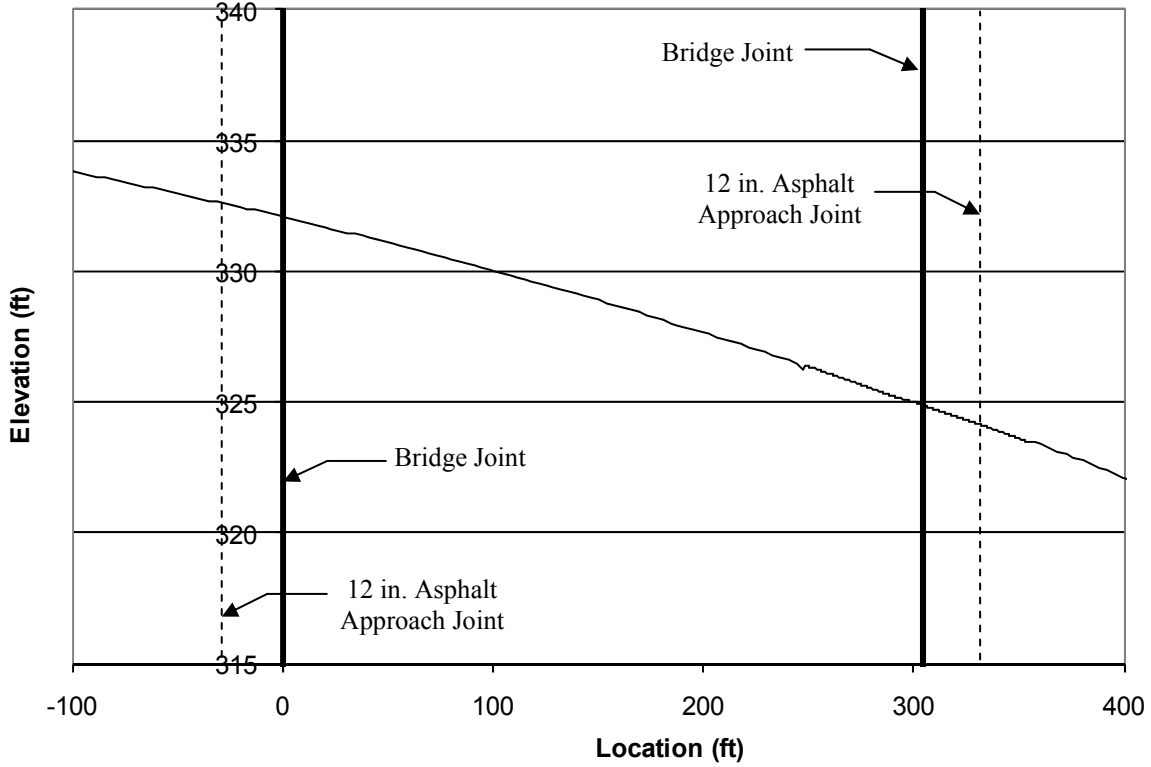
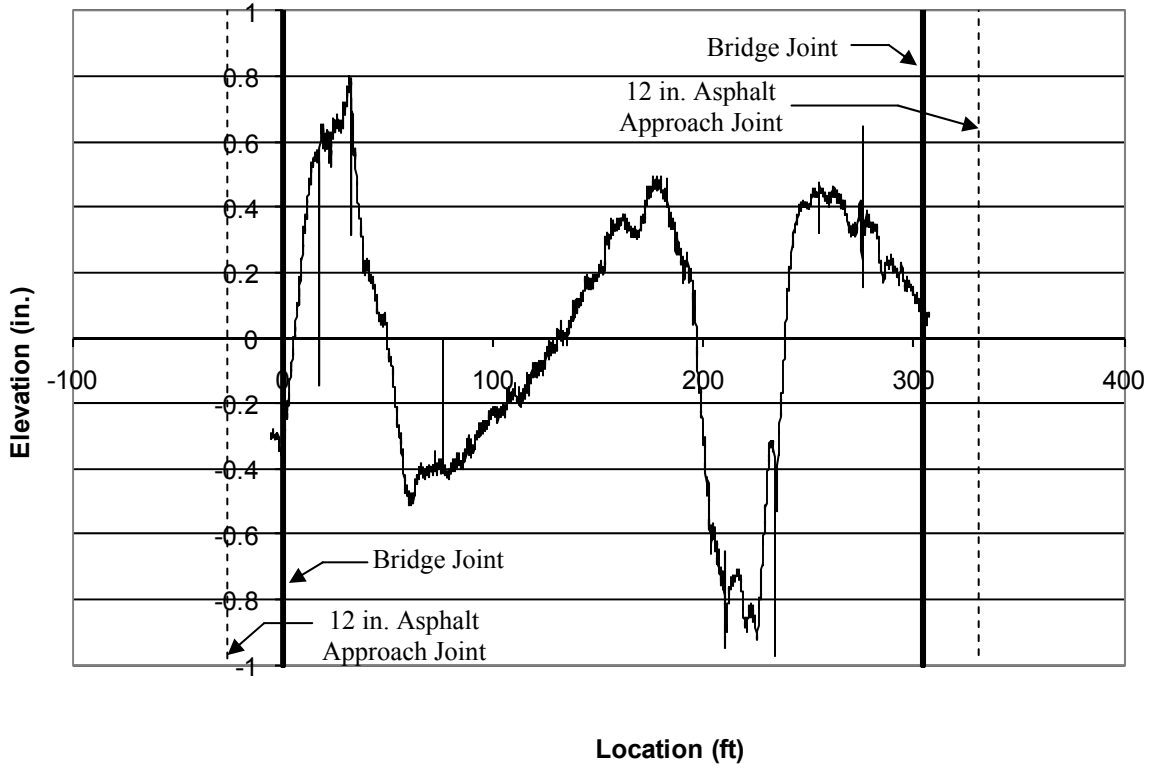
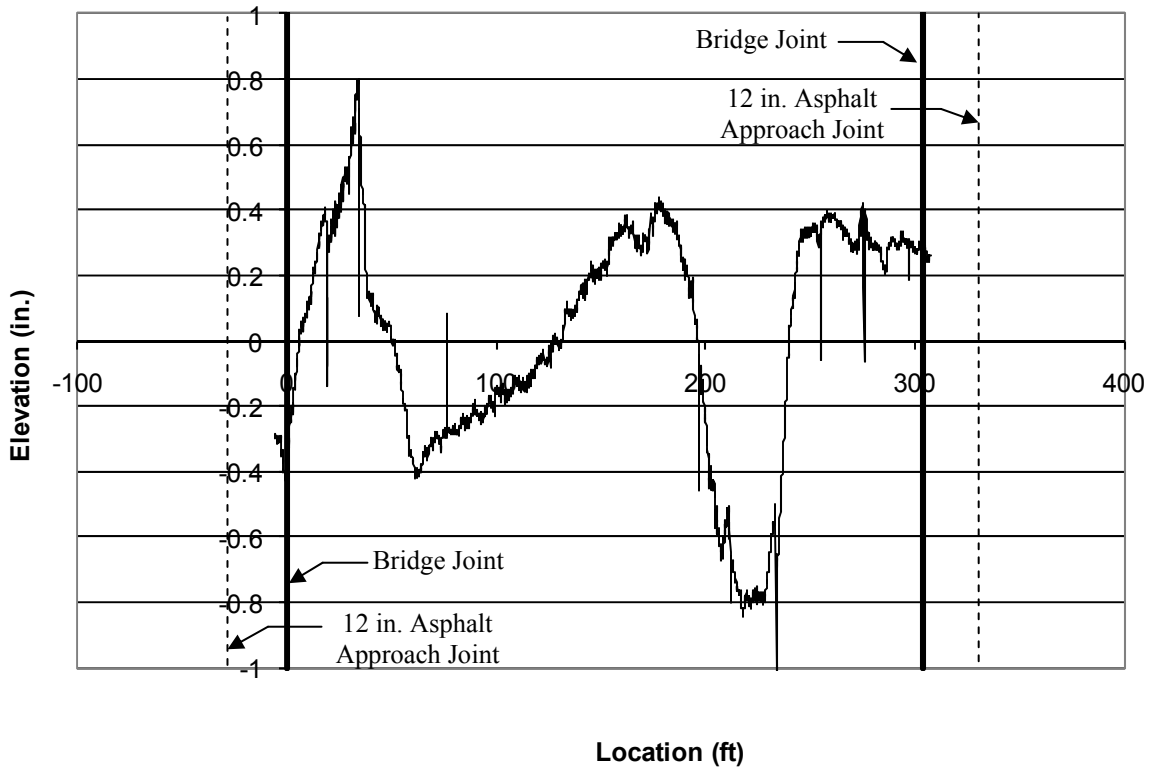
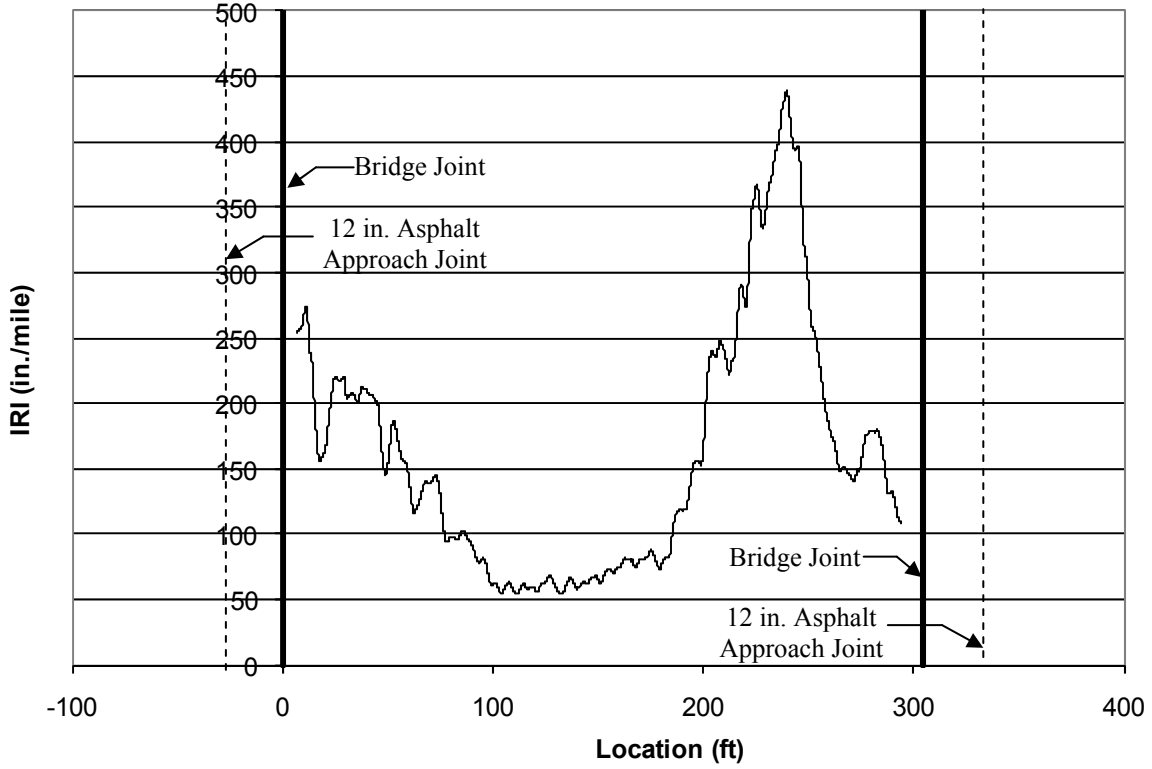
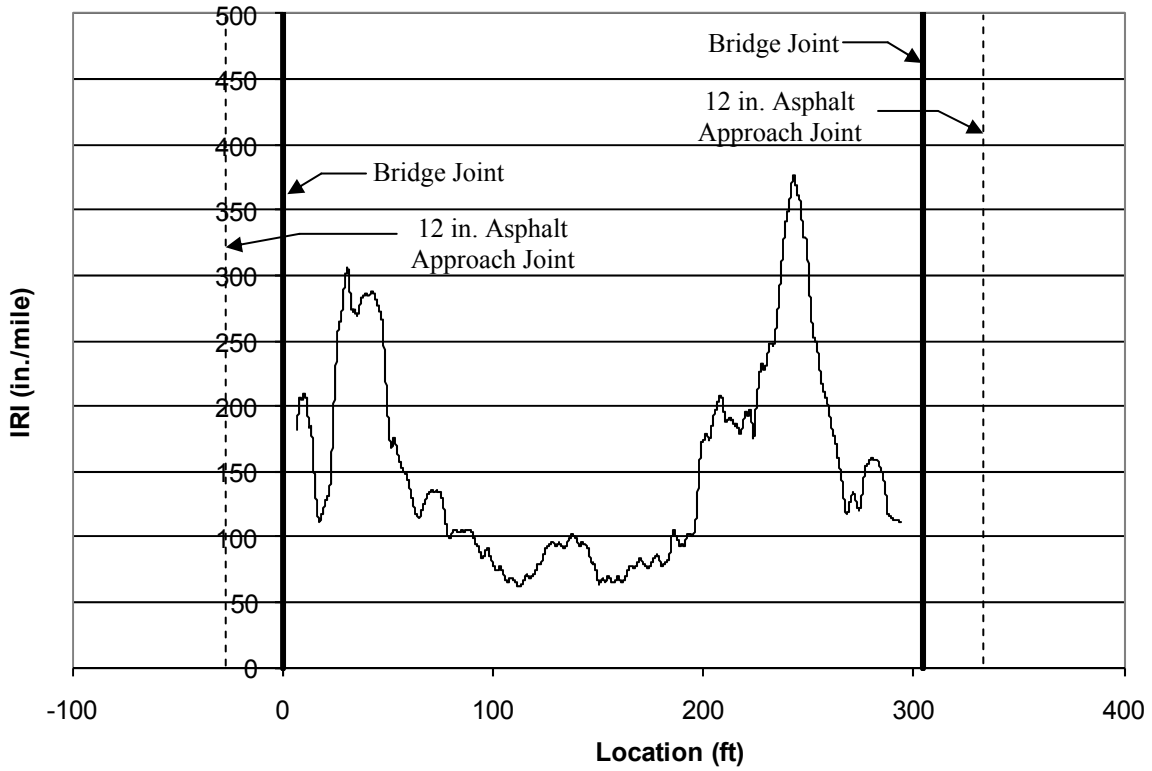
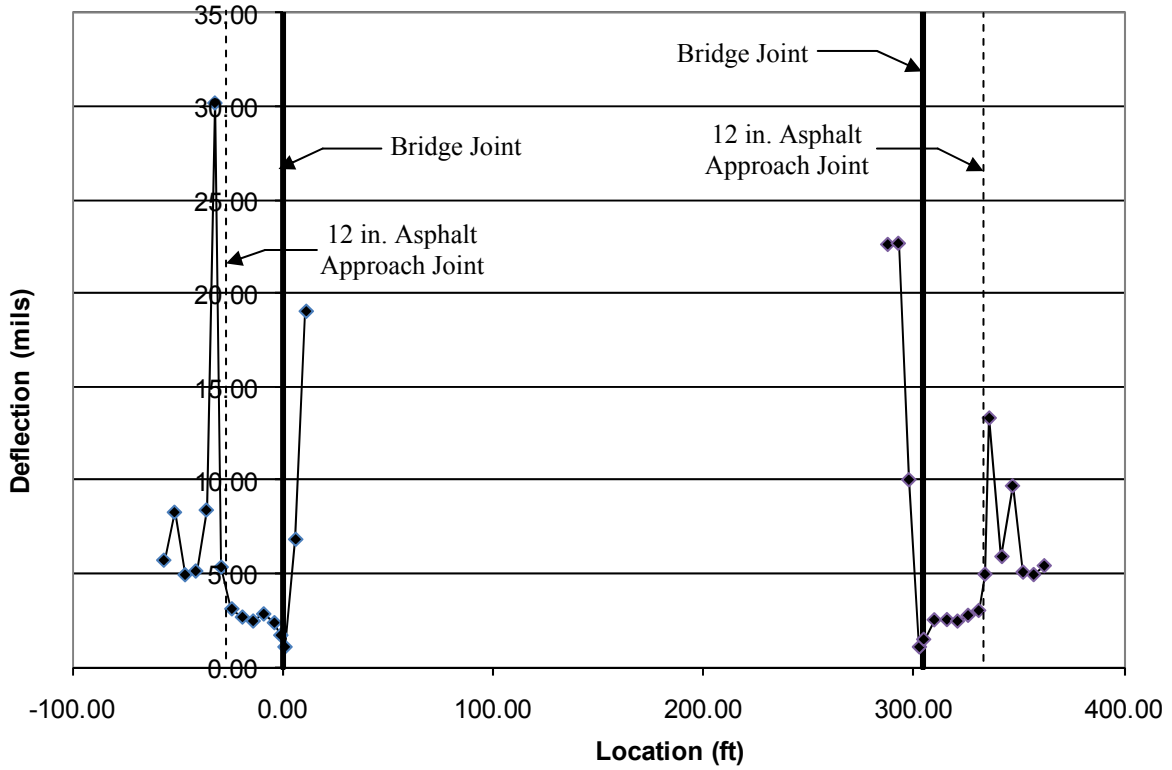
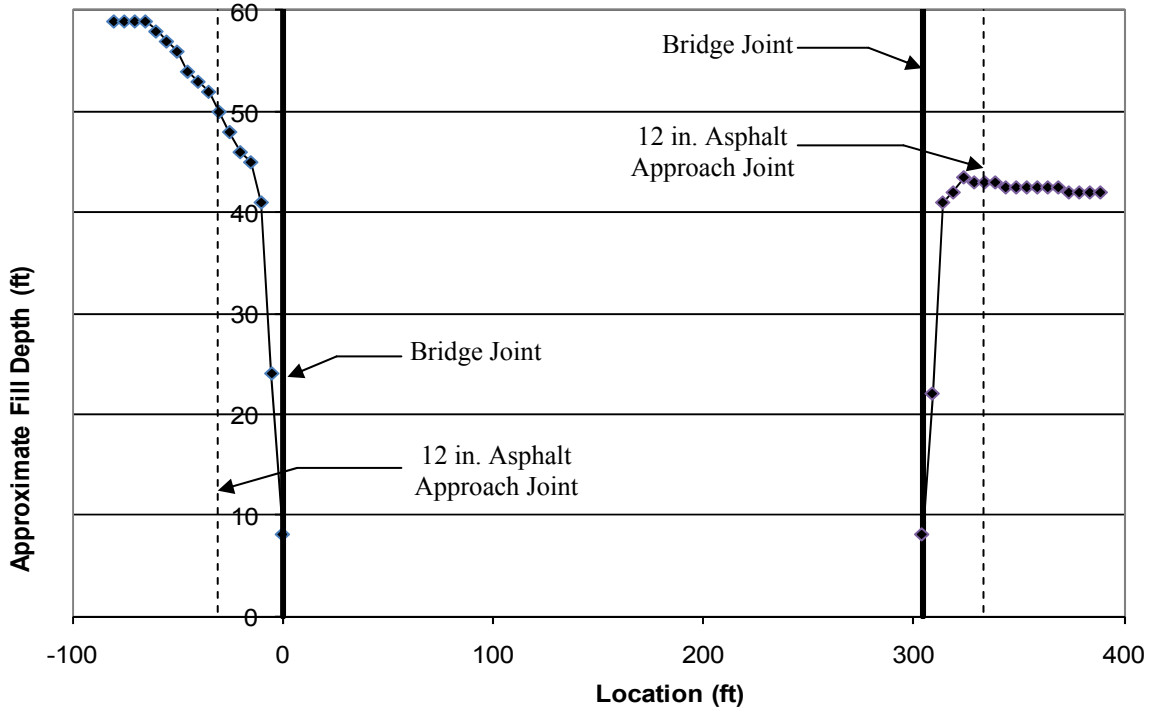
Figure 5.47. FRA 270-32.36 bridge geometric testing results

Figures 5.47a and 5.47b show the results of the laser-based survey. Generally, only one area showed a slight discontinuity in the survey results—approximately 75 ft from the bridge exit. The profiler data seems to substantiate the survey results, indicating this area has high IRI values (approaching 450). However, overall, the survey, raw profiler, and IRI data indicate a bridge with generally good rideability characteristics.

With only one exception, the FWD results indicate a support system that has very consistent stiffness characteristics. It is possible that this stiffness consistency contributed to the smoothness characteristics.
