Identification and Evaluation of Pavement-Bridge Interface Ride Quality Improvement and Corrective Strategies

Institute for Transportation

Report Number FHWA/OH-2011/1

January 2011

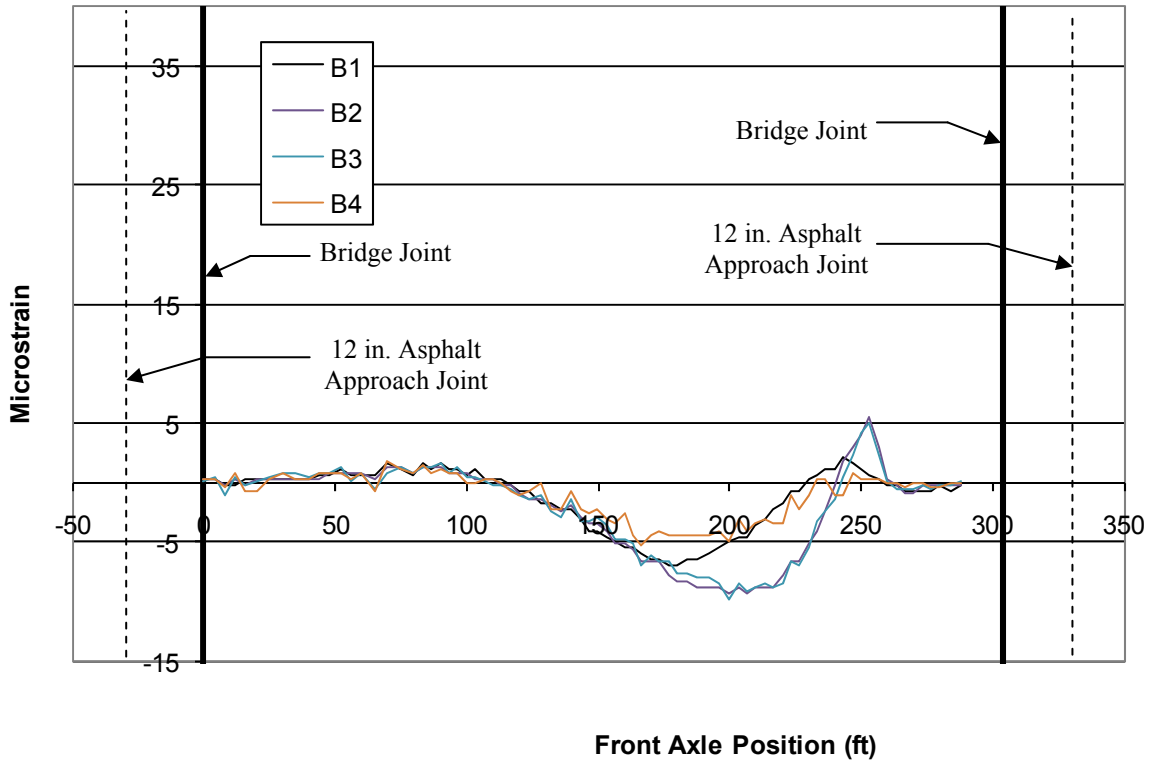
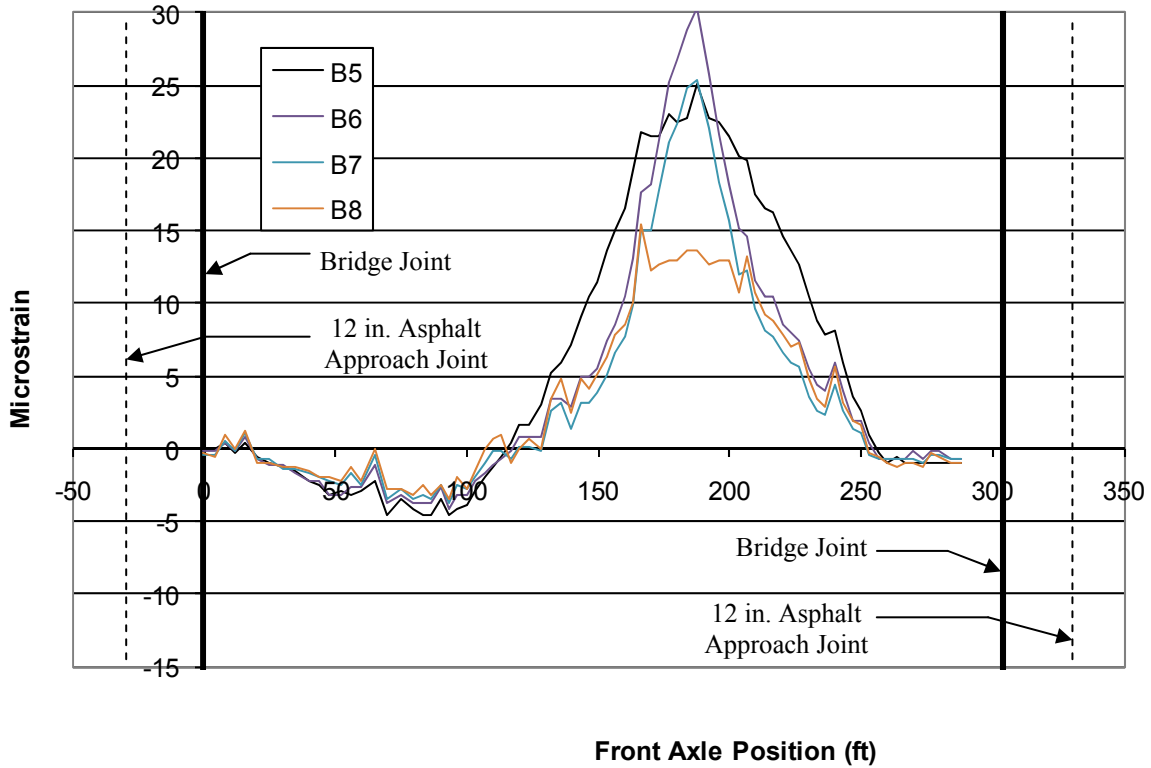
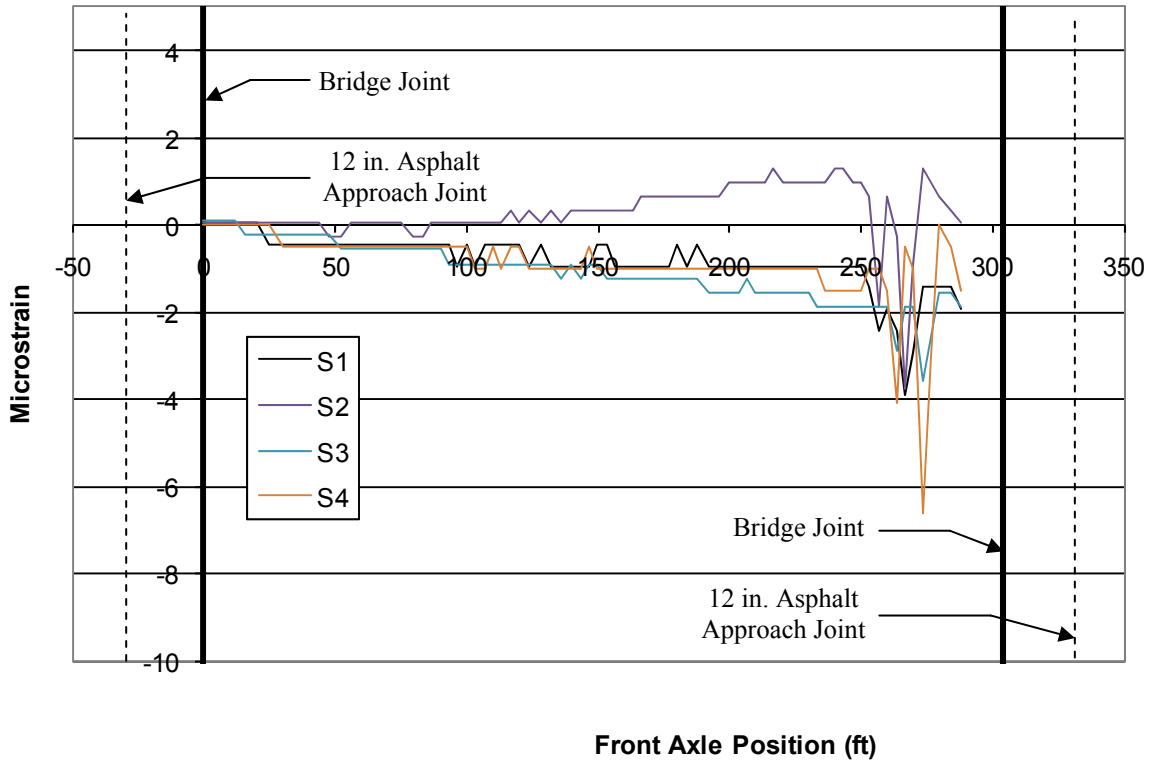
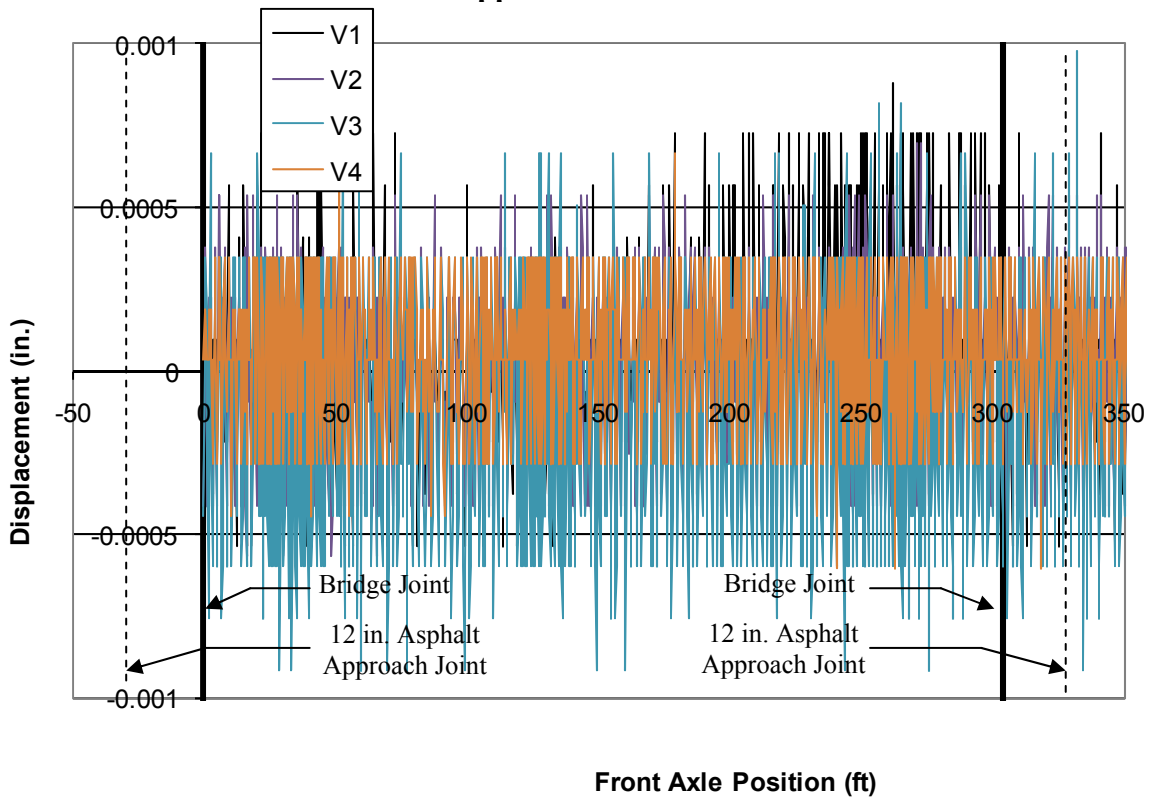
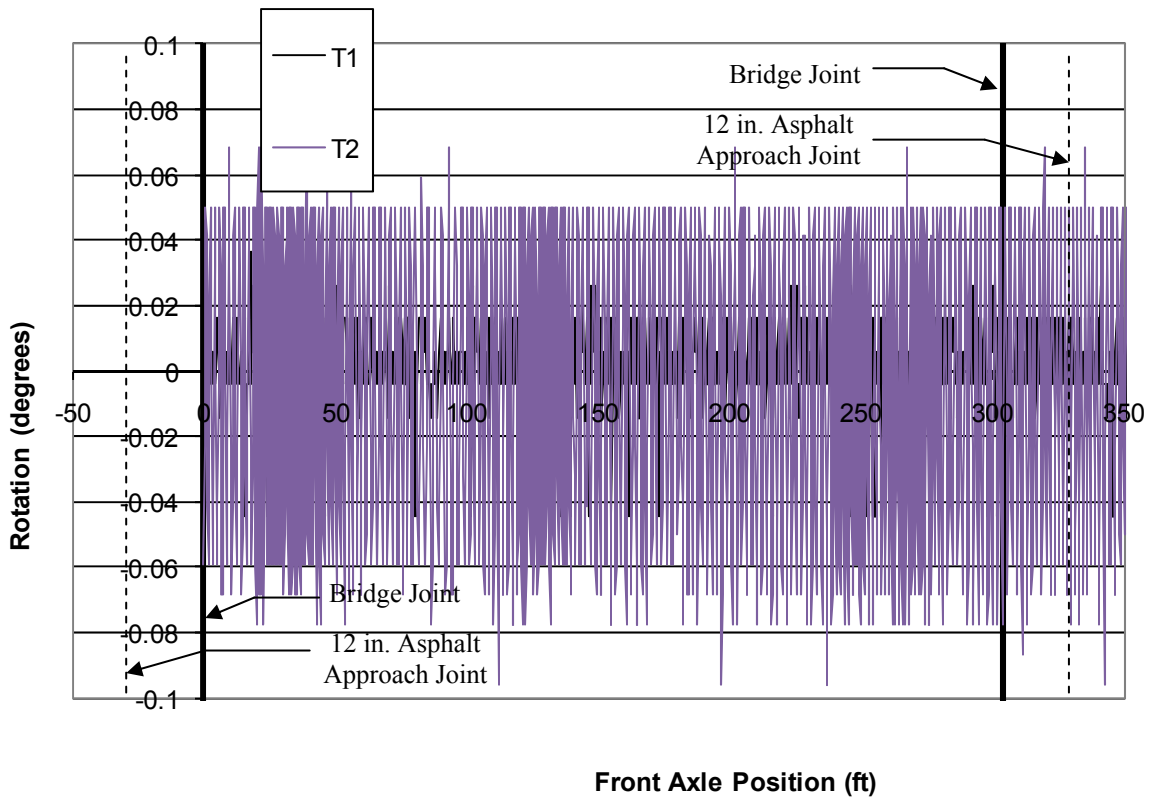
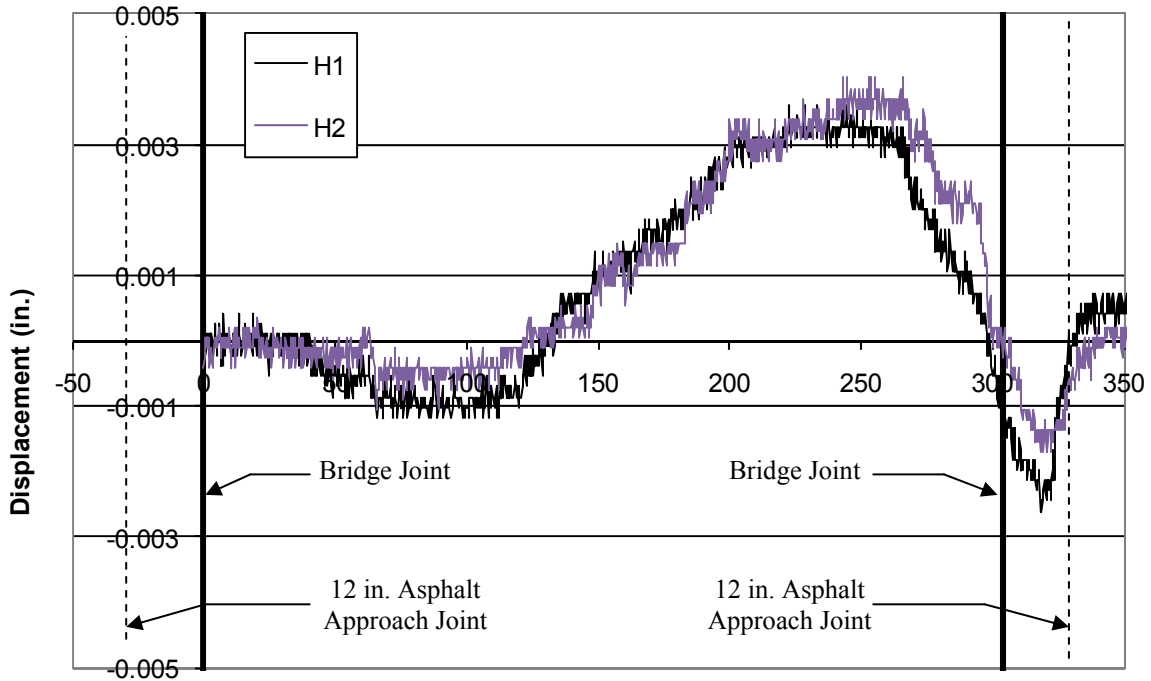
As shown in Figure 5.49, the near girder end strain gages indicated very little end restraint occurring at the bridge bearings. This finding is further observed in the near midspan strain gages. In general, the measured girder strain levels are low with measured stresses under 1 ksi.

As in previously-described testing, very little measured slab strain and relative displacement indicated that the slab is behaving as a “unit.” This type of unified behavior is probably most impacted by the high degree of consistency in the support system stiffness.

As before, it was found the abutment did not rotate, but that it did have observable live load induced movement. This movement again has signs of strain sign reversal, indicating that the abutment is moving into and out of the supporting soil.

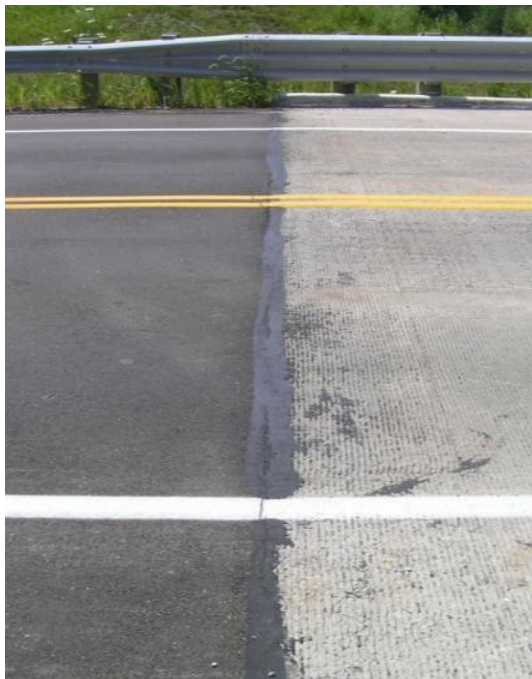
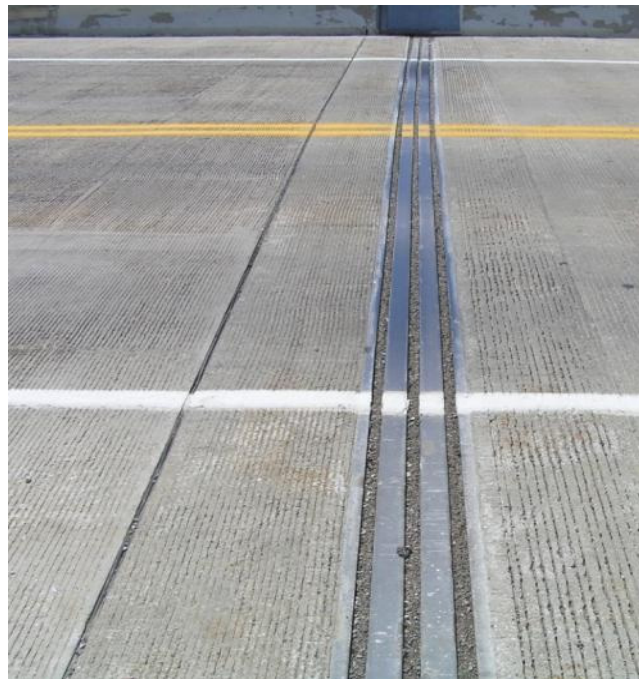
Figure 5.52. Approach slab joint at the pavement and bridge

The ERI 60-2.39 bridge was built circa 1999 and carries two lanes of bi-directional traffic over the Vermilion River. The bridge has five spans with an overall length of about 1,128 ft. (See Figure 5.50). The bridge superstructure consists of five 60 in. deep continuous steel plate girders with a composite reinforced concrete deck. The girders are simply supported at the abutments as shown in Figure 5.51. The abutment has a 21 in. backwall extending up from the girder bearing to prevent the backfill from coming in contact with the superstructure. A strip seal expansion joint was placed between the girder and the backwall. The approach slab is rest on a 6 in. paving notch, which is part of the back wall. The approach slab is 25 ft long and butts directly against the asphalt pavement. The approach slab joint at the pavement and at the bridge is shown in Figure 5.52.

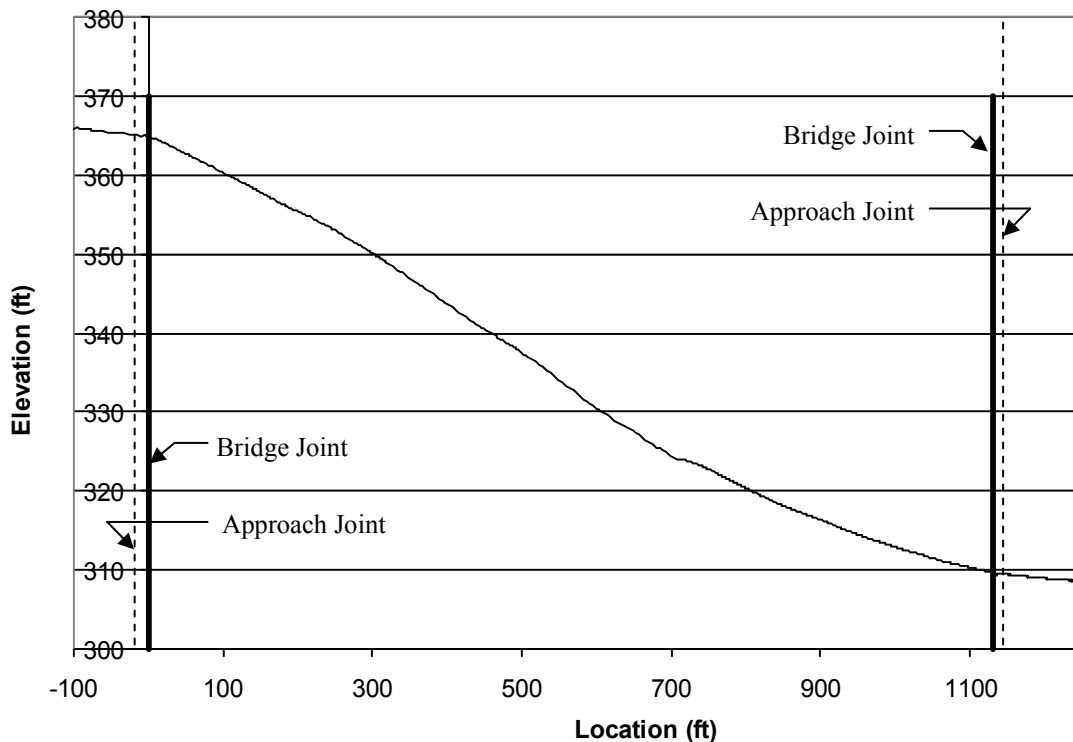
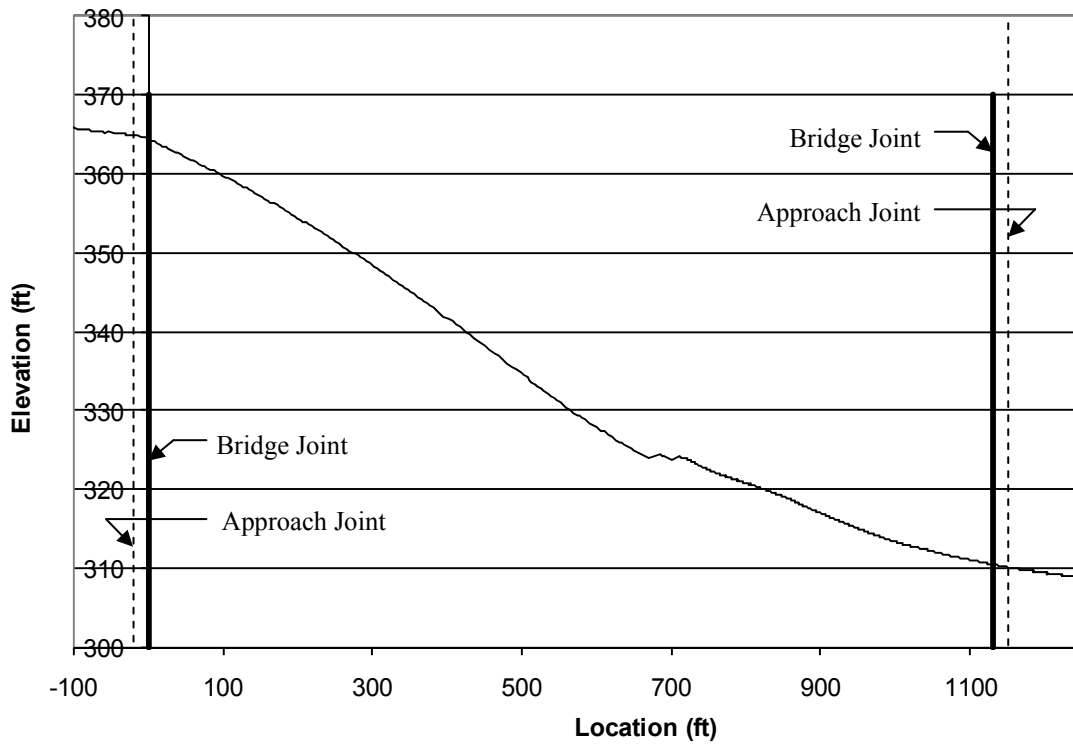
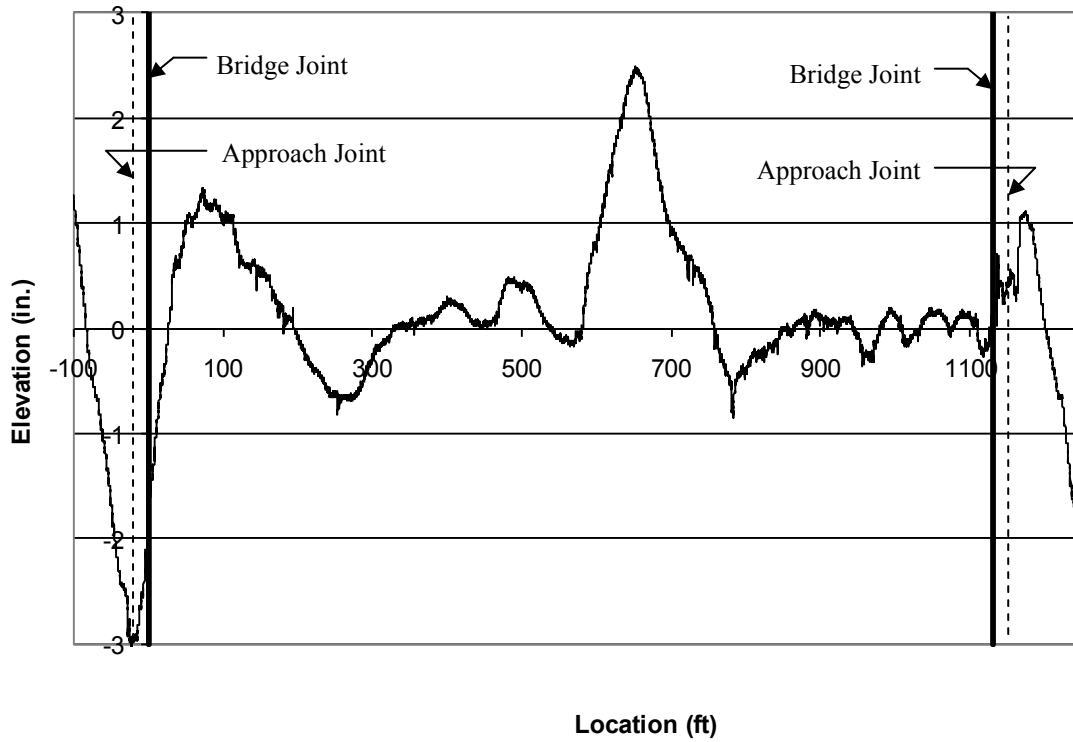
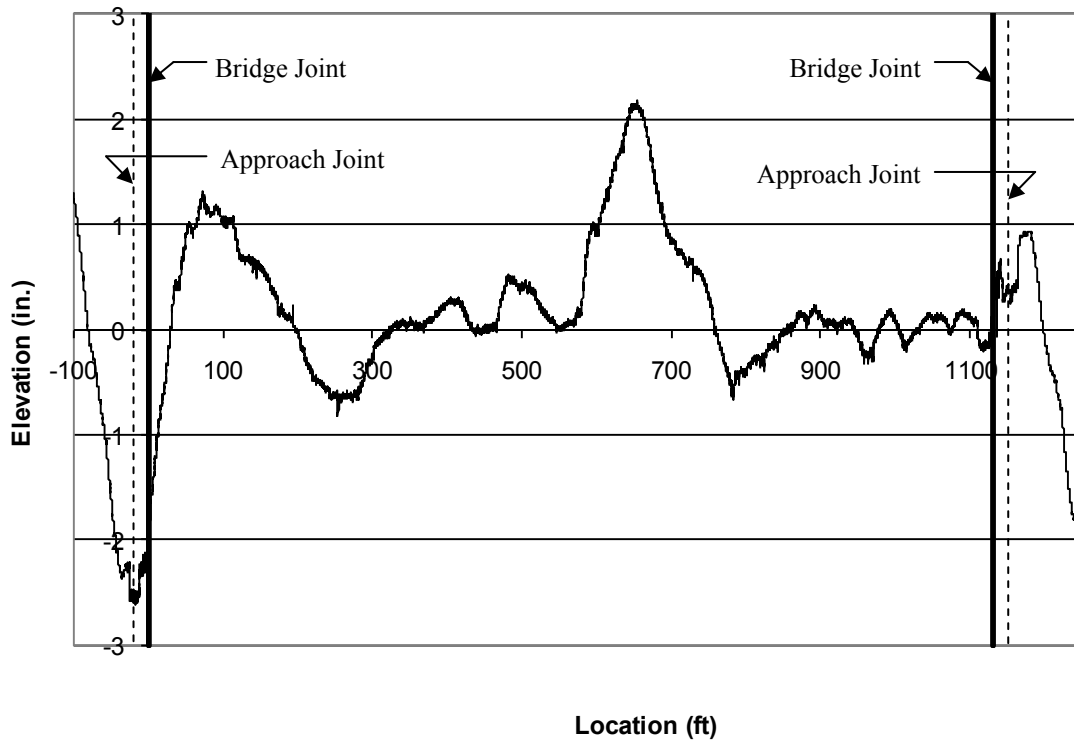
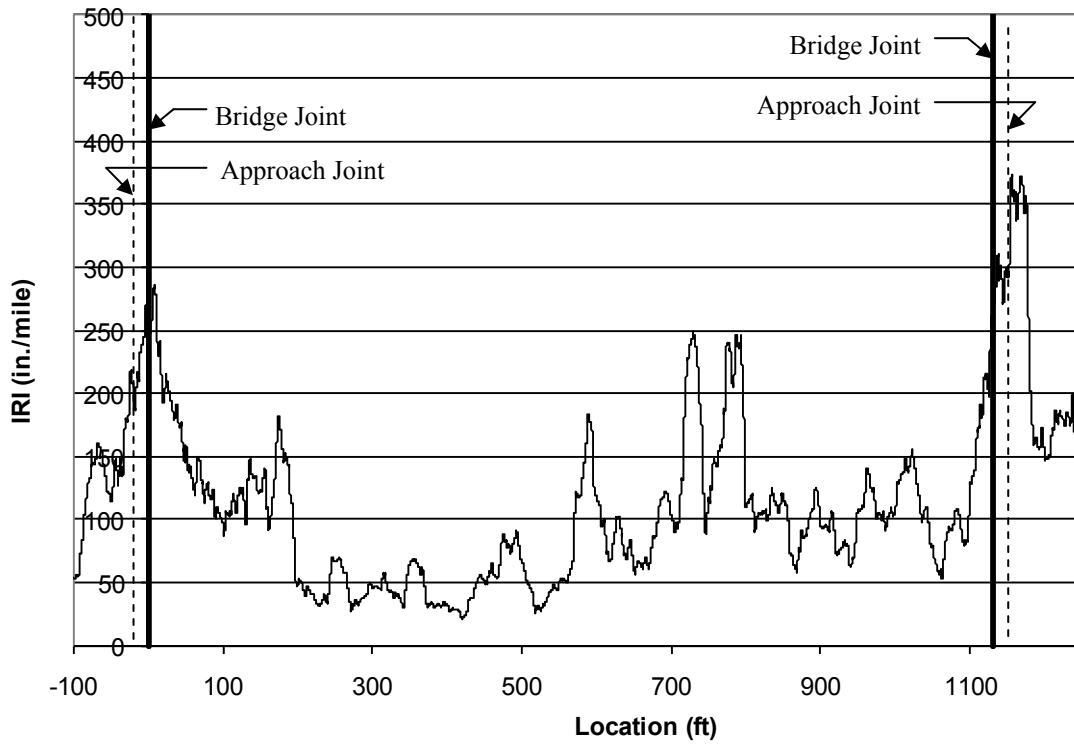
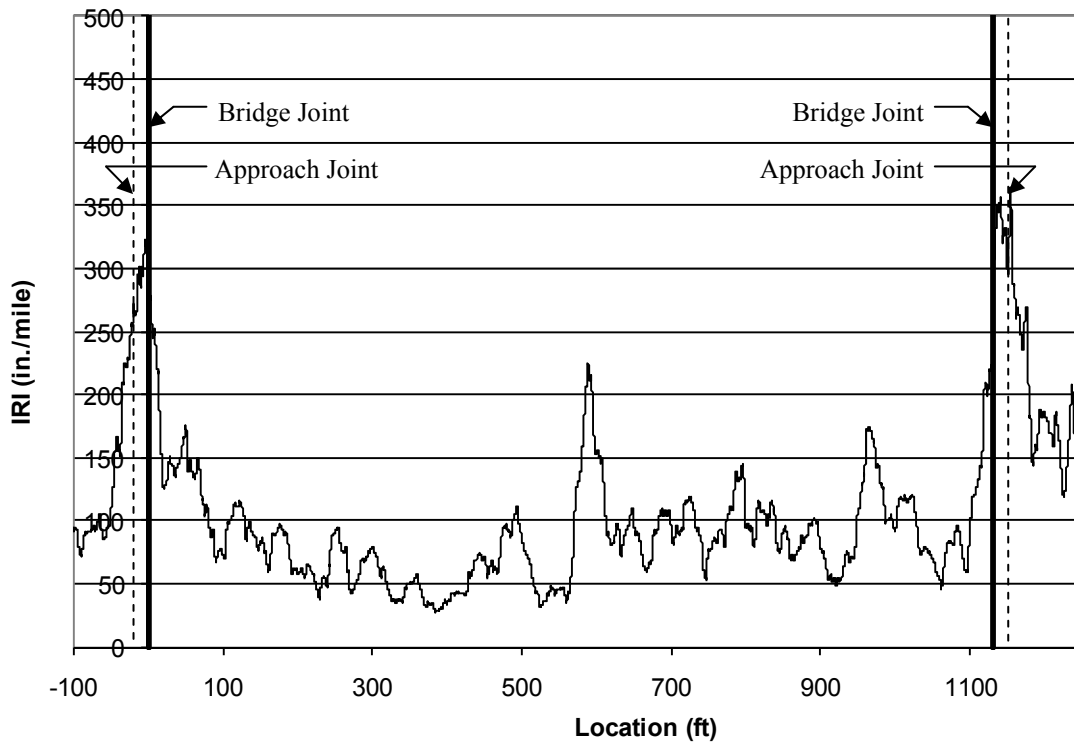
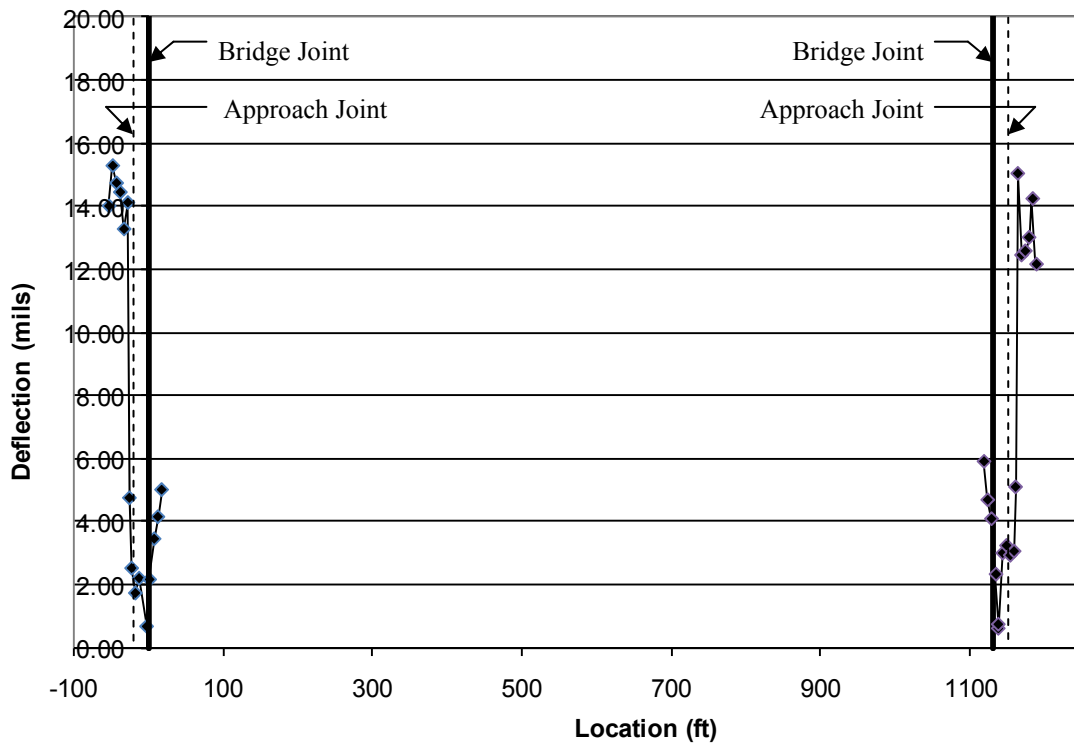
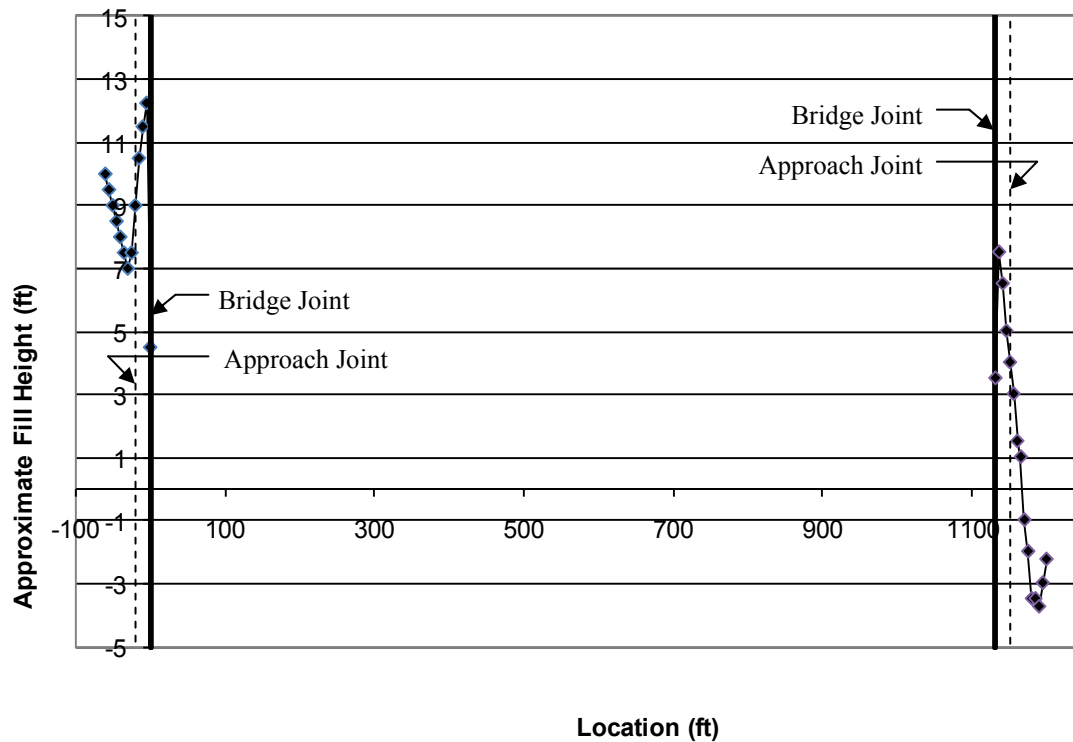
Figure 5.55. ERI 60-2.39 bridge geometric testing results

Figures 5.55a and 5.55b show the results of the laser-based survey. Generally, the survey results indicated a relatively consistent and gradually changing bridge profile. The only exceptions are at approximately 700 ft from the bridge entrance, as well as only slight discontinuities at each bridge end. (Note these are somewhat obscured due to the scale of the plots in the report).

The profiler and IRI data also indicate a relatively consistent surface with slight discontinuities at each end and at the 700 ft location. The FWD test results indicate a region extending approximately 25 ft from the bridge end where the support system is quite stiff. From 25 ft on, the support is less stiff but very consistent.

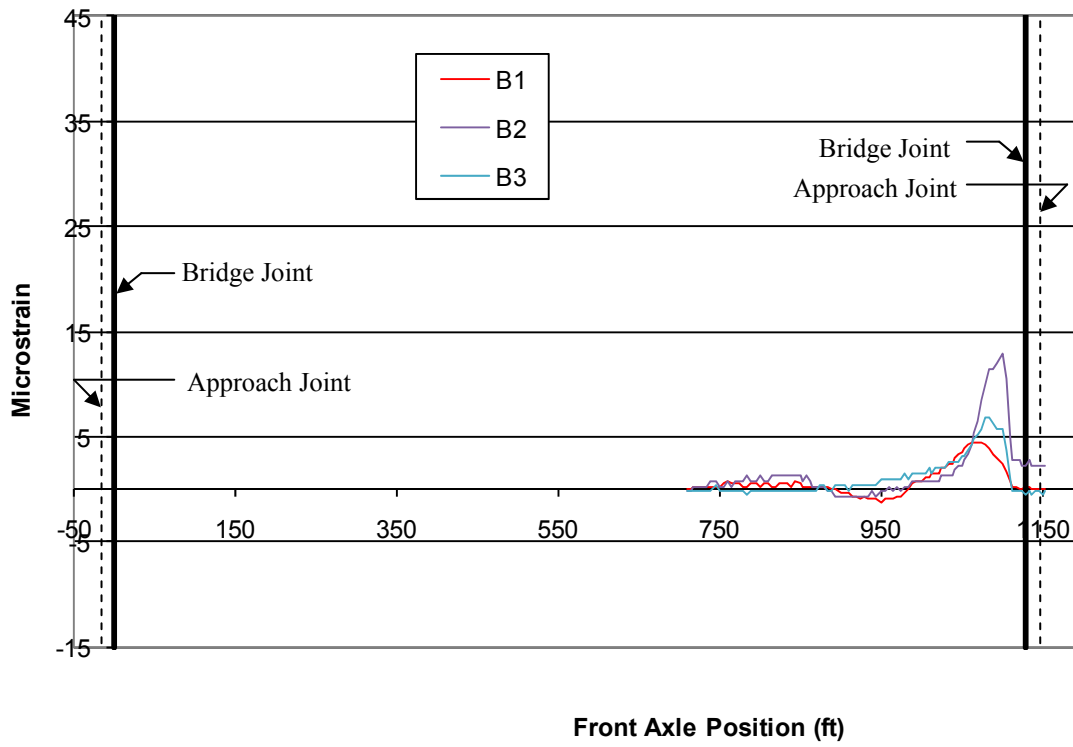
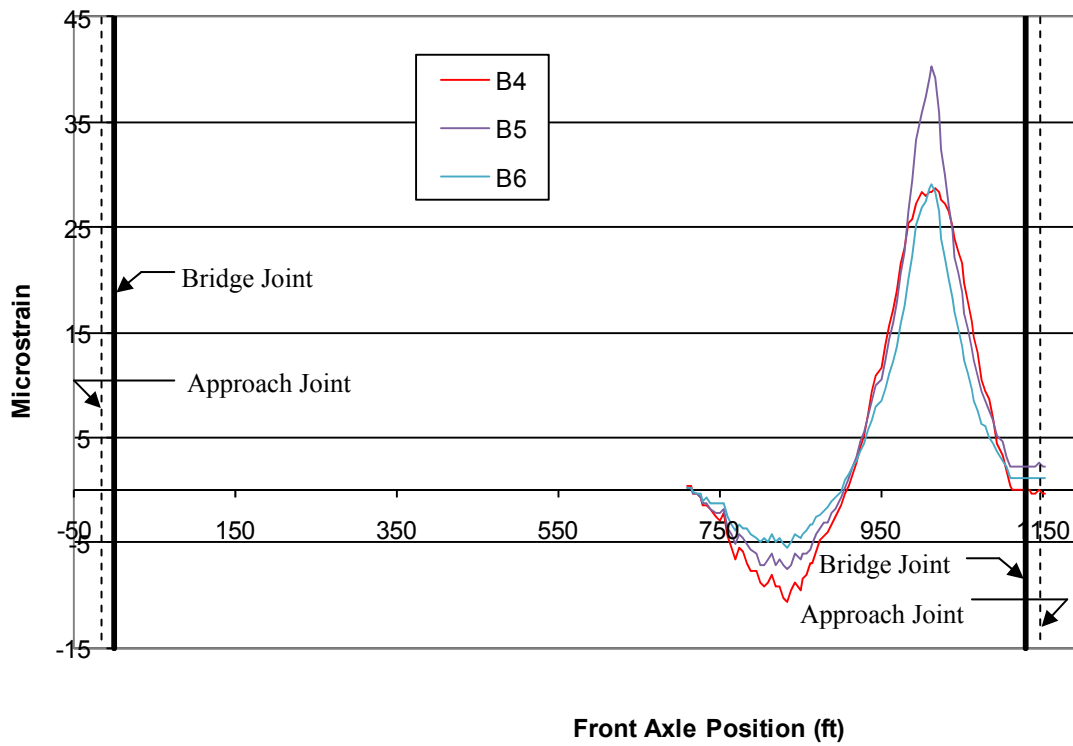
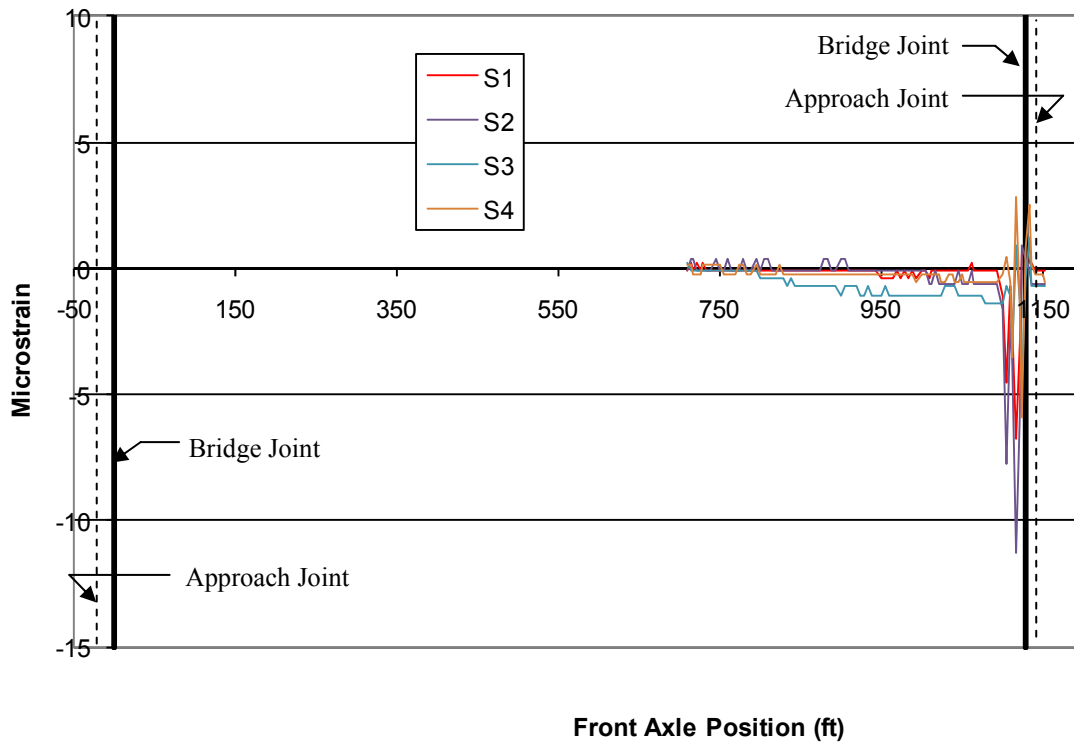
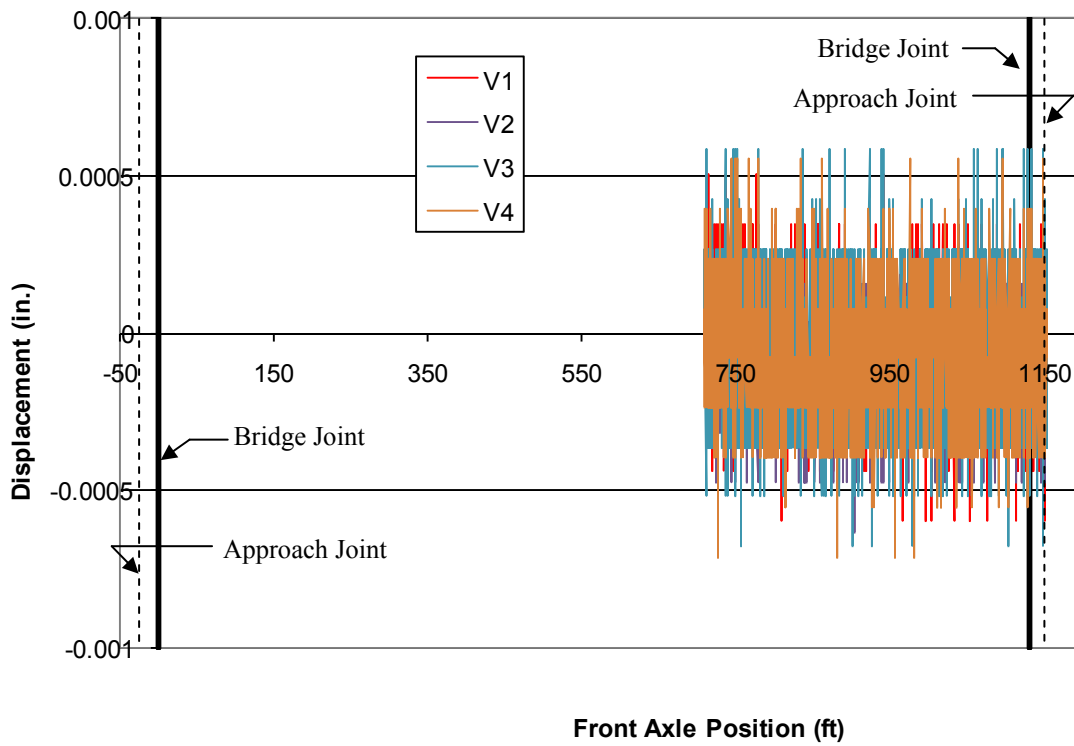
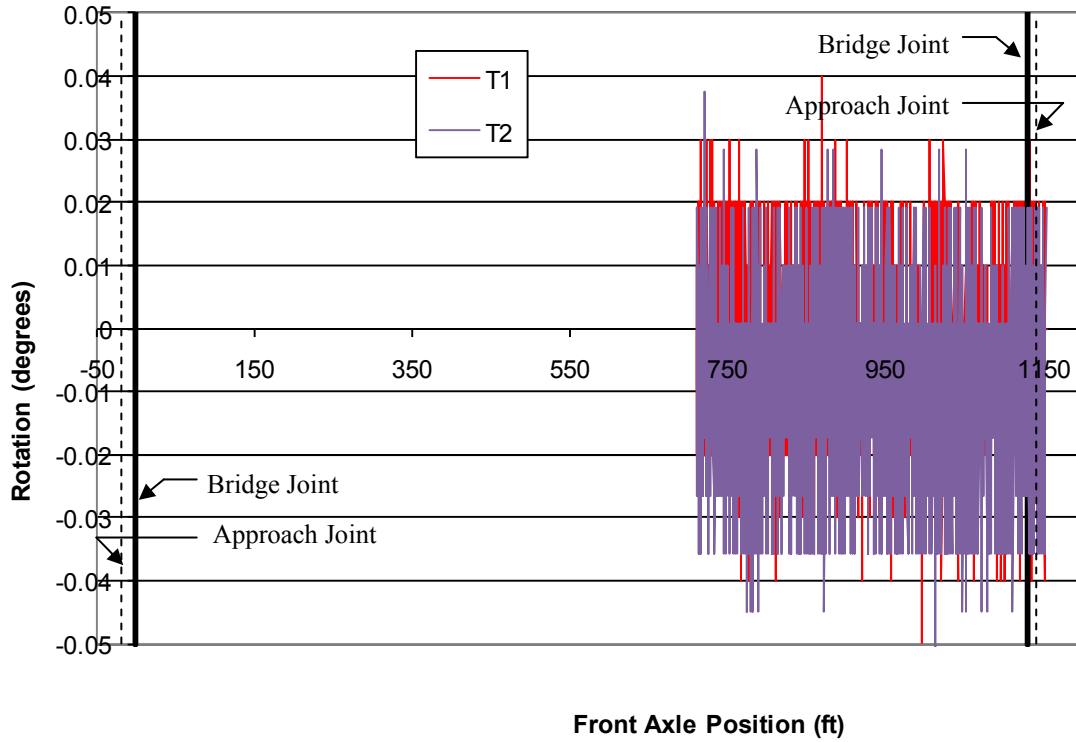
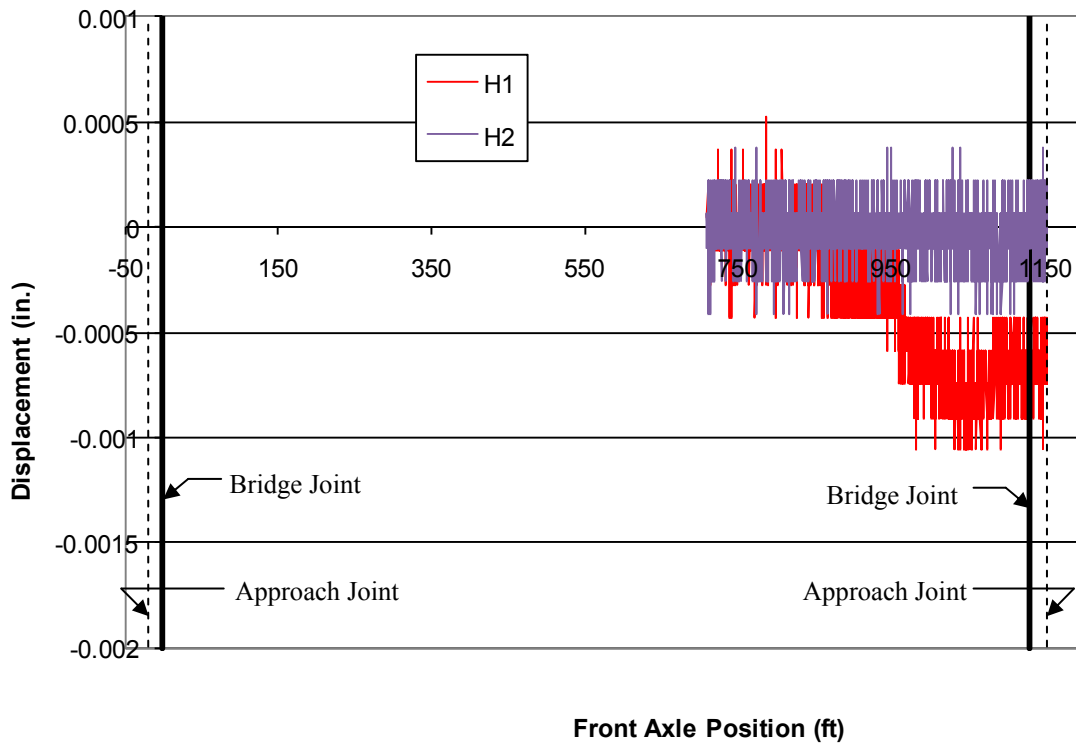
Figure 5.57. ERI 60-2.39 bridge live load testing results

As seen in Figure 5.57, the near girder end strain gages indicate very little end restraint; this behavior is further confirmed by the near midspan strain gages. In general, the stresses at all locations are high, relative to others tested as part of this work. However, the maximum recorded live load stress was just over 1ksi. The approach slab had larger measured strains than other bridges tested during this work. However, the measured strains were still relatively low. Also, relatively vertical displacement of the slab was found to be negligible.

During live load testing, the ERI 60-2.39 bridge abutment was observed to rotate when loaded. However, the rotations are considered to be small. Furthermore, like all other bridges tested, the abutment was observed to translate under live loads. Unlike the other bridges, the movement was only “away” from the soil and back to “neutral.”

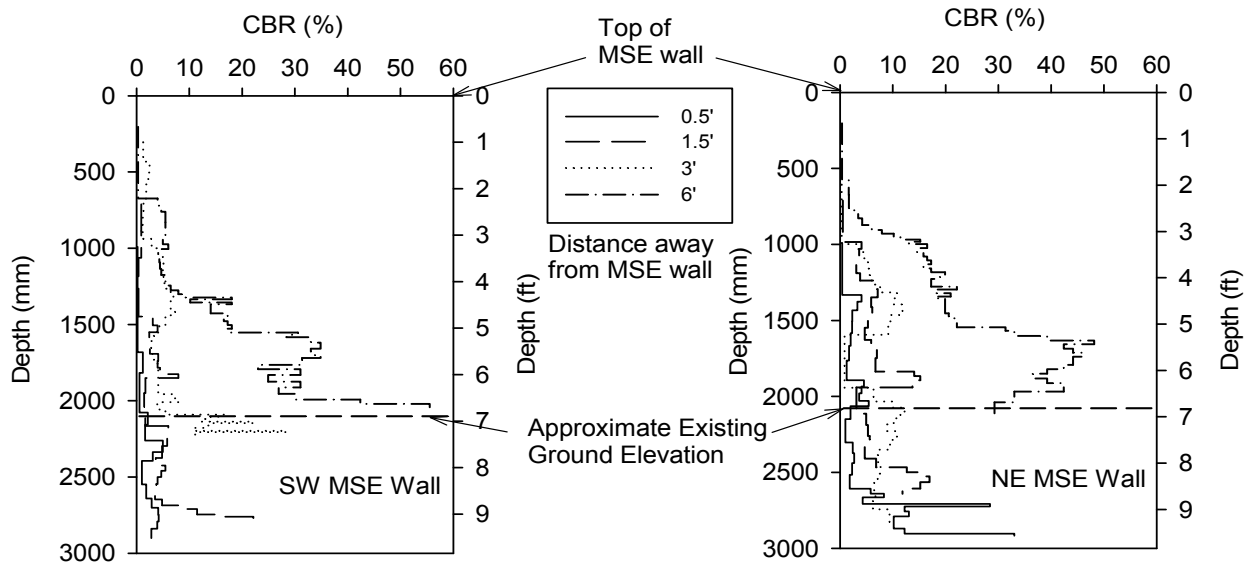
Figure 6.24. DCP-CBR profiles at selected distances away from the NE and SW MSE walls – Bridge #1

The CBR values ranged from 0 to 10% at 0.5 ft to 3 ft away from the MSE walls for the upper 6.6 ft of the backfill, which indicates variability and relatively low strength of the backfill material (See Figure 6.24). The tests performed at 6 ft away from the MSE showed higher CBR values at depths greater than about 4.9 ft. Because the DCP tests were conducted at the fill stage, no compaction had occurred in the upper 1.6 ft of loose lift. Figure 6.25 shows CBR values with distance away from the MSE for selected depths. Results show an increase in CBR value with distance from the MSE with depth.

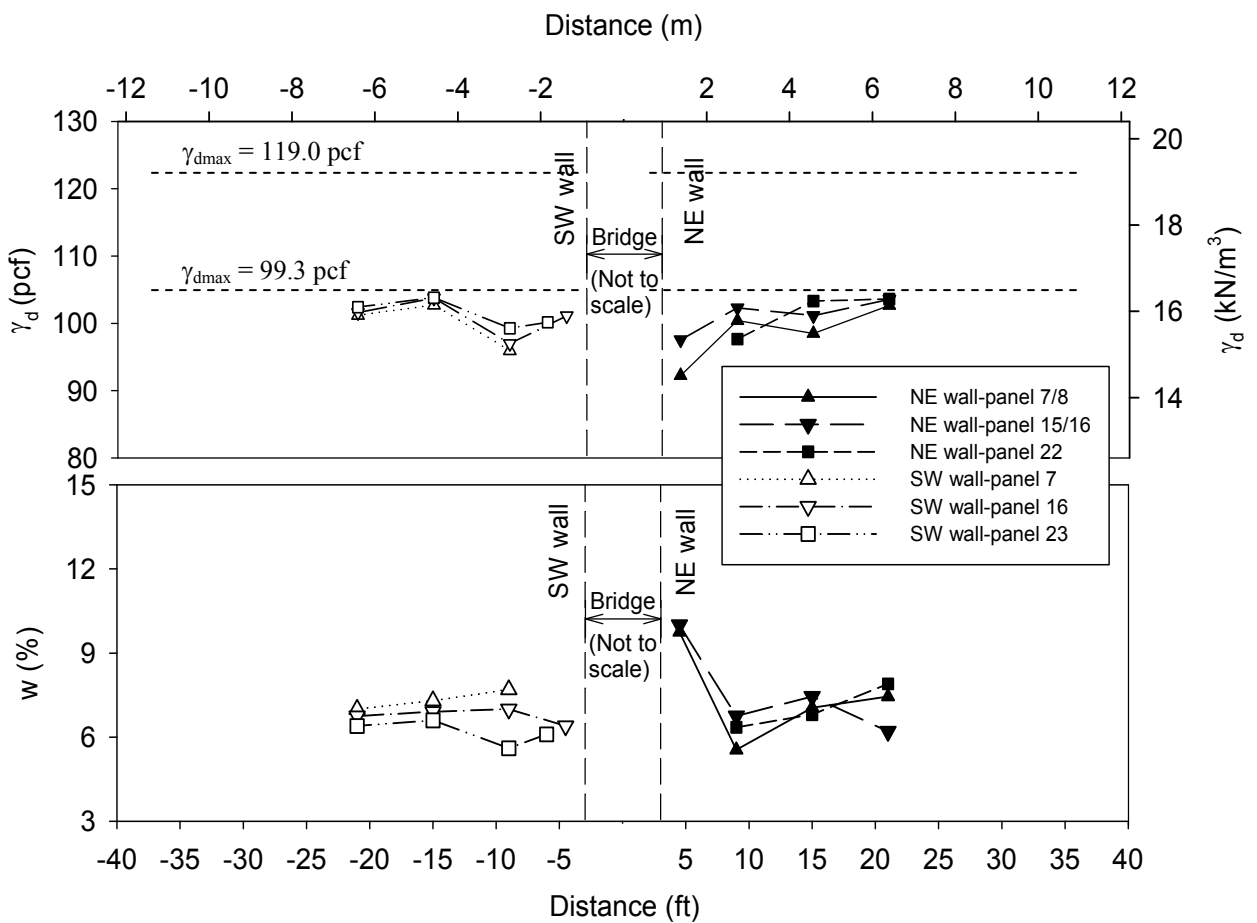
Figure 6.26. Moisture and dry density measurements at selected distances away from the MSE walls – Bridge #1

The dry density measurements of the backfill material at the SW wall and NE wall ranged from 95 to 105 pcf. The moisture content measurements were relatively constant for the measured locations, except for the tests conducted at 1.5 ft away the NE wall, which could be the result of that location having been watered just before the measurements were taken. Figure 6.26 shows the moisture contents, which ranged from 5 to 10% for the test locations.

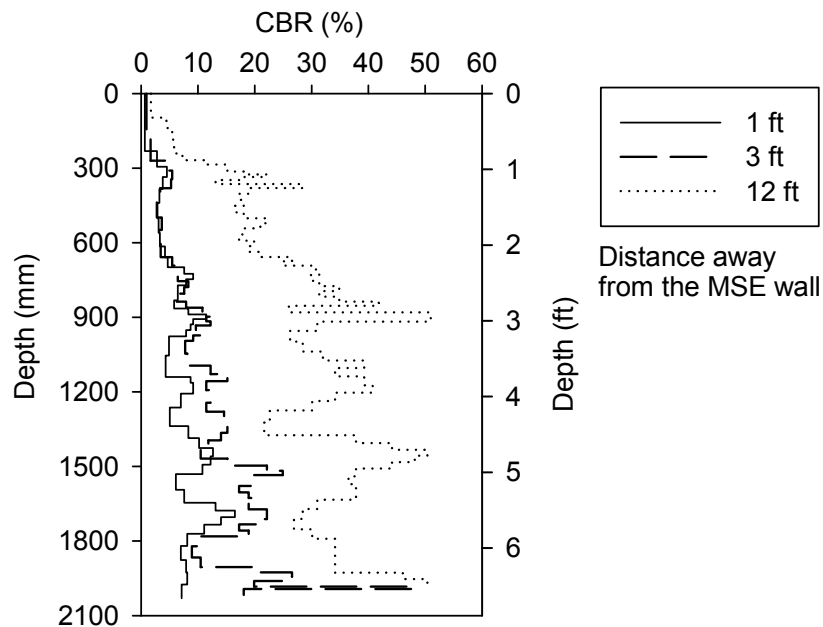
Figure 6.28. DCP-CBR profiles at selected distances away from the MSE wall – Bridge #2 (USCS: SW-SM)

DCP tests were performed at distances of 1 ft, 3 ft, and 12 ft away from the MSE wall. Between 1 and 3 ft away from the MSE wall, the CBR values did not change significantly; the test conducted at 12 ft away from the MSE wall showed a higher CBR value. The CBR values for the tests conducted at 1 ft and 3 ft away from the MSE wall ranged from 0.7 to 23% from the surface to 6.6 ft below the ground, and the DCP test conducted at 12 ft away from the MSE wall showed the CBR value ranged from 1.7 to 50%, which indicates a significant increase. DCP tests results are presented in Figure 6.28

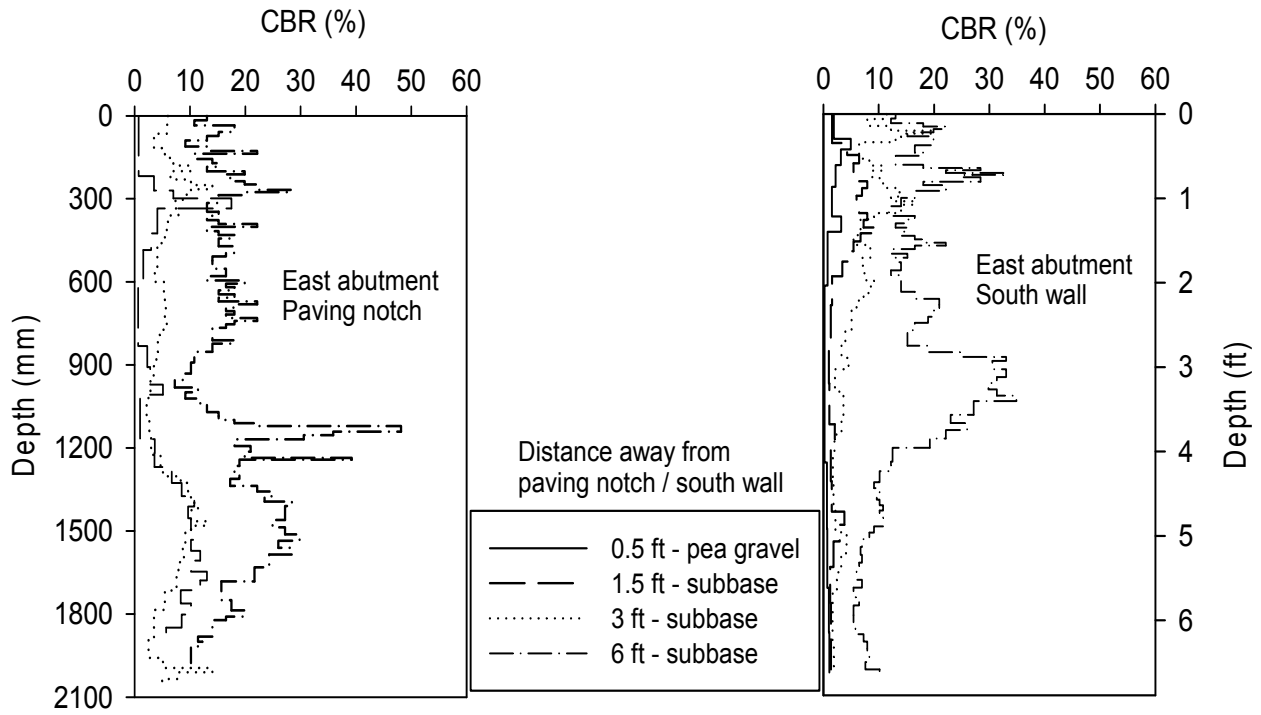
Figure 6.30. DCP-CBR profiles at selected distances away from south wall and paving notch at east abutment – Bridge #3

CBR values generally increased with distance away from the paving notch and the south wall (See Figure 6.30). There is a soft layer at about 3.28 ft below the surface along the tested lane perpendicular to the paving notch. The CBR values near the paving notch ranged from 1 to 15% at the distance from 1.5 to 3 ft away from the paving notch and, at 6 ft away from the paving notch, the CBR values ranged from 9 to 48%. The tests conducted along the lane perpendicular to the south wall returned CBR values that ranged from 0.2 to 20% within 3 ft of the wall and the CBR values for the test at 6 ft away the wall ranged from 5 to 35%.
