Identification and Evaluation of Pavement-Bridge Interface Ride Quality Improvement and Corrective Strategies

Institute for Transportation

Report Number FHWA/OH-2011/1

January 2011

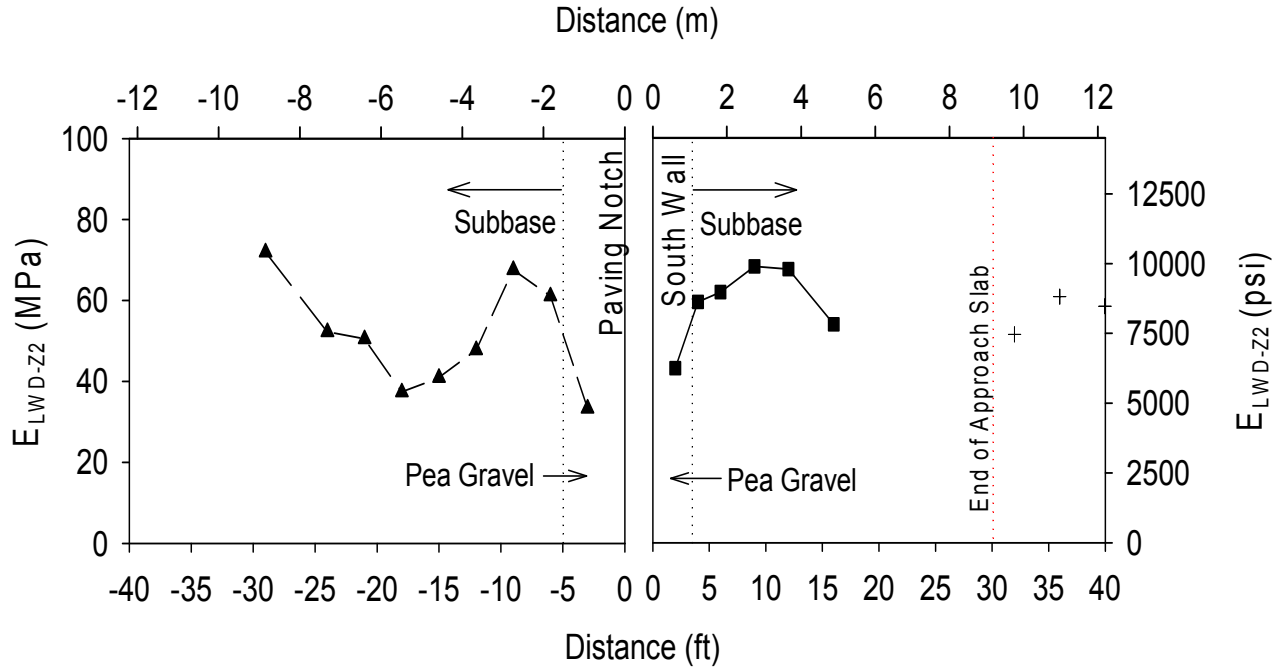
Figure 6.31. E_{LWD-z2} measurements at selected distances away from paving notch and south wall on the east abutment – Bridge #3

Figure 6.31 shows the LWD modulus change at test locations away from the paving notch and the south wall. LWD tests were conducted at the same location as DCP tests, in general, and three tests were conducted at the location behind the end of the approach slab. For these test locations, the individual LWD modulus values ranged from 4,786 to 10,443 psi, and there was no significant difference between the test locations with sub-base or those without sub-base material. Figure 6.31 shows the modulus values with distance from the paving notch.

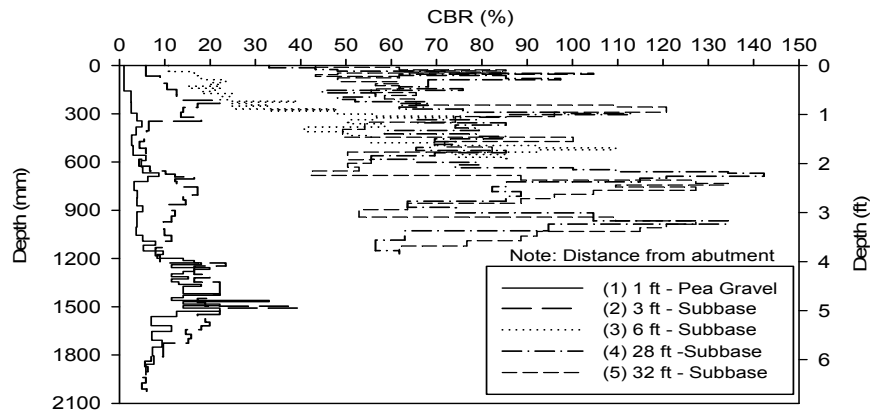
Figure 6.33. DCP-CBR profiles at selected distances away from the abutment – Bridge #4

DCP tests were conducted at four locations inside the approach slab at 1 ft, 3 ft, 6 ft, and 28 ft away from the paving notch and one test was conducted at 2 ft behind the end of the approach slab (See Figure 6.32). The CBR value generally increases with distance away from wall, and there is a stiff layer at a depth of 3.9 ft to 4.9 ft for the test location within 3 ft away from the wall (See Figure 6.33). The test conducted at 6 ft away from the paving notch indicates that the backfill started getting stiff from 1 ft below the surface and no significant changes of strength for the location near the end of the approach slab.

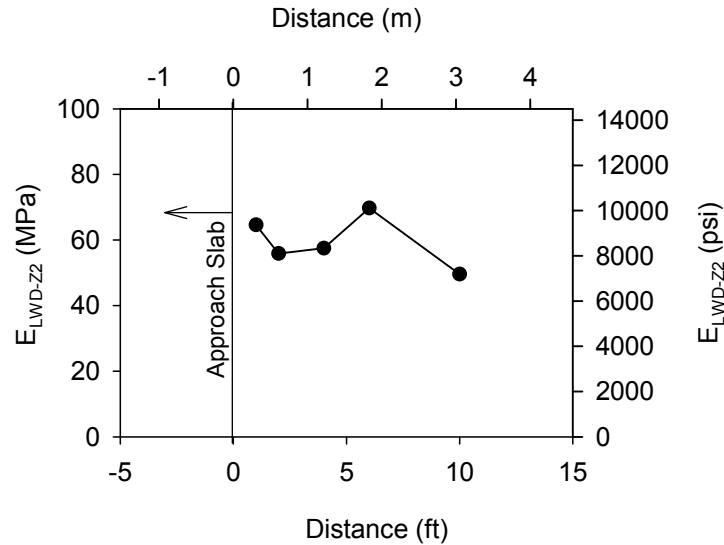
Figure 6.34. E_{LWD-zz} at selected distances away from the approach slab – Bridge #4

Because of the construction stage at Bridge #4, LWD tests were not conducted *inside* the approach slab region. LWD tests were conducted at five points *behind* the end of the approach slab and the tests results indicate modulus values from 7,252 to 9,427 psi (See Figure 6.34).

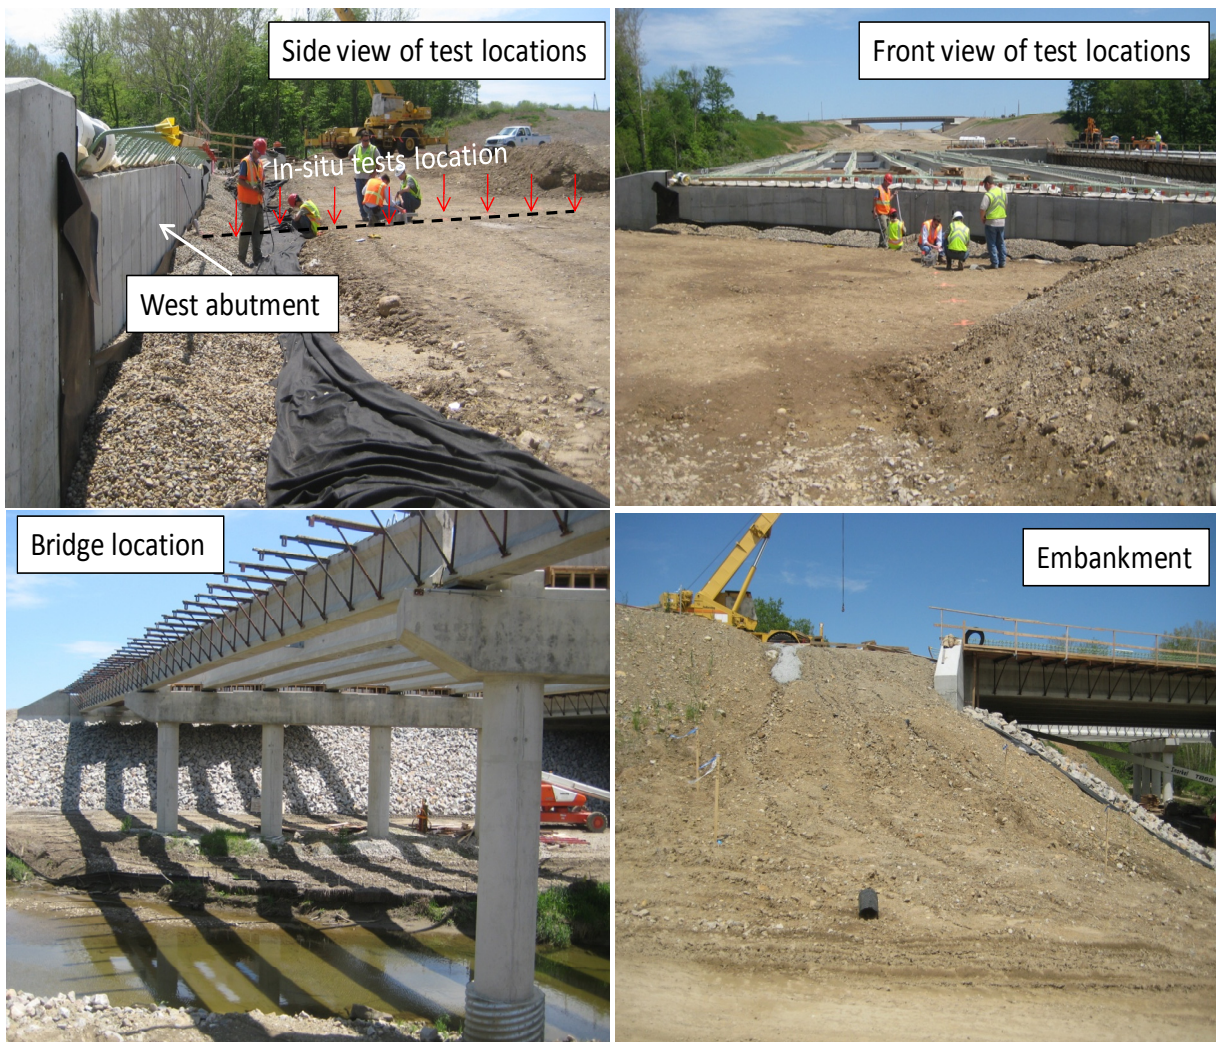
Figure 6.35. Bridge #5 (LIC-37-1225L) at Licking 161 over Moots Run

Bridge # 5 is located at Licking 161 over Moots Run. The bridge consists of three-span composite pre-stressed concrete I-beams with cap, column piers, and semi-integral abutments with 25 ft long approach slabs. The backfill material used in the east abutment and west abutment were silty sand with gravel and silty gravel with sand, respectively. A layer of pea gravel was placed next to the abutment with 5 to 6 ft deep. The west abutment rests on hard rock shale and the east abutment rests on alluvium soils. Figure 6.35 provides the test location, site overview, and location of Bridge # 5.

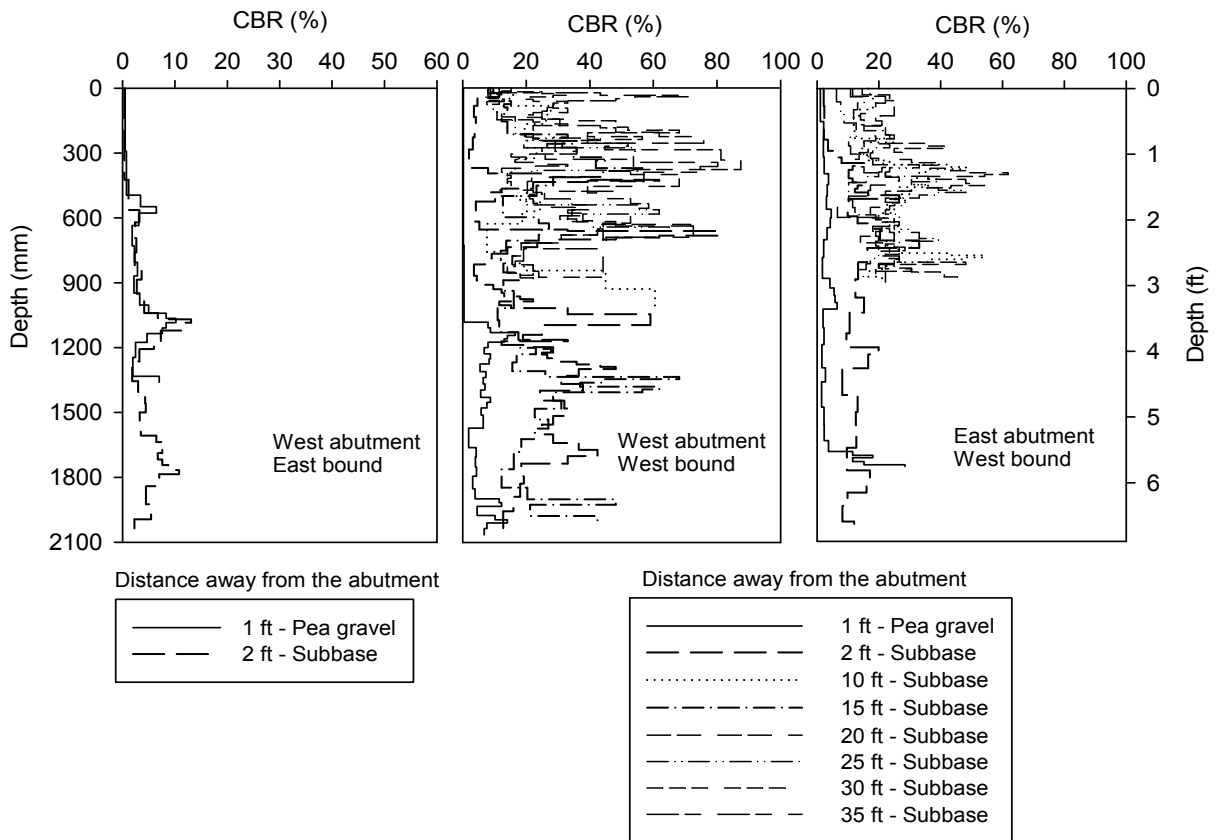
Figure 6.37. DCP-CBR profiles at test locations away from the east and west abutments – Bridge #5

The tests performed at the distances of 1 ft and 2 ft away the abutment provided similar CBR profiles along the west abutment eastbound lane. The CBR profiles for both west abutment and east abutment indicate the lowest strength occurred at 1 ft away from the abutment and then increase with distance away the abutment. LWD test results show that the modulus generally increases with distance away from wall and that the dry unit weight measurements also show a similar trend.

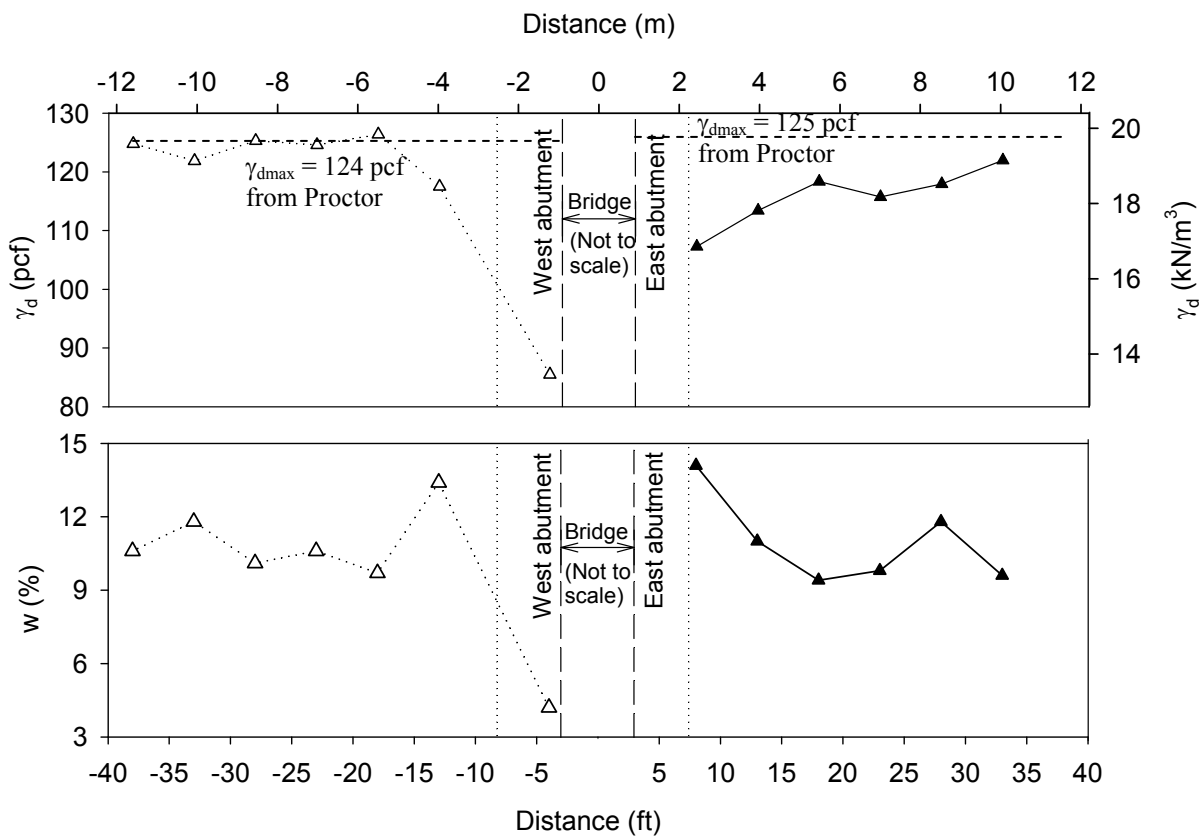
Figure 6.39. Moisture and dry density measurements at test locations away from the east and west abutments – Bridge #5

The moisture measurements near the west abutment indicate the lowest moisture content was next to the abutment and that, at further distances away from the abutment, the moisture content ranged from 9 to 12%. The results from the east abutment indicated the moisture content decreased with distance away from the abutment from 5 to 20 ft and within the range of 9 to 12%.

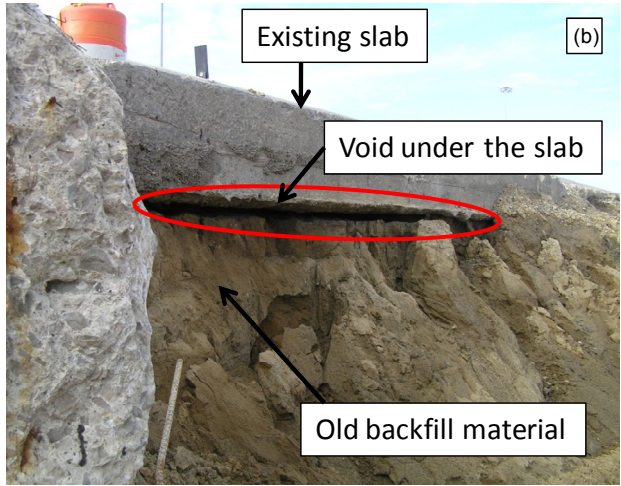
b. void under the existing slab and old backfill material

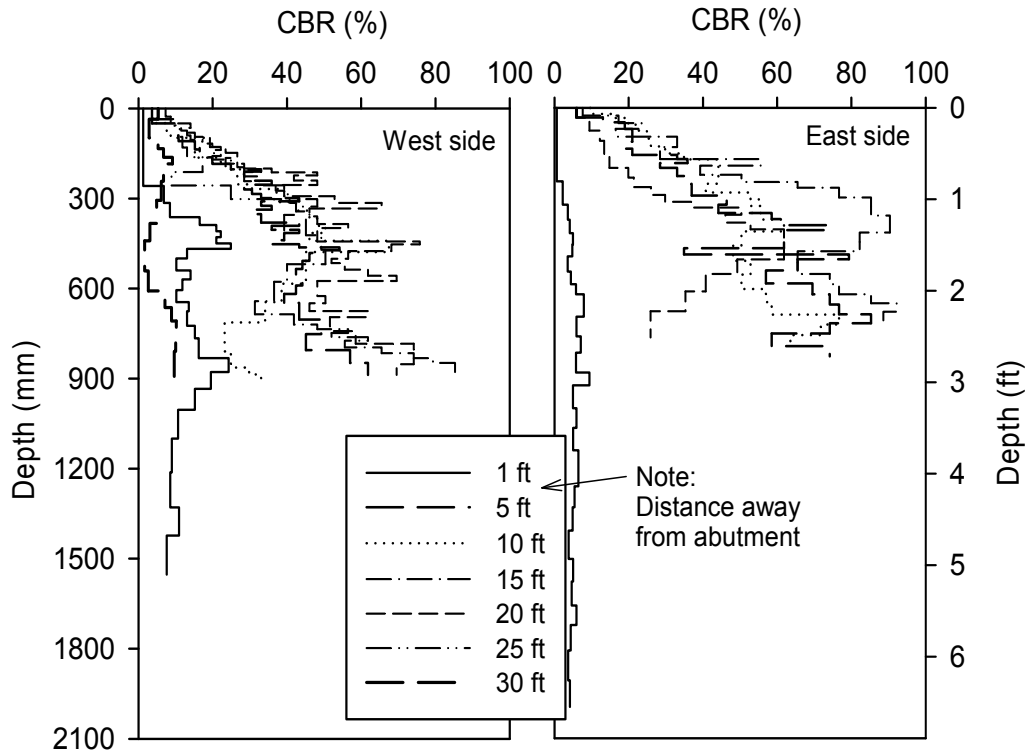
Figure 6.41. DCP-CBR profiles at test locations away from the south abutment for west and east lanes – Bridge #6 (USCS: GP-GM)

DCP tests were conducted on two testing lanes (west and east) at 1 ft away from the abutment and then at 5 ft intervals to 30 ft from the abutment. Figure 6.41 provides the DCP tests results in terms of CBR values for both west and east lanes. The CBR profile from the west lane shows that, at the same depth, CBRs increase with distance away from wall, but, with the distance of 25 to 30 ft away from the wall, the CBR values start to decrease. That may be caused by an existing wall near the end of the west lane. The DCP tests conducted on the east lane also give the similar conclusion.

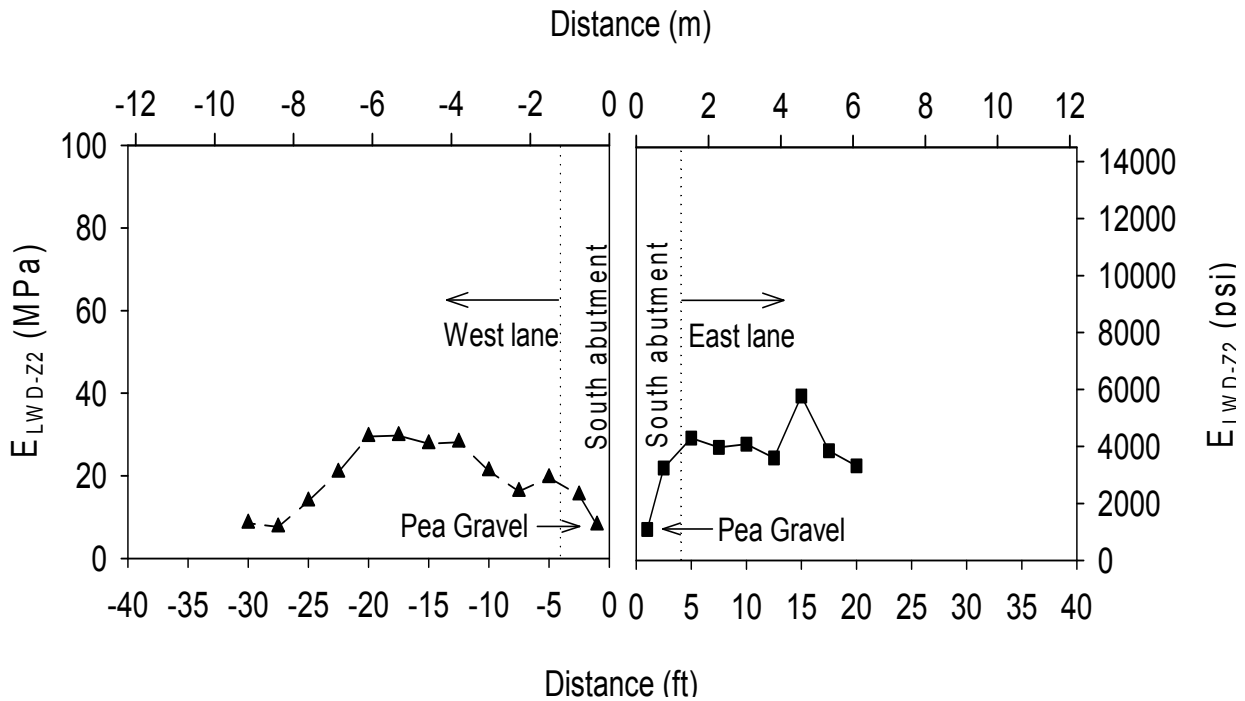
Figure 6.42. E_{LWD-Z2} at test locations away from the south abutment on east and west lanes – Bridge #6 (USCS: GP-GM)

LWD tests were performed on both the east and west testing lanes along the south abutment. Nine testing points were constructed on the east testing lane and thirteen points were tested along the west lane on the south abutment. Figure 6.42 shows that the E_{LWD-Z2} varies with distance away from the south abutment for both testing lanes. The LWD test results indicated that the modulus values at the middle part of the two testing lanes are higher than the E_{LWD} measured at the ends, and the modulus values from the two testing lanes show similar trends and the typical E_{LWD-Z2} range was 725 to 4,351 psi.

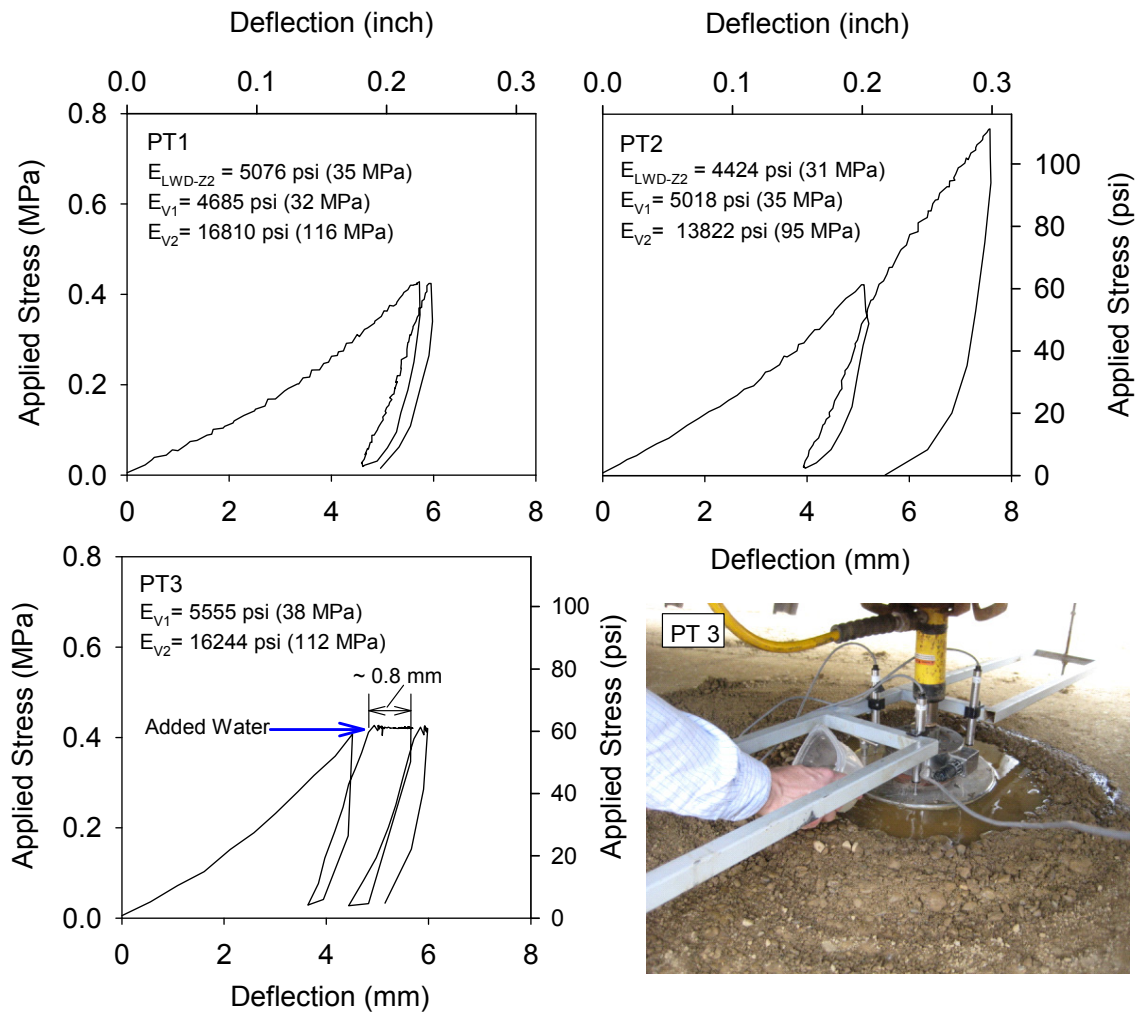
Figure 6.43. Stress-strain curves for static plate load tests – Bridge #6 (USCS: GP-GM)

PLTs were conducted at three locations that parallel the new abutment within a distance of 16 ft from the abutment. At the third testing point, water was introduced at the surface of the soil, while maintaining a static stress of 58 psi, to evaluate the collapse potential of the backfill material. Figure 6.43 shows the PLT results and test setup. The PLT indicates minimal in situ collapse potential, because only 0.3 in. additional settlement was shown when the material was saturated and, that was less than the settlement during the loading stage.

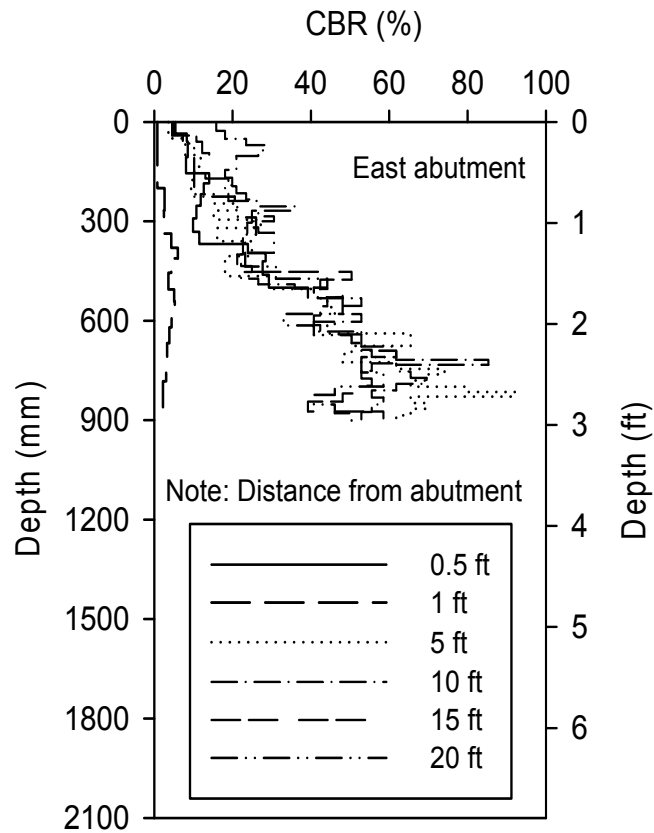
Figure 6.45. DCP-CBR profiles at test locations away from east abutment – Bridge #7

Based on the DCP-CBR profile, the measurements at 1 ft away from the wall indicated the lowest strength profile. The LWD test results indicate that modulus values for the backfill ranged from 725 to 5,076 psi.
