FINAL REPORT

GLULAM TIMBER DECK BRIDGES

Virginia Highway & Transportation Research Council
(A Cooperative Organization Sponsored Jointly by the Virginia
Department of Highways & Transportation and
the University of Virginia)

November 1978
VHTRC 79-R26

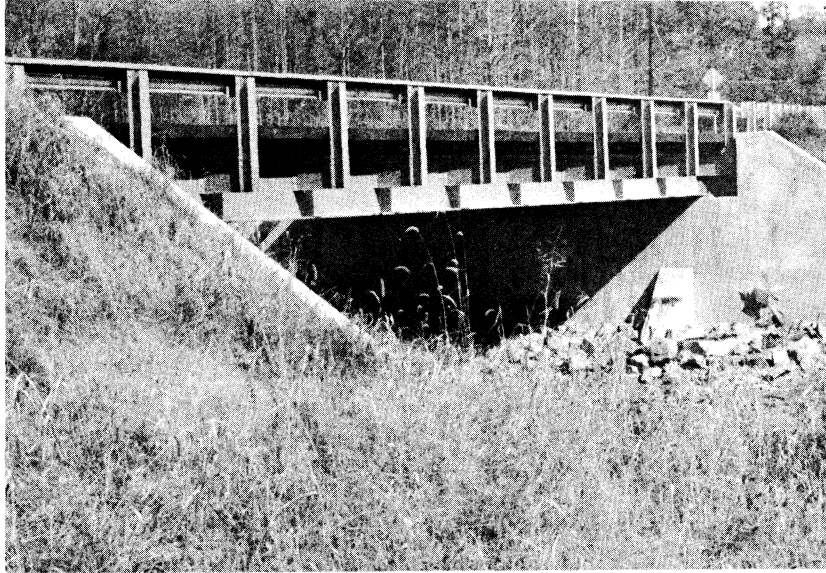
Figure 1. Fairfax County bridge.

The first bridge with glulam deck panels to be opened to traffic carries Rte. 641 over Pohick Creek in Fairfax County 0.1 mile west of Rte. 638 near the Woodbridge Exit of I-95. Guy H. Lewis & Sons, Inc. of McLean, Virginia, constructed the 72-ft. span structure which is described in Table 1 and shown in Figure 1.

A 45-ton truck crane was used to position the panels, primarily because the fill material required for the roadway had not been placed and a small crane or front-end loader could be gotten to the deck at the time. Also, the 45-ton crane was on hand because it had to be used to position the structural steel. A steel section extending the width of the bridge was positioned between rail posts to support the three 10-ton jacks used to jack the panels together (see Figure 2). Although the dowels appeared to fit loosely in the dowel holes, some of the panels tended to bind during the last stage of being jacked together. Because the panels were wider at the ends than in the middle there often was a crack as wide as 3/4 in. between adjacent panels. A section which varied in width from 8-1/2 in. at one end to 11-1/4 in. at the other had to be cut from the last panel. Since the concrete backwalls had been cast with the abutments, several of the last panels had to be jacked upward in order to get the last panel jacked onto the dowells while positioned over the backwall. Primarily because many of the panels had to be jacked apart and turned around, repositioned, or jacked up off the bolsters and because the contractor was waiting for advice from the fabricators of the panels and from highway officials, 5 days elapsed between positioning of the first and the last panels. Some of the panels had to be installed twice because numbers were not clearly stamped on all of them and the contractor was not aware that they had to be installed according to the numbers. The panels had to be jacked from the bolsters because the contractor failed to place the flashing under the panels at each joint.

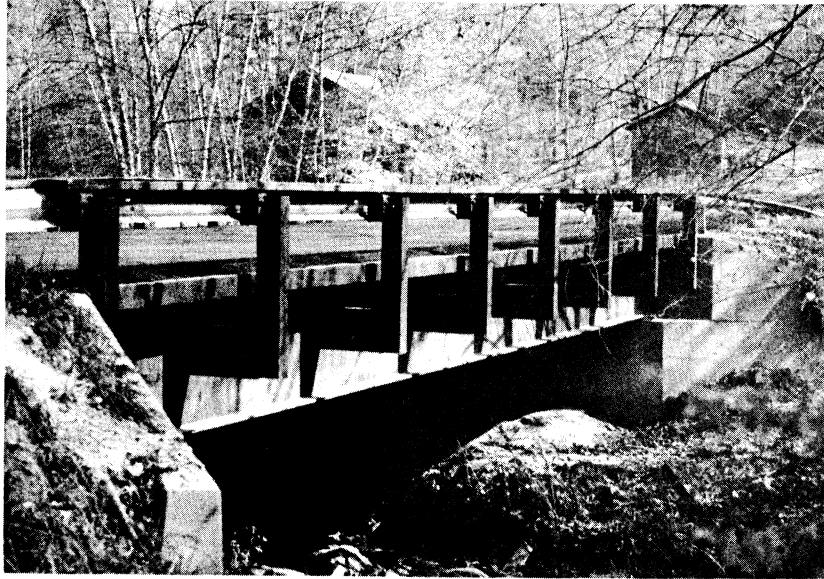
Figure 3. Patrick County bridge.

The second bridge with glulam panels was constructed on Rte. 645 near the North Carolina line in Patrick County. Shown in Figure 3, the 56-ft. single-span structure was constructed by a bridge crew from the Department's Martinsville Residency to replace a deteriorated timber deck structure having three short spans. The superstructure is described in Table 1 and is identical to the design specified on the Standard Plans for Glulam Panels on Steel Stringers.⁽⁴⁾

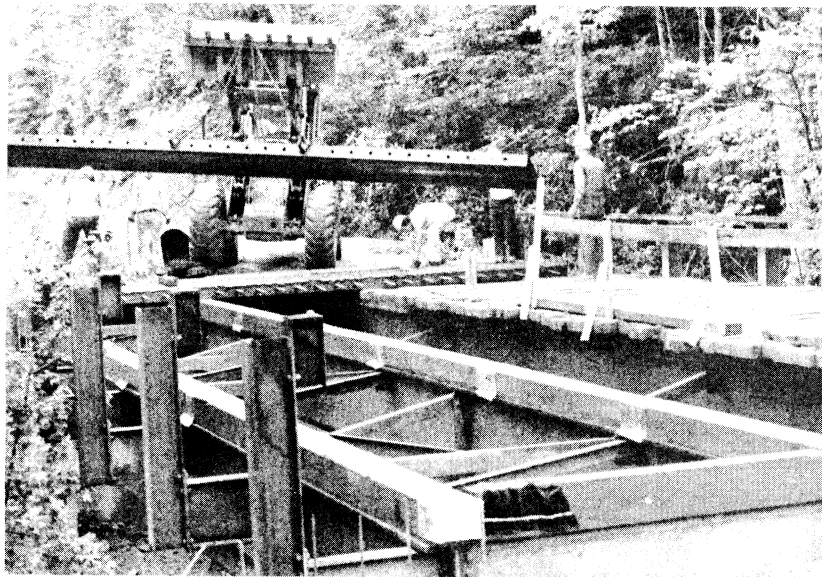
Traffic was maintained on Rte. 645 as the new bridge was constructed by widening one existing abutment and altering one existing pier to provide the other new abutment. While the old bridge was in service, two of the new steel stringers were placed on the widened portion of the substructure and covered with a temporary plank deck. Traffic was directed onto the temporary deck while the old structure was dismantled and the other two new steel stringers were erected. Once all the structural steel was in place, the timber planks were removed and the glulam panels were positioned as shown in Figure 4. Although the first few panels were jacked into position after being placed on the stringers, it was decided that the best procedure was to place all the panels on the stringers and then jack them together. Once all the panels were on stringers there was a larger surface upon which to work than was provided by the one-lane, temporary deck.

Figure 4. Traffic was maintained as temporary timber planks were replaced with glulam panels on Patrick County bridge.

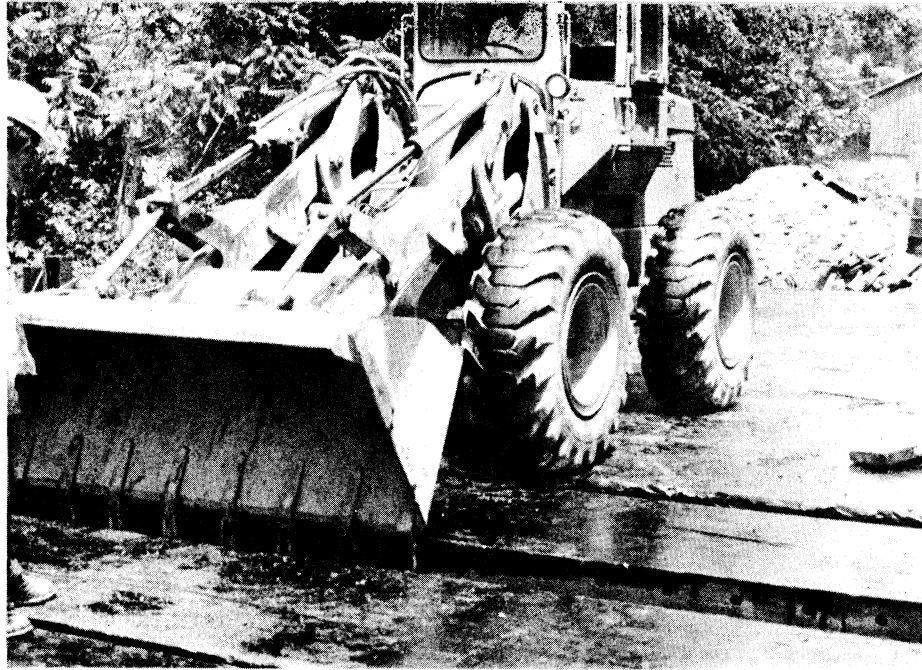
The panels went together easily because many of the dowels fit fairly loosely in their holes and most of the panels fit together fairly well. Quite often the front-end loader used to position the panels on the stringers could be used to pull or push the panels together (as shown in Figure 5) and the jacks were not needed.

Figure 5. Front-end loader used to pull panels together on Patrick County bridge.

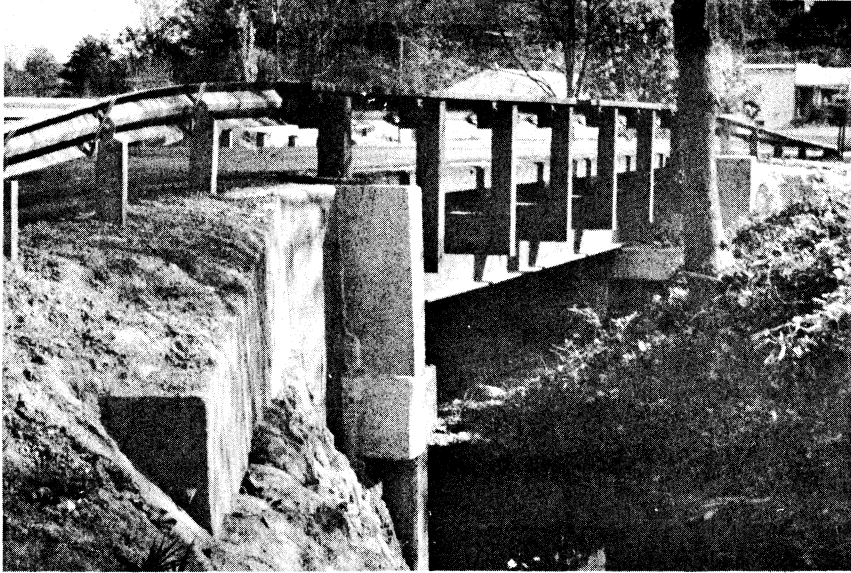
Figure 6. Henry County bridge.

The same bridge crew that constructed the Patrick County bridge constructed the third glulam bridge. This bridge, which is shown in Figure 6, is located on Rte. 687 in Henry County not far from Martinsville. The 12 Douglas fir panels used were fabricated in Albert Lee, Minnesota, in February 1978, shipped to Richmond, where they were treated with creosote in March, and were delivered to the Martinsville Residency in March. Each end panel was 3 ft. wide and the 10 interior panels were the standard 4 ft. in width. A description of the bridge superstructure, which is of the standard design, is given in Table 1.
