ENGINEERING MEASURES FOR REDUCING WRONG-WAY DRIVING

N. K. Vaswani
Senior Research Scientist

Virginia Highway & Transportation Research Council
(A Cooperative Organization Sponsored Jointly by the Virginia
Department of Highways & Transportation and
the University of Virginia)

September 1975
VHTRC 76-R8

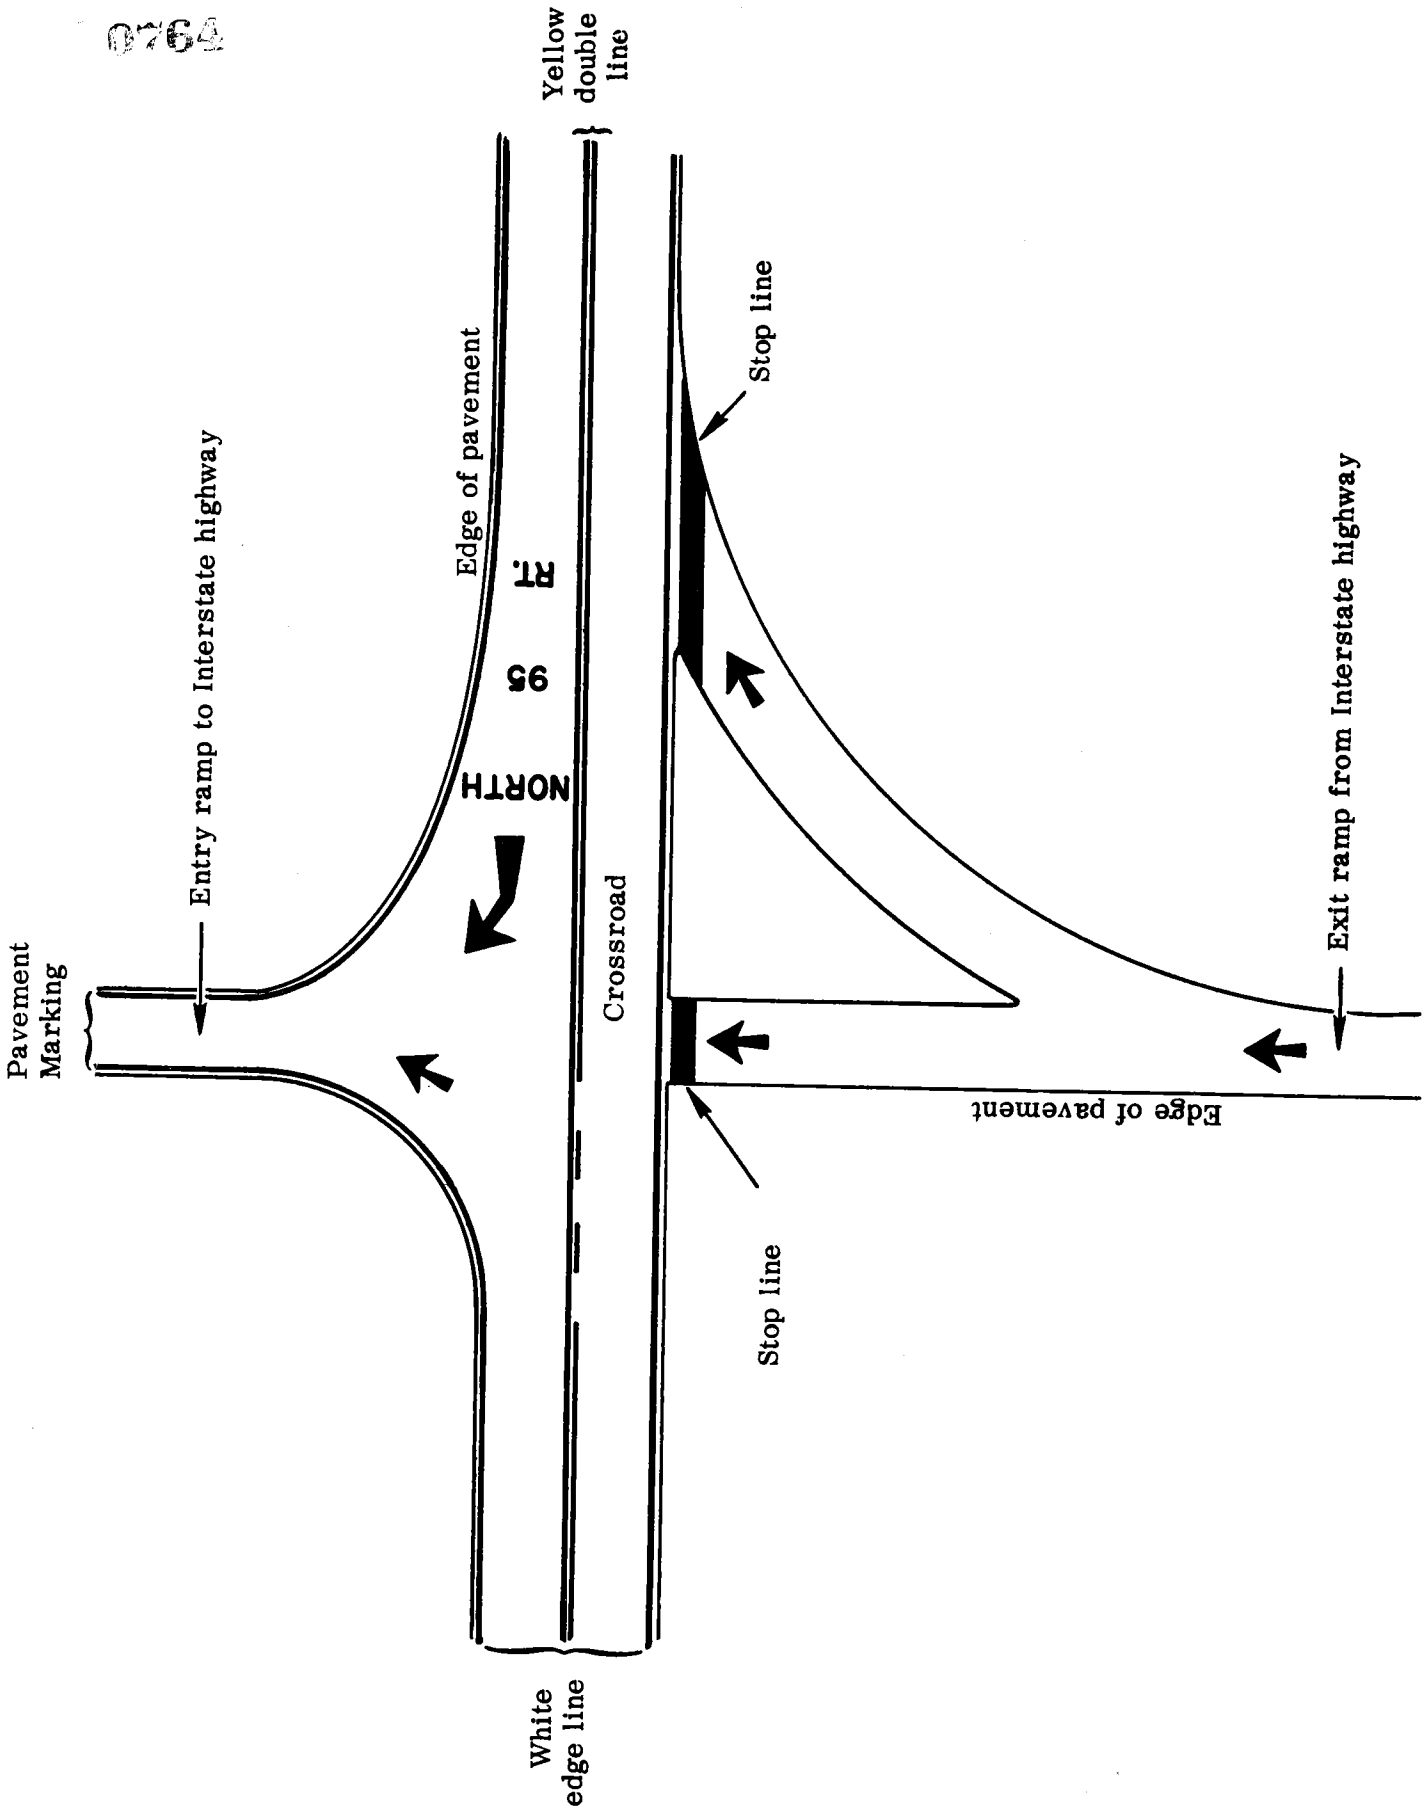
Figure 13. Suggested pavement stripe or removal of flares on exit ramps.

Figure 13 shows the suggested pavement stripe for removal of flares and the provision of stop lines on exit ramps.

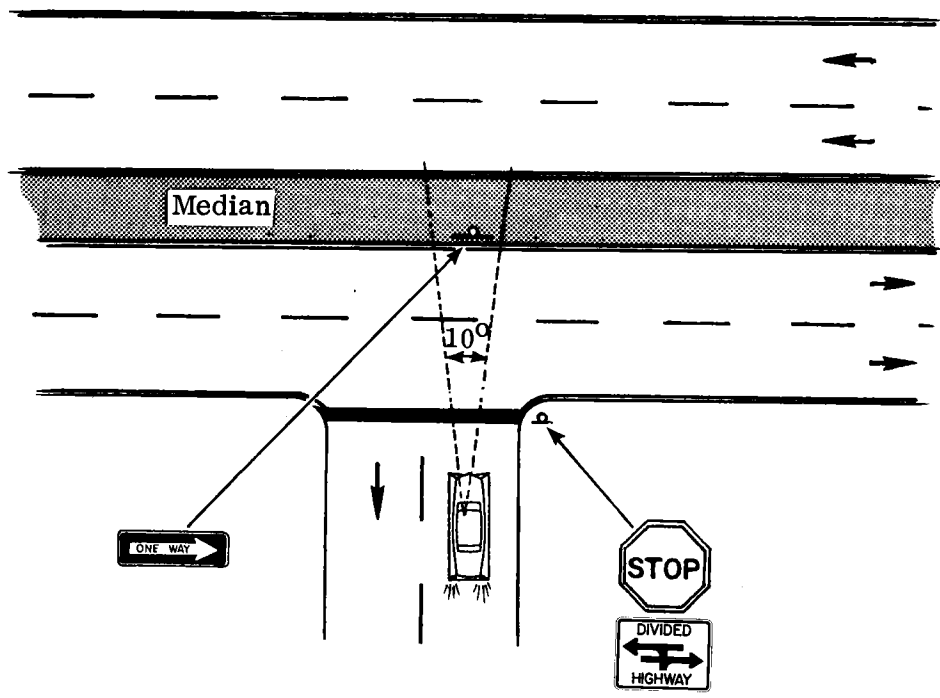
These signing plans should consider placement of signs based on night visibility. Some of the signs are not visible during dark under low beam headlights as shown in Figures 11 and 12. The sign shown in Figure 21 is not visible at night under low beam headlights when the driver makes an exit into the divided highway. If all drivers are able to find their path under poor visibility by low beam headlights at night without a particular sign, it is obvious that this particular sign has no utility during the daytime. Hence the location of signs should be based on night visibility.

Figure 21. Poor location of one-way sign. For optimum effectiveness, sign should be directly opposite vehicle leaving shopping center.

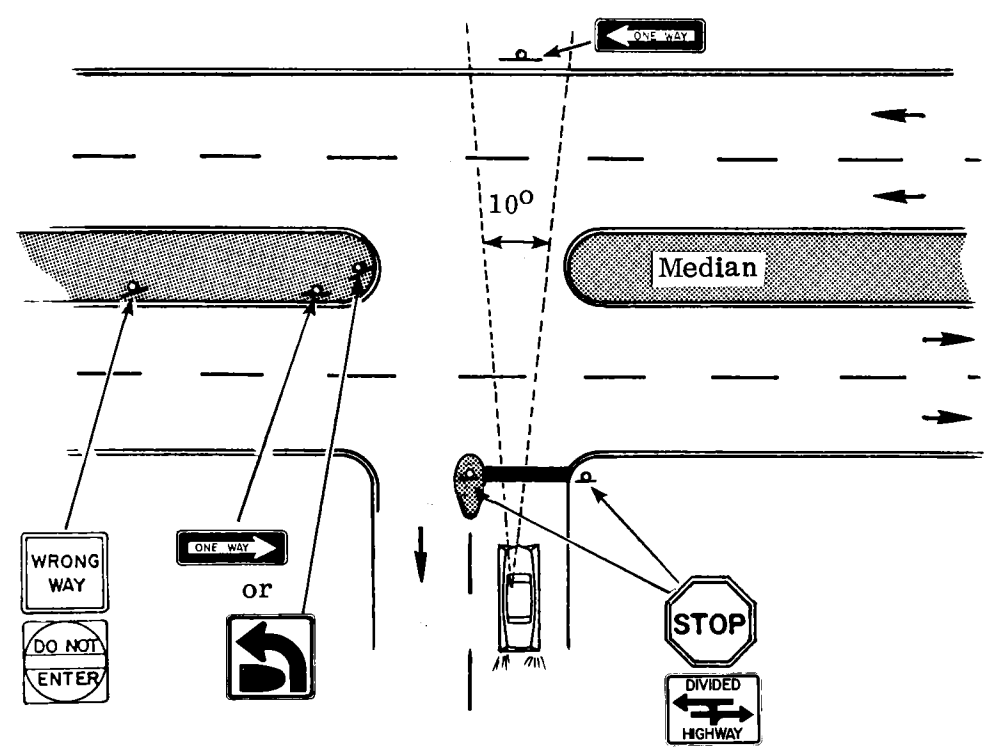
Figure 22. Diagram for sign placement in residential area or small business area, e.g., area with gas station, club, restaurant, or motel.

Diagrams for the above four intersections are shown in Figures 22 through 24. The one-way sign opposite the traffic entering from the crossroad in Figures 22 and 23 should be placed within the central two quarters of the entry lane width, such that it always remains within the 10° cone of vision (i.e. 5° to each side of the centerline). The diagrammatic "Tee", "crossroad", and "left turn over the median" signs should be provided when the undivided crossroad slopes away from the divided crossroad, or the opposite traffic lanes of the divided crossroad are at different elevations and thus prevent visibility of all the lanes of the crossroad. These diagrammatic signs need not be provided when the undivided crossroad slopes towards the divided crossroad such that all the lanes of the divided crossroad are visible to the driver approaching the 4-lane divided intersection.

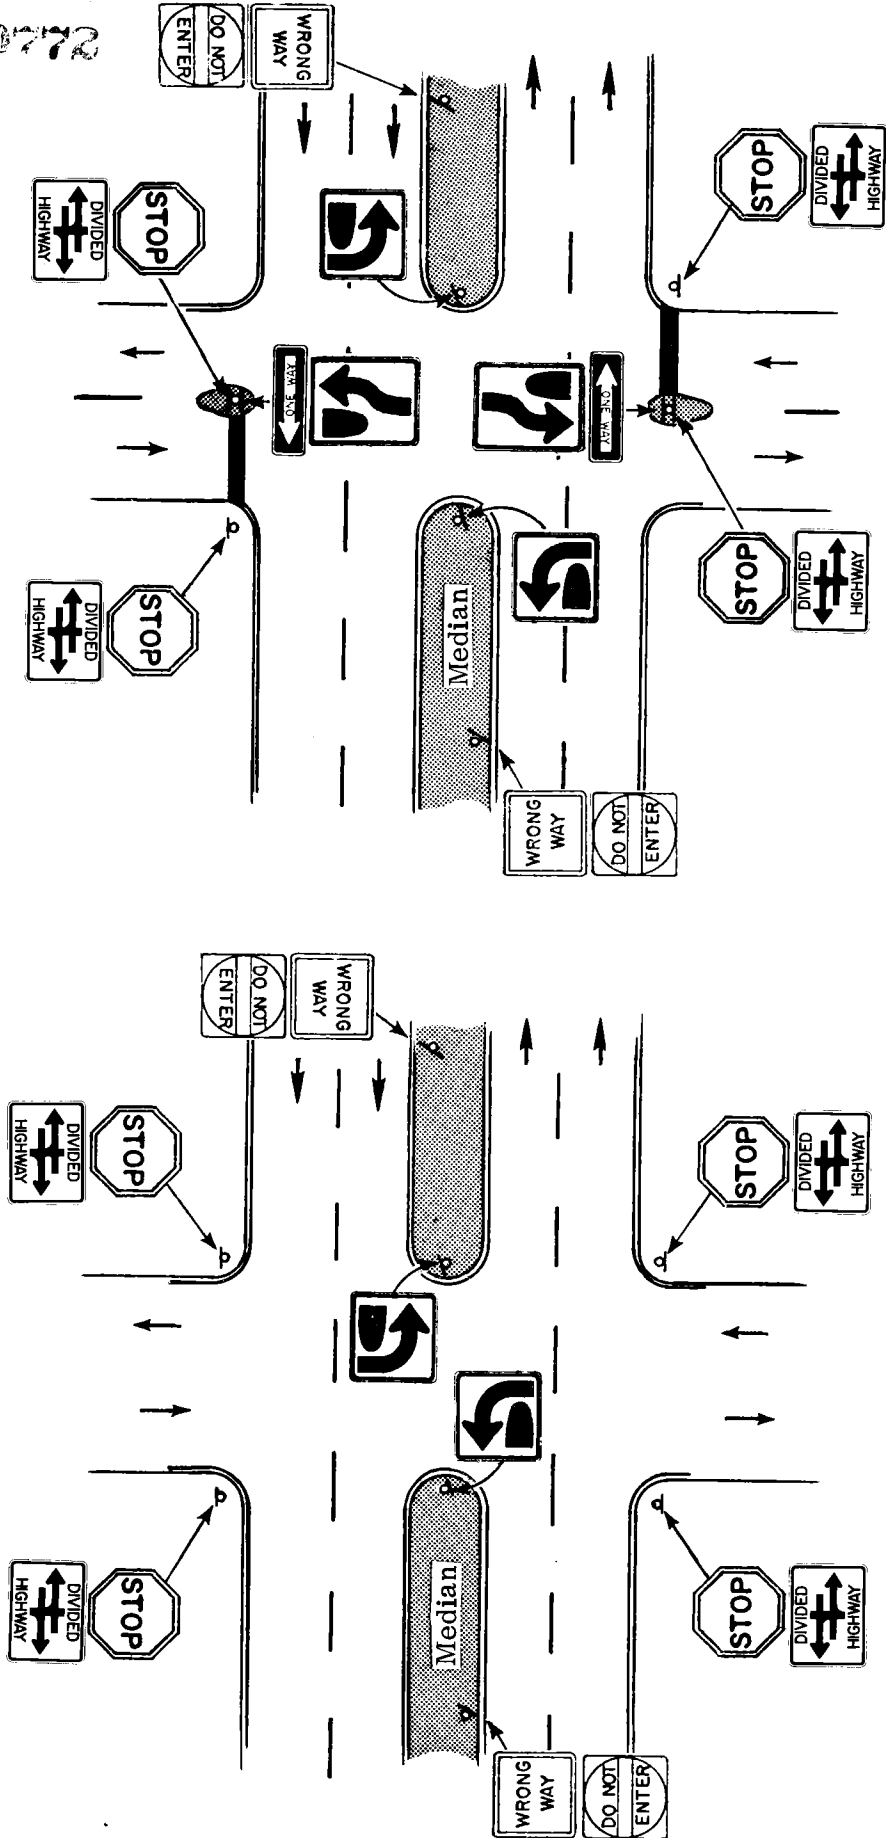
Figure 24. Low traffic intersection in rural area.*
