EVALUATION OF THE ON-FLEX EXPANSION JOINT
SEALING SYSTEM FOR BRIDGE DECKS

Marvin H. Hilton
Senior Research Scientist

Virginia Highway & Transportation Research Council
(A Cooperative Organization Sponsored Jointly by the Virginia
Department of Highways & Transportation and
the University of Virginia)

January 1984
VHTRC 84-R22

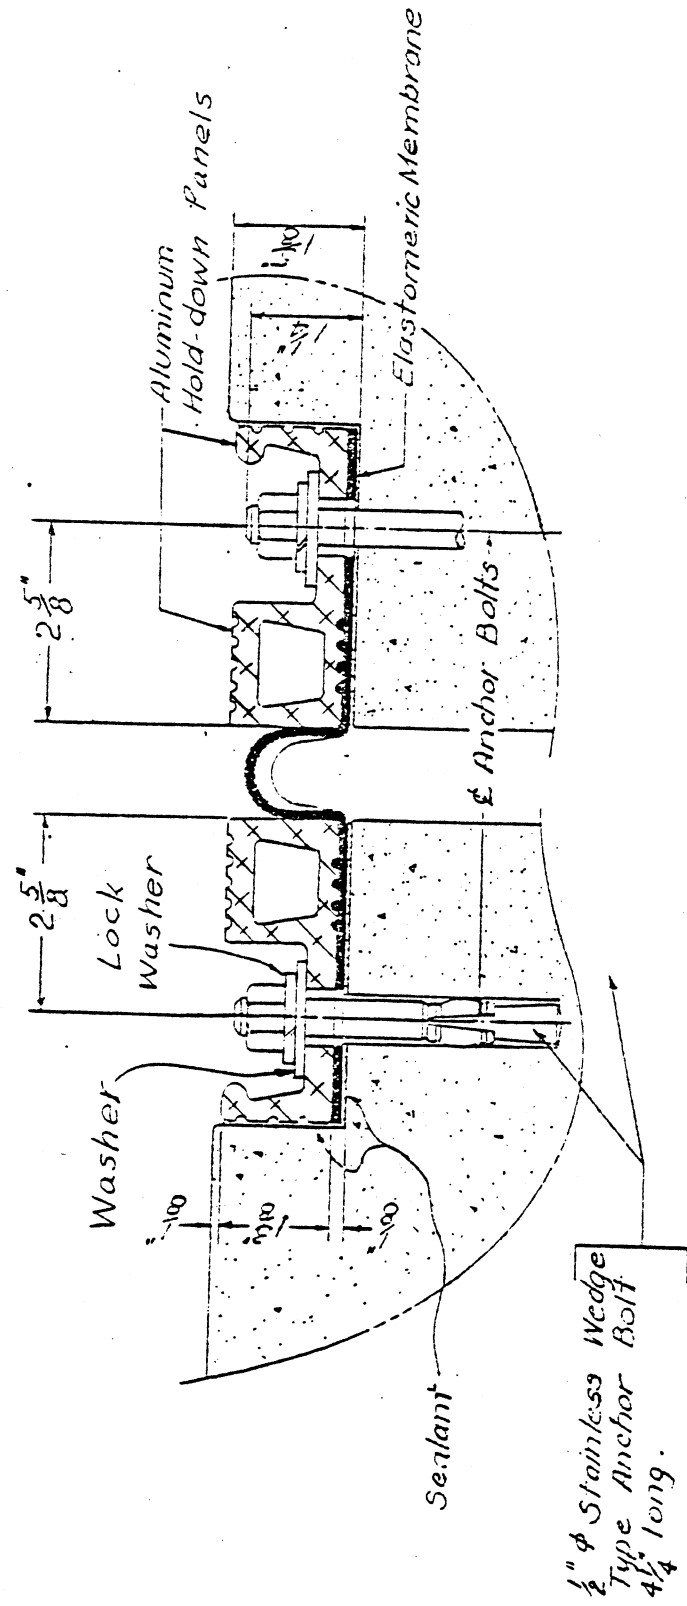
In an earlier study of the first use of the ON-FLEX joint in Virginia, it was noted that several problems associated with the drilling of the anchor bolt holes made the installation of the joint difficult. (1) Besides being a slow process, the location of deck reinforcing steel often interfered with the drilling process. As a result, some irregular spacing of the anchor bolts was required because the holes could not be drilled at the proper locations. In addition, some of the holes were drilled too deep and when the wedge type bolts were inserted they also were too deep, which decreased the thread available for the nut and washer. Therefore, one of the recommendations of the study was that the anchor bolts for the joint should be preset during construction of the bridge deck. Subsequent to that evaluation, an appropriate anchor bolt design was incorporated to allow for presetting inserts

Figure 1. Typical section through the ON-FLEX 25 bridge deck expansion joint showing wedge type anchor bolt. 1 in. = 2.54 cm.

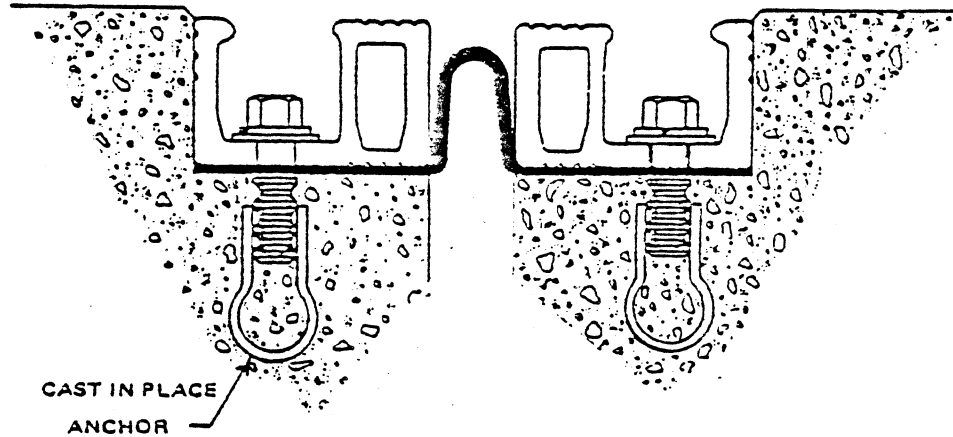
in the forms prior to placement of the deck concrete. A typical section of this cast-in-place anchorage system is shown in Figure 2. Although an ON-FLEX 45 joint is shown, the cast-in-place anchorage system can be used on the 25 model as well. Of the four bridges included in this study, two were constructed with the cast-in-place type anchorage and two with the wedge type anchorage.

Figure 2. Typical section of the ON-FLEX 45 bridge deck expansion joint showing the cast-in-place type anchorage.

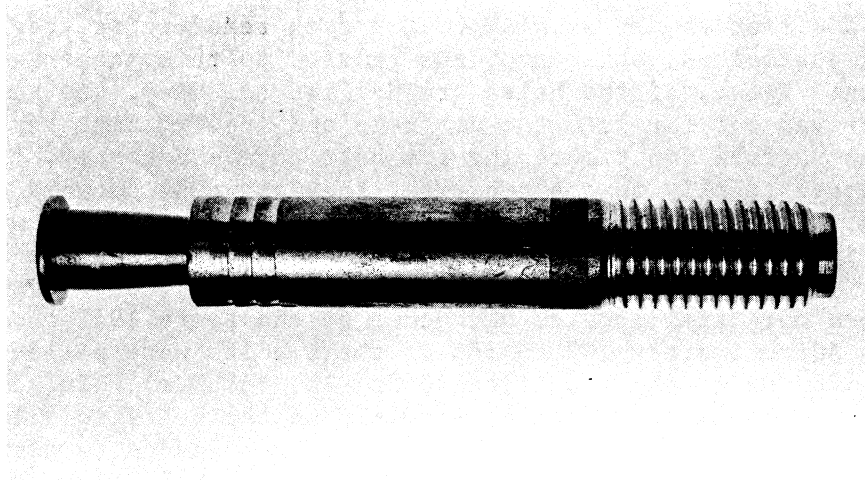
There were fewer problems with the second bridge as compared to the first. As a precaution, however, the anchor bolts were coated with epoxy when driven into the deck. There were no problems with torquing and re-torquing the anchor bolts on the SBL of the Route 95 connection bridge. The contractor, however, spent about 12 hours locating, drilling, and placing the bolts for each of the two approximately 90 ft. (27.4 m) long joints.

Figure 5. Typical anchor bolt used in the drilled holes on the SBL Route 95 connection over the WBL of Route 295.

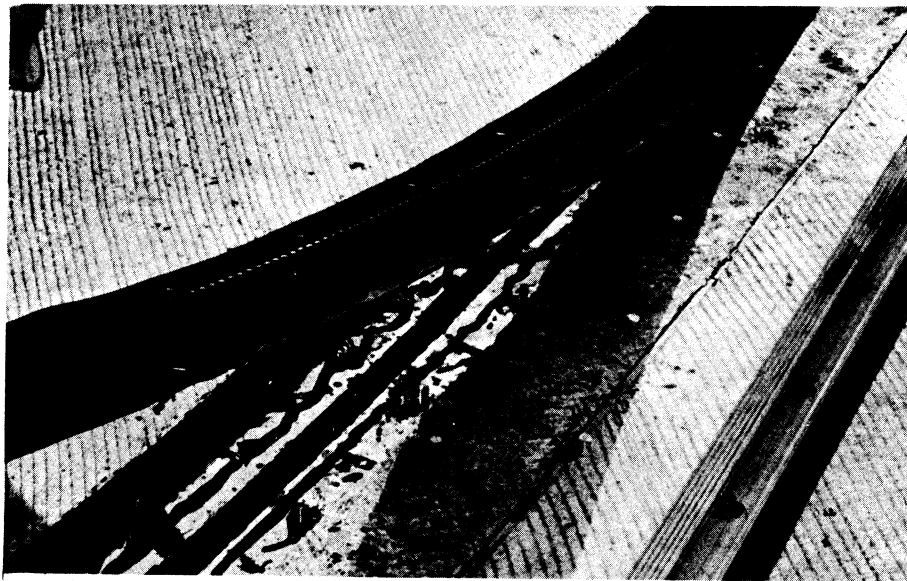
Prior to installing the neoprene, the joint trough is cleaned, holes are punched in the material at each anchor bolt location, and a sealant material placed in the trough. At first, a considerable amount of sealant material was placed in the trough, as shown in Figure 8. This was later reduced because it was thought that some of the difficulty in obtaining the specified torque on the anchor bolts was due to the heavy application of sealant. The reduced amount of sealant used on a subsequent installation can be seen in Figure 9, which also shows the elastomeric membrane being installed.

Figure 9. Placement of elastomeric membrane over a lighter application of sealant material.

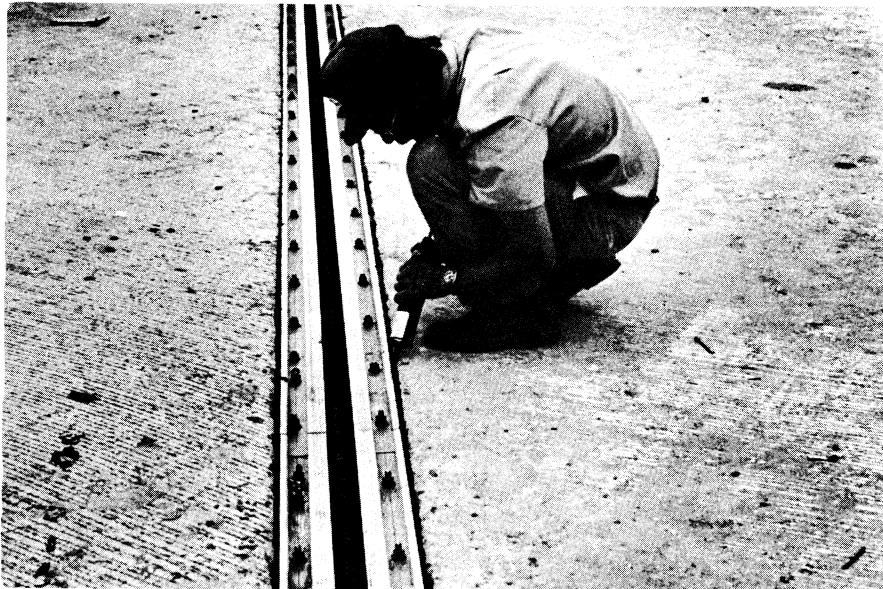
Before the hold-down channels were placed, additional sealant was placed on top of the elastomeric material. The nuts were tightened and later re-torqued to the specified amount. The use of a lighter application of sealant did appear to reduce the need for several re-torques to complete tightening of the nuts. The last operation involved placing the sealant material along the edge of the hold-down channels at the face of the concrete deck (Figure 11).

Figure 11. Placing sealant along edge of hold-down channel and concrete deck.
