FINAL REPORT

FIELD STUDY OF A PEDESTRIAN BRIDGE OF REINFORCED PLASTIC

December 1985
VHTRC 86-R21

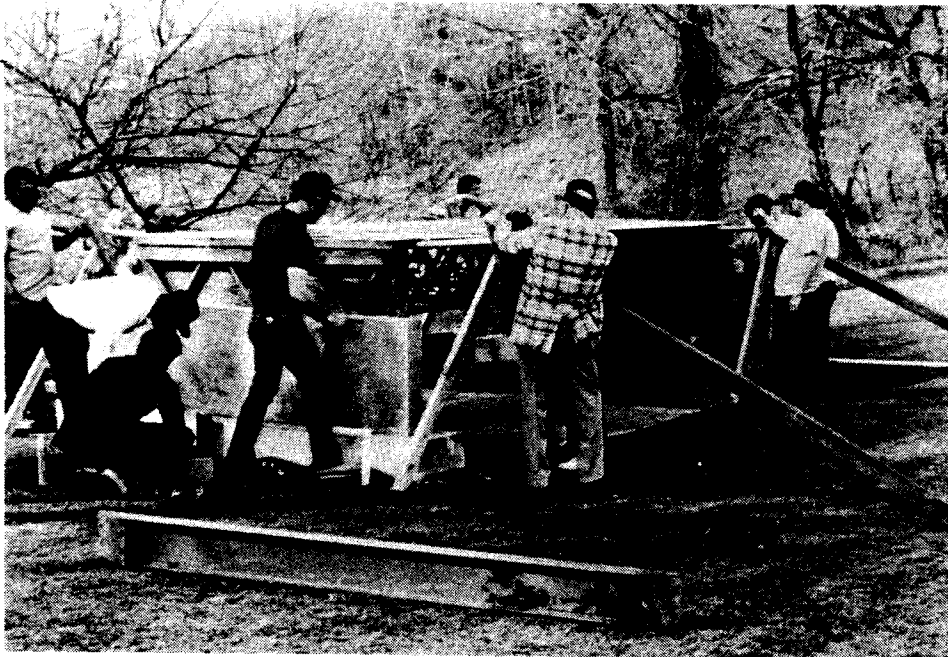
Figure 5. Adjusting bridge and bearing pads prior to final installation.

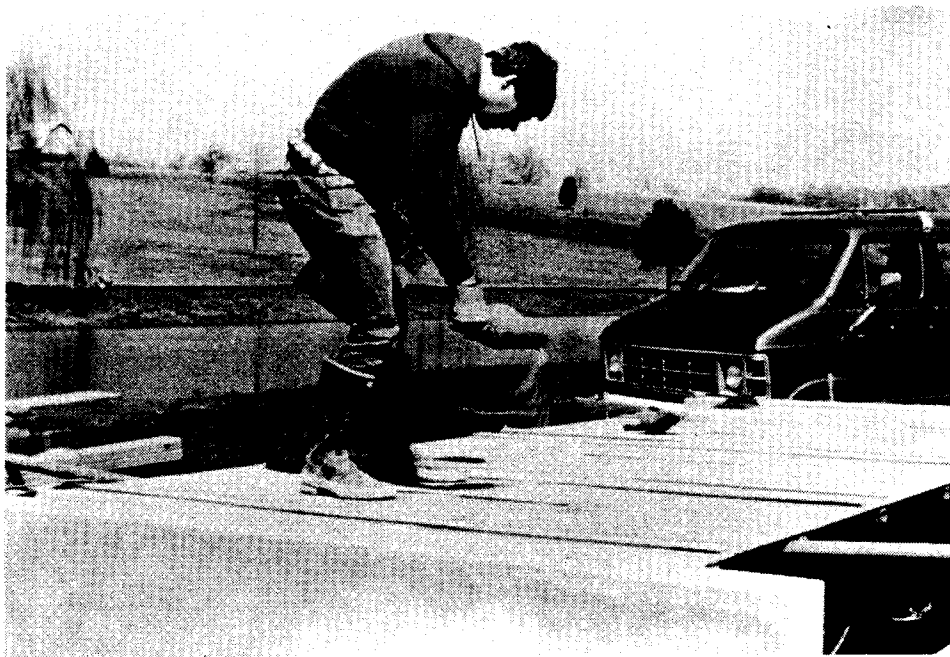
Successive layers of polymer concrete were applied at intervals of approximately 2 hours to allow sufficient time for the resin binder to cure. Figure 6 shows the hand application of sand at a rate of 2.5 lb/yd² to the liquid resin to provide an individual layer thickness of approximately 1/8 in. Excessive amounts of sand were applied to ensure maximum aggregate content in the layer of concrete. The small deck area to be covered did not warrant the use of mechanical equipment for placing the materials. Figure 7 shows the texture of the surface of the polymer concrete after it had cured. Excess sand was removed after each layer was cured in preparation for the next resin coating. Eight layers of sand and resin were applied over various areas of the deck to provide a crown along the center of the deck to facilitate water drainage to the sides of the otherwise flat surface. Application of the polymer concrete in successive layers also permitted the buildup of a greater thickness at mid-span to compensate for the deflection of the bridge due to its own weight and the weight of the wearing course. The polyester binder used in the concrete was PolyLite 92-339 (Reichhold Chemical) and the aggregate was a silica sand from Morie Sand & Gravel. A Morie #1 grading was used on layers 1-4 and a Morie #2 on the top 4 layers. A complete description of the properties of the polymer concrete is given in a report by Sprinkel wherein the resin is designated as PolyLite 90-570.(6)

- Figure 6. Sand aggregate applied to polyester resin to form polymer concrete wearing course.

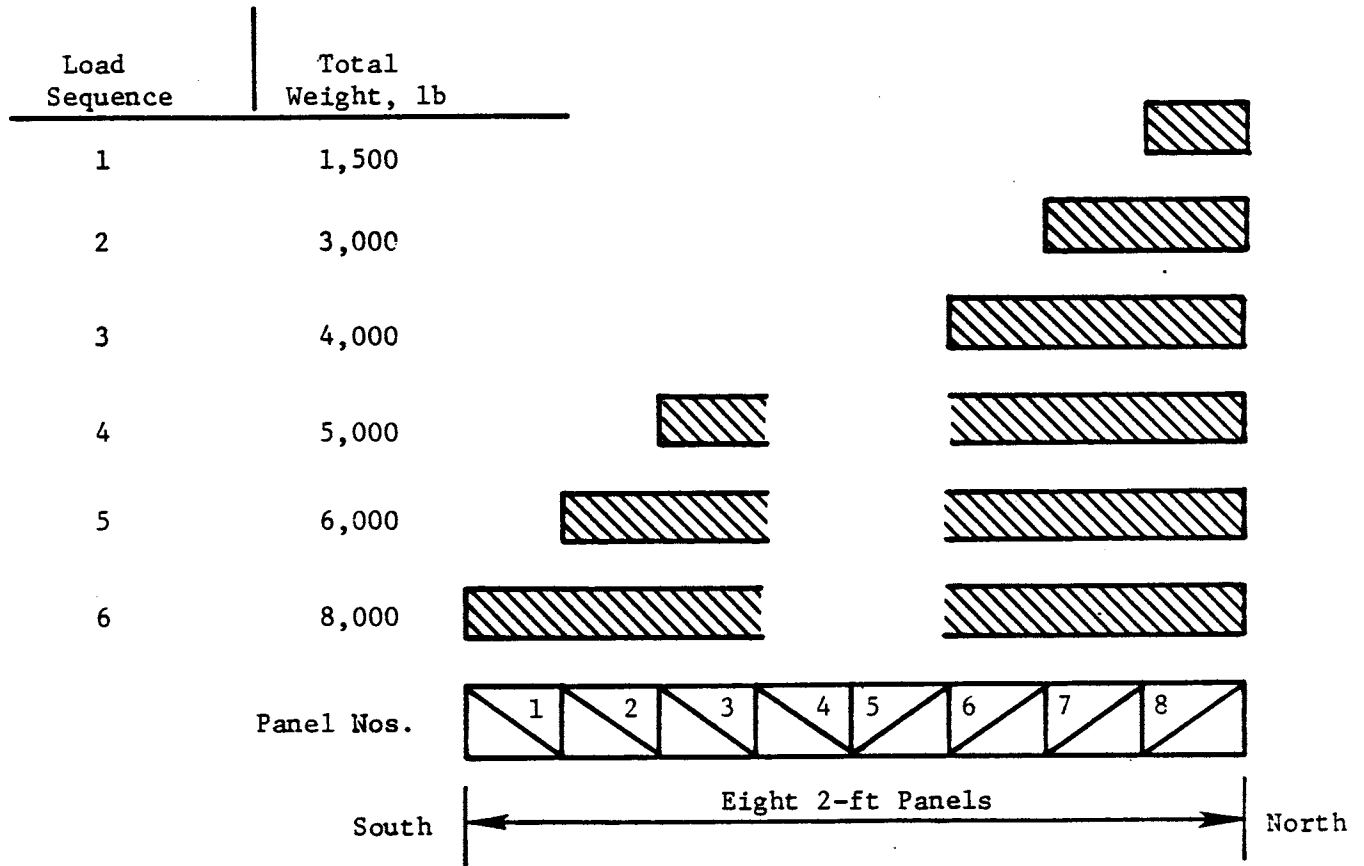
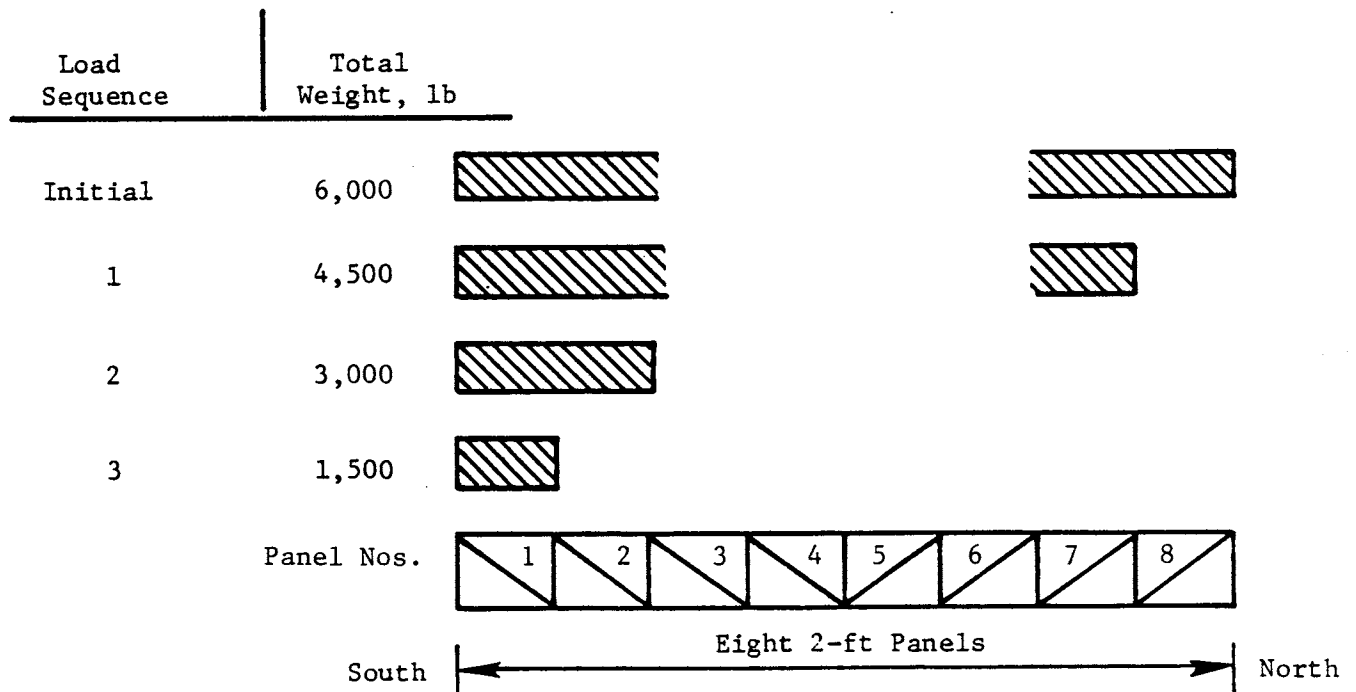
Loads were applied by filling 55-gal steel drums with water (≈ 500 lb total per drum) in the sequence shown in Figure 8. Note that the two center panels of the bridge were not loaded. The progressive manner of loading provided a "moving" load from one end of the bridge to the other, which reversed the direction of the shear force in panels 6 and 7 as the load was added to the bridge. The original design with the heavy concrete deck slab precluded a shear reversal in the panels with the application of the design live load, so the diagonal elements in the panels were expected to resist only tensile forces resulting from transverse shears. Consequently, the deck elements (1/2 in thick flange, 1/4 in thick cover plates, and 1/2 in thick polymer concrete) were required to transmit the total live shear force from the loaded portion to the centerline of the bridge. Minor buckling of the plates was observed in several of the panels and considerable buckling occurred in the diagonal elements in panels 5 and 6 as the live load was applied successively to the end panels. The diagonals in panel 5 of one of the outside girders remained slightly buckled throughout the load test period. It is probable that the nonuniform application of the live load or slight differences in the end supports induced sufficient torsional distortions into the superstructure to shift the shear forces from one girder to another. Differential distortions of this magnitude were not detectable by the deflection and strain measurements made during the application of the load.

Figure 8. Sequence of application and removal of loads to bridge deck by means of water-filled drums.

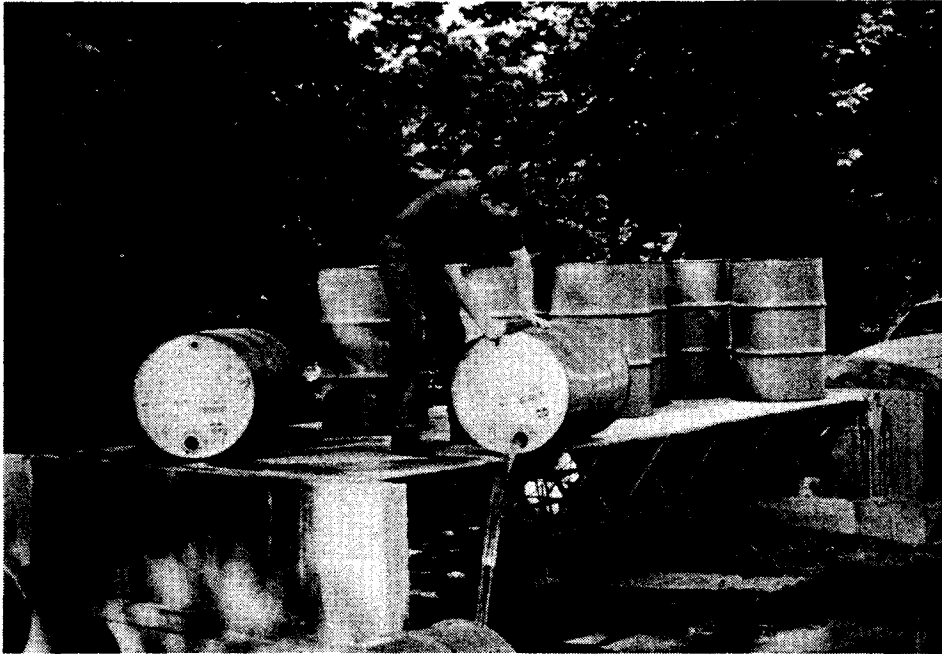
After 61 days under live load, all drums were removed, and rebound deflections of the bridge were measured over a period of 46.5 hours. The unloading sequence for live load removal was depicted in Figure 8. Figure 10 shows drums being emptied on the deck to minimize probable disturbance of the deck due to the shifting of heavy drums to the edge of the deck. In general, the same progressive load removal sequence was used as was followed for the application of the load to observe the effect of a load "passing" off of the structure. Some buckling of the diagonals in panels 3 and 4 was observed as the load was removed, but not as much buckling was noticed as had occurred in the opposite end of the girders when the load was applied.

Figure 10. Removal of live load from the bridge deck.

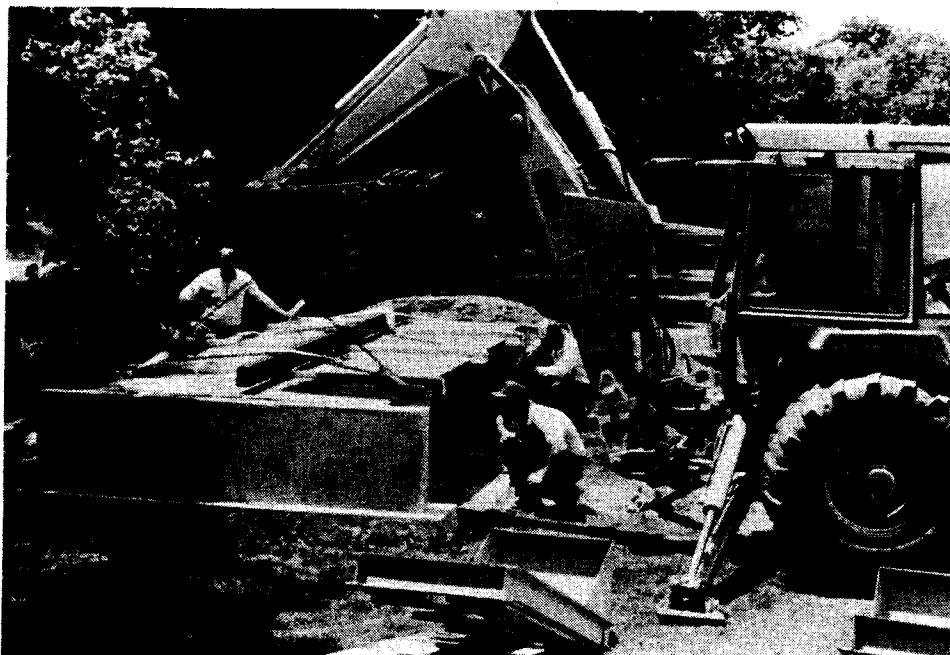
As upward force was applied from the front-end loader to the strongback, it was evident that the ends of the bridge were either wedged into or bonded firmly to the concrete seats. By moving a cargo strap first to one end and then the other end of the bridge and concentrating the lifting force, the supports were loosened from their seats - but not without considerable deformation of the deck and the application of excessive forces to the end stiffeners. The northern end of the bridge was disengaged from the seat without difficulty, but the southern end appeared to defy all efforts of the construction crew to loosen it by preplanned procedures. As frustrations grew, gentle treatment dissolved into action with sledgehammers, long steel prybars, and the application of maximum load capacity from the front-end loader. Just before the bridge broke loose from the concrete seat, the deck was so distorted and the abuse to the fragile pultruded members had become so severe that the project director, distracted and alarmed for the safety of the structure, failed to photograph the extreme measures used. However, a number of photographs were made of the handling of the bridge and several are included in Figures 22 through 24 to document the procedure.

Upon removal of the superstructure from the concrete seats, it was determined that the northern end of the bridge had resisted removal because of the wedge action of the bearing pads on the support elements. However, the southern end had been bonded to the concrete abutments by small quantities of polyester resin which had drained from the end of the deck plate during the application of the polymer concrete wearing course. Figure 25 shows the principal area on the surface of the concrete backwall over which the polyester resin drained. Apparently the clearance between the top transverse stiffener and the backwall of the abutment was small enough to trap a quantity of the resin, which cured and bonded the two mating surfaces securely. The forces and efforts required to break the polyester from the abutment attest to the strength of the binder, and they explain why the deck assembly could be drastically distorted without spalling the layer of polymer concrete from the pultruded deck plate.

Figure 22. Loosening the northern end of the bridge from the concrete seat with power equipment.

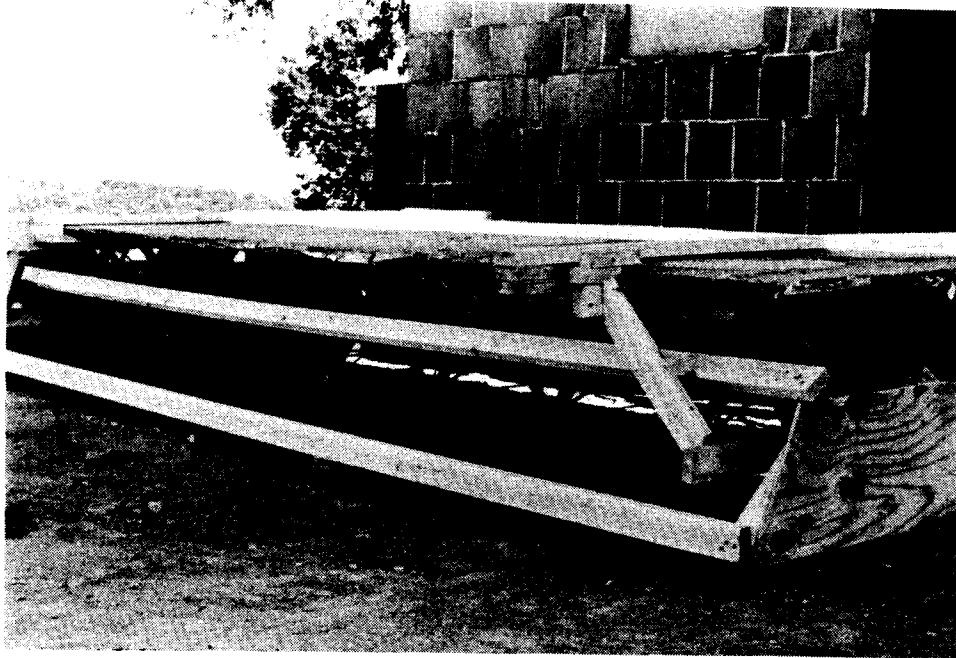
Figure 26 shows the superstructure in storage in Pen Park with temporary wooden supports in place. The wooden framing material seen in the photograph was used to protect the web elements and to maintain alignment of the end stiffeners during handling.

Figure 26. Crated superstructure in storage area in Pen Park.
