FINAL REPORT

EVALUATION OF A BRIDGE DECK EXPANSION JOINT

June 1986  
VHTRC 86-R44

A particular type of proprietary joint, the Royston Unidam Type LK-120, was installed in 1980 as an experimental feature on the eastbound lane (EBL) of the Rte. 50 bridge over the Shenandoah River in Clarke County, Virginia. This report includes a review of the installation of that expansion joint and an evaluation of its performance after five years in service.

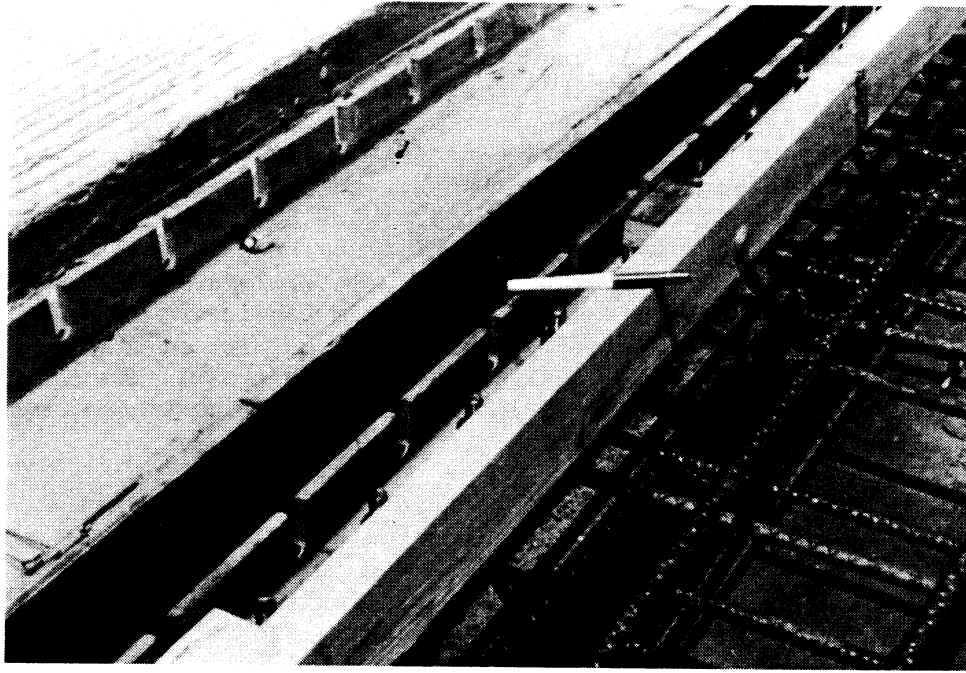
The anchor bolts and the slotted steel angles were positioned at the joint prior to placement of the concrete deck. Figure 3 is a view of the joint area where the concrete for one span has been placed but that for the

adjacent span has not. It can be noted that the steel angles used for mounting the elastomer are in place. In placing the Unidam joint it is important that these angles be set the required distance apart, since the vertical faces of the preformed elastomer must abut those of the angles as nearly as possible. If the distance between the vertical faces of the angles is too great, for example, there will be a gap between the elastomer and the angles. On both joints the distance between the steel angles, as installed, was too great. Consequently, installation of the elastomer was delayed until several thin steel shims were fabricated to fill the gaps. Two 1/4 in thick steel shims were used on the joint at the east end and one at the joint on the west end of the continuous spans. The installation of the elastomer thus had to be delayed until the shims were fabricated and delivered to the bridge site.

Figure 3. View of the joint area during bridge deck construction. Note that the angles used for mounting the elastomer are positioned prior to placement of the concrete deck.

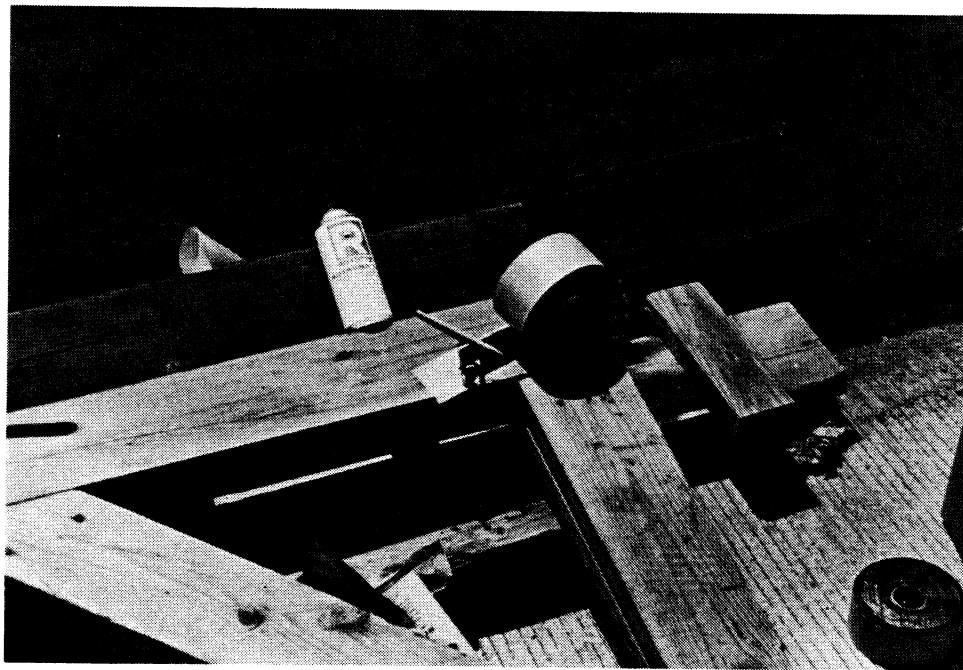
Once the concrete deck has been placed, the slotted steel angles are permanently set and the elastomer can be installed. On this particular bridge a 2 in wide, 1/4 in thick sealing material was placed between the shim and the vertical leg of the angle to seal the interface (Figure 4). Next, the steel rods were inserted into the openings in the neoprene and the openings plugged (The openings and plugs for the rods alternate from side to side of the elastomer.) The elastomer was then placed in the trough between the two slotted steel angles such that the horizontal anchor bolts dropped into the slots (Figure 5). When the nuts were tightened, the horizontal anchor bolts tended to slip inside of the elastomer. In many cases it was necessary for the workmen to wedge a screwdriver against the anchor bolt so that the nut could be tightened. To prevent the nuts from working loose during service under traffic, they were spot welded to the steel angles (Figure 6). It should be noted that no mastic or sealing material was placed on the horizontal surface of the trough. The seal between the vertical legs of the steel angles and the elastomer was depended upon to prevent leakage through the joint.

Figure 4. Sealing material used between the shim and vertical leg of the angles.

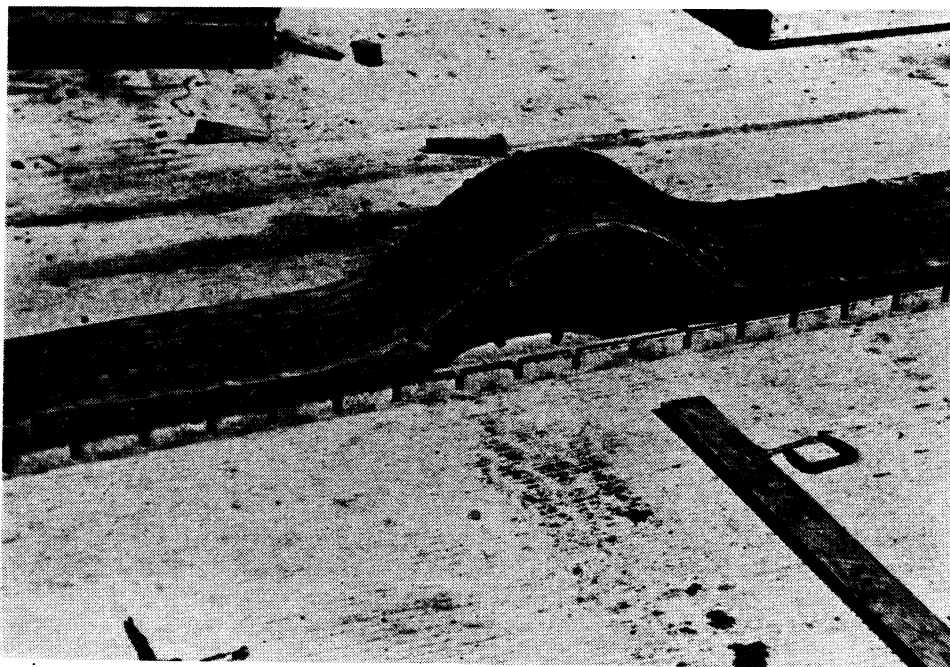
Figure 5. Elastomer being placed in joint area.

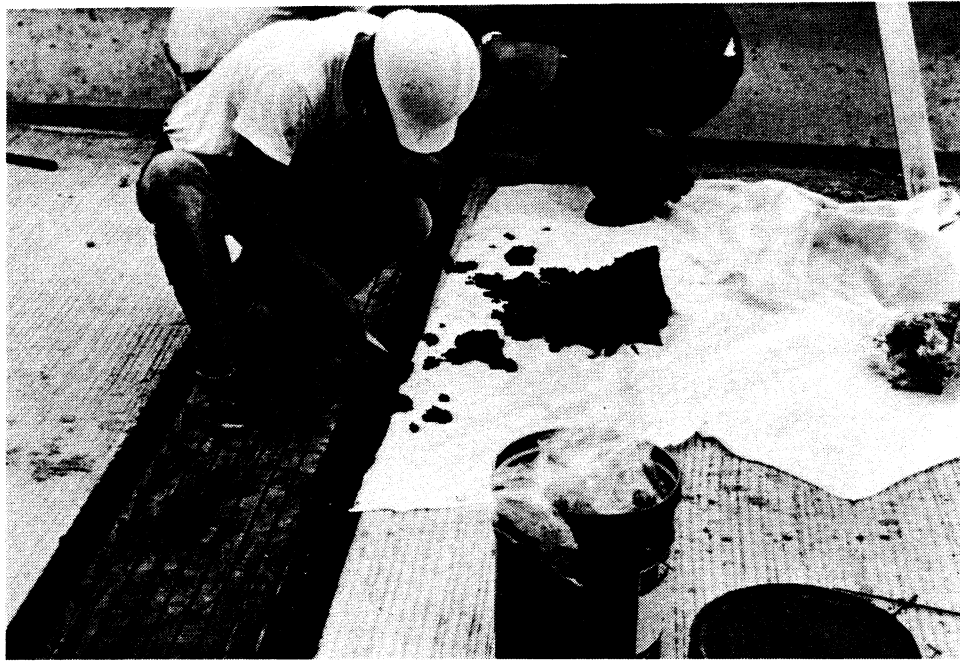
The remaining 4-in trough on each side of the elastomer was cleaned, a primer adhesive applied, and the trough finally filled with an asphaltic material (Figure 7). The asphaltic material was compacted to complete the installation.

Figure 7. Placing asphaltic material in small troughs on each side of the elastomer.
