1. Report No. VTRC 91-R7	2. Government Accession No.	3. Recipient's Catalog No.	
4. Title and Subtitle Installation and Performance Evaluation of the Wabocrete FMV Joint System for Bridge Decks		5. Report Date August 1990

August 1990
VTRC 91-R7

**INSTALLATION AND PERFORMANCE EVALUATION
OF THE WABOCRETE FMV JOINT SYSTEM FOR BRIDGE DECKS**

Marvin H. Hilton

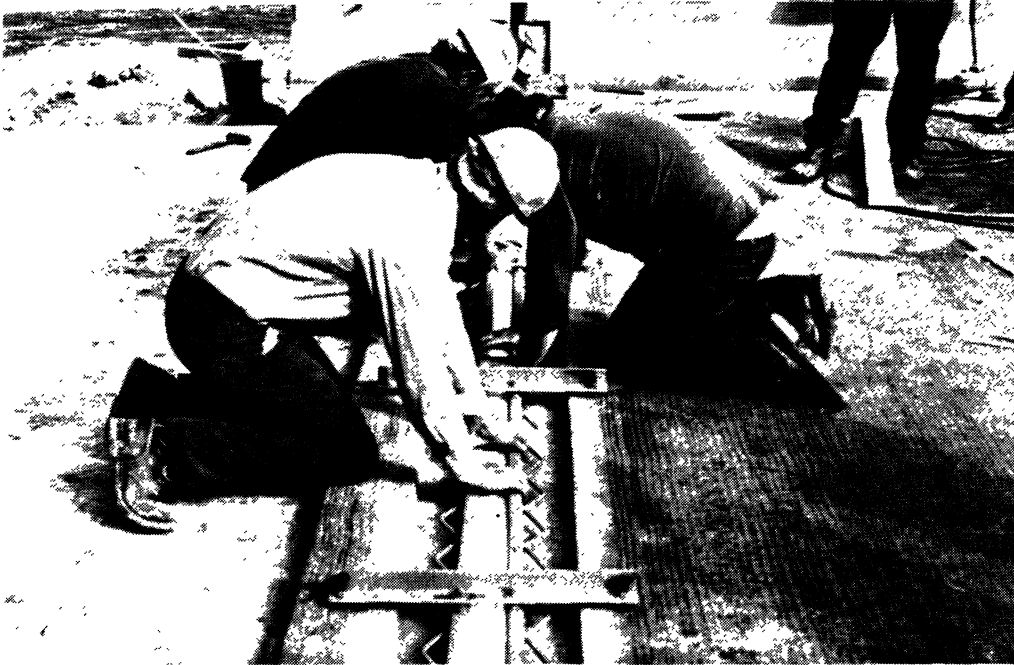
With the steel extrusion unit placed in the blockout (Figure 5), the Wabocrete FMV material was troweled into the cavity, and the surface area was smoothed. The trowels were heated with torches as necessary to prevent the binder from sticking to them. As the surface was smoothed, heating ducts were moved into place in order to keep heat on the material during curing. The heat was applied through the night by space heaters placed at the ends of the ducts. Ordinarily, curing could be accomplished in approximately two hours by applying heat.

Figure 5. Workers aligning the joint hardware in the deck blockout. Cross angles are used for leveling the joint to proper elevation.
