AN INVESTIGATION OF STREAKING ON HIGHWAY TRAFFIC SIGNS

R. N. Robertson
Highway Research Engineer

Virginia Highway Research Council
(A Cooperative Organization Sponsored Jointly by the Virginia
Department of Highways and the University of Virginia)

May 1974
VHRC 73-R48

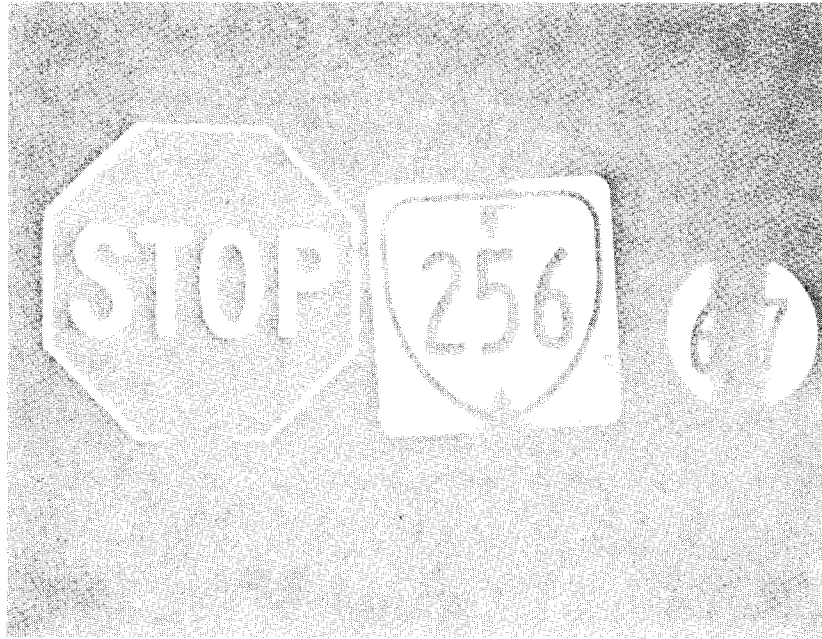
For a sign to be effective, it should not only be properly installed, but it must be legible at all times. The Virginia Department of Highways requires that all signs be inspected at least twice a year to make certain they are kept in proper position, clean, and legible. During a nighttime sign inspection, dark streaks were observed on the faces of many reflectorized signs. Generally, the streaks were in line with the bolts that secured the signs to the posts. The streaks adversely affected the retroreflective characteristics of the reflective material, thereby reducing the brightness of the sign as shown in Figure 1. During daylight, the streaks were not visible (Figure 2).

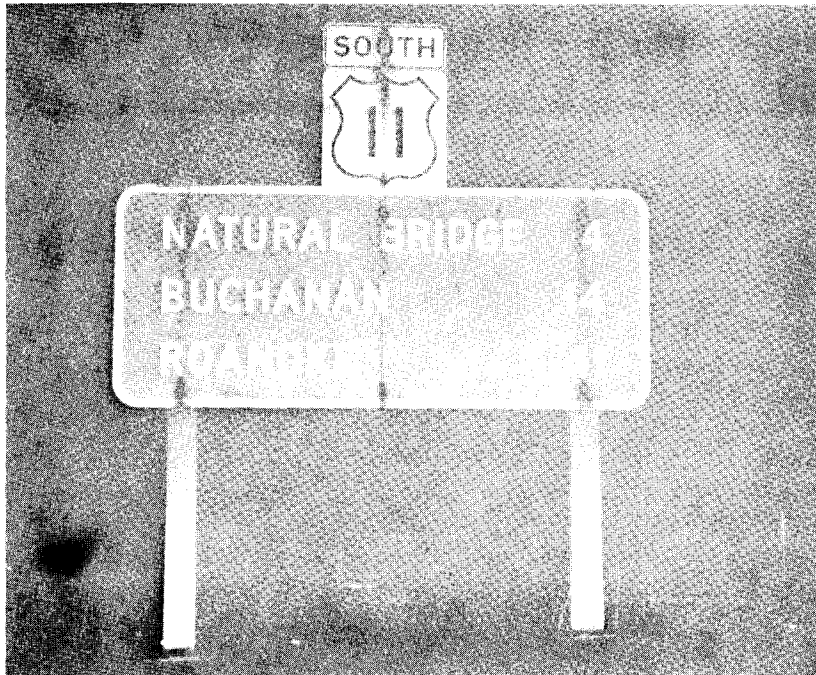
Figure 3. Test signs.

The four signs selected for analysis are shown in Figure 3. The details relative to the location, placement, installation date, mounting hardware, maintenance, and characteristics of each sign are in Appendix A.

The analysis revealed that the residue was titanium dioxide, the white pigment in oil base and latex paints. As the paint weathered and aged, it deteriorated, rain carried the residue down the post to the top of the sign or through a bolt hole, and then along the sign face, leaving the deposit of titanium dioxide.

3. In order to remove the streaks and restore the brightness, it is recommended that the existing signs be clear coated in accordance with the reflective sheeting manufacturer's instructions.

4. On future sign installations, it is recommended that the sign panel be offset from the painted post with a spacer similar to a nylon washer approximately $1\frac{1}{2}$ inches in diameter and $1/8$ inch thick. This arrangement will keep the aluminum from contacting the paint and eliminate the chemical reaction (which breaks down the paint) between the two. Furthermore, the rain transporting the paint residue can continue down the post rather than going down the sign face.
