SIDEWALK UNDERMINING STUDIES

Phase III - Field and Model Studies

April 1979
VHTRC 79-R35

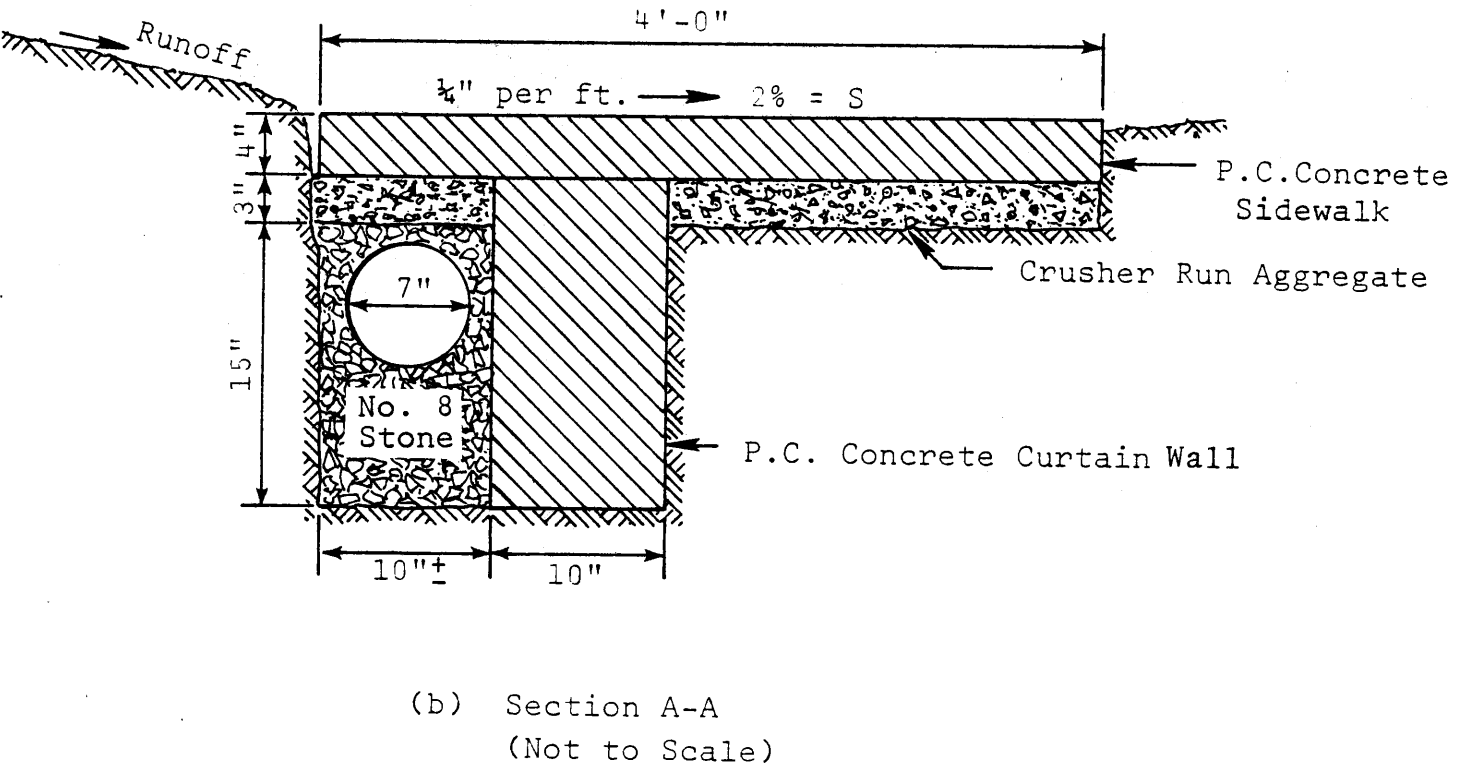
system. A schematic of this replacement procedure is shown in Figure 4. While this method of replacement was successful in that undermining has not recurred to date, it was very expensive and there was general disagreement concerning the sizes of pipe to be used on the various grades encountered in the maintenance replacement program. Hydraulic studies performed during this initial phase yielded a nomograph from which pipe sizes could be determined for particular field conditions, and from the studies it was concluded that a 178 mm (7") diameter pipe would be adequate for most practical cases. (2)

Figure 4. Sidewalk reconstruction with curtain wall and drainage system. (1 in. = 25.4 mm)

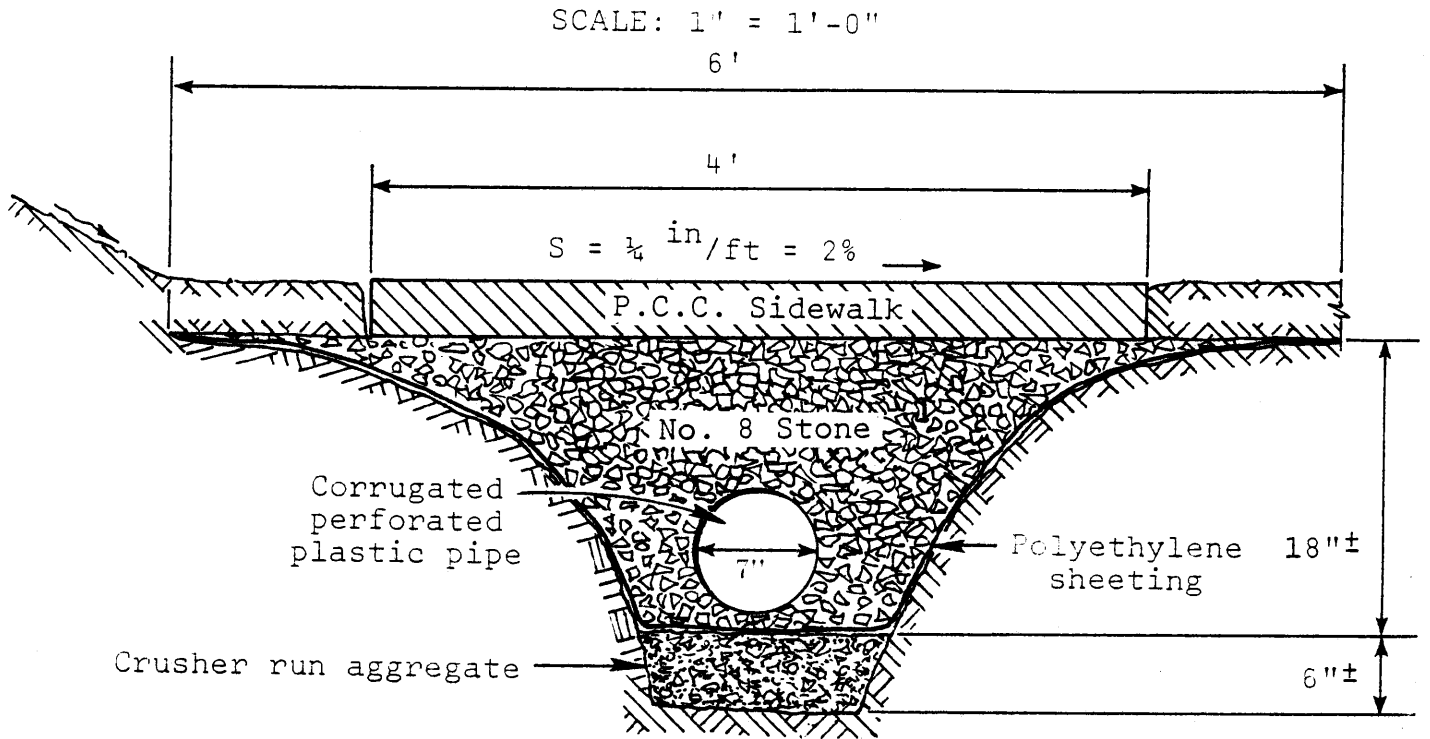
Figure 5. Cross section of experimental sidewalk installation.
(1 ft. = 0.3 m)

Test site 5 is the location of the initial installation of the underdrain system proposed by McGhee in Phase I and shown schematically in Figure 5 of this report. This installation was made in August 1974 by a maintenance crew of the Fairfax Residency in replacing an undermined sidewalk at a site that obviously does meet the criteria for identifying sites likely to experience undermining. It should be emphasized that even though the underdrain design has been used almost exclusively in replacing undermined sidewalks since its adoption, it was recommended as an interim solution until a more economical solution could be found.⁽²⁾

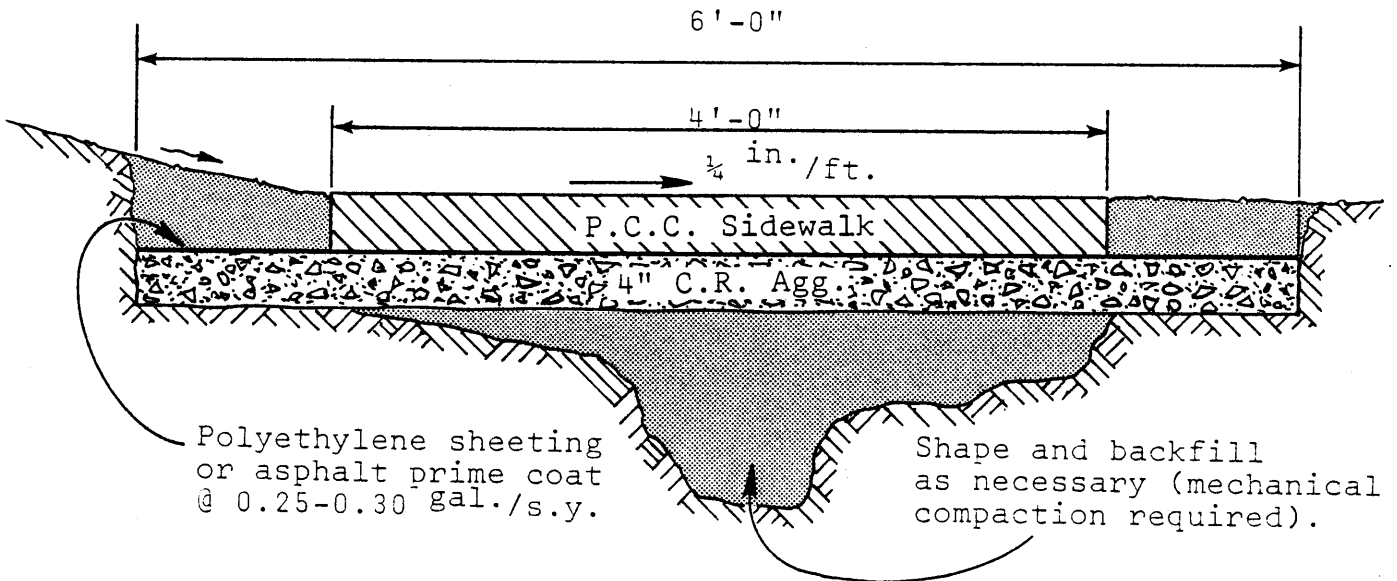
Figure 6. Proposed sidewalk replacement without underdrains.
(Metric conversion 1 ft. = 0.3 m).

The effectiveness of the design without underdrains is somewhat questionable, especially if it is used as the singular repair procedure in a severe situation. A similar method of prevention was studied with the use of the model sidewalk set up in the Council's laboratories and will be discussed later in this report.

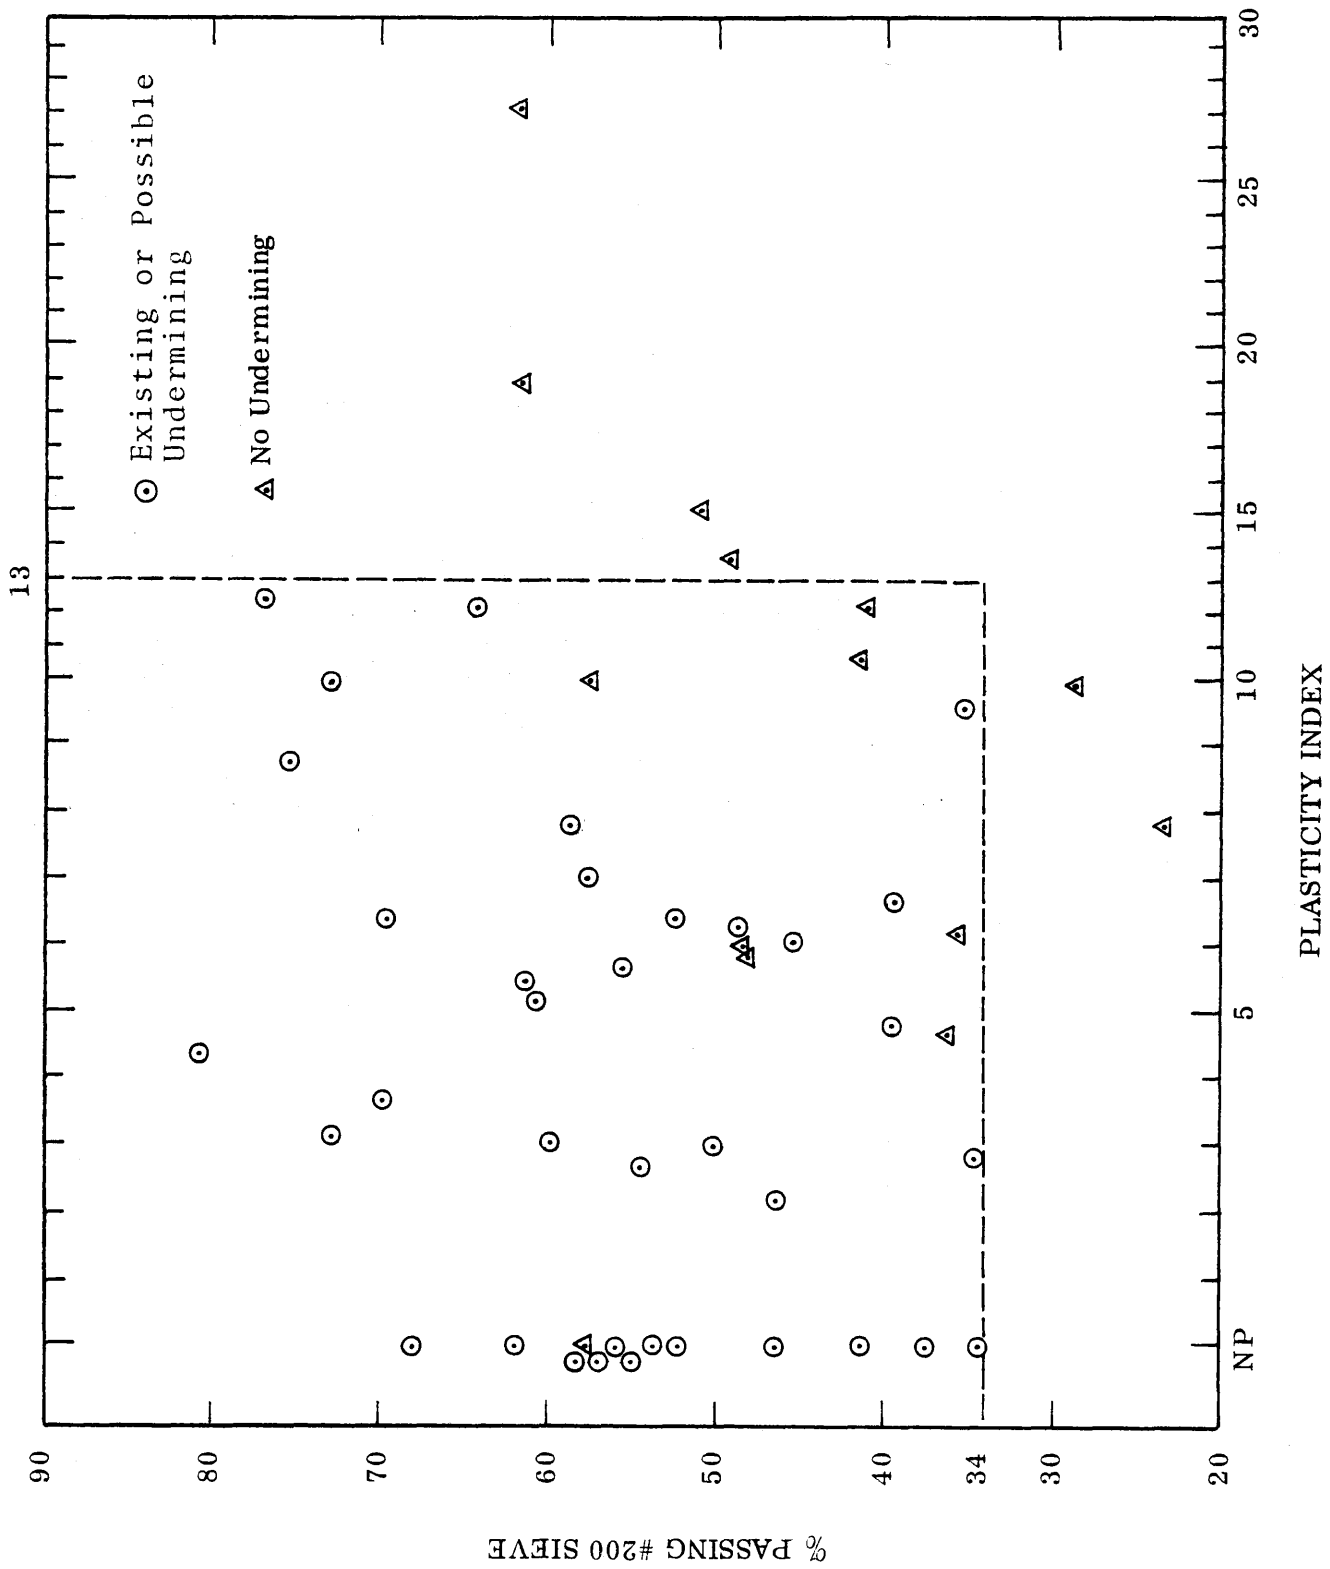
The relationship of undermining to the soil's erodibility characteristics as defined in this alternate system is shown graphically in Figure 7. Because of the economy and ease with which this system can be applied, it was recommended for use in new sidewalk construction to identify sites where there is a high probability that sidewalk undermining will occur.(3)

Figure 7. Undermining of sample sites plotted as percent passing #200 sieve versus plasticity index.

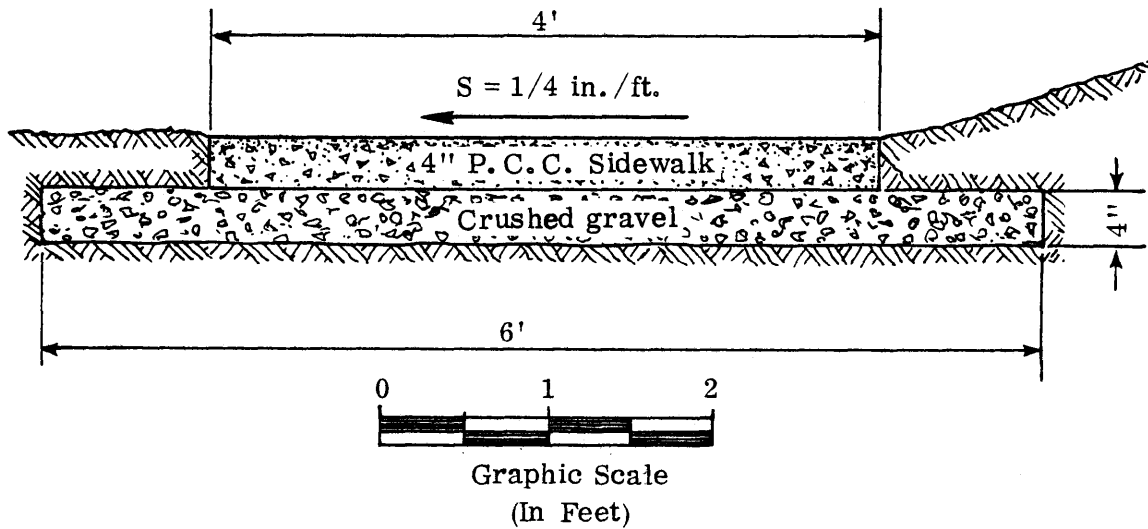
Figure 8. Design of installations made
at test sites 1 and 2.

On October 31 and November 1, 1977, sidewalk slabs were removed at 3 test sites to permit visual inspection of the subgrade. These were Test Area #2 (crushed gravel subbase with cut-off walls as shown in Figure 8), Test Area #4 25 mm (4") pipe underdrain placed along the high side of the sidewalk as shown in Figure 10), and Test Area #5 (polyethylene sheeting with 175 mm (7") plastic pipe and No. 8 stone underdrain system as shown in Figure 5). It should be pointed out that Test Area #5 was inspected when feasible during a rainstorm and the drain was always found to be carrying clear water. Thus this system has been extremely effective in preventing the reoccurrence of sidewalk undermining. In addition, a sidewalk slab was removed at a location where undermined sidewalk had been replaced with the combination curtain wall and 7" underdrain pipe (refer to Figure 4) and a slab was lifted enough for visual inspection at Test Area #3 (curtain wall poured monolithically and on the high side of the sidewalk as shown in Figure 9).

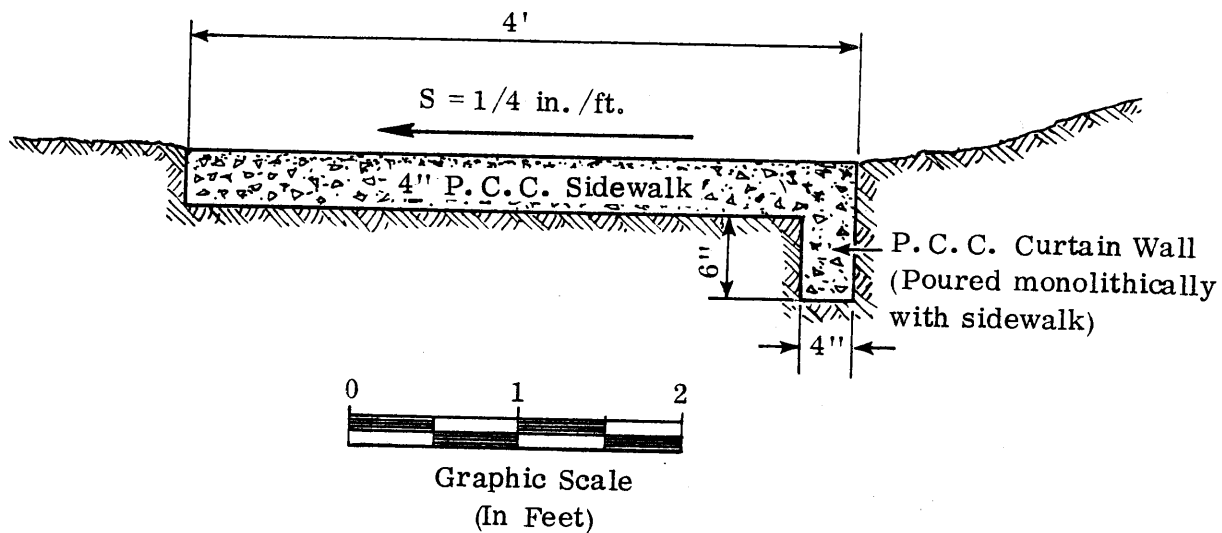
Figure 9. Design of installation at test site 3.

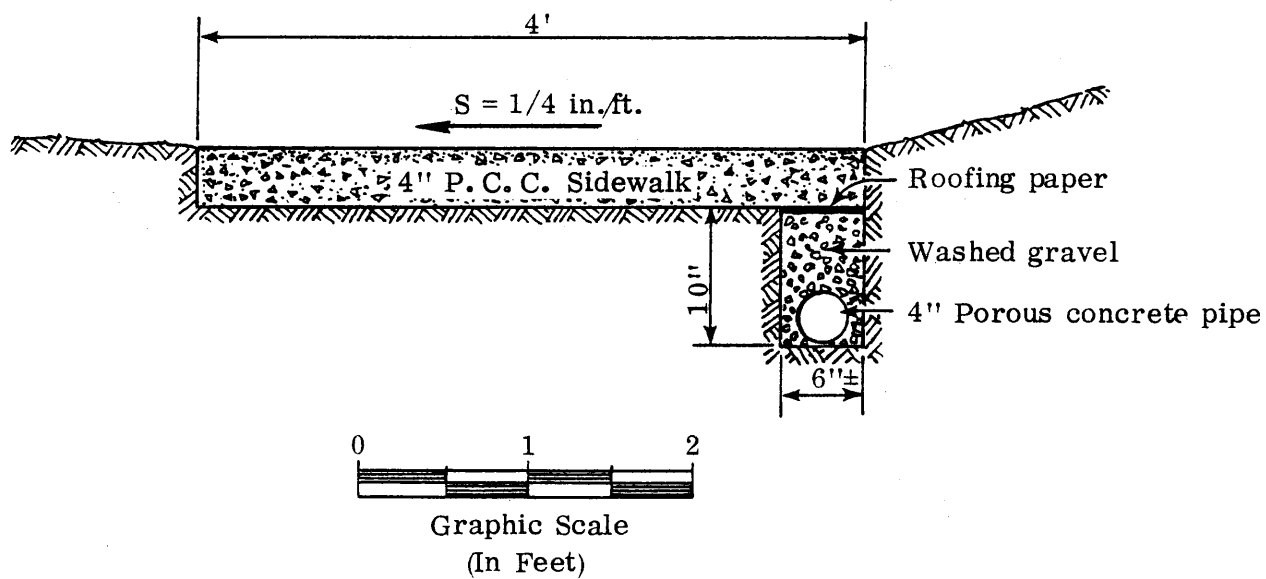
Figure 10. Design of installation at test site 4.

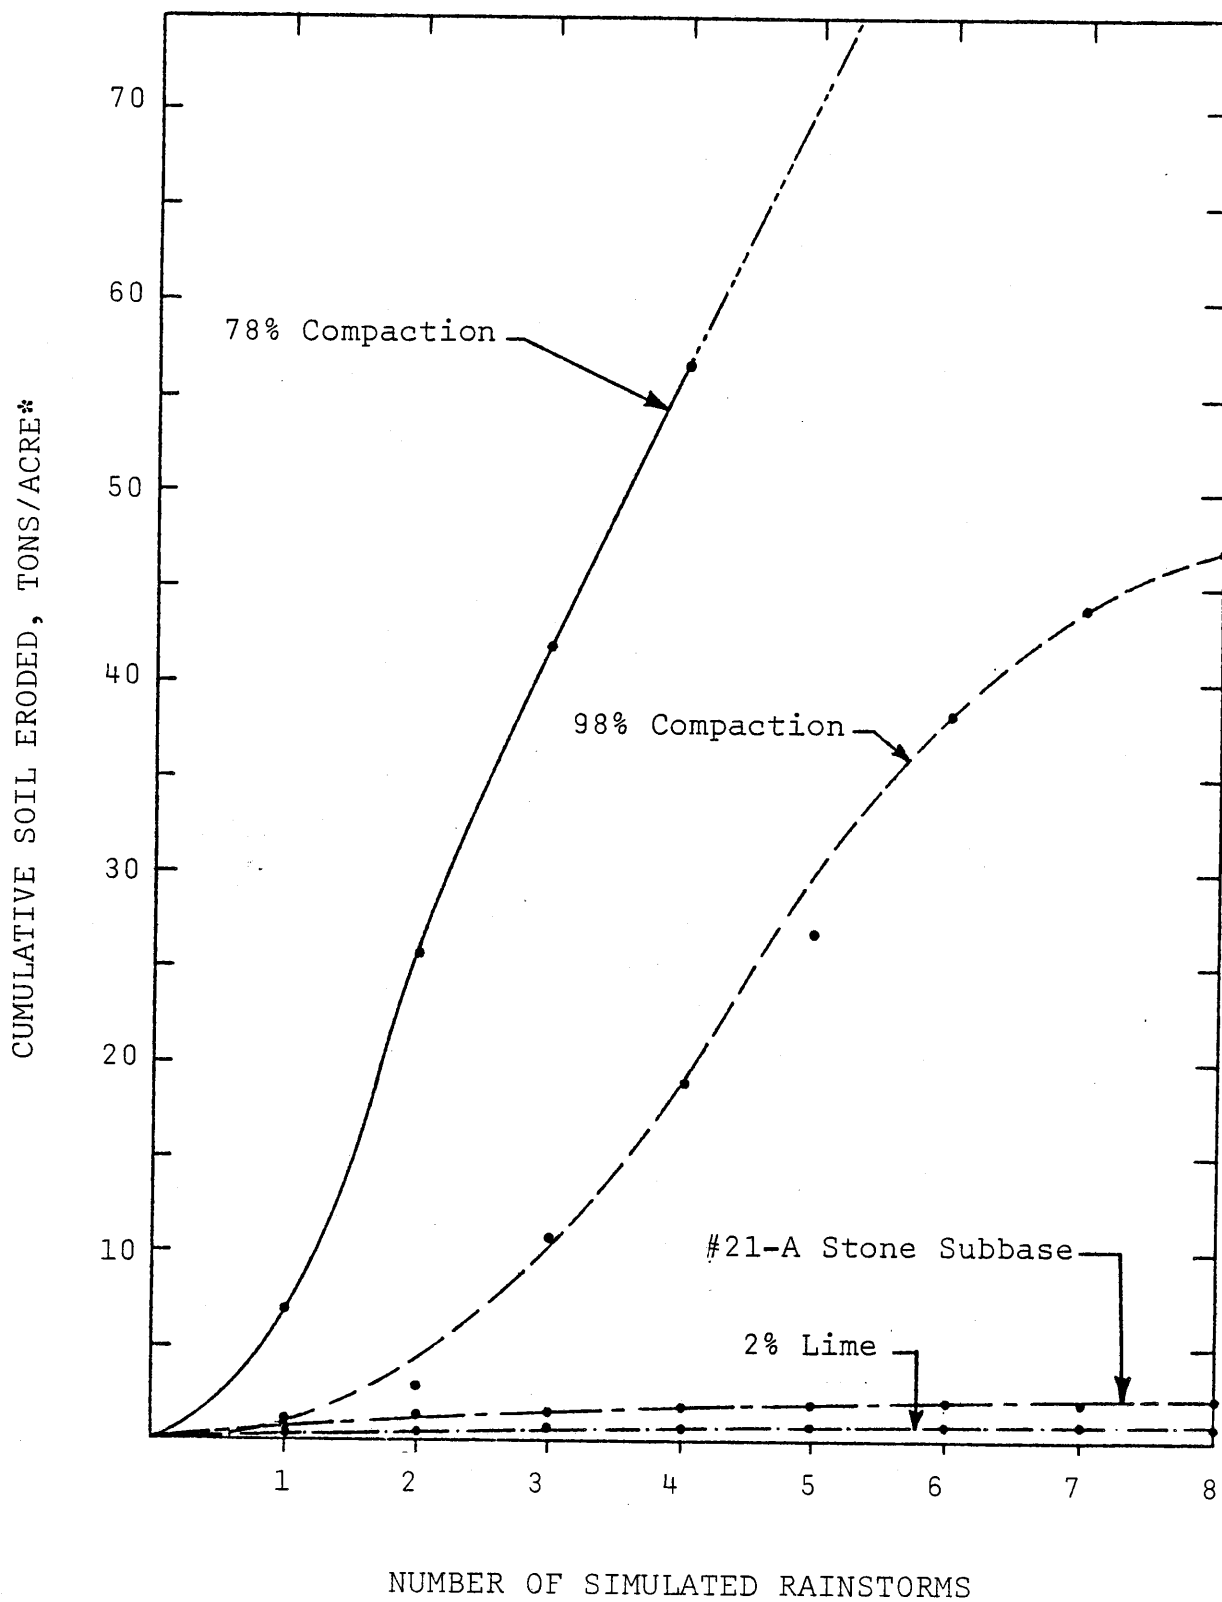
In Figure 21 the cumulative soil eroded versus the number of simulated rainstorms is plotted for each setup of the model. An examination of the plots results in the following conclusions:

Figure 21. Plots of cumulative soil eroded versus number of simulated rainstorms for each setup of the model. (*Metric conversion 1 ton/acre = 0.22 kg/m².)

drains may do so. Thus, of the solutions to the undermining problem tested through the use of the model sidewalk, lime-modification of the soil would seem to have the best overall potential.
