FULL-DEPTH REPAIR OF JOINTED PCC PAVEMENTS  
CAST-IN-PLACE AND PRECAST PROCEDURES

Samuel S. Tyson  
Research Engineer

Virginia Highway & Transportation Research Council  
(A Cooperative Organization Sponsored Jointly by the Virginia  
Department of Highways & Transportation and  
the University of Virginia)

March 1976  
VHTRC 76-R44

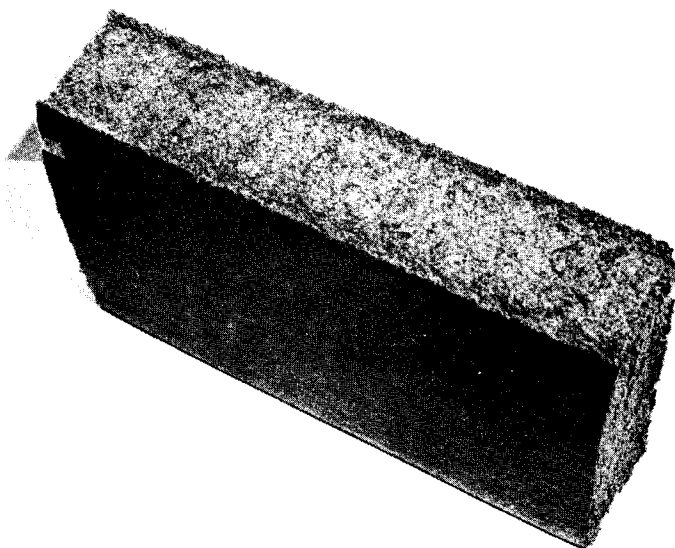
Figure 7. Fracture plane in old pavement containing compacted layer of finely ground concrete underlain by thin coherent layer of calcite.
