Virginia Transportation Research Council

Condition Assessment
and Determination of Methods
for Evaluating Corrosion Damage
in Piles Encapsulated in Protective Jackets
on the Hampton Roads Bridge-Tunnel

April 2010
VTRC 10-R13

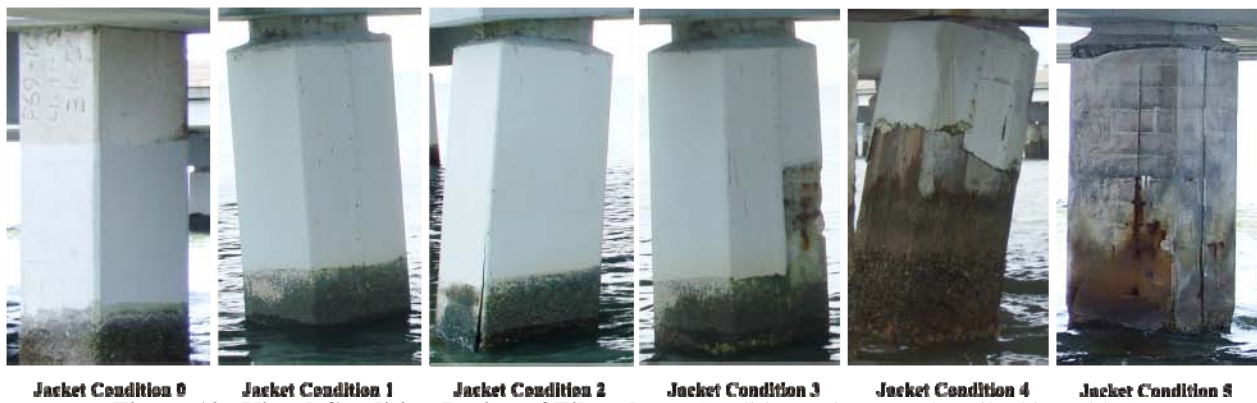
Figure 10. Visual Condition Rating of Fiberglass. Condition ratings are described in Table 2.

Figure 10 and Table 2 provide a description of the fiberglass condition, the associated rating, and a sample image of a pile that received that rating. For fiberglass condition ratings of 3 or higher, mortar was exposed and could be visually assessed. Fiberglass casings were inspected only above the water line, so if a casing was completely missing above the water line, the condition rating was 5. In this instance, a part of the casing could still exist below the water line.

The inspection of the fiberglass casings revealed a variety of conditions. The fiberglass was covered by significant marine growth in the tidal region of the pile. Damage to the fiberglass casings was common, in the form of splits along the corners, sections missing, or the complete loss of the fiberglass, all of which were commonly seen on HRBT (Figure 10).

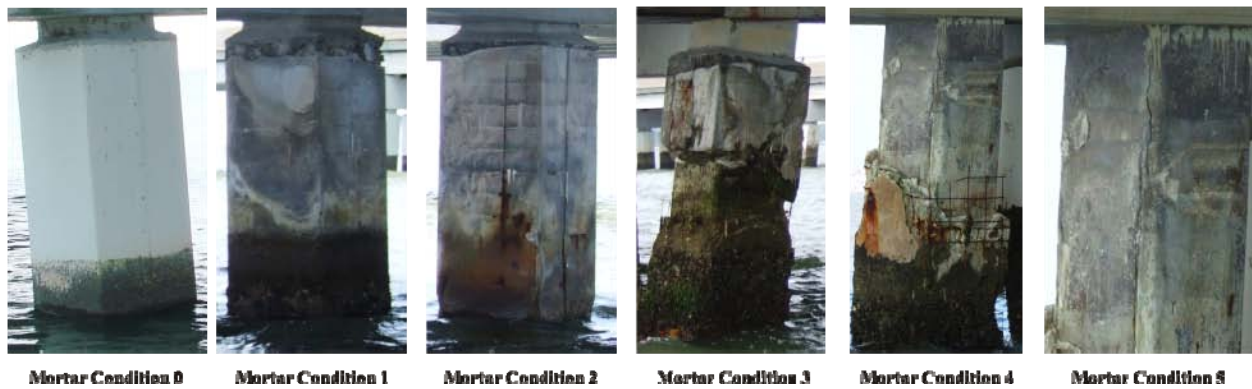
Figure 11. Visual Condition Rating of Mortar. The ratings are described in Table 2.

When the fiberglass casing was partially loose or missing, only part of the mortar was exposed. In such cases, the mortar condition rating was based on the exposed portion, which might vary in size from pile to pile. Inspection of the mortar was based on the portion above the water line. If the mortar had completely fallen off above the water line, the mortar condition rating was 5 even though mortar could still be intact below the water line.

During the visual inspection, the mortar was typically seen to have cracking, corrosion product, section loss, foreign objects cast into the mortar, and poor consolidation (Figure 11). When the mortar was exposed, typically the reinforcement that was in the mortar was also exposed and suffering from corrosion activity. On a majority of the piles, the mortar reinforcement was placed with very little to no cover. The top portion of the mortar was typically poorly consolidated, resulting in substantial honeycombing. Epoxy was placed in the tidal zone of most piles before the jackets were installed. That epoxy was left in place when jackets were installed, requiring the mortar to bond to the epoxy.

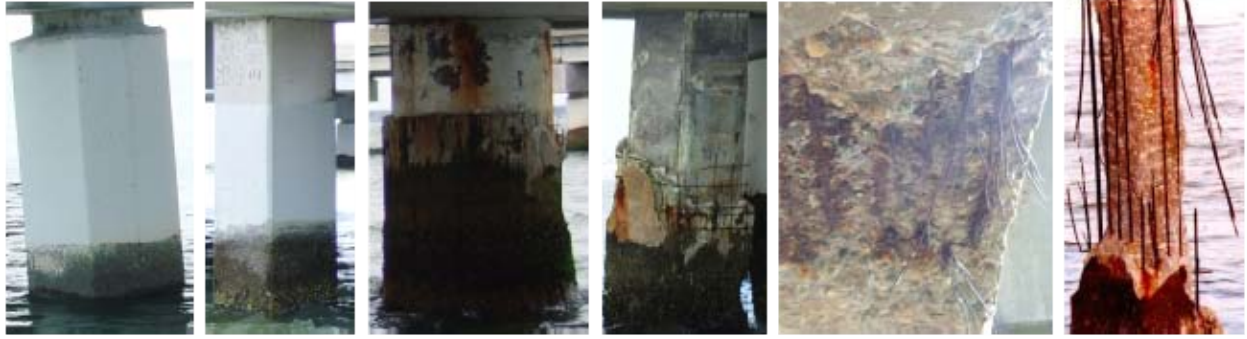
The substrate was mostly obscured from view because of the fiberglass and mortar. When the substrate was exposed, substrate damage was seen in the form of cracking and rust staining (Figure 12). Several piles had large vertical cracks down the length of the substrate. Since inspection was performed by boat, only large cracks could be identified. During the in-depth inspection of the piles, smaller cracks were observed in several piles (Figure 21). During the visual inspection, no spalling or section loss was observed in the substrate. This resulted in no piles receiving a substrate condition rating above 3.

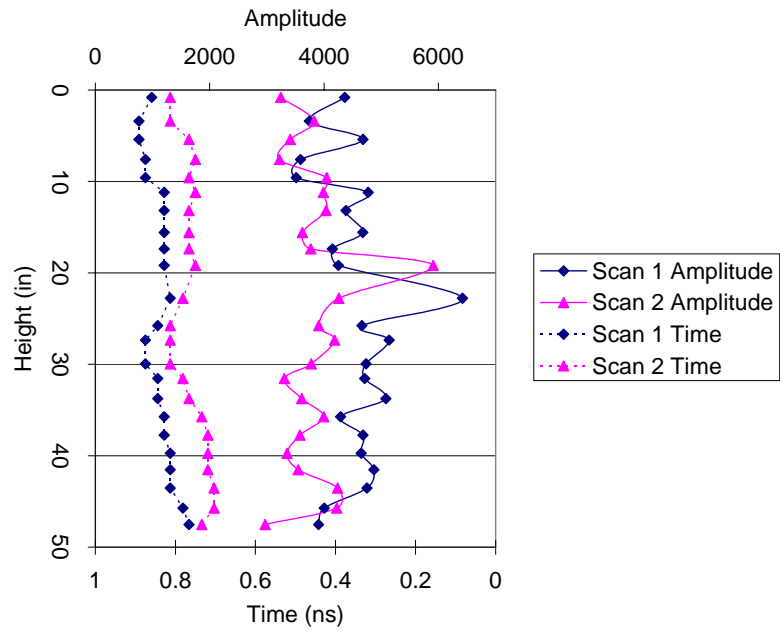
Figure 22. Structure 2900, Bent 45, Pile A, Ground-Penetrating Radar Scan of Horizontal Steel

The steel amplitudes from Pile A ranged from 3,000 to 5,000, and the amplitudes from Pile B ranged from 2,000 to 4,000. Pile B steel reflection amplitudes were significantly lower than those of Pile A, indicating that the Pile B reinforcement has corrosion damage. This was confirmed during the autopsy, when it was revealed that Pile B had corrosion product on the steel reinforcement. The autopsy of Pile A did not reveal any damage to the reinforcement.

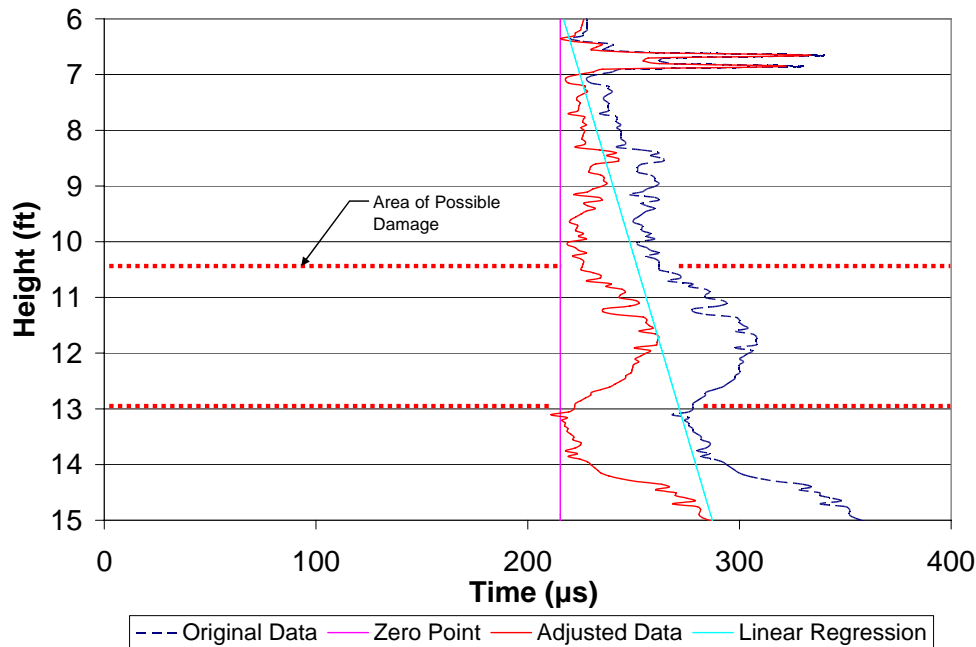
Figure 26. First Arrival Time Plot

The CSL scans were used to identify locations of interest, which could be locations of possible corrosion damage, consolidation issues, change in material properties, and other damage. These locations are indicated by a significant increase in first arrival time (FAT) or significant decrease in energy. Figure 26 shows an area of interest at a depth of 10.5 to 13 ft,

where the FAT increased significantly. Locations of interest were determined by a significant change from the established “zero point” of each CSL scan. The zero point established for each CSL scan was based on the shortest FAT from that scan. Figure 26 shows how the FAT plot was corrected for misalignment of the tubes by subtracting the inherent slope determined by a linear regression.

In Figure 26, a height of 6 ft corresponds to the water level. The water level was not constant because of wave and tidal action. Because of this water fluctuation, FAT values corresponding to approximately the top 1 ft of the scan must be disregarded because they will be affected by this periodic loss of the water couple. This can be seen by the sudden increase of FAT at 6.5 ft in Figure 26.

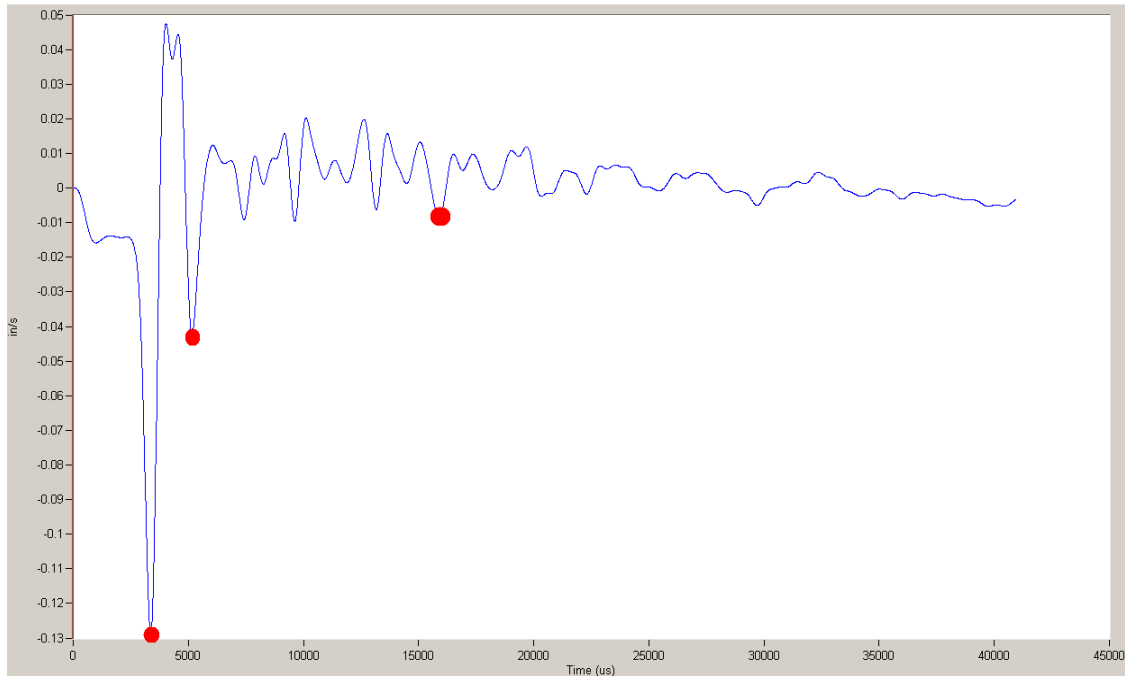
Figure 27. Sonic Echo Analysis

Figure 27 shows the response from the test conducted on Structure 2866, Bent 28, Pile C. Analysis revealed that the first reflection was at a depth of 13 ft and the second at 89.6 ft. According to construction documents, square piles were to be driven to a minimum depth of 71 ft and cylinder piles were to be driven to a minimum depth of 79 ft, below the mud line. Thus,

89.6 ft was a reasonable value for the length of the pile. The reflection at 13 ft could be the mud line or a location between the mud line and the water level. At the time of the test, the water level was 6.6 ft below the pile cap, which means the reflection was at approximately 6.4 ft below the water line.

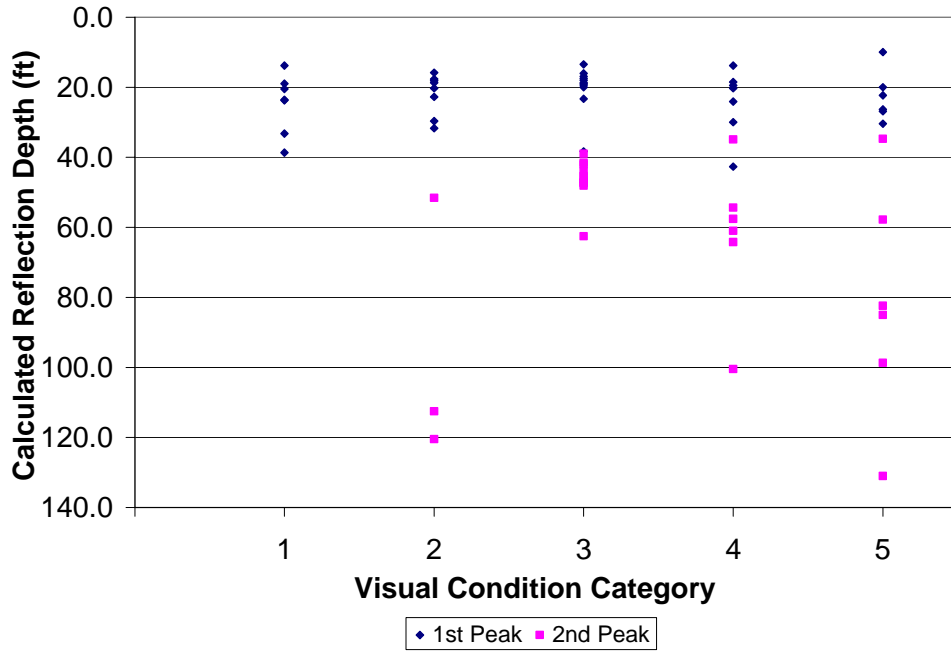
Figure 30. Sonic Echo Reflections Measured by Accelerometer: Ordered by Overall Visual Condition Rating

To determine if the depths of reflections were related to the overall visual condition rating, the responses from the accelerometer (Figure 30) and geophone (Figure 31) were plotted versus pile overall visual condition rating. After review of the plots, trends were apparent for the geophone and accelerometer data plotted versus condition rating. The depth associated with the second peak increased as the visual condition rating of the pile worsened. A second peak was not identified for any piles with an overall visual condition rating of 1.

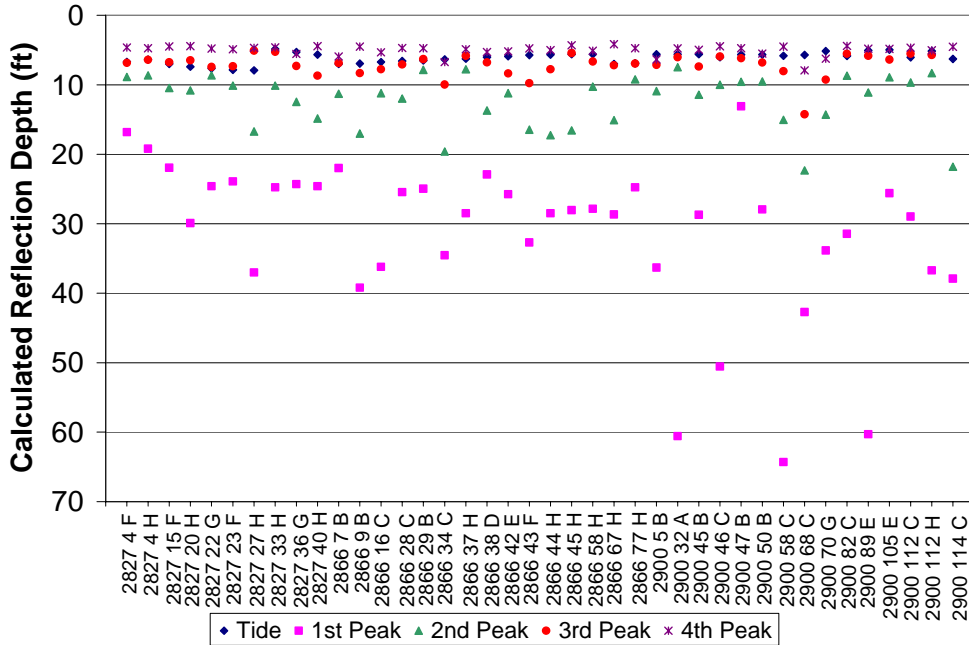
Figure 33. Impulse Response Reflections Measured by Geophone

The four highest peaks of every IR test were plotted for the responses recorded by the geophone (Figure 33) and the accelerometer (Figure 34).

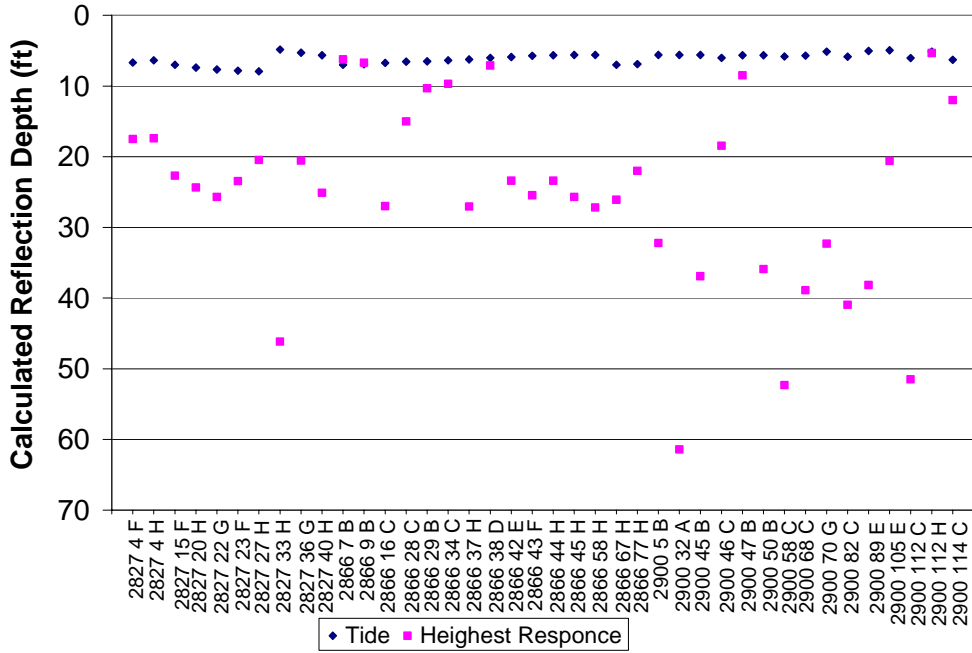
Figure 37. Impulse Response Peak Reflection Measured by Accelerometer

The IR results were also plotted with just the highest amplitude IR response to simplify the analysis. Figure 37 is a plot of the depth to the strongest reflection and the location of the water line at the time of each test, using the data collected from the accelerometer. Several piles had strong reflections near the tidal zone, which indicated possible damage to these piles. Figure 38 is a plot of the same data used for Figure 37, but it is organized by overall visual condition rating. The reflections above 10 ft are of most concern, because these occurred in the tidal zone, where oxygen and water are available.

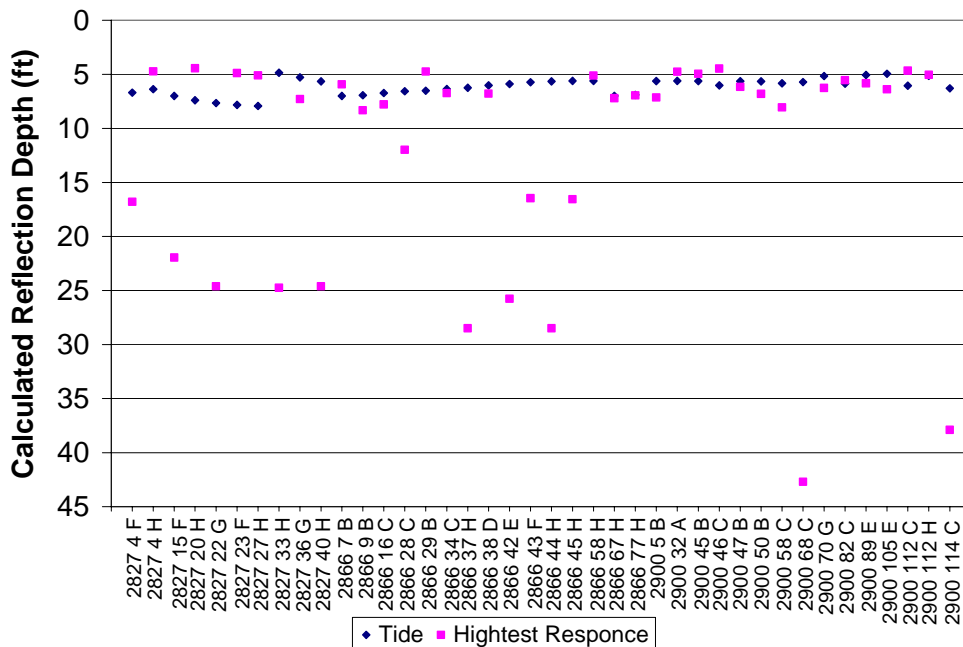
Figure 39. Impulse Response Highest Peak Measured by Geophone

Figure 39 is a plot of the distance to the strongest reflection using the data collected by geophone. It was apparent that the geophone detected more reflections at a depth of less than 10 ft than the accelerometer. Since the geophone was placed on the top of the cap and the accelerometer was placed below the cap on the exposed substrate of the pile, the ringing within the pile cap was more prominent in the geophone data. Figure 40 presents the geophone data organized by overall visual condition rating. No clear trend emerged as with the SE data. Most of the responses were less than a 10-ft depth for all condition rating categories.

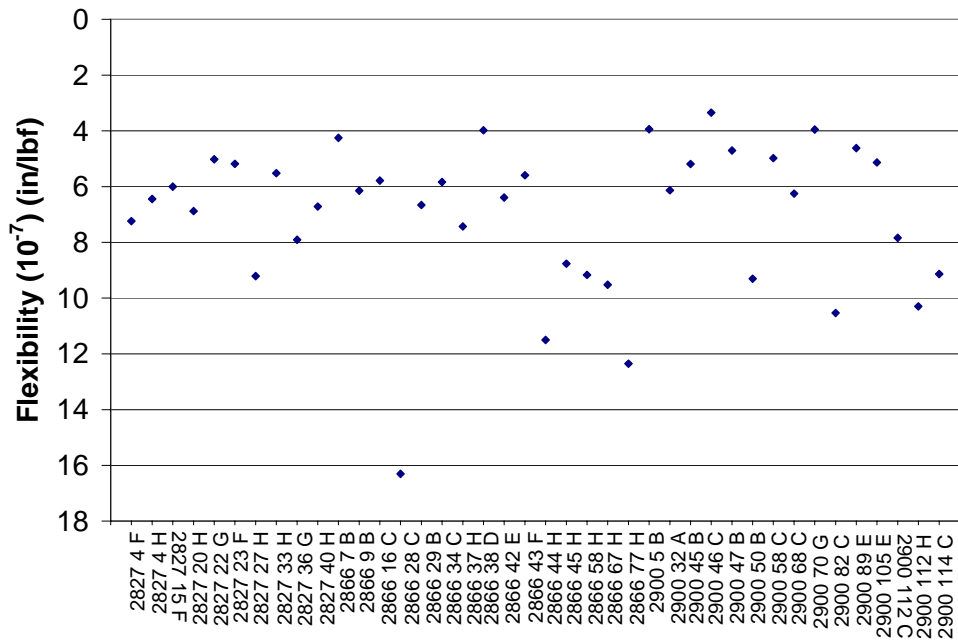
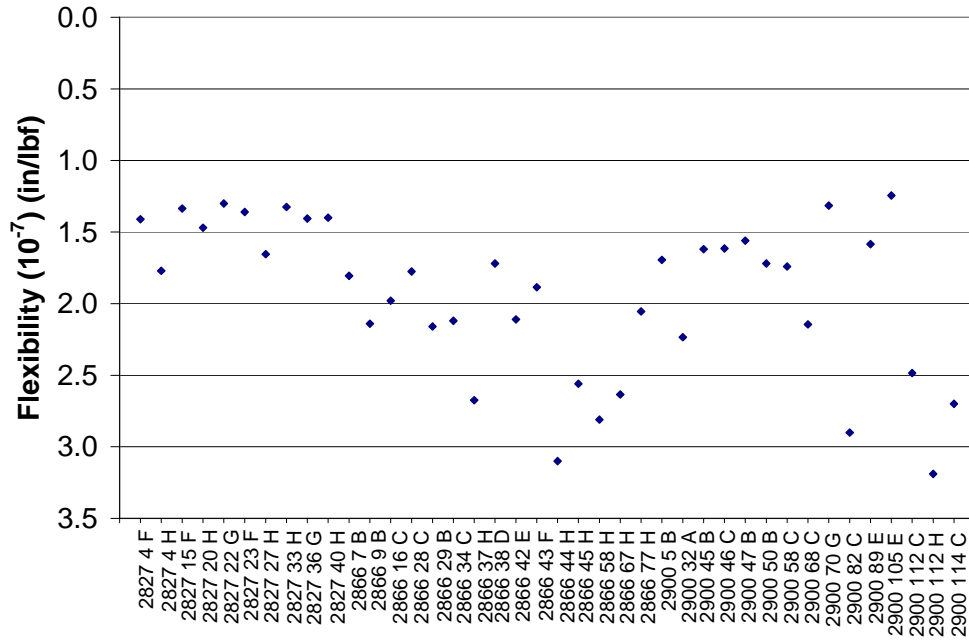
IR was also used to calculate the axial flexibility of the pile by calculating the initial slope of the IR data, from 0 to 20 Hz. This frequency range was chosen because at that range the entire pile is anticipated to be completely activated by the frequency range. The flexibility measures the deflection of the pile attributable to a unit load, which in the case of the HRBT piles will be determined by the portion of the pile above the soil that is free to move and the interaction of the soil in the form of skin friction. Using only a 3-lb hammer does not excite the pile very much, so the calculated flexibility represents primarily the portion above the soil and the skin friction of the pile for a short distance into the soil. The length of the pile that is above the soil is important and will affect the flexibility of a pile. Figures 41 and 42 are the plots of the flexibility calculated from accelerometer and geophone data, respectively.

When a pile is damaged, its flexibility will increase, because a change in section dimension directly affects structural stiffness. Piles with high-calculated flexibility could possibly be damaged. The flexibilities were also plotted versus overall visual condition rating (Figures 43 and 44). No clear trend emerged.

A geophone is better than an accelerometer at detecting lower frequencies. For flexibility data in the 0 to 20 Hz range, the geophone is more trustworthy (D. Sack, personal communication, March 4, 2009). However, the geophone results are affected by its placement on the pile cap.

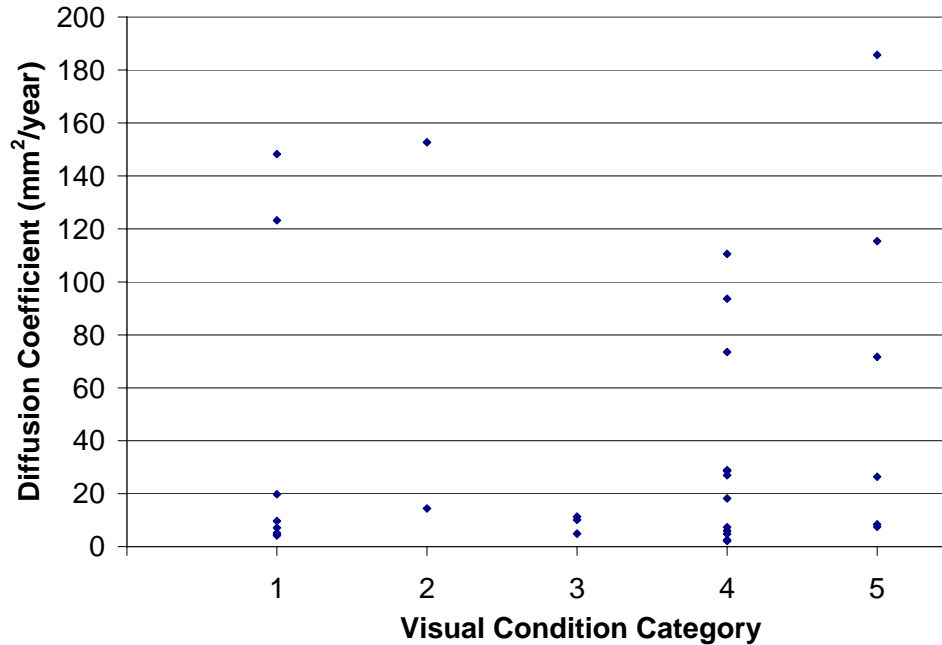
Figure 45. Diffusion Coefficients of the Substrate. To make the plot legible, the y-axis was capped at 200 mm²/yr, even though there were a few higher values. Table 8 lists the individual values above 200 mm²/yr.

Samples of the mortar and the substrate were taken to perform chloride analysis on 16 of the 52 selected piles. Apparent diffusion coefficients calculated for substrate concrete ranged from 2 mm²/yr to well over 200 mm²/yr. Figure 45 presents the apparent diffusion coefficients for the substrate concrete samples collected. Figure 46 presents the apparent diffusion coefficients for the mortar samples. In both figures, the diffusion rates were plotted versus the overall visual condition rating of the pile.

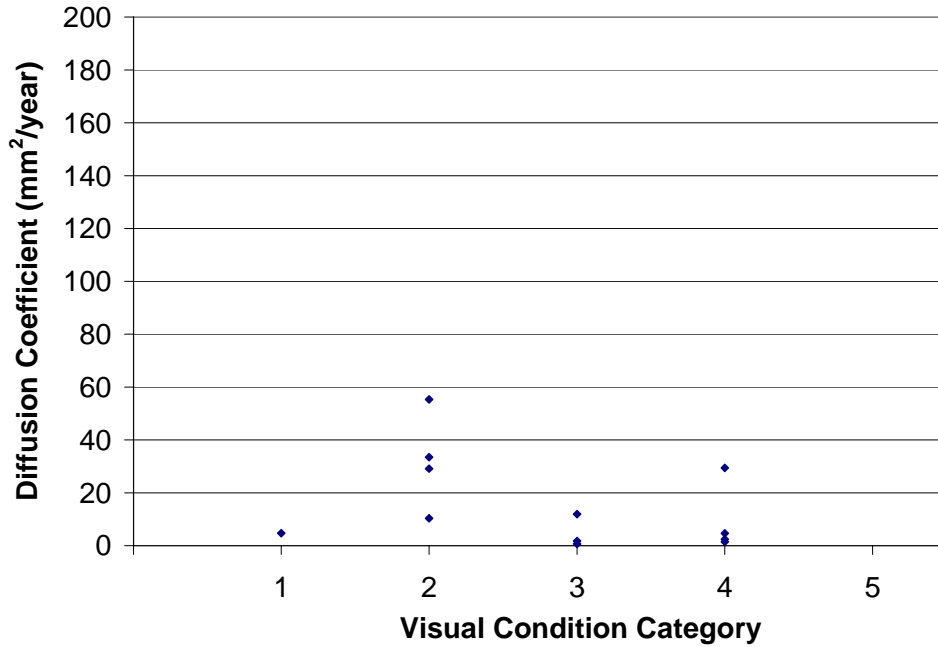
Figure 46. Diffusion Coefficients of the Mortar. To make the plot legible, the y-axis was capped at 200 mm²/yr, even though there were a few higher values. Table 8 lists the individual values above 200 mm²/yr.

The diffusion coefficients calculated from the mortar samples are misleadingly low. The one-dimensional solution of Fick's law of diffusion used is based on several assumptions, including diffusion from one surface into a semi-infinite medium. The mortar samples violate both of these assumptions since the mortar is only 4 in thick and the chlorides are diffusing from both the jacket and substrate interfaces of the mortar.

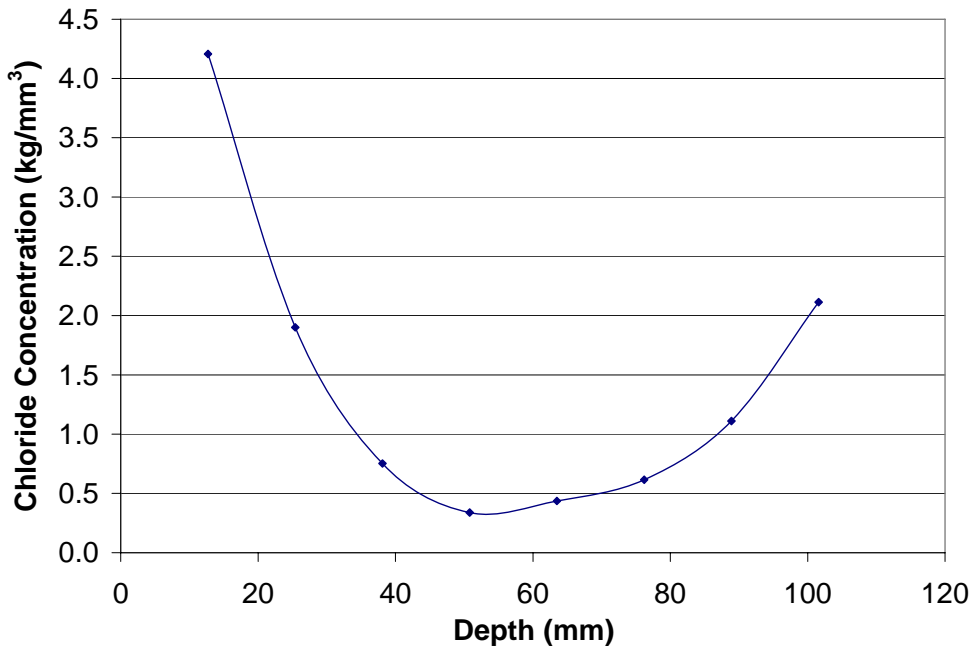
Figure 47. Chloride Profile of Mortar

The chloride profiles of the mortar samples revealed that chlorides were diffusing from two directions (Figure 47). The face of the mortar exposed to the water was expected to have a high chloride concentration, and as the depth increased that concentration was expected to decrease. The concentration decreased until about midway through the sample, where the concentration started to increase again. This was the case for almost every mortar sample collected.

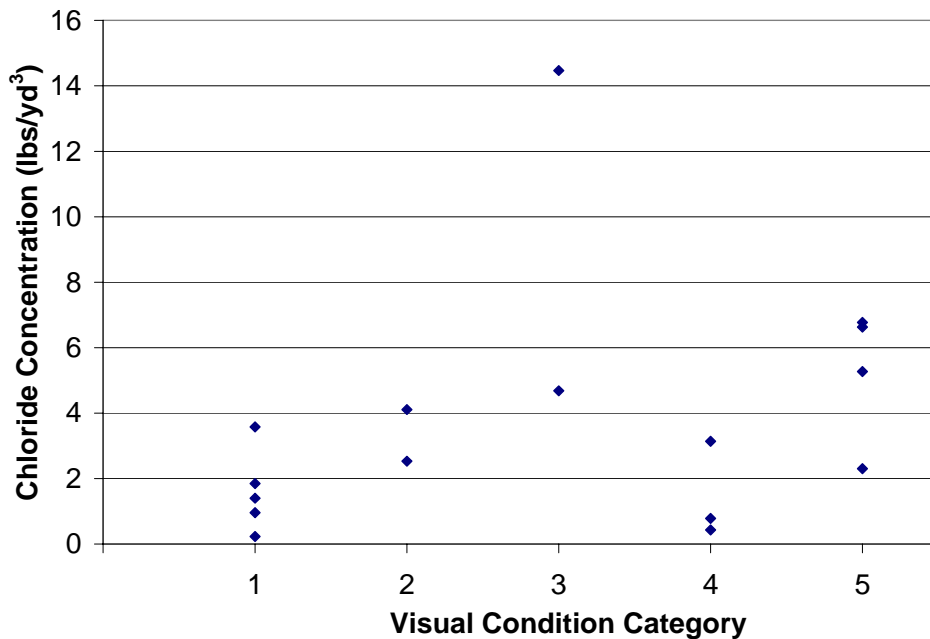
Figure 48. Chloride Concentrations at Substrate Reinforcement

The chloride concentration at the depth of the steel reinforcement was tested to determine if the nominal chloride concentration needed to induce corrosion (threshold) had been reached (Figure 48). There is no single value for the threshold for steel reinforcement: it varies depending on many factors, but typically a value ranging from 1 lb Cl⁻/yd³ concrete to 2 lb Cl⁻/yd³ concrete is assumed as the threshold for conventionally reinforced structures (Broomfield, 2007; Funahashi, 1990). The HRBT piles have conventional reinforcement bars and prestressed tendons. Tendons typically have a lower threshold than conventional bars because of internal stresses, greater surface area (Hartt and Rapa, 1998), and different metallurgy. All but four piles had a chloride concentration above 2 lb/yd³ at the reinforcement level, and only two piles had a concentration below 1 lb/yd³. There were significant amounts of chloride at the steel depth to damage severely or destroy the passive oxide layer on the reinforcement.

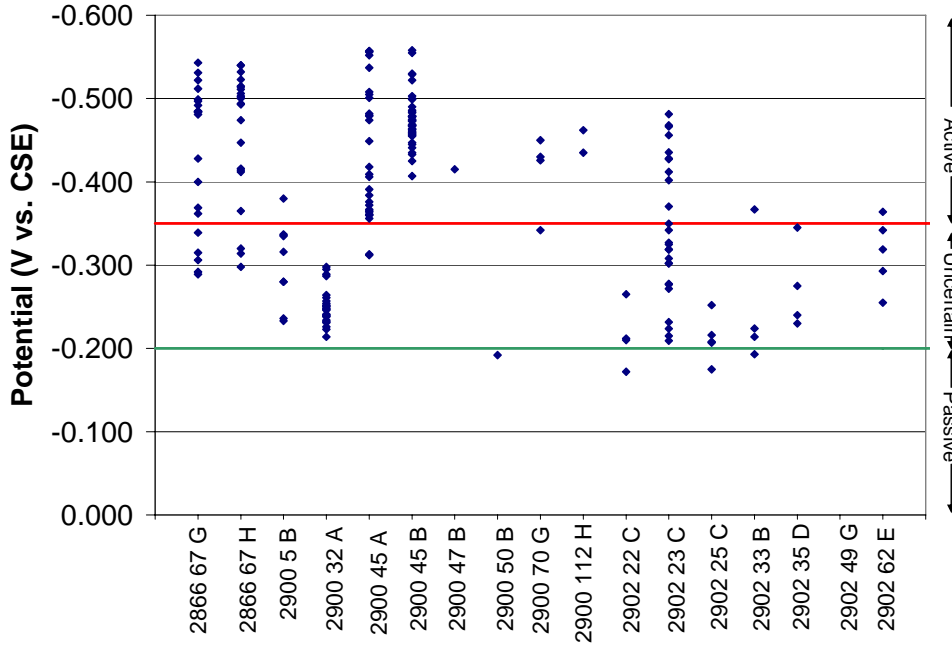
Figure 49. Half-Cell Measurements

Half-cell potential measurements were made on the substrates of 15 piles. Figure 49 presents the results. A majority, 64% (170 measurements), indicated a potential more negative than -0.350 V vs. CSE. Only 4 measurements were more positive than -0.200 V vs. CSE. A majority of the half-cell measurements indicated that active corrosion in the substrate reinforcement was probable.

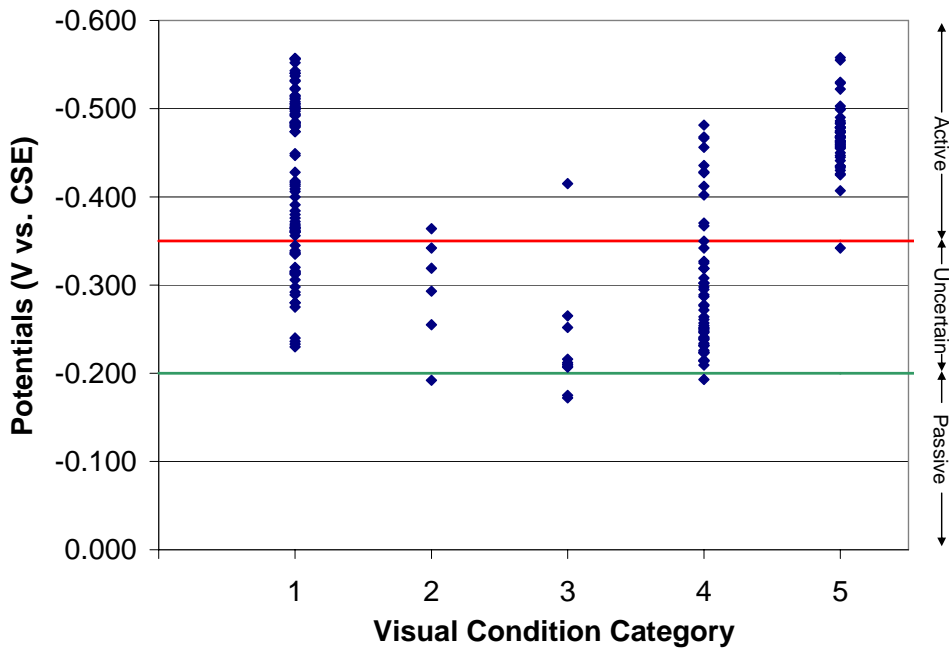
Figure 50. Half-Cell Measurements Sorted by Overall Visual Condition Rating

When the measurements were sorted by the overall visual condition rating of the pile, a clear trend of condition worsening as potentials become more negative did not exist, as one might expect. Potential measurements made on piles with condition ratings of 4 and 5

suggested active corrosion, which was consistent with the visual assessment. However, the condition rating 1 category had a significant number of measurements indicating active corrosion potential and a significant number indicating uncertain corrosion activity. Measurements made on piles with a condition rating of 2 or 3 were mostly in the region between -0.200 V vs. CSE and -0.350 V vs. CSE, indicating corrosion activity was uncertain.

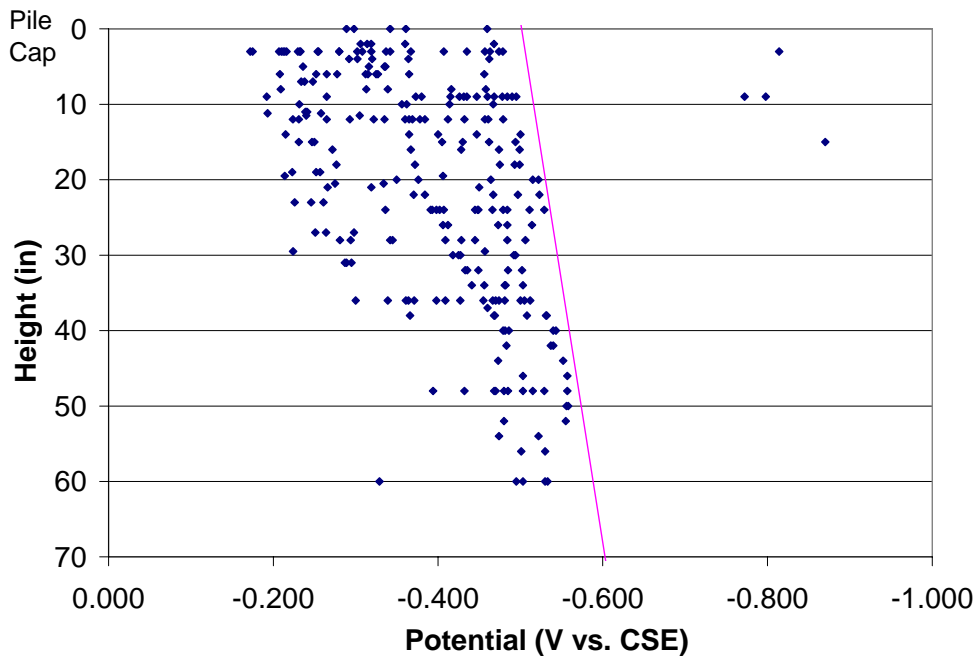
The largest risk for corrosion activity occurs in the tidal zone of the pile (Hartt and Rapa, 1998). In addition, half-cell measurements are affected by moisture and oxygen levels. To determine if the half-cell measurements changed with elevation, they were plotted as a function of the elevation at which the measurements were made (Figure 51). The measurements in the range of -0.350 to -0.200 V vs. CSE were primarily made at higher elevations. Measurements that were more negative than -0.350 V vs. CSE were made consistently over all elevations. At the front of the data, there was a slight slope of increased negativity as depth increased, but the total change was only -0.10 V vs. CSE. In Figure 51, zero on the y-axis represents the bottom of the pile cap.

Figure 51. Half-Cell Measurements Sorted by Elevation of Measurement. Zero on the y-axis represents the bottom of the pile cap.

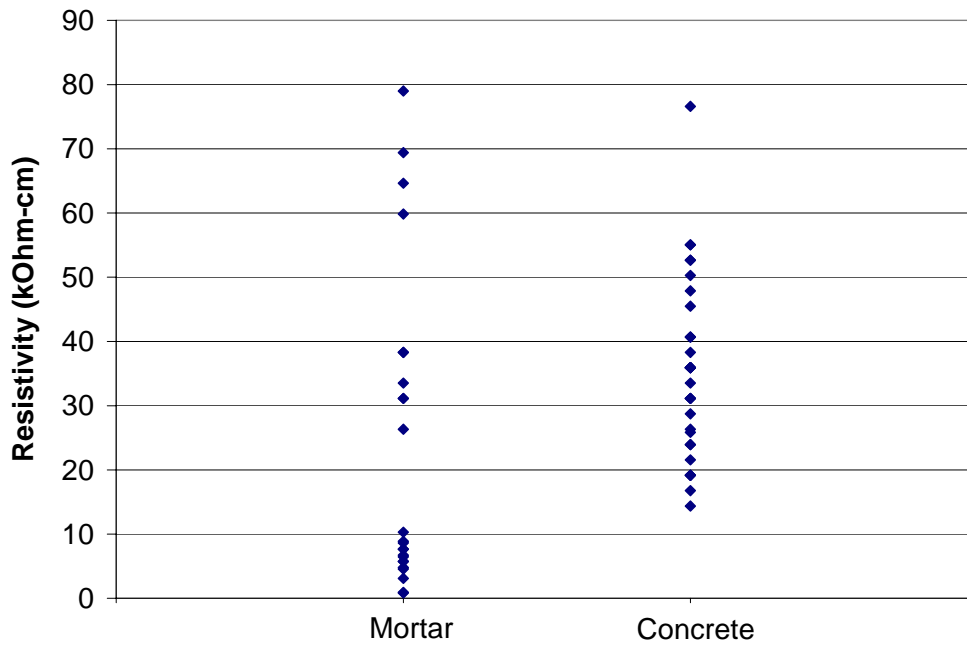
Figure 52. Resistivity Measurements of Five Piles

The average value of resistivity for the mortar was 23.1 kOhm-cm with a standard deviation of 24.1 kOhm-cm. There was a high variation in the mortar resistivity measurements, as 54% (14 measurements) of the measurements were below 10 kOhm-cm and 23% (6 measurements) of the measurements were below 5 kOhm-cm. Below 5 kOhm-cm, the risk for corrosion is very high; in the range between 5 kOhm-cm and 10 kOhm-cm, the risk for corrosion activity is moderate (Elkey and Sellevold, 1995; Malhotra and Carino, 2004). There is a lot of uncertainty about the limit where corrosion activity is a low risk. Values for low corrosion risk have been given as 10 kOhm-cm (Elkey and Sellevold, 1995), 20 kOhm-cm (Bungey, 1989), and 50 kOhm-cm (Feliu et al., 1996). The mortar resistivity values ranged as high as 79 kOhm-cm.

The average value of resistivity for the substrate concrete was 35.5 kOhm-cm with a standard deviation of 14.1 kOhm-cm. Every resistivity measurement made on the concrete was above 10 kOhm-cm, indicating a low risk for corrosion activity.

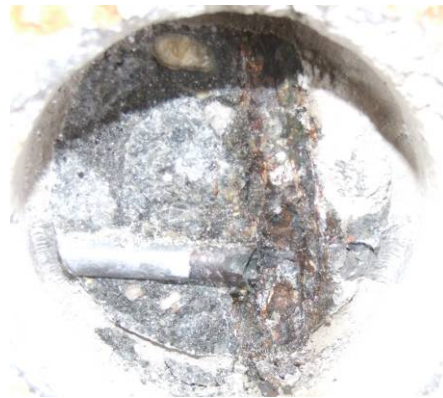
Figure 61. Structure 2900, Bent 45, Pile B, Exposed Vertical Strand

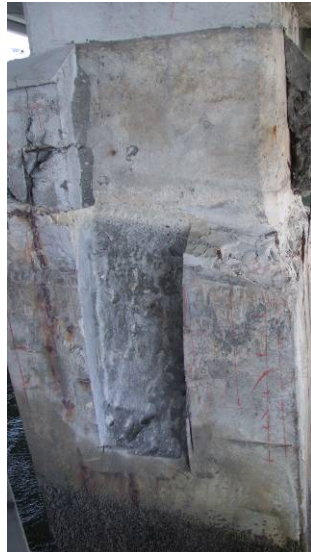
The jacket mortar of this pile had visible corrosion product and section loss (Figure 62). The mortar contained the proper reinforcement. However, it did not have the proper 2-in cover but instead had almost no cover. Once the mortar and WWF were removed, the substrate did not show visual signs of corrosion damage (Figure 63). Coring of the substrate exposed the reinforcement, which revealed some light corrosion product (Figure 64). Prior to autopsy, the overall visual condition rating of this pile was 4. Previous NDE work had determined the pile could have damage. After autopsy, the overall condition rating changed to 5.

Figure 63. Structure 2902, Bent 23, Pile C, Exposed Substrate
